AS-BUILT REPAIR QUANTITY TABLE

PROJECT NO. HB-0017
DARE COUNTY
 BRIDGE NO. 270009

STATE OF NORTH CAROLINA
 DEPARTMENT OF TRANSPORTATION
 RALEIGH
BENT 203 & BENT 204

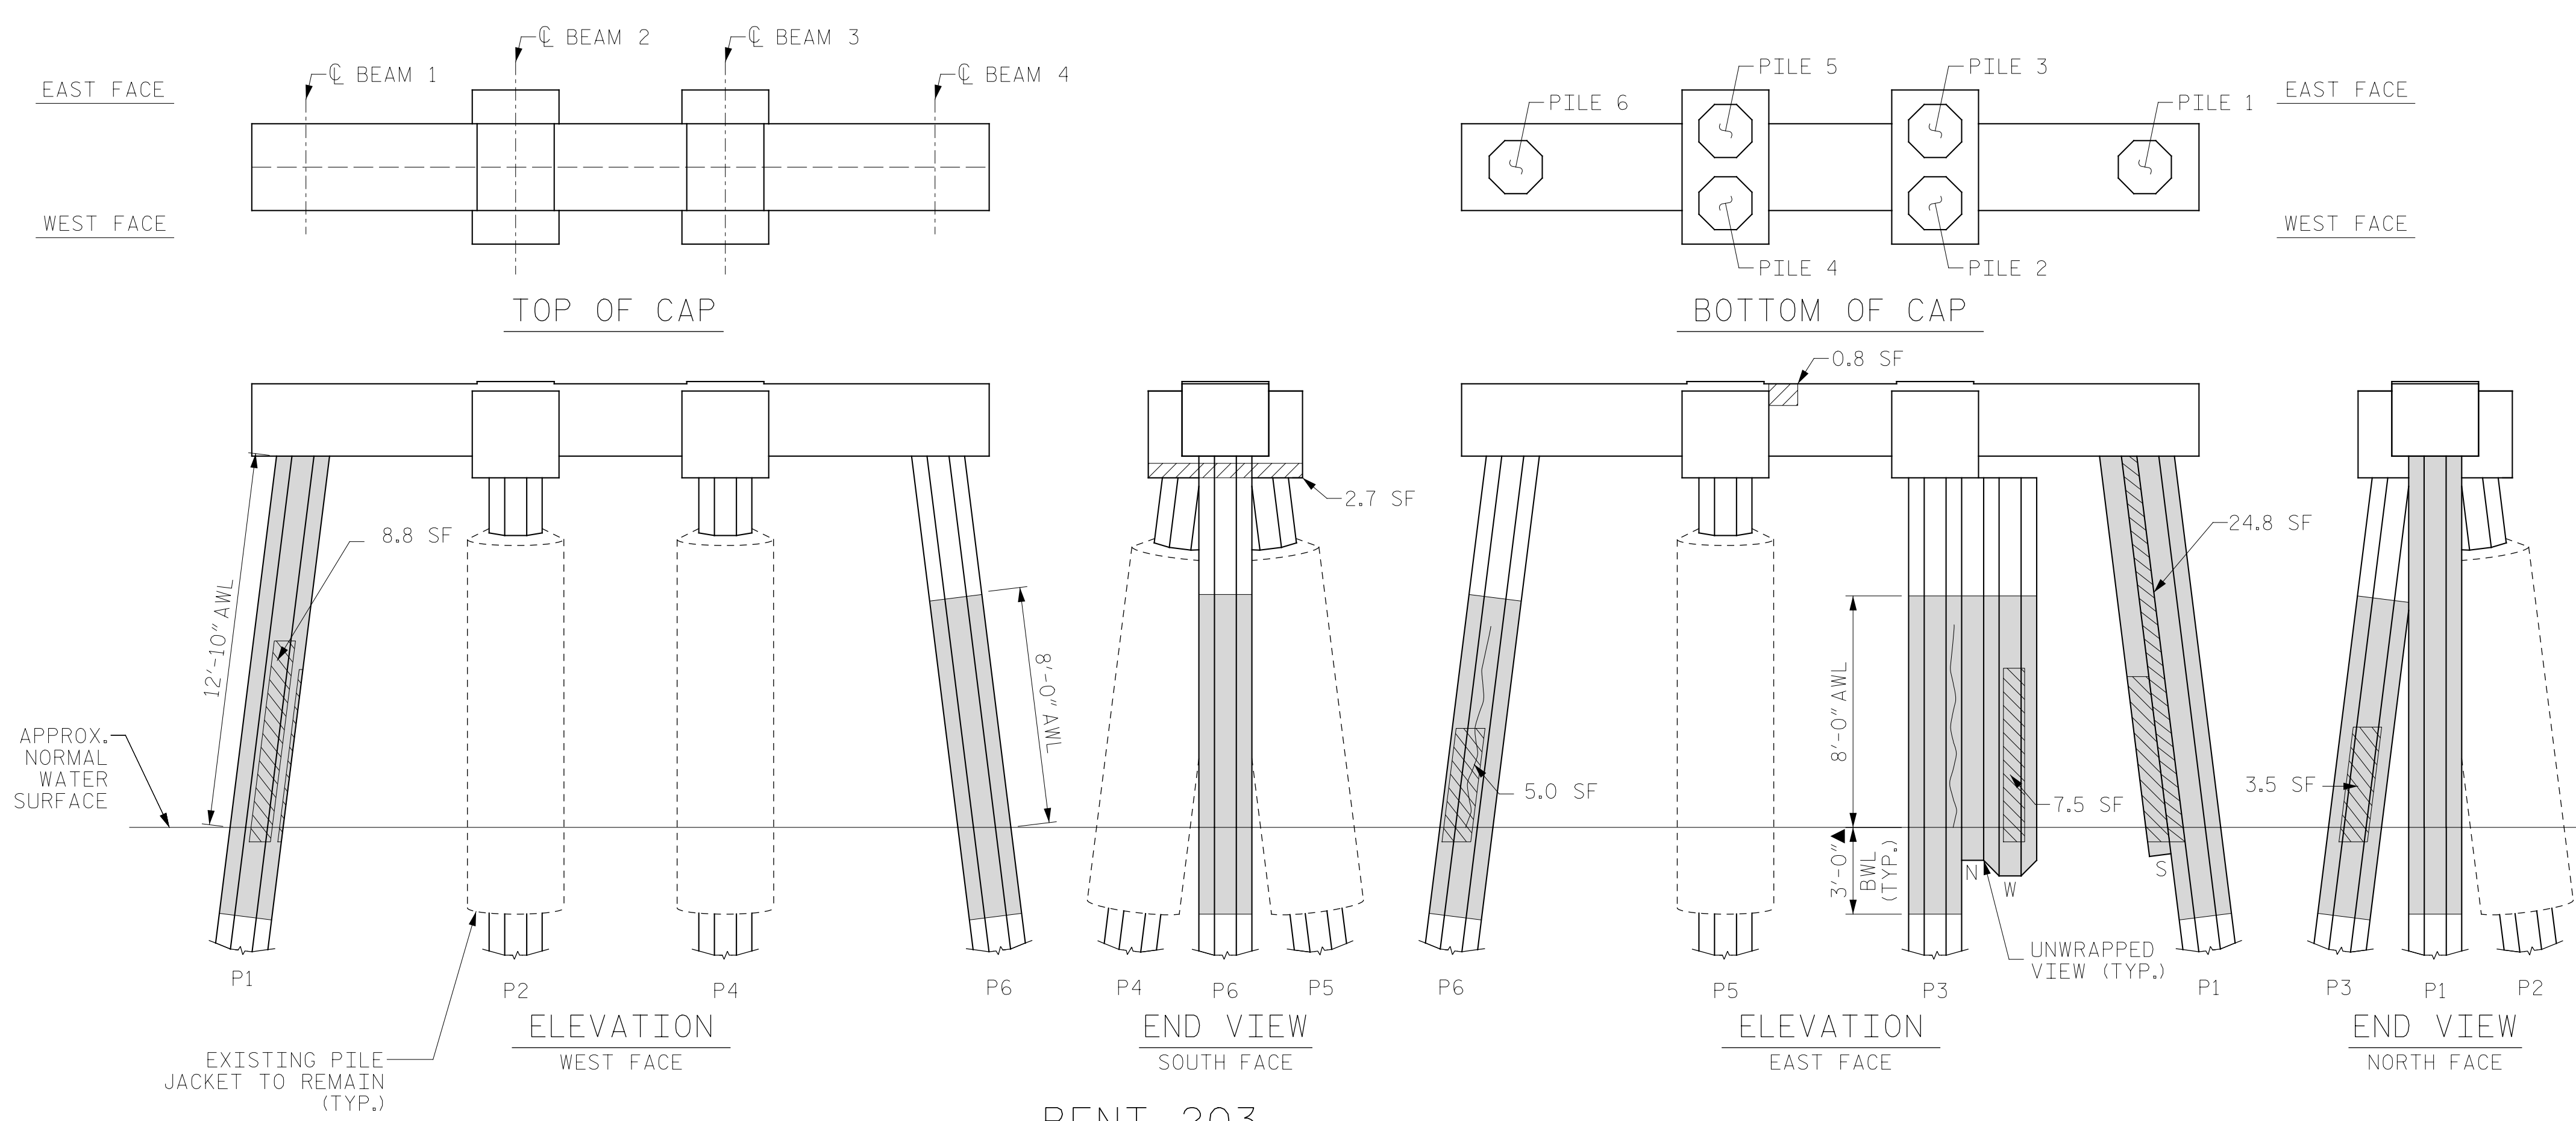
CAP REPAIRS			
SHOTCRETE REPAIRS	3.5 SF	1.8 CF	SF CF
EPOXY RESIN INJECTION	- LF		LF
PILE REPAIRS			
PILE CONCRETE RESTORATION	49.5 SF	21.1 CF	SF CF
FRP PROTECTIVE SYSTEM AWL	175.9 SF		
FRP PROTECTIVE SYSTEM BWL	54.9 SF

DIRECTION							
		NW	W	SW	S	SE	E	NE	N
BENT 203	PILE 1	3	-	-	-	-	7	-	1
	PILE 2	-	-	-	-	-	-	-	-
	PILE 3	6	-	-	7	-	5	7	-
	PILE 4	-	-	-	-	-	-	-	-
	PILE 6	-	-	-	4	2	4	-	4
BENT 204	PILE 1	-	-	-	-	-	-	-	-
	PILE 2	-	-	-	-	-	-	-	-
	PILE 3	3	7	8	6	-	5	9	-
	PILE 4	7	-	6	-	2	-	4	4

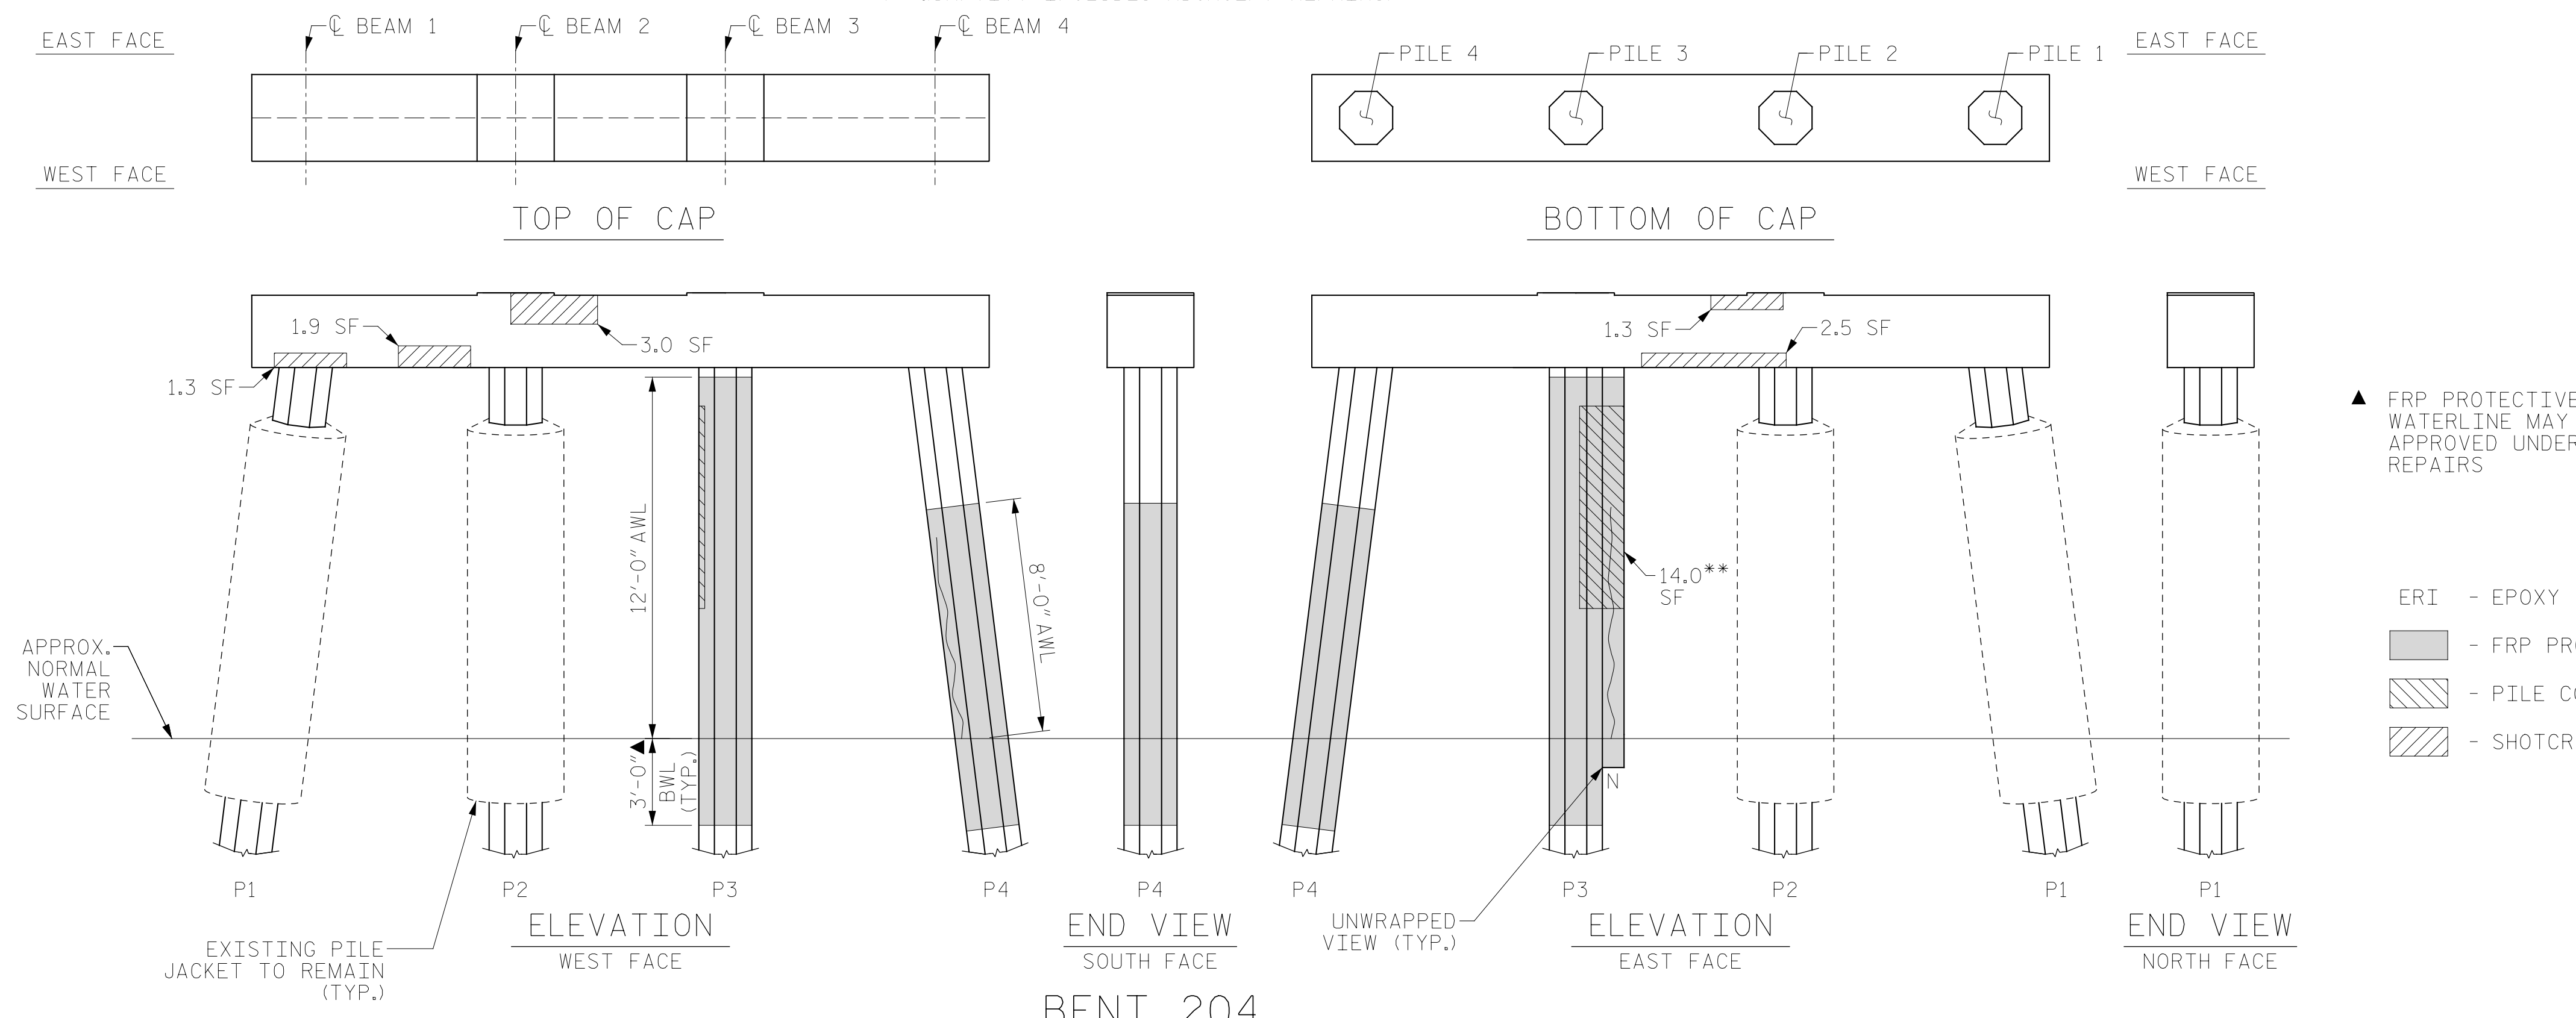
BENT 204

CAP REPAIRS			
SHOTCRETE REPAIRS	10.0 SF	5.0 CF	SF CF
EPOXY RESIN INJECTION	- LF		LF
PILE REPAIRS			
PILE CONCRETE RESTORATION	14.0 SF	5.6 CF	SF CF
FRP PROTECTIVE SYSTEM AWL	122.0 SF		
FRP PROTECTIVE SYSTEM BWL	36.6 SF
