AS-BUILT REPAIR QUANTITY TABLE

PROJECT NO. HB-0017
DARE COUNTY
 BRIDGE NO. 270009

BENT 205 & BENT 206

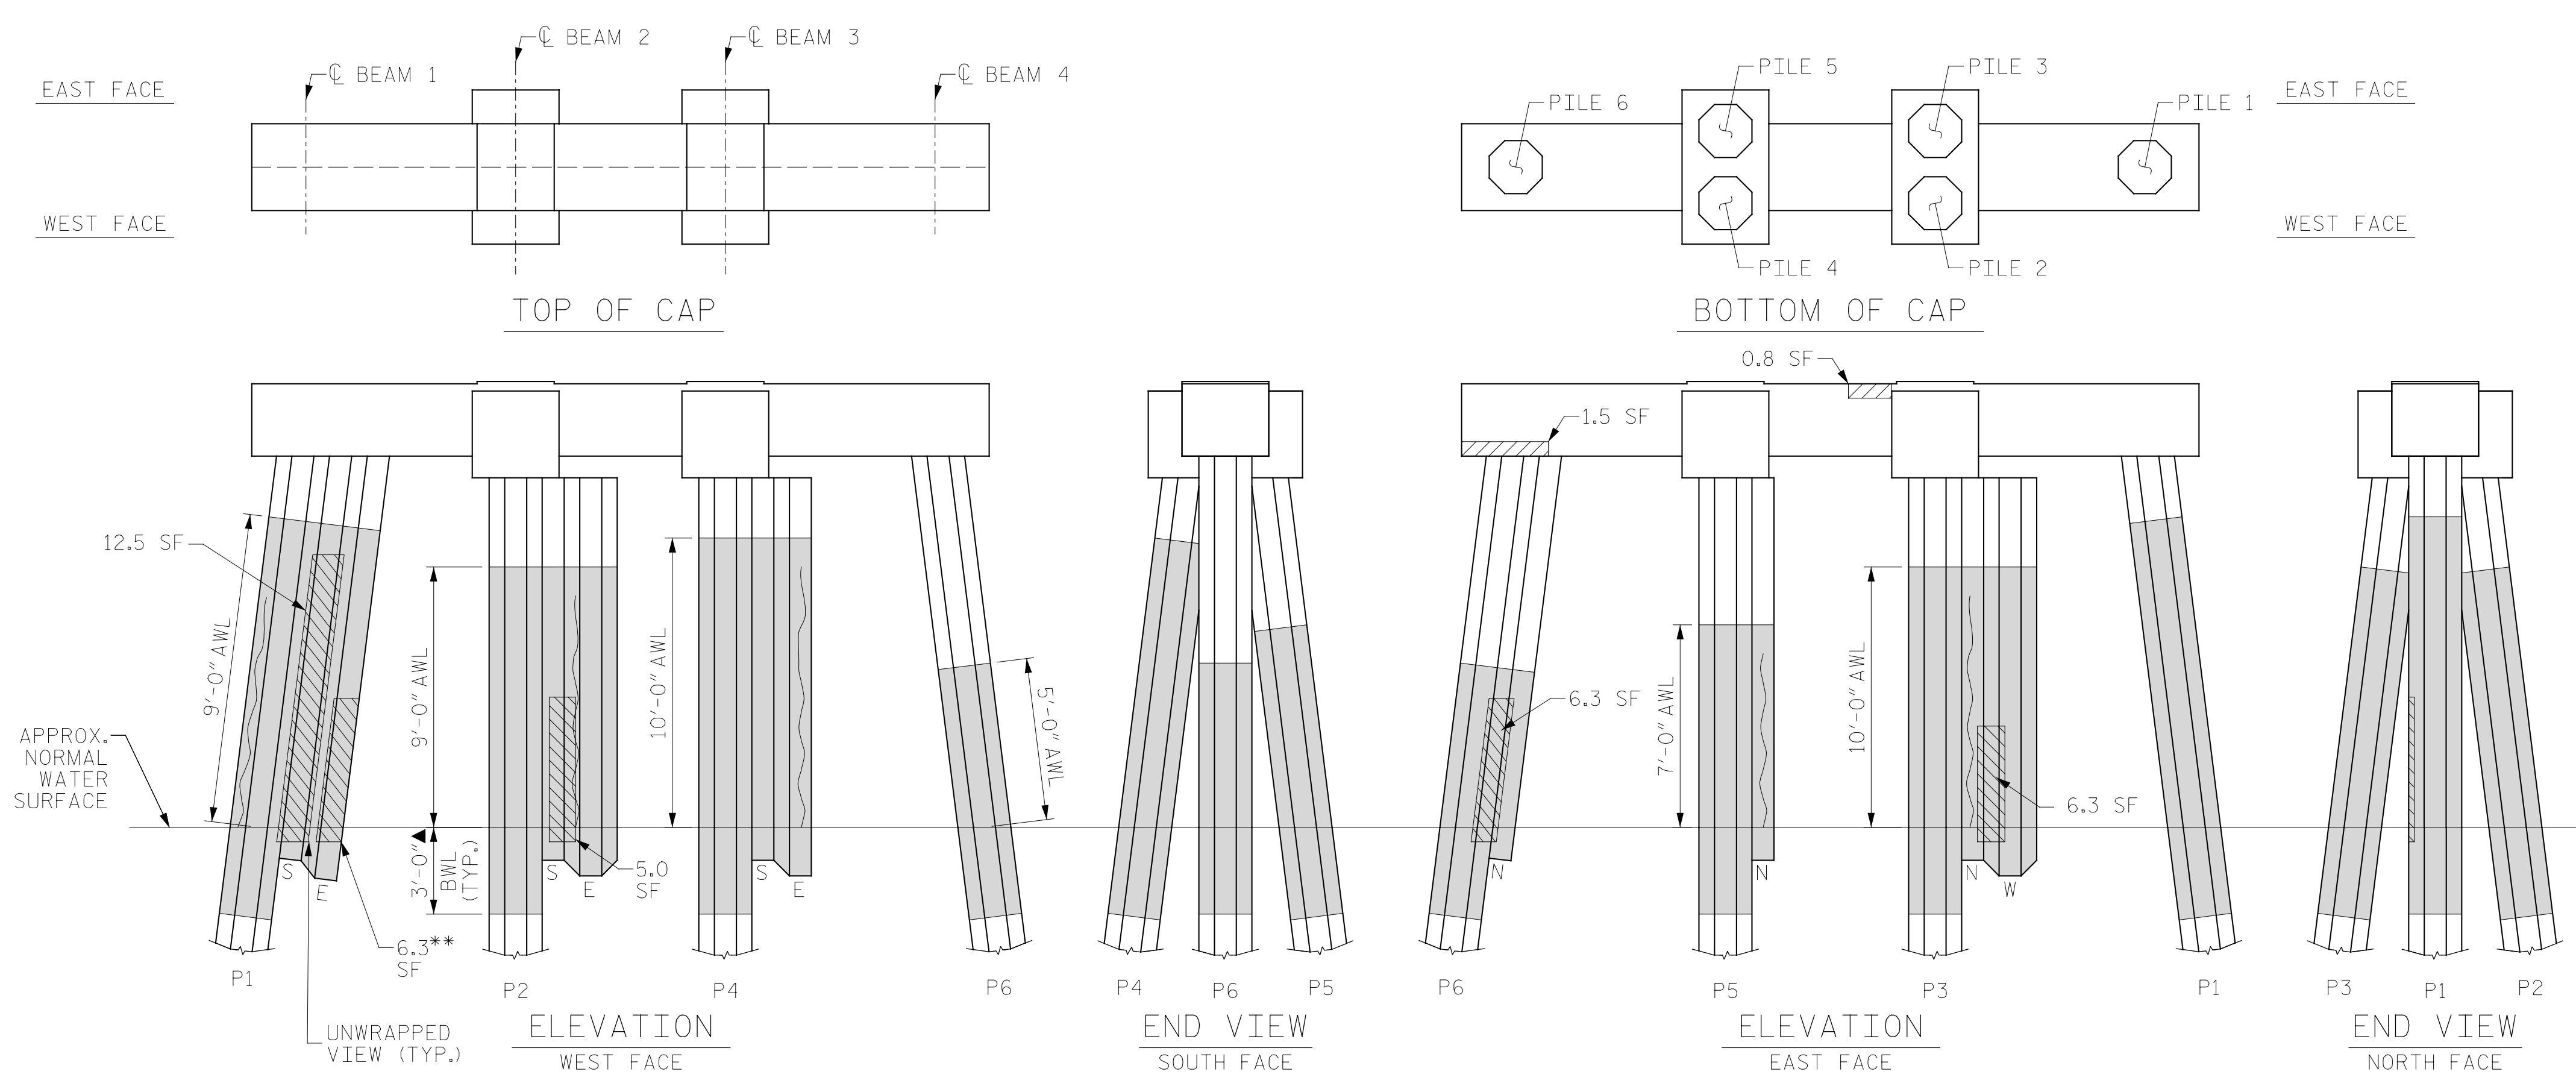
CAP REPAIRS			
SHOTCRETE REPAIRS	2.3 SF	1.2 CF	SF CF
EPOXY RESIN INJECTION	- LF		LF
PILE REPAIRS			
PILE CONCRETE RESTORATION	36.3 SF	15.4 CF	SF CF
FRP PROTECTIVE SYSTEM AWL	311.7 SF		
FRP PROTECTIVE SYSTEM BWL	109.8 SF

DIRECTION							
		NW	W	SW	S	SE	E	NE	N
BENT 205	PILE 1	8	6	-	-	-	3	5	-
	PILE 2	-	-	-	-	4	6	4	-
	PILE 3	-	-	-	-	9	-	6	8
	PILE 4	-	-	-	-	8	9	9	-
	PILE 5	-	-	-	-	2	-	-	6
	PILE 6	-	-	-	-	-	-	-	-
BENT 206	PILE 1	-	-	-	-	-	-	-	-
	PILE 2	-	-	-	-	-	-	-	-
	PILE 3	7	-	8	3	9	9	-	-
	PILE 4	6	6	6	6	6	9	4	8

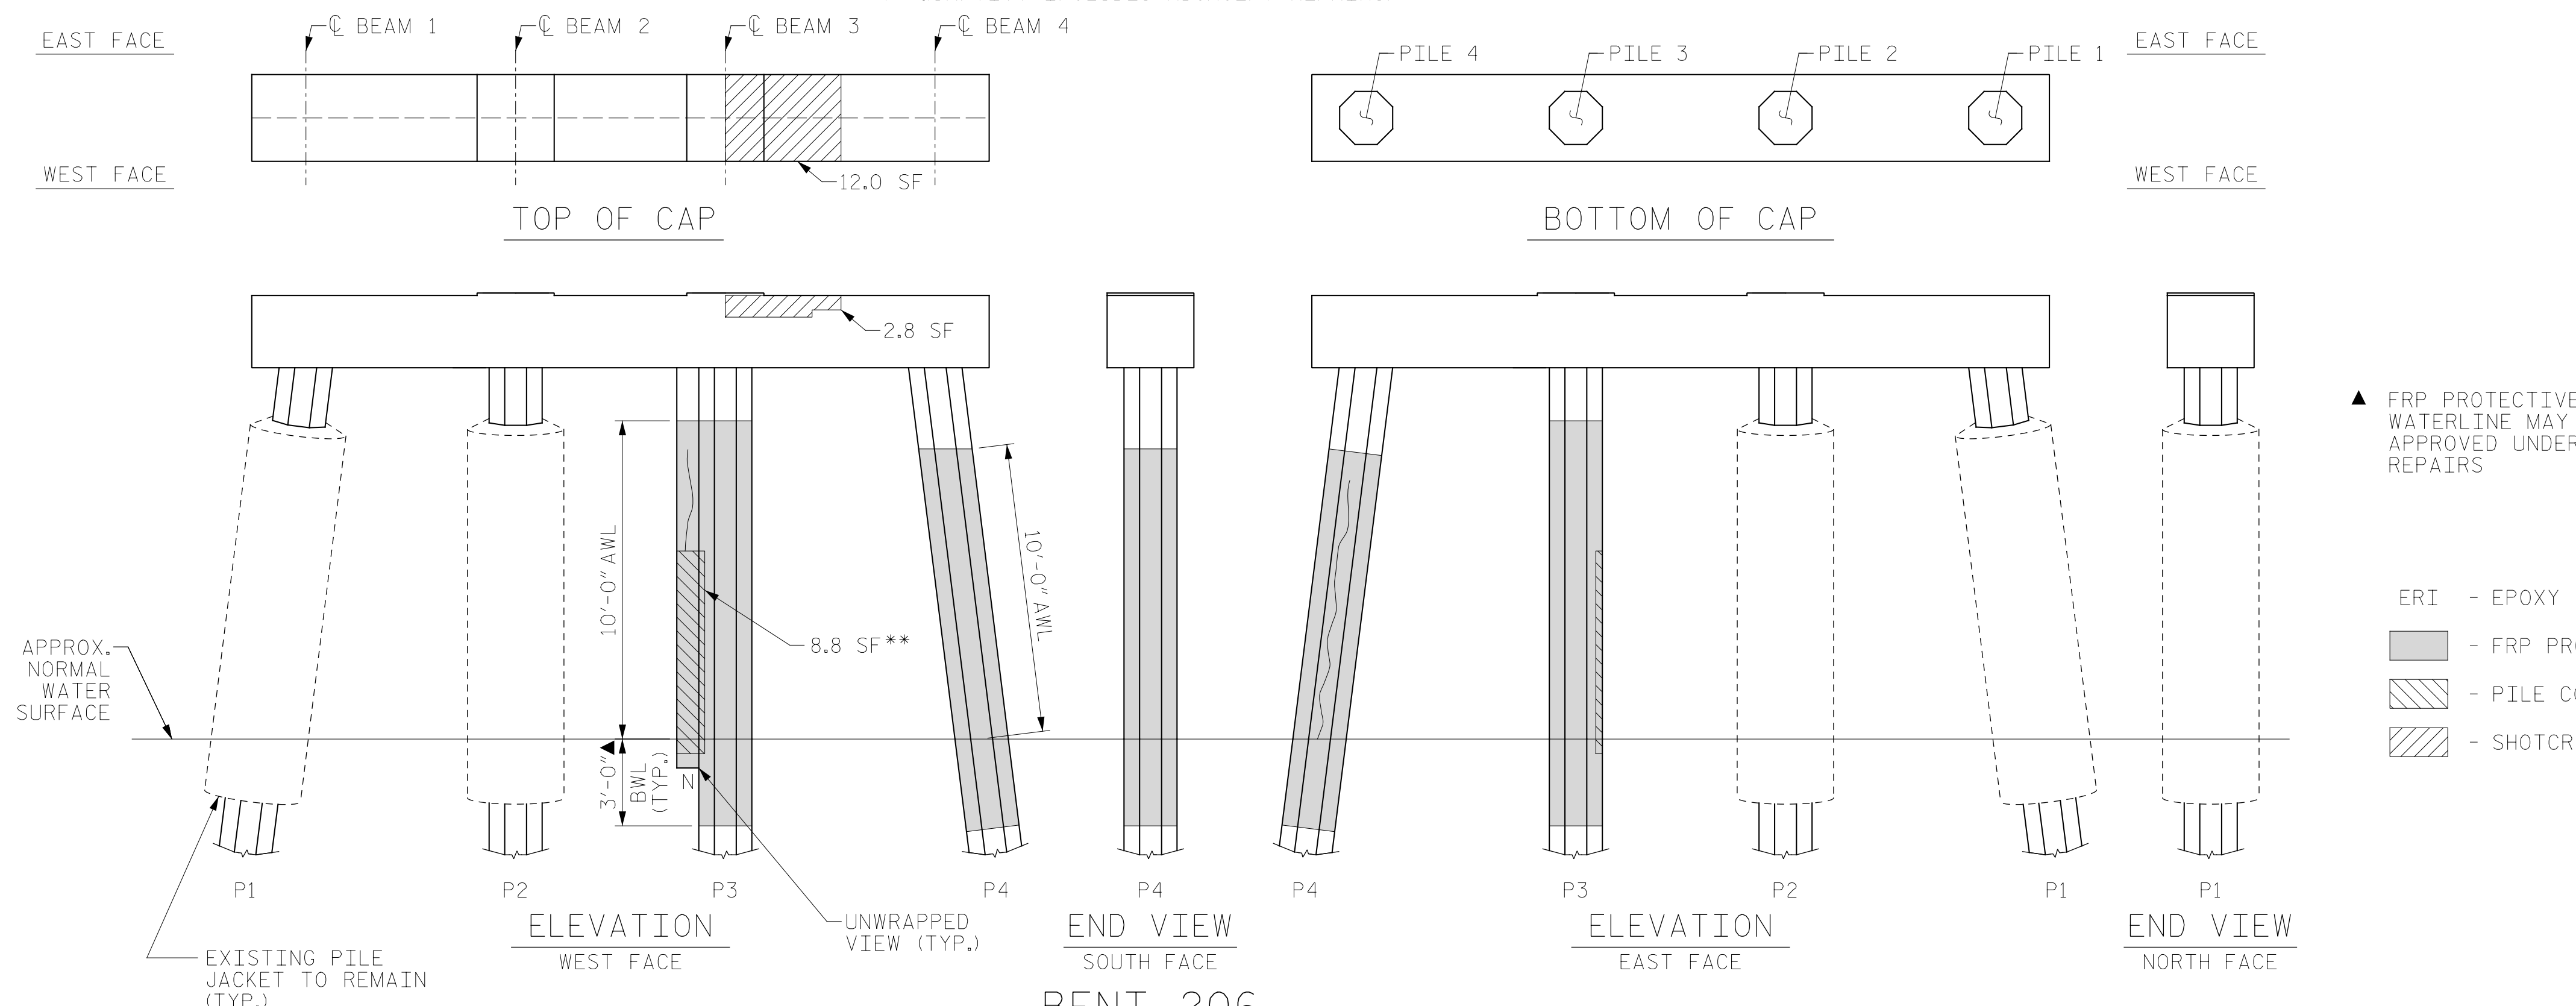
BENT 206

CAP REPAIRS			
SHOTCRETE REPAIRS	14.8 SF	7.4 CF	SF CF
EPOXY RESIN INJECTION	- LF		LF
PILE REPAIRS			
PILE CONCRETE RESTORATION	8.8 SF	3.8 CF	SF CF
FRP PROTECTIVE SYSTEM AWL	122.0 SF		
FRP PROTECTIVE SYSTEM BWL	36.6 SF
