AS-BUILT REPAIR QUANTITY TABLE

PROJECT NO. HB-0017  
DARE COUNTY  
 BRIDGE NO. 270009

BENT 213 & BENT 214

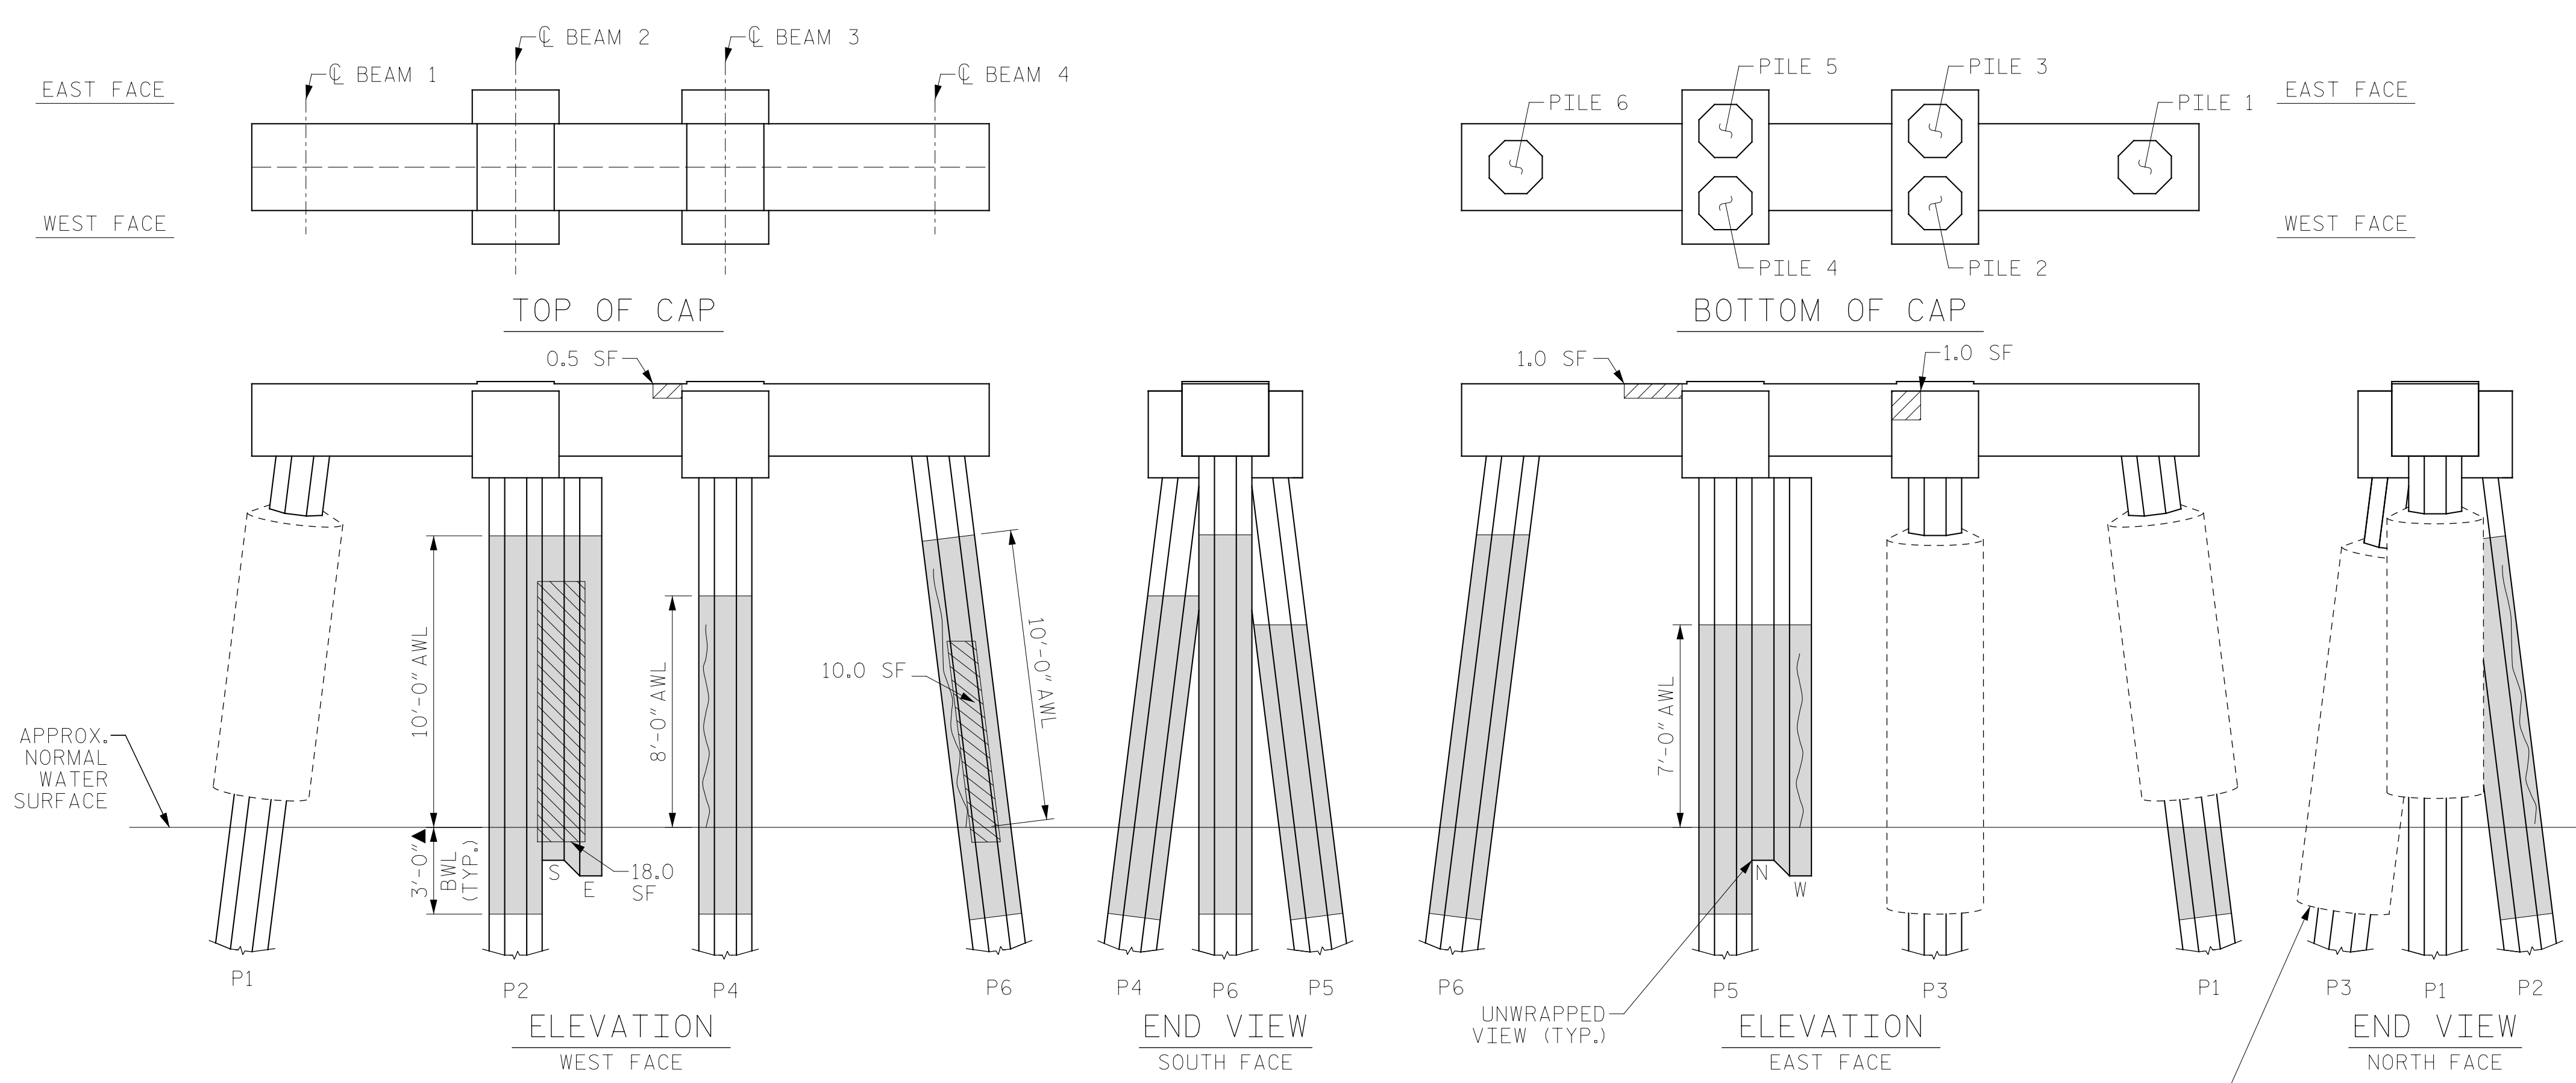
BENT 213

CAP REPAIRS			
SHOTCRETE REPAIRS	2.5 SF	1.3 CF	SF CF
EPOXY RESIN INJECTION	- LF		LF
PILE REPAIRS			
PILE CONCRETE RESTORATION	28.0 SF	11.4 CF	SF CF
FRP PROTECTIVE SYSTEM AWL	213.5 SF		
FRP PROTECTIVE SYSTEM BWL	73.2 SF

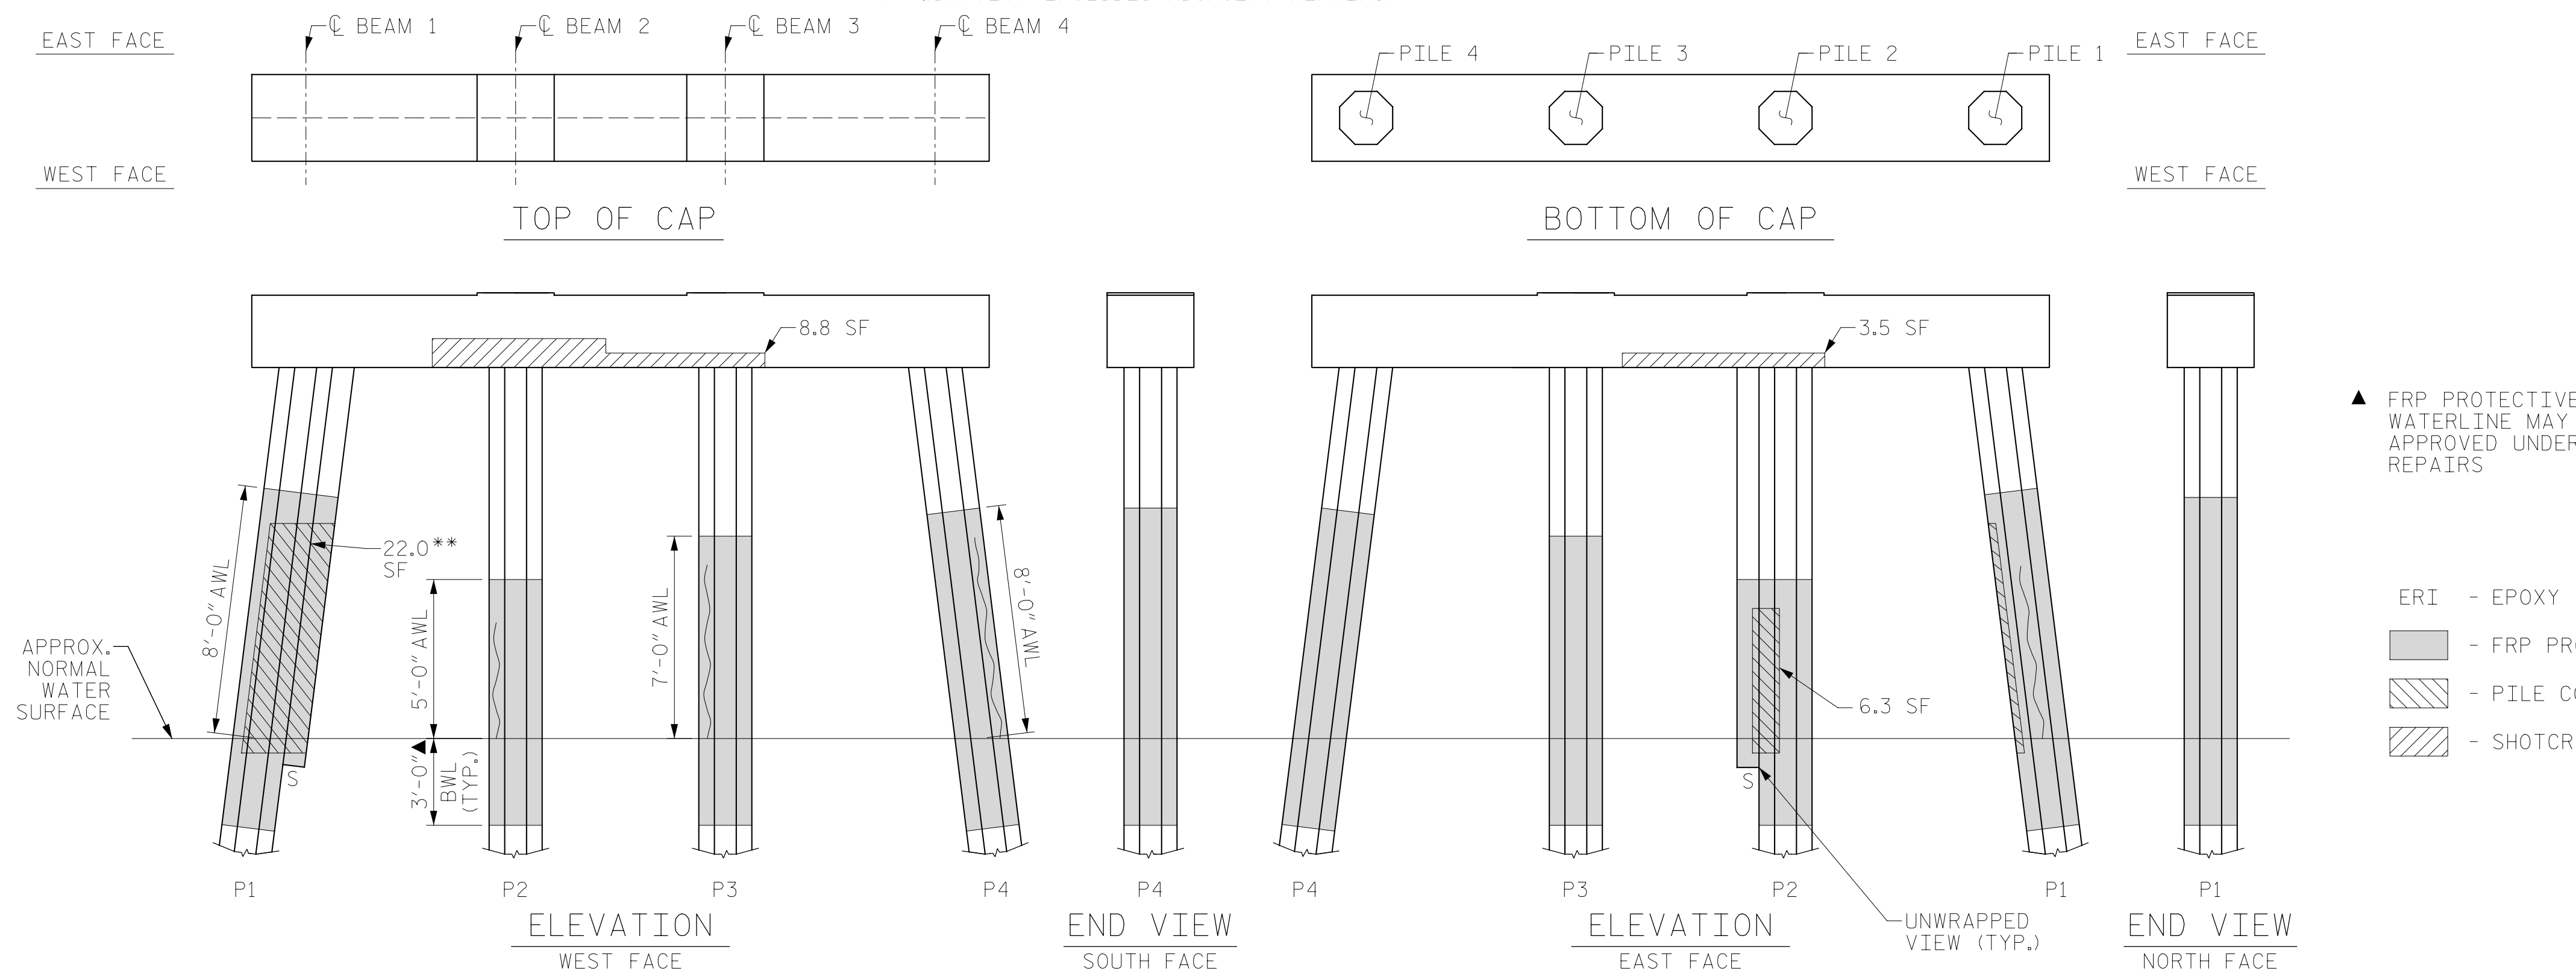
BENT 214

CAP REPAIRS			
SHOTCRETE REPAIRS	12.3 SF	6.2 CF	SF CF
EPOXY RESIN INJECTION	- LF		LF
PILE REPAIRS			
PILE CONCRETE RESTORATION	28.3 SF	11.4 CF	SF CF
FRP PROTECTIVE SYSTEM AWL	170.8 SF		
FRP PROTECTIVE SYSTEM BWL	73.2 SF
