AS-BUILT REPAIR QUANTITY TABLE

PROJECT NO. HB-0017
DARE COUNTY
BRIDGE NO. 270009

STATE OF NORTH CAROLINA
DEPARTMENT OF TRANSPORTATION
RALEIGH
BENT 217 & BENT 218

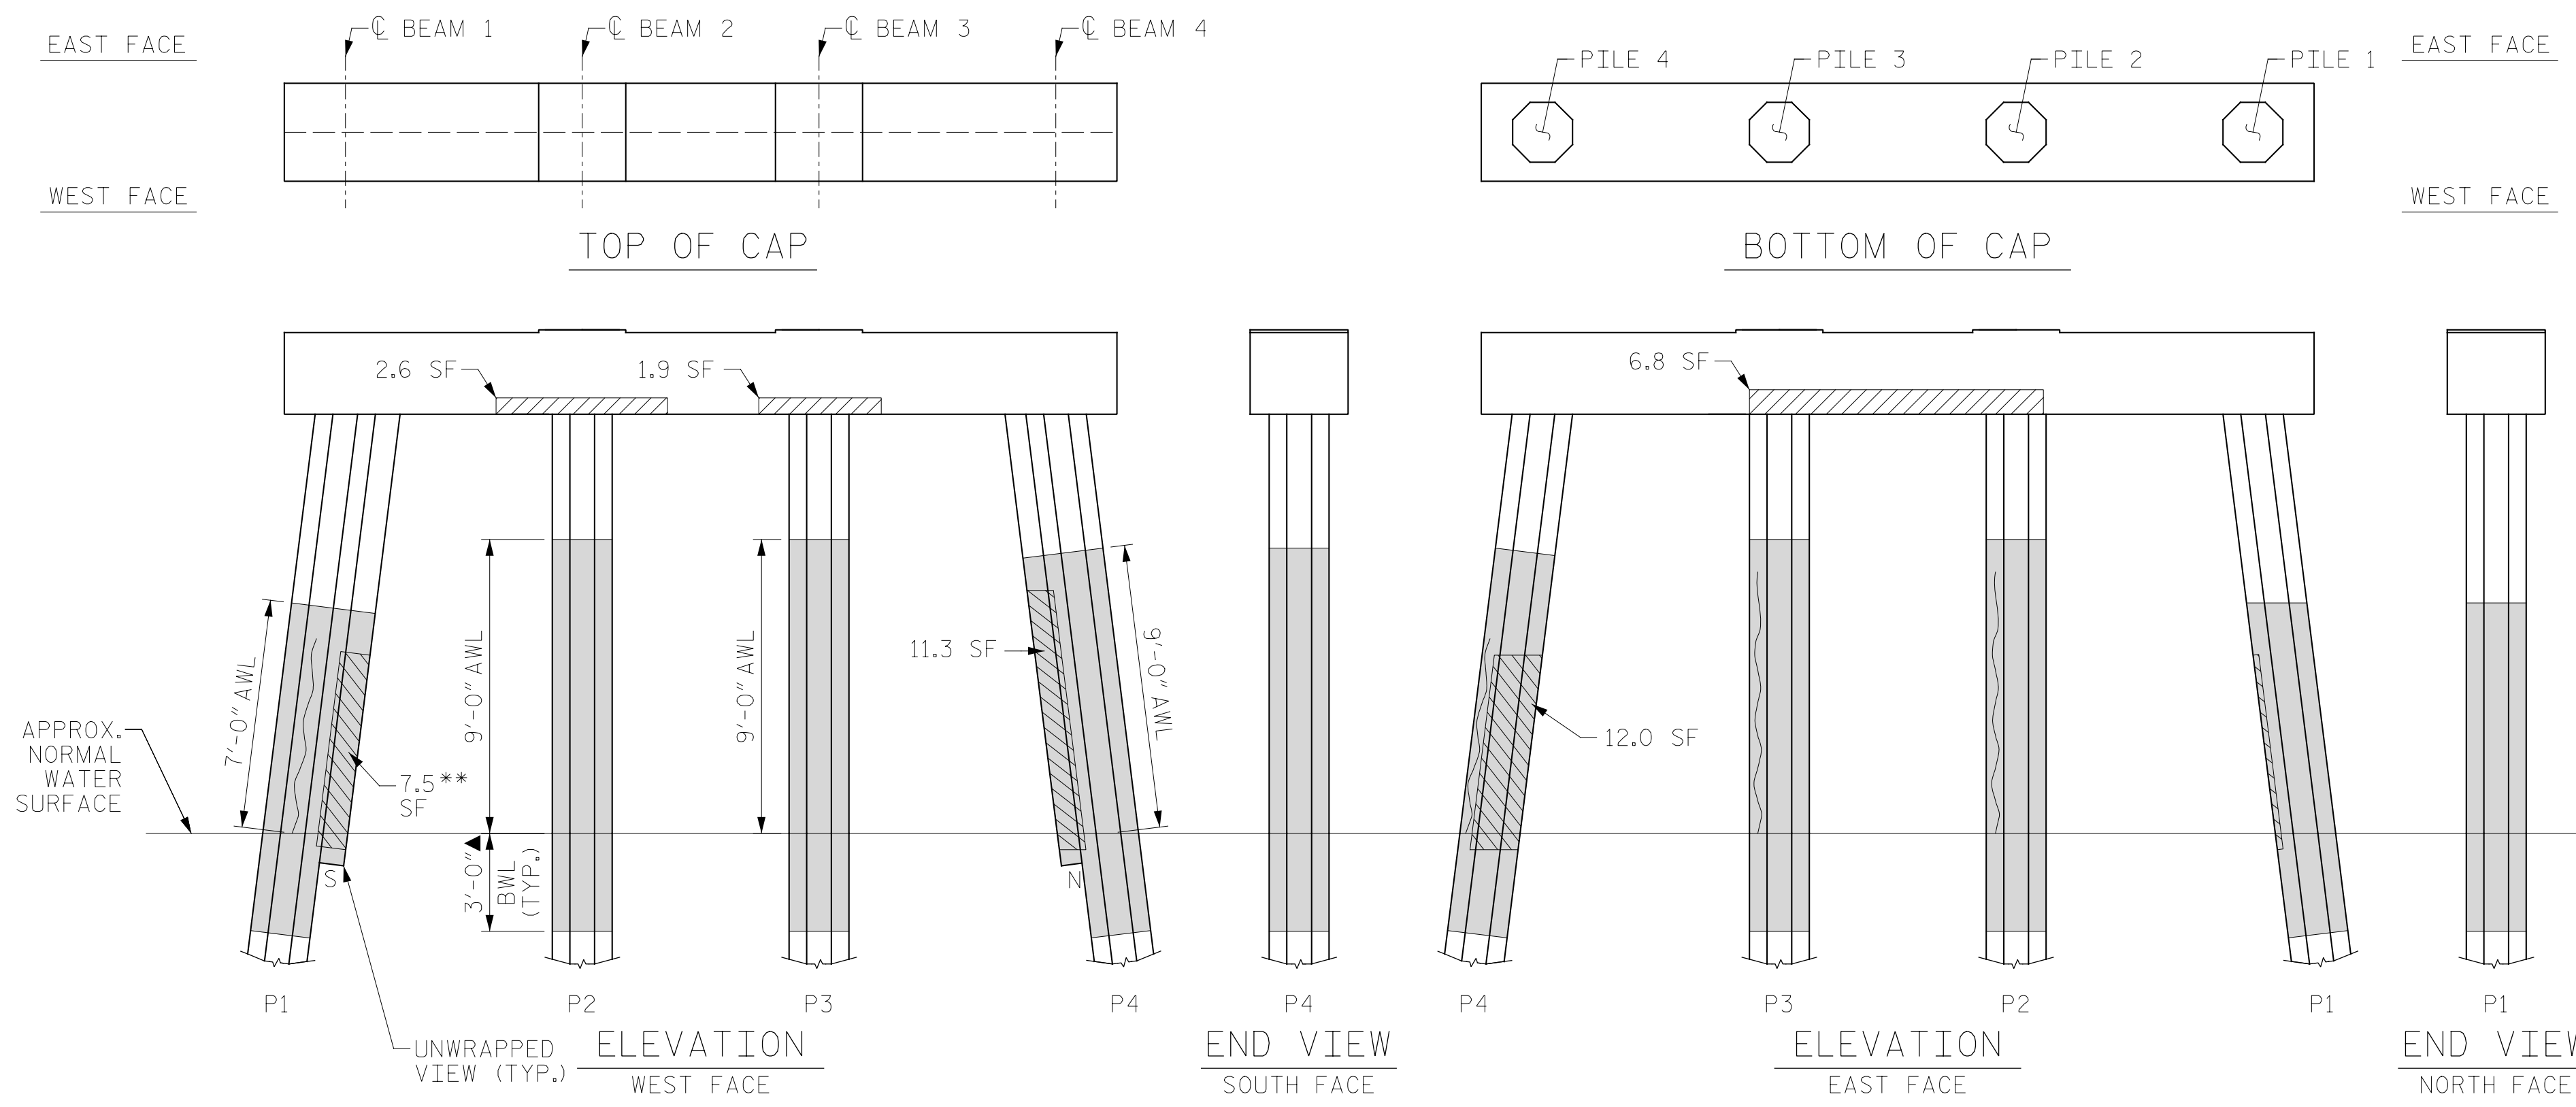
BENT 217

CAP REPAIRS			
SHOTCRETE REPAIRS	11.3 SF	5.7 CF	SF CF
EPOXY RESIN INJECTION	- LF		LF
PILE REPAIRS			
PILE CONCRETE RESTORATION	30.8 SF	12.7 CF	SF CF
FRP PROTECTIVE SYSTEM AWL	207.4 SF		
FRP PROTECTIVE SYSTEM BWL	73.2 SF

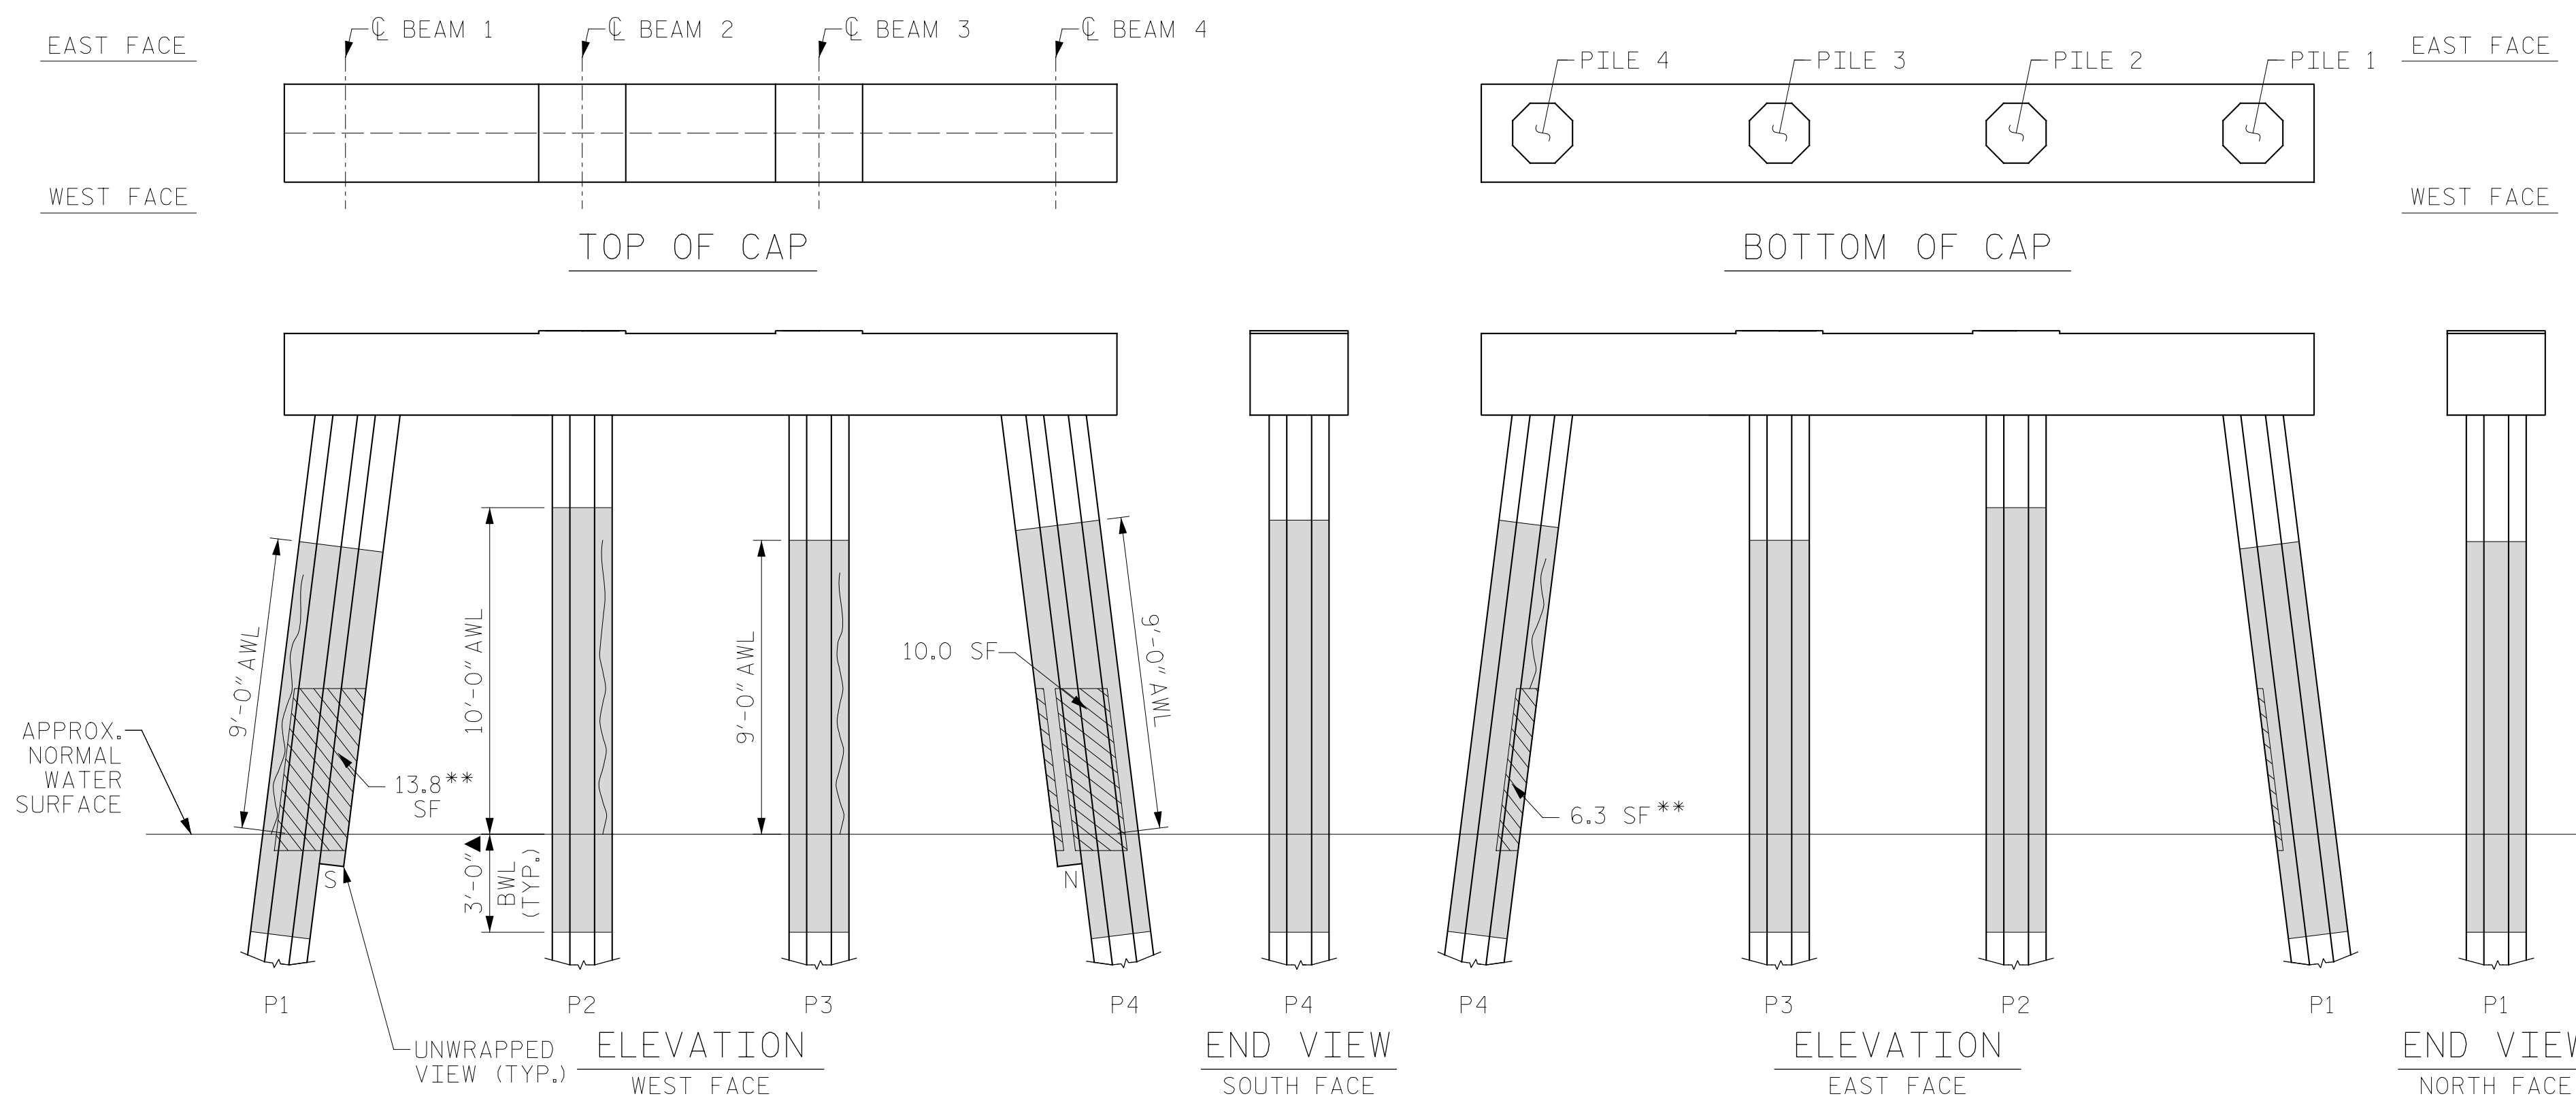
BENT 218

CAP REPAIRS			
SHOTCRETE REPAIRS	- SF	- CF	SF CF
EPOXY RESIN INJECTION	- LF		LF
PILE REPAIRS			
PILE CONCRETE RESTORATION	30.0 SF	12.0 CF	SF CF
FRP PROTECTIVE SYSTEM AWL	225.7 SF		
FRP PROTECTIVE SYSTEM BWL	73.2 SF
