PROJECT NO. DARE COUNTY 270009 BRIDGE NO._

> STATE OF NORTH CAROLINA DEPARTMENT OF TRANSPORTATION RALEIGH

BENT 223 & BENT 224

SHEET NO.					
\Box	NO.	BY:	DATE:	NO.	BY:	DATE:	S-281
	1			3			TOTAL SHEETS
	2			4			355

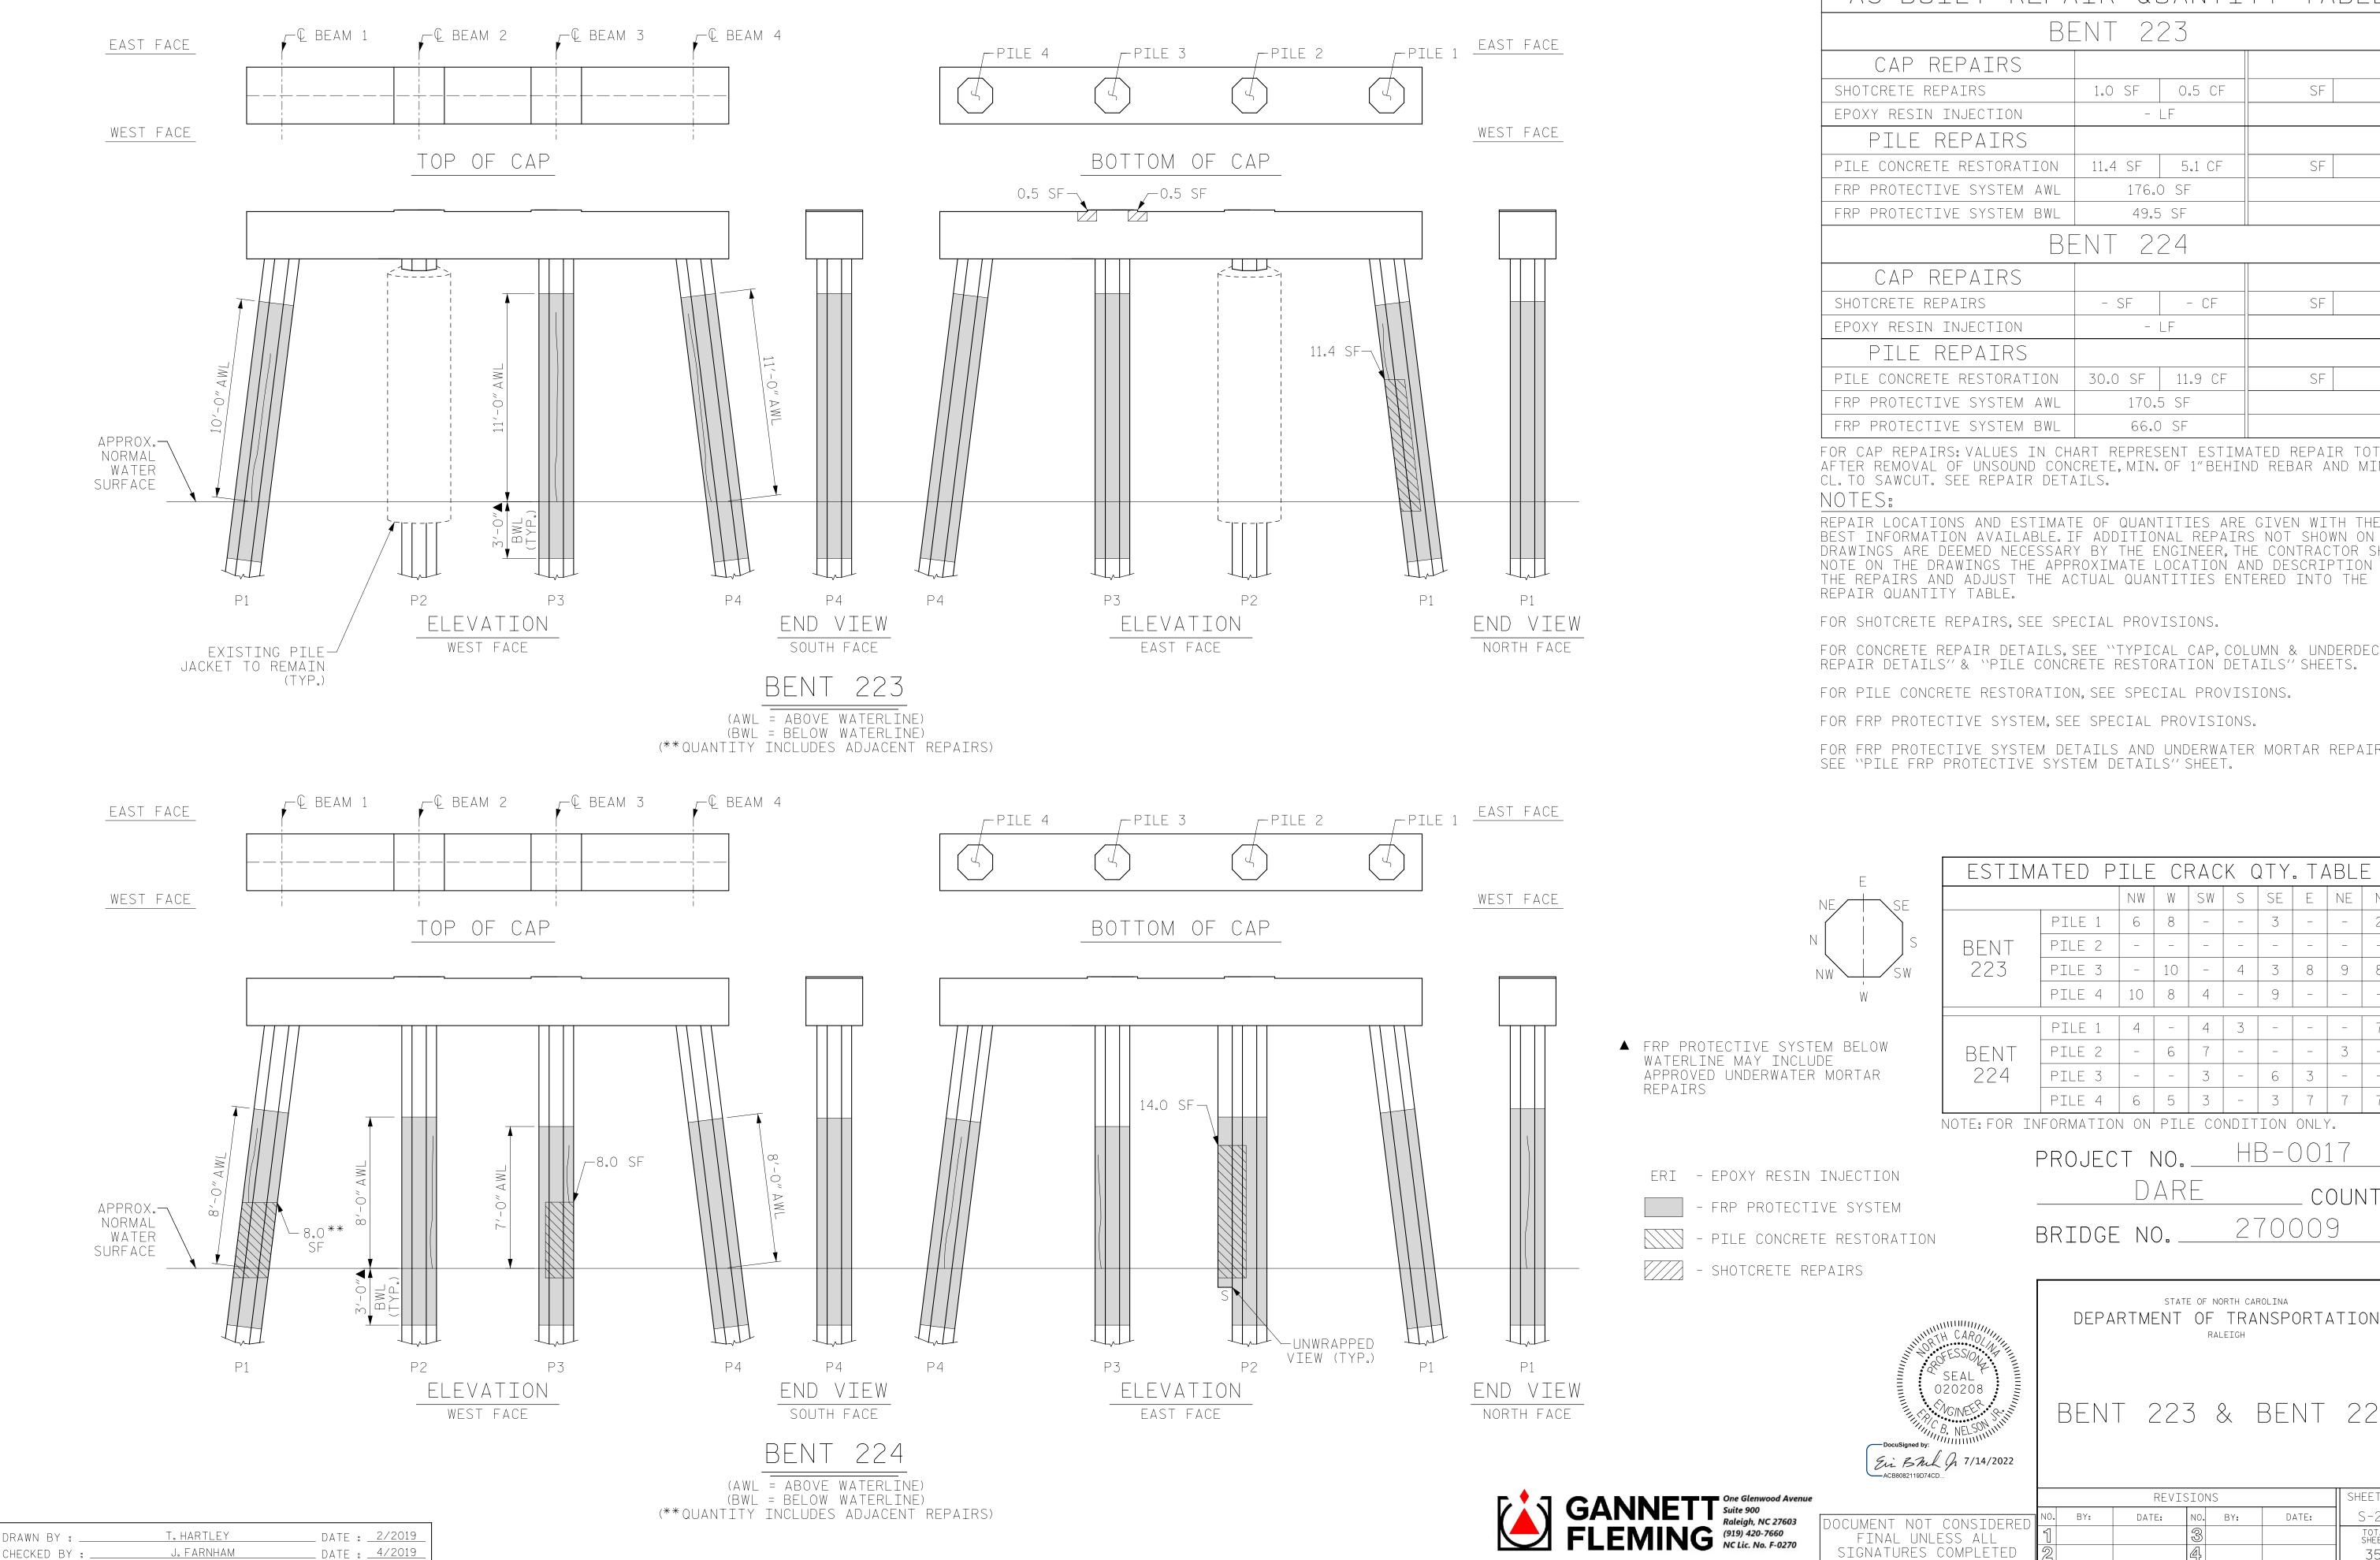
AS-BUILT REPAIR QUANTITY TABLE BENT 223 SF 1.0 SF | 0.5 CF - LF PILE CONCRETE RESTORATION SF 11.4 SF | 5.1 CF FRP PROTECTIVE SYSTEM AWL 176.0 SF FRP PROTECTIVE SYSTEM BWL 49.5 SF BENT 224 SF - SF - CF - LF PILE CONCRETE RESTORATION 30.0 SF | 11.9 CF SF 170.5 SF

ESTIMATED FILE CRACK QTT. TABLE										
		NW	W	SW	S	SE	E	NE	N	
BENT 223	PILE 1	6	8	_	_	3	_	_	2	
	PILE 2	-	_	_	_	_	_	_	_	
	PILE 3	_	10	_	4	3	8	9	8	
	PILE 4	10	8	4	_	9	-	-	_	
	PILE 1	4	_	4	3	_	_	_	7	
BENT	PILE 2	_	6	7	_	_	_	3	_	
224	PILE 3	-	_	3	_	6	3	_	_	
	PILE 4	6	5	3	-	3	7	7	7	
NOTE, FOR INFORMATION ON PILE CONDITION ONLY
