AS-BUILT REPAIR QUANTITY TABLE

PROJECT NO. HB-0017  
DARE COUNTY  
BRIDGE NO. 270009

STATE OF NORTH CAROLINA  
DEPARTMENT OF TRANSPORTATION  
RALEIGH

BENT 227 & BENT 228

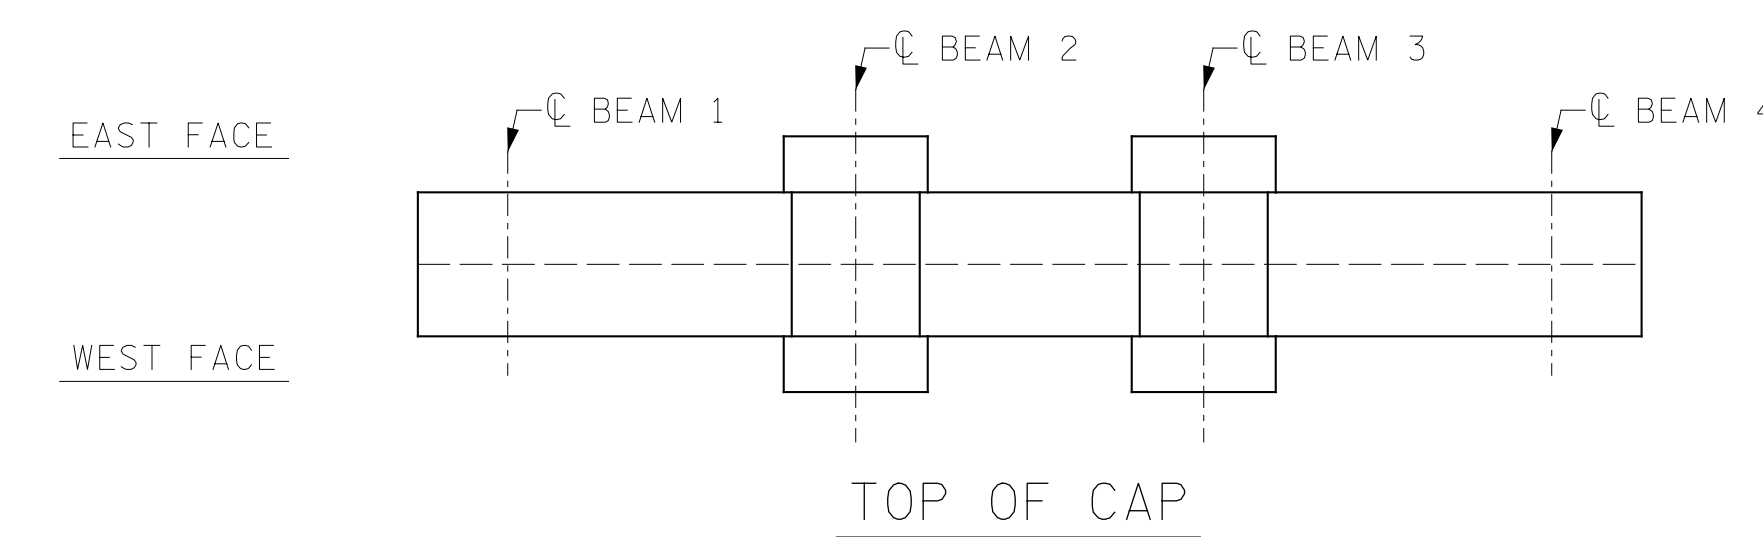
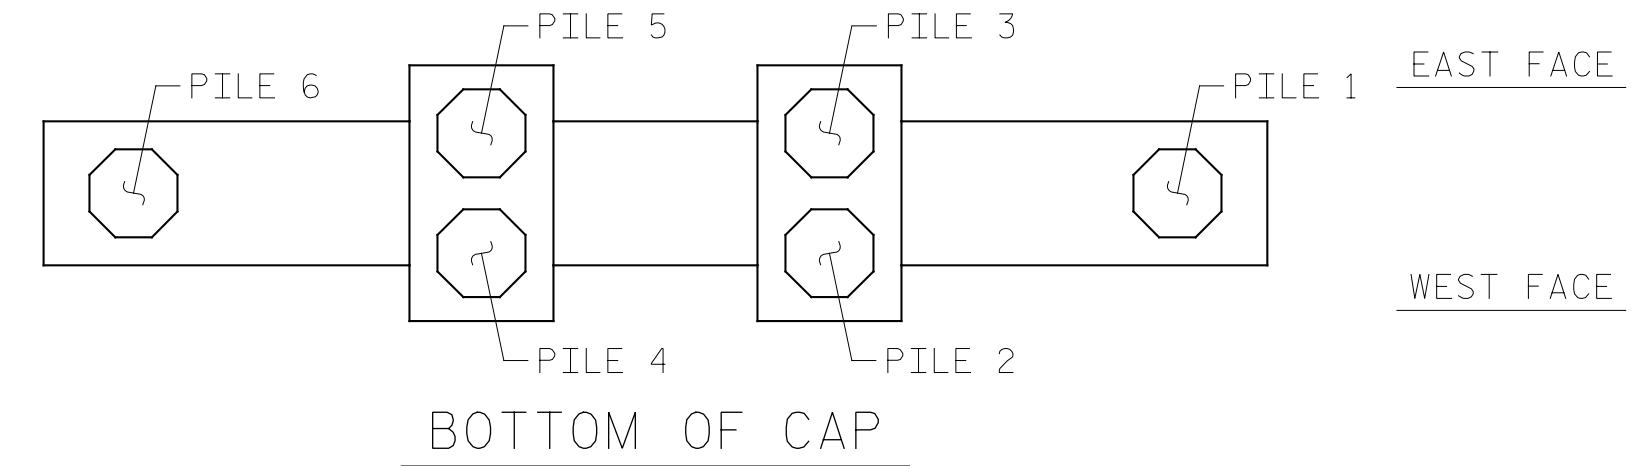
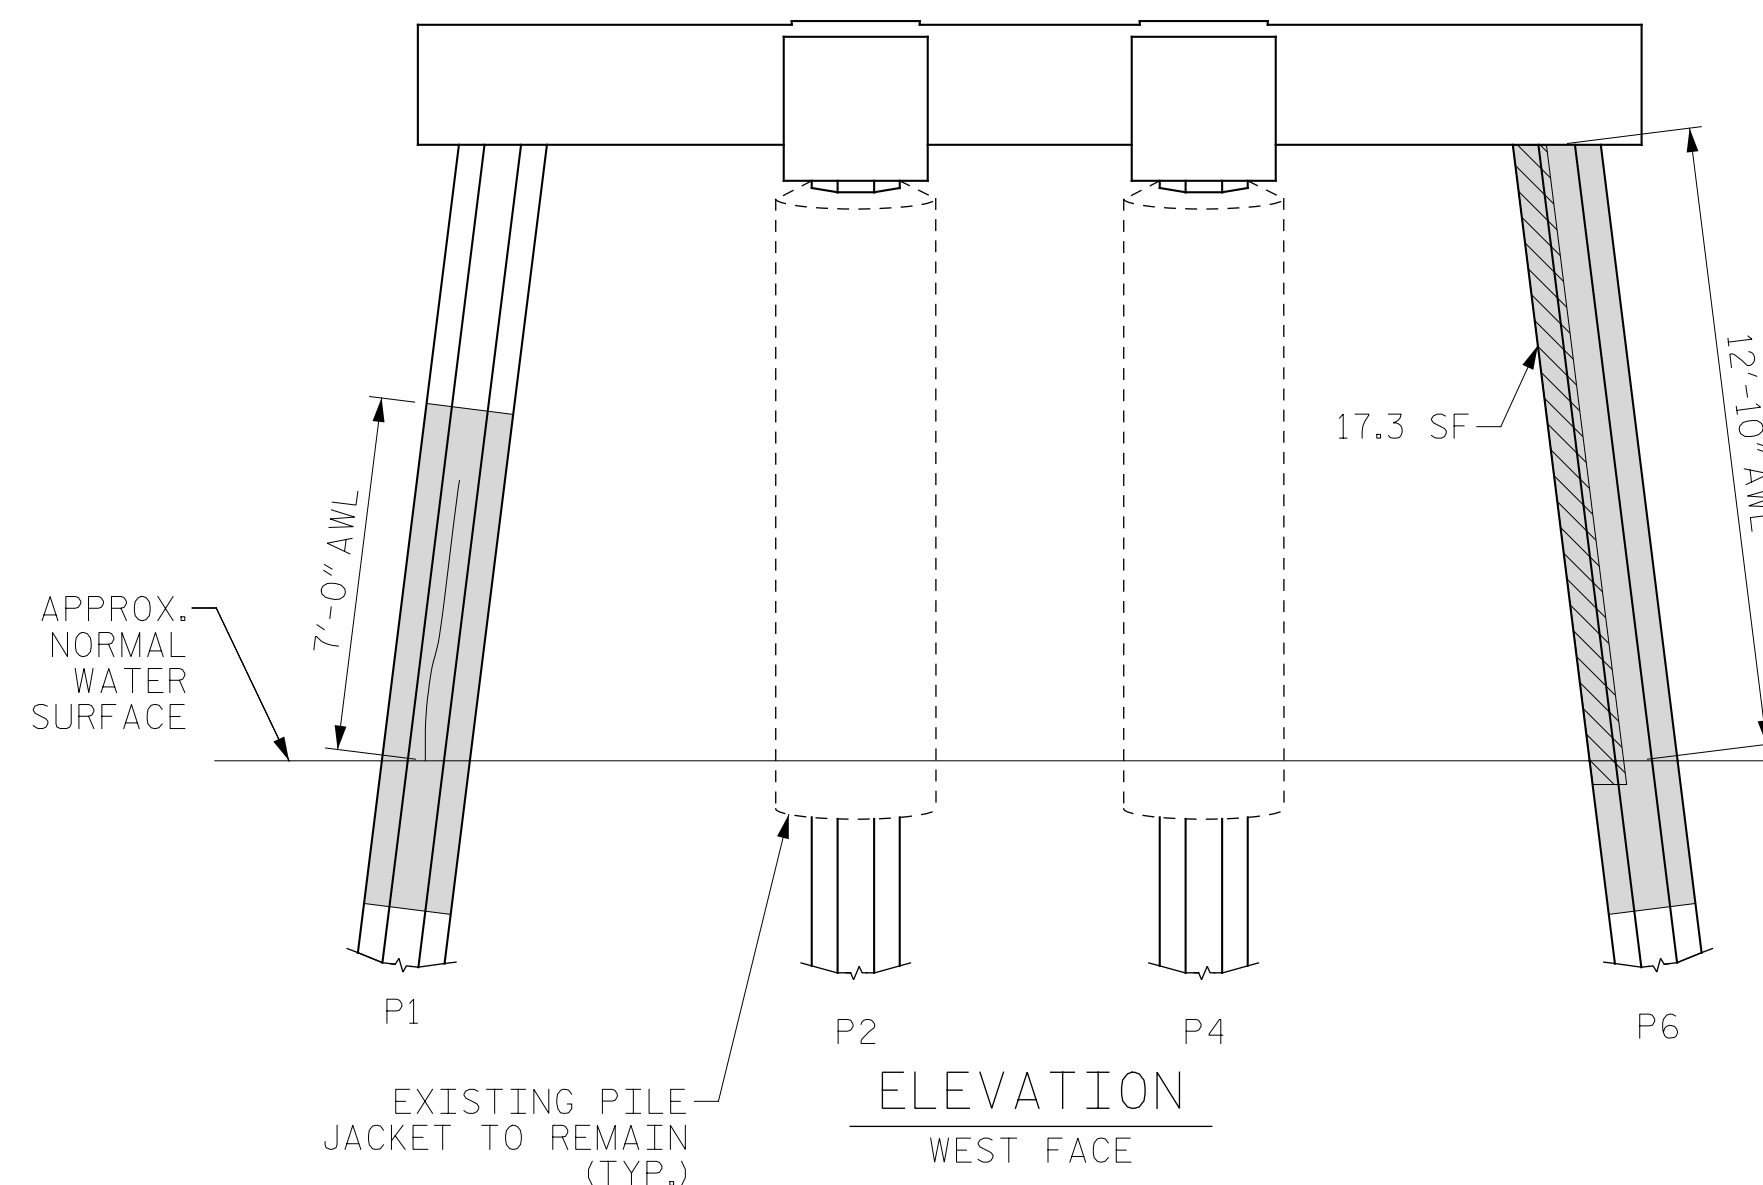
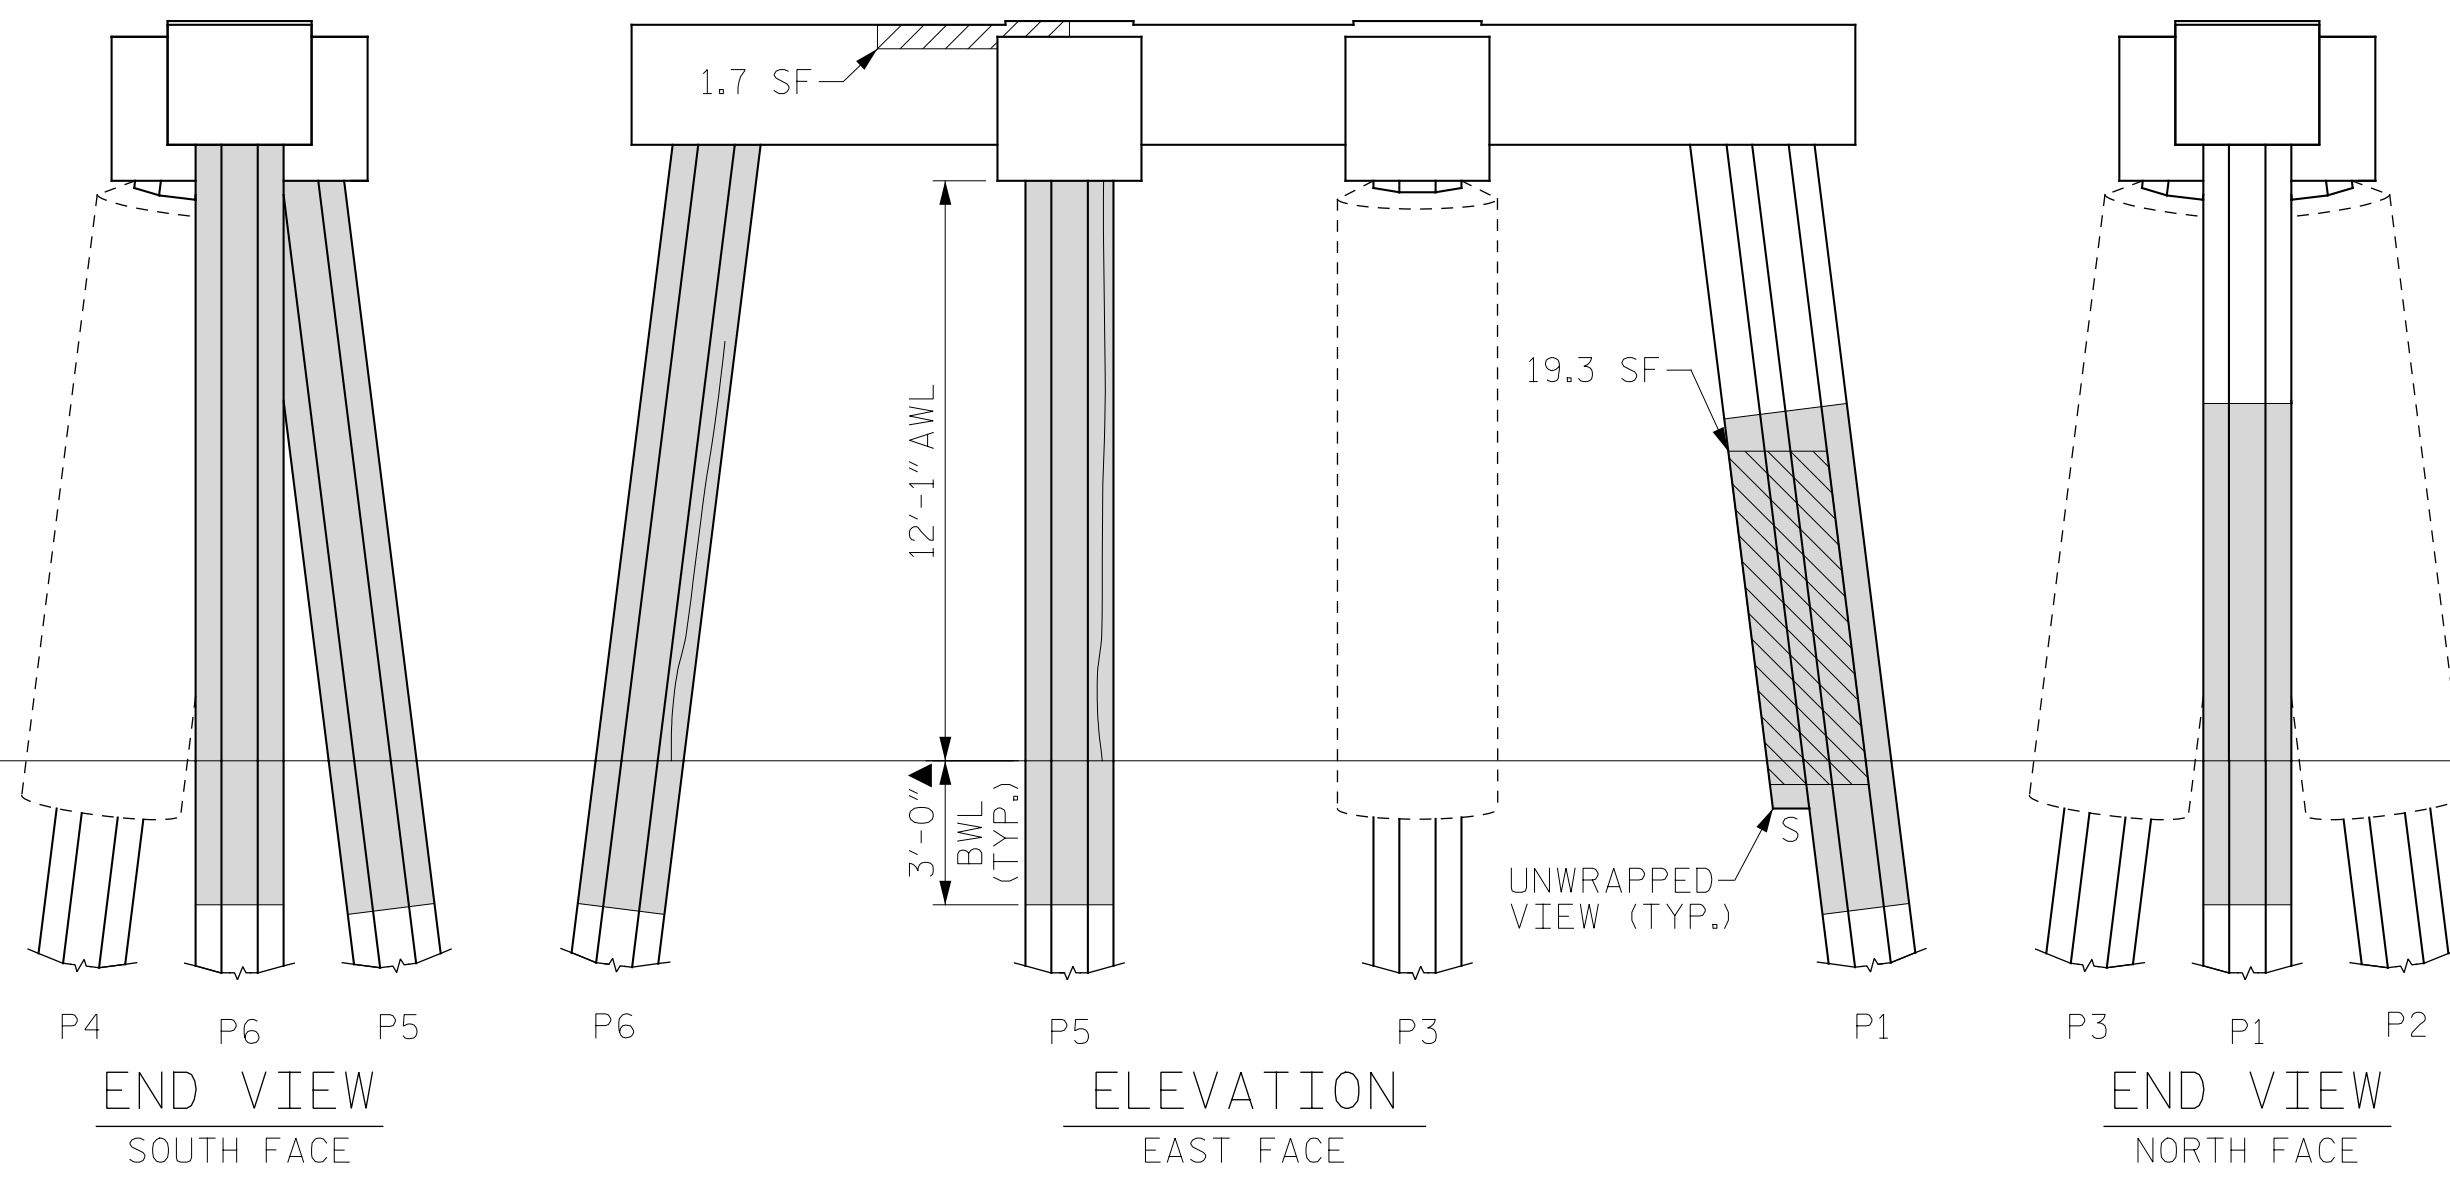
BENT 227

CAP REPAIRS			
SHOTCRETE REPAIRS	1.7 SF	0.9 CF	SF CF
EPOXY RESIN INJECTION	- LF		LF
PILE REPAIRS			
PILE CONCRETE RESTORATION	36.5 SF	15.0 CF	SF CF
FRP PROTECTIVE SYSTEM AWL	181.0 SF		
FRP PROTECTIVE SYSTEM BWL	49.5 SF

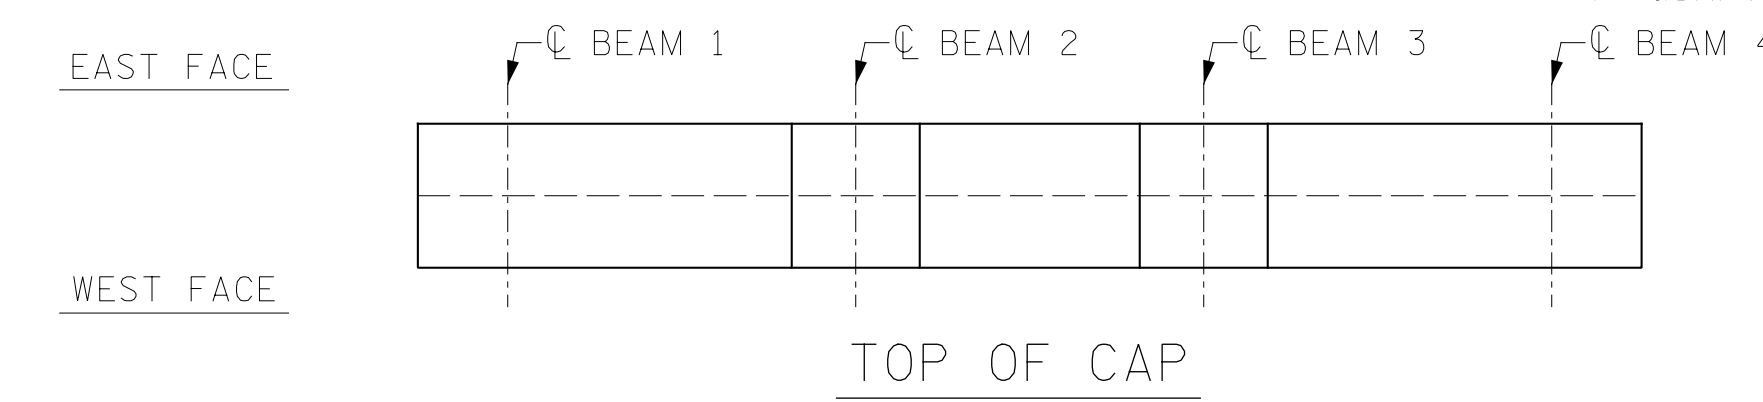
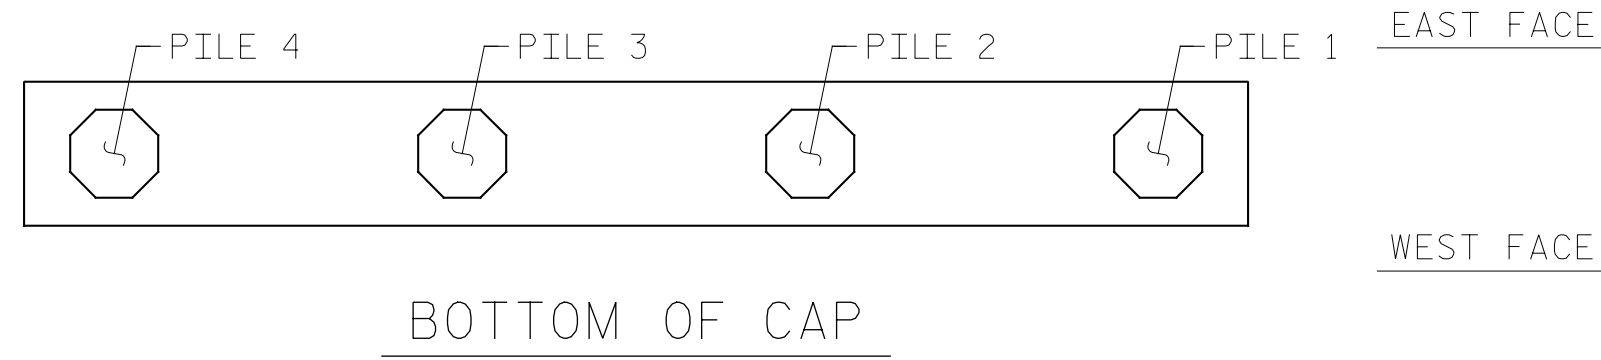
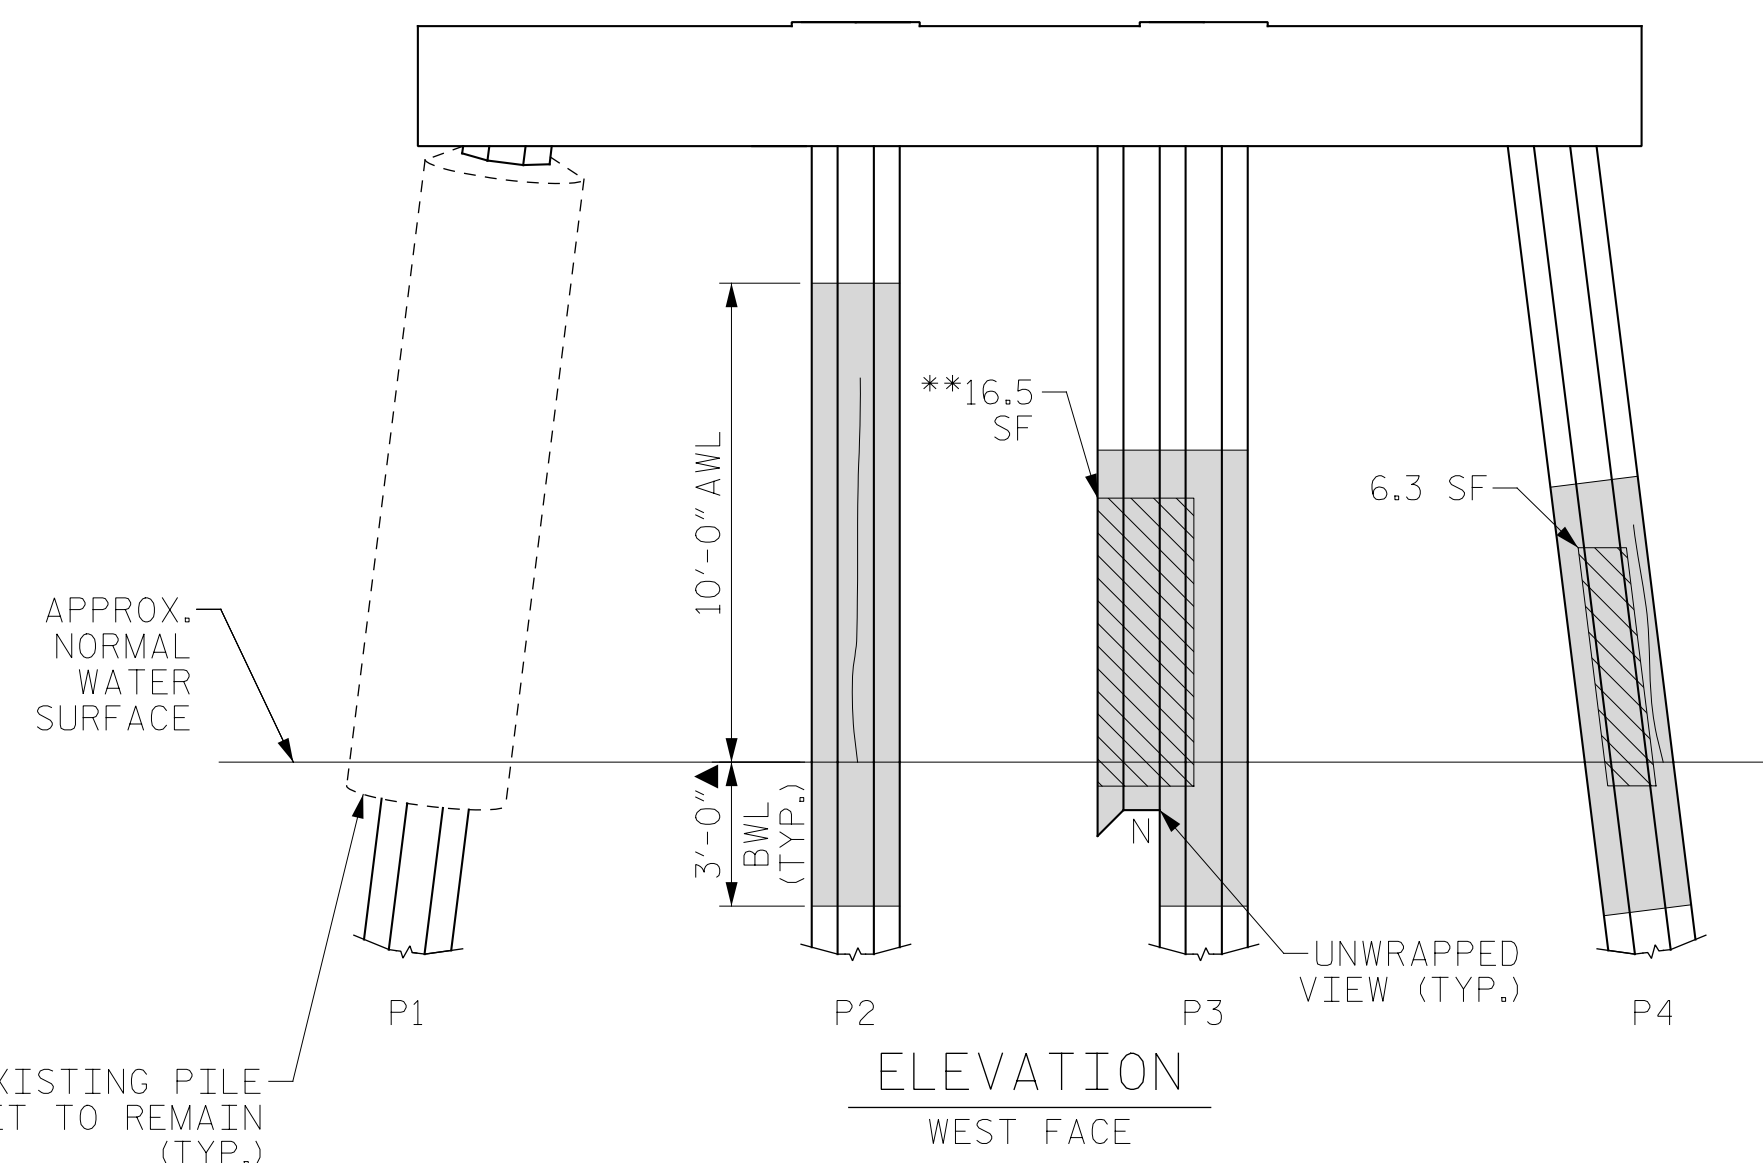
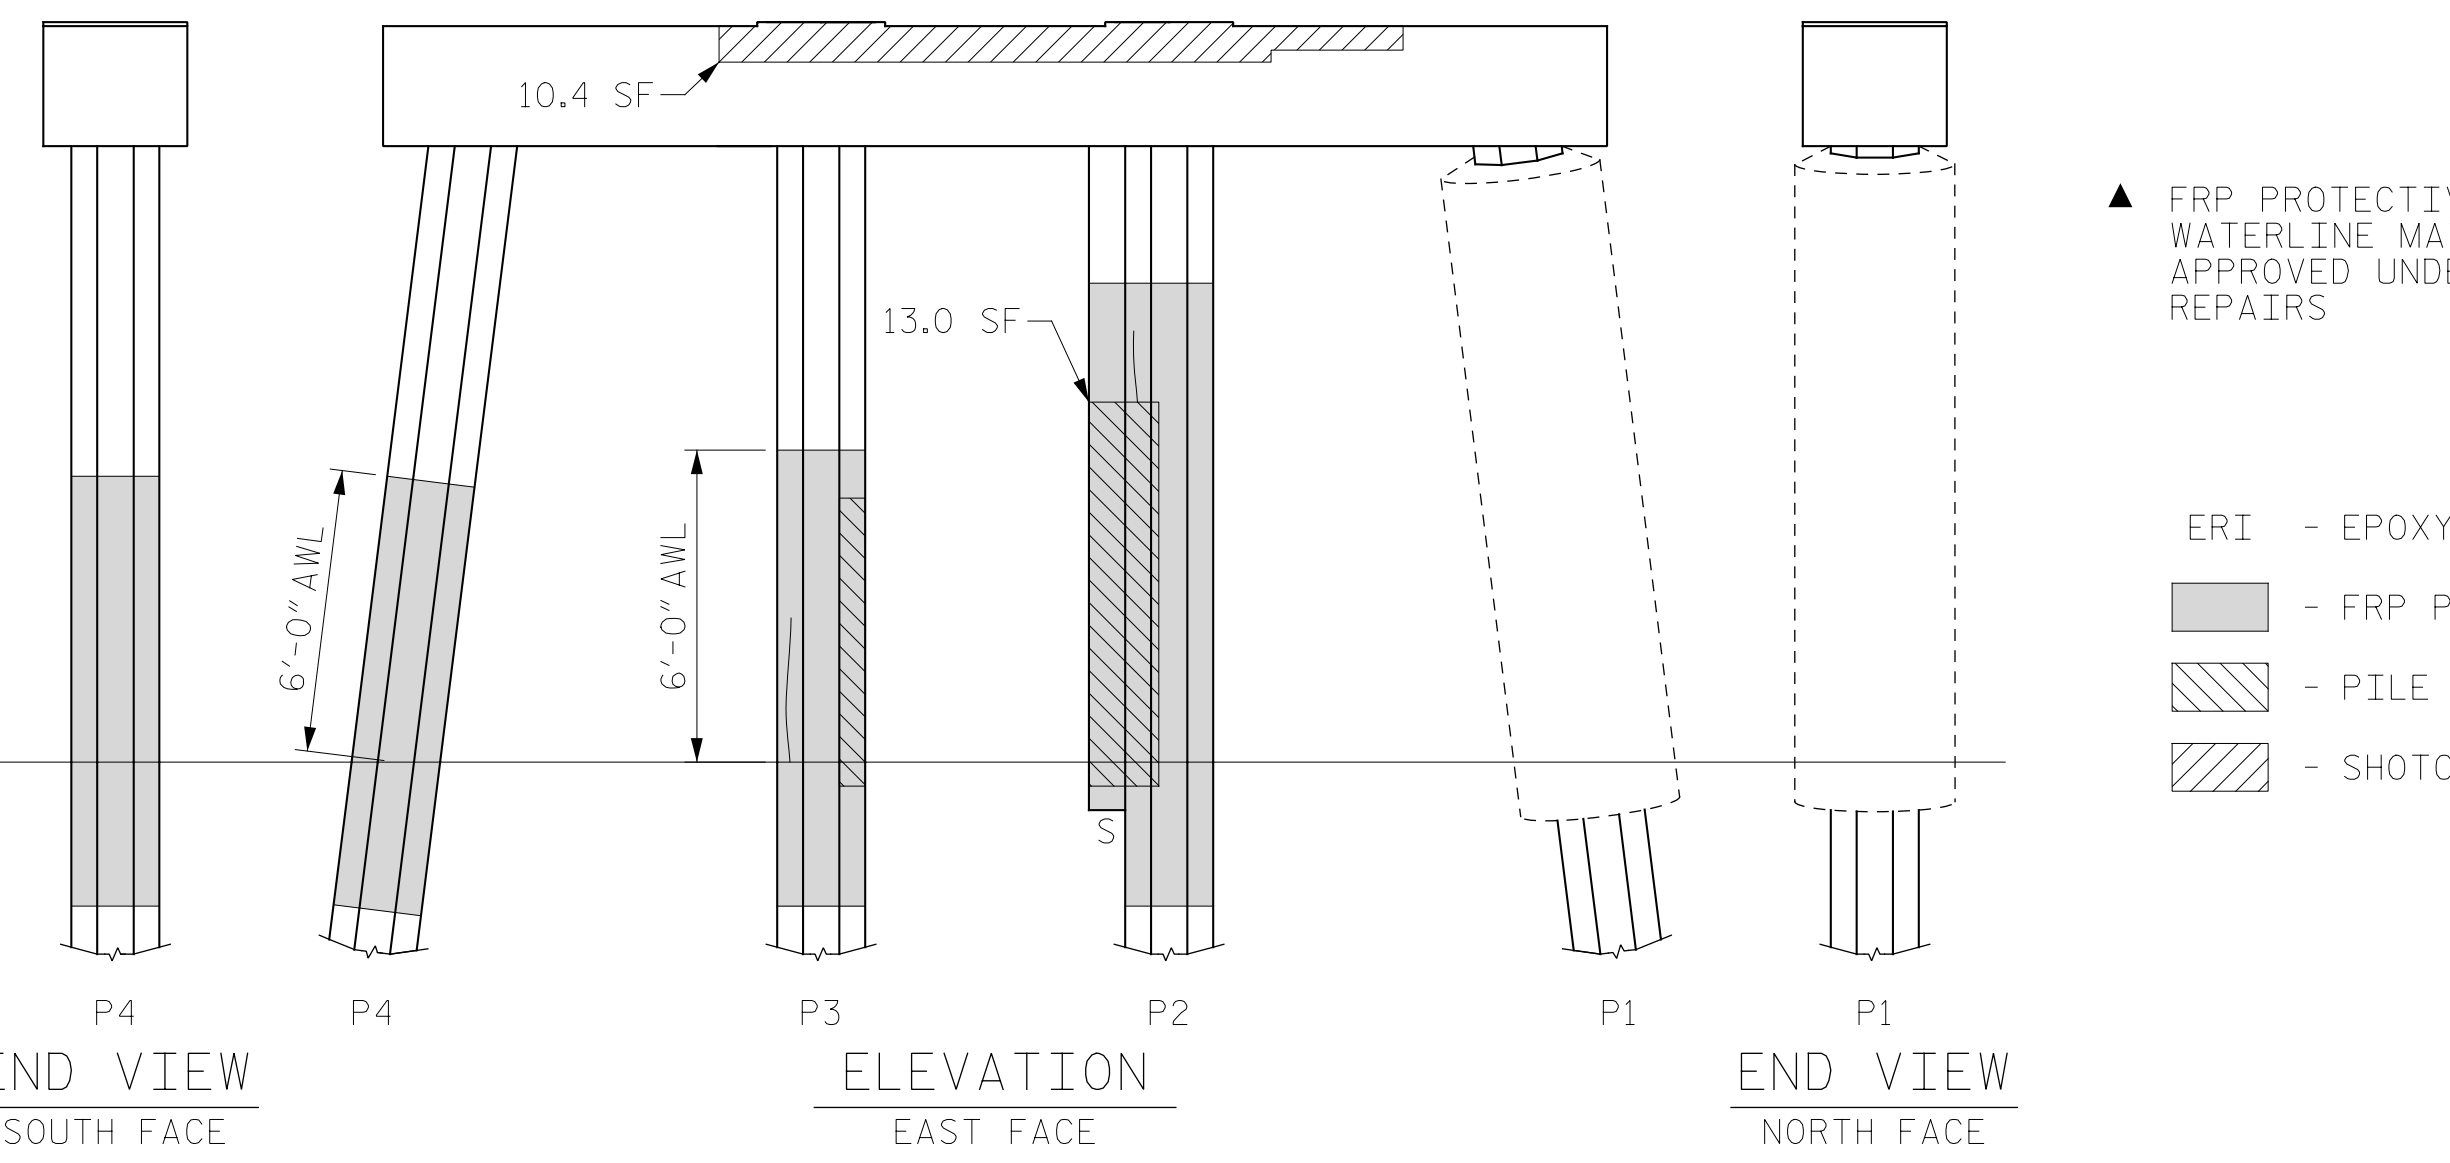
BENT 228

CAP REPAIRS			
SHOTCRETE REPAIRS	10.4 SF	5.2 CF	SF CF
EPOXY RESIN INJECTION	- LF		LF
PILE REPAIRS			
PILE CONCRETE RESTORATION	35.8 SF	15.0 CF	SF CF
FRP PROTECTIVE SYSTEM AWL	121.0 SF		
FRP PROTECTIVE SYSTEM BWL	49.5 SF
