270009 BRIDGE NO.

STATE OF NORTH CAROLINA DEPARTMENT OF TRANSPORTATION RALEIGH

BENT 231 & BENT 232

SHEET NO REVISIONS NO. BY: S-285 DATE: DATE: TOTAL SHEETS 355

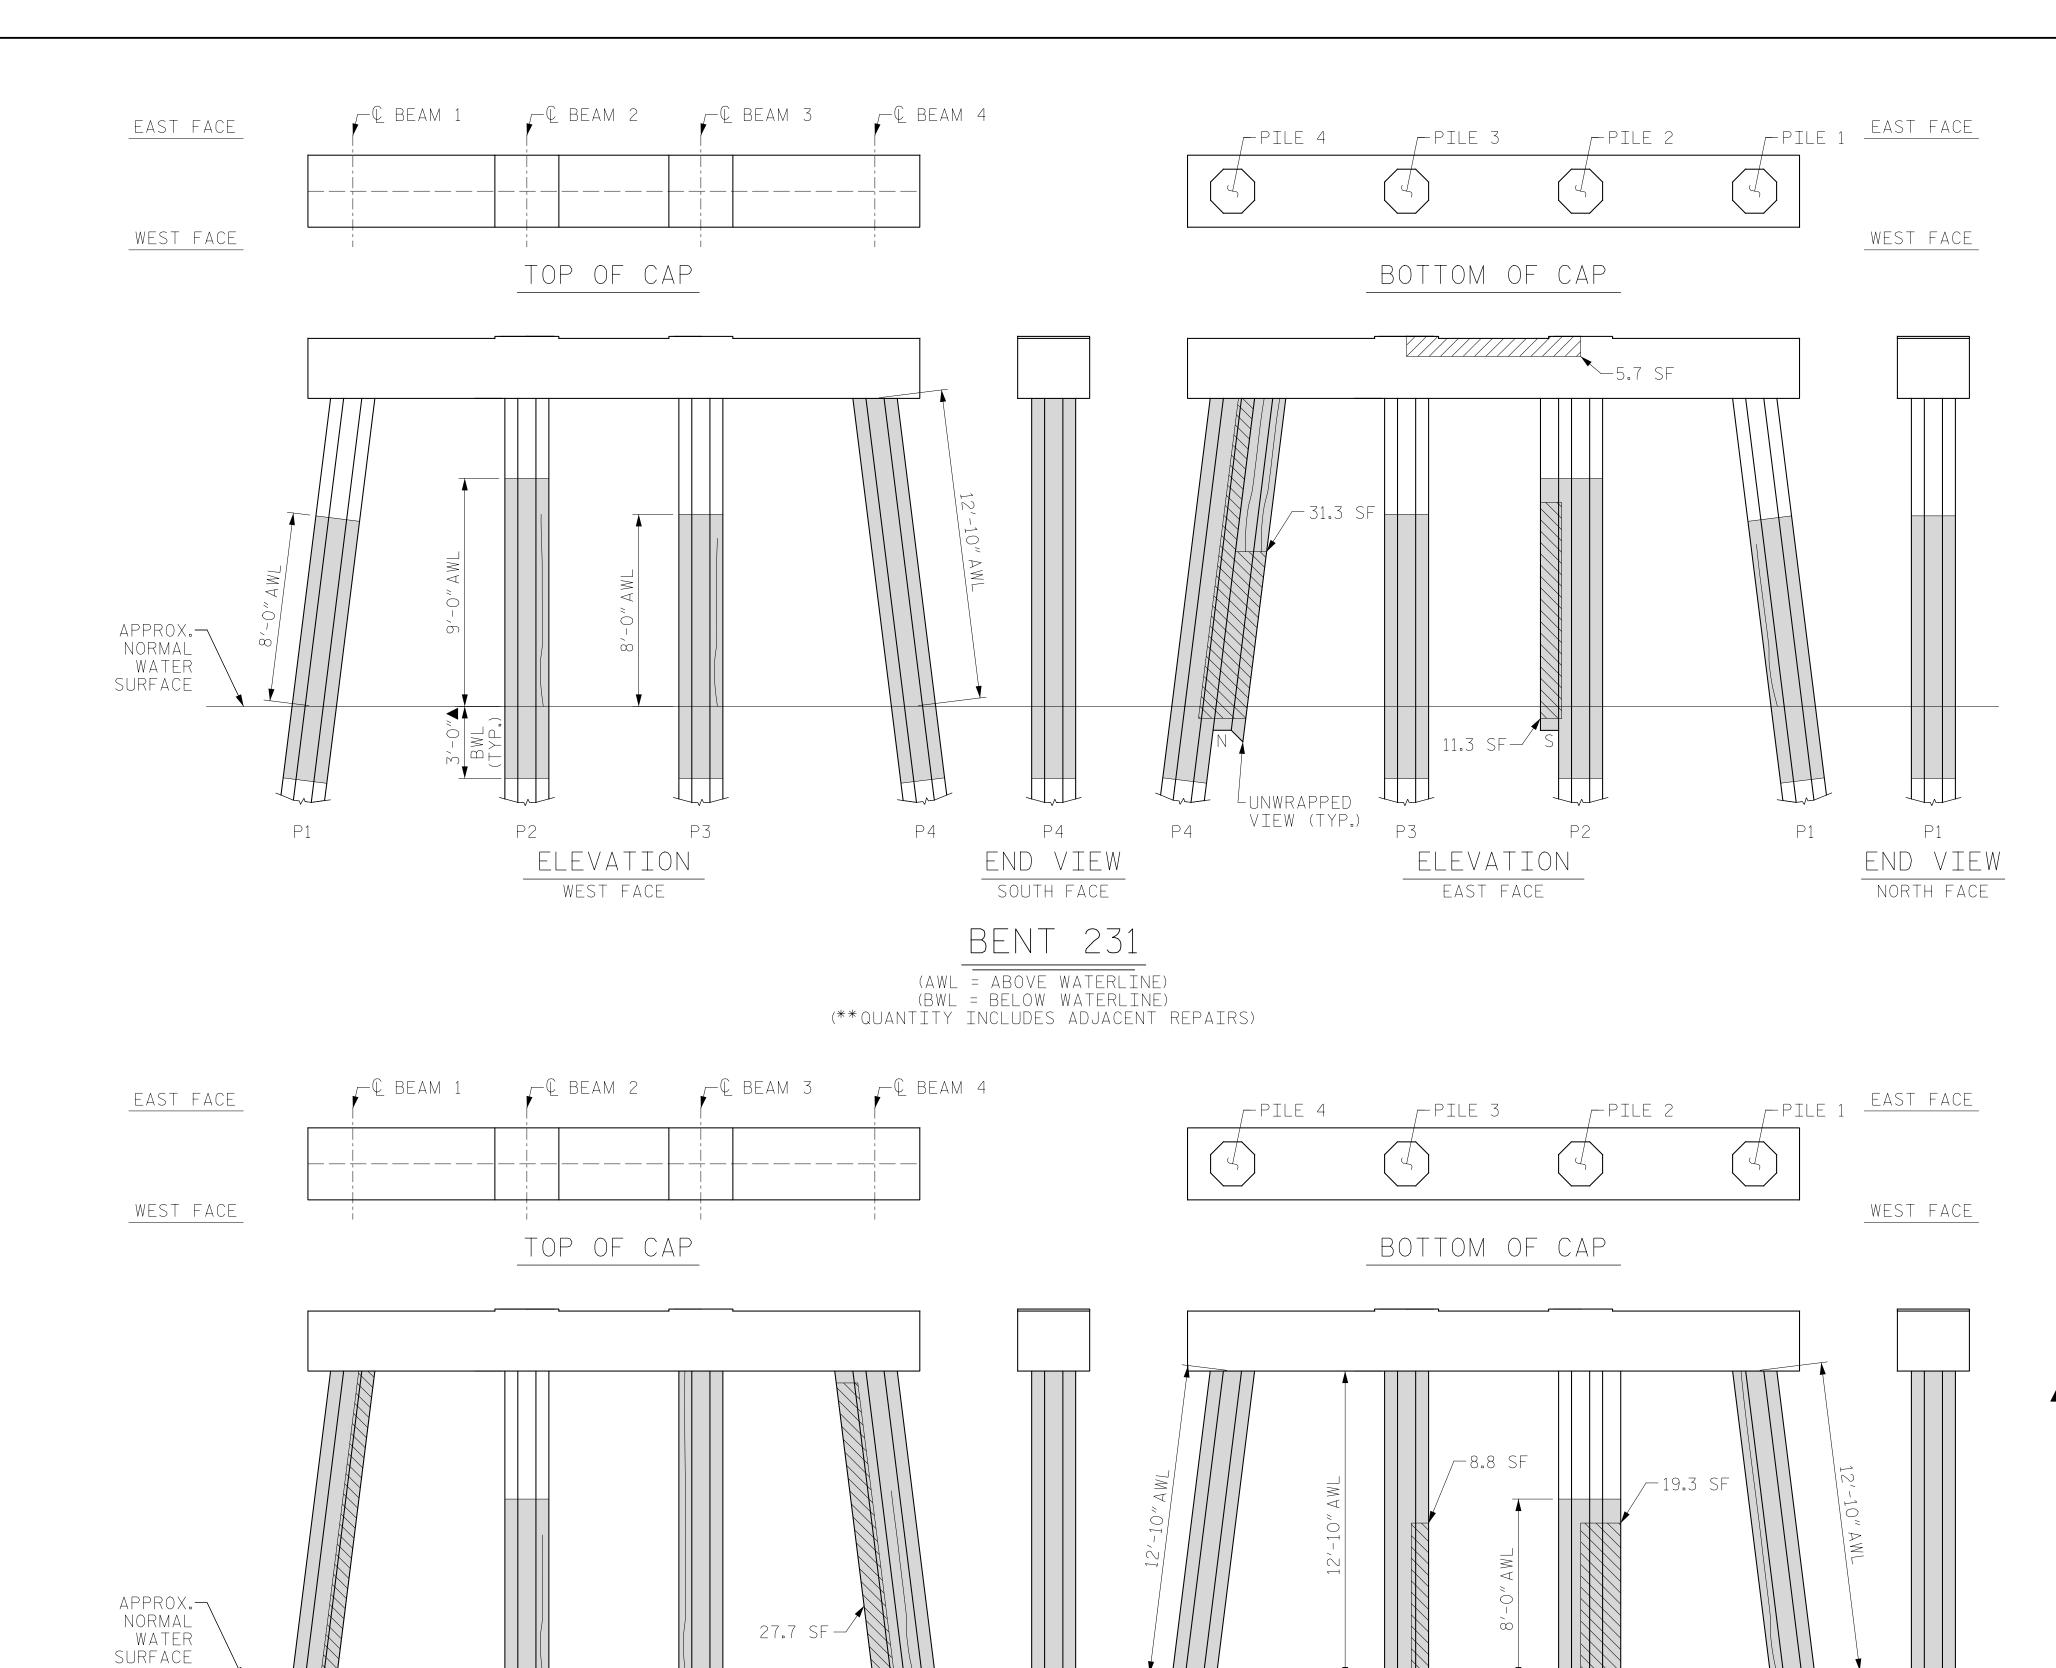
AS-BUILT REPAIR QUANTITY TABLE BENT 231 CAP REPAIRS 5.7 SF | 2.9 CF SF SHOTCRETE REPAIRS EPOXY RESIN INJECTION - LF PILE REPAIRS SF PILE CONCRETE RESTORATION 42.5 SF | 17.6 CF FRP PROTECTIVE SYSTEM AWL 213.6 SF FRP PROTECTIVE SYSTEM BWL 66.0 SF BENT 232 CAP REPAIRS SF SHOTCRETE REPAIRS - SF - CF EPOXY RESIN INJECTION - LF PILE REPAIRS PILE CONCRETE RESTORATION 72.9 SF | 29.6 CF SF FRP PROTECTIVE SYSTEM AWL 255.8 SF

ESTIMATED PILE CRACK QTY. TABLE									
		NW	W	SW	S	SE	E	NE	N
BENT 231	PILE 1	_	6		7	7	6	_	6
	PILE 2	_	_	8	_	8	7	_	5
	PILE 3	_	=	7	7	-	5	7	6
	PILE 4	6	8	6	3	-	_	-	6
BENT 232			1 7		17	1 7			
	PILE 1	_	13	_	13	13	6	_	6
	PILE 2	_	_	6	6	4	_	_	_
	PILE 3	13	8	7	7	8	8	_	8
	PILE 4	_	8	4	3	4	6	_	-
OTE, FOR THEORMATION ON RILE CONDITION ONLY
