AS-BUILT REPAIR QUANTITY TABLE

PROJECT NO. HB-0017
DARE COUNTY
 BRIDGE NO. 270009

BENT 233 & BENT 234

REVISIONS						SHEET NO. S-286
NO.	BY:	DATE:	NO.	BY:	DATE:	
1			3			TOTAL SHEETS 355
2			4

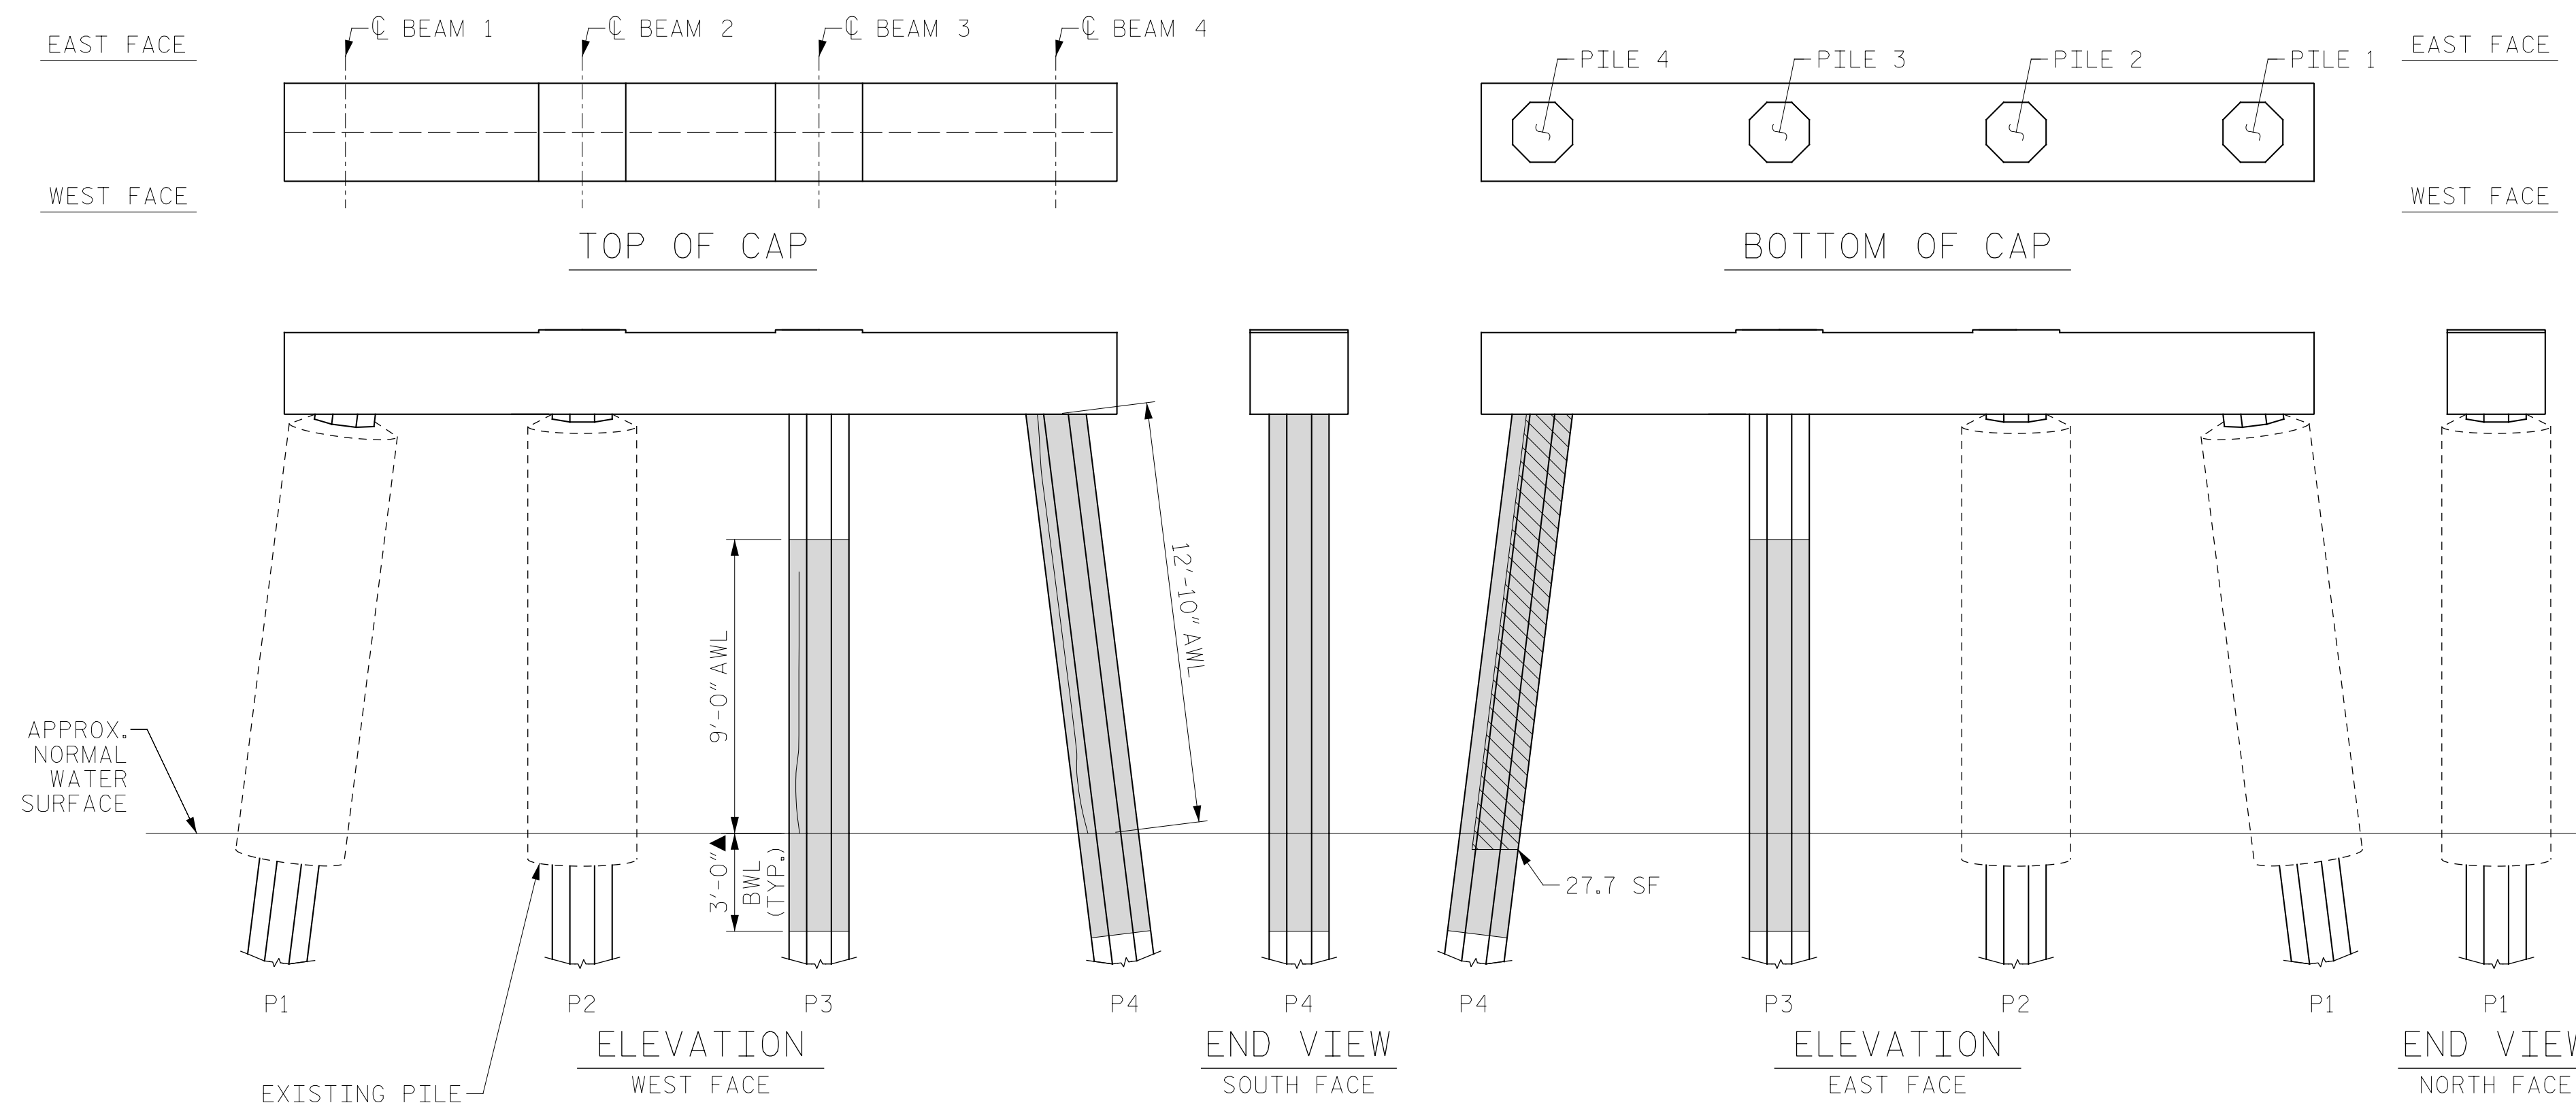
BENT 233

CAP REPAIRS			
SHOTCRETE REPAIRS	- SF	- CF	SF CF
EPOXY RESIN INJECTION	- LF		LF
PILE REPAIRS			
PILE CONCRETE RESTORATION	27.7 SF	10.9 CF	SF CF
FRP PROTECTIVE SYSTEM AWL	120.1 SF		
FRP PROTECTIVE SYSTEM BWL	33.0 SF

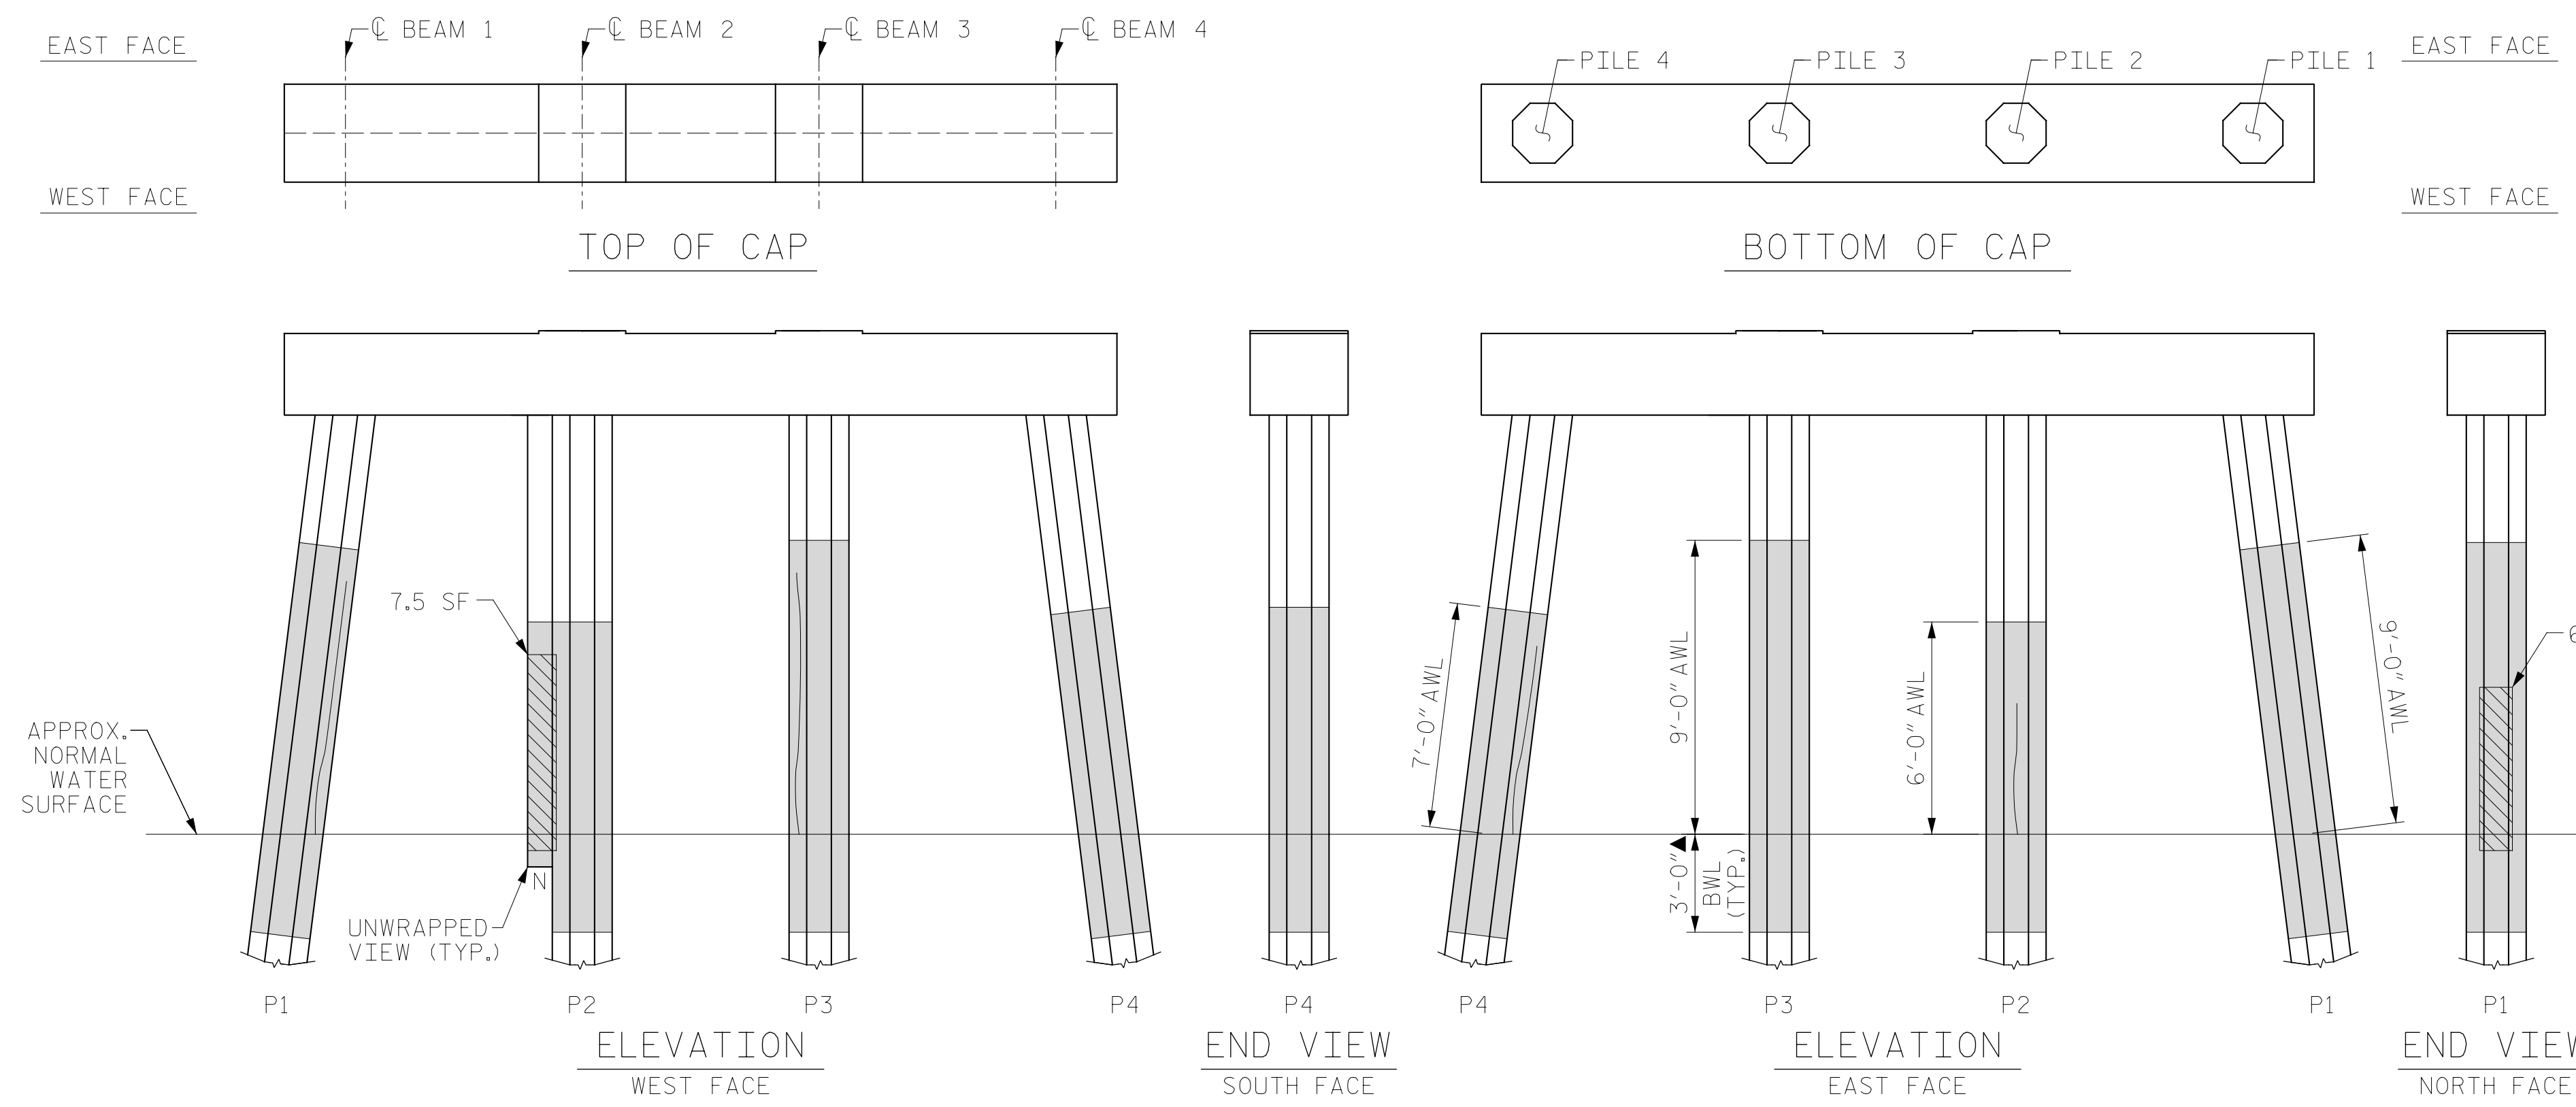
BENT 234

CAP REPAIRS			
SHOTCRETE REPAIRS	- SF	- CF	SF CF
EPOXY RESIN INJECTION	- LF		LF
PILE REPAIRS			
PILE CONCRETE RESTORATION	13.8 SF	5.8 CF	SF CF
FRP PROTECTIVE SYSTEM AWL	170.5 SF		
FRP PROTECTIVE SYSTEM BWL	66.0 SF
