AS-BUILT REPAIR QUANTITY TABLE

PROJECT NO. HB-0017
DARE COUNTY
BRIDGE NO. 270009

BENT 241 & BENT 242

REVISIONS						SHEET NO. S-290
NO.	BY:	DATE:	NO.	BY:	DATE:	
1			3			TOTAL SHEETS 355
2			4

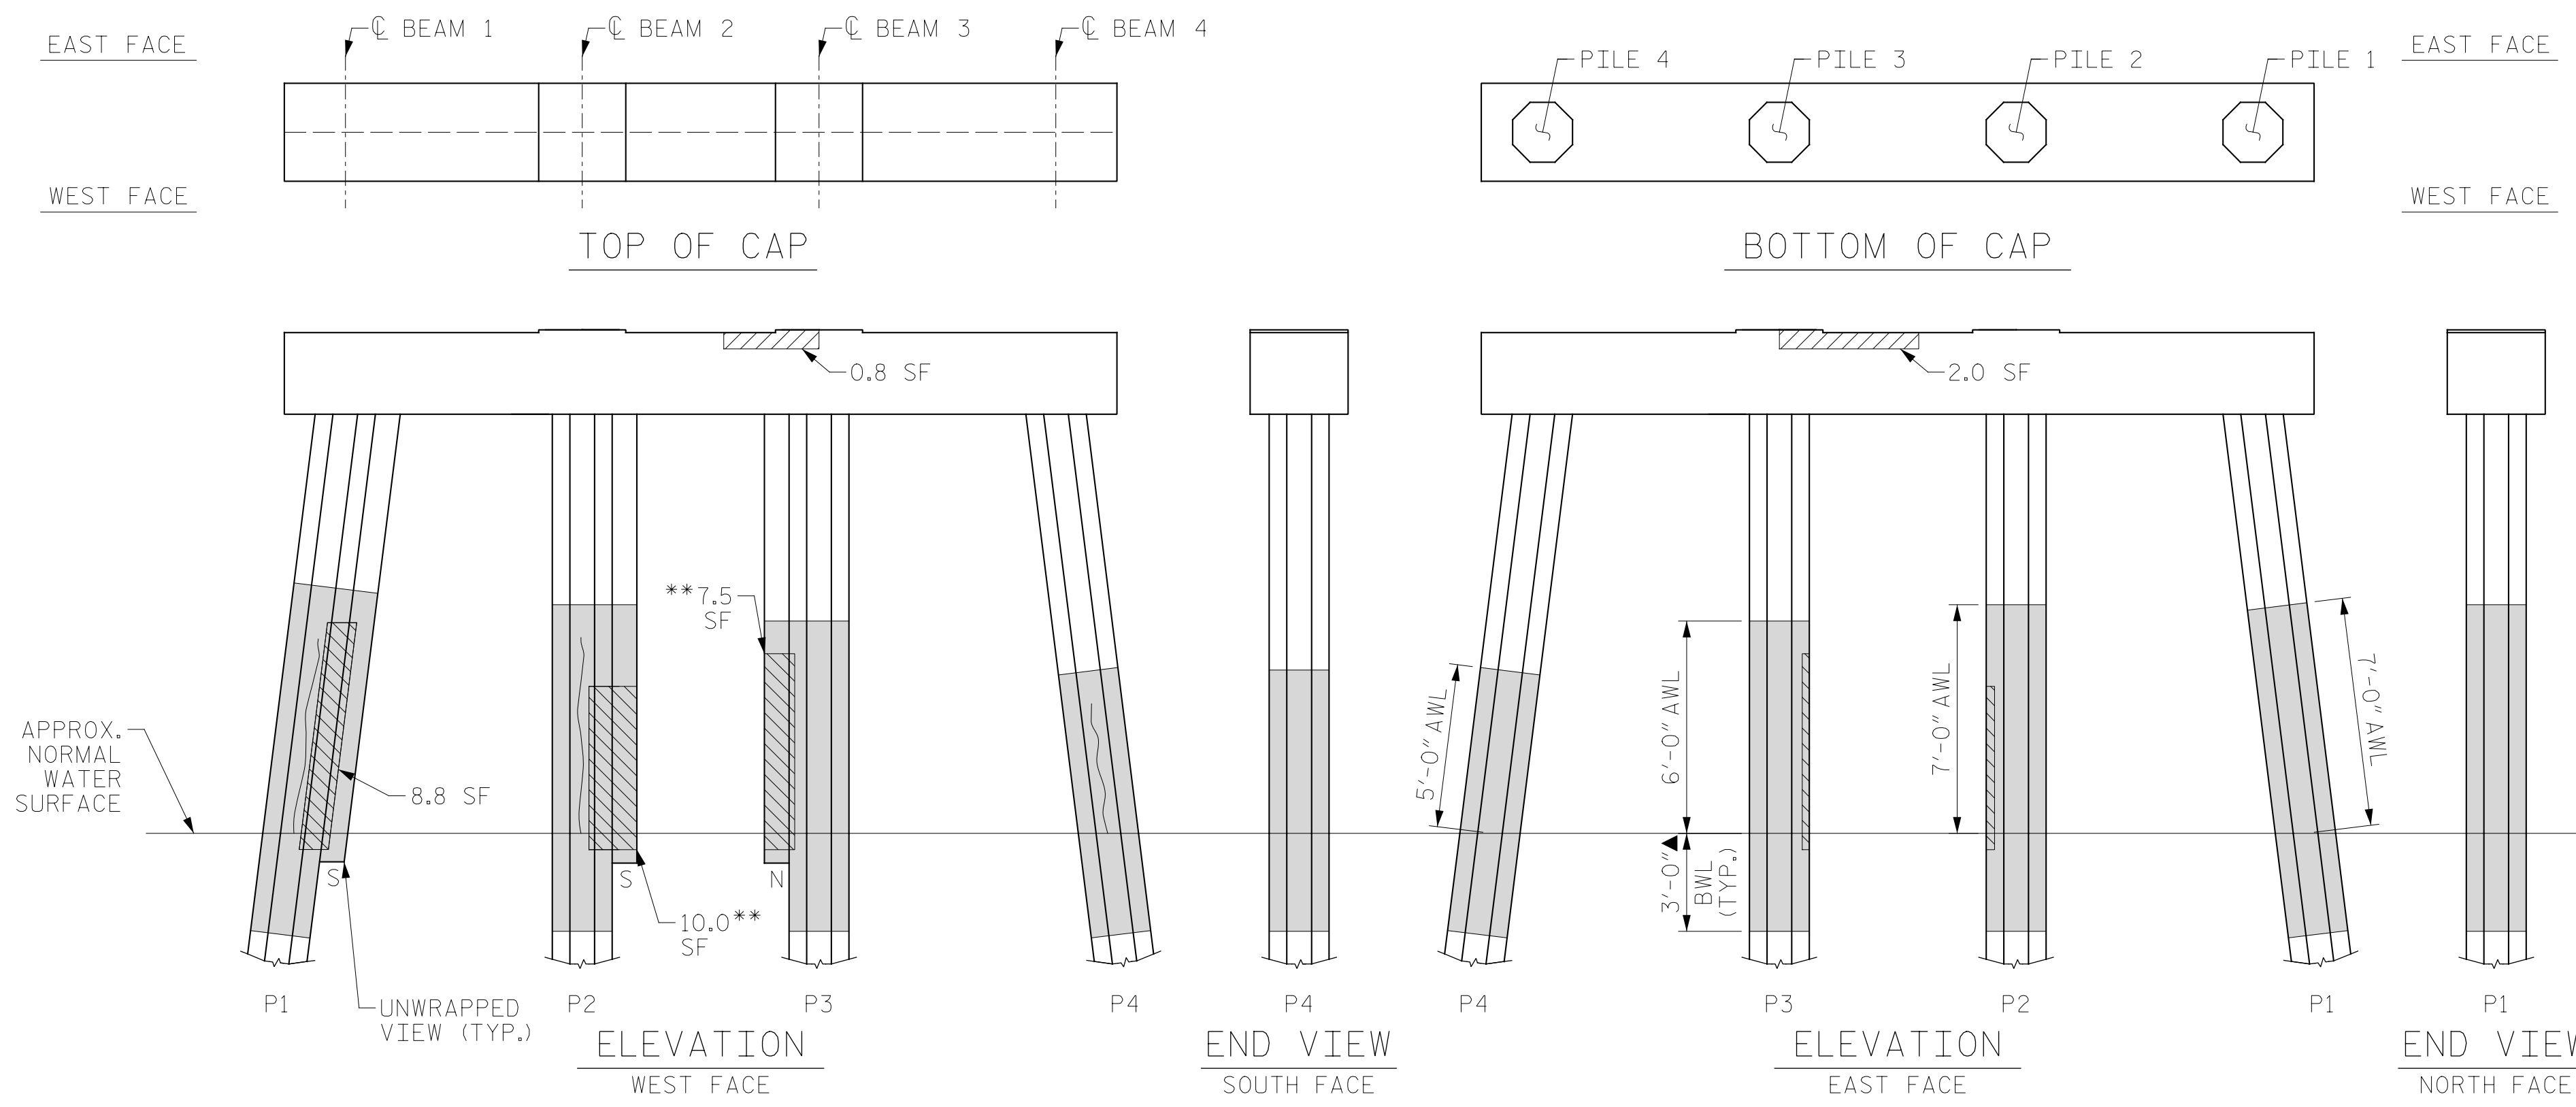
BENT 241

CAP REPAIRS			
SHOTCRETE REPAIRS	2.8 SF	1.4 CF	SF CF
EPOXY RESIN INJECTION	- LF		LF
PILE REPAIRS			
PILE CONCRETE RESTORATION	26.3 SF	10.9 CF	SF CF
FRP PROTECTIVE SYSTEM AWL	137.5 SF		
FRP PROTECTIVE SYSTEM BWL	66.0 SF

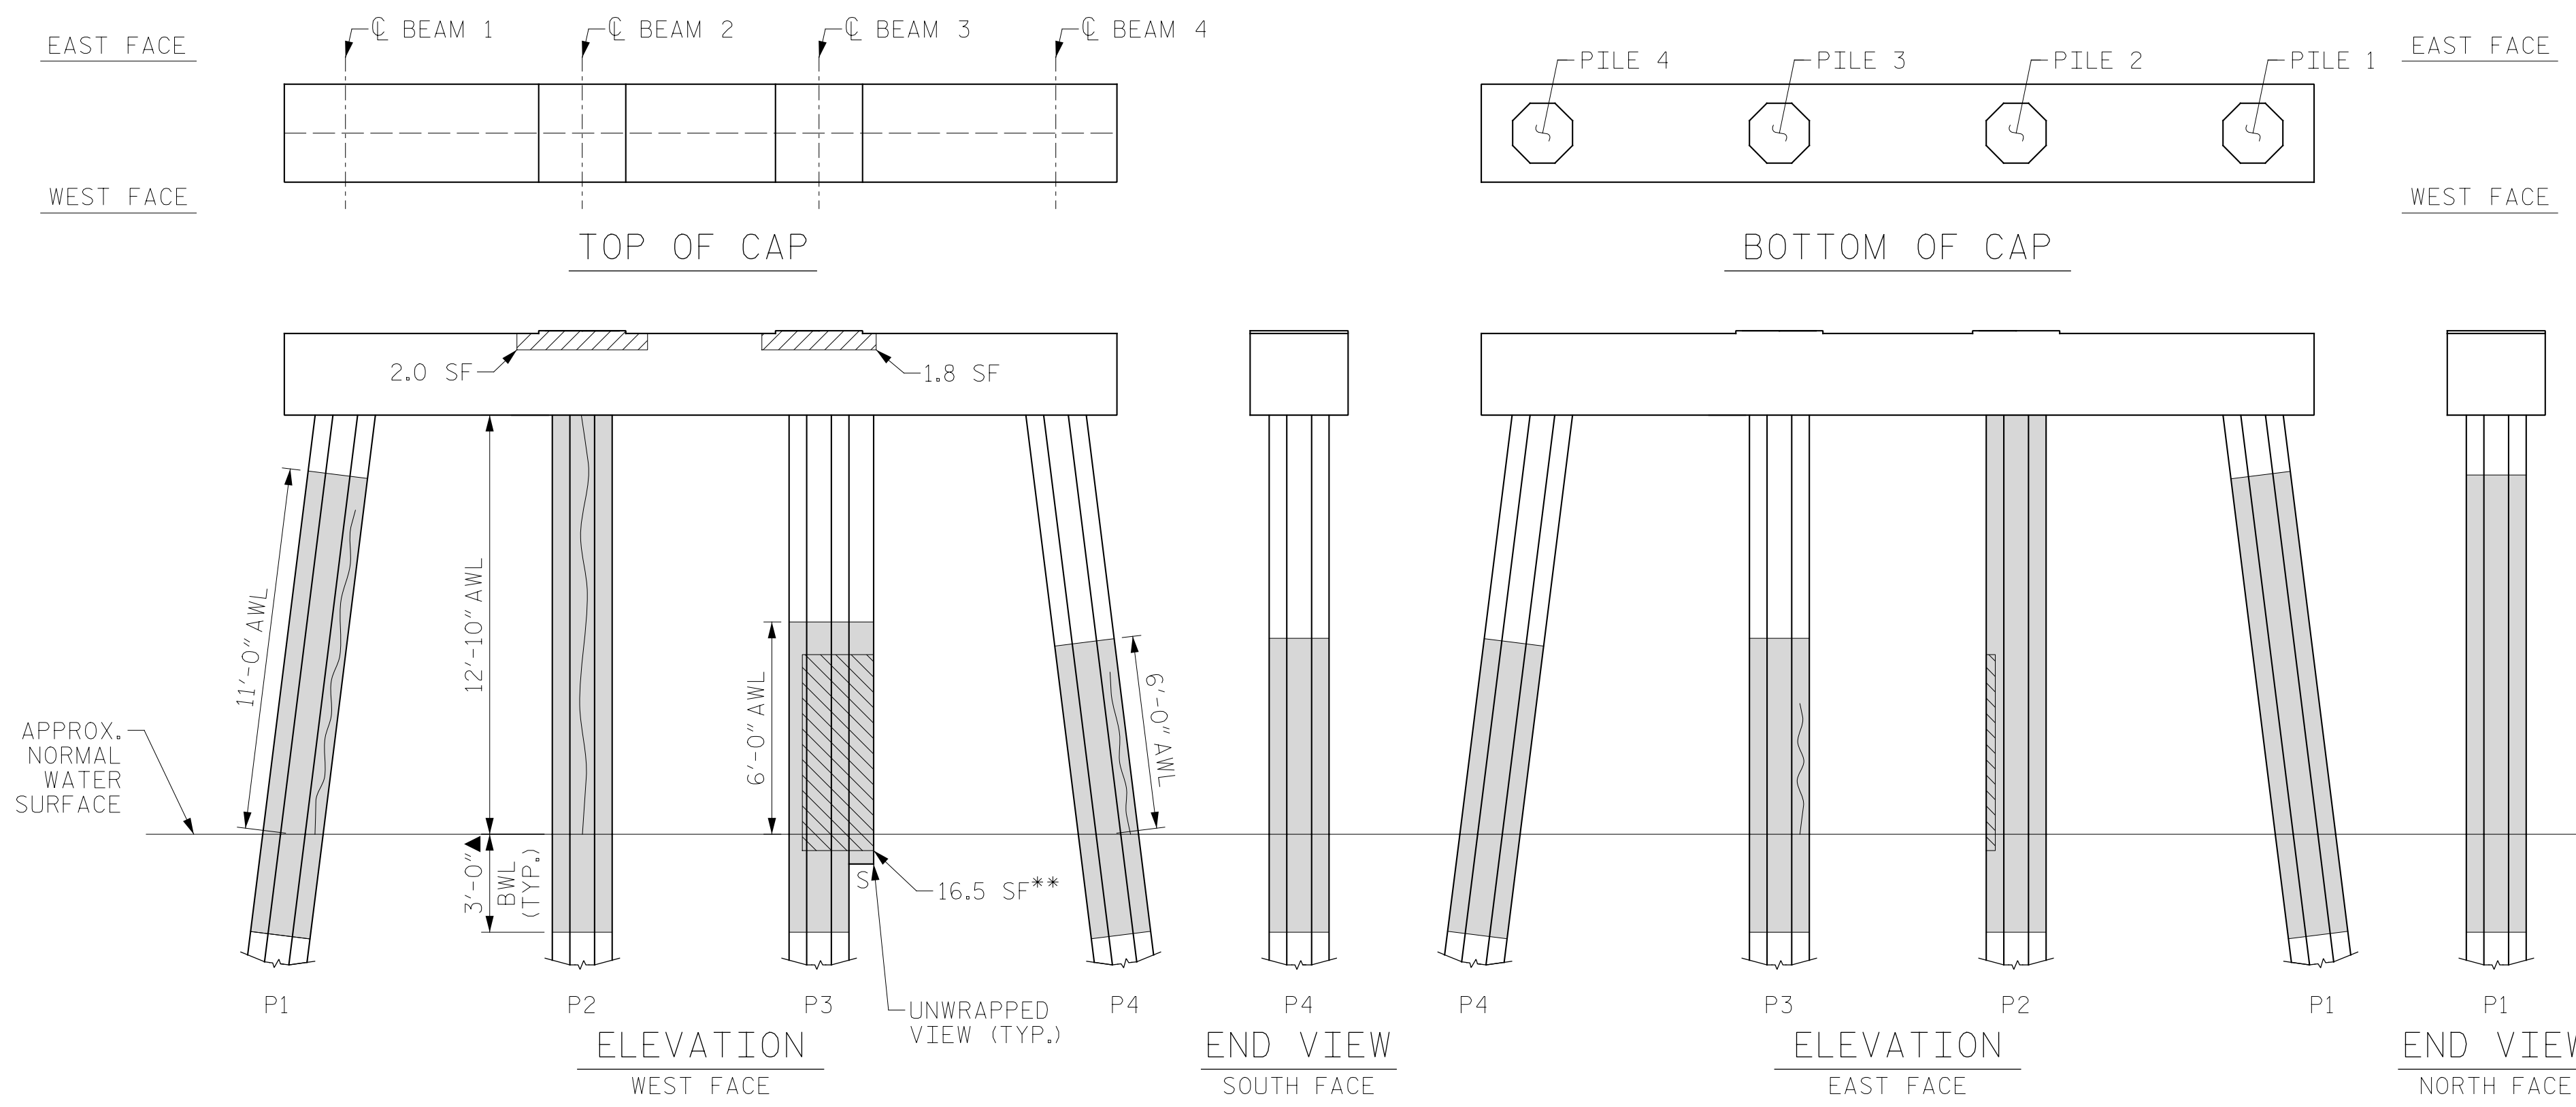
BENT 242

CAP REPAIRS			
SHOTCRETE REPAIRS	3.8 SF	1.9 CF	SF CF
EPOXY RESIN INJECTION	- LF		LF
PILE REPAIRS			
PILE CONCRETE RESTORATION	16.5 SF	6.6 CF	SF CF
FRP PROTECTIVE SYSTEM AWL	197.1 SF		
FRP PROTECTIVE SYSTEM BWL	66.0 SF
