AS-BUILT REPAIR QUANTITY TABLE

PROJECT NO. HB-0017  
DARE COUNTY  
BRIDGE NO. 270009

STATE OF NORTH CAROLINA  
DEPARTMENT OF TRANSPORTATION  
RALEIGH

BENT 245 & BENT 246

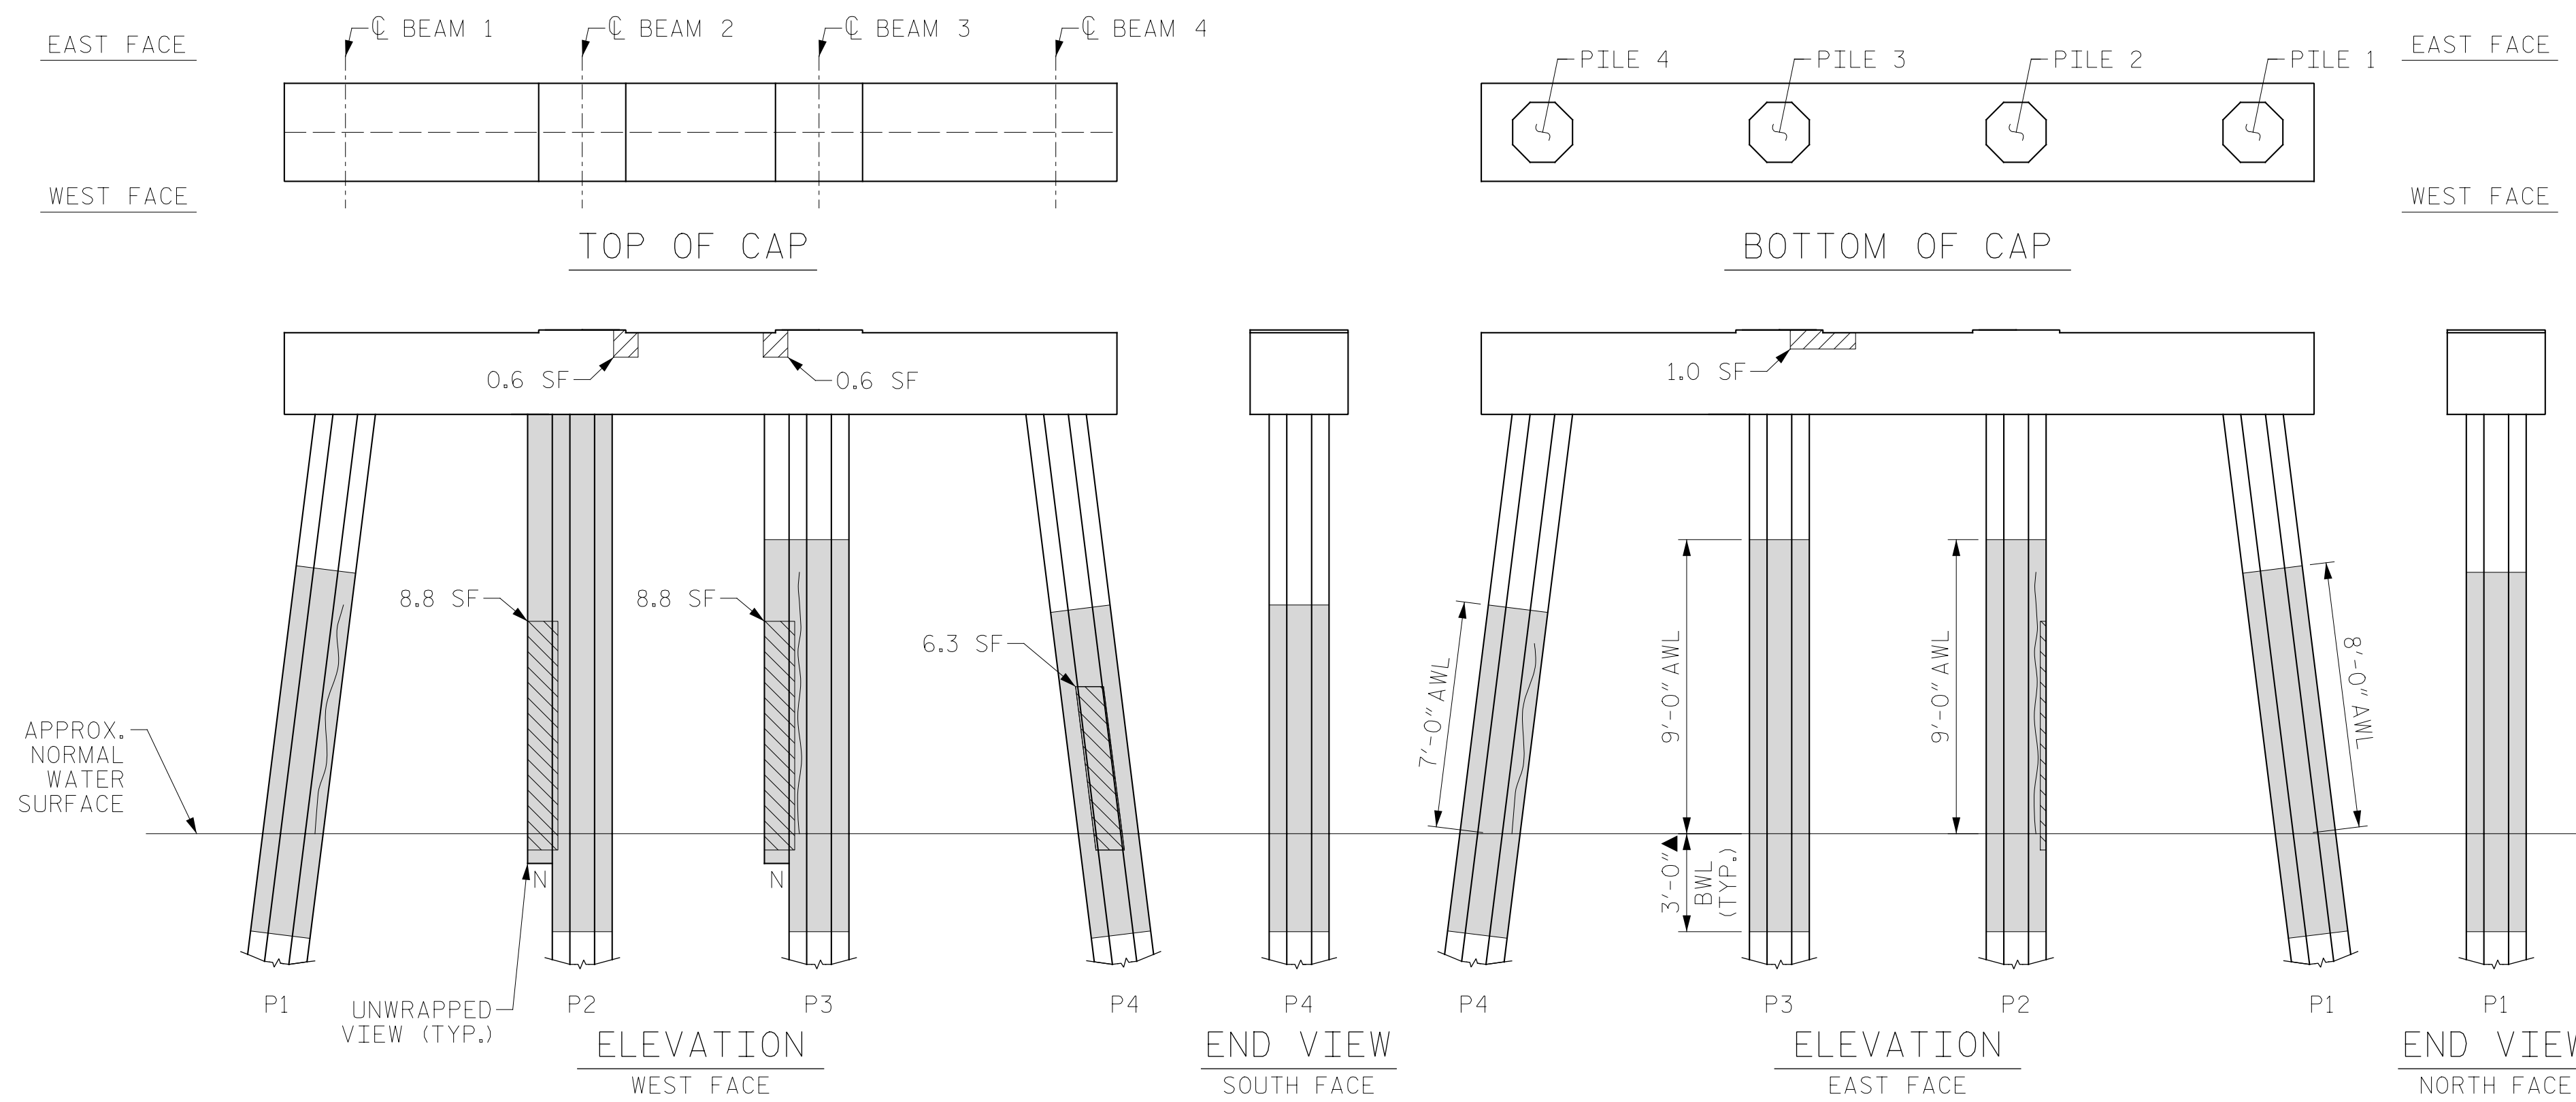
BENT 245

CAP REPAIRS			
SHOTCRETE REPAIRS	2.2 SF	1.1 CF	SF CF
EPOXY RESIN INJECTION	- LF		LF
PILE REPAIRS			
PILE CONCRETE RESTORATION	23.7 SF	10.1 SF	SF CF
FRP PROTECTIVE SYSTEM AWL	181.5 SF		
FRP PROTECTIVE SYSTEM BWL	66.0 SF

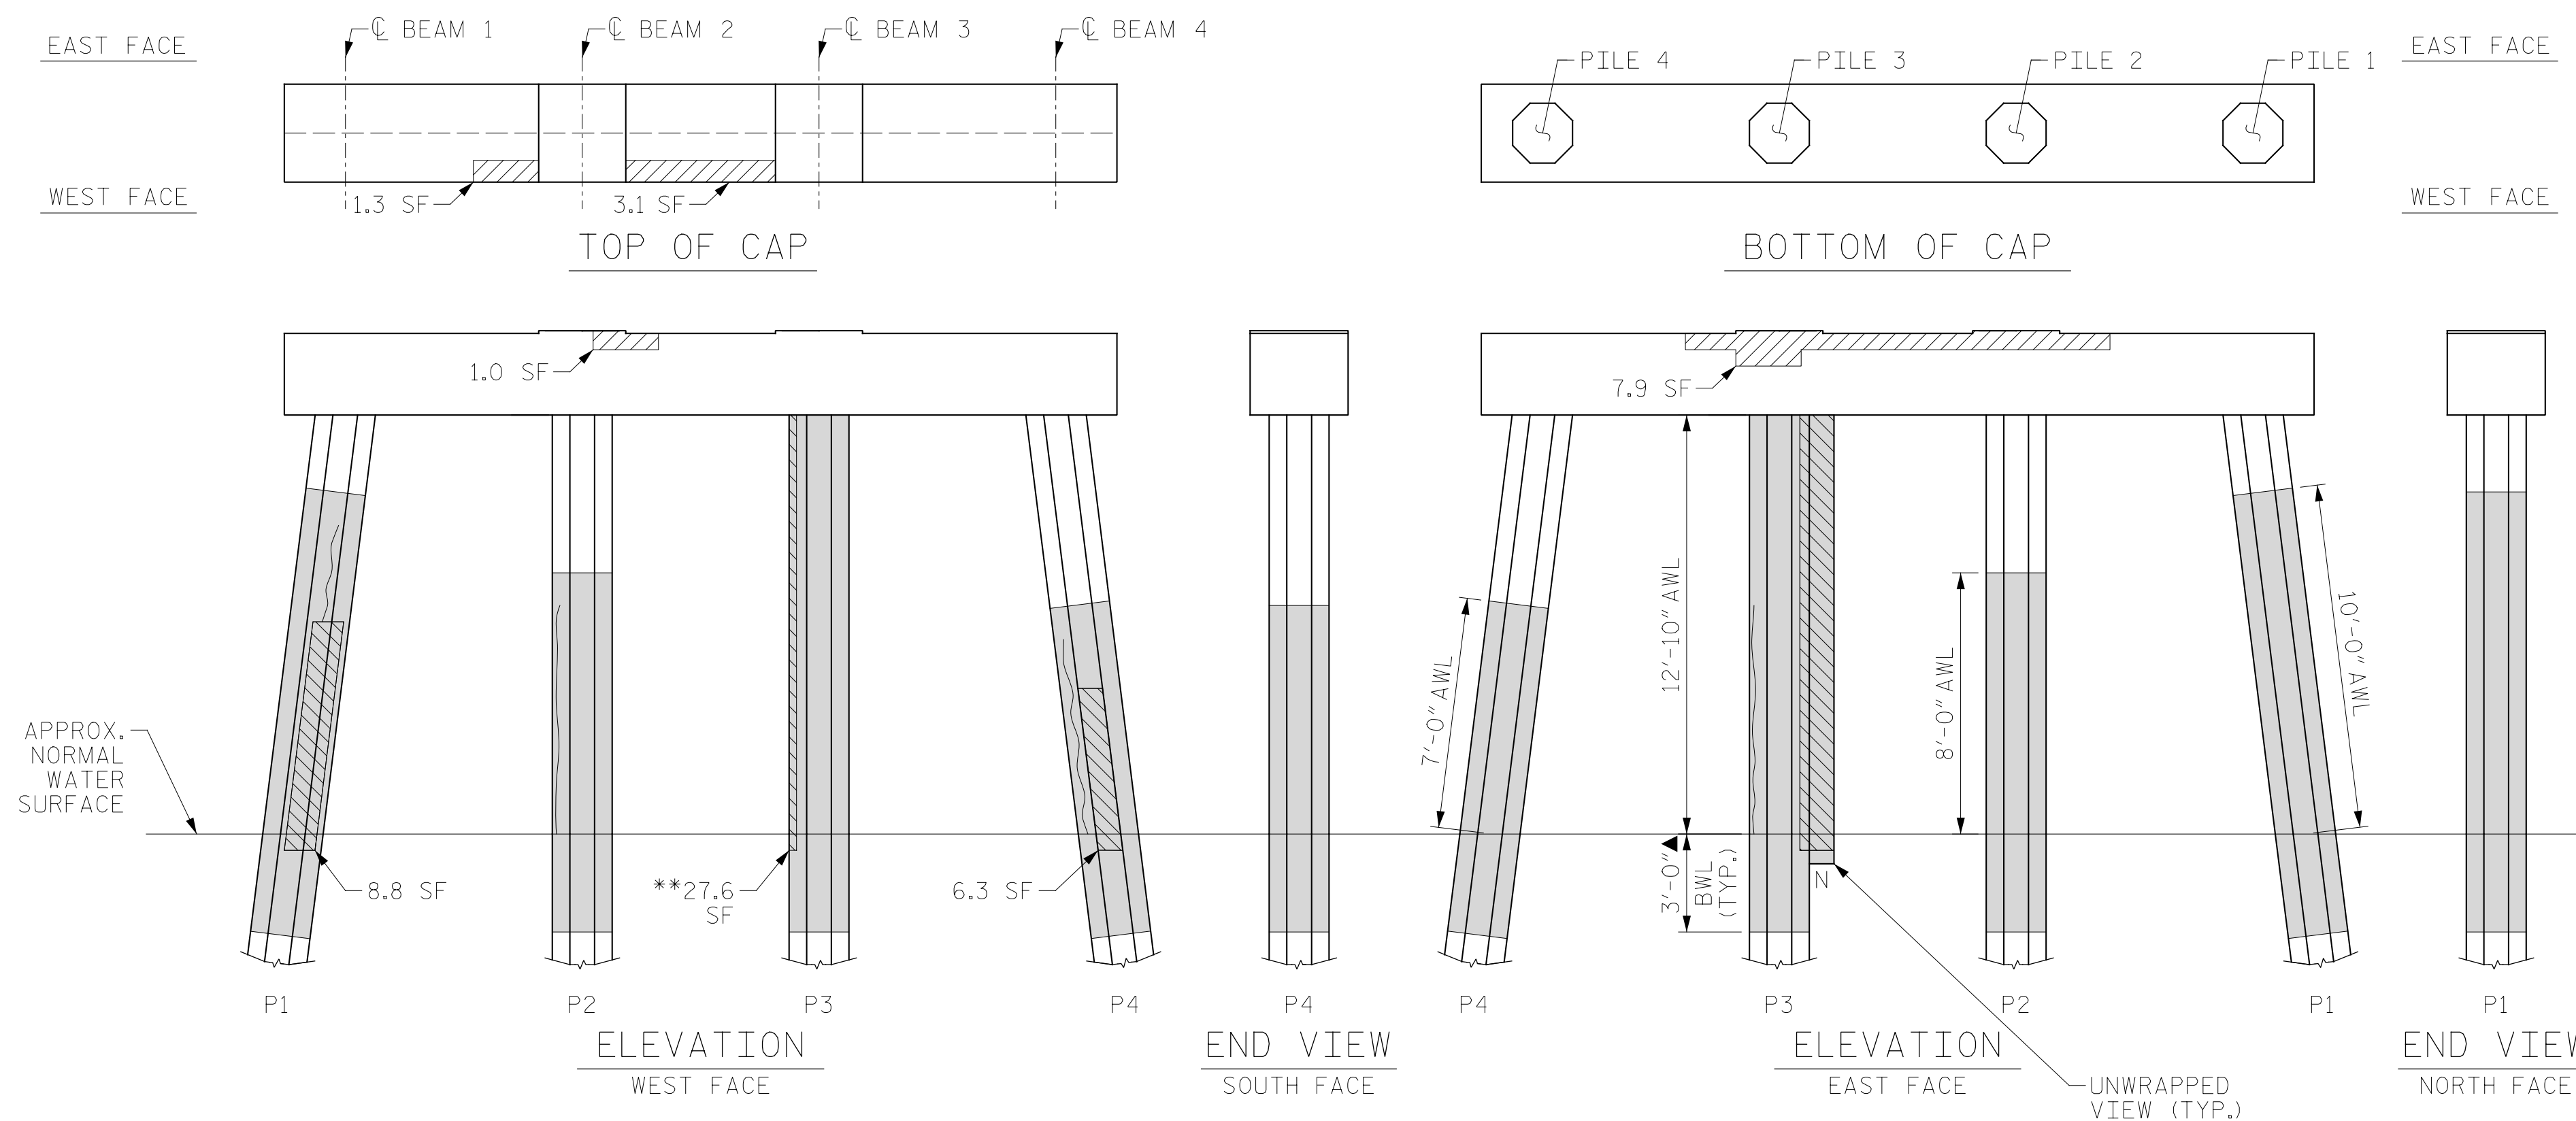
BENT 246

CAP REPAIRS			
SHOTCRETE REPAIRS	13.3 SF	6.7 CF	SF CF
EPOXY RESIN INJECTION	- LF		LF
PILE REPAIRS			
PILE CONCRETE RESTORATION	42.6 SF	17.3 CF	SF CF
FRP PROTECTIVE SYSTEM AWL	213.6 SF		
FRP PROTECTIVE SYSTEM BWL	66.0 SF
