AS-BUILT REPAIR QUANTITY TABLE

270009 BRIDGE NO._

STATE OF NORTH CAROLINA DEPARTMENT OF TRANSPORTATION RALEIGH

BENT 247 & BENT 248

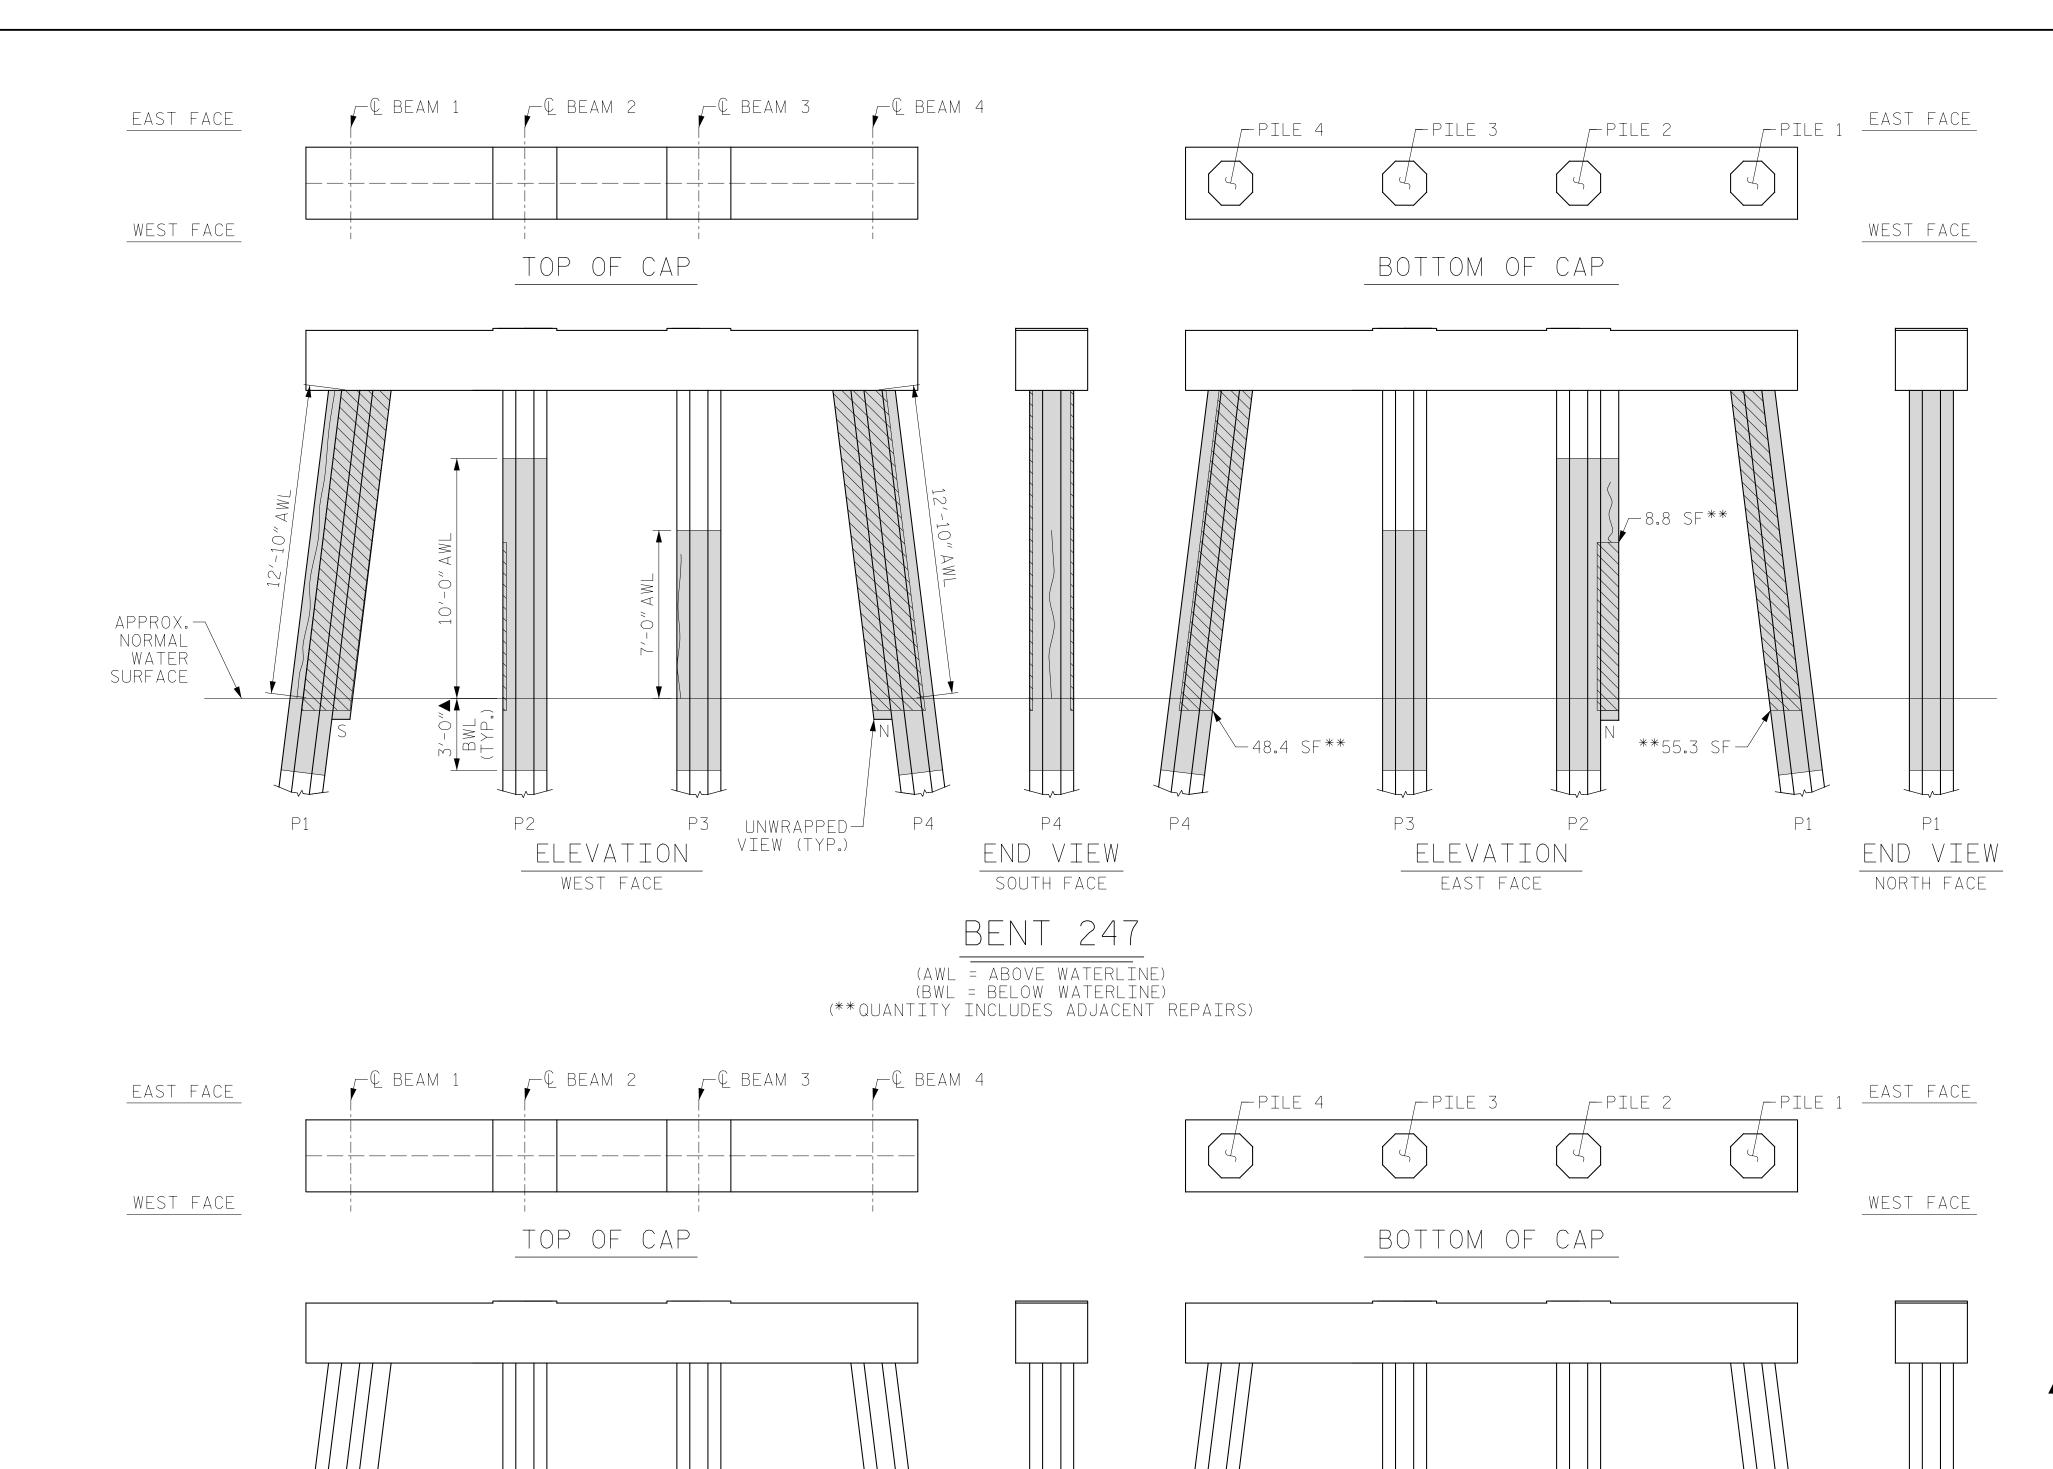
ESTIMATED PILE CRACK QTY. TABLE										
		NW	W	SW	S	SE	E	NE	N	
BENT 247	PILE 1	9	_	_	_	_	_	8	8	
	PILE 2	6	8	_	4	4	5	_	3	
	PILE 3	_	_	6	4	3	_	_	4	
	PILE 4	-	-	-	7	-	13	-	_	
BENT 248	PILE 1	_	2	_	_	3	4	_	_	
	PILE 2	7	_	4	_	_	_	_	_	
	PILE 3	7	_	_	4	_	_	_	_	
	PILE 4	_	5	4	-	3	6	_	_	
NOTE: FOR INFORMATION ON PILE CONDITION ONLY.

FOR CAP REPAIRS: VALUES IN CHART REPRESENT ESTIMATED REPAIR TOTALS

(AWL = ABOVE WATERLINE)
(BWL = BELOW WATERLINE)
(**QUANTITY INCLUDES ADJACENT REPAIRS)

AFTER REMOVAL OF UNSOUND CONCRETE, MIN. OF 1"BEHIND REBAR AND MIN. 2

FOR CONCRETE REPAIR DETAILS, SEE "TYPICAL CAP, COLUMN & UNDERDECK

FOR FRP PROTECTIVE SYSTEM DETAILS AND UNDERWATER MORTAR REPAIRS,

REPAIR DETAILS" & "PILE CONCRETE RESTORATION DETAILS" SHEETS.

SEE "PILE FRP PROTECTIVE SYSTEM DETAILS" SHEET.
