HB-0017 PROJECT NO.___ DARE COUNTY

270009 BRIDGE NO. .

STATE OF NORTH CAROLINA DEPARTMENT OF TRANSPORTATION RALEIGH

BENT 249 & BENT 250

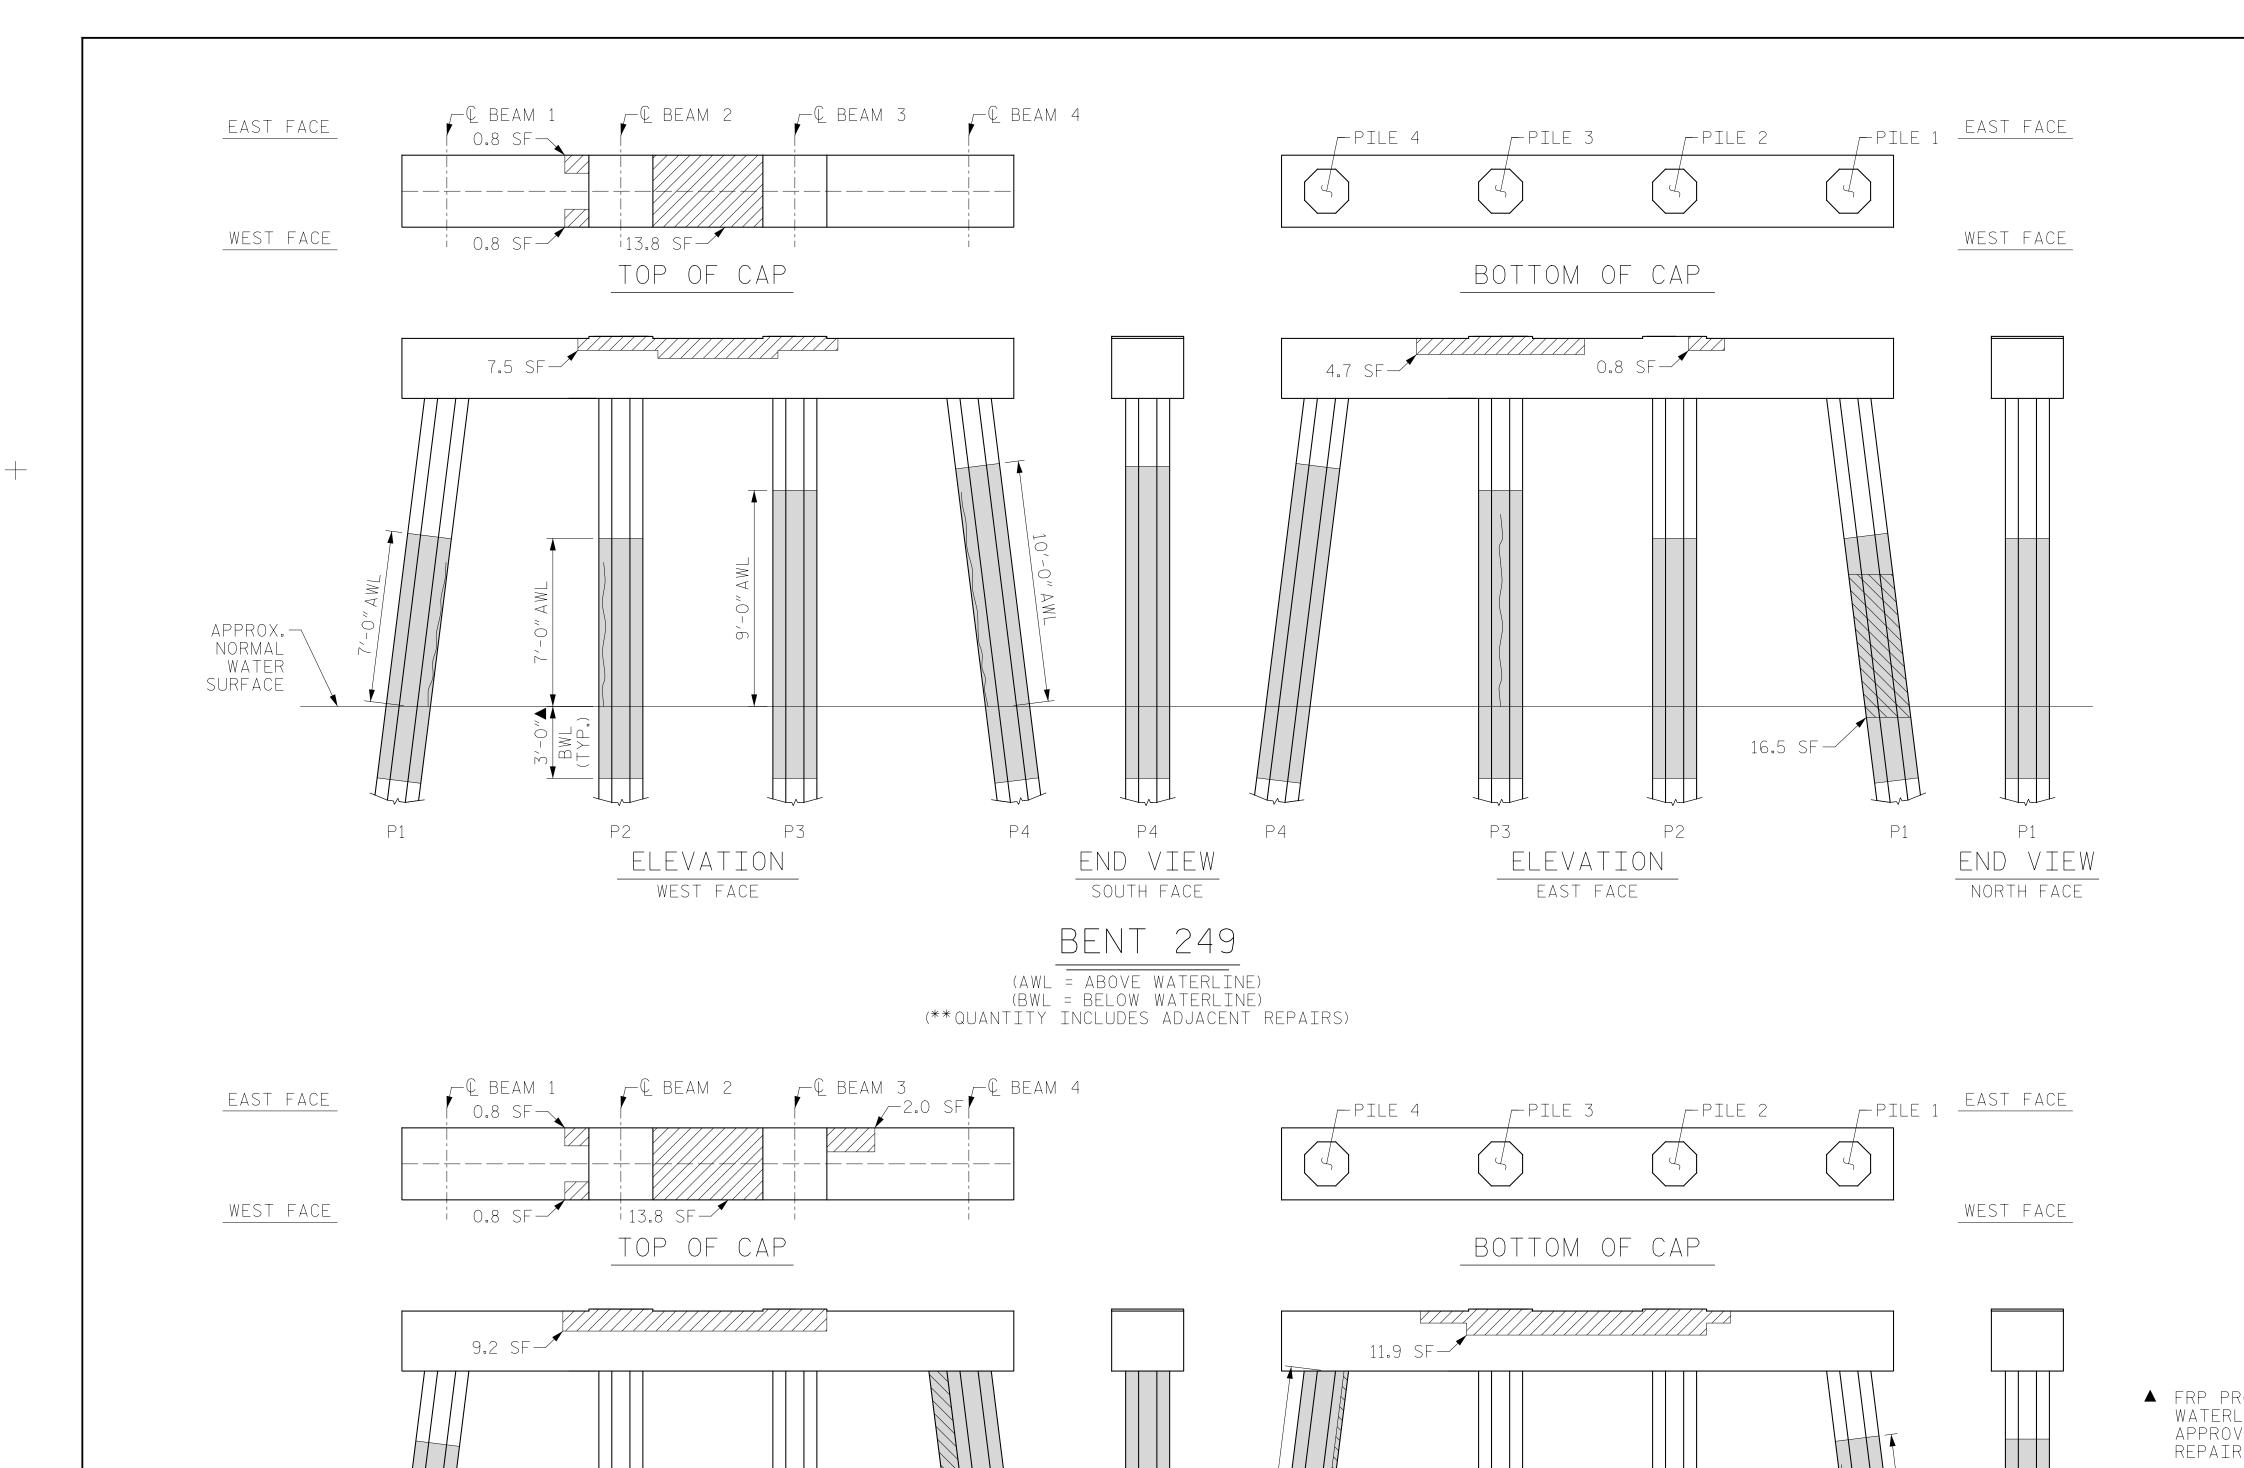
ESTIMATED PILE CRACK QTY. TABLE NW W SW S SE E NE N BENT 249 | 4 | - | 3 | 6 | 8 | 8 | 8 BENT 250

NOTE: FOR INFORMATION ON PILE CONDITION ONLY.

FOR CONCRETE REPAIR DETAILS, SEE "TYPICAL CAP, COLUMN & UNDERDECK REPAIR DETAILS" & "PILE CONCRETE RESTORATION DETAILS" SHEETS.

FOR FRP PROTECTIVE SYSTEM DETAILS AND UNDERWATER MORTAR REPAIRS,

SEE "PILE FRP PROTECTIVE SYSTEM DETAILS" SHEET.
