AS-BUILT REPAIR QUANTITY TABLE

PROJECT NO. HB-0017  
DARE COUNTY  
BRIDGE NO. 270009

BENT 253 & BENT 254

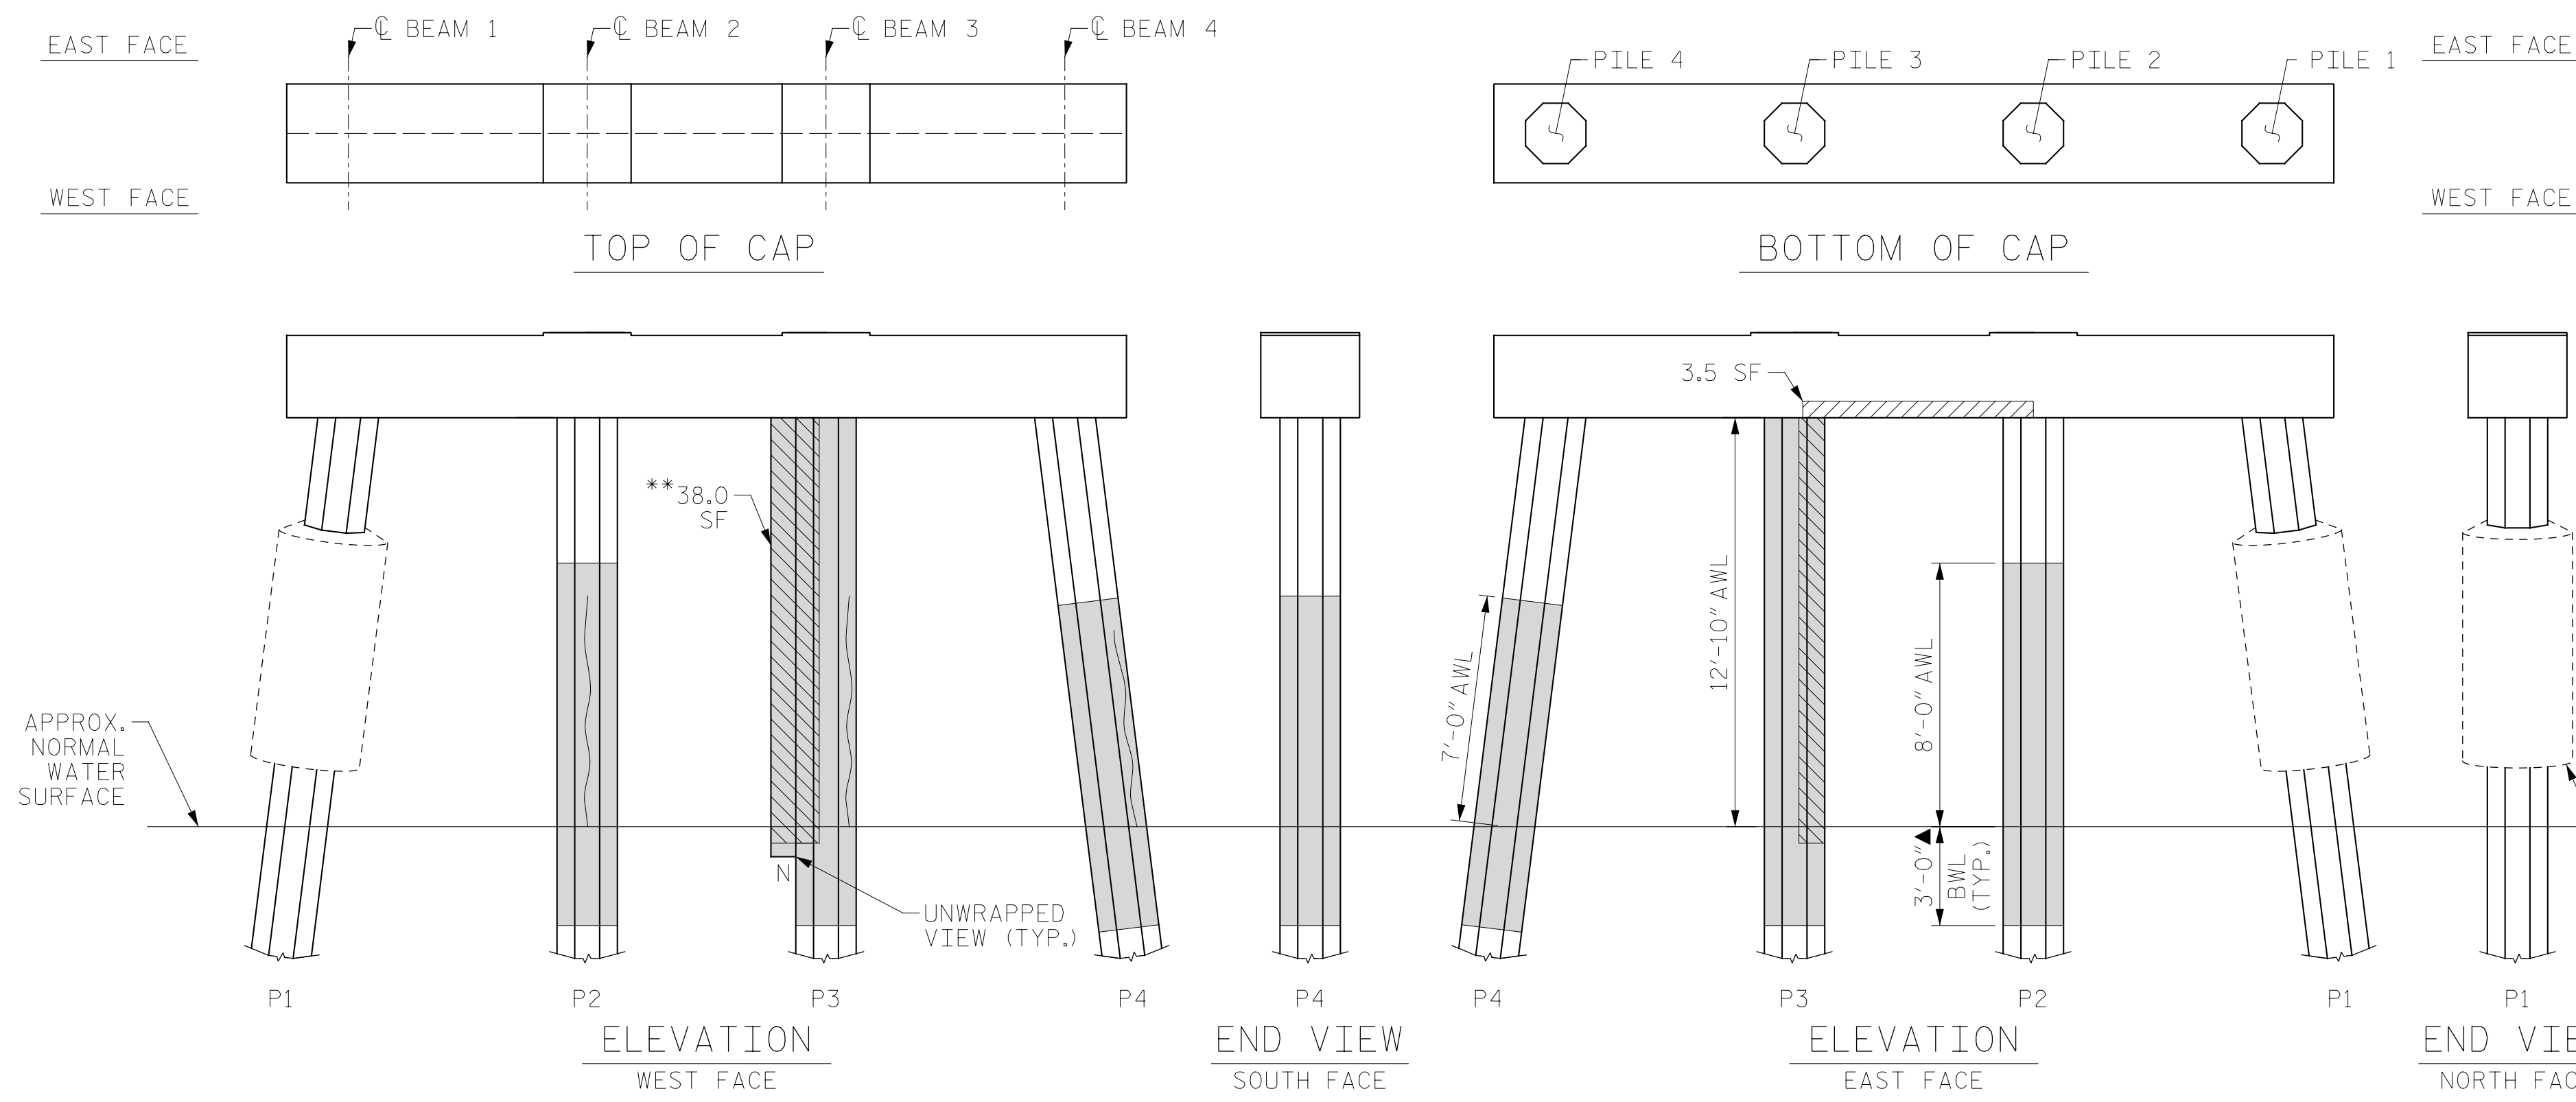
BENT 253

CAP REPAIRS			
SHOTCRETE REPAIRS	3.5 SF	1.8 CF	SF CF
EPOXY RESIN INJECTION	- LF		LF
PILE REPAIRS			
PILE CONCRETE RESTORATION	38.0 SF	15.1 CF	SF CF
FRP PROTECTIVE SYSTEM AWL	153.1 SF		
FRP PROTECTIVE SYSTEM BWL	49.5 SF

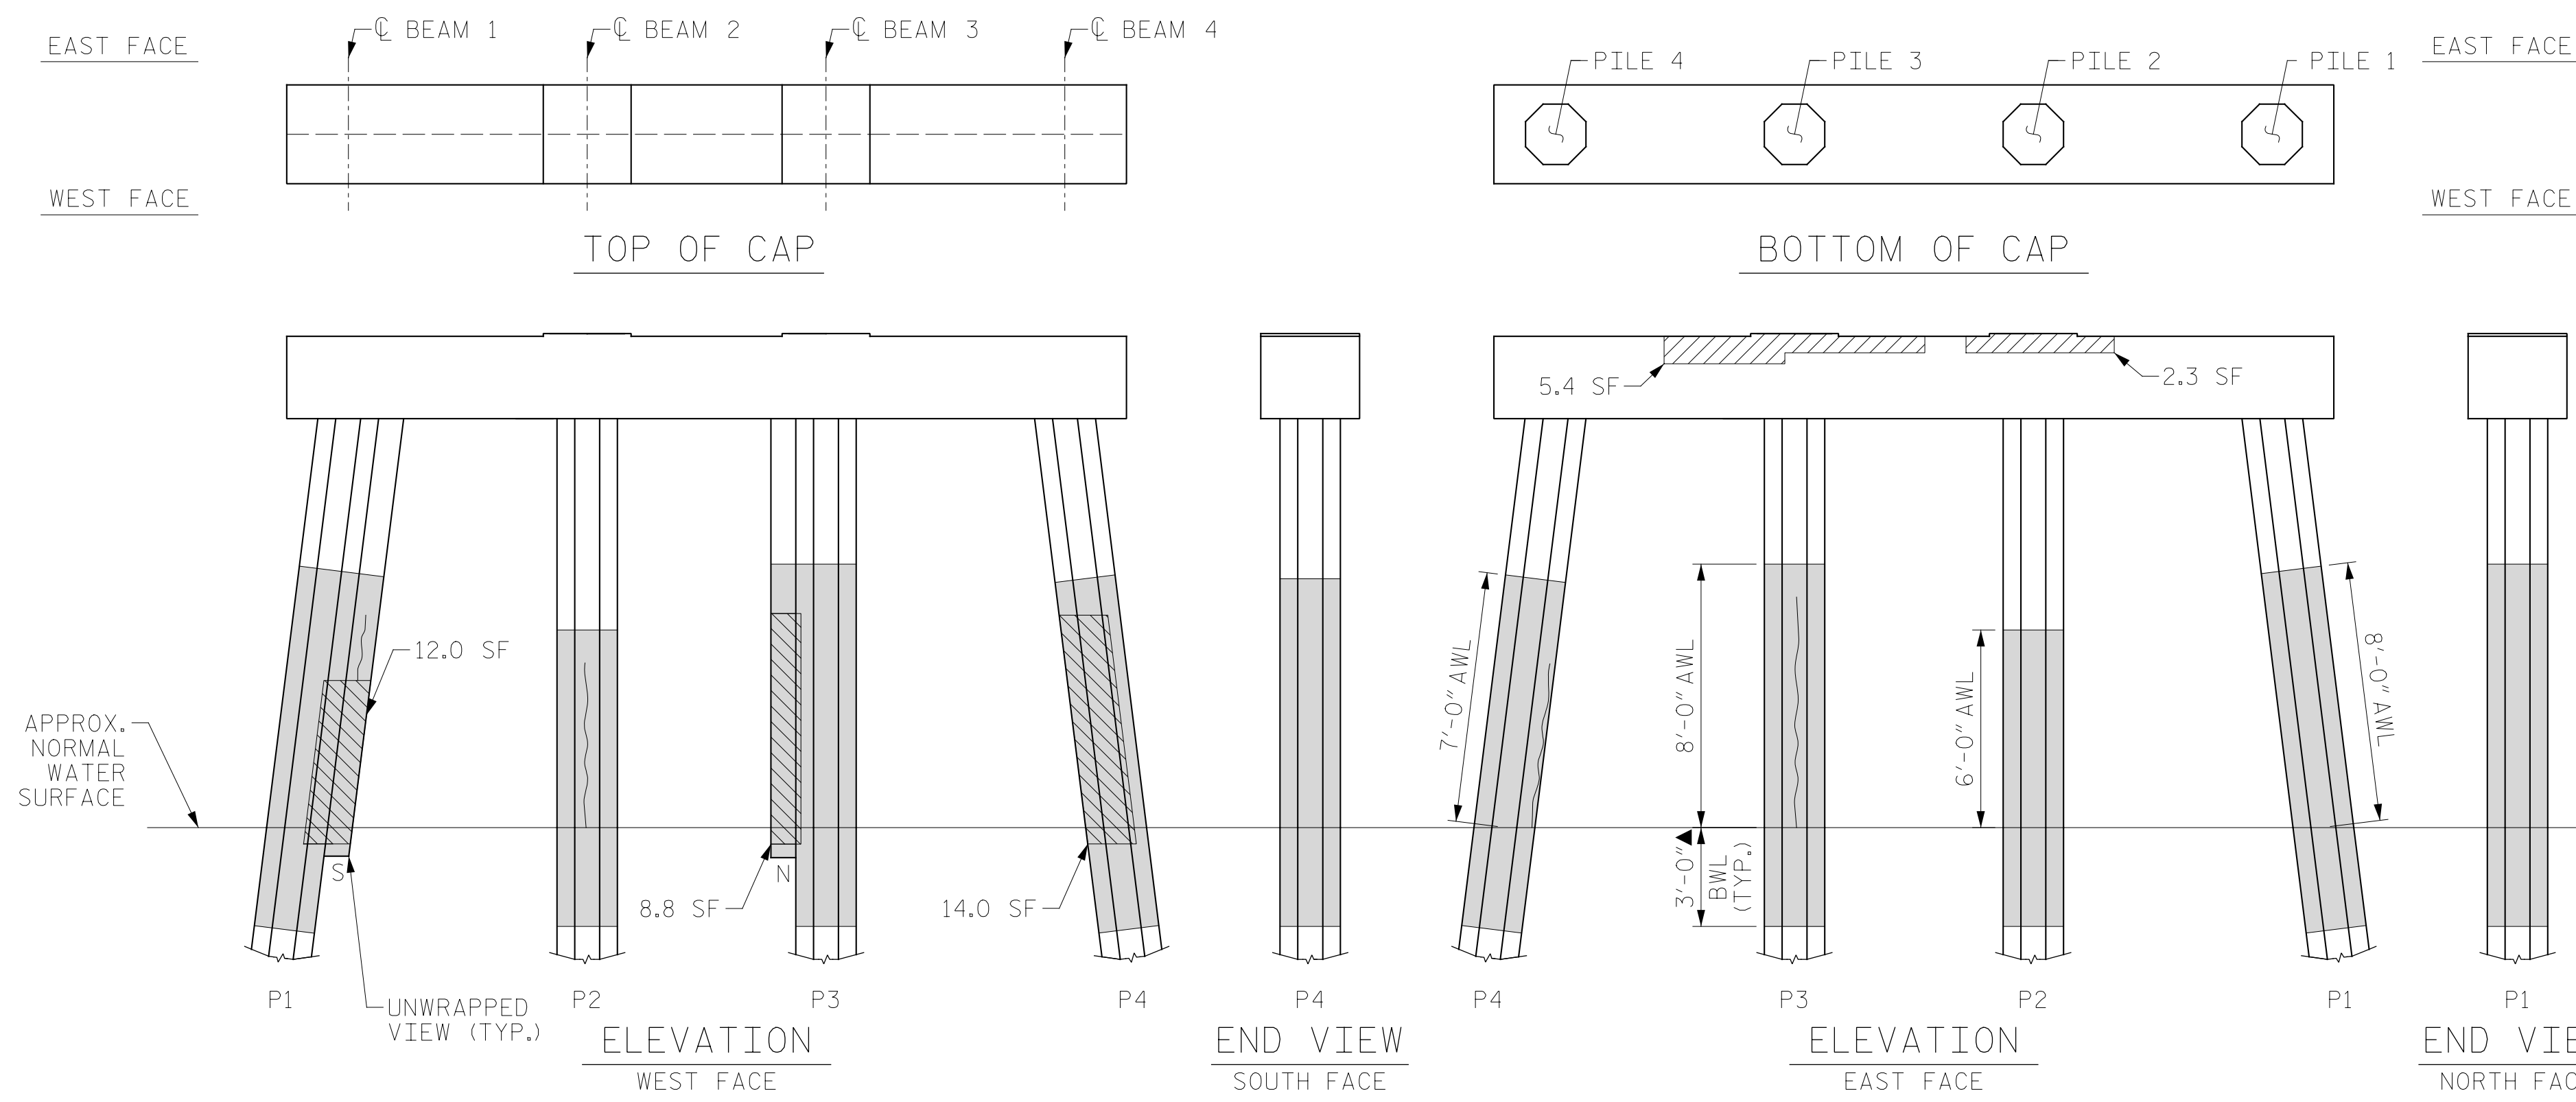
BENT 254

CAP REPAIRS			
SHOTCRETE REPAIRS	7.7 SF	3.9 CF	SF CF
EPOXY RESIN INJECTION	- LF		LF
PILE REPAIRS			
PILE CONCRETE RESTORATION	34.8 SF	14.0 CF	SF CF
FRP PROTECTIVE SYSTEM AWL	159.5 SF		
FRP PROTECTIVE SYSTEM BWL	66.0 SF
