AS-BUILT REPAIR QUANTITY TABLE

PROJECT NO. HB-0017
DARE COUNTY
BRIDGE NO. 270009

BENT 255 & BENT 256

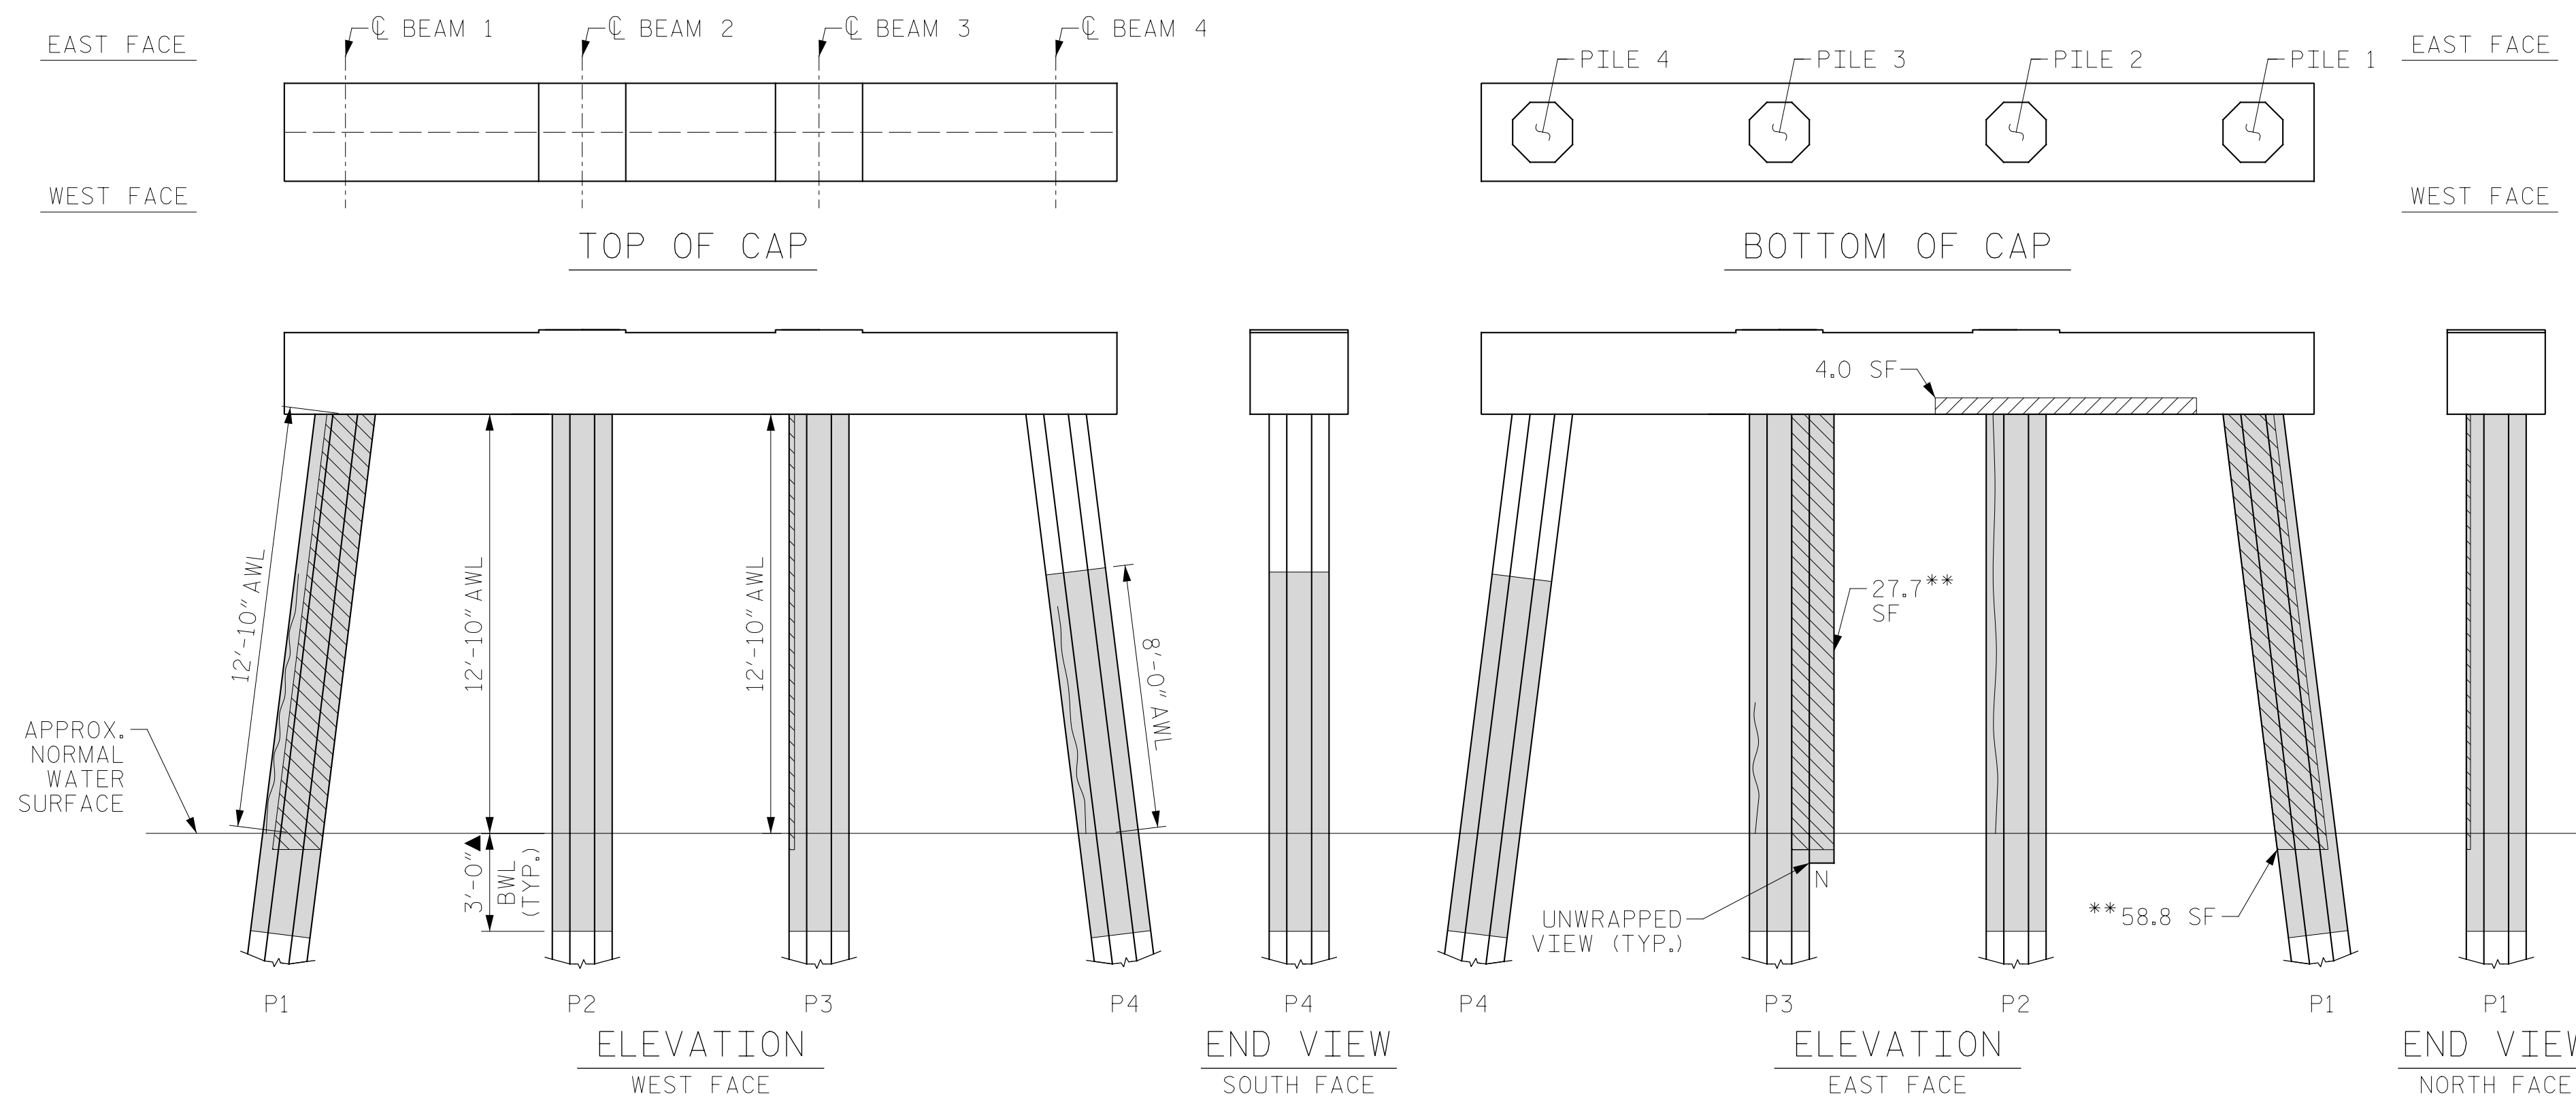
BENT 255

CAP REPAIRS				
SHOTCRETE REPAIRS	4.0 SF	2.0 CF	SF	CF
EPOXY RESIN INJECTION	- LF			LF
PILE REPAIRS				
PILE CONCRETE RESTORATION	86.4 SF	33.1 CF	SF	CF
FRP PROTECTIVE SYSTEM AWL	255.8 SF			
FRP PROTECTIVE SYSTEM BWL	66.0 SF

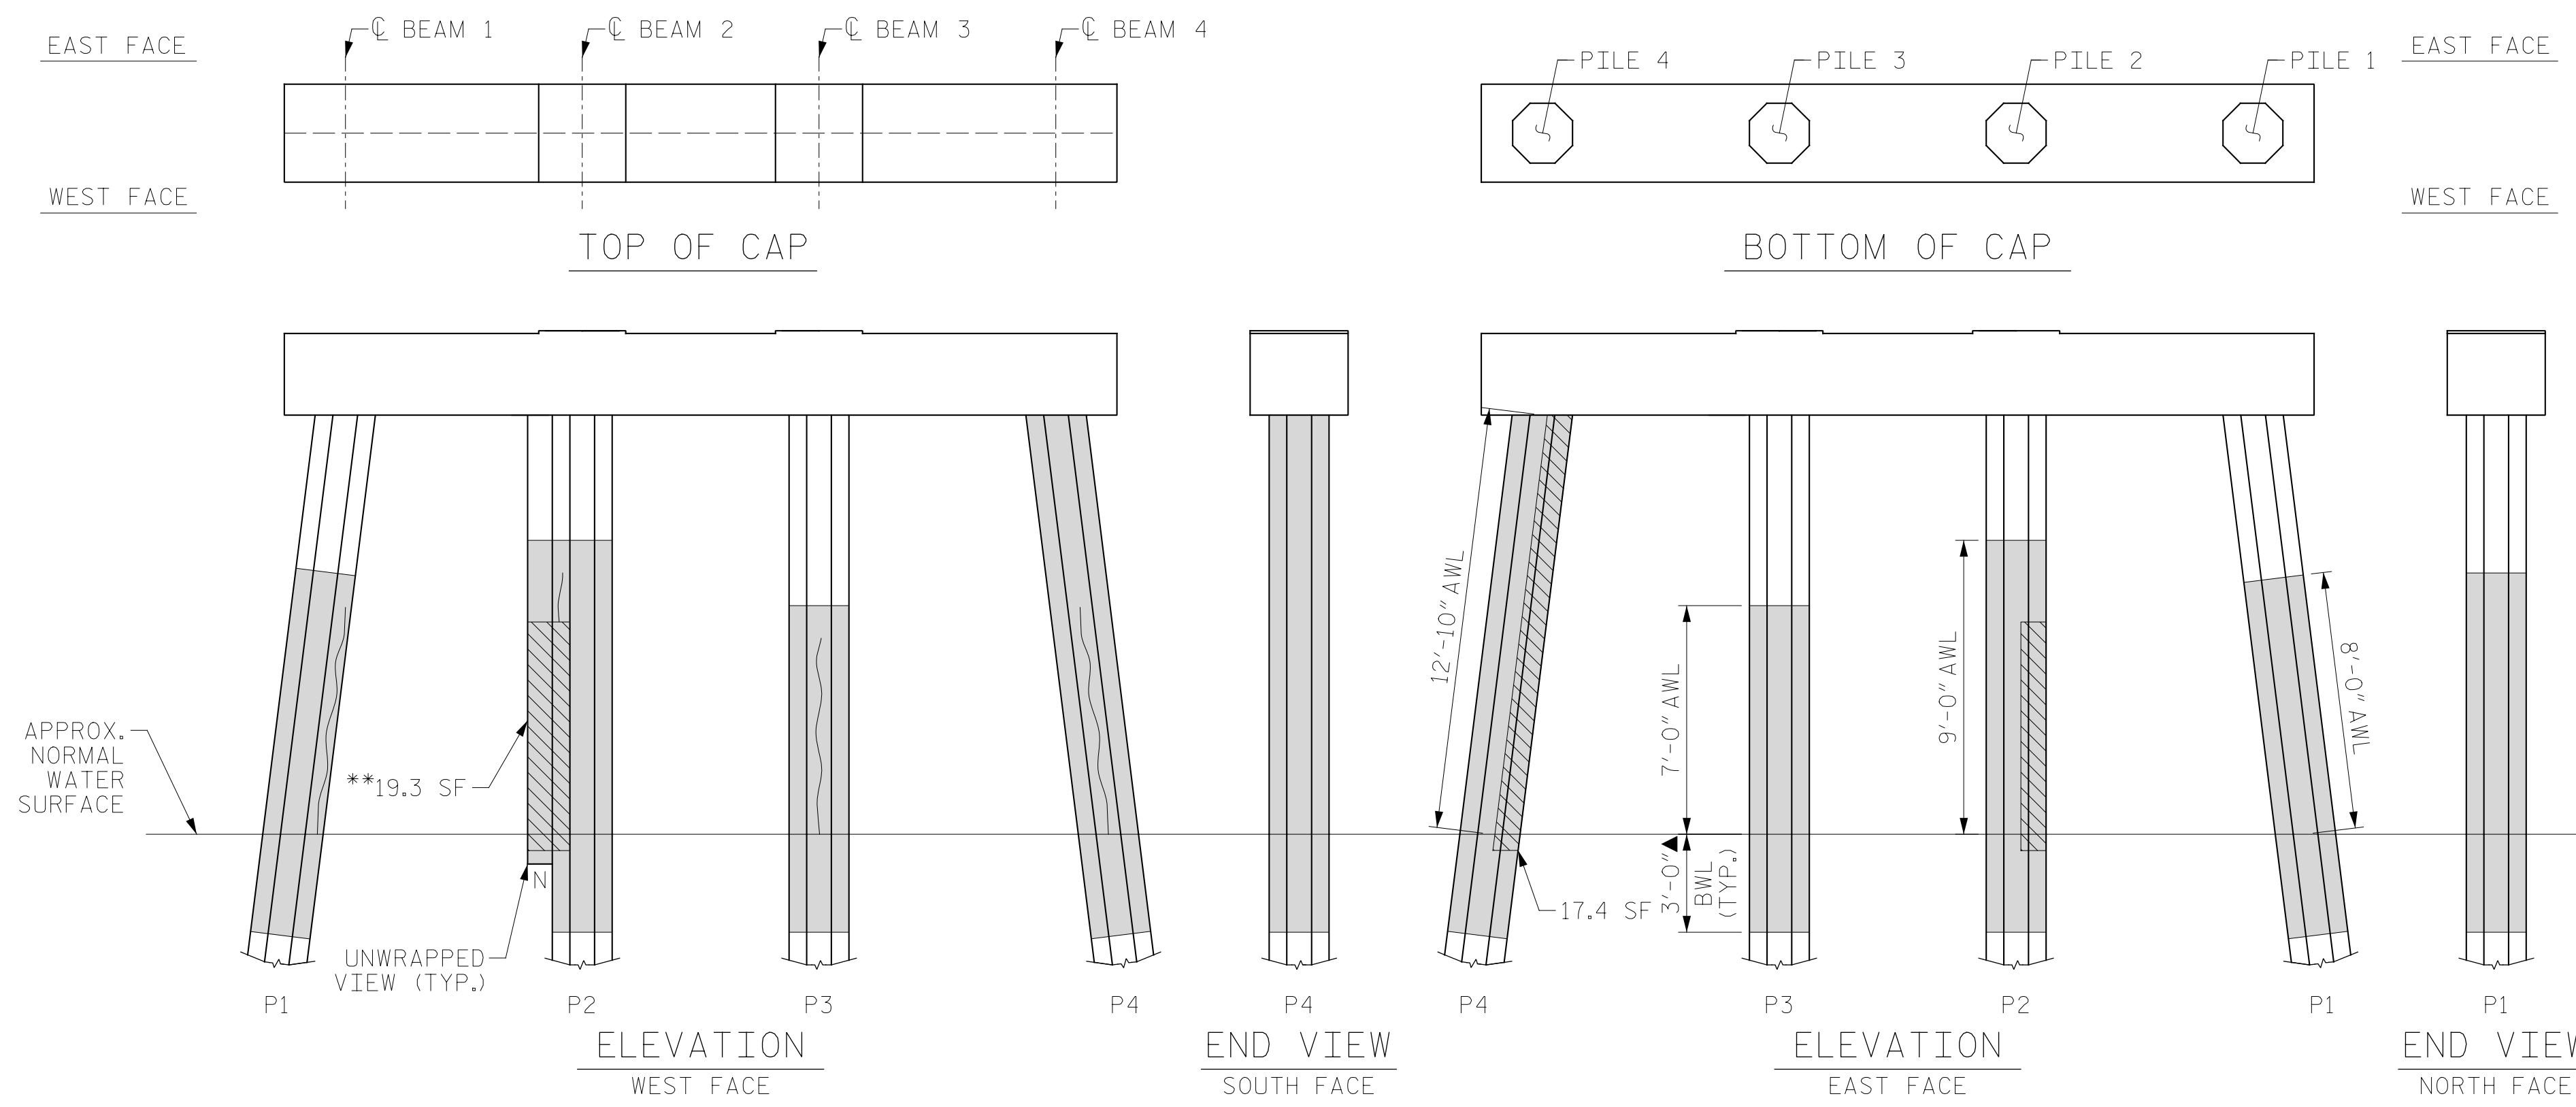
BENT 256

CAP REPAIRS				
SHOTCRETE REPAIRS	- SF	- CF	SF	CF
EPOXY RESIN INJECTION	- LF			LF
PILE REPAIRS				
PILE CONCRETE RESTORATION	36.5 SF	15.0 CF	SF	CF
FRP PROTECTIVE SYSTEM AWL	202.6 SF			
FRP PROTECTIVE SYSTEM BWL	66.0 SF
