AS-BUILT REPAIR QUANTITY TABLE

PROJECT NO. HB-0017  
DARE COUNTY  
BRIDGE NO. 270009

BENT 257 & BENT 258

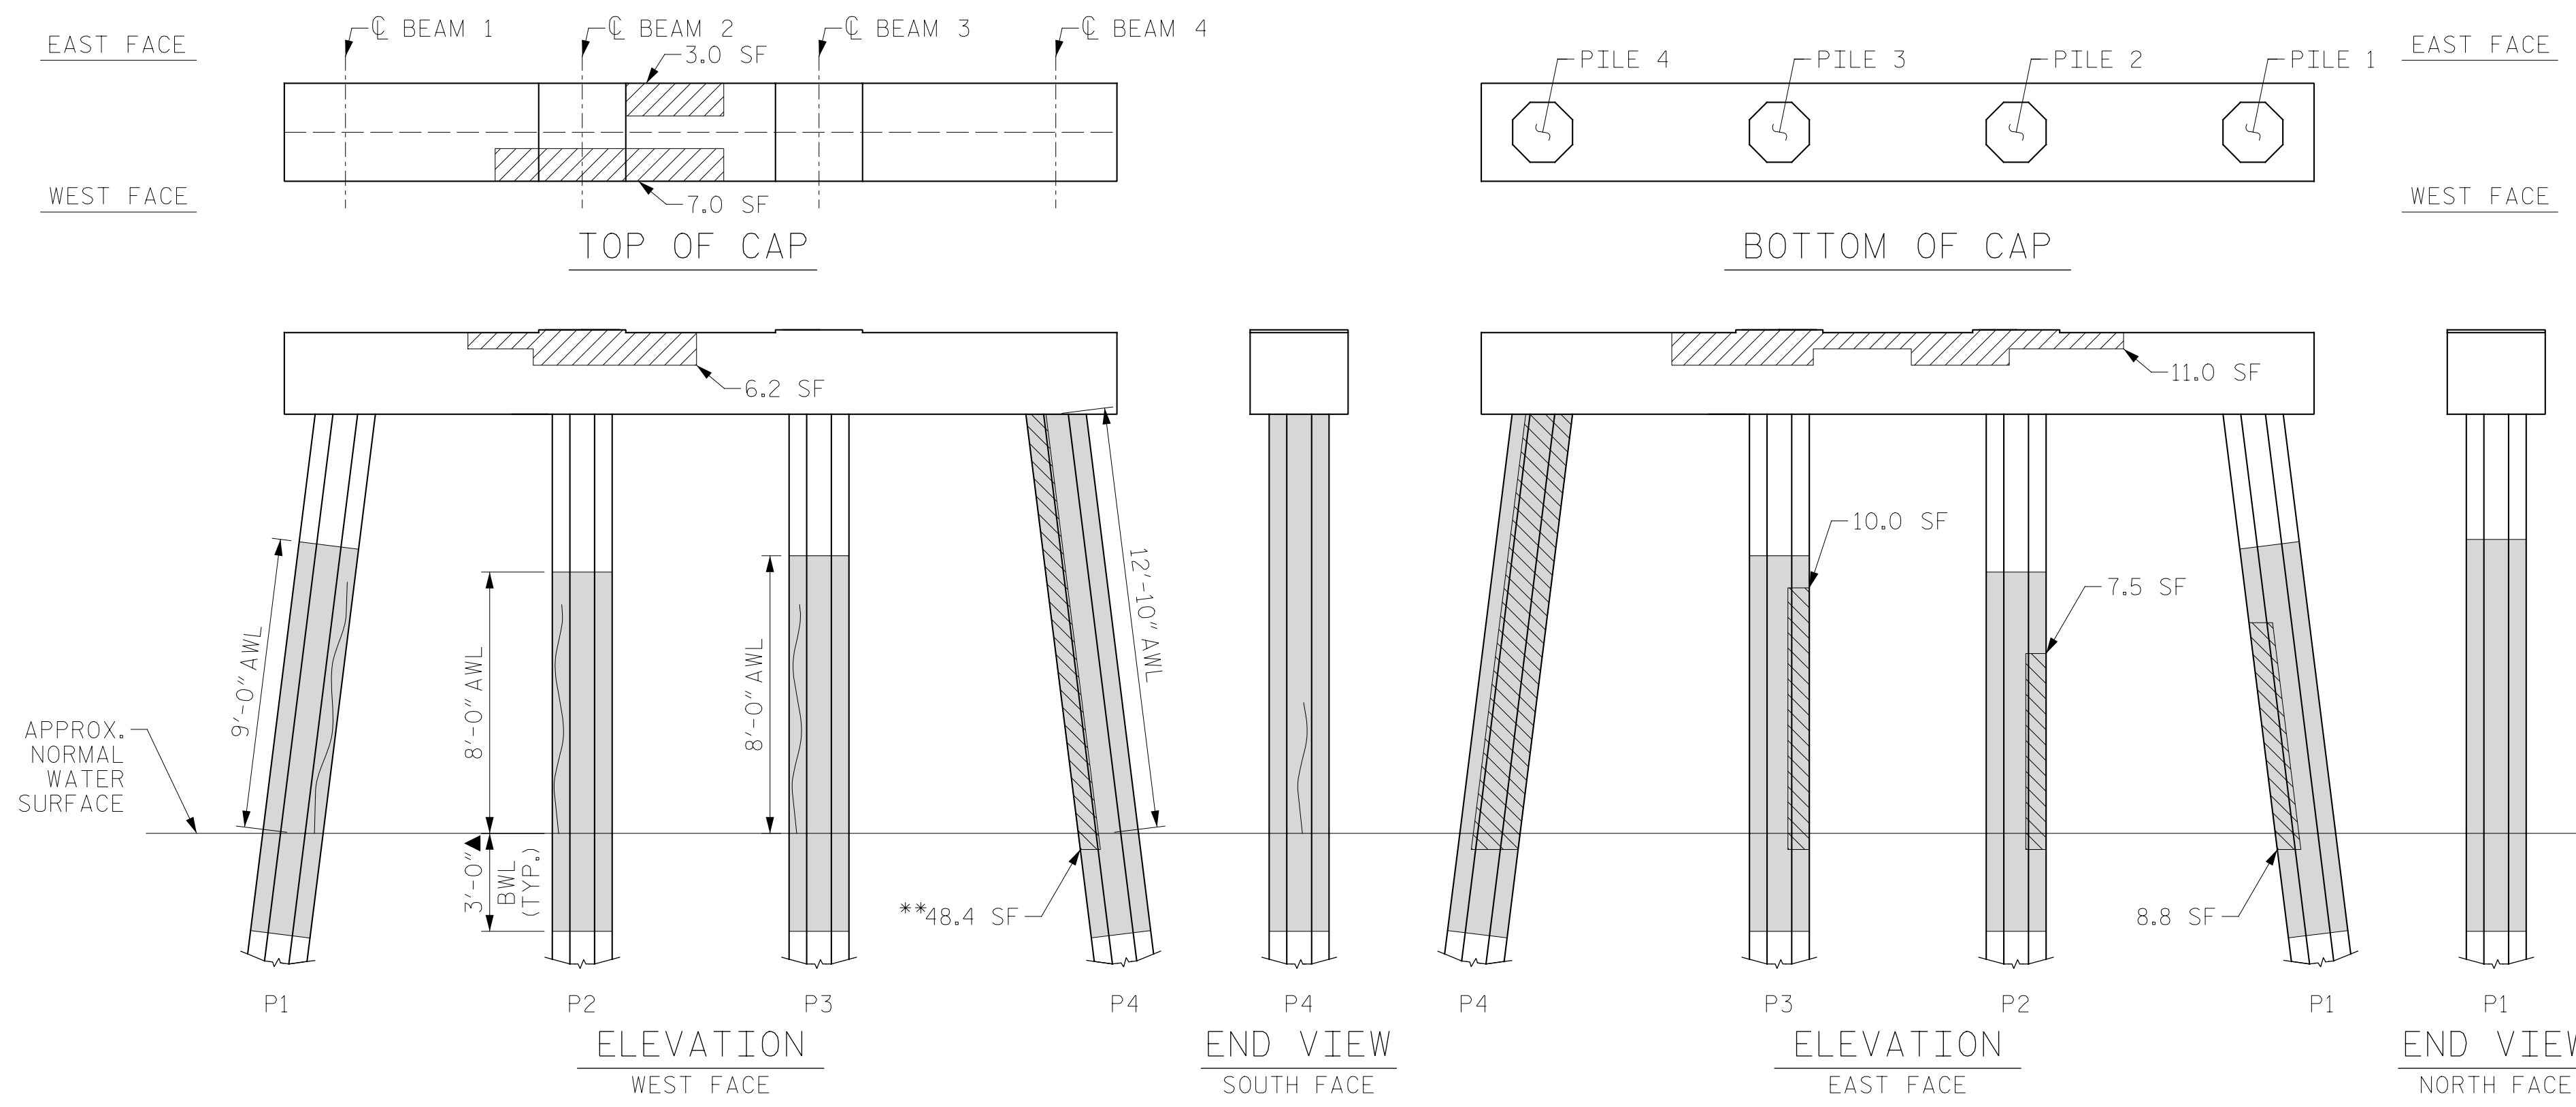
BENT 257

CAP REPAIRS			
SHOTCRETE REPAIRS	27.2 SF	13.6 CF	
EPOXY RESIN INJECTION	- LF		
PILE REPAIRS			
PILE CONCRETE RESTORATION	74.7 SF	29.0 CF	
FRP PROTECTIVE SYSTEM AWL	208.1 SF		
FRP PROTECTIVE SYSTEM BWL	66.0 SF

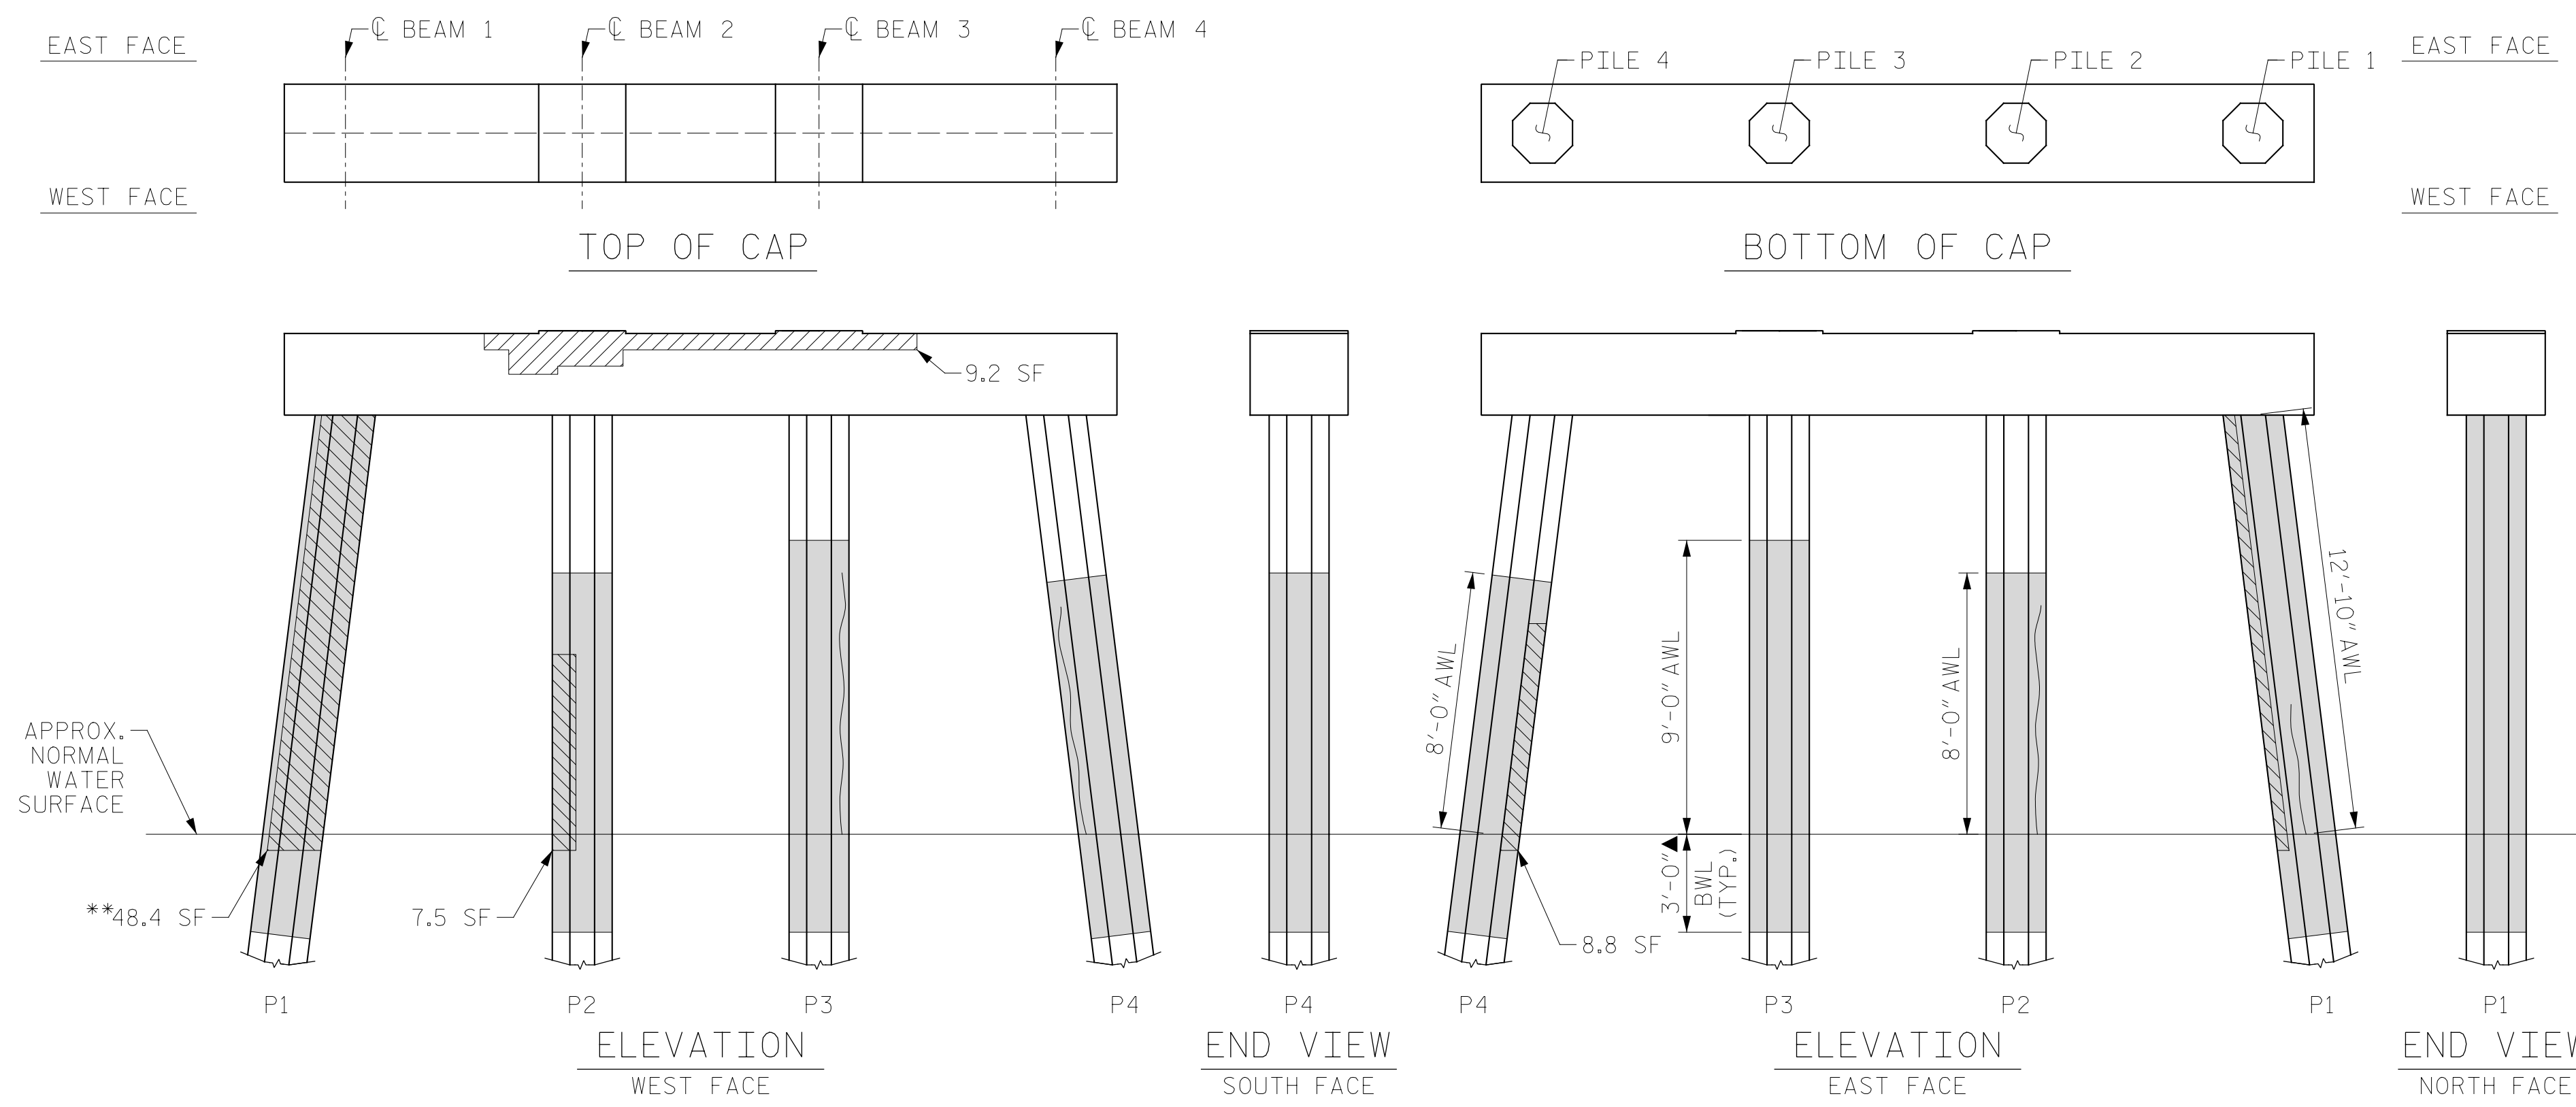
BENT 258

CAP REPAIRS			
SHOTCRETE REPAIRS	9.2 SF	4.6 CF	
EPOXY RESIN INJECTION	- LF		
PILE REPAIRS			
PILE CONCRETE RESTORATION	64.7 SF	24.7 CF	
FRP PROTECTIVE SYSTEM AWL	208.1 SF		
FRP PROTECTIVE SYSTEM BWL	66.0 SF
