AS-BUILT REPAIR QUANTITY TABLE

PROJECT NO. HB-0017  
DARE COUNTY  
 BRIDGE NO. 270009

REVISIONS						SHEET NO.
NO.	BY:	DATE:	NO.	BY:	DATE:	S-299
1			3			TOTAL SHEETS
2			4			355

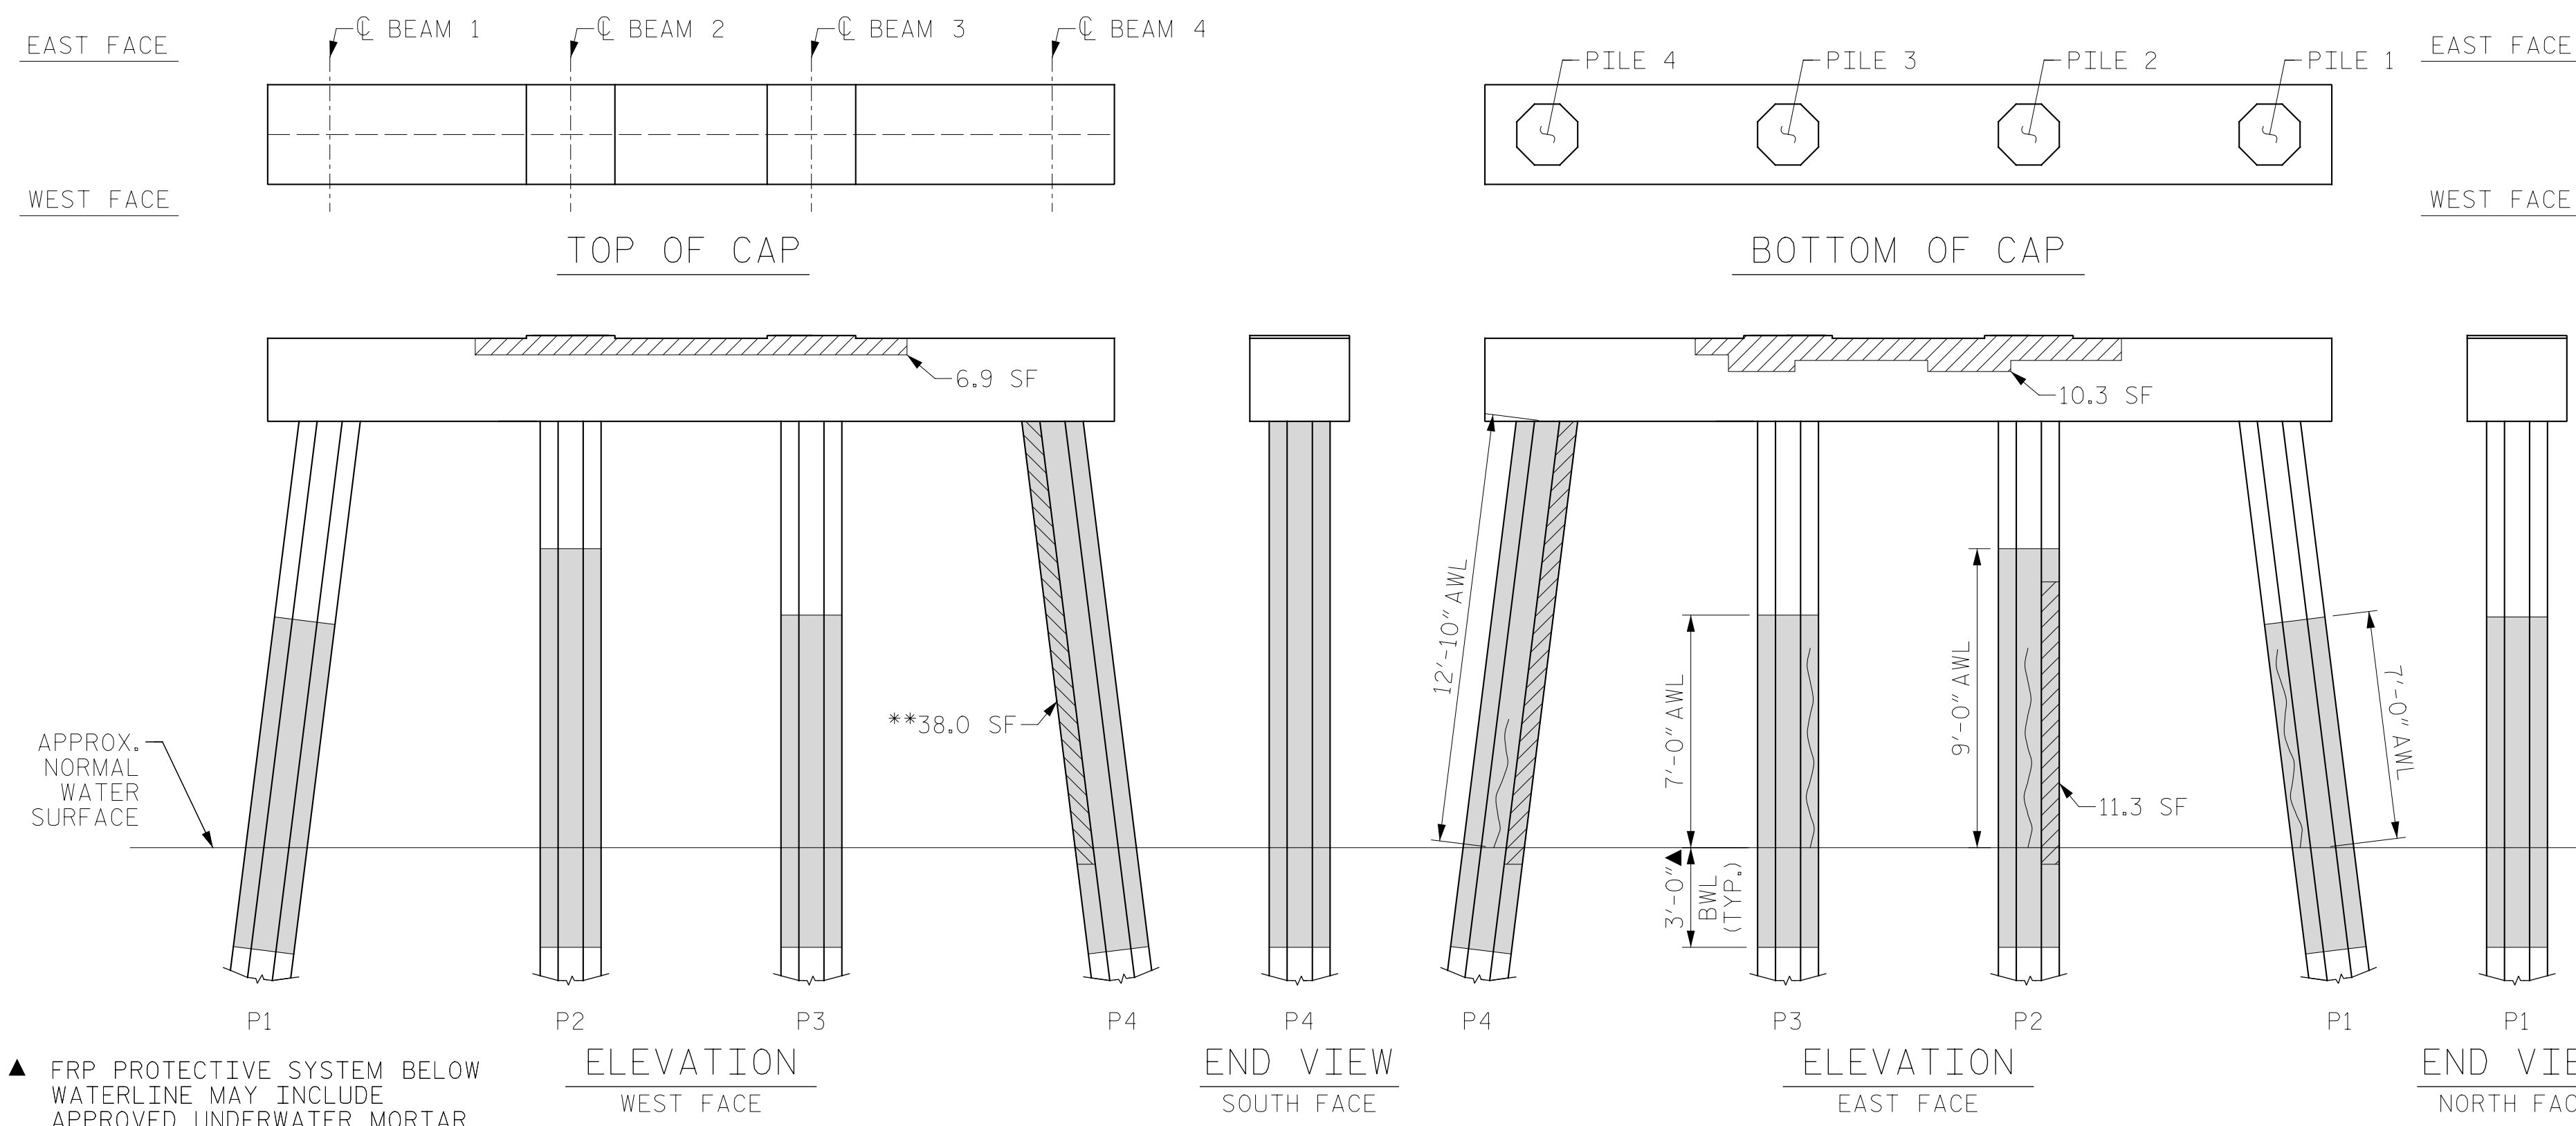
BENT 259

CAP REPAIRS		ESTIMATE			
SHOTCRETE REPAIRS	17.2 SF	8.6 CF	SF	CF	
EPOXY RESIN INJECTION	- LF				LF
PILE REPAIRS		ESTIMATE			
PILE CONCRETE RESTORATION	49.3 SF	19.8 CF	SF	CF	
FRP PROTECTIVE SYSTEM AWL	197.1 SF				
FRP PROTECTIVE SYSTEM BWL	66.0 SF

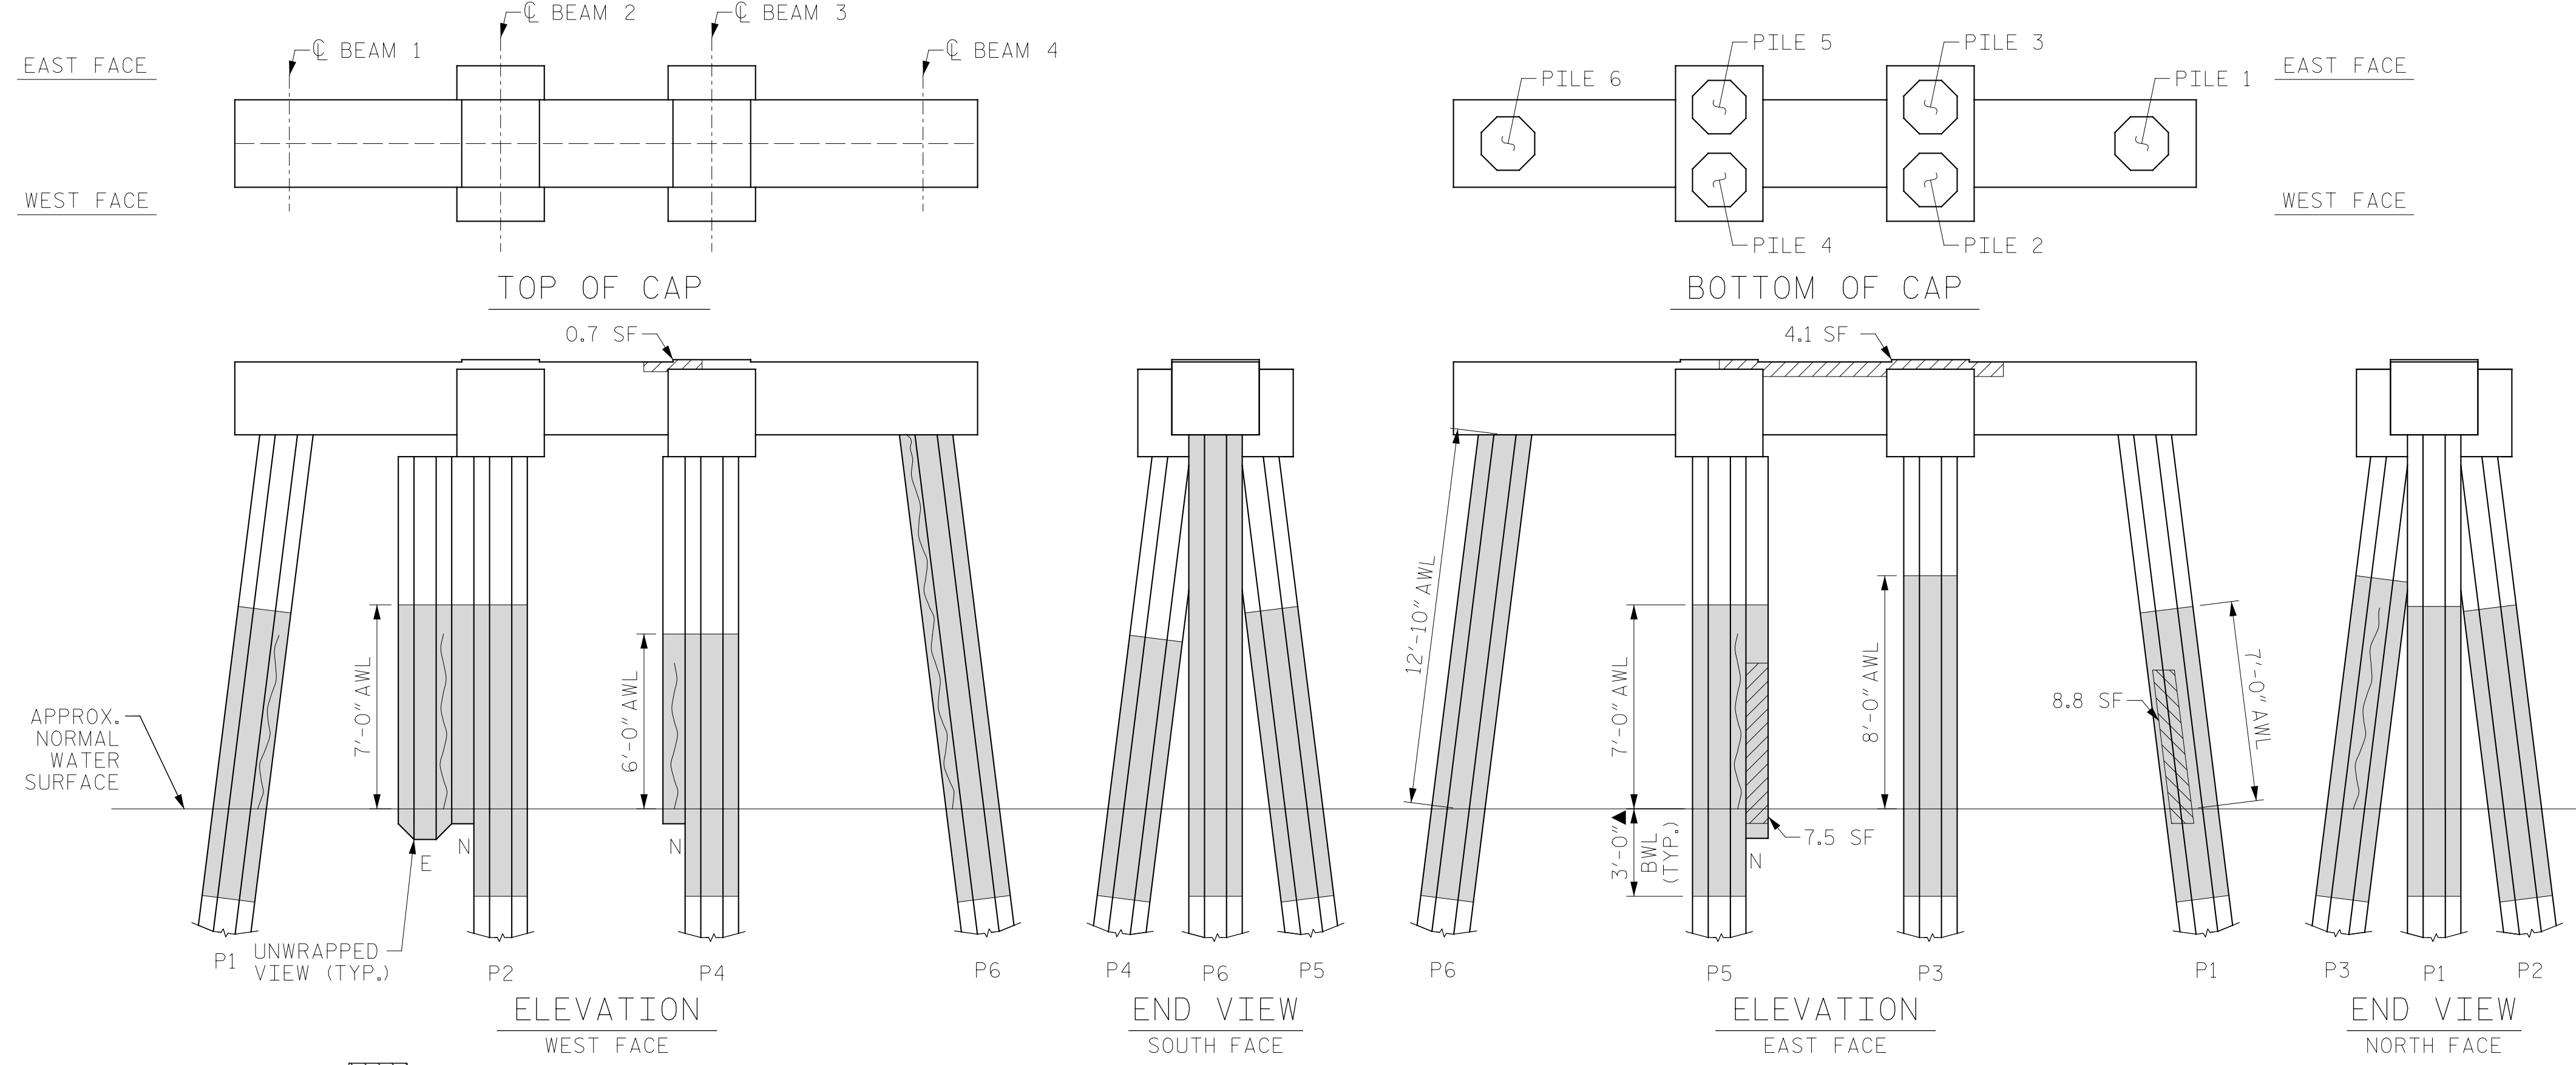
BENT 260

CAP REPAIRS		ESTIMATE			
SHOTCRETE REPAIRS	4.8 SF	2.4 CF	SF	CF	
EPOXY RESIN INJECTION	- LF				LF
PILE REPAIRS		ESTIMATE			
PILE CONCRETE RESTORATION	16.3 SF	6.9 CF	SF	CF	
FRP PROTECTIVE SYSTEM AWL	263.1 SF				
FRP PROTECTIVE SYSTEM BWL	99.0 SF
