AS-BUILT REPAIR QUANTITY TABLE

PROJECT NO. HB-0017
DARE COUNTY
BRIDGE NO. 270009

BENT 261 & BENT 262

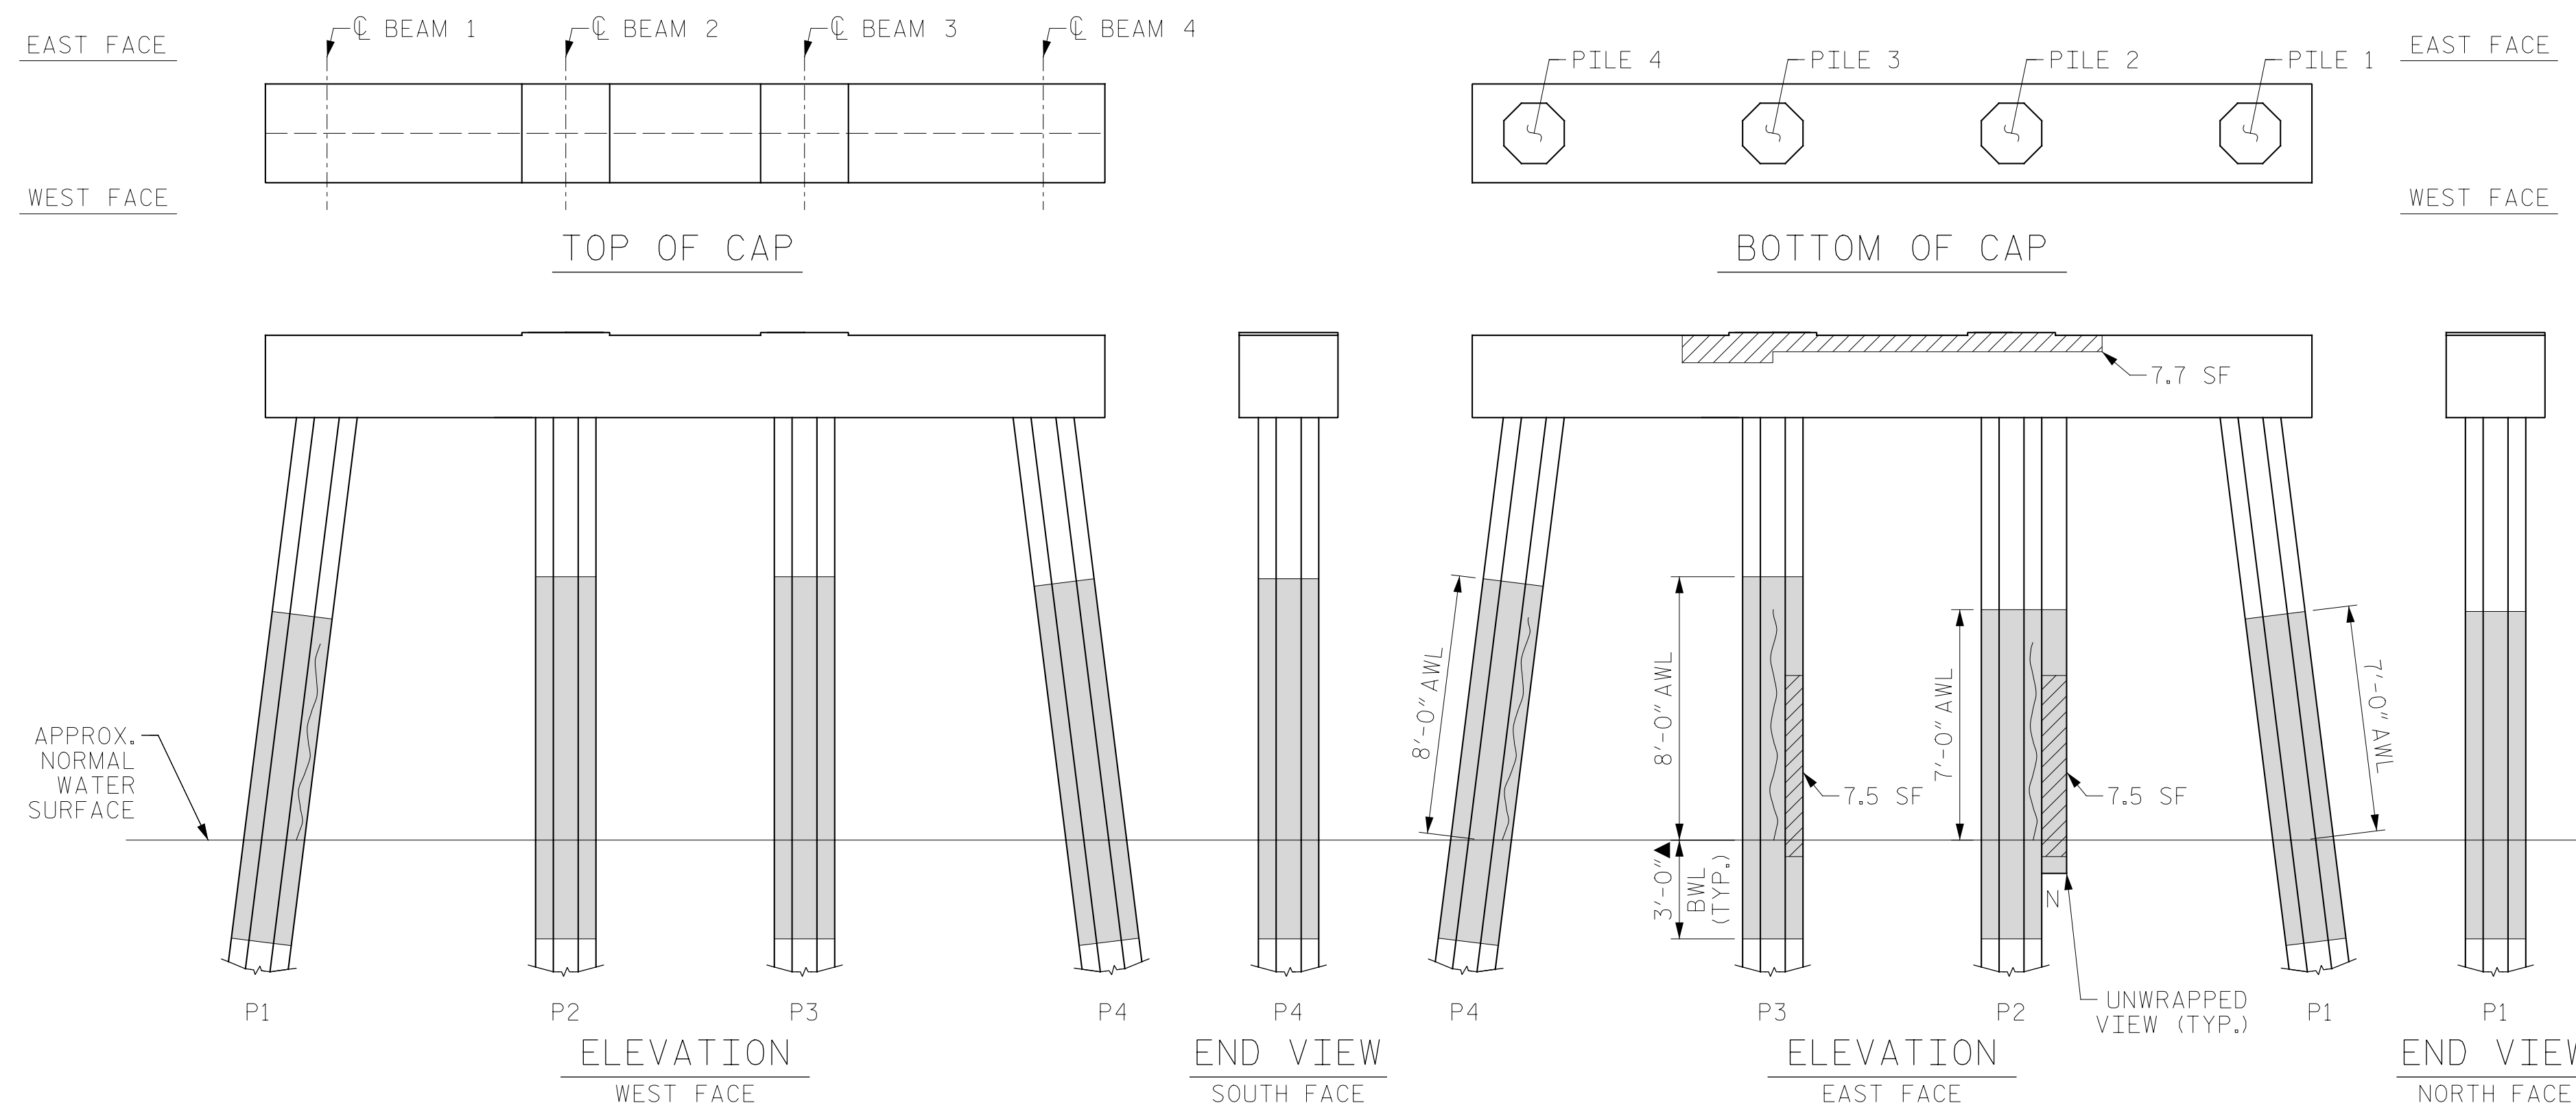
BENT 261

CAP REPAIRS		ESTIMATE			
SHOTCRETE REPAIRS	7.7 SF	3.9 CF	SF	CF	
EPOXY RESIN INJECTION	- LF				LF
PILE REPAIRS		ESTIMATE			
PILE CONCRETE RESTORATION	15.0 SF	6.4 CF	SF	CF	
FRP PROTECTIVE SYSTEM AWL	165.0 SF				
FRP PROTECTIVE SYSTEM BWL	66.0 SF

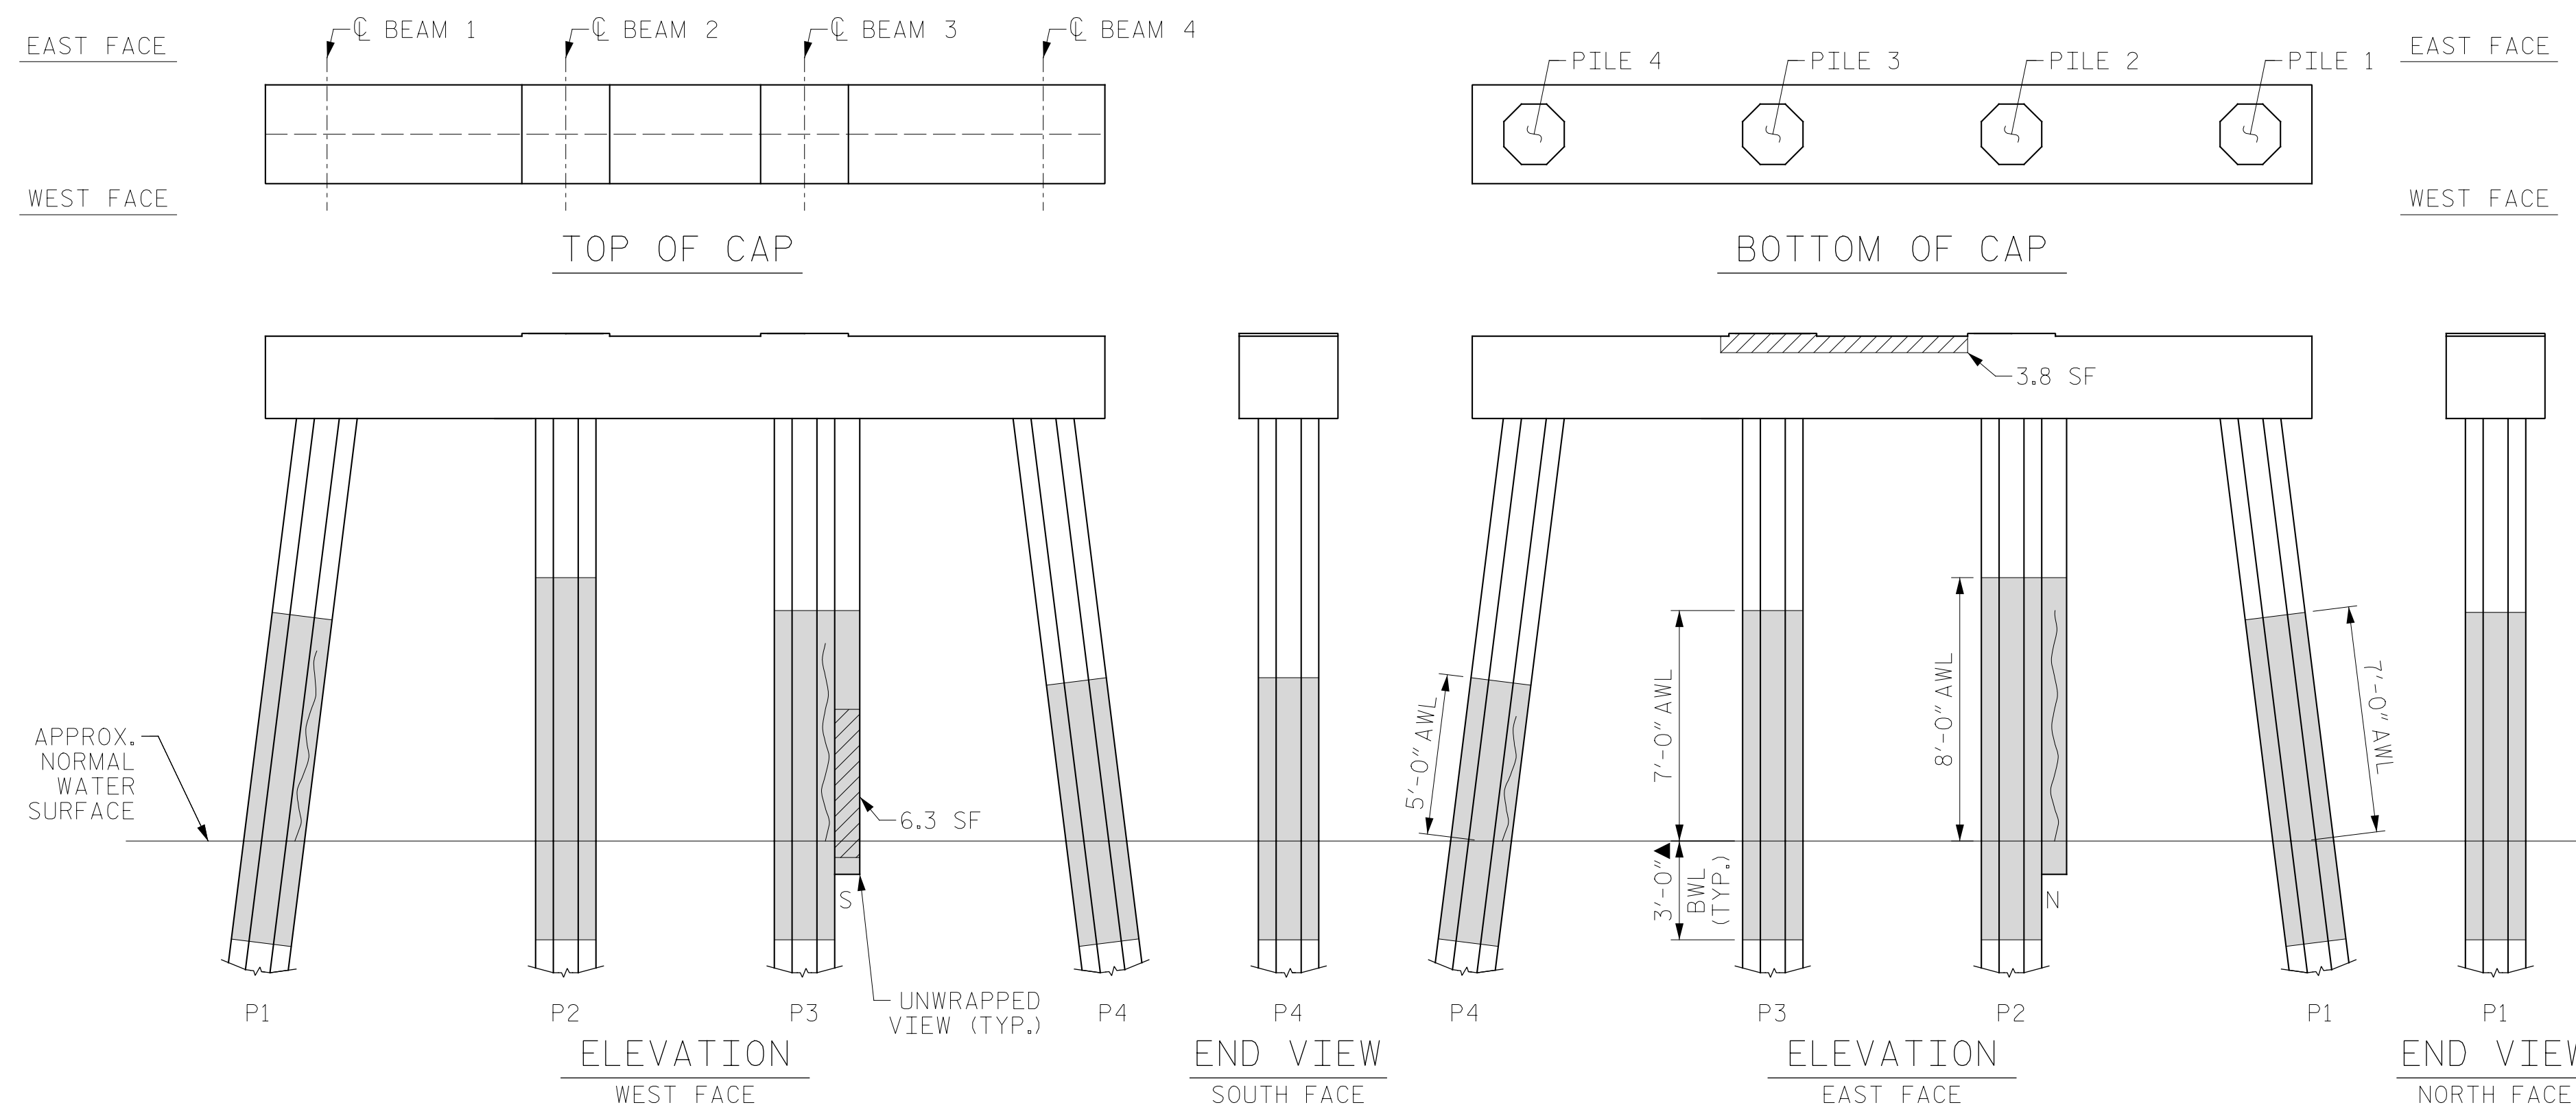
BENT 262

CAP REPAIRS		ESTIMATE			
SHOTCRETE REPAIRS	3.8 SF	1.9 CF	SF	CF	
EPOXY RESIN INJECTION	- LF				LF
PILE REPAIRS		ESTIMATE			
PILE CONCRETE RESTORATION	6.3 SF	2.7 CF	SF	CF	
FRP PROTECTIVE SYSTEM AWL	148.5 SF				
FRP PROTECTIVE SYSTEM BWL	66.0 SF
