AS-BUILT REPAIR QUANTITY TABLE BENT 263

DARE COUNTY

STATE OF NORTH CAROLINA DEPARTMENT OF TRANSPORTATION RALEIGH

BENT 263 & BENT 264

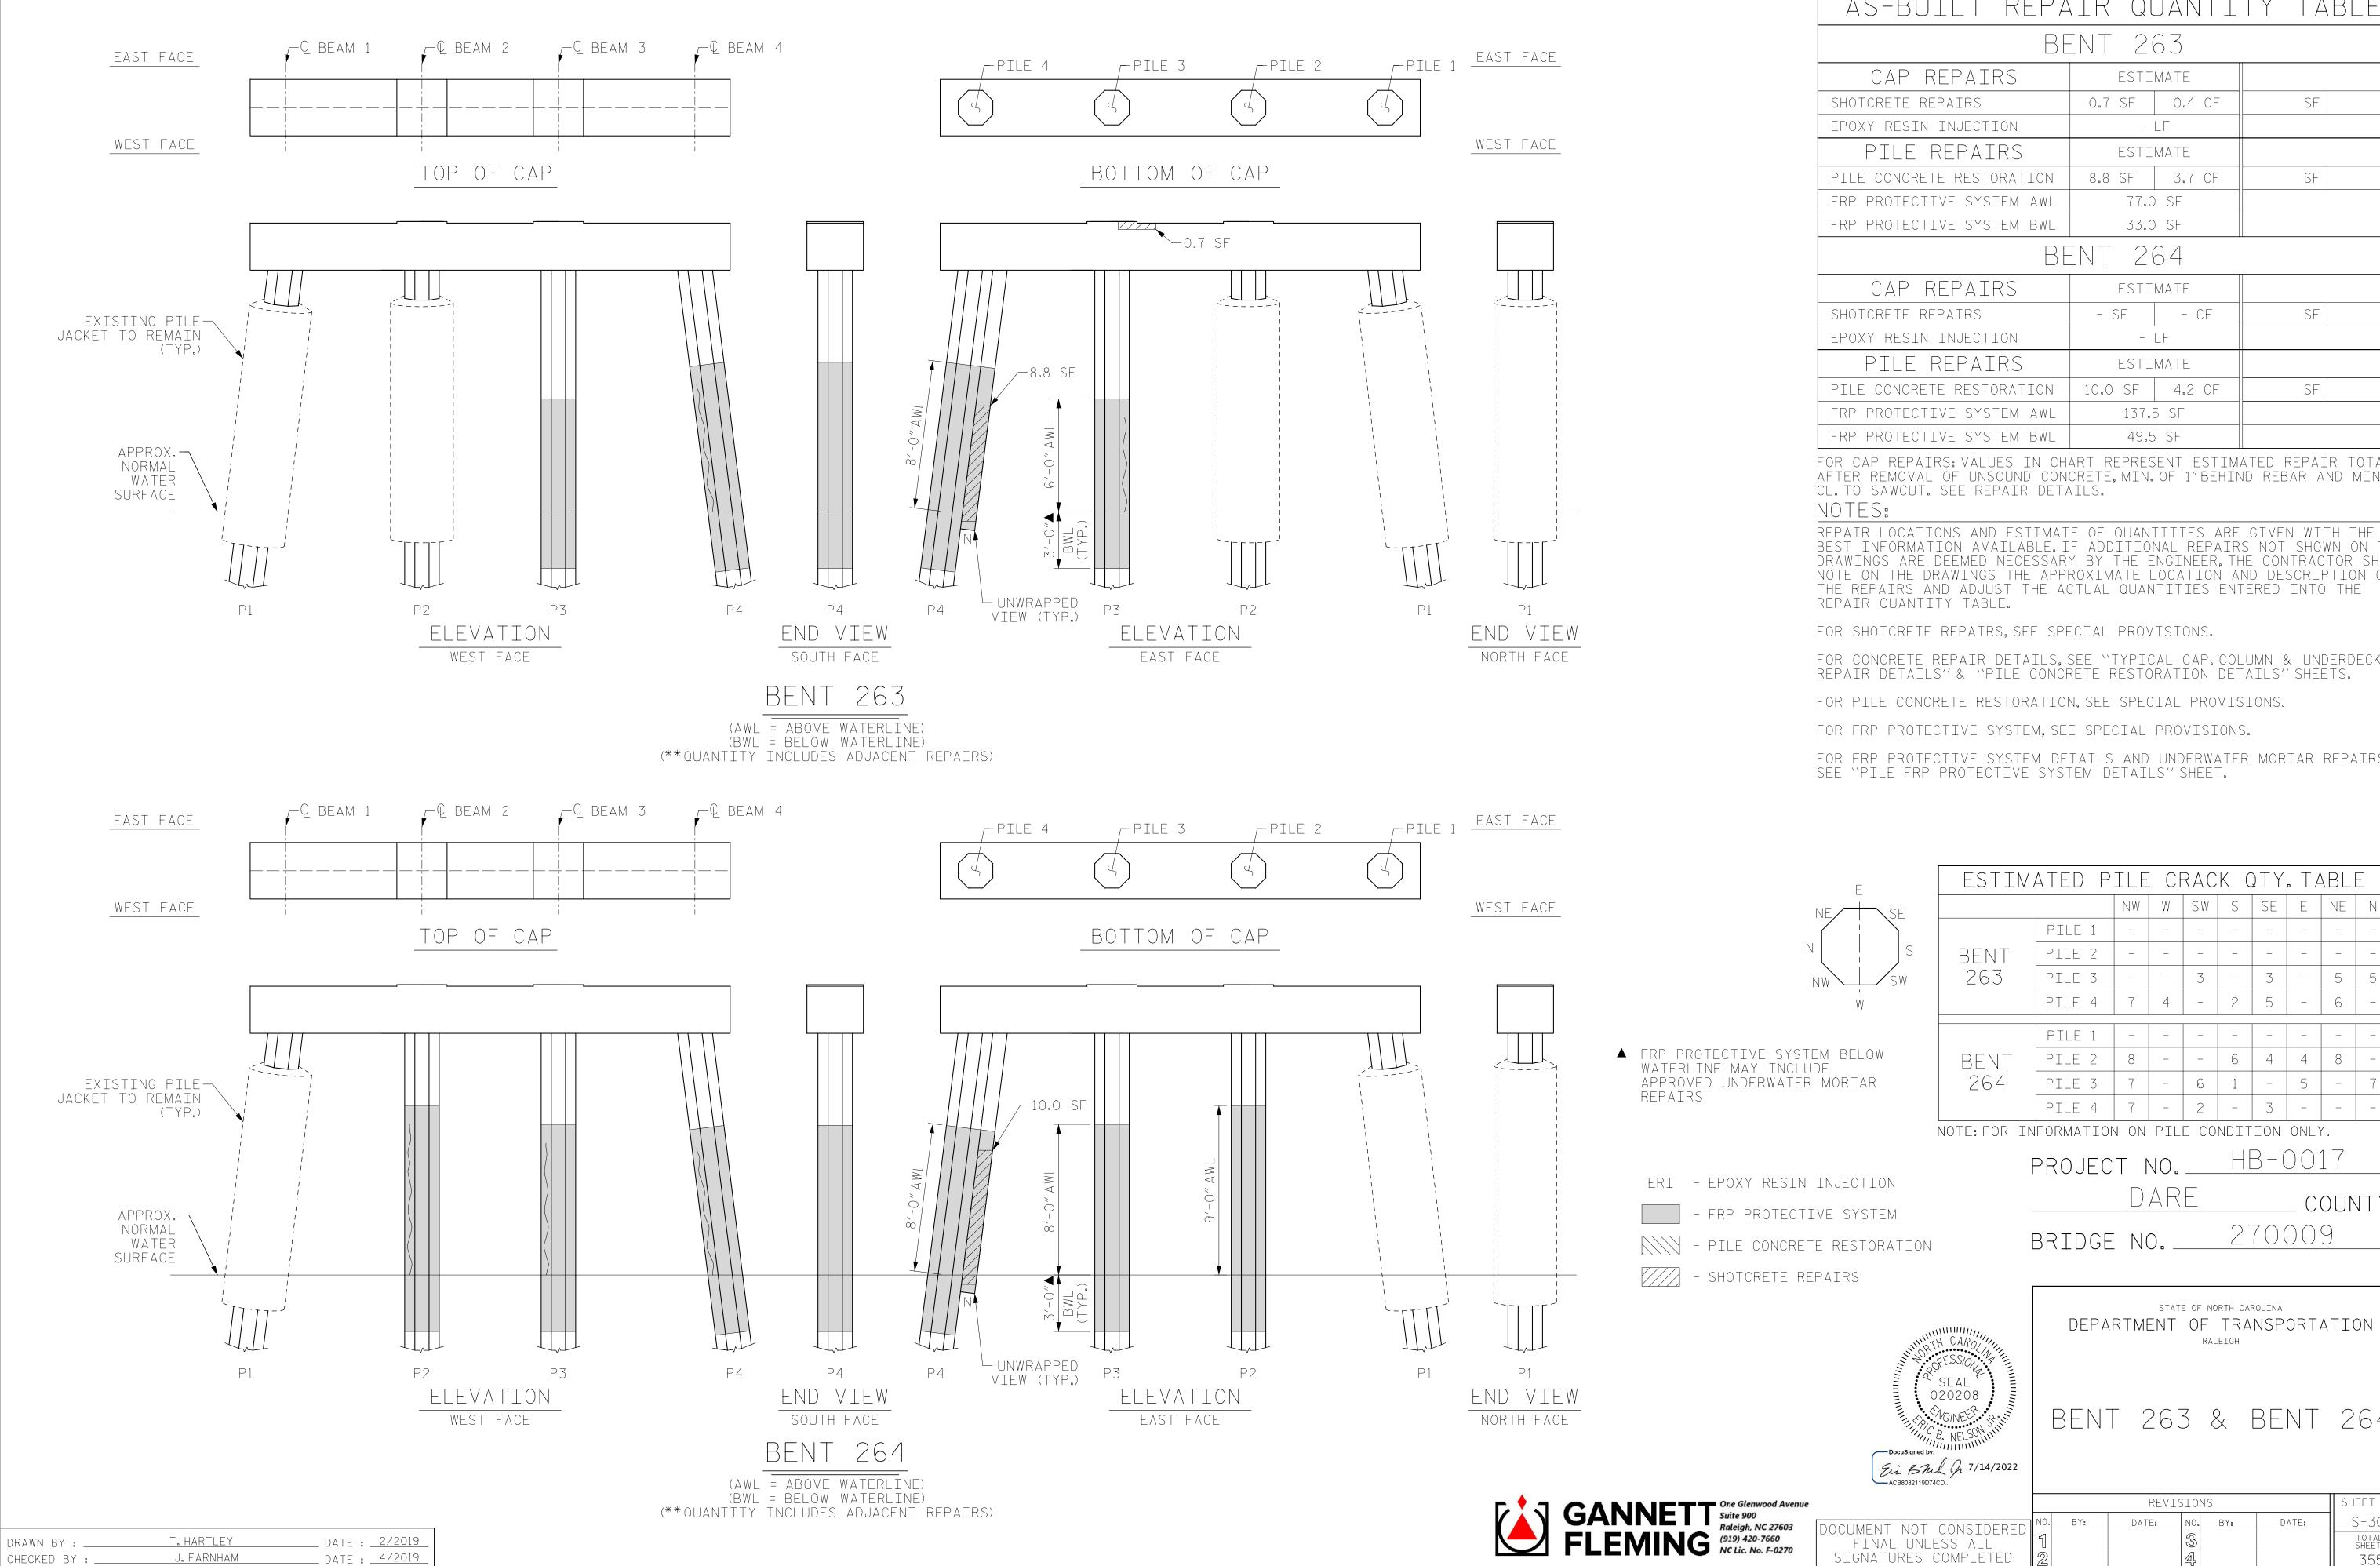
CAP REPAIRS	ESTIMATE			
SHOTCRETE REPAIRS	0.7 SF	0.4 CF	SF	CF
EPOXY RESIN INJECTION	- LF			LF
PILE REPAIRS	ESTIMATE			
PILE CONCRETE RESTORATION	8.8 SF	3.7 CF	SF	CF
FRP PROTECTIVE SYSTEM AWL	77.0 SF			
FRP PROTECTIVE SYSTEM BWL	33.0 SF

CAP REPAIRS	ESTIMATE			
SHOTCRETE REPAIRS	- SF	- CF	SF	CF
EPOXY RESIN INJECTION	- LF			LF
PILE REPAIRS	ESTIMATE			
PILE CONCRETE RESTORATION	10.0 SF	4.2 CF	SF	CF
FRP PROTECTIVE SYSTEM AWL	137.5 SF			
FRP PROTECTIVE SYSTEM BWL	49.5 SF

ESTIMATED PILE CRACK QTY. TABLE									
		NW	W	SW	S	SE	E	NE	Ν
BENT 263	PILE 1	_	_	_	_	_	_	_	_
	PILE 2	_	_	_	_	_	_	_	_
	PILE 3	_	=	3	_	3	=	5	5
	PILE 4	7	4	_	2	5	_	6	_
BENT 264	PILE 1	_	_	_	_	_	_	-	-
	PILE 2	8	_	_	6	4	4	8	-
	PILE 3	7	_	6	1	_	5	_	7
	PILE 4	7	-	2	-	3	-	-	-
OTE: FOR INFORMATION ON PILE CONDITION ONLY.
