DARE COUNTY 270009 BRIDGE NO.

STATE OF NORTH CAROLINA DEPARTMENT OF TRANSPORTATION RALEIGH

HB-0017

BENT 265 & BENT 266

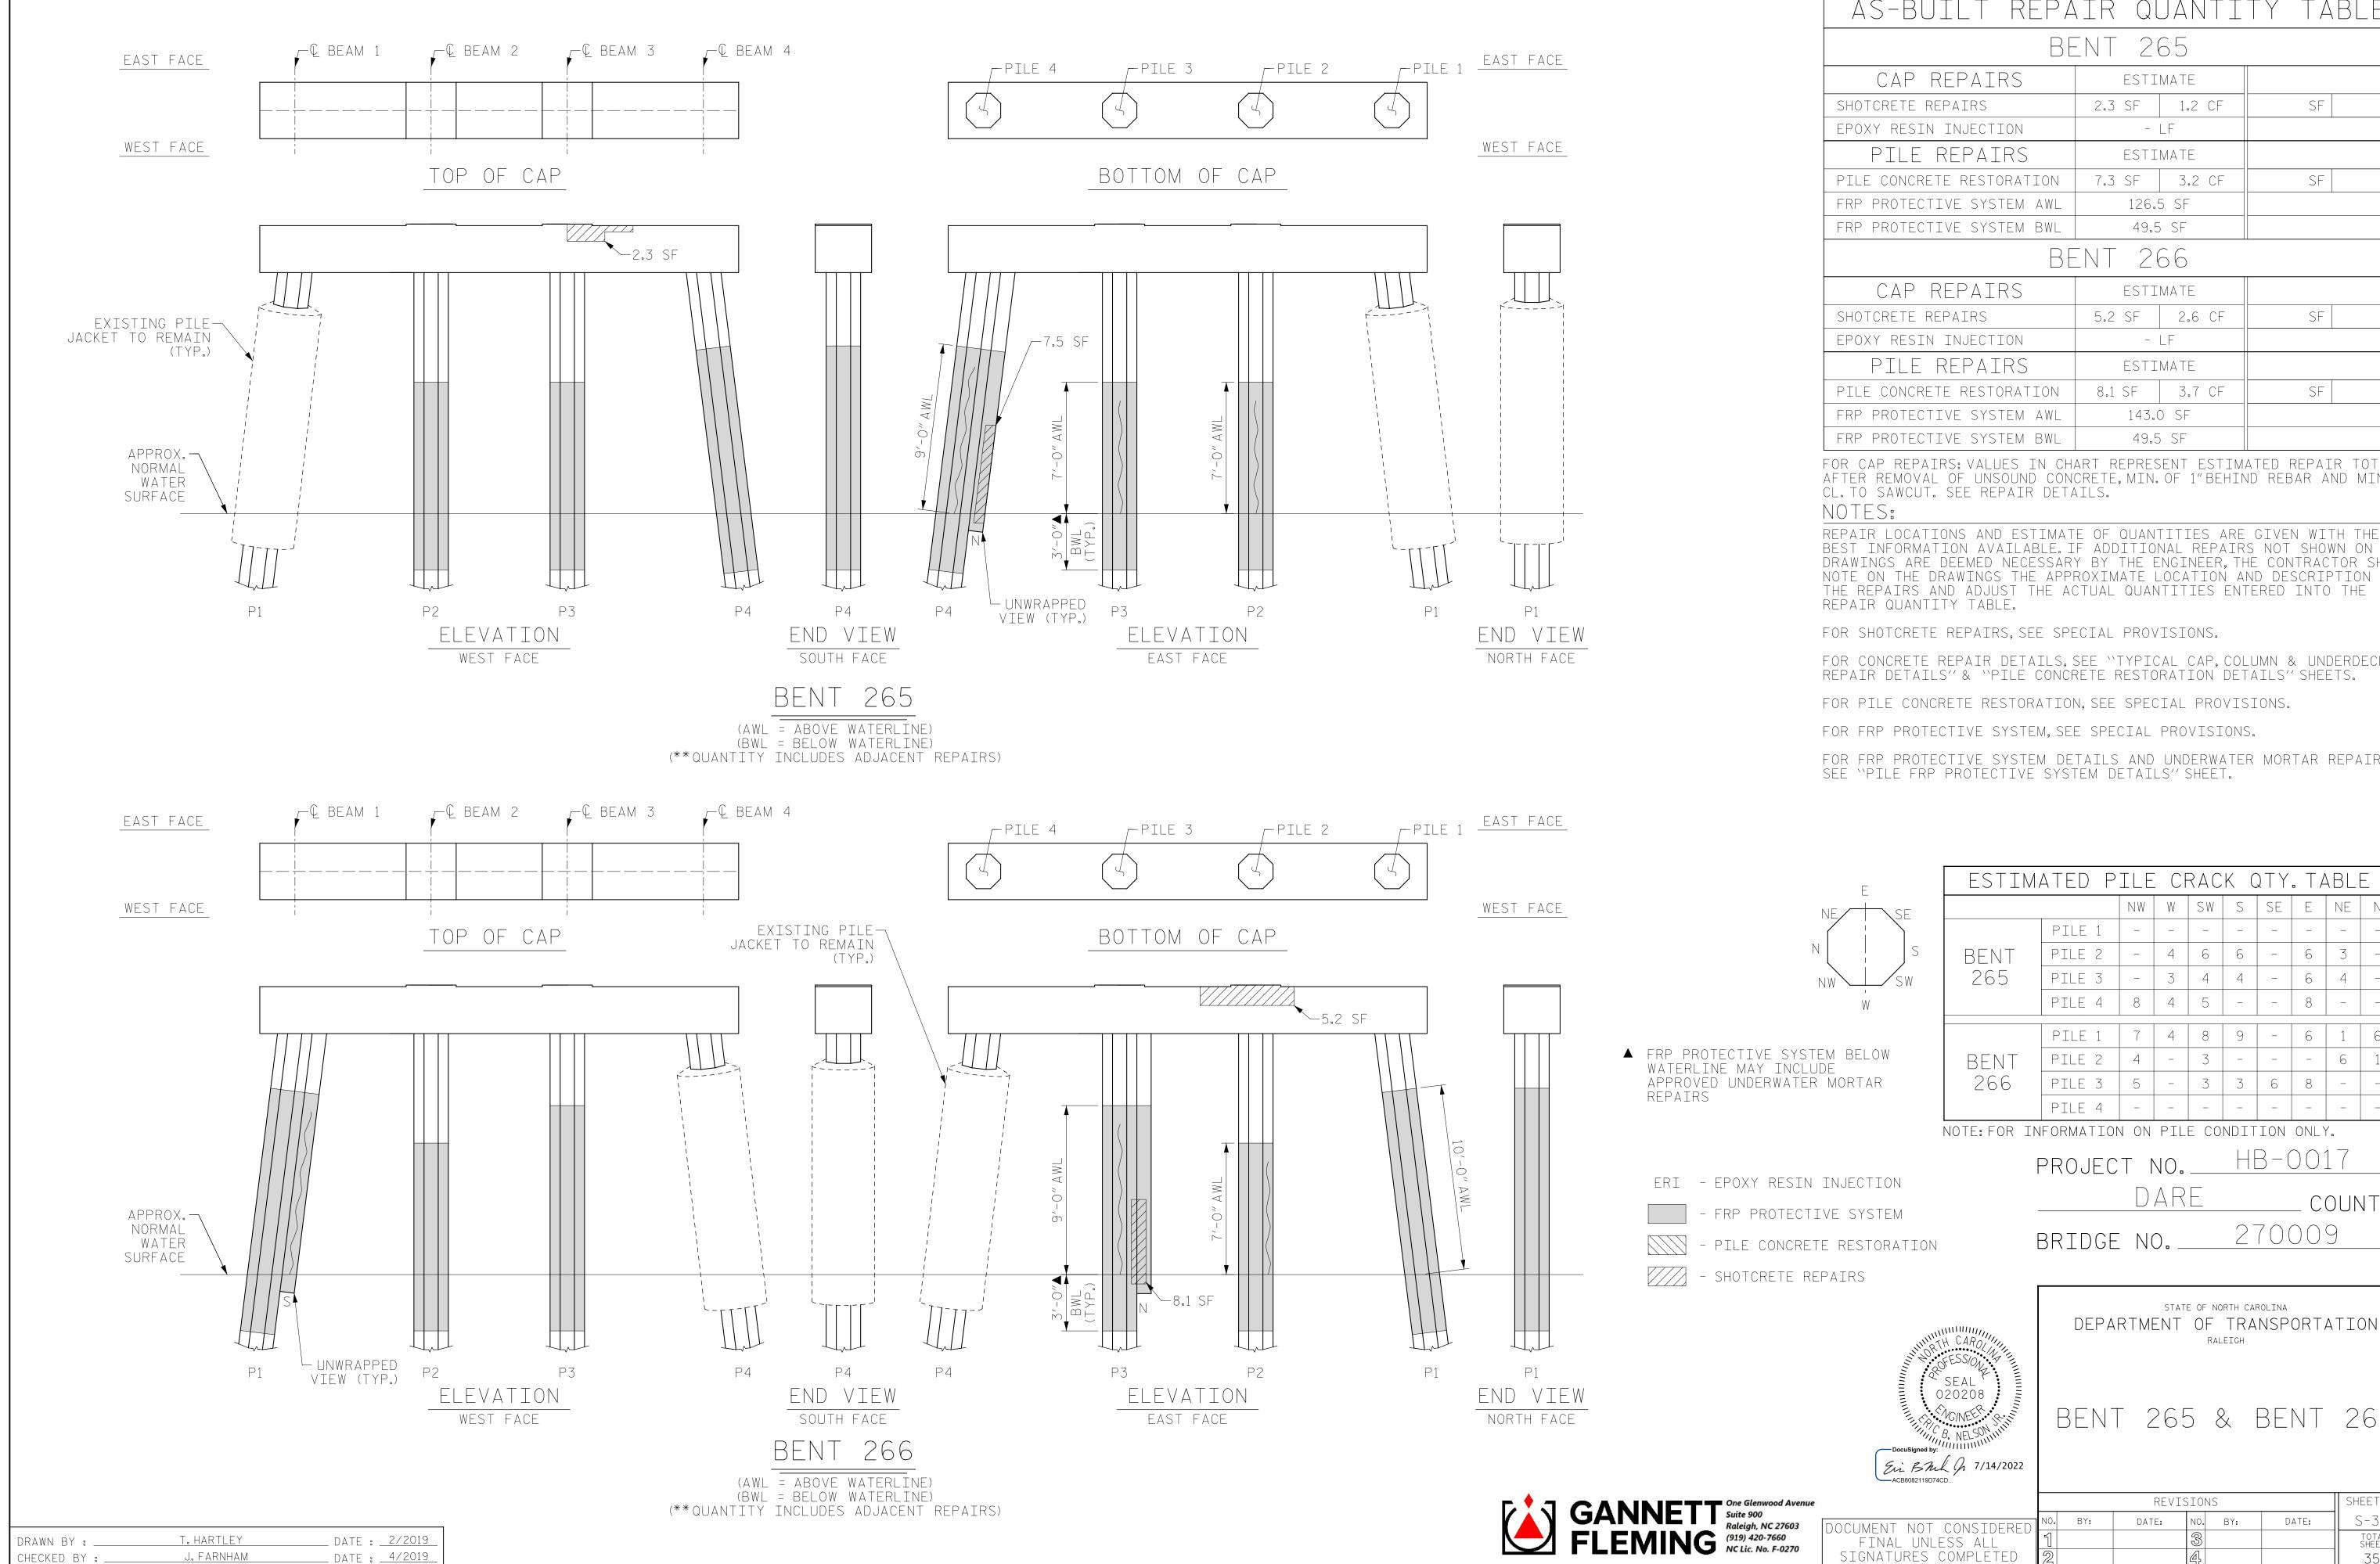
FOR CAP REPAIRS: VALUES IN CHART REPRESENT ESTIMATED REPAIR TOTALS AFTER REMOVAL OF UNSOUND CONCRETE, MIN. OF 1"BEHIND REBAR AND MIN. 2 CL. TO SAWCUT. SEE REPAIR DETAILS.

FOR CONCRETE REPAIR DETAILS, SEE "TYPICAL CAP, COLUMN & UNDERDECK REPAIR DETAILS" & "PILE CONCRETE RESTORATION DETAILS" SHEETS.

FOR FRP PROTECTIVE SYSTEM DETAILS AND UNDERWATER MORTAR REPAIRS, SEE "PILE FRP PROTECTIVE SYSTEM DETAILS" SHEET.
