AS-BUILT REPAIR QUANTITY TABLE

PROJECT NO. HB-0017
DARE COUNTY
 BRIDGE NO. 270009

BENT 267 & BENT 268

REVISIONS						SHEET NO.
NO.	BY:	DATE:	NO.	BY:	DATE:	S-303
1			3			TOTAL SHEETS
2			4			355

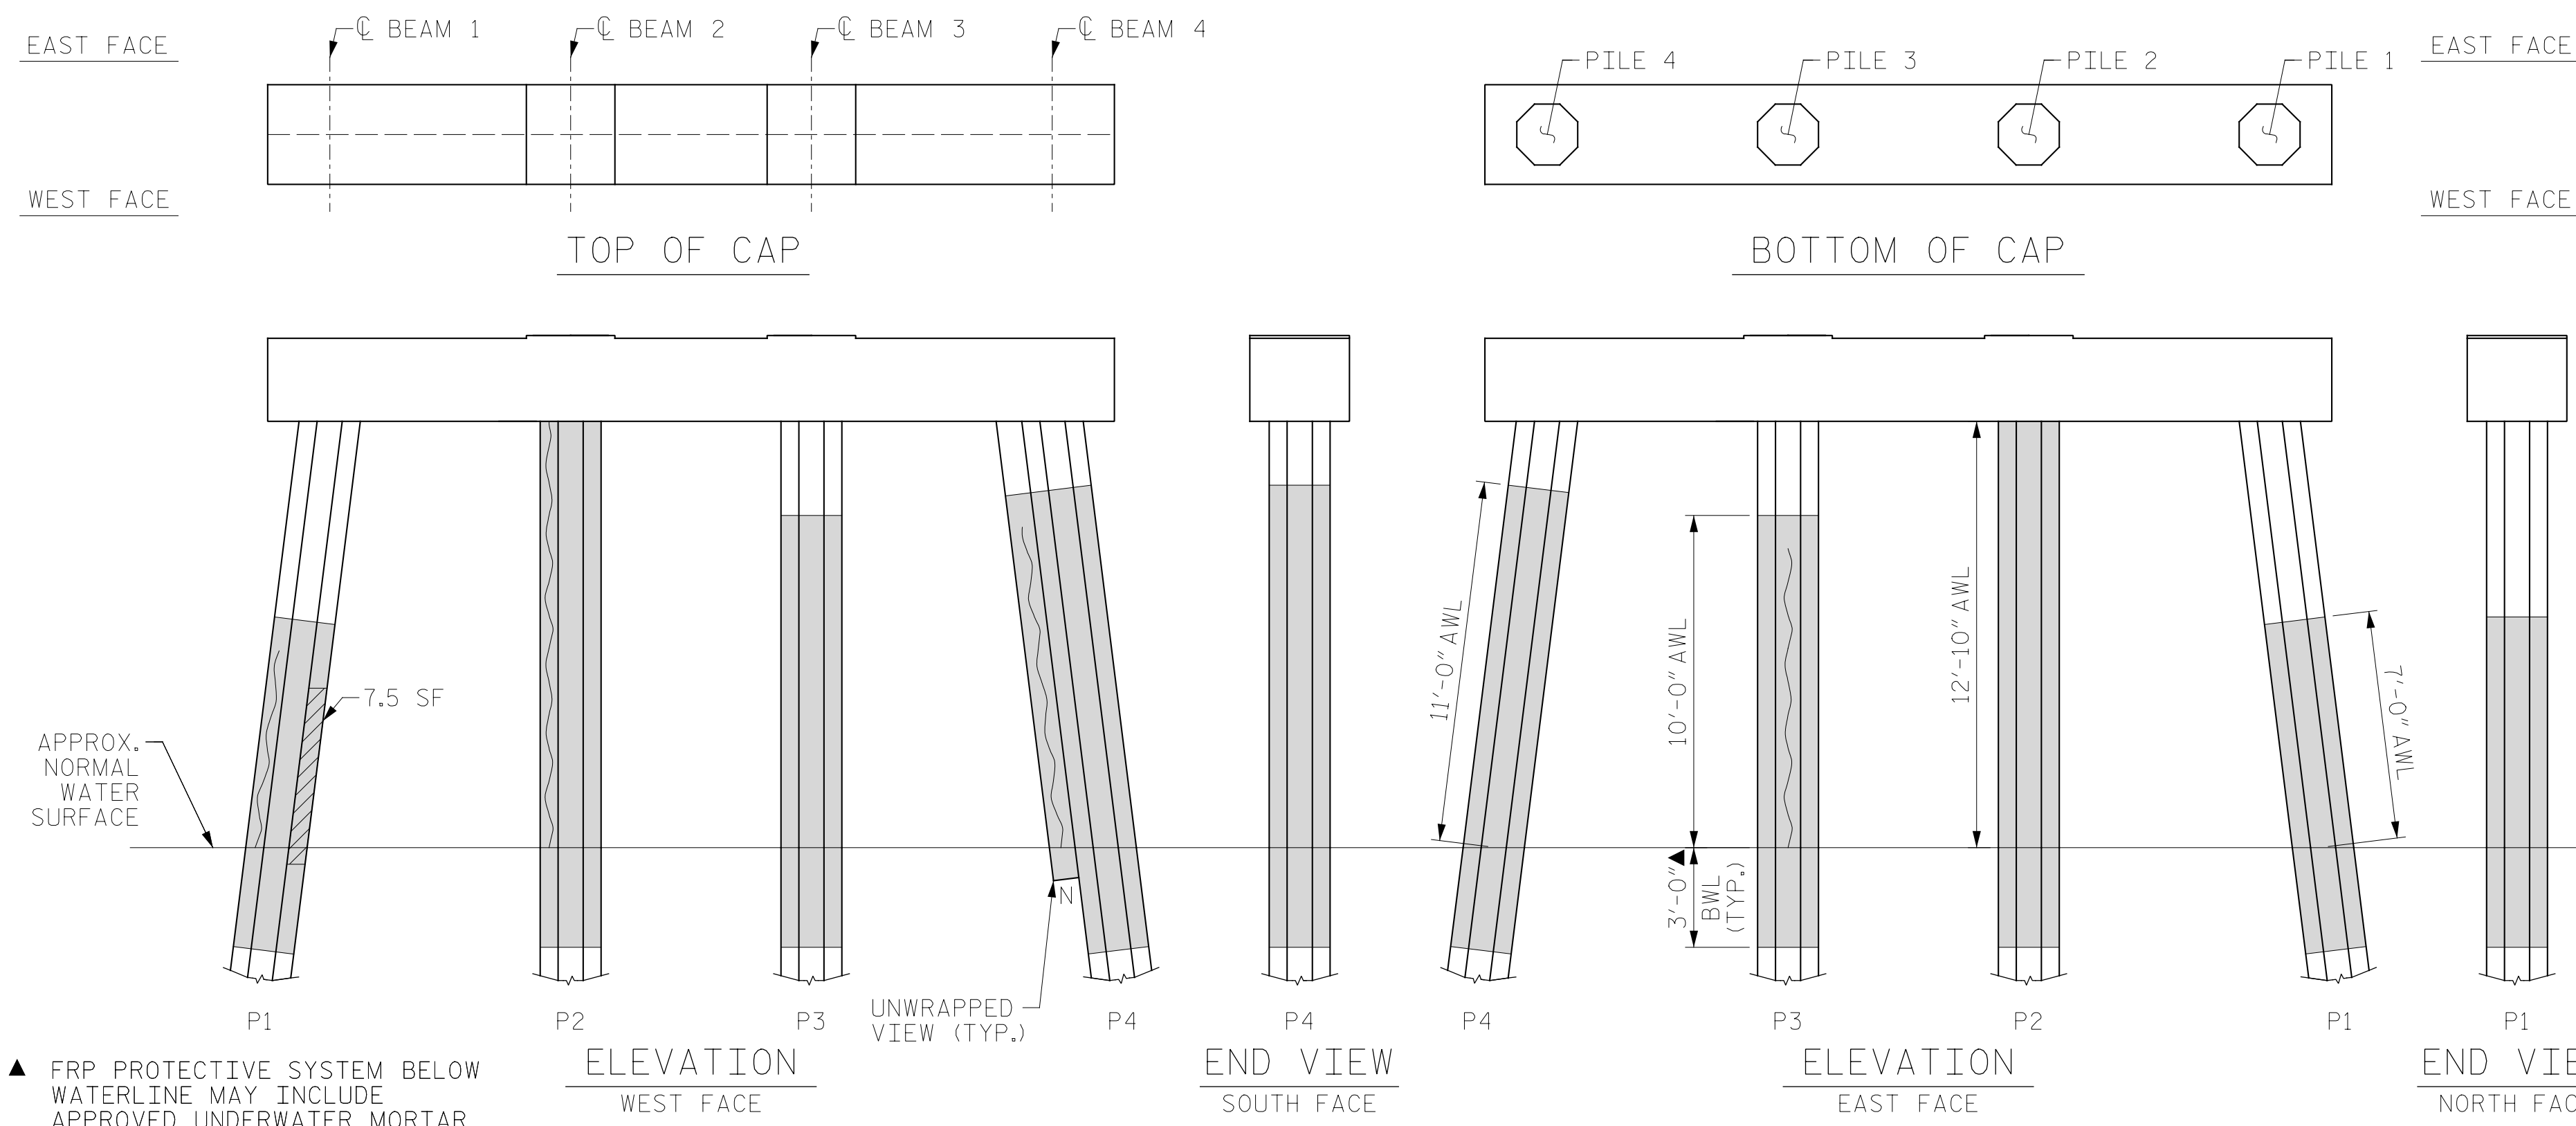
BENT 267

CAP REPAIRS		ESTIMATE			
SHOTCRETE REPAIRS	- SF	- CF	SF	CF	
EPOXY RESIN INJECTION		- LF			LF
PILE REPAIRS		ESTIMATE			
PILE CONCRETE RESTORATION	7.3 SF	3.2 CF	SF	CF	
FRP PROTECTIVE SYSTEM AWL	224.6 SF				
FRP PROTECTIVE SYSTEM BWL	66.0 SF

BENT	PILE	DIRECTION							
		NW	W	SW	S	SE	E	NE	N
267	PILE 1	6	5	-	5	-	-	5	-
	PILE 2	13	3	9	-	18	8	-	-
	PILE 3	9	9	9	-	9	9	9	-
	PILE 4	-	-	-	-	6	8	9	10
268	PILE 1	-	-	-	-	-	5	7	-
	PILE 2	-	-	-	-	-	-	-	-
	PILE 3	-	-	-	-	-	-	-	2
	PILE 4	-	-	4	4	-	-	6	-
	PILE 5	-	-	3	-	-	-	-	-
	PILE 6	-	7	-	5	7	-	-	6

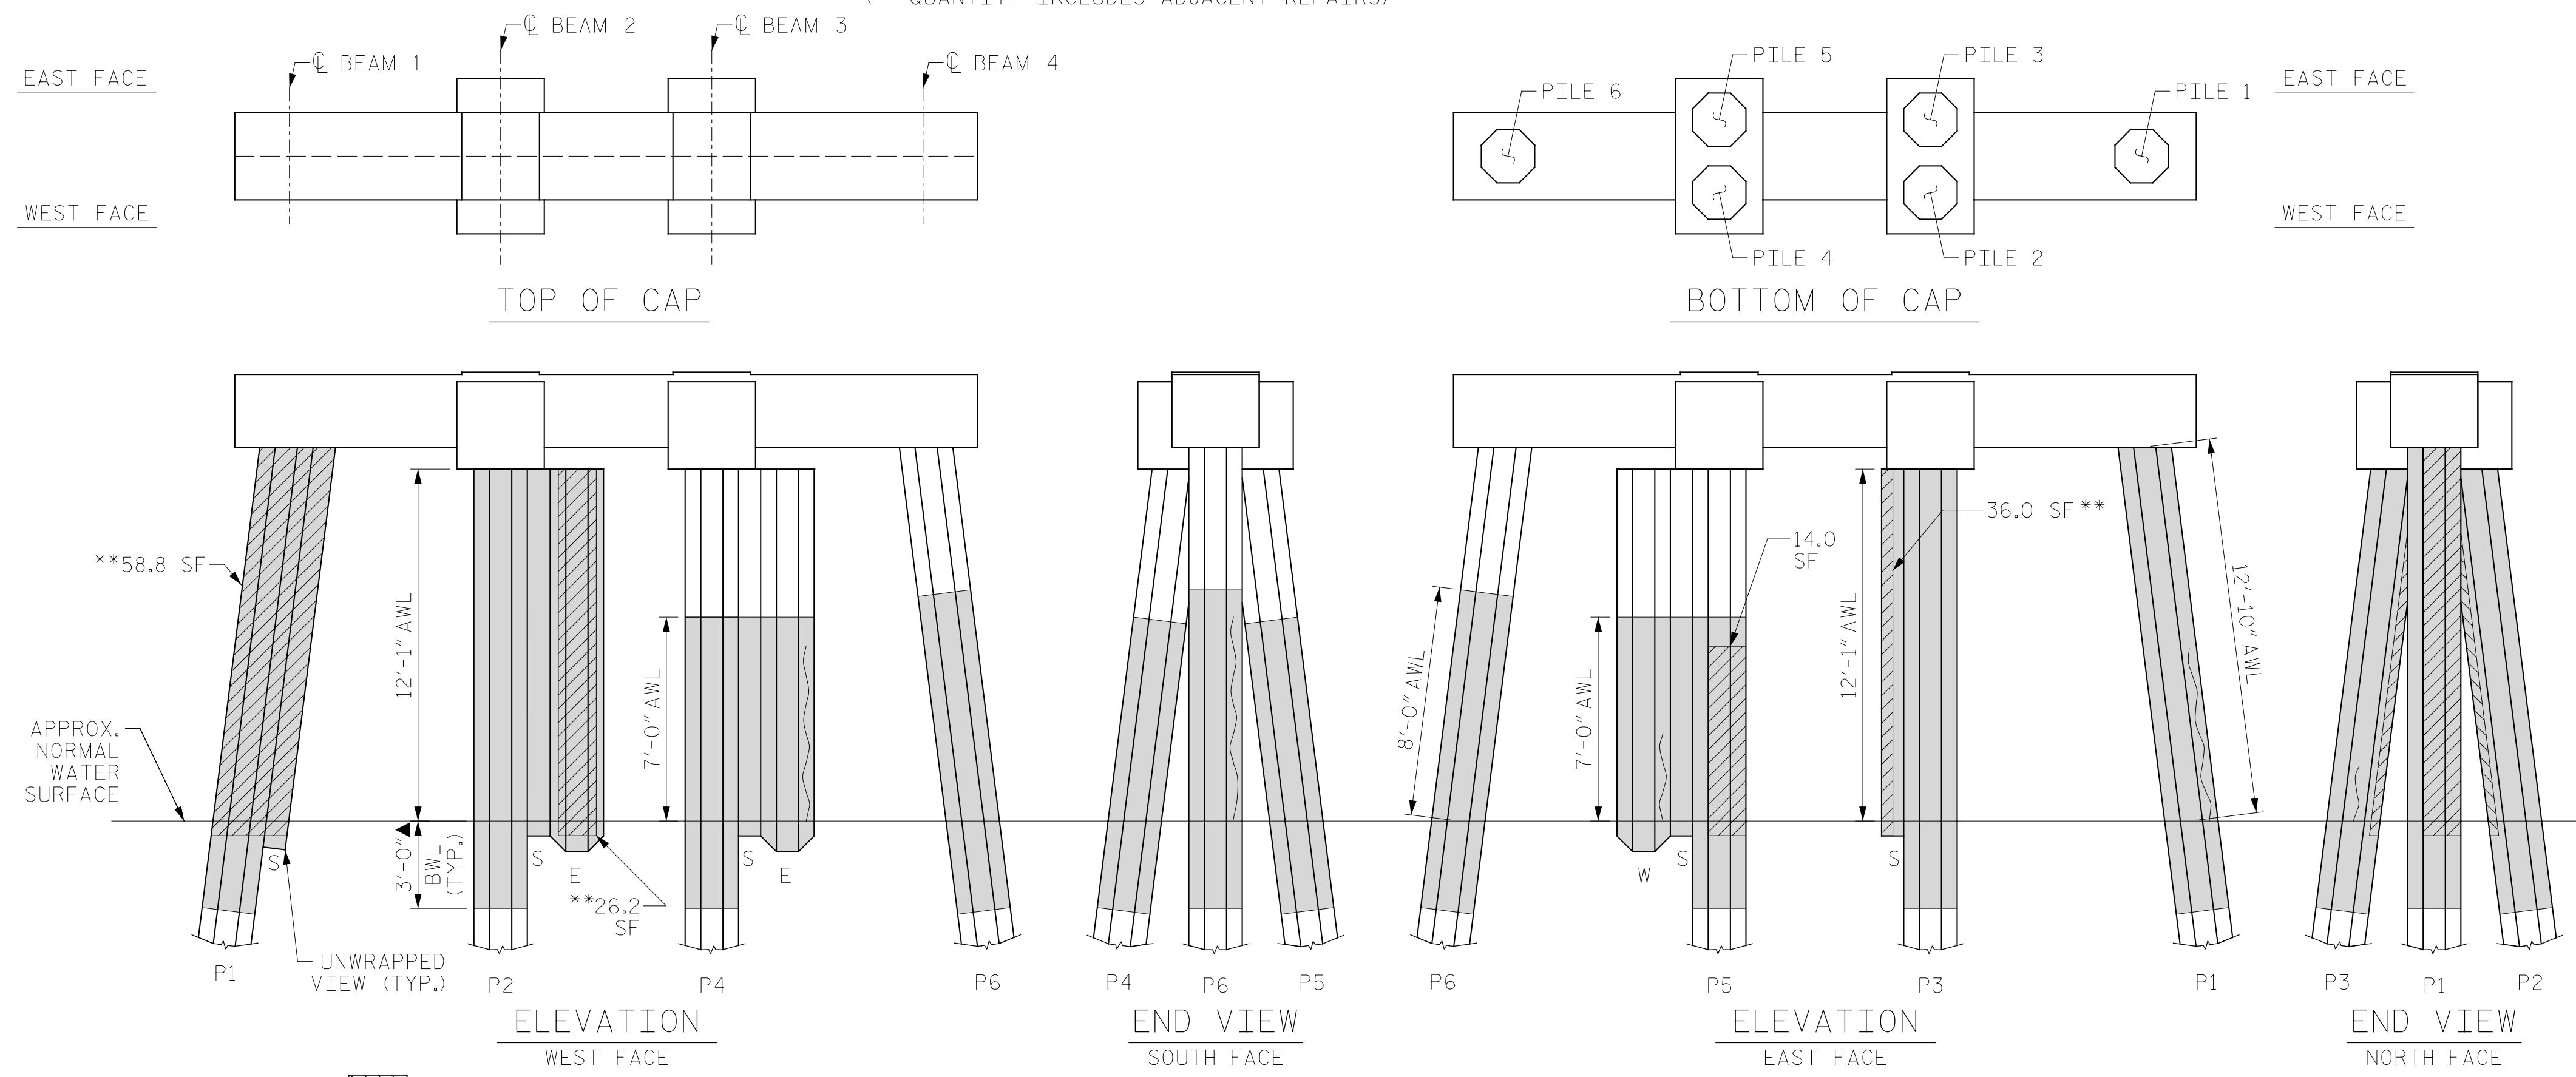
BENT 268

CAP REPAIRS		ESTIMATE			
SHOTCRETE REPAIRS	- SF	- CF	SF	CF	
EPOXY RESIN INJECTION		- LF			LF
PILE REPAIRS		ESTIMATE			
PILE CONCRETE RESTORATION	134.9 SF	52.3 CF	SF	CF	
FRP PROTECTIVE SYSTEM AWL	324.5 SF				
FRP PROTECTIVE SYSTEM BWL	99.0 SF
