AS-BUILT REPAIR QUANTITY TABLE

PROJECT NO. HB-0017
DARE COUNTY
BRIDGE NO. 270009

STATE OF NORTH CAROLINA
DEPARTMENT OF TRANSPORTATION
RALEIGH

BENT 275 & BENT 276

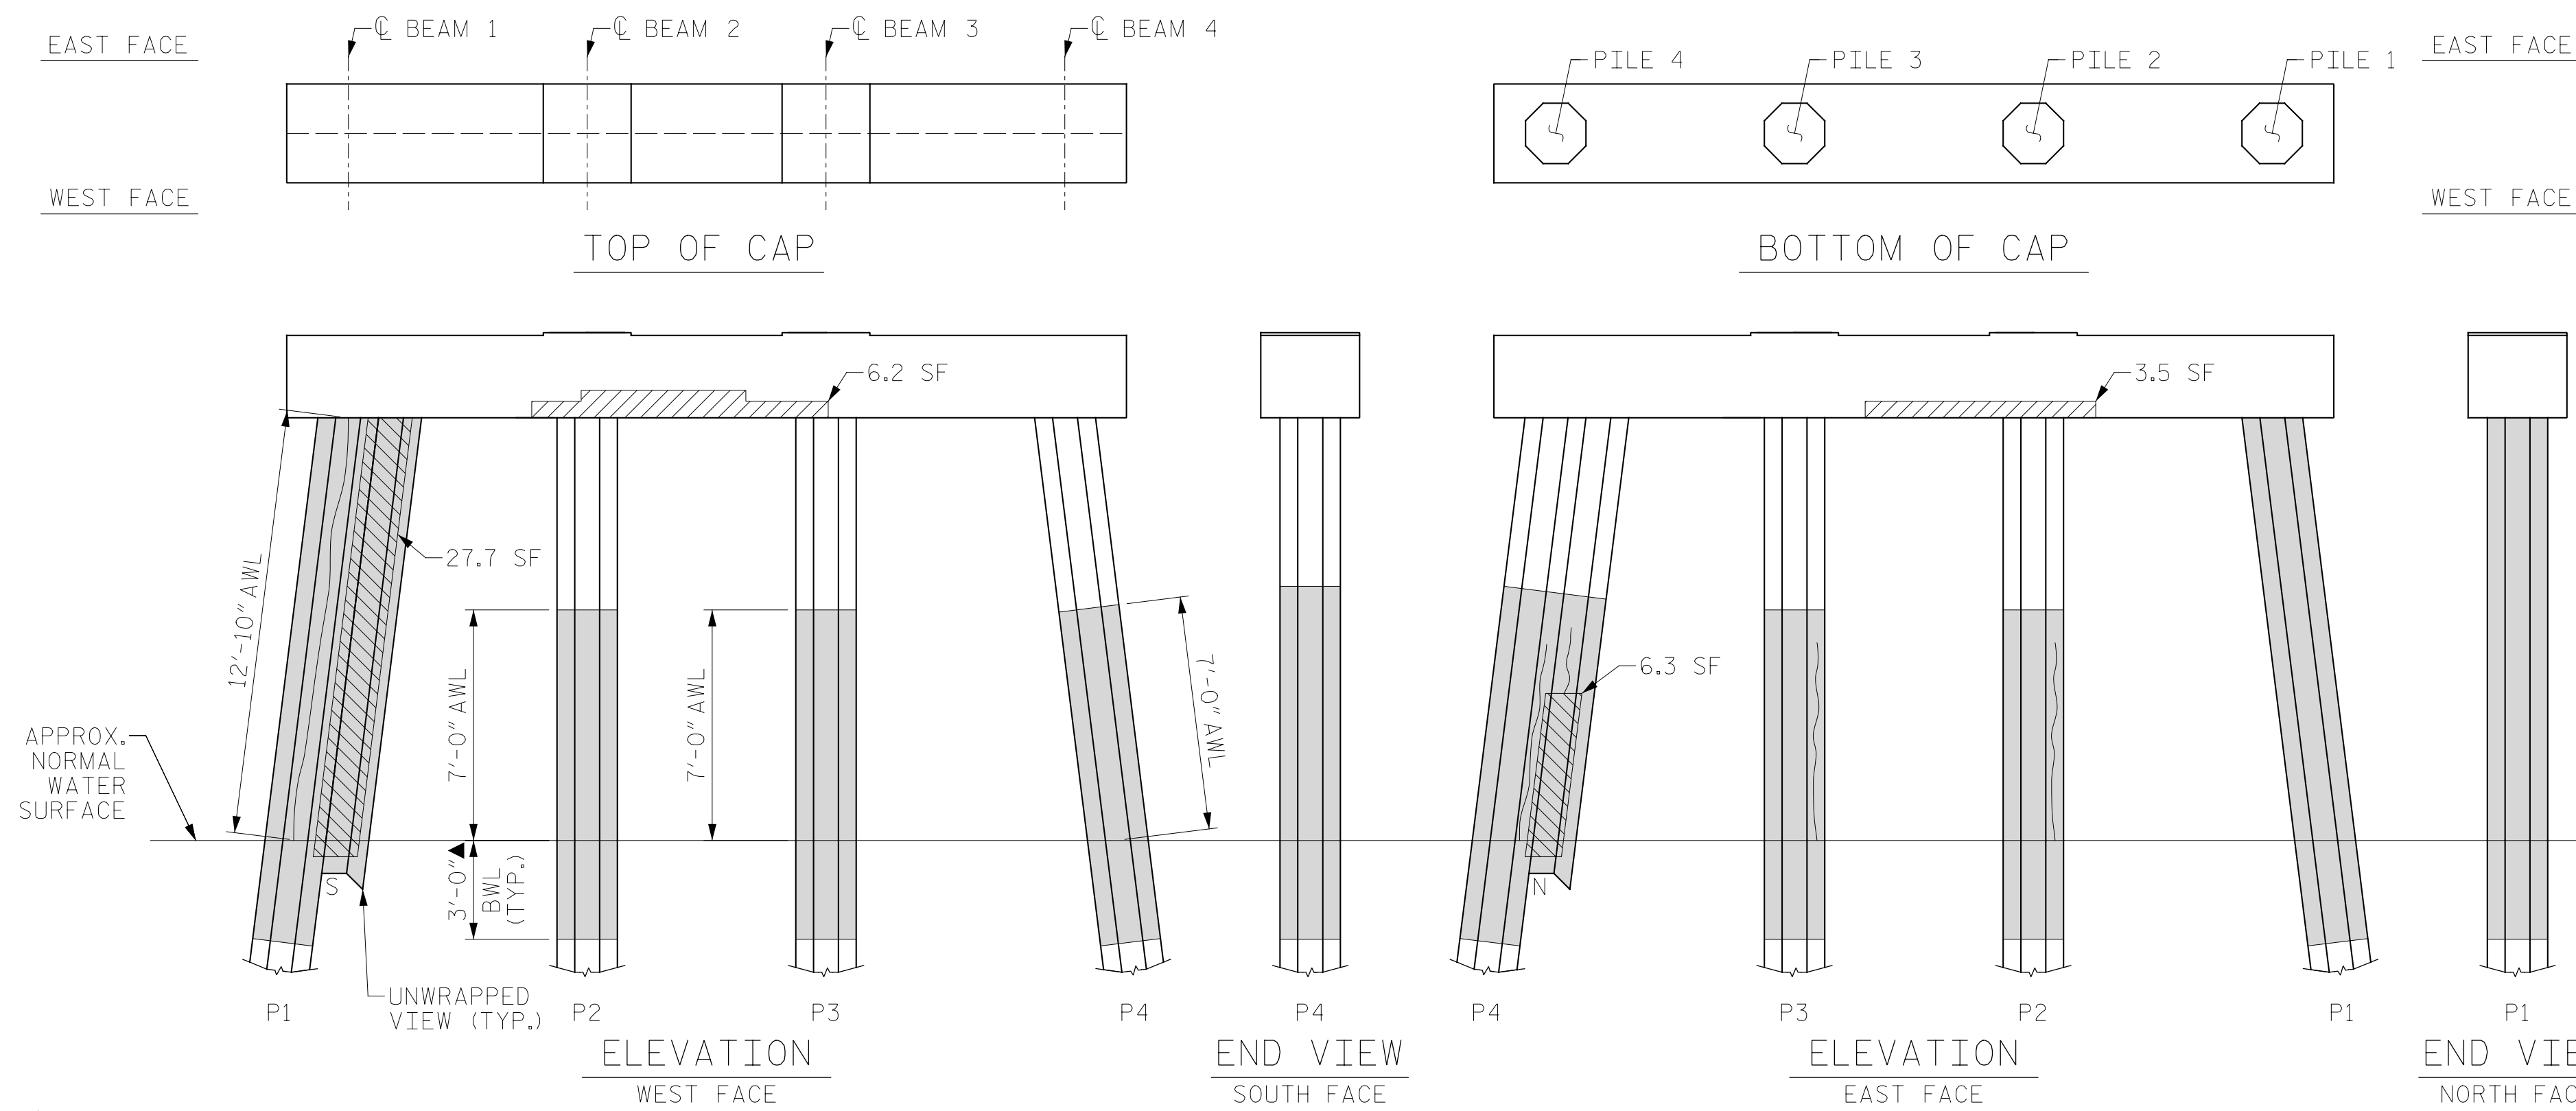
BENT 275

| CAP REPAIRS | | | |
|---|---|---|---|
| SHOTCRETE REPAIRS | 9.7 SF | 4.9 CF | SF CF |
| PILE CONCRETE RESTORATION | 33.9 SF | 13.6 CF | SF CF |
| FRP PROTECTIVE SYSTEM AWL | 186.1 SF | | |
| FRP PROTECTIVE SYSTEM BWL | 66.0 SF | | |

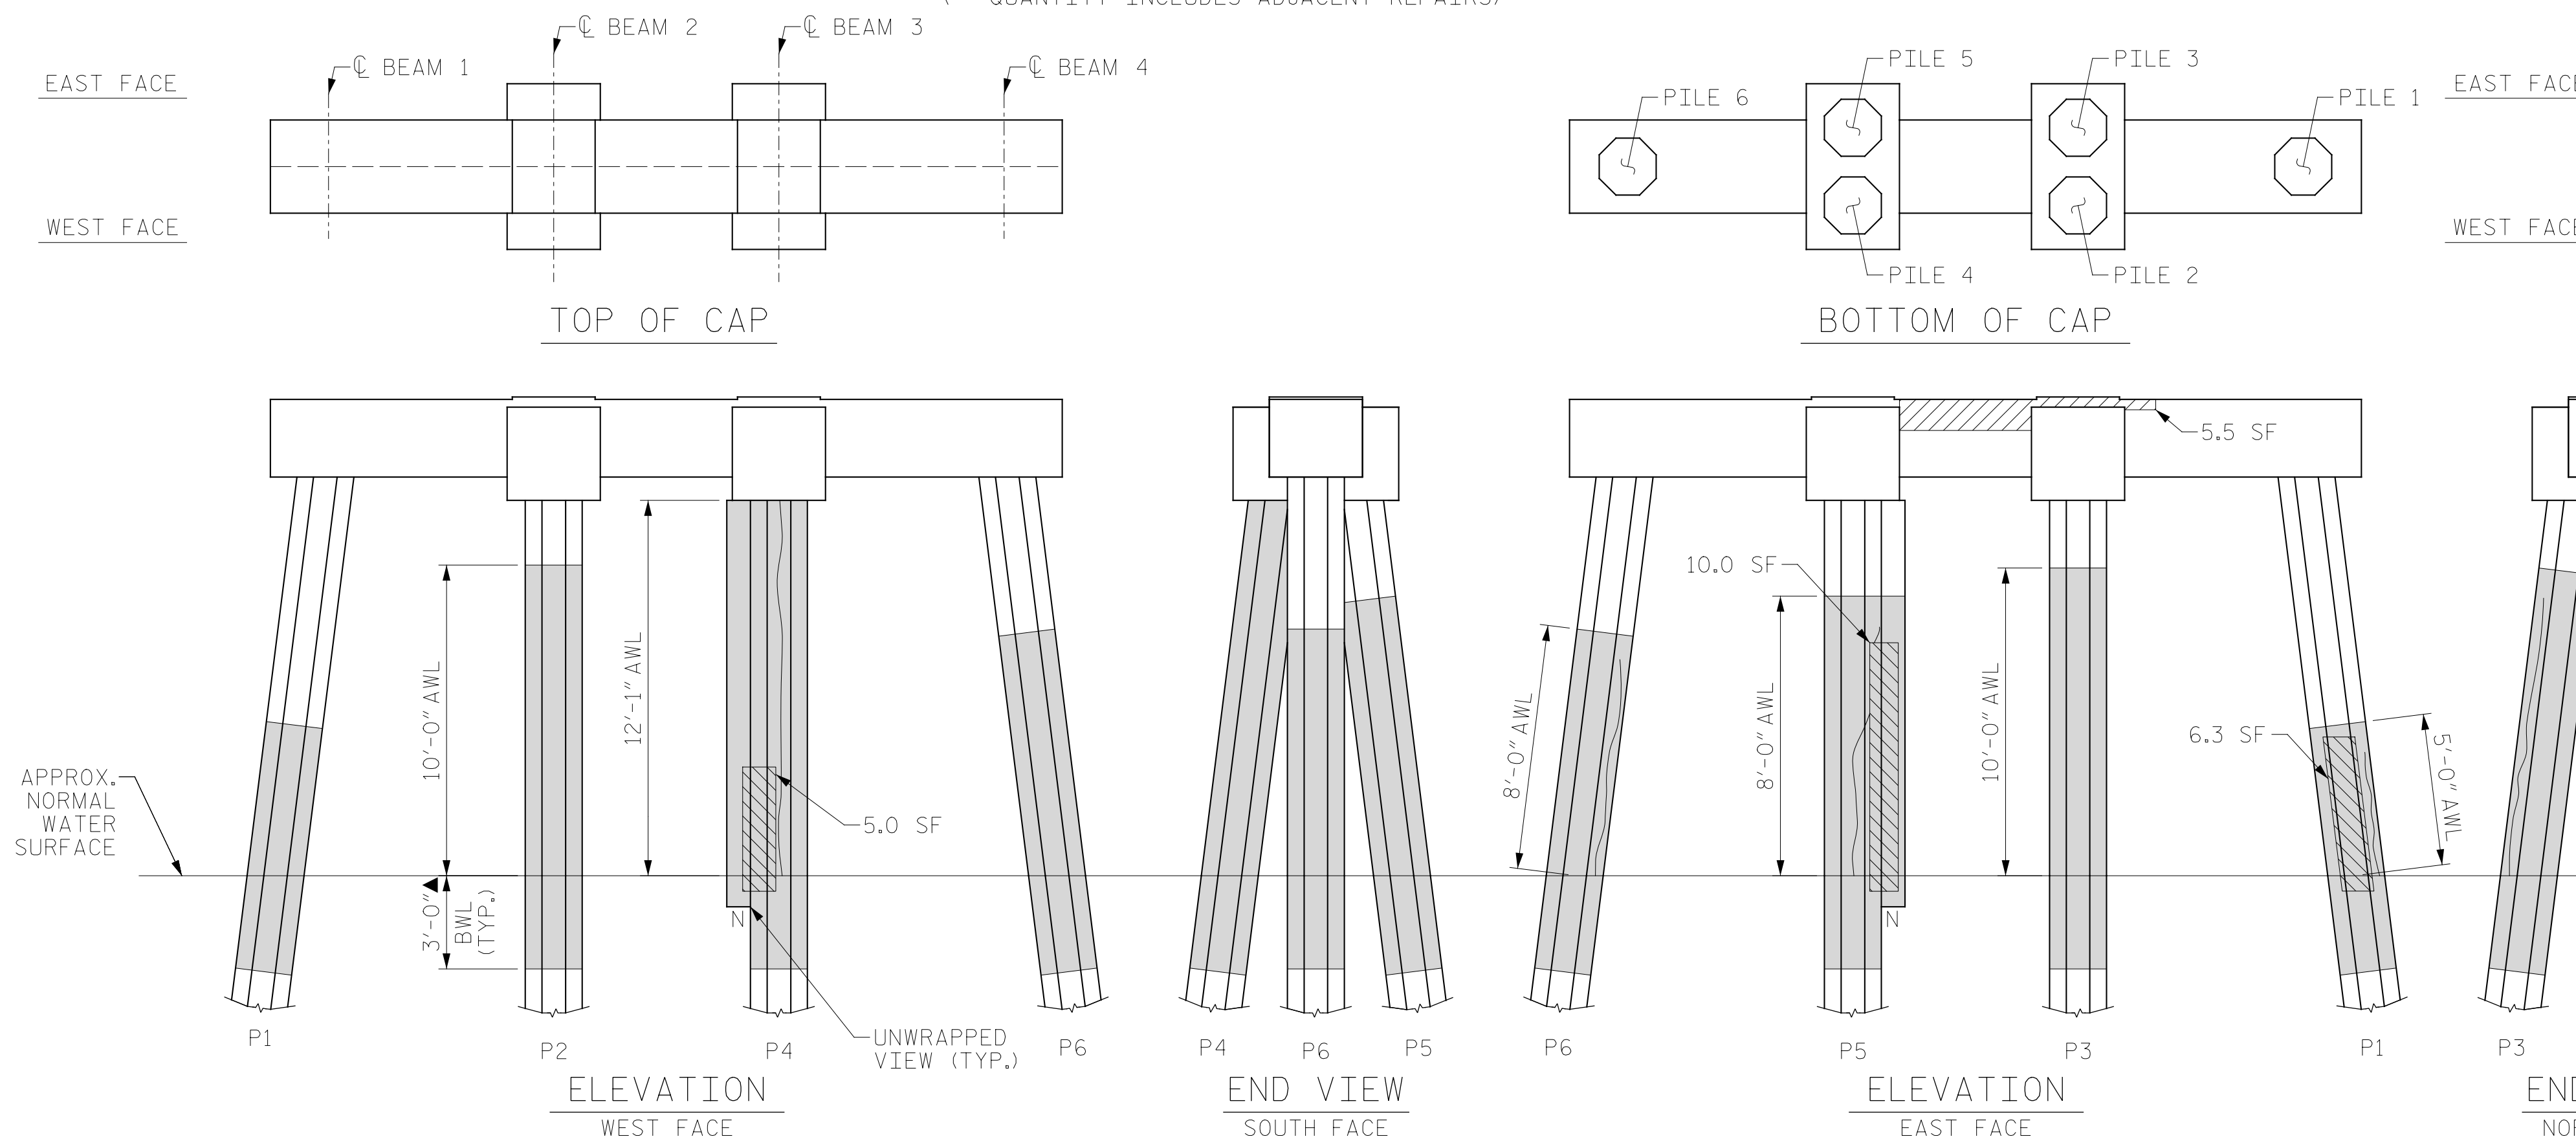
BENT 276

| CAP REPAIRS | | | |
|---|---|---|---|
| SHOTCRETE REPAIRS | 5.5 SF | 2.8 CF | SF CF |
| PILE CONCRETE RESTORATION | 21.3 SF | 9.0 CF | SF CF |
| FRP PROTECTIVE SYSTEM AWL | 292.0 SF | | |
| FRP PROTECTIVE SYSTEM BWL | 99.0 SF | | |
