AS-BUILT REPAIR QUANTITY TABLE BENT 281 SF 1.5 SF | 0.8 CF - LF

COUNTY 270009

STATE OF NORTH CAROLINA DEPARTMENT OF TRANSPORTATION RALEIGH

BENT 281 & BENT 282

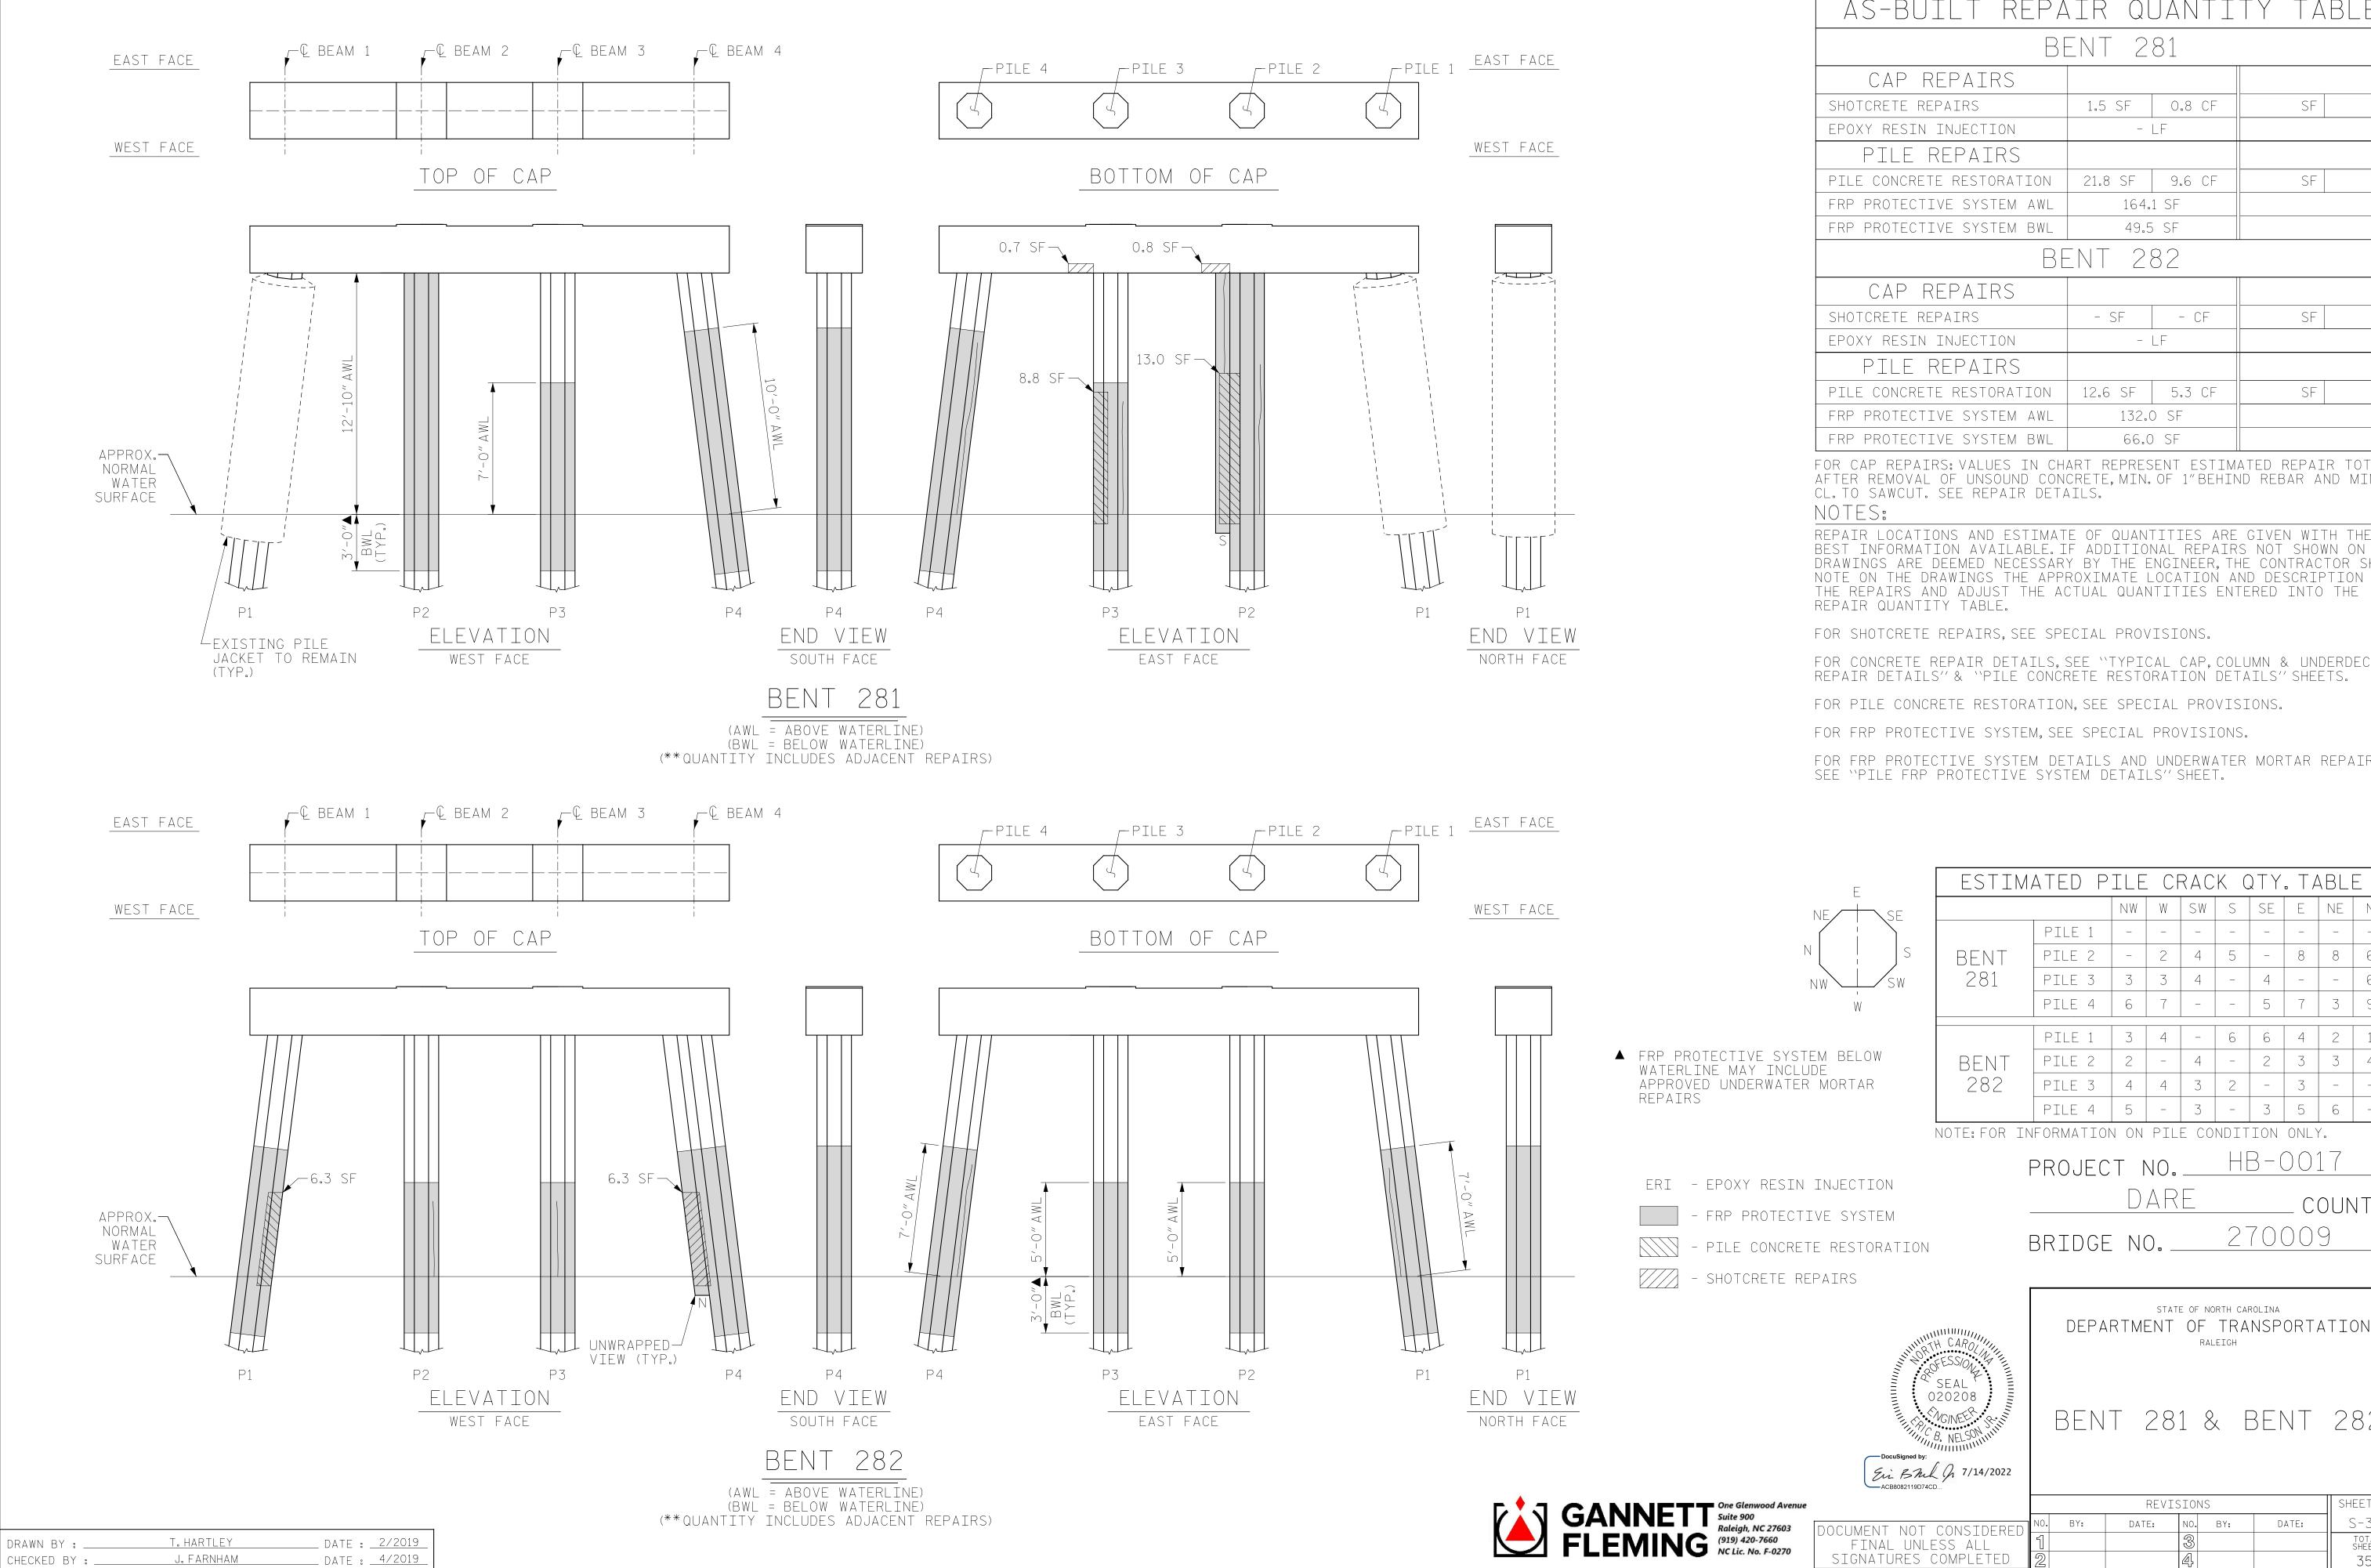
PILE CONCRETE RESTORATION | 21.8 SF | 9.6 CF SF FRP PROTECTIVE SYSTEM AWL 164.1 SF FRP PROTECTIVE SYSTEM BWL 49.5 SF

CAP REPAIRS							
SHOTCRETE REPAIRS	- SF - CF		SF	CF			
EPOXY RESIN INJECTION	_	LF	LF				
PILE REPAIRS							
PILE CONCRETE RESTORATION	12.6 SF	5.3 CF	SF	CF			
FRP PROTECTIVE SYSTEM AWL	132.0) SF					
FRP PROTECTIVE SYSTEM BWL	66.0 SF

ESTIMATED PILE CRACK QTY. TABLE									
		NW	W	SW	S	SE	E	NE	N
	PILE 1	_	_	_	_	_	_	_	_
BENT	PILE 2	_	2	4	5	_	8	8	6
281	PILE 3	3	3	4	_	4	_	_	6
	PILE 4	6	7	_	_	5	7	3	9
	PILE 1	3	4	-	6	6	4	2	1
BENT	PILE 2	2	_	4	_	2	3	3	4
282	PILE 3	4	4	3	2	_	3	_	_
	PILE 4	5	_	3	_	3	5	6	_
NOTE: FOR INFORMATION ON PILE CONDITION ONLY.
