AS-BUILT REPAIR QUANTITY TABLE

PROJECT NO. HB-0017
DARE COUNTY
BRIDGE NO. 270009

BENT 283 & BENT 284

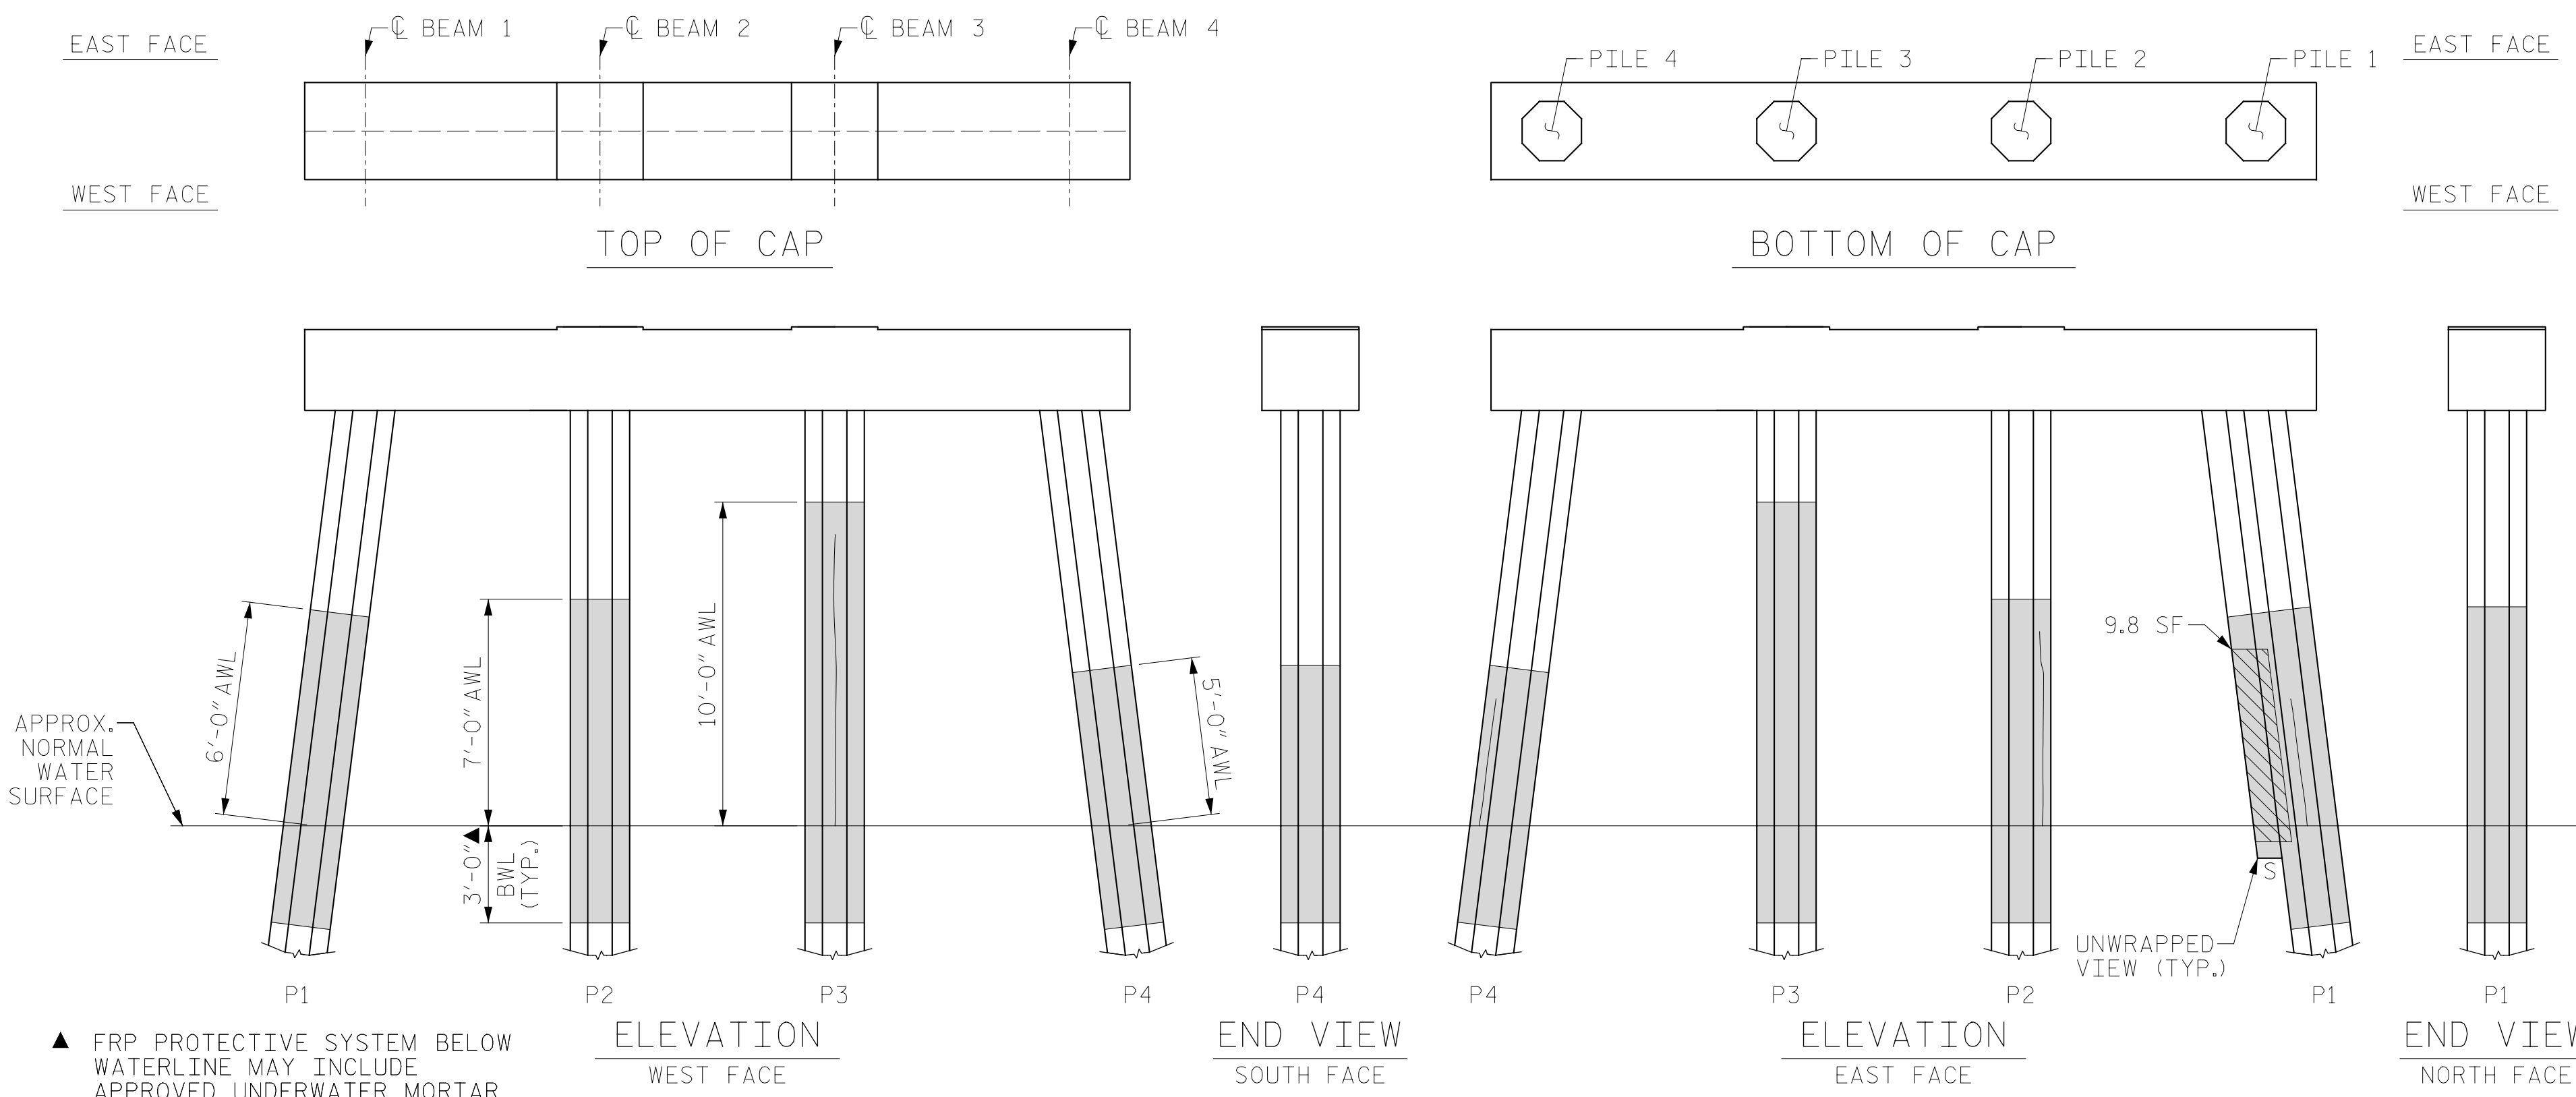
BENT 283

▲ FRP PROTECTIVE SYSTEM BELOW WATERLINE MAY INCLUDE APPROVED UNDERWATER MORTAR REPAIRS

| CAP REPAIRS | | | |
|---|---|---|---|
| PILE CONCRETE RESTORATION | 9.8 SF | 4.4 CF | SF CF |
| FRP PROTECTIVE SYSTEM AWL | 154.0 SF | | |
| FRP PROTECTIVE SYSTEM BWL | 66.0 SF | | |

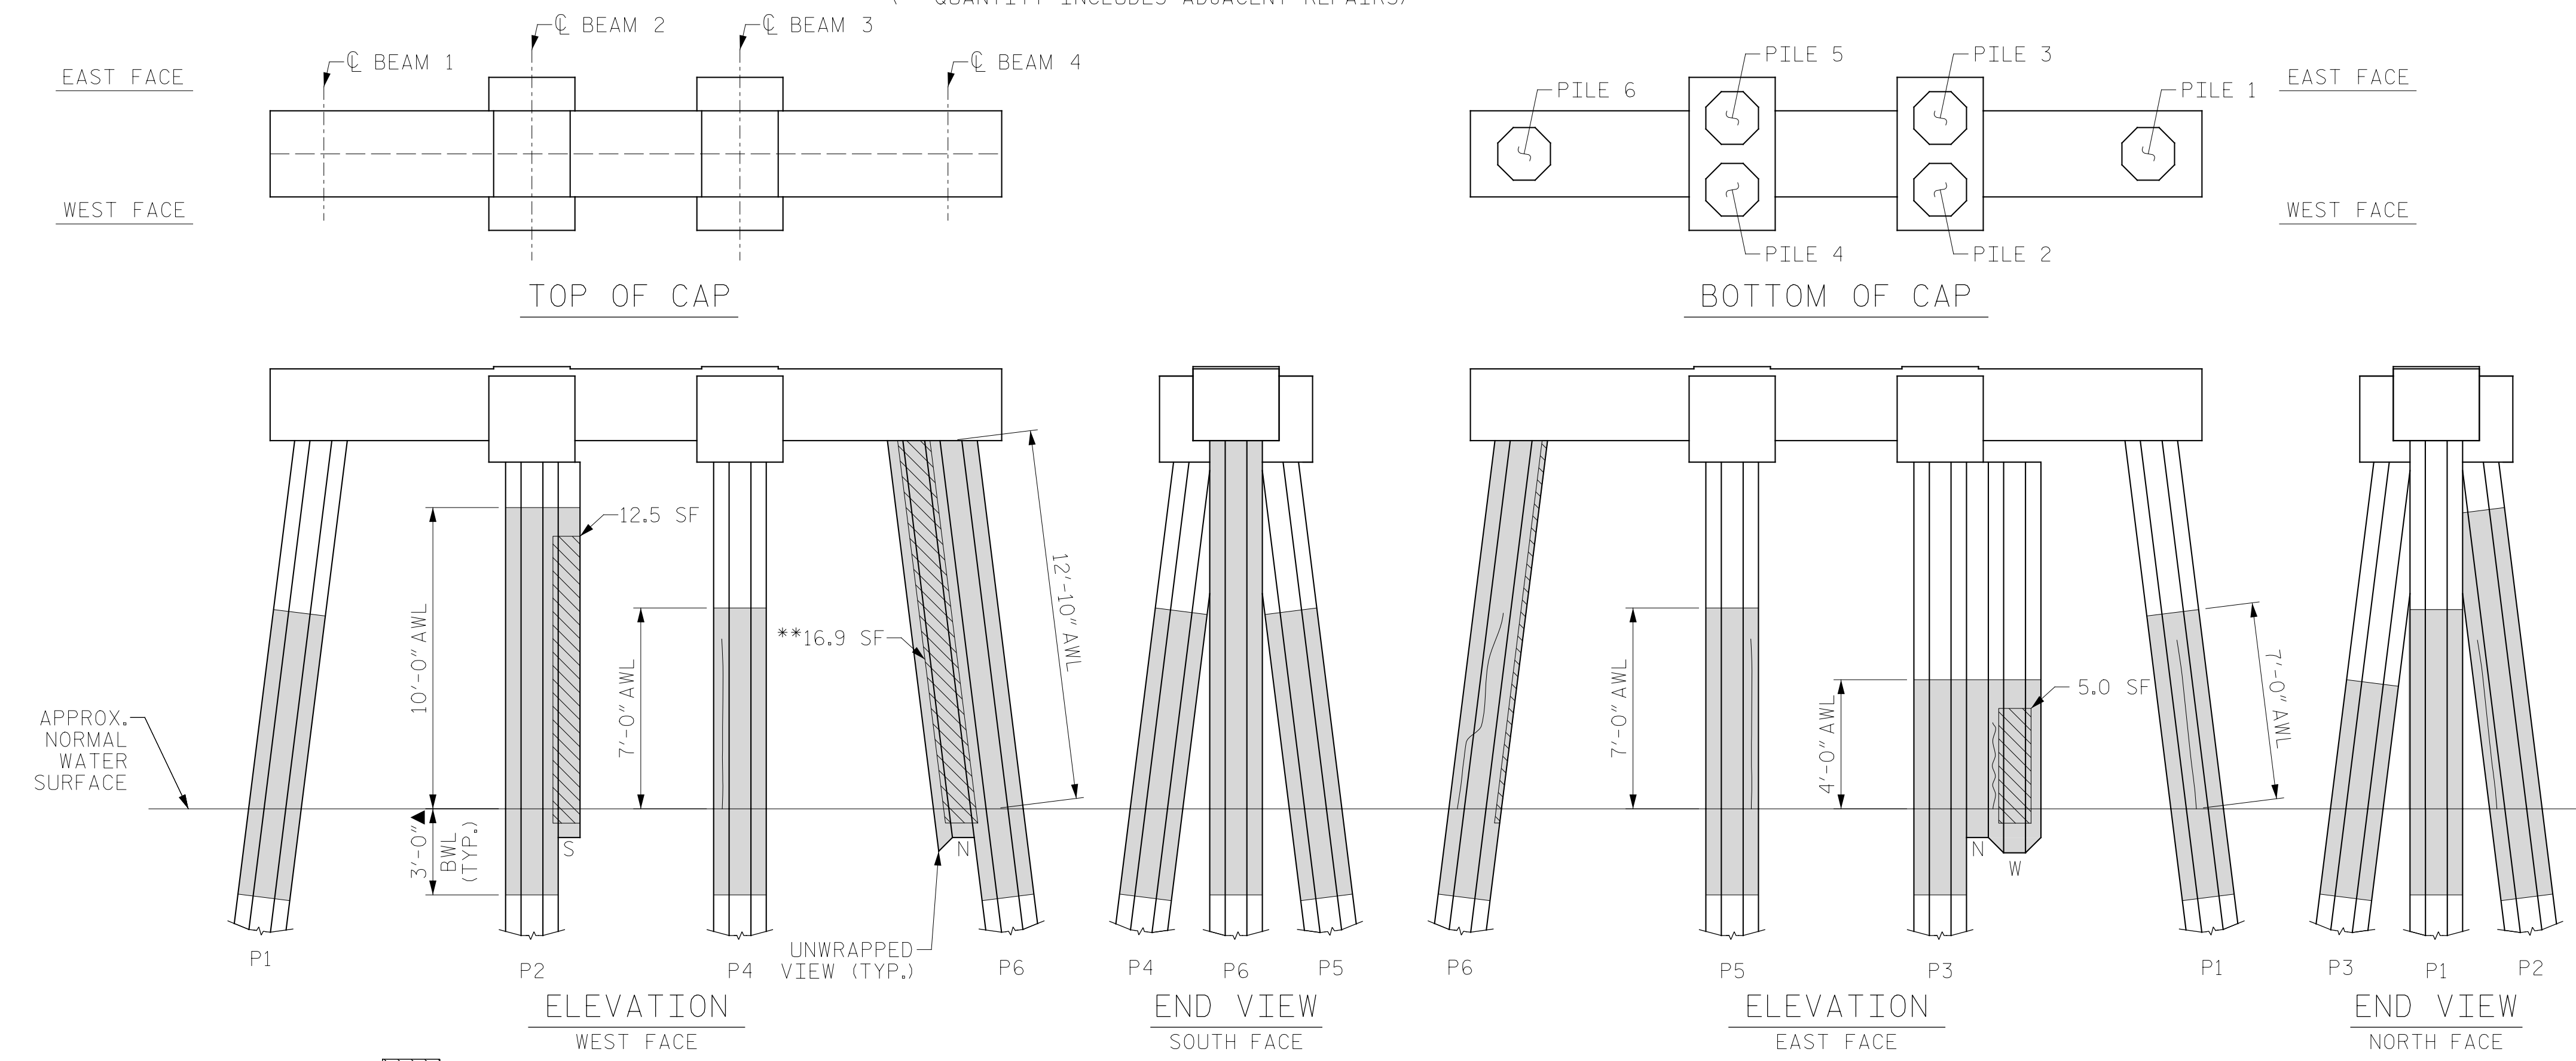
BENT 284

ERI - EPOXY RESIN INJECTION
- FRP PROTECTIVE SYSTEM
- PILE CONCRETE RESTORATION
- SHOTCRETE REPAIRS

| CAP REPAIRS | | | |
|---|---|---|---|
| PILE CONCRETE RESTORATION | 34.4 SF | 14.6 CF | SF CF |
| FRP PROTECTIVE SYSTEM AWL | 263.1 SF | | |
| FRP PROTECTIVE SYSTEM BWL | 99.0 SF | | |
