AS-BUILT REPAIR QUANTITY TABLE

PROJECT NO. HB-0017
DARE COUNTY
BRIDGE NO. 270009

BENT 285 & BENT 286

REVISIONS						SHEET NO.
NO.	BY:	DATE:	NO.	BY:	DATE:	S-312
1			3			TOTAL SHEETS
2			4			355

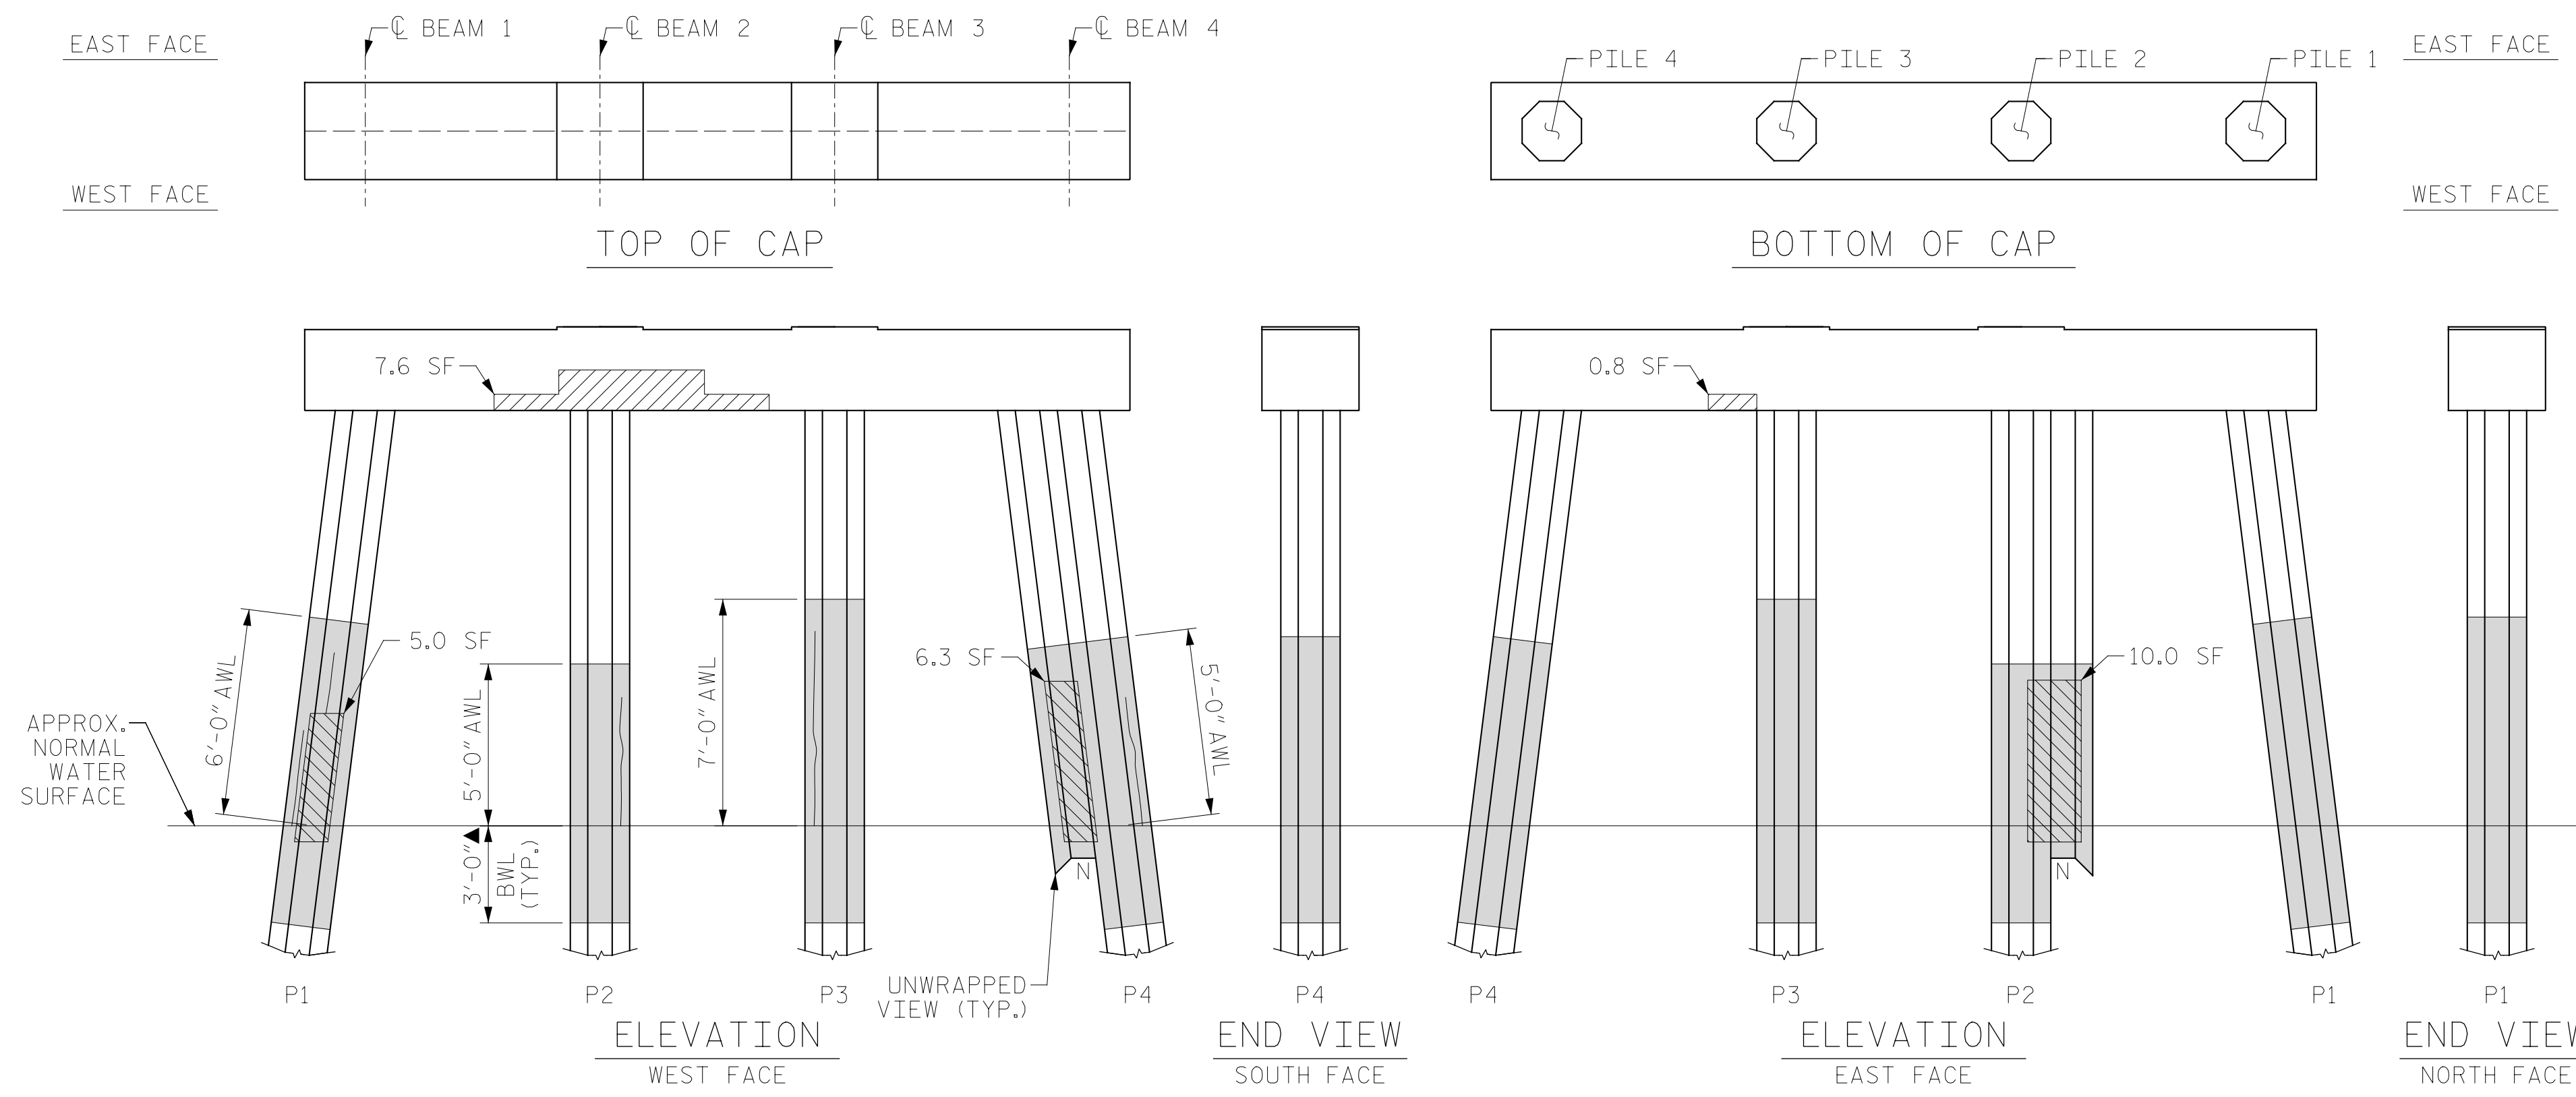
BENT 285

CAP REPAIRS			
SHOTCRETE REPAIRS	8.4 SF	4.2 CF	SF CF
EPOXY RESIN INJECTION	- LF		LF
PILE REPAIRS			
PILE CONCRETE RESTORATION	21.3 SF	8.7 CF	SF CF
FRP PROTECTIVE SYSTEM AWL	126.5 SF		
FRP PROTECTIVE SYSTEM BWL	66.0 SF

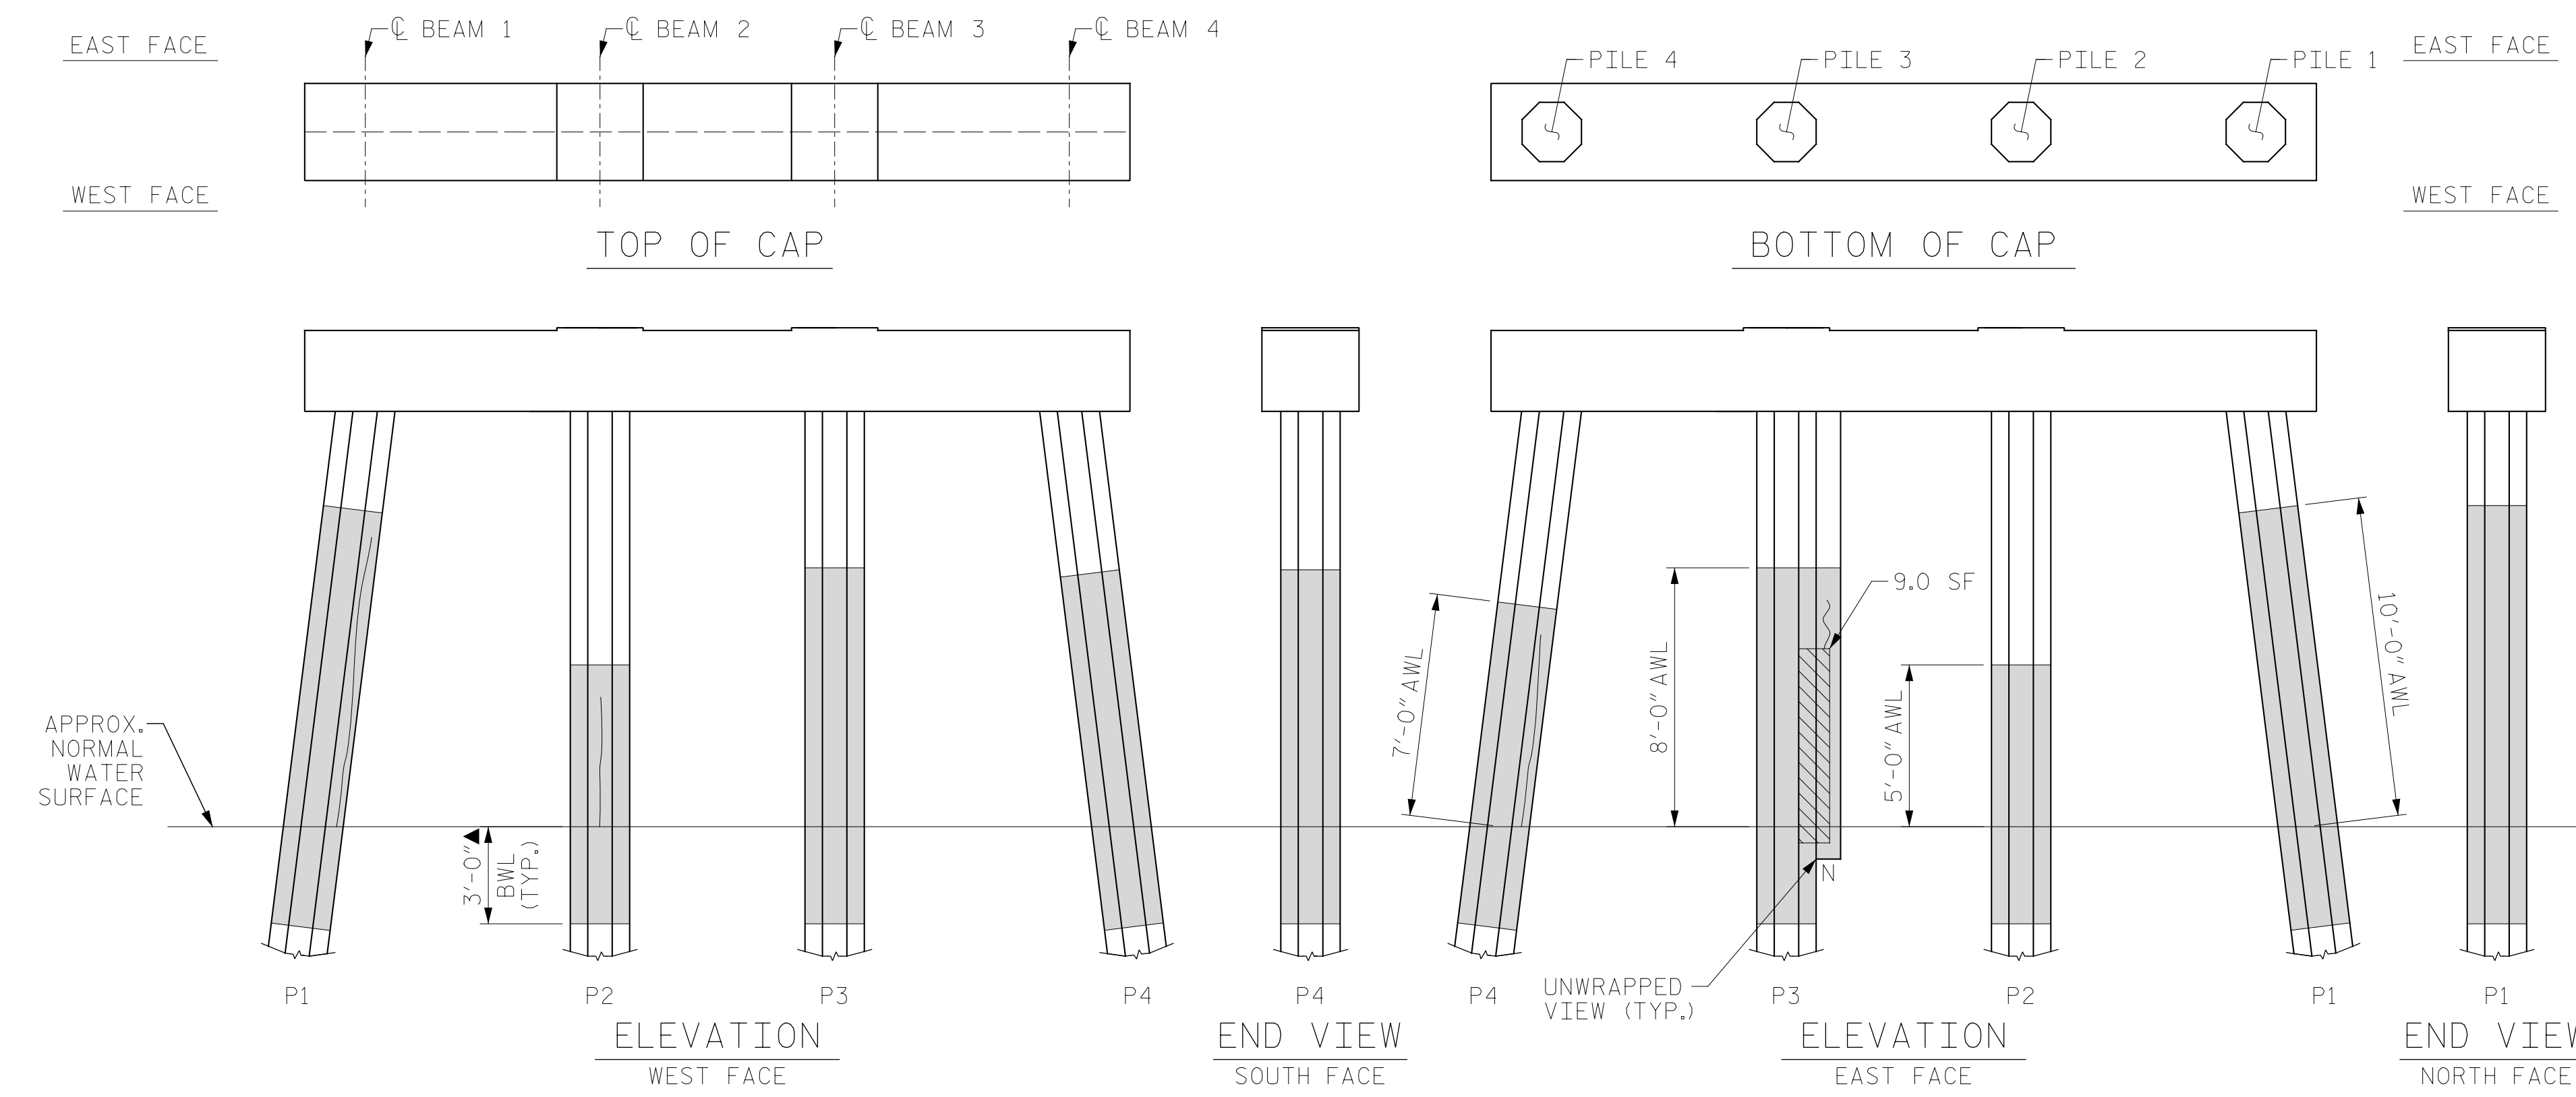
BENT 286

CAP REPAIRS			
SHOTCRETE REPAIRS	- SF	- CF	SF CF
EPOXY RESIN INJECTION	- LF		LF
PILE REPAIRS			
PILE CONCRETE RESTORATION	9.0 SF	4.0 CF	SF CF
FRP PROTECTIVE SYSTEM AWL	165.0 SF		
FRP PROTECTIVE SYSTEM BWL	66.0 SF
