AS-BUILT REPAIR QUANTITY TABLE

PROJECT NO. HB-0017
DARE COUNTY
BRIDGE NO. 270009

BENT 287 & BENT 288

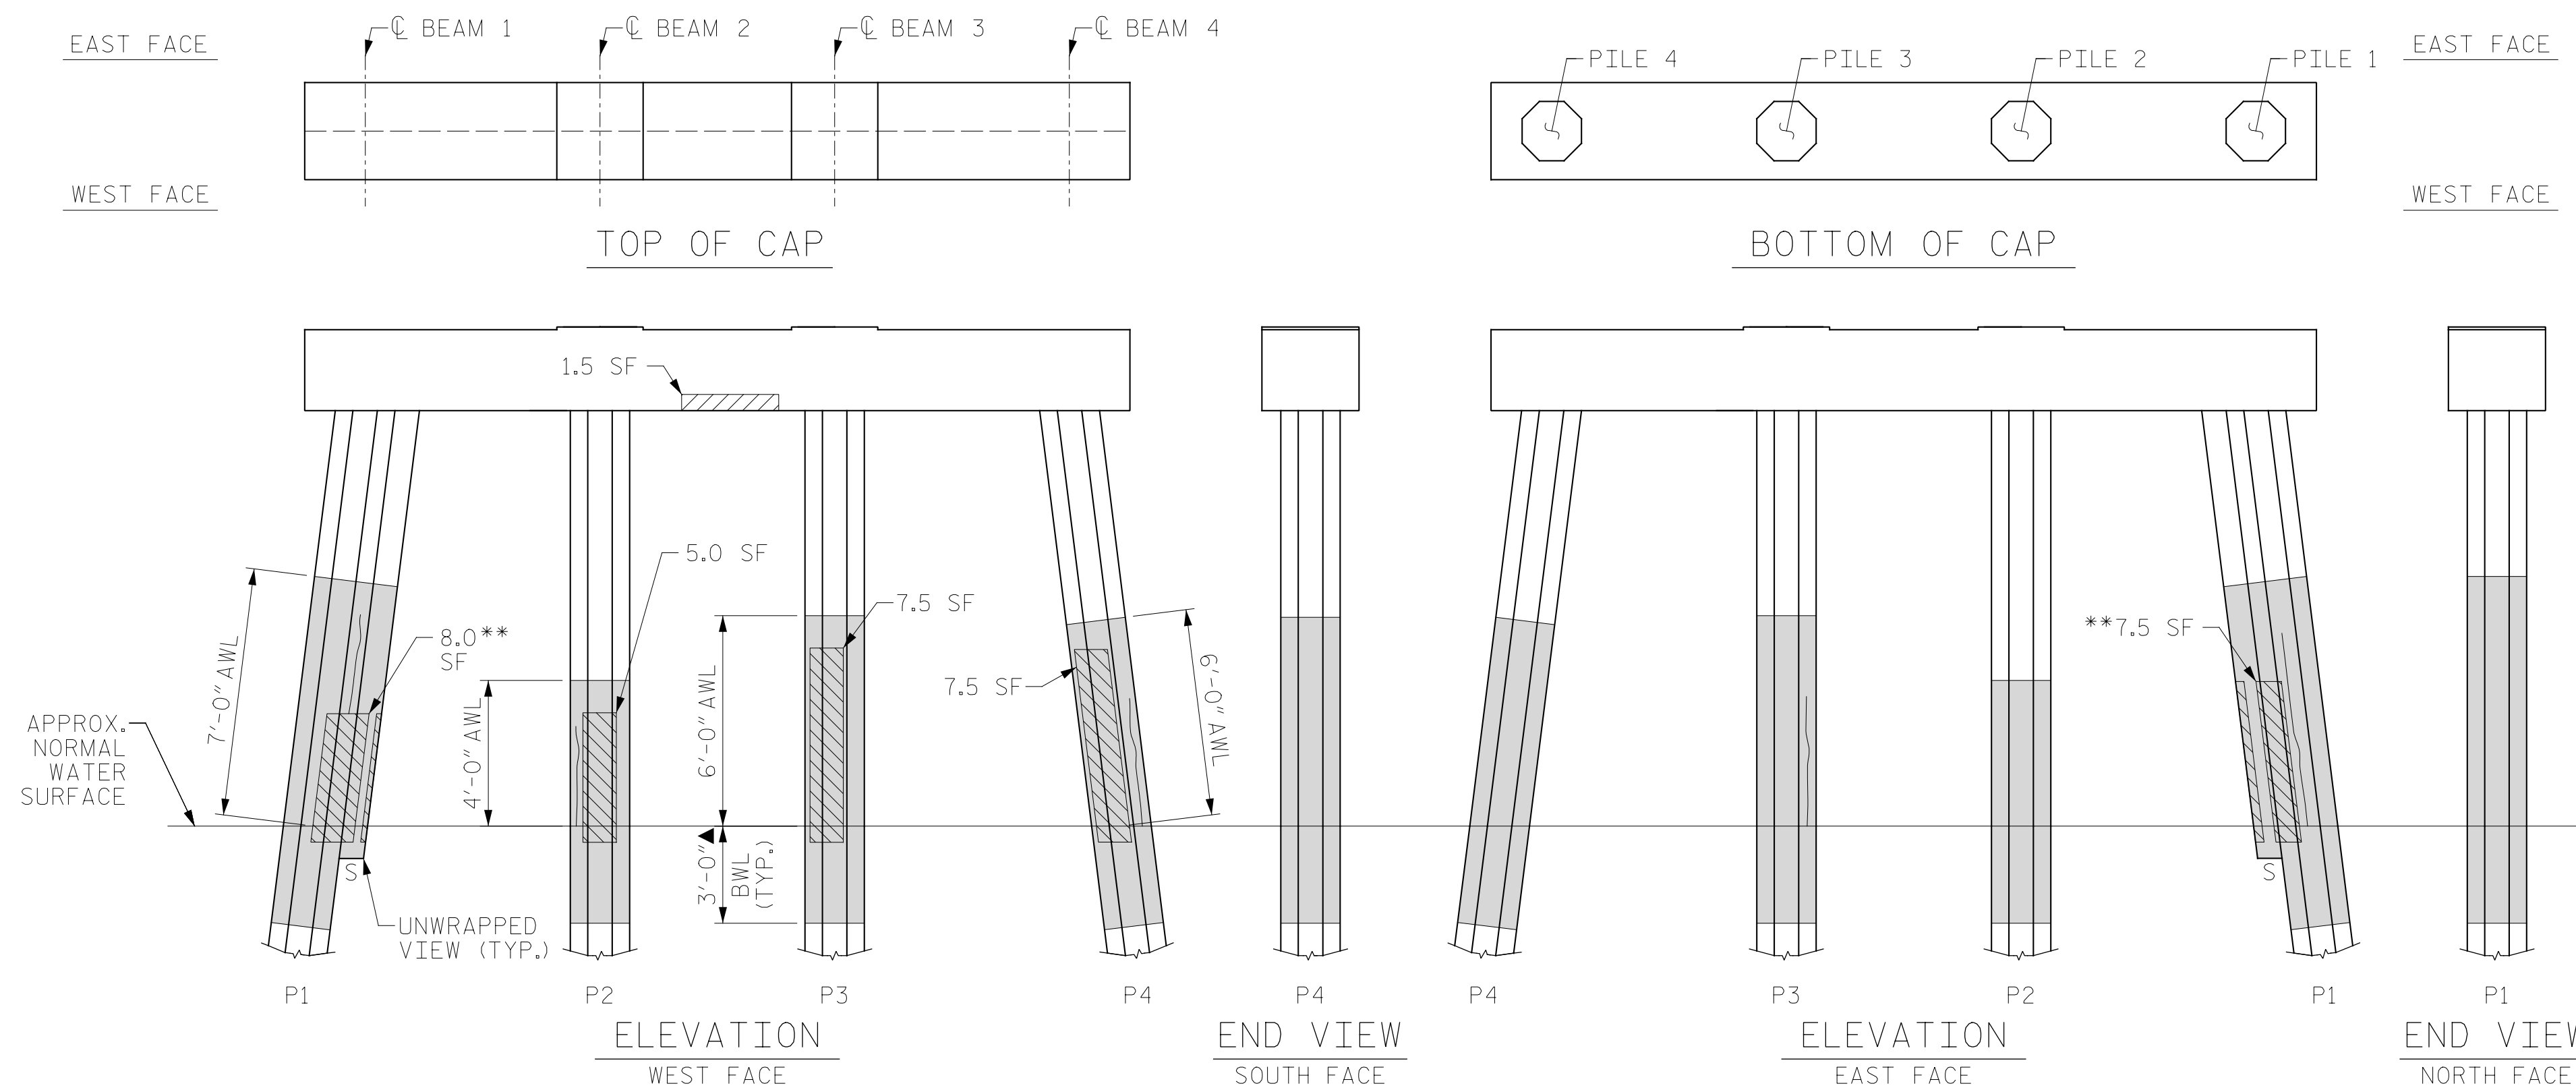
BENT 287

CAP REPAIRS			
SHOTCRETE REPAIRS	1.5 SF	0.8 CF	
EPOXY RESIN INJECTION	- LF		
PILE REPAIRS			
PILE CONCRETE RESTORATION	35.5 SF	14.9 CF	
FRP PROTECTIVE SYSTEM AWL	126.5 SF		
FRP PROTECTIVE SYSTEM BWL	66.0 SF

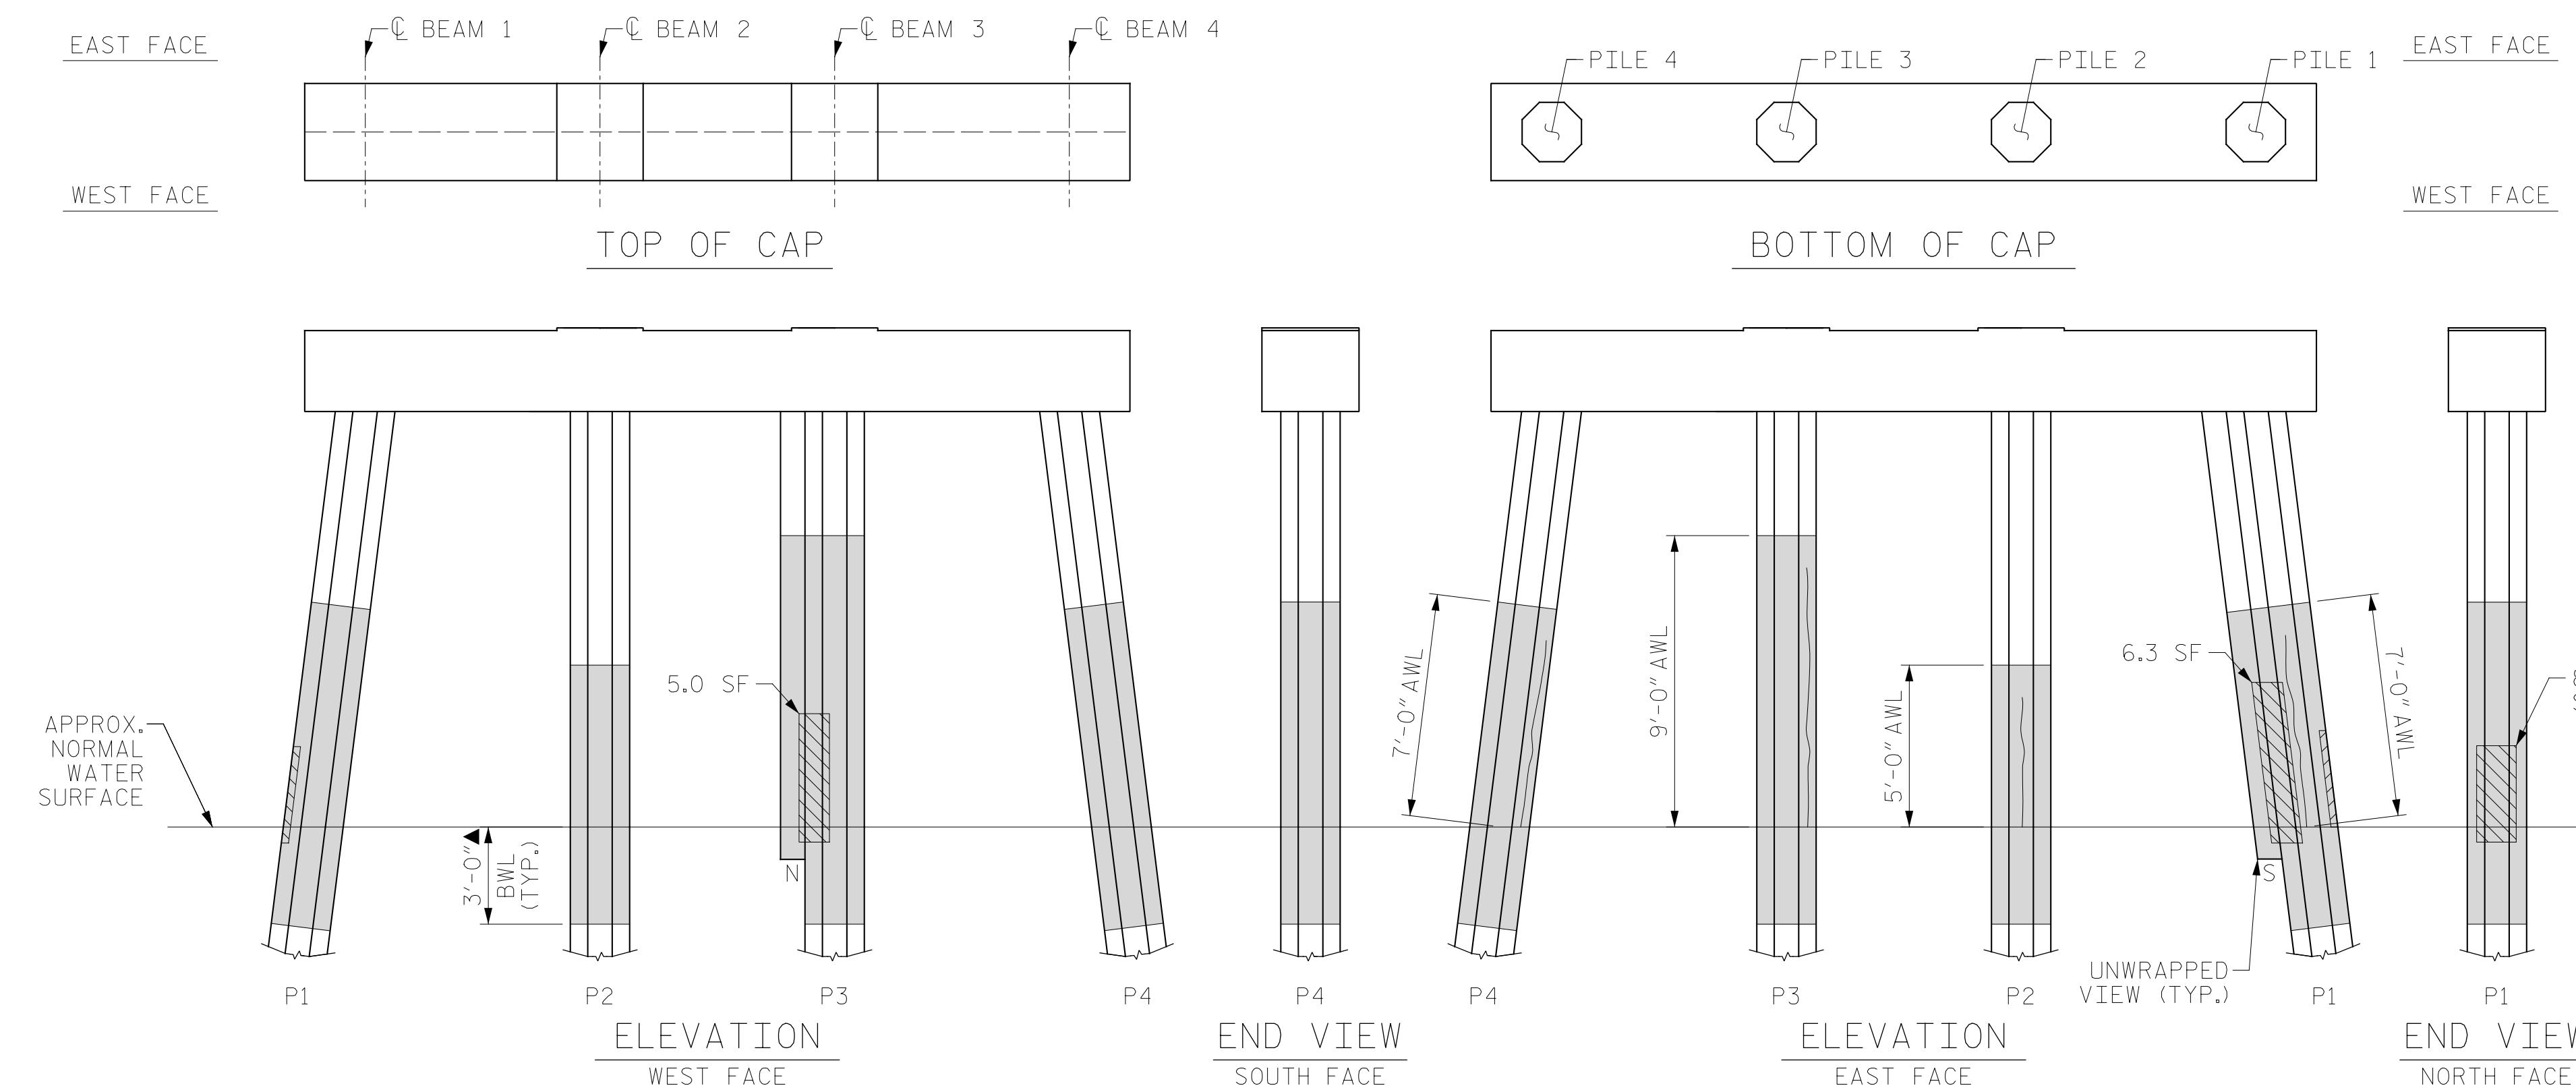
BENT 288

CAP REPAIRS			
SHOTCRETE REPAIRS	- SF	- CF	
EPOXY RESIN INJECTION	- LF		
PILE REPAIRS			
PILE CONCRETE RESTORATION	19.3 SF	7.9 CF	
FRP PROTECTIVE SYSTEM AWL	154.0 SF		
FRP PROTECTIVE SYSTEM BWL	66.0 SF
