AS-BUILT REPAIR QUANTITY TABLE

PROJECT NO. HB-0017
DARE COUNTY
BRIDGE NO. 270009

BENT 291 & BENT 292

REVISIONS						SHEET NO.
NO.	BY:	DATE:	NO.	BY:	DATE:	S-315
1			3			
2			4			TOTAL SHEETS: 355

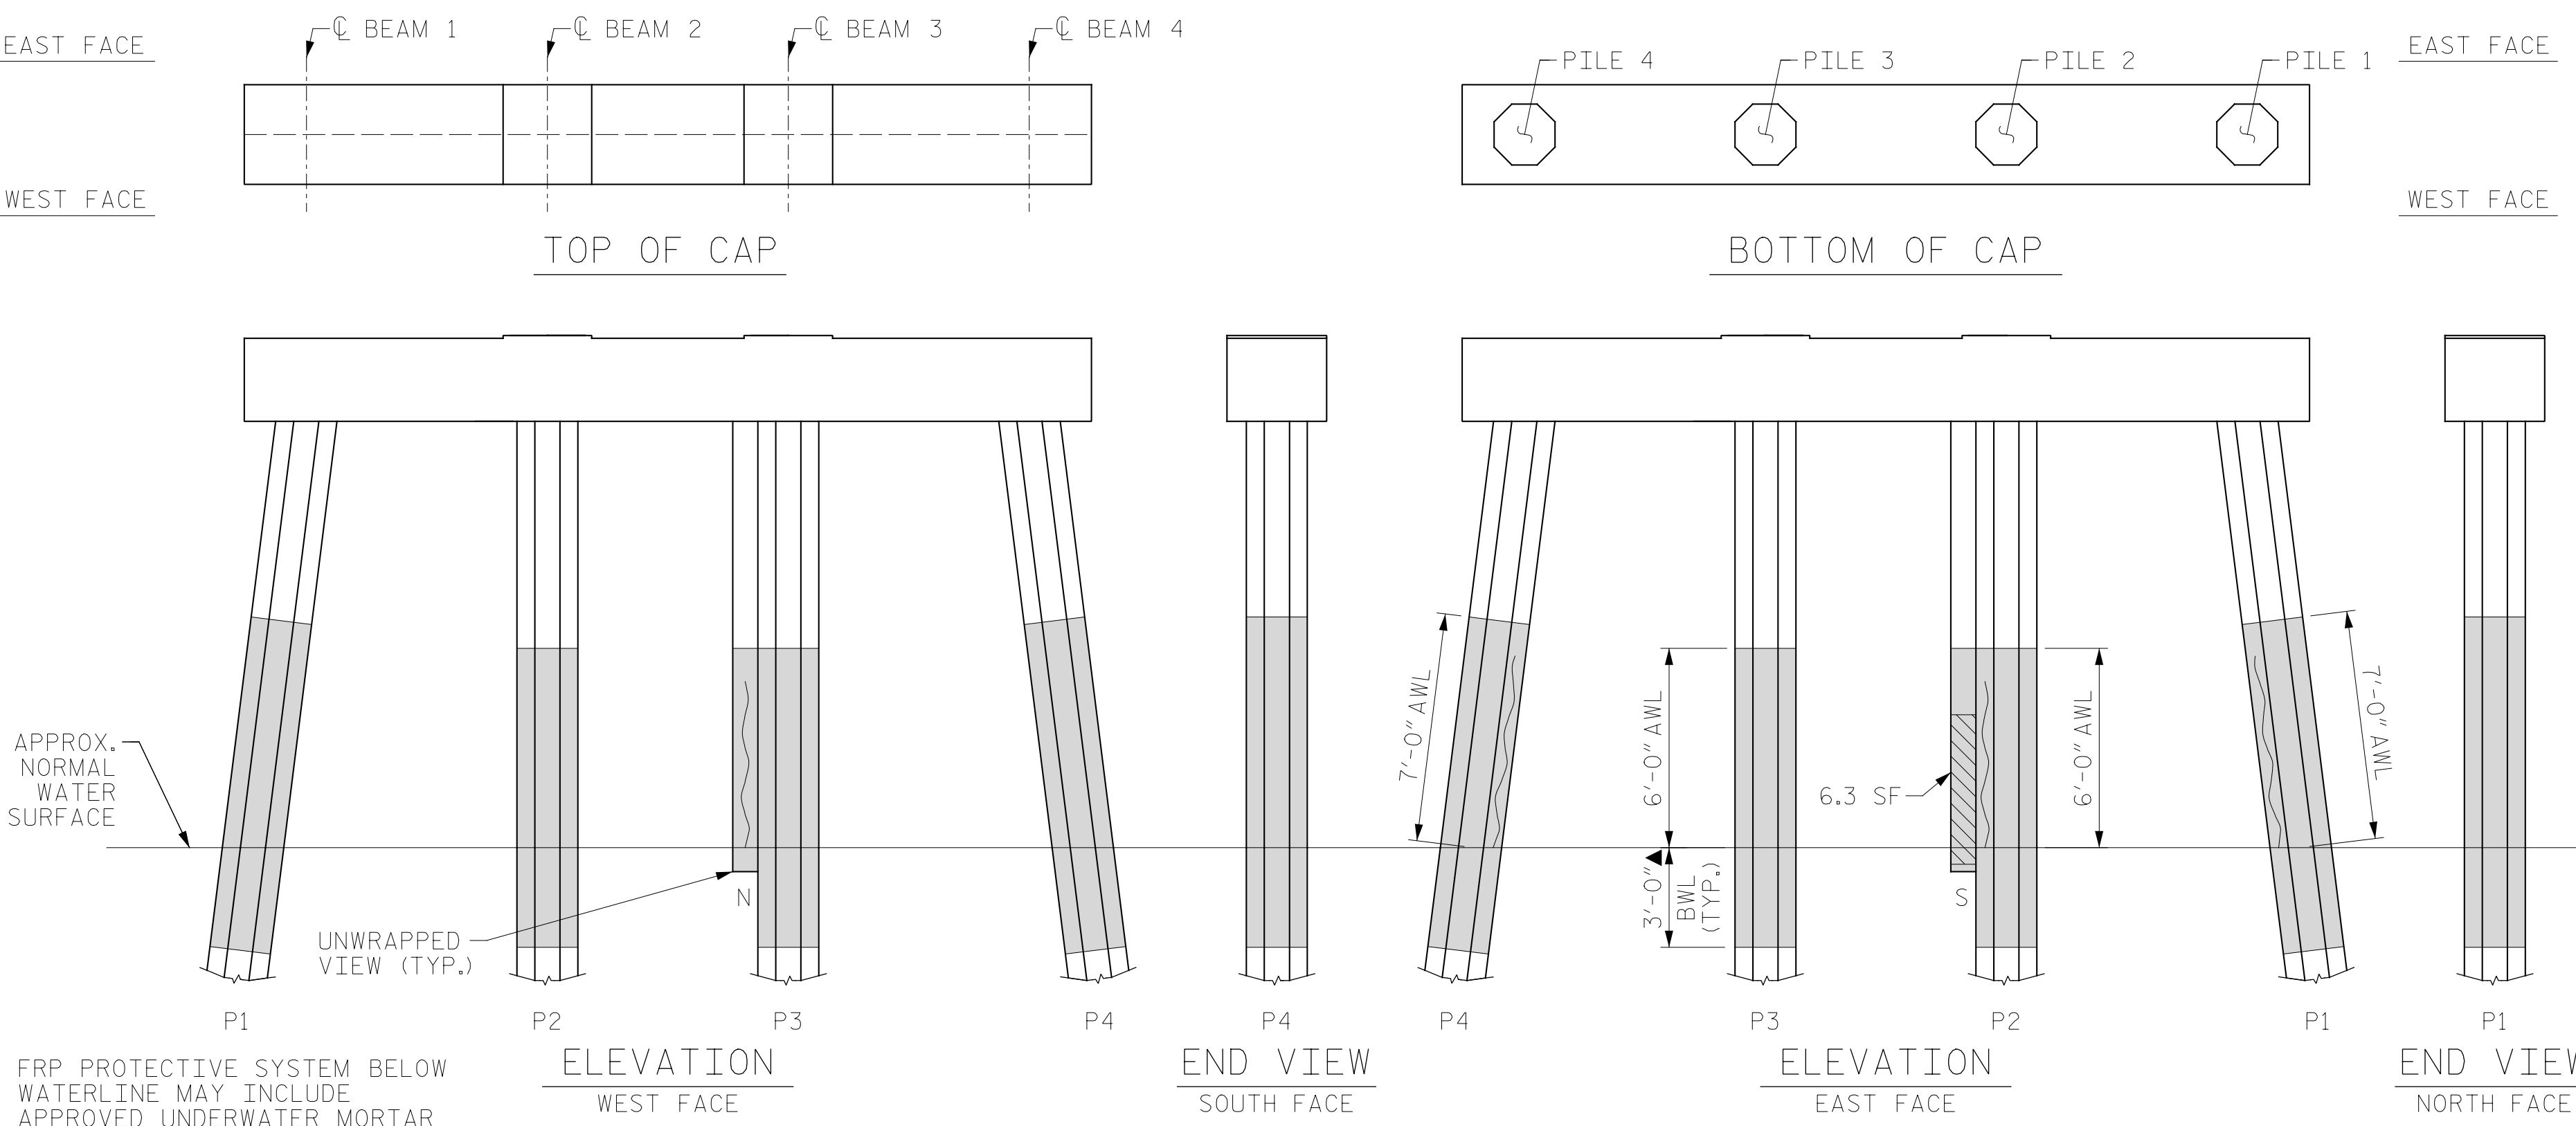
BENT 291

CAP REPAIRS		ESTIMATE			
SHOTCRETE REPAIRS	- SF	- CF	SF	CF	
EPOXY RESIN INJECTION		- LF			LF
PILE REPAIRS		ESTIMATE			
PILE CONCRETE RESTORATION	6.3 SF	2.7 CF	SF	CF	
FRP PROTECTIVE SYSTEM AWL	143.0 SF				
FRP PROTECTIVE SYSTEM BWL	66.0 SF

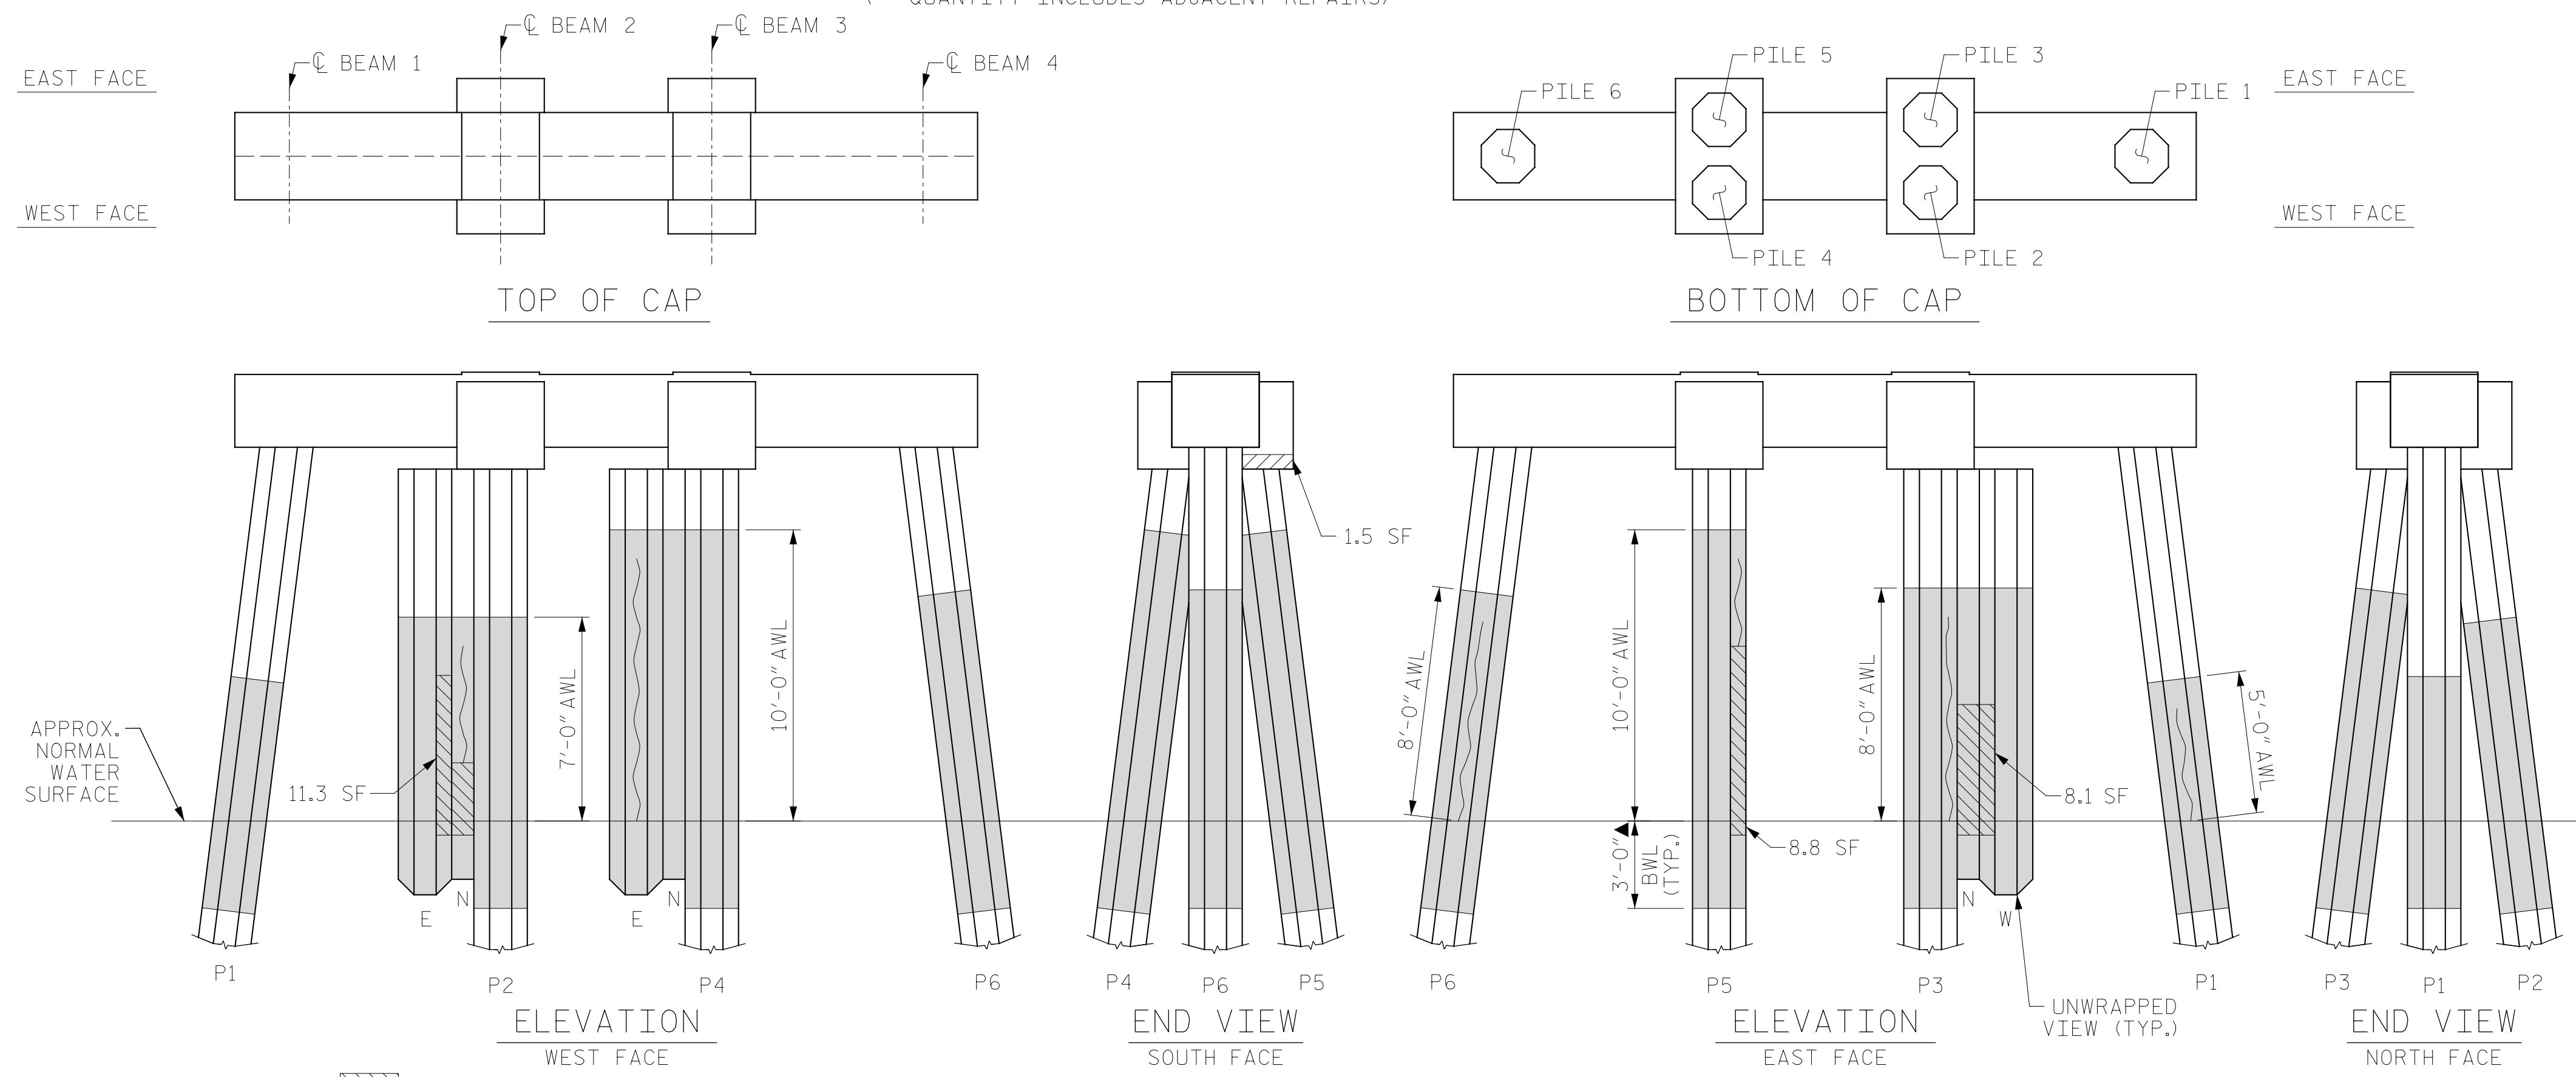
BENT 292

CAP REPAIRS		ESTIMATE			
SHOTCRETE REPAIRS	1.5 SF	0.8 CF	SF	CF	
EPOXY RESIN INJECTION		- LF			LF
PILE REPAIRS		ESTIMATE			
PILE CONCRETE RESTORATION	28.1 SF	12.1 CF	SF	CF	
FRP PROTECTIVE SYSTEM AWL	264.0 SF				
FRP PROTECTIVE SYSTEM BWL	99.0 SF
