AS-BUILT REPAIR QUANTITY TABLE

PROJECT NO. HB-0017
DARE COUNTY
BRIDGE NO. 270009

BENT 293 & BENT 294

REVISIONS						SHEET NO.
NO.	BY:	DATE:	NO.	BY:	DATE:	S-316
1			3			TOTAL SHEETS
2			4			355

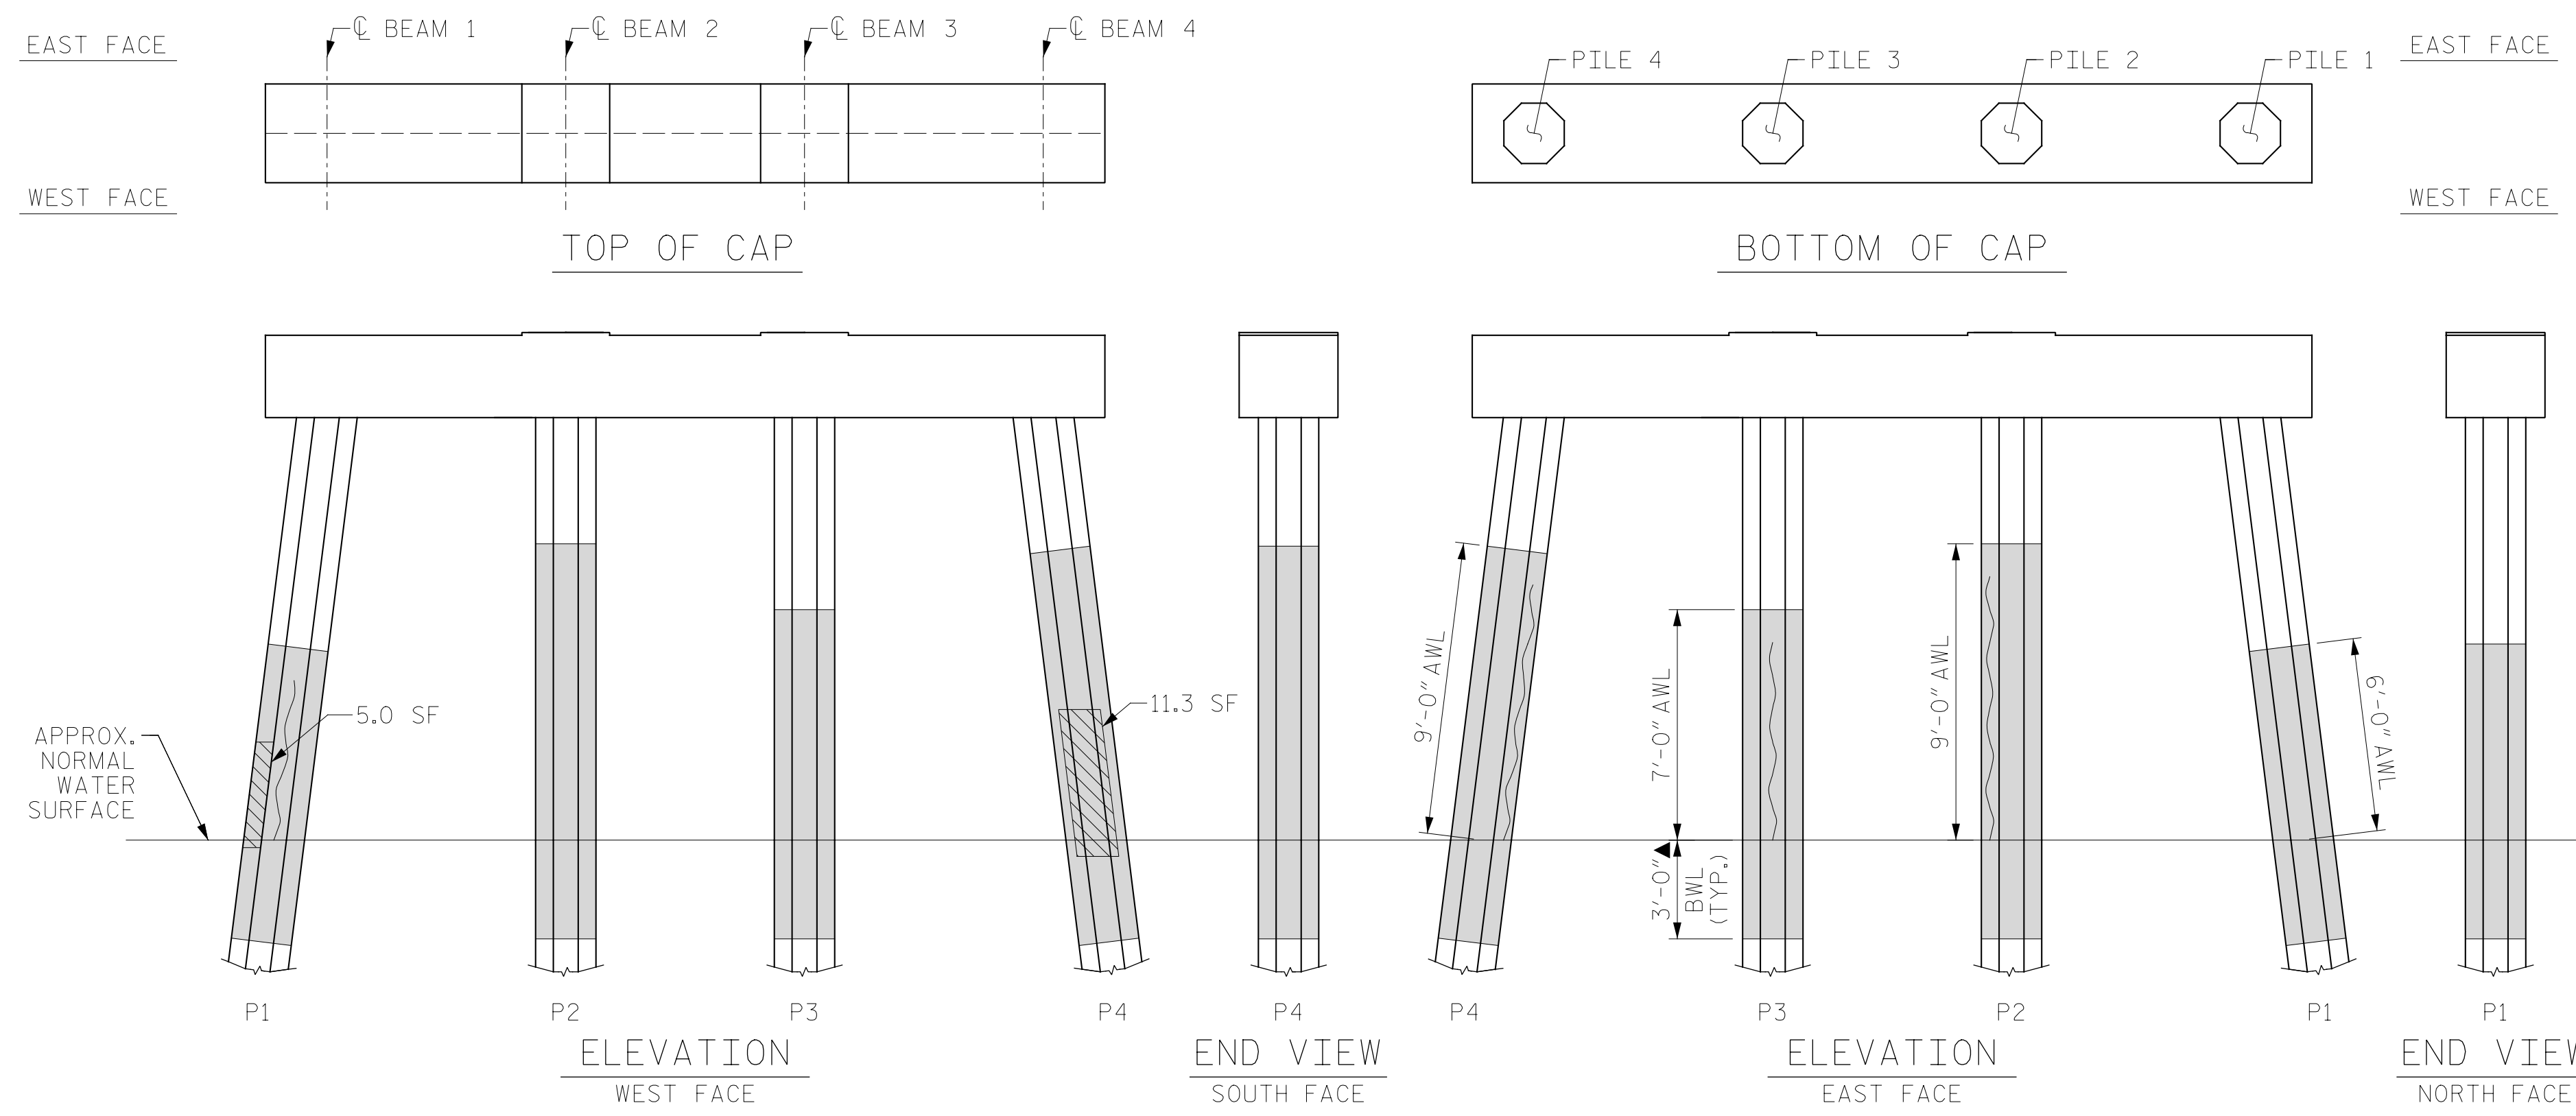
BENT 293

CAP REPAIRS		ESTIMATE			
SHOTCRETE REPAIRS	- SF	- CF	SF	CF	
EPOXY RESIN INJECTION	- LF				LF
PILE REPAIRS		ESTIMATE			
PILE CONCRETE RESTORATION	16.3 SF	6.8 CF	SF	CF	
FRP PROTECTIVE SYSTEM AWL	170.5 SF				
FRP PROTECTIVE SYSTEM BWL	66.0 SF

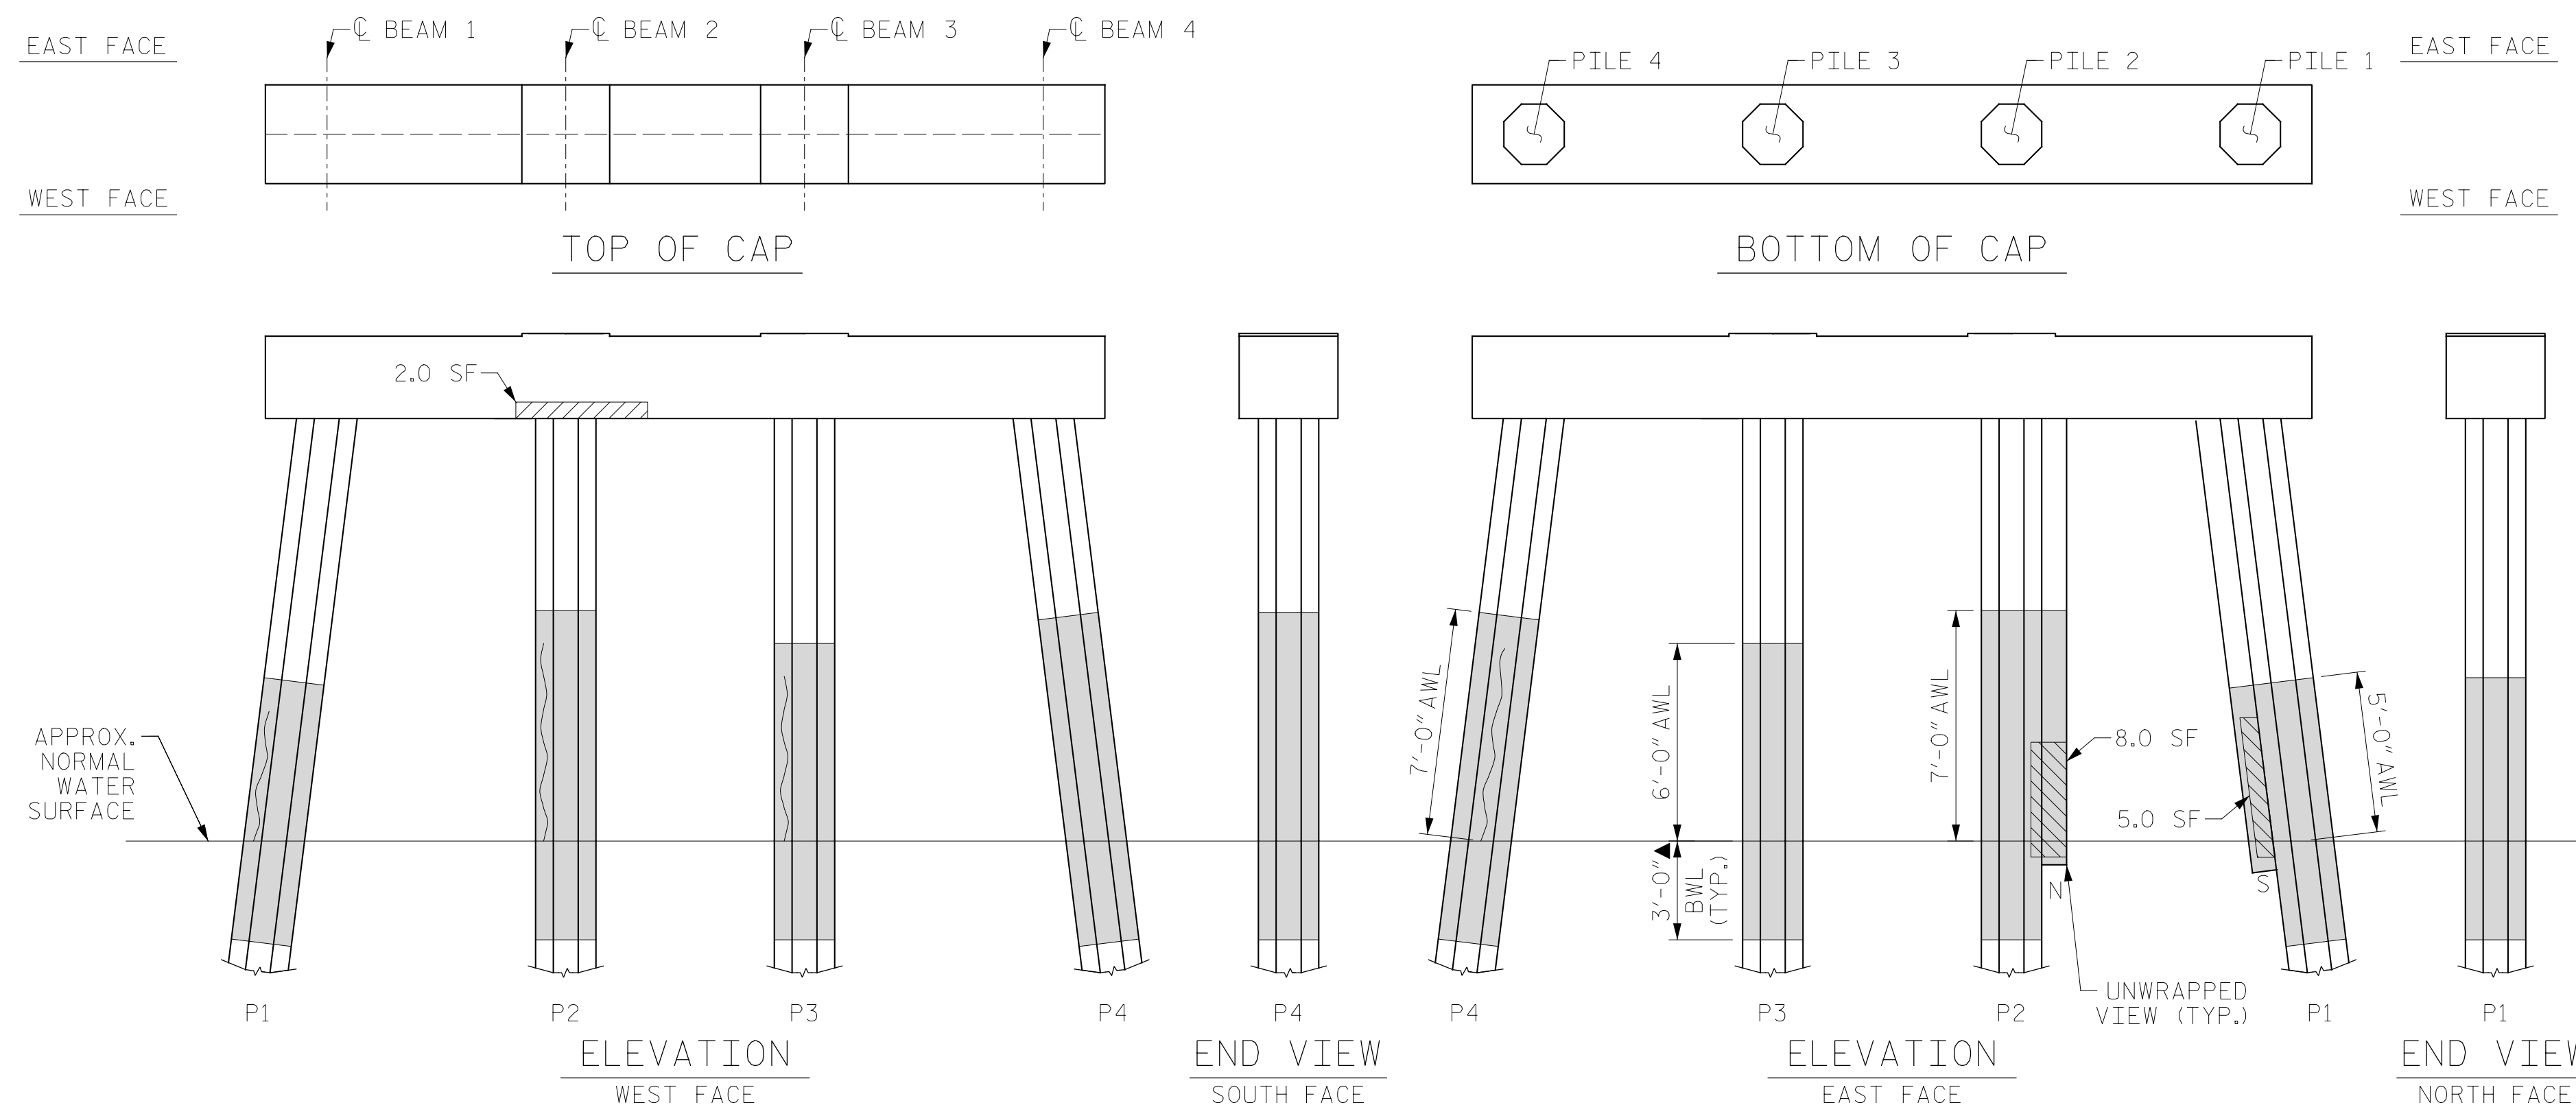
BENT 294

CAP REPAIRS		ESTIMATE			
SHOTCRETE REPAIRS	2.0 SF	1.0 CF	SF	CF	
EPOXY RESIN INJECTION	- LF				LF
PILE REPAIRS		ESTIMATE			
PILE CONCRETE RESTORATION	13.0 SF	5.2 CF	SF	CF	
FRP PROTECTIVE SYSTEM AWL	137.5 SF				
FRP PROTECTIVE SYSTEM BWL	66.0 SF
