AS-BUILT REPAIR QUANTITY TABLE

> STATE OF NORTH CAROLINA DEPARTMENT OF TRANSPORTATION

BENT 297 & BENT 298

SHEET NO.				
NO.	BY:	DATE:	NO.	BY:	DATE:	S-318
1			B			TOTAL SHEETS
\mathbb{N}			4			355

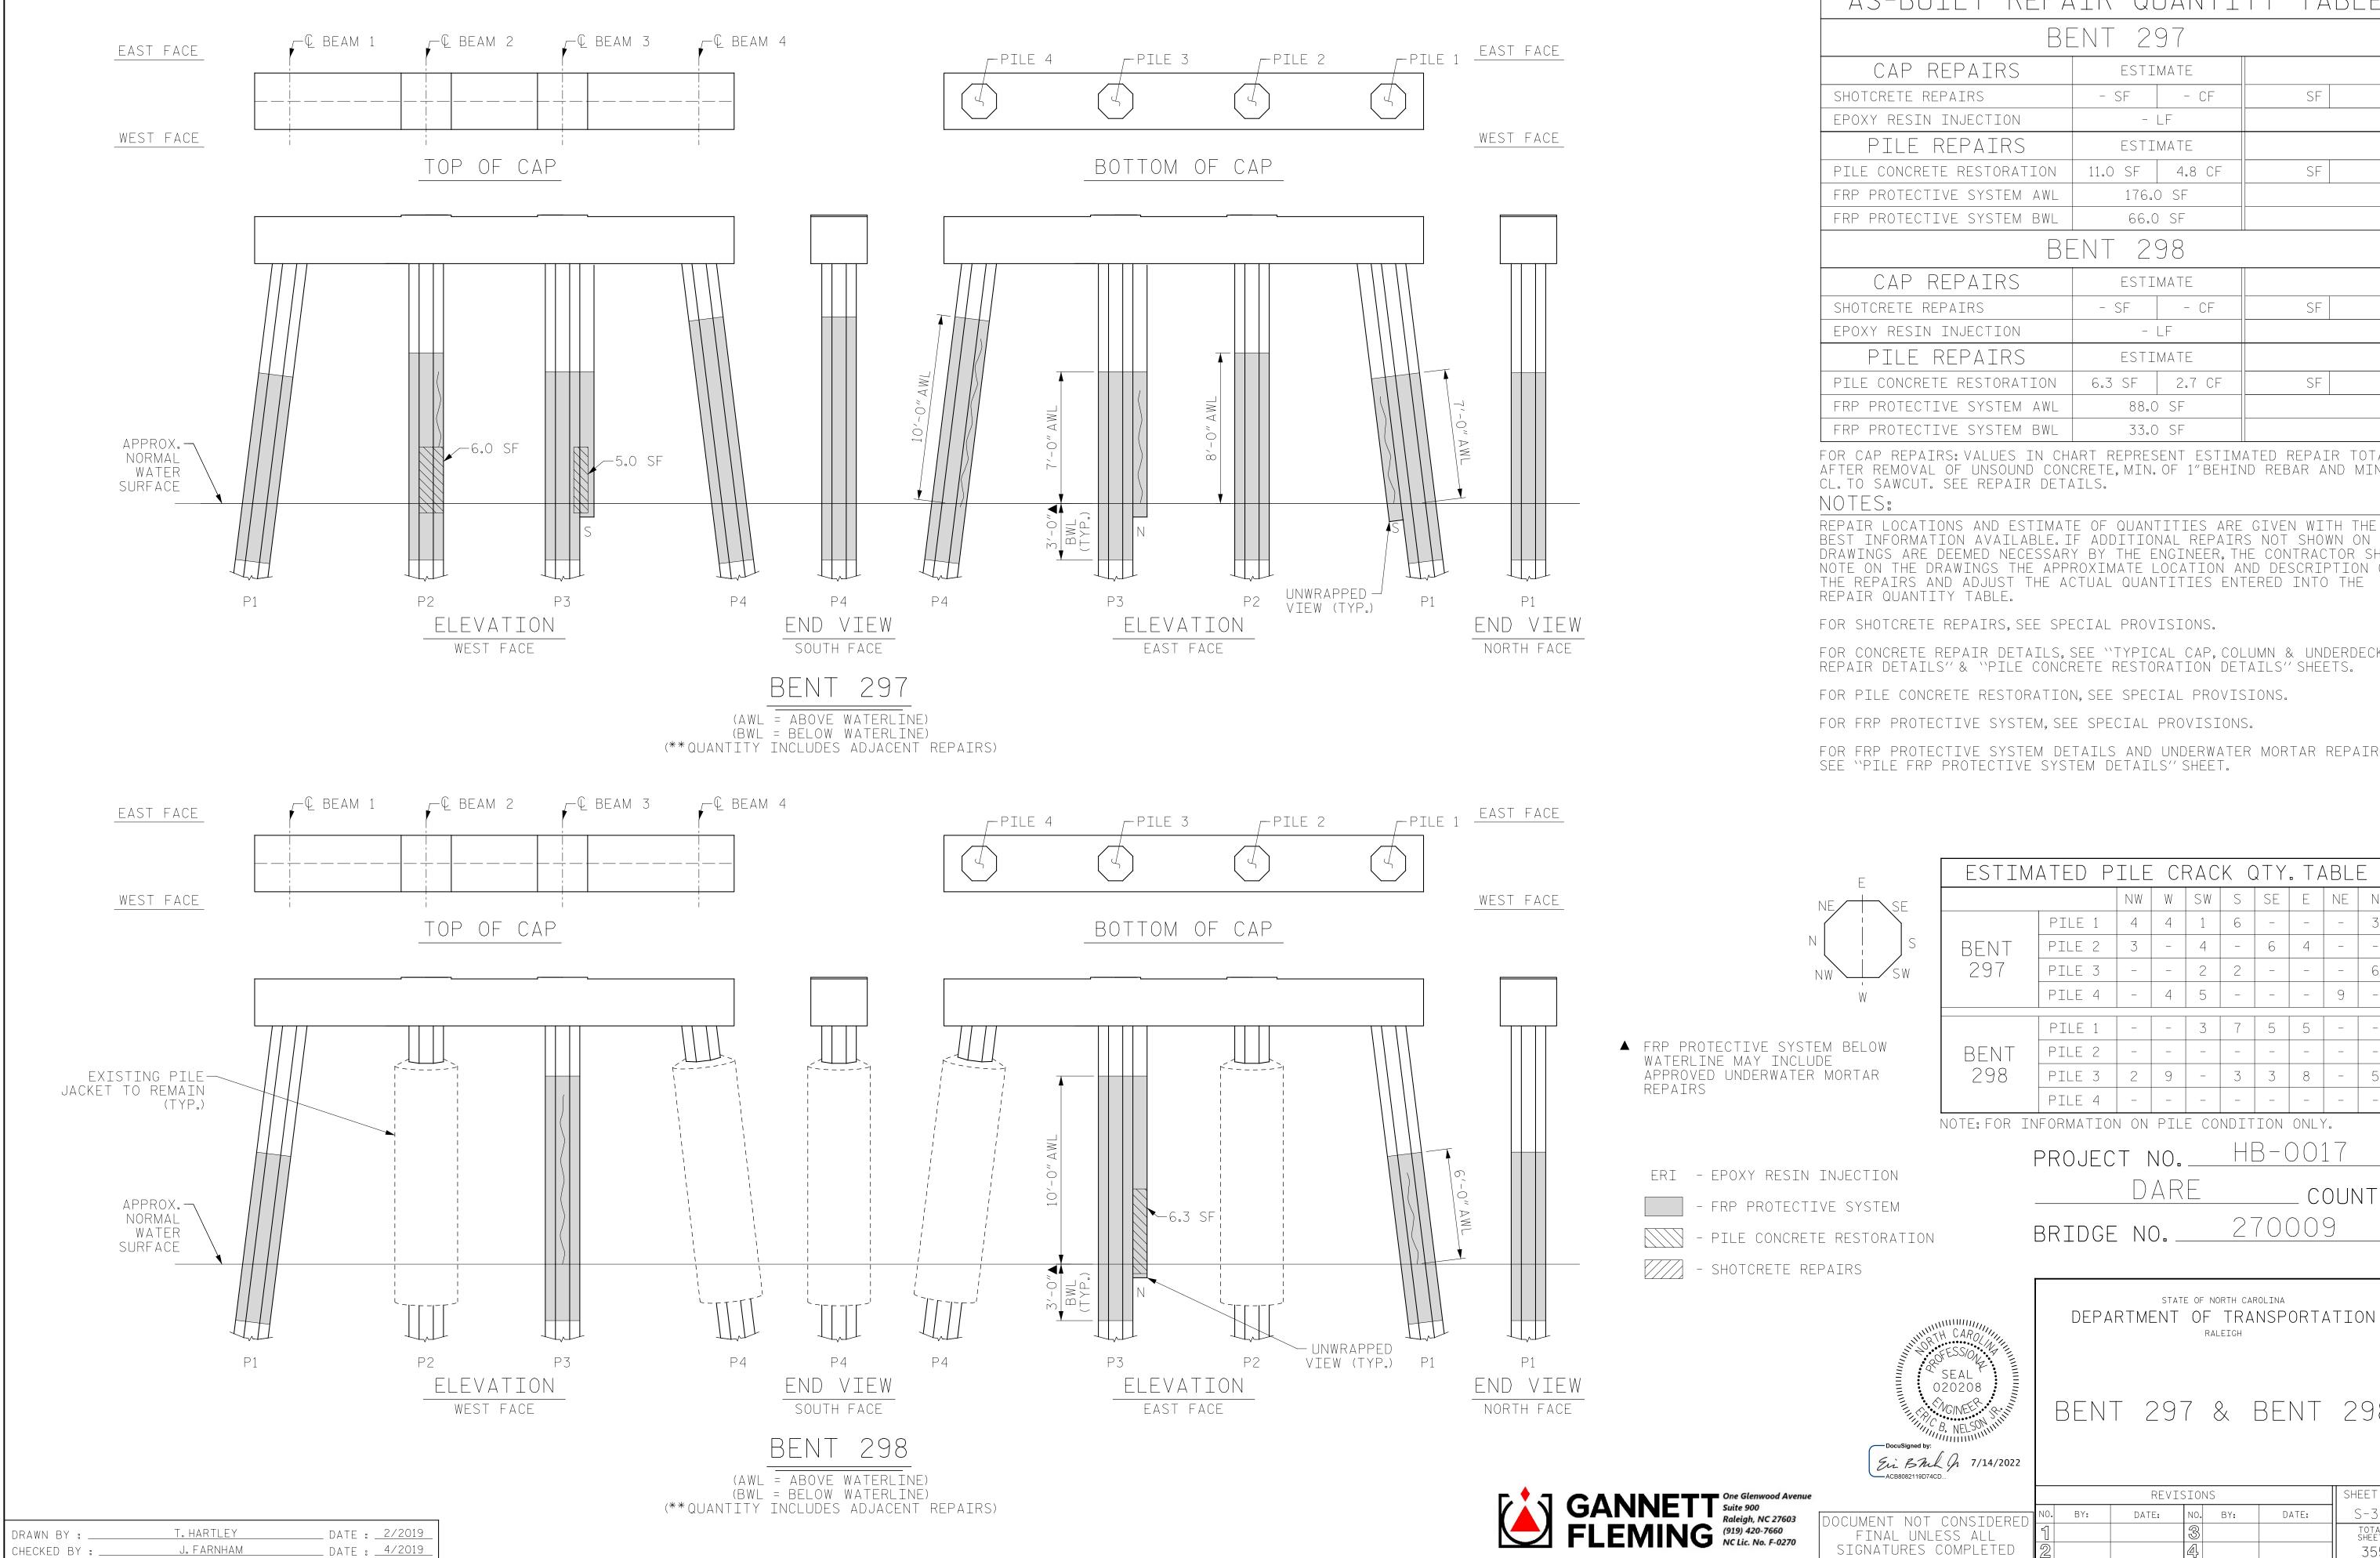
BENT 297							
CAP REPAIRS	ESTI	MATE					
SHOTCRETE REPAIRS	- SF	- CF	SF	CF			
EPOXY RESIN INJECTION	- LF			LF			
PILE REPAIRS	ESTI	MATE					
PILE CONCRETE RESTORATION	11.0 SF	4.8 CF	SF	CF			
FRP PROTECTIVE SYSTEM AWL	176.0 SF						
FRP PROTECTIVE SYSTEM BWL	66.0 SF

CAP REPAIRS	ESTIMATE					
SHOTCRETE REPAIRS	- SF	- CF	SF	CF		
EPOXY RESIN INJECTION	- LF			LF		
PILE REPAIRS	ESTI	MATE				
PILE CONCRETE RESTORATION	6.3 SF	2.7 CF	SF	CF		
FRP PROTECTIVE SYSTEM AWL	88.0 SF					
FRP PROTECTIVE SYSTEM BWL	33.0 SF

ESTIMATED TILE CNACK QTT. TABLE									
		NW	W	SW	S	SE	E	NE	Ν
	PILE 1	4	4	1	6	_	_	_	3
BENT	PILE 2	3	_	4	_	6	4	_	_
297	PILE 3	_	_	2	2	_	=	_	6
	PILE 4	-	4	5	I	-	ı	9	-
	PILE 1	_	_	3	7	5	5	_	-
BENT	PILE 2	_	_	_	_	_	_	_	_
298	PILE 3	2	9	_	3	3	8	_	5
	PILE 4	_	_	_	_	_	_	_	-
OTE, FOR INFORMATION ON PILE CONDITION ONLY

FOR CAP REPAIRS: VALUES IN CHART REPRESENT ESTIMATED REPAIR TOTALS AFTER REMOVAL OF UNSOUND CONCRETE, MIN. OF 1"BEHIND REBAR AND MIN. 2

FOR CONCRETE REPAIR DETAILS, SEE "TYPICAL CAP, COLUMN & UNDERDECK REPAIR DETAILS" & "PILE CONCRETE RESTORATION DETAILS" SHEETS.

FOR FRP PROTECTIVE SYSTEM DETAILS AND UNDERWATER MORTAR REPAIRS,
