AS-BUILT REPAIR QUANTITY TABLE

PROJECT NO. HB-0017
DARE COUNTY
 BRIDGE NO. 270009

BENT 299 & BENT 300

REVISIONS						SHEET NO.
NO.	BY:	DATE:	NO.	BY:	DATE:	S-319
1			3			TOTAL SHEETS
2			4			355

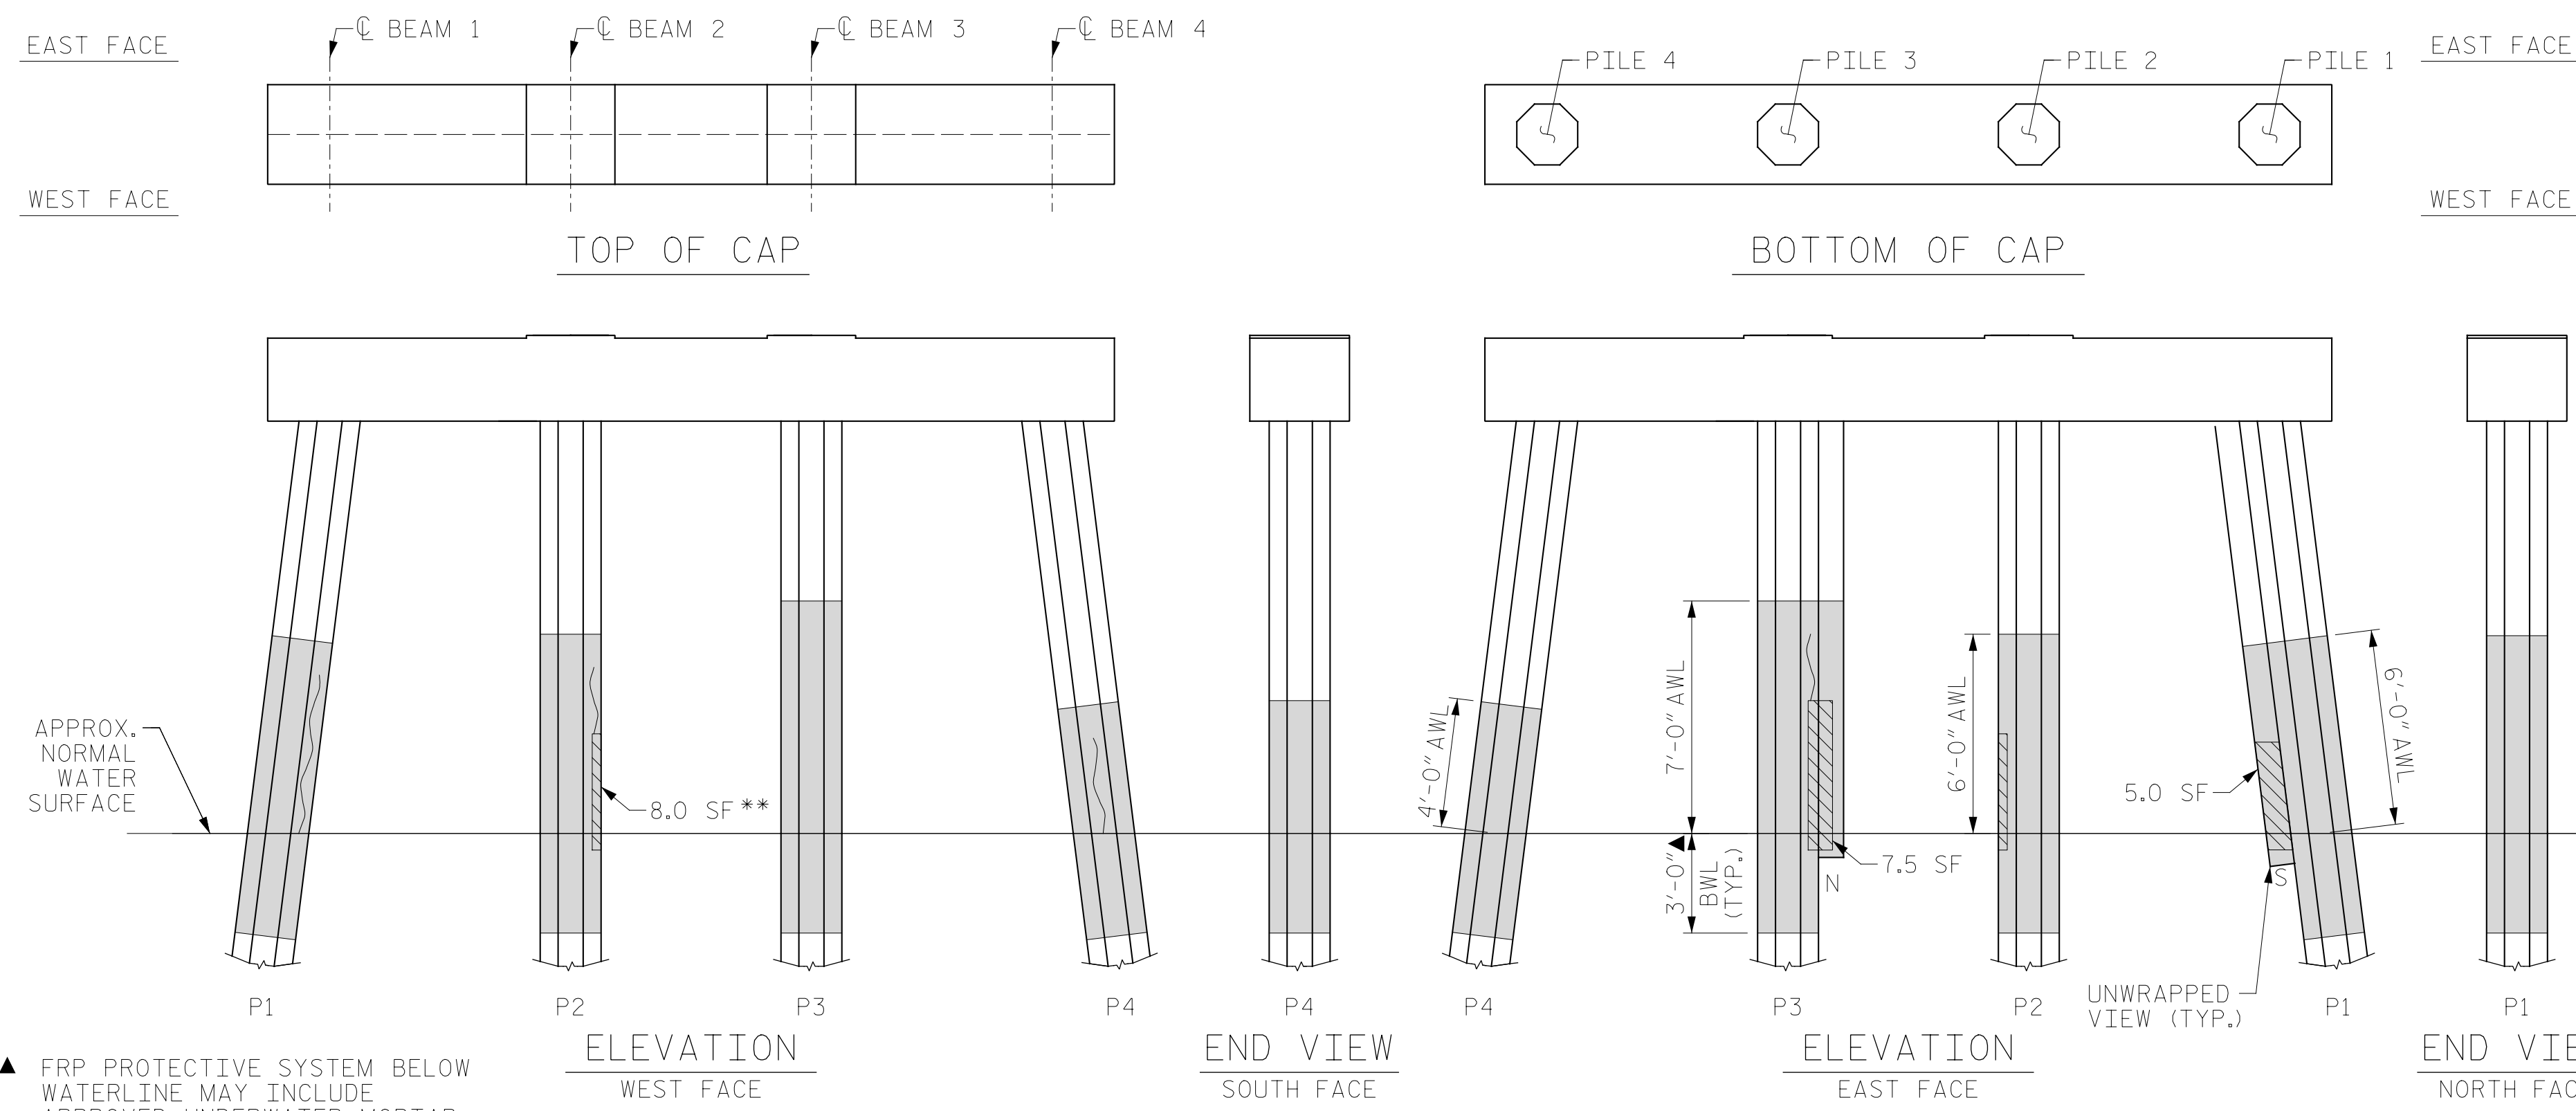
BENT 299

CAP REPAIRS		ESTIMATE			
SHOTCRETE REPAIRS	- SF	- CF	SF	CF	
EPOXY RESIN INJECTION		- LF			LF
PILE REPAIRS		ESTIMATE			
PILE CONCRETE RESTORATION	20.5 SF	8.6 CF	SF	CF	
FRP PROTECTIVE SYSTEM AWL	126.5 SF				
FRP PROTECTIVE SYSTEM BWL	66.0 SF

BENT	PILE	DIRECTION							
		NW	W	SW	S	SE	E	NE	N
299	PILE 1	3	4	5	-	5	-	-	-
	PILE 2	-	-	2	-	-	3	3	-
	PILE 3	2	2	2	2	-	2	2	-
	PILE 4	3	3	3	3	-	2	2	-
300	PILE 1	7	-	6	-	-	-	-	5
	PILE 2	-	-	-	-	-	-	-	-
	PILE 3	-	-	-	5	4	5	6	4
	PILE 4	-	-	10	10	-	12	3	-
	PILE 5	-	-	-	3	-	-	-	-
	PILE 6	-	-	-	4	4	2	-	4

▲ FRP PROTECTIVE SYSTEM BELOW WATERLINE MAY INCLUDE APPROVED UNDERWATER MORTAR REPAIRS

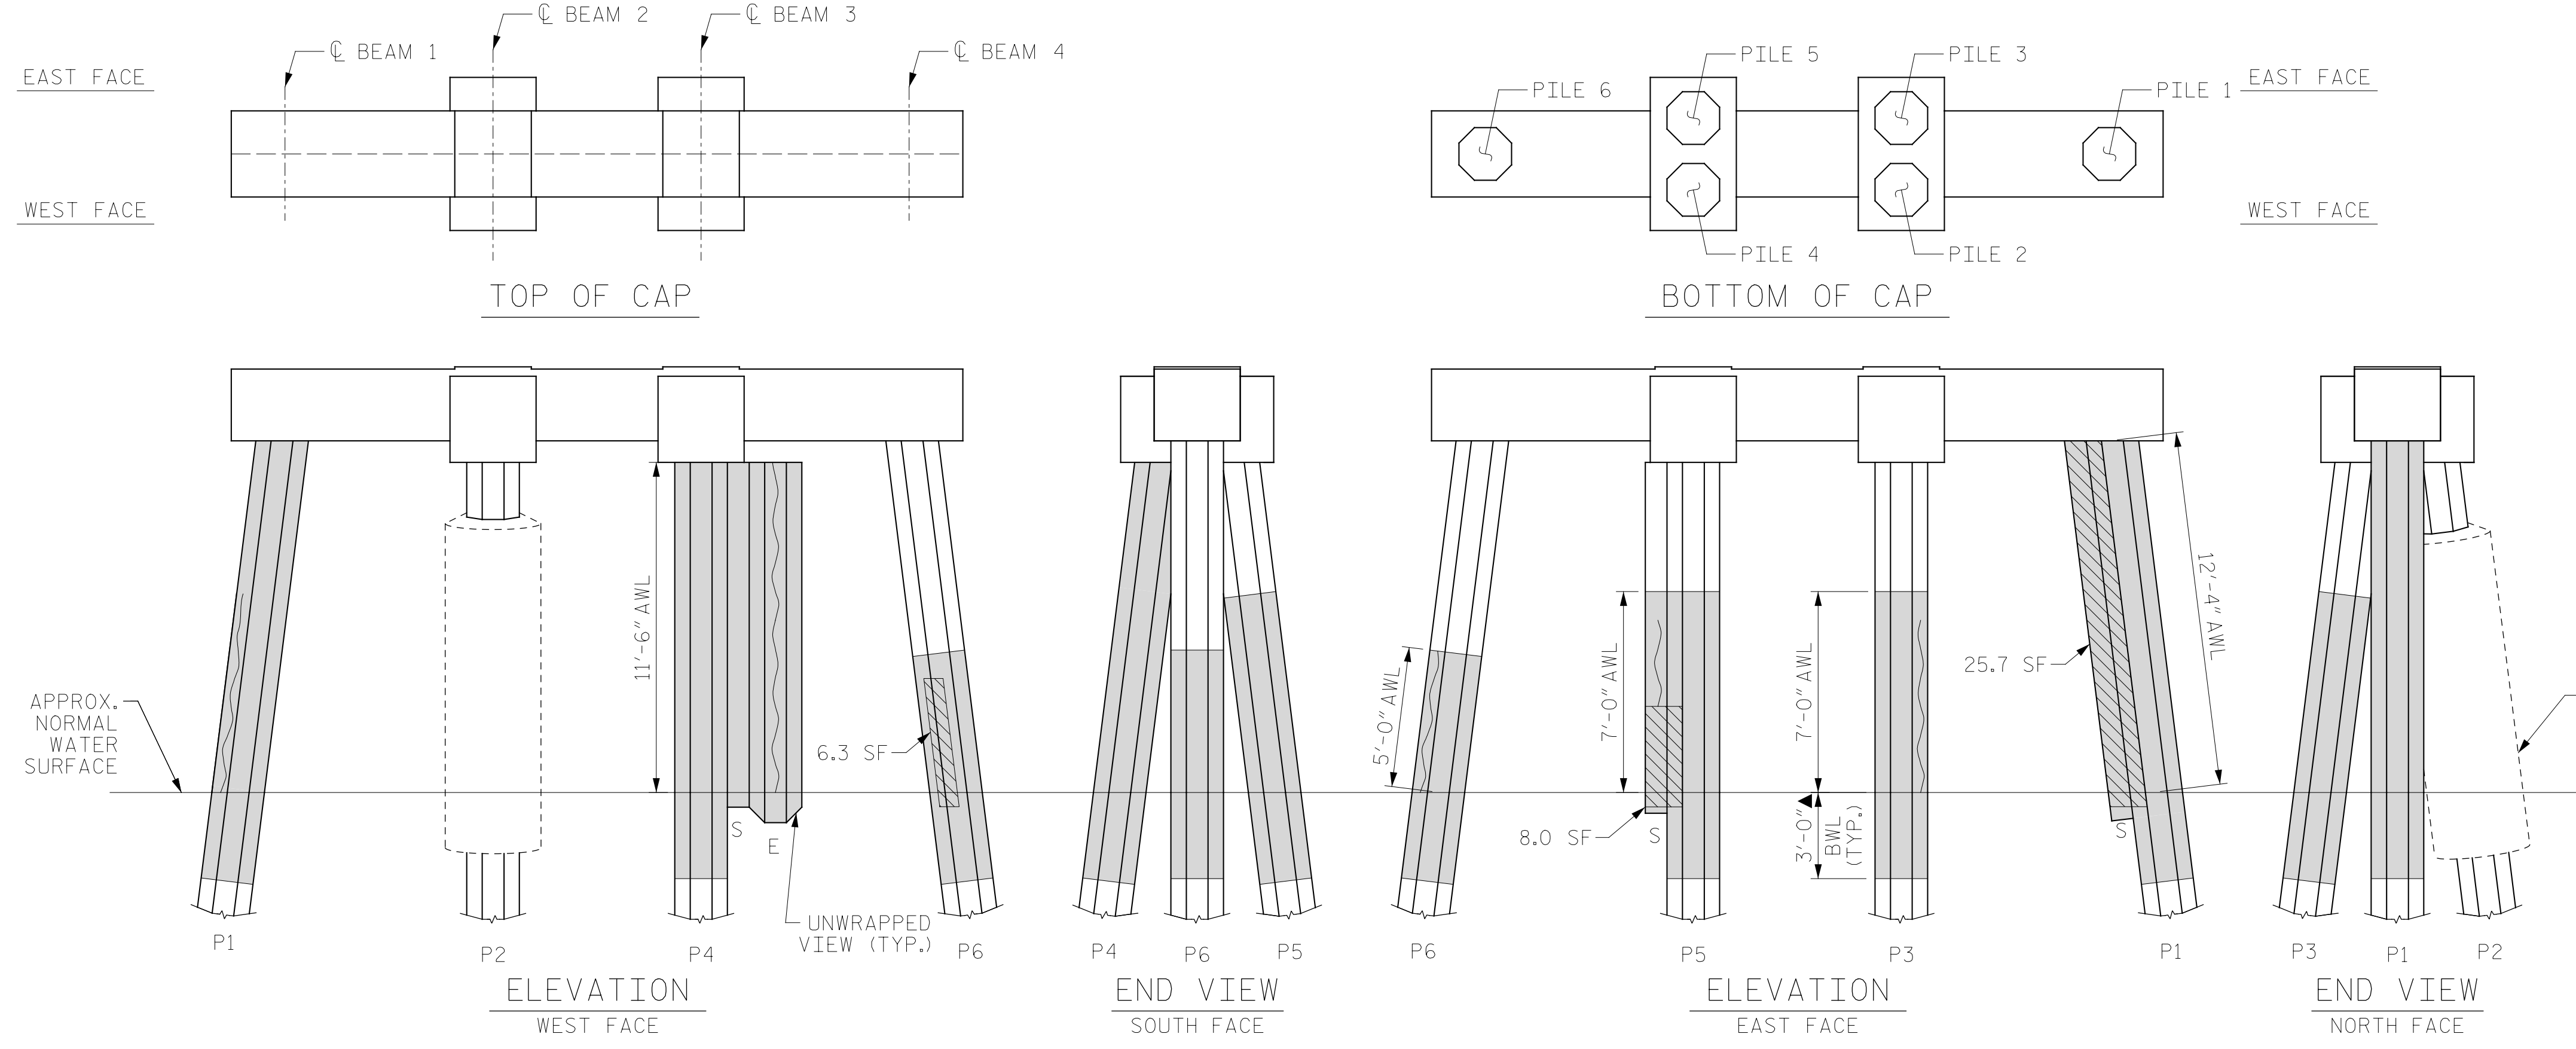
BENT 300

CAP REPAIRS		ESTIMATE			
SHOTCRETE REPAIRS	- SF	- CF	SF	CF	
EPOXY RESIN INJECTION		- LF			LF
PILE REPAIRS		ESTIMATE			
PILE CONCRETE RESTORATION	39.9 SF	15.9 CF	SF	CF	
FRP PROTECTIVE SYSTEM AWL	235.6 SF				
FRP PROTECTIVE SYSTEM BWL	82.5 SF
