AS-BUILT REPAIR QUANTITY TABLE

PROJECT NO. HB-0017  
DARE COUNTY  
BRIDGE NO. 270009

STATE OF NORTH CAROLINA  
DEPARTMENT OF TRANSPORTATION  
RALEIGH

BENT 301 & BENT 302

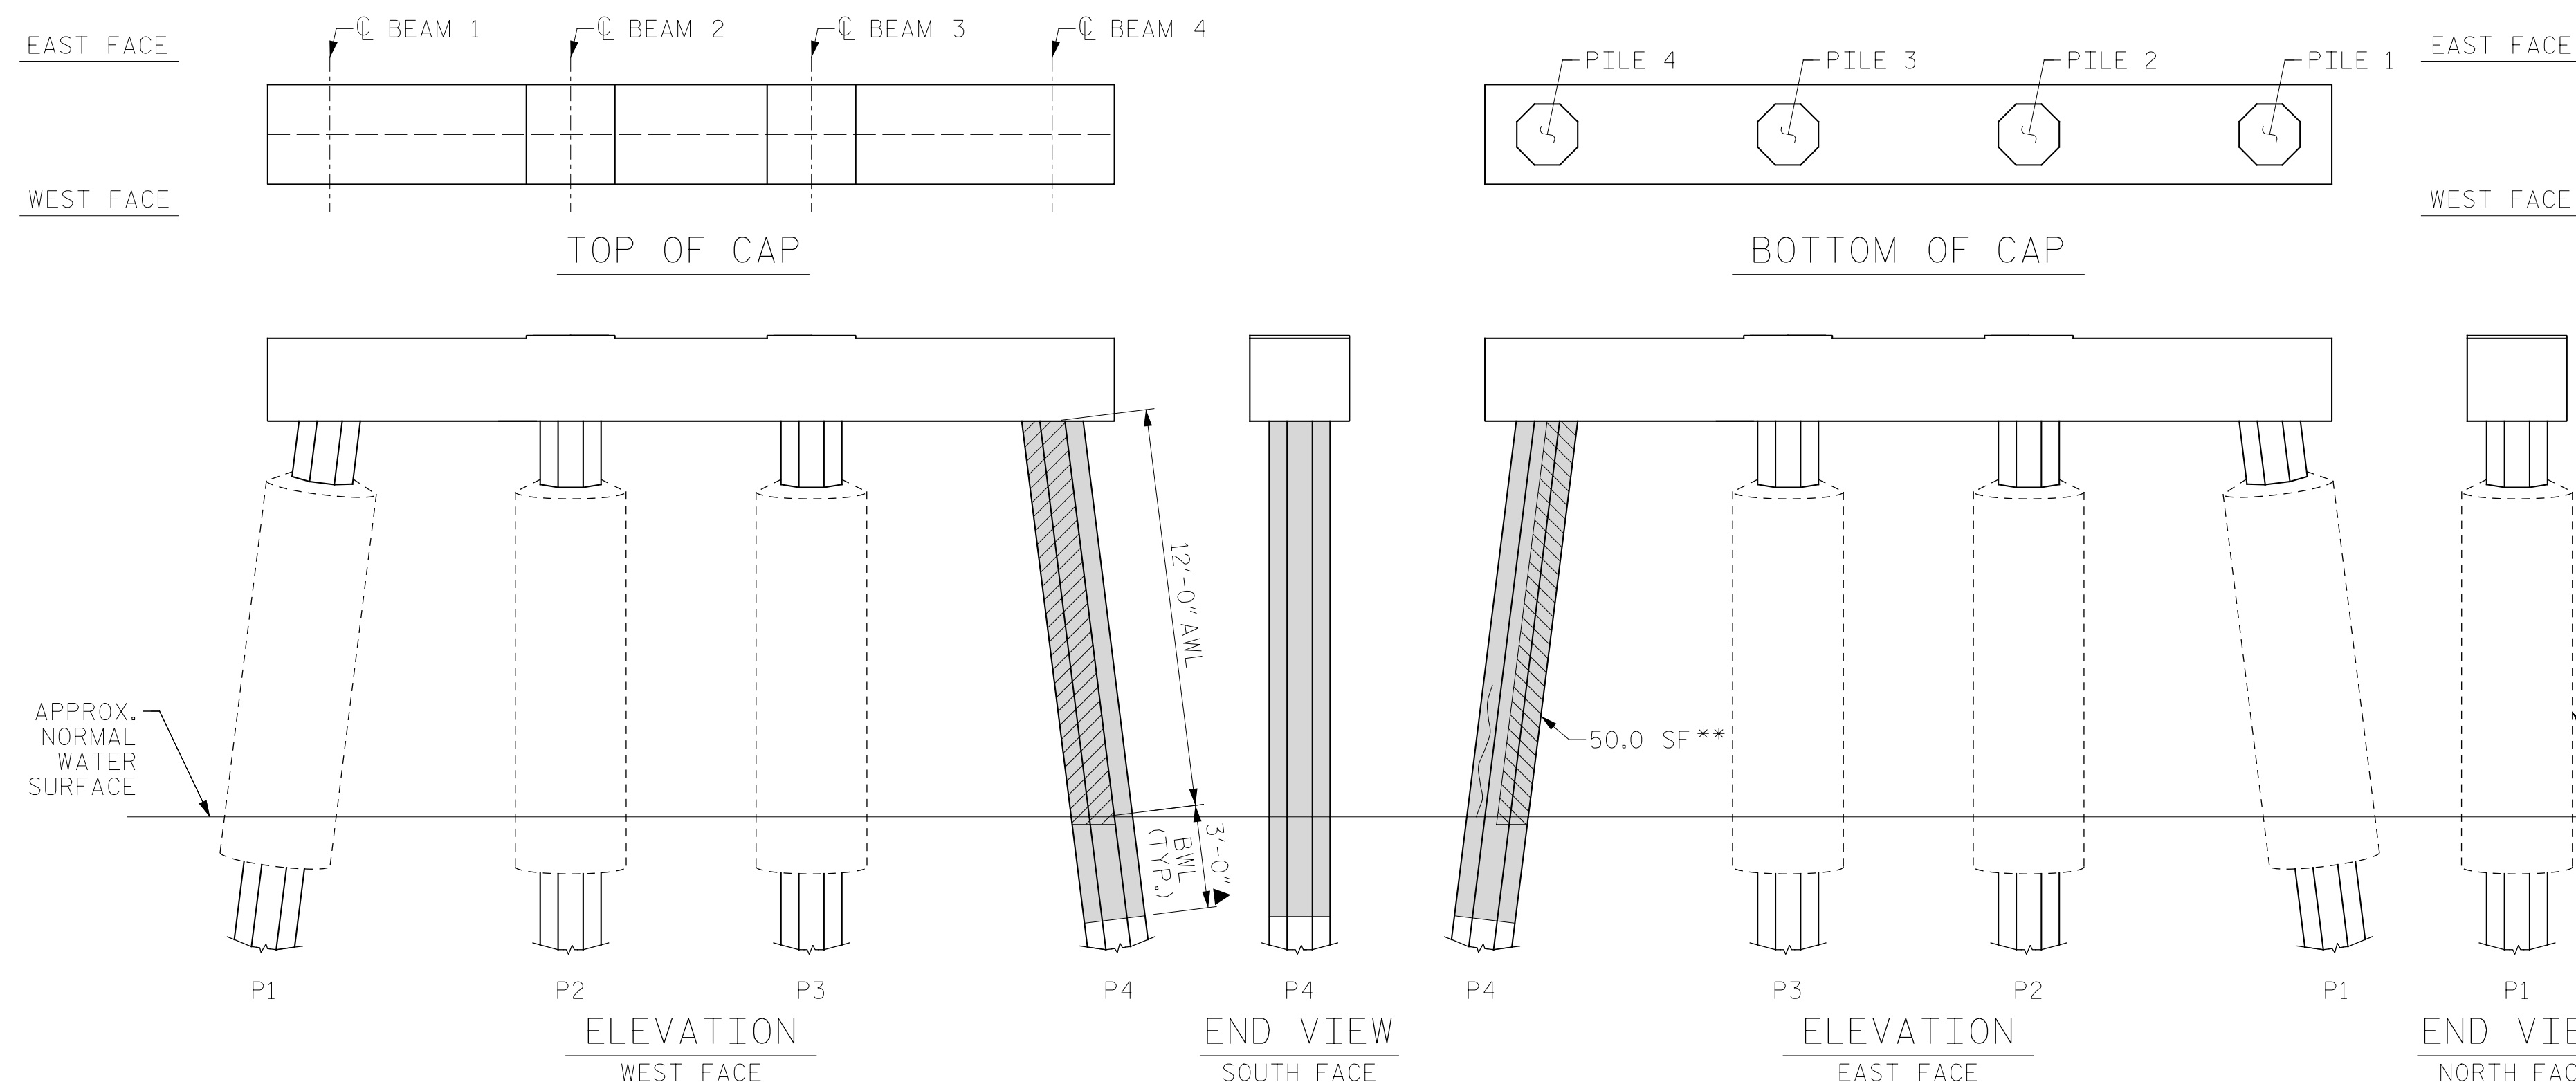
CAP REPAIRS		ESTIMATE			
SHOTCRETE REPAIRS	- SF	- CF	SF	CF	
EPOXY RESIN INJECTION	- LF				LF
PILE REPAIRS		ESTIMATE			
PILE CONCRETE RESTORATION	50.0 SF	18.5 CF	SF	CF	
FRP PROTECTIVE SYSTEM AWL	66.0 SF				
FRP PROTECTIVE SYSTEM BWL	16.5 SF

NW	W	SW	S	SE	E	NE	N
BENT 301	PILE 1	-	-	-	-	-	-	-	-
	PILE 2	-	-	-	-	-	-	-	-
	PILE 3	-	-	-	-	-	-	-	-
	PILE 4	-	-	-	-	4	-	-	-
BENT 302	PILE 1	-	-	6	-	4	5	2	2
	PILE 2	-	4	6	4	-	3	3	-
	PILE 3	4	5	-	4	-	-	3	-
	PILE 4	-	-	-	3	-	3	-	-

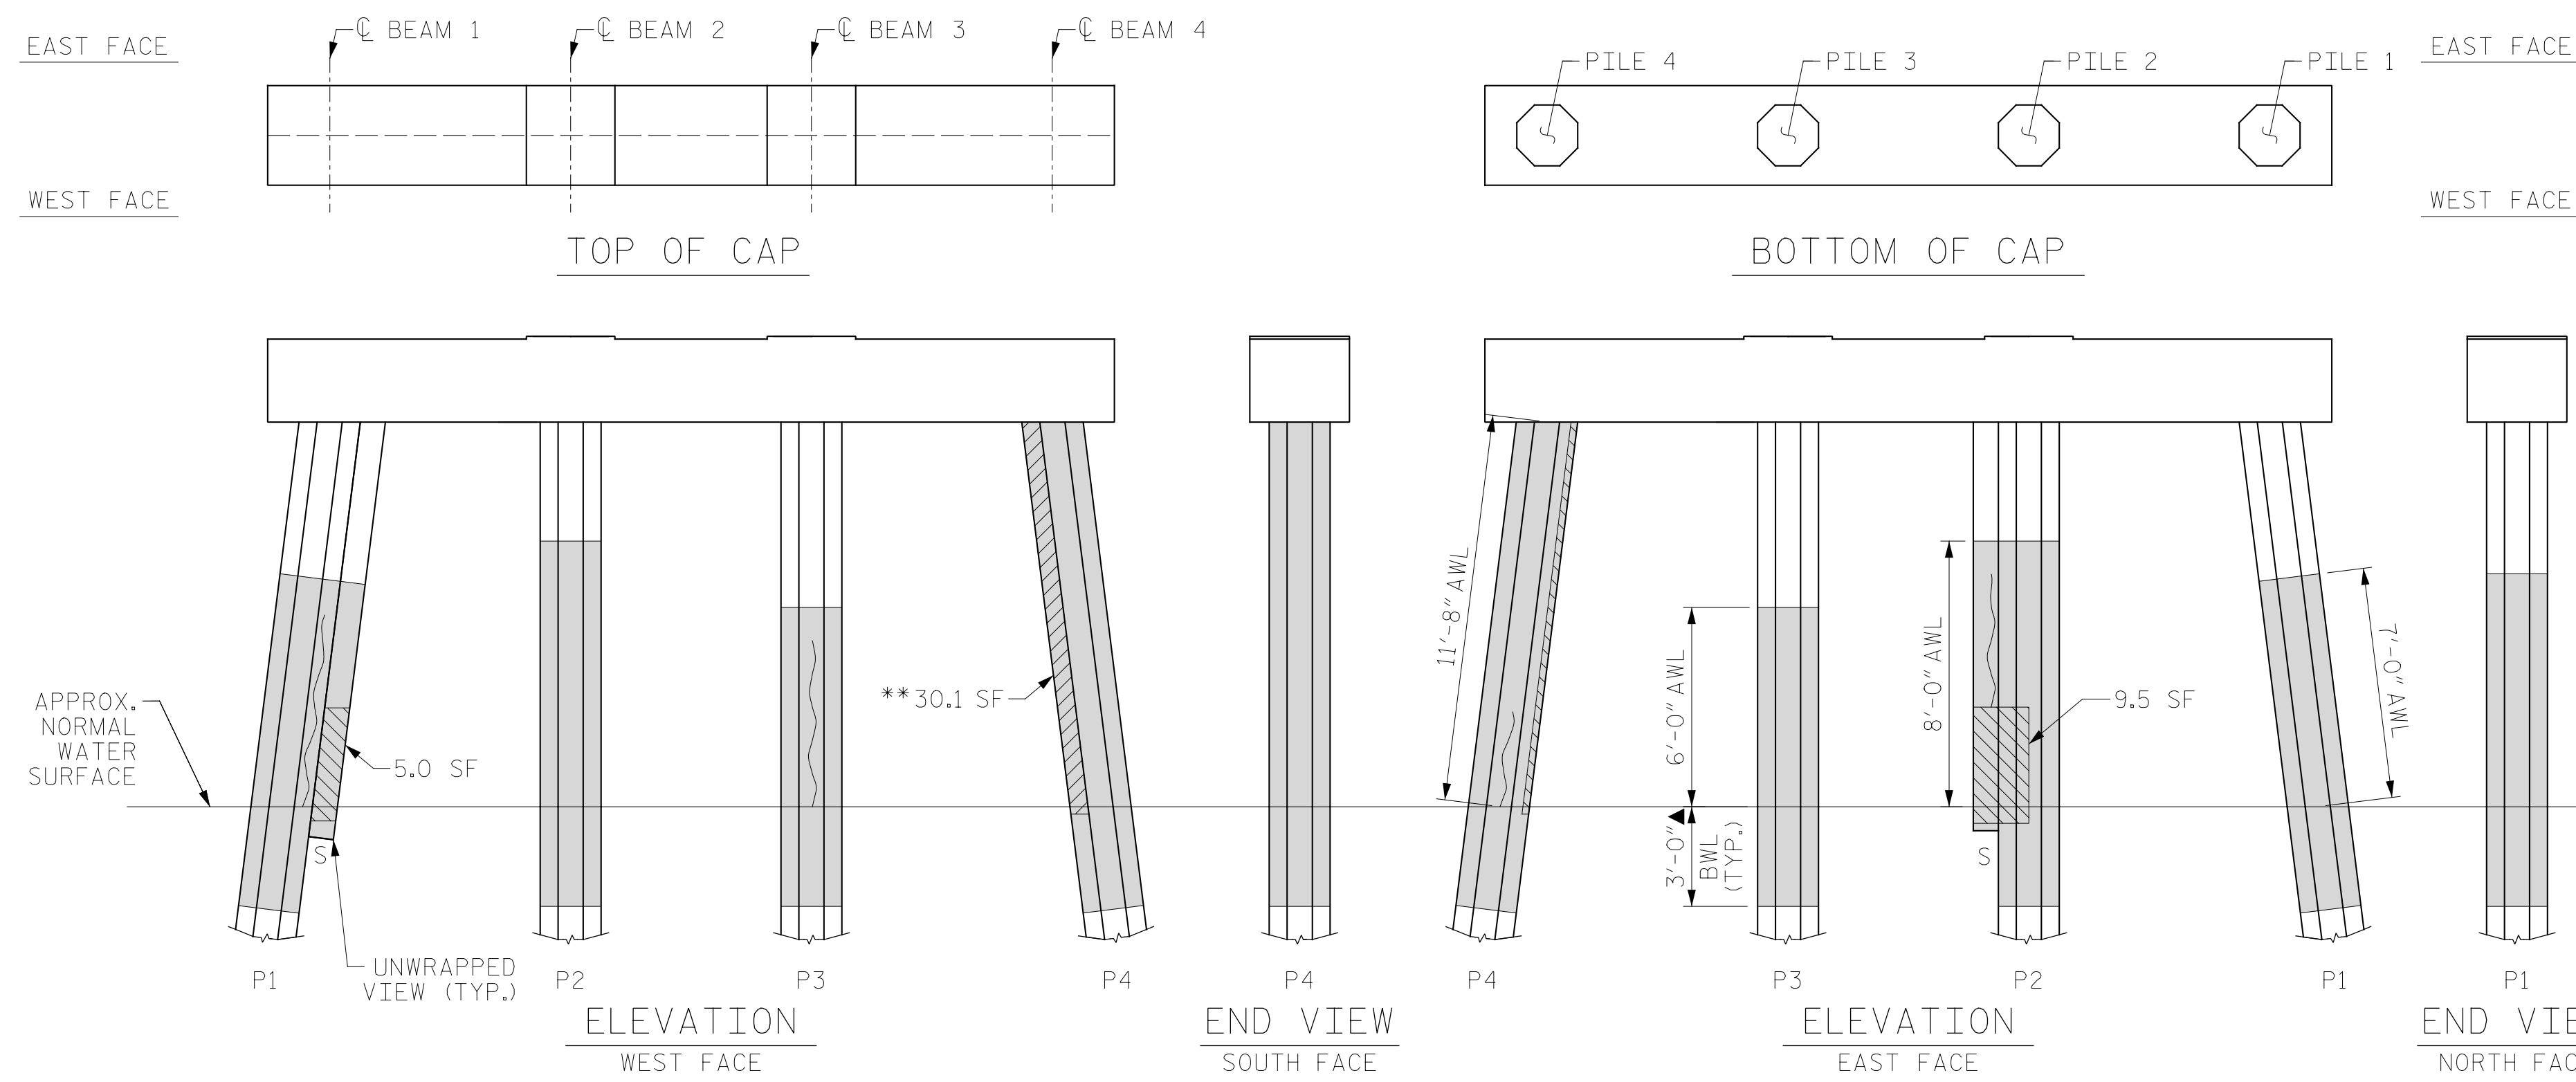
BENT 302

CAP REPAIRS		ESTIMATE			
SHOTCRETE REPAIRS	- SF	- CF	SF	CF	
EPOXY RESIN INJECTION	- LF				LF
PILE REPAIRS		ESTIMATE			
PILE CONCRETE RESTORATION	44.6 SF	18.1 CF	SF	CF	
FRP PROTECTIVE SYSTEM AWL	179.7 SF				
FRP PROTECTIVE SYSTEM BWL	66.0 SF
