AS-BUILT REPAIR QUANTITY TABLE

PROJECT NO. HB-0017
DARE COUNTY
BRIDGE NO. 270009

BENT 307 & BENT 308

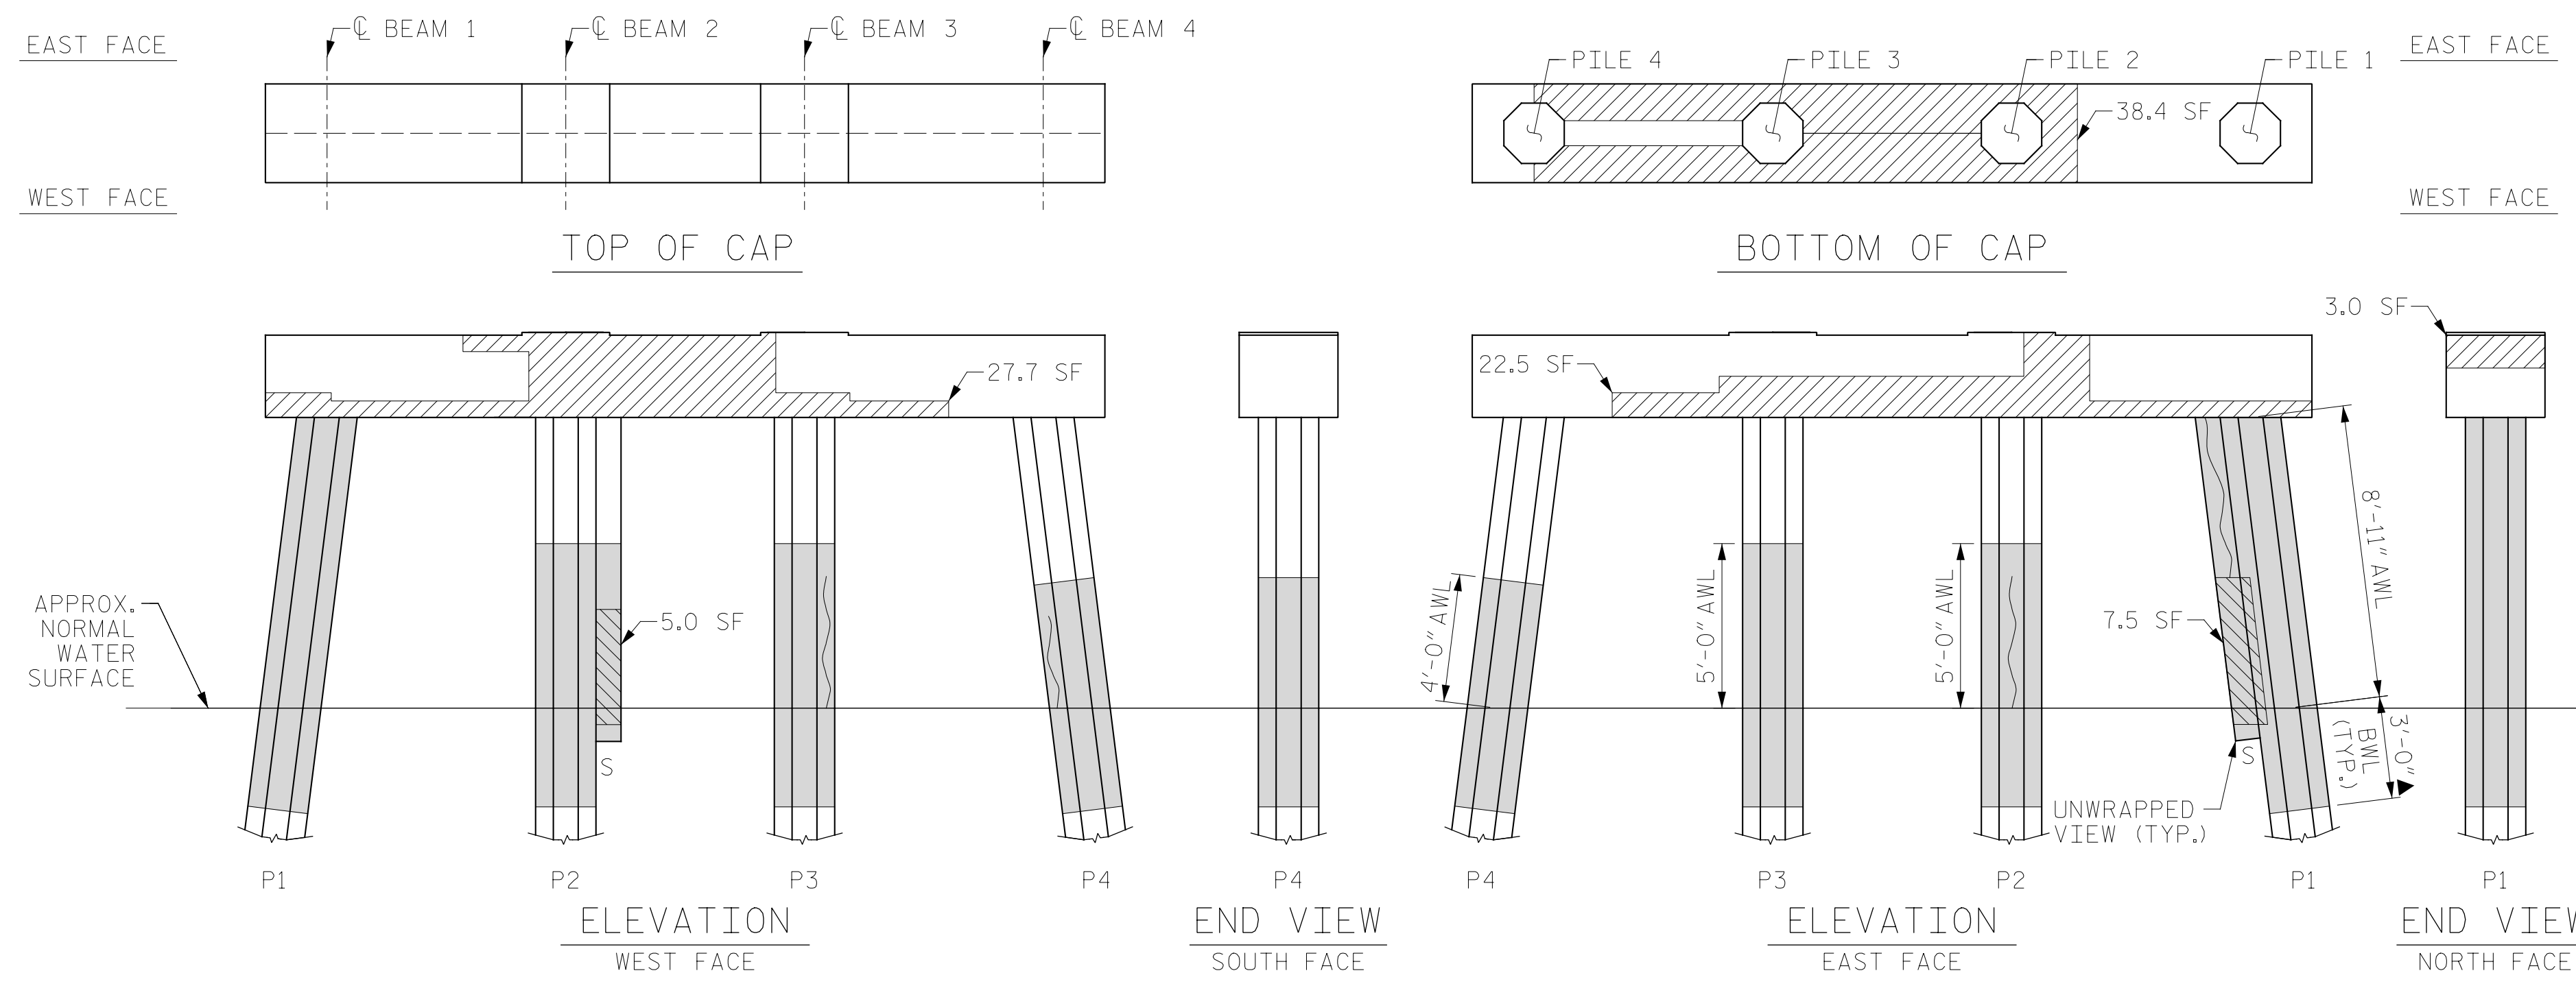
CAP REPAIRS		ESTIMATE			
SHOTCRETE REPAIRS	91.6 SF	45.8 CF	SF	CF	
EPOXY RESIN INJECTION	-	LF			LF
PILE REPAIRS		ESTIMATE			
PILE CONCRETE RESTORATION	12.5 SF	5.4 CF	SF	CF	
FRP PROTECTIVE SYSTEM AWL	126.0 SF				
FRP PROTECTIVE SYSTEM BWL	66.0 SF

BENT	PILE	DIRECTION							
		NW	W	SW	S	SE	E	NE	N
BENT 307	PILE 1	4	-	9	-	5	-	-	3
	PILE 2	-	-	4	-	4	4	-	-
	PILE 3	-	1	4	-	2	2	2	-
	PILE 4	3	1	-	2	-	-	-	-
BENT 308	PILE 1	8	-	-	-	4	-	-	-
	PILE 2	-	-	-	-	4	-	-	-
	PILE 3	-	4	4	-	-	-	-	-
	PILE 4	1	-	-	-	3	-	-	-
	PILE 5	5	-	3	-	-	4	-	5
	PILE 6	-	-	4	-	-	2	-	8

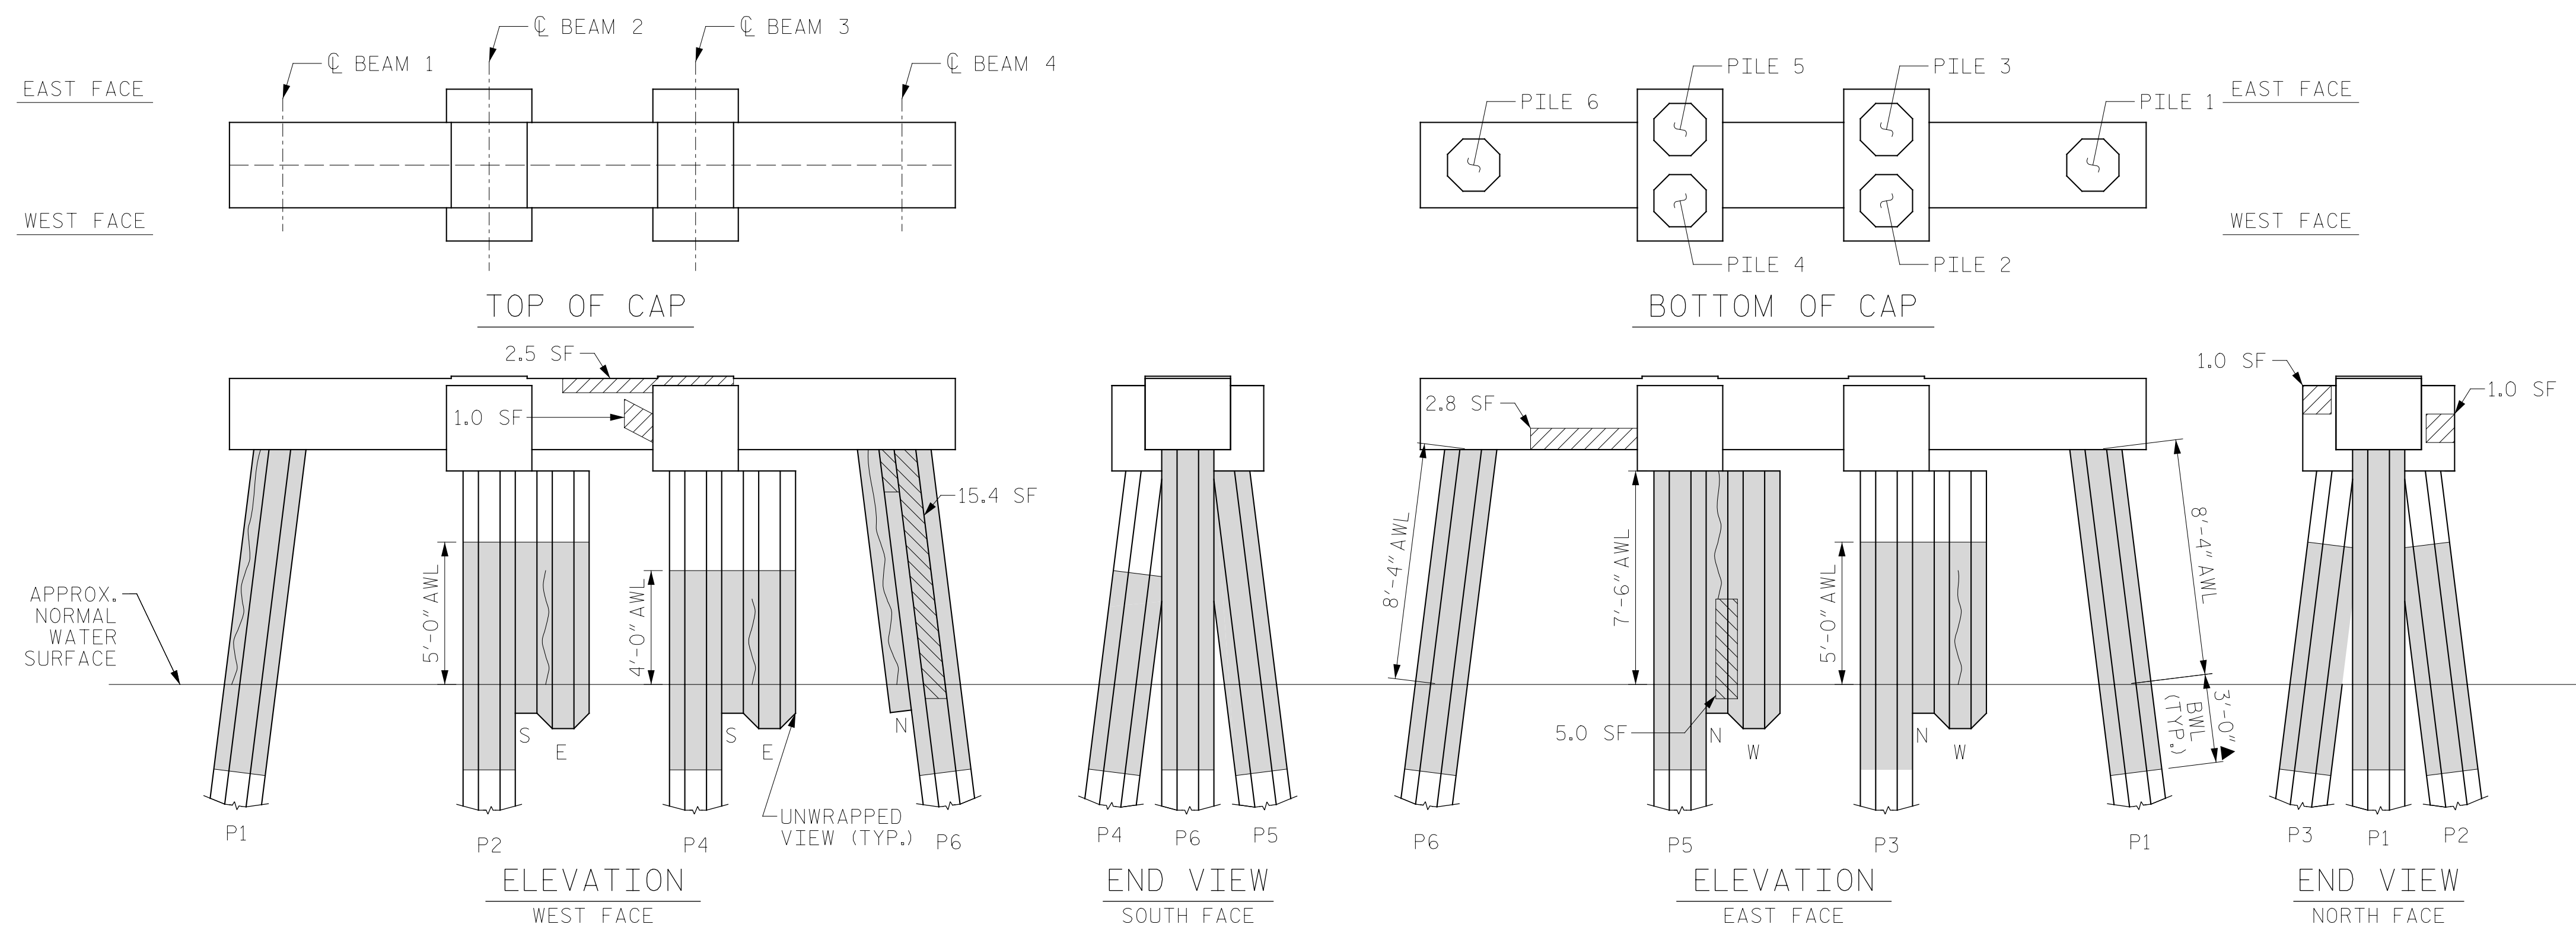
BENT 308

CAP REPAIRS		ESTIMATE			
SHOTCRETE REPAIRS	8.3 SF	4.2 CF	SF	CF	
EPOXY RESIN INJECTION	-	LF			LF
PILE REPAIRS		ESTIMATE			
PILE CONCRETE RESTORATION	18.4 SF	7.8 CF	SF	CF	
FRP PROTECTIVE SYSTEM AWL	209.9 SF				
FRP PROTECTIVE SYSTEM BWL	99.0 SF
