I						
AS-BUILT REPA	TY TA	BLE				
BENT 311						
CAP REPAIRS	ESTI	MATE				
SHOTCRETE REPAIRS	17.5 SF	8.8 CF	SF	CF		
EPOXY RESIN INJECTION	_	LF		LF		
PILE REPAIRS	ESTIMATE					
PILE CONCRETE RESTORATION	14.4 SF	6.1 CF	SF	CF		
FRP PROTECTIVE SYSTEM AWL	90.3 SF					
FRP PROTECTIVE SYSTEM BWL	66.0 SF					
B	ent 3	12				
CAP REPAIRS	ESTIMATE					
SHOTCRETE REPAIRS	74.6 SF	37.3 CF	SF	CF		
EPOXY RESIN INJECTION	- LF			LF		
PILE REPAIRS	ESTIMATE					
PILE CONCRETE RESTORATION	- SF	- CF	SF	CF		
FRP PROTECTIVE SYSTEM AWL	64.2 SF					
FRP PROTECTIVE SYSTEM BWL	49.5 SF

- EPOXY RESIN INJECTION			$\Box$	AR	F			$\cap$		ITV
- FRP PROTECTIVE SYSTEM										
- PILE CONCRETE RESTORATION BRIDGE NO. 270009										
- SHOTCRETE REPAIRS										
				STAT	E OF NO	RTH CAR	ROL TNA			
	DEPARTMENT OF TRANSPORTATION									
DEPARTMENT OF TRANSPORTATION RALEIGH DEVARTMENT OF TRANSPORTATION RALEIGH BENT 311 & BENT 312										
SEAL F										
	20208				1 0	F		. —		1
BENT 311 & BENT 312						12				
Ein Bhu ACB8082119D740	c 7/14/2022									
One Glenwood Avenue				REVIS	SIONS		1			EET NO.
Suite 900 Raleigh, NC 27603 (919) 420-7660		NO. BY:	DAT	E:	NO.	BY:	D	ATE:		5-325 Total
G (919) 420-7660 NC Lic. No. F

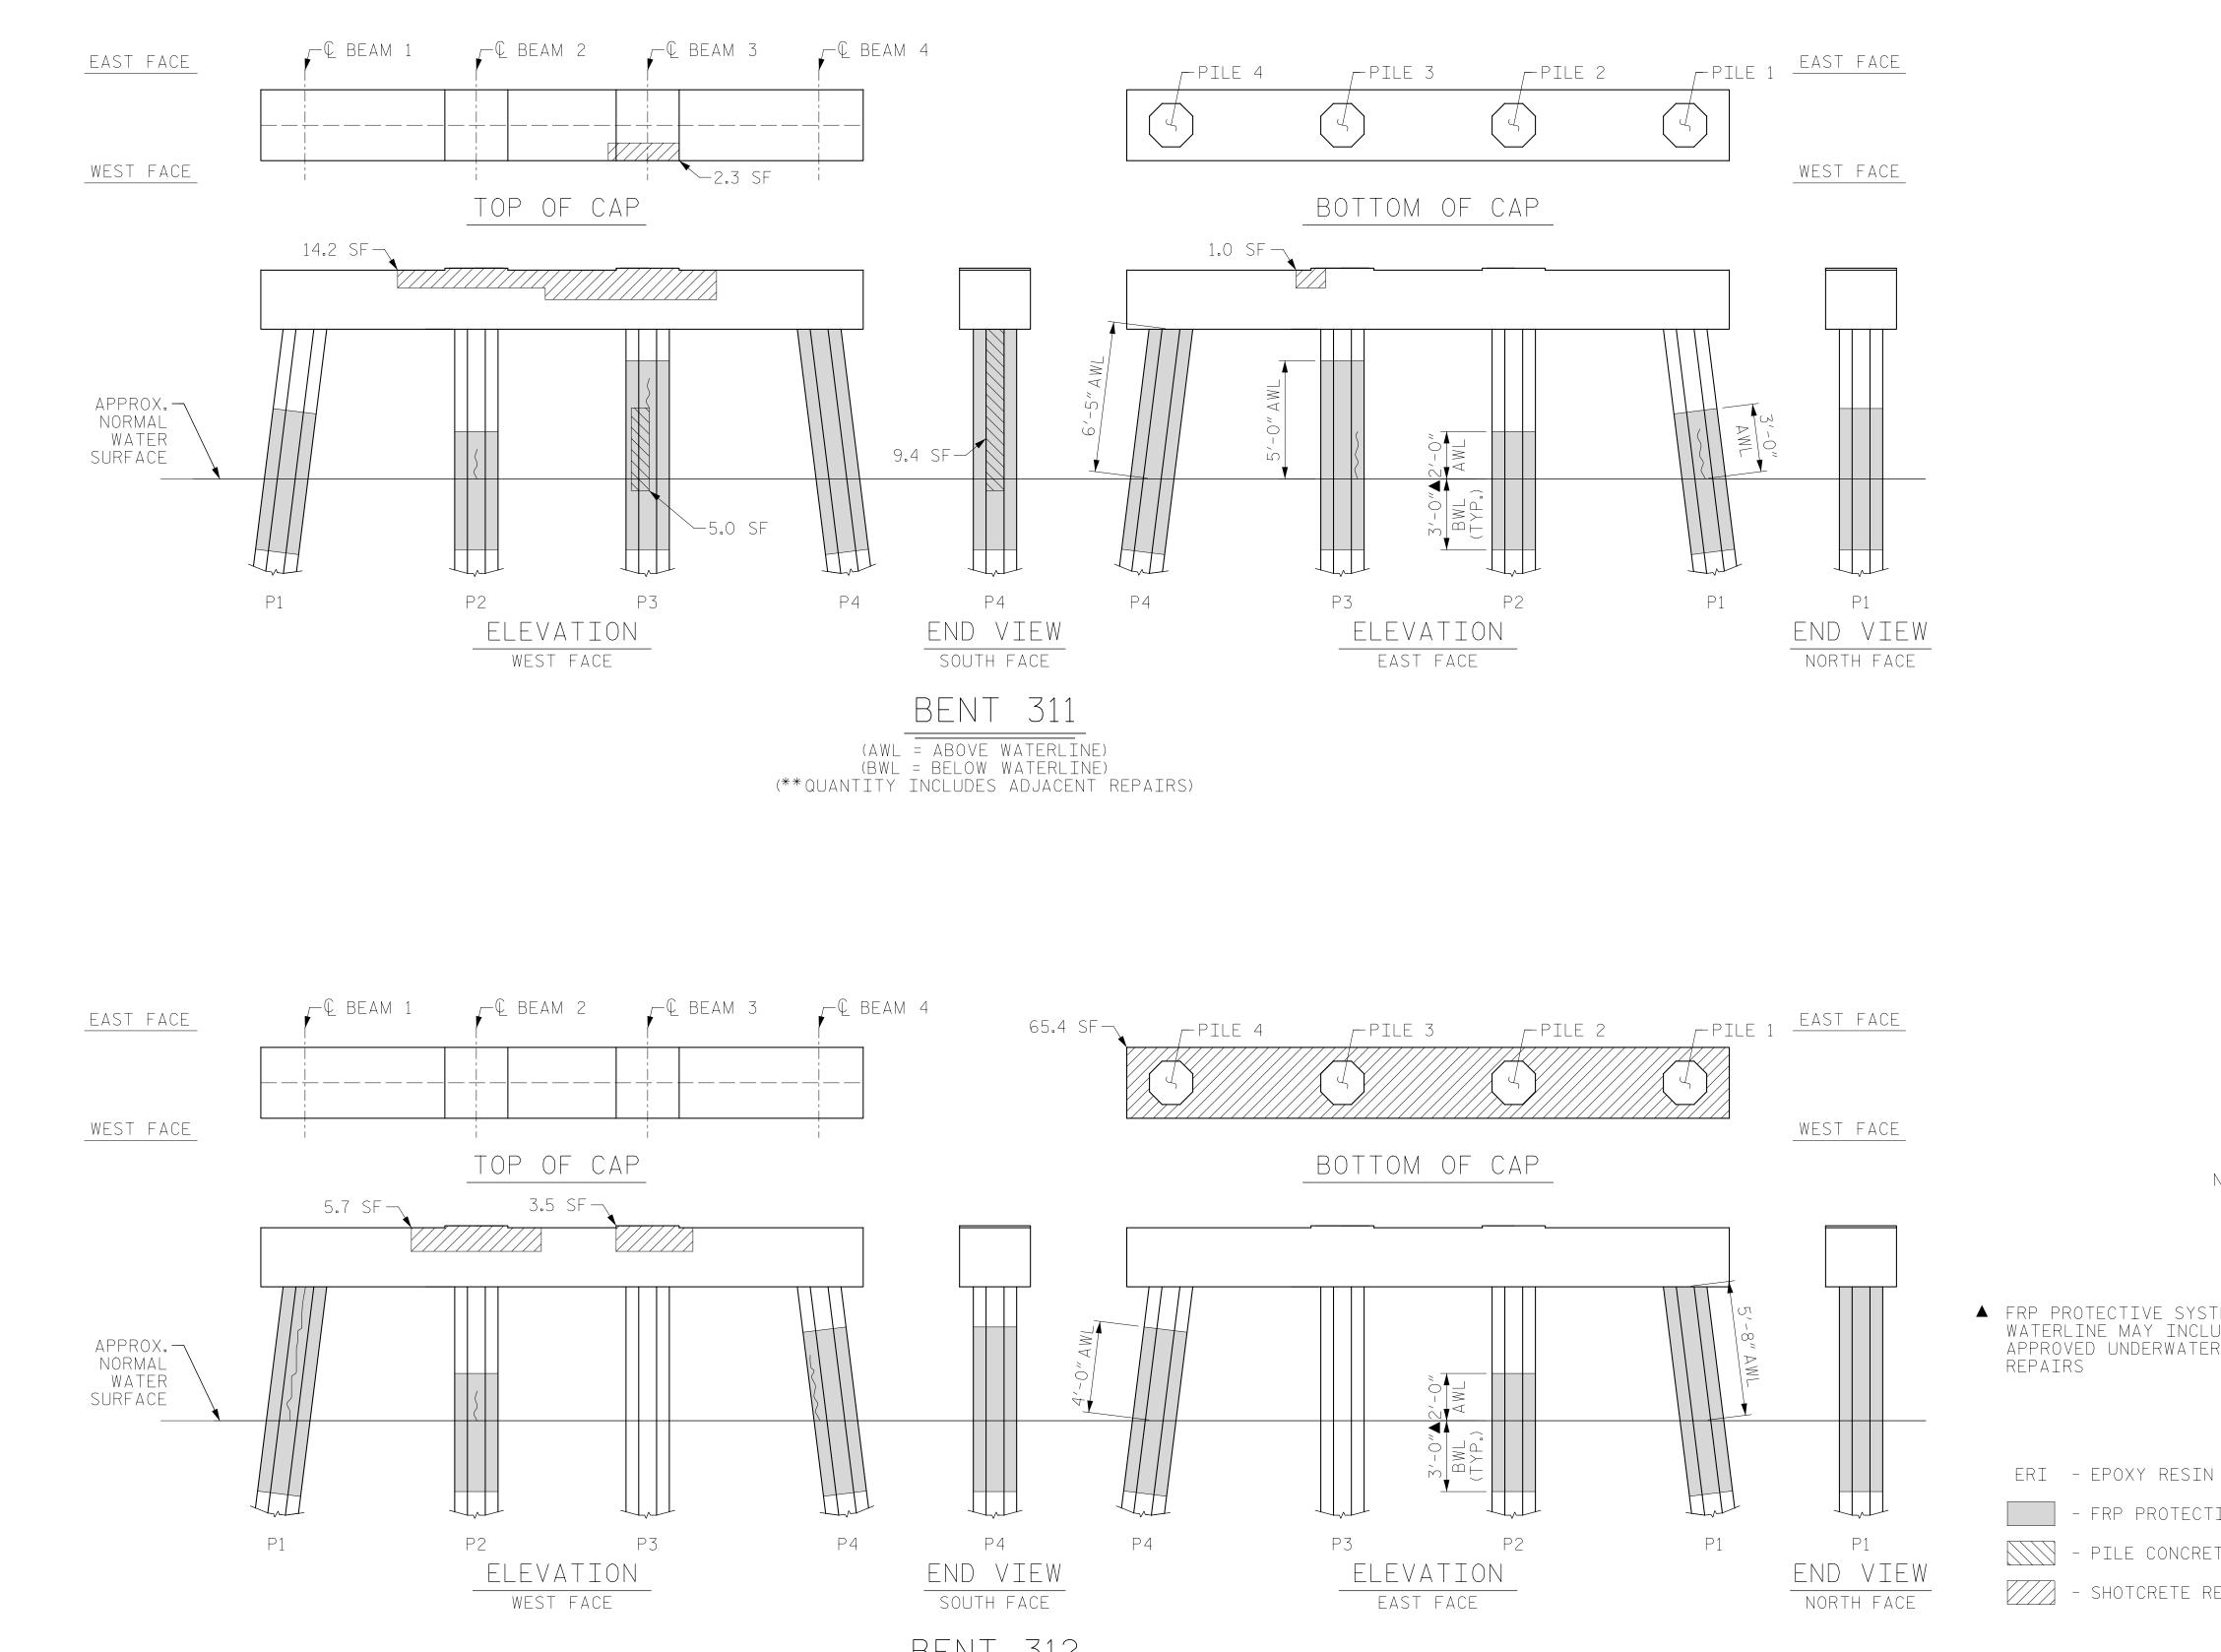
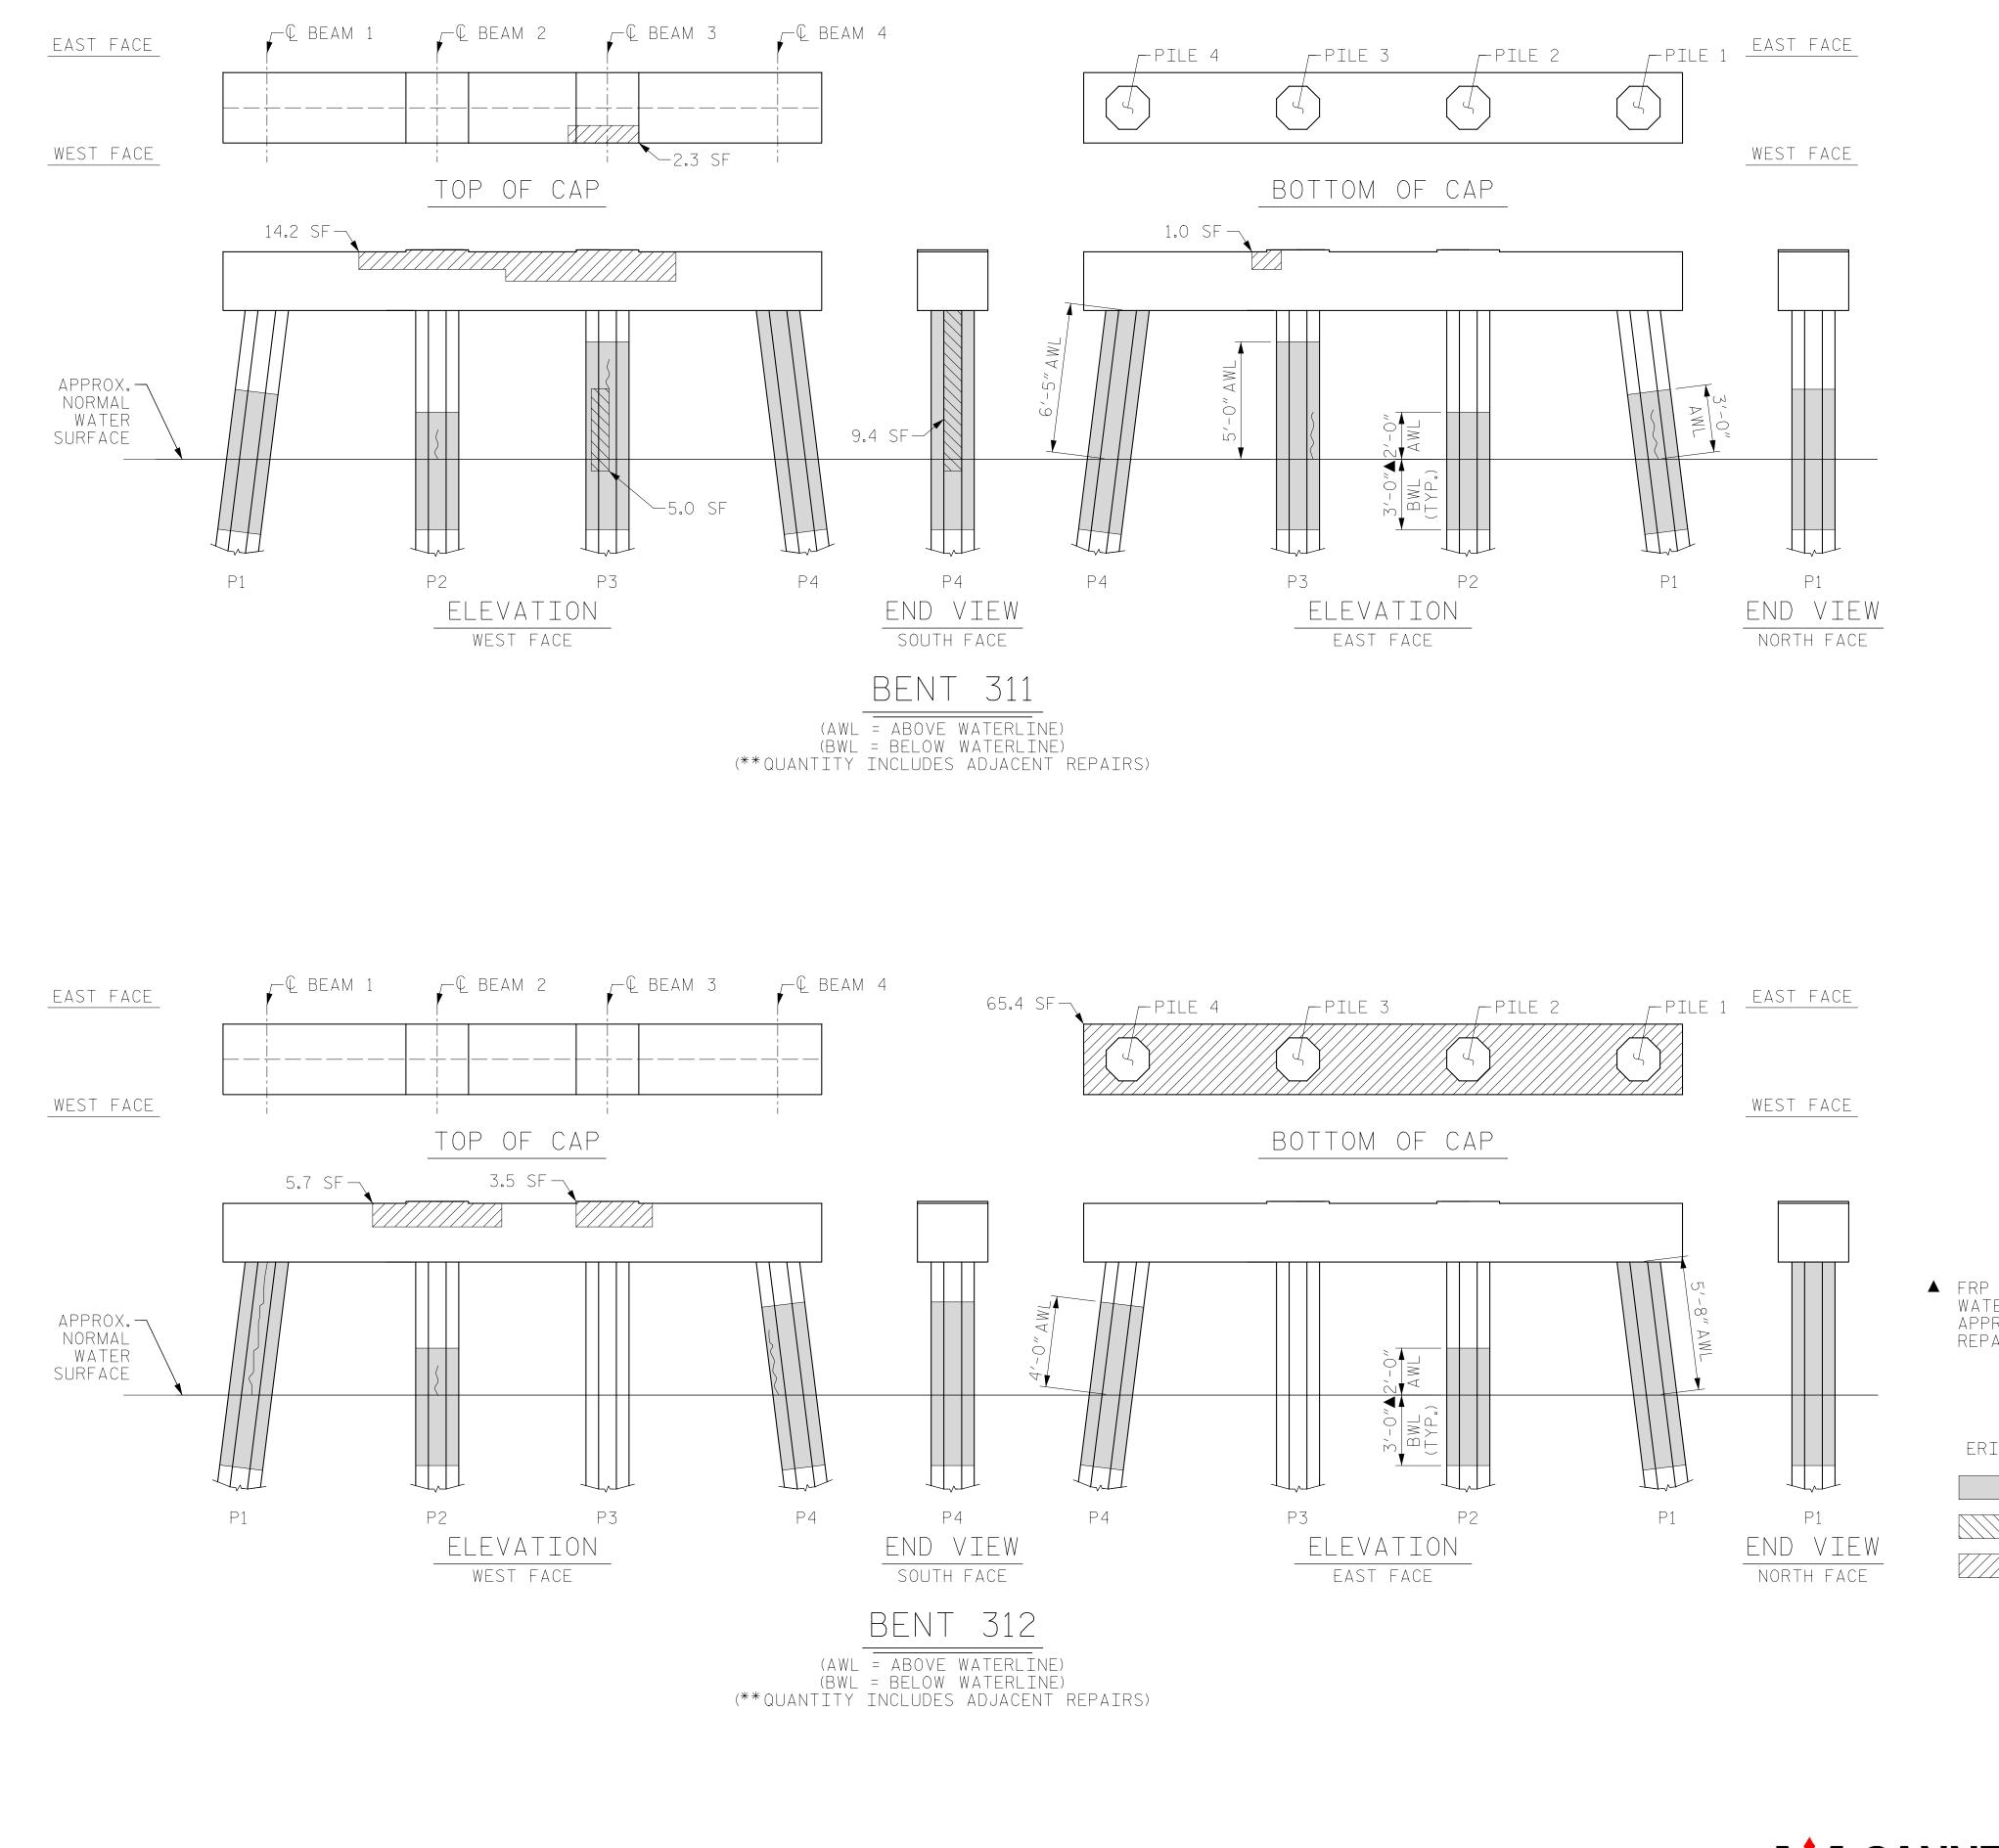
E	ESTIN	IATED P	ILE		RAC	KC	)ΤΥ	. TA	BL	_
NE			NW	W	SW	S	SE	E	NE	Ν
N S		PILE 1	_	-	_	2	_	2	-	_
	BENT	PILE 2	1	-	-	-	-	_	-	1
NW SW	311	PILE 3	_	1	-	-	2	_	-	1
W		PILE 4	_	-	-	_	-	_	-	-
		PILE 1	_	6	_	_	_	_	_	_
ROTECTIVE SYSTEM BELOW LINE MAY INCLUDE	BENT	PILE 2	_	1	1	_	_	-	-	_
VED UNDERWATER MORTAR RS	312	PILE 3	-	-	-	-	-	_	-	-
		PILE 4	-	1	-	_	-	-	-	3
	NOTE: FOR I	NFORMATIO	N ON	PIL	E CO	NDIT	ION	ONLY	°	
		PROJEC		NO.		$\left  - \right  \right $	∃ – (

FOR CAP REPAIRS: VALUES IN CHART REPRESENT ESTIMATED REPAIR TOTALS AFTER REMOVAL OF UNSOUND CONCRETE, MIN. OF 1"BEHIND REBAR AND MIN. 2 CL. TO SAWCUT. SEE REPAIR DETAILS. NOTES:

FOR CONCRETE REPAIR DETAILS, SEE ``TYPICAL CAP, COLUMN & UNDERDECK REPAIR DETAILS" & "PILE CONCRETE RESTORATION DETAILS" SHEETS. FOR PILE CONCRETE RESTORATION, SEE SPECIAL PROVISIONS.

FOR FRP PROTECTIVE SYSTEM DETAILS AND UNDERWATER MORTAR REPAIRS, SEE ``PILE FRP PROTECTIVE SYSTEM DETAILS' SHEET.
