AS-BUILT REPAIR QUANTITY TABLE

PROJECT NO. HB-0017
DARE COUNTY
BRIDGE NO. 270009

BENT 73 & BENT 74

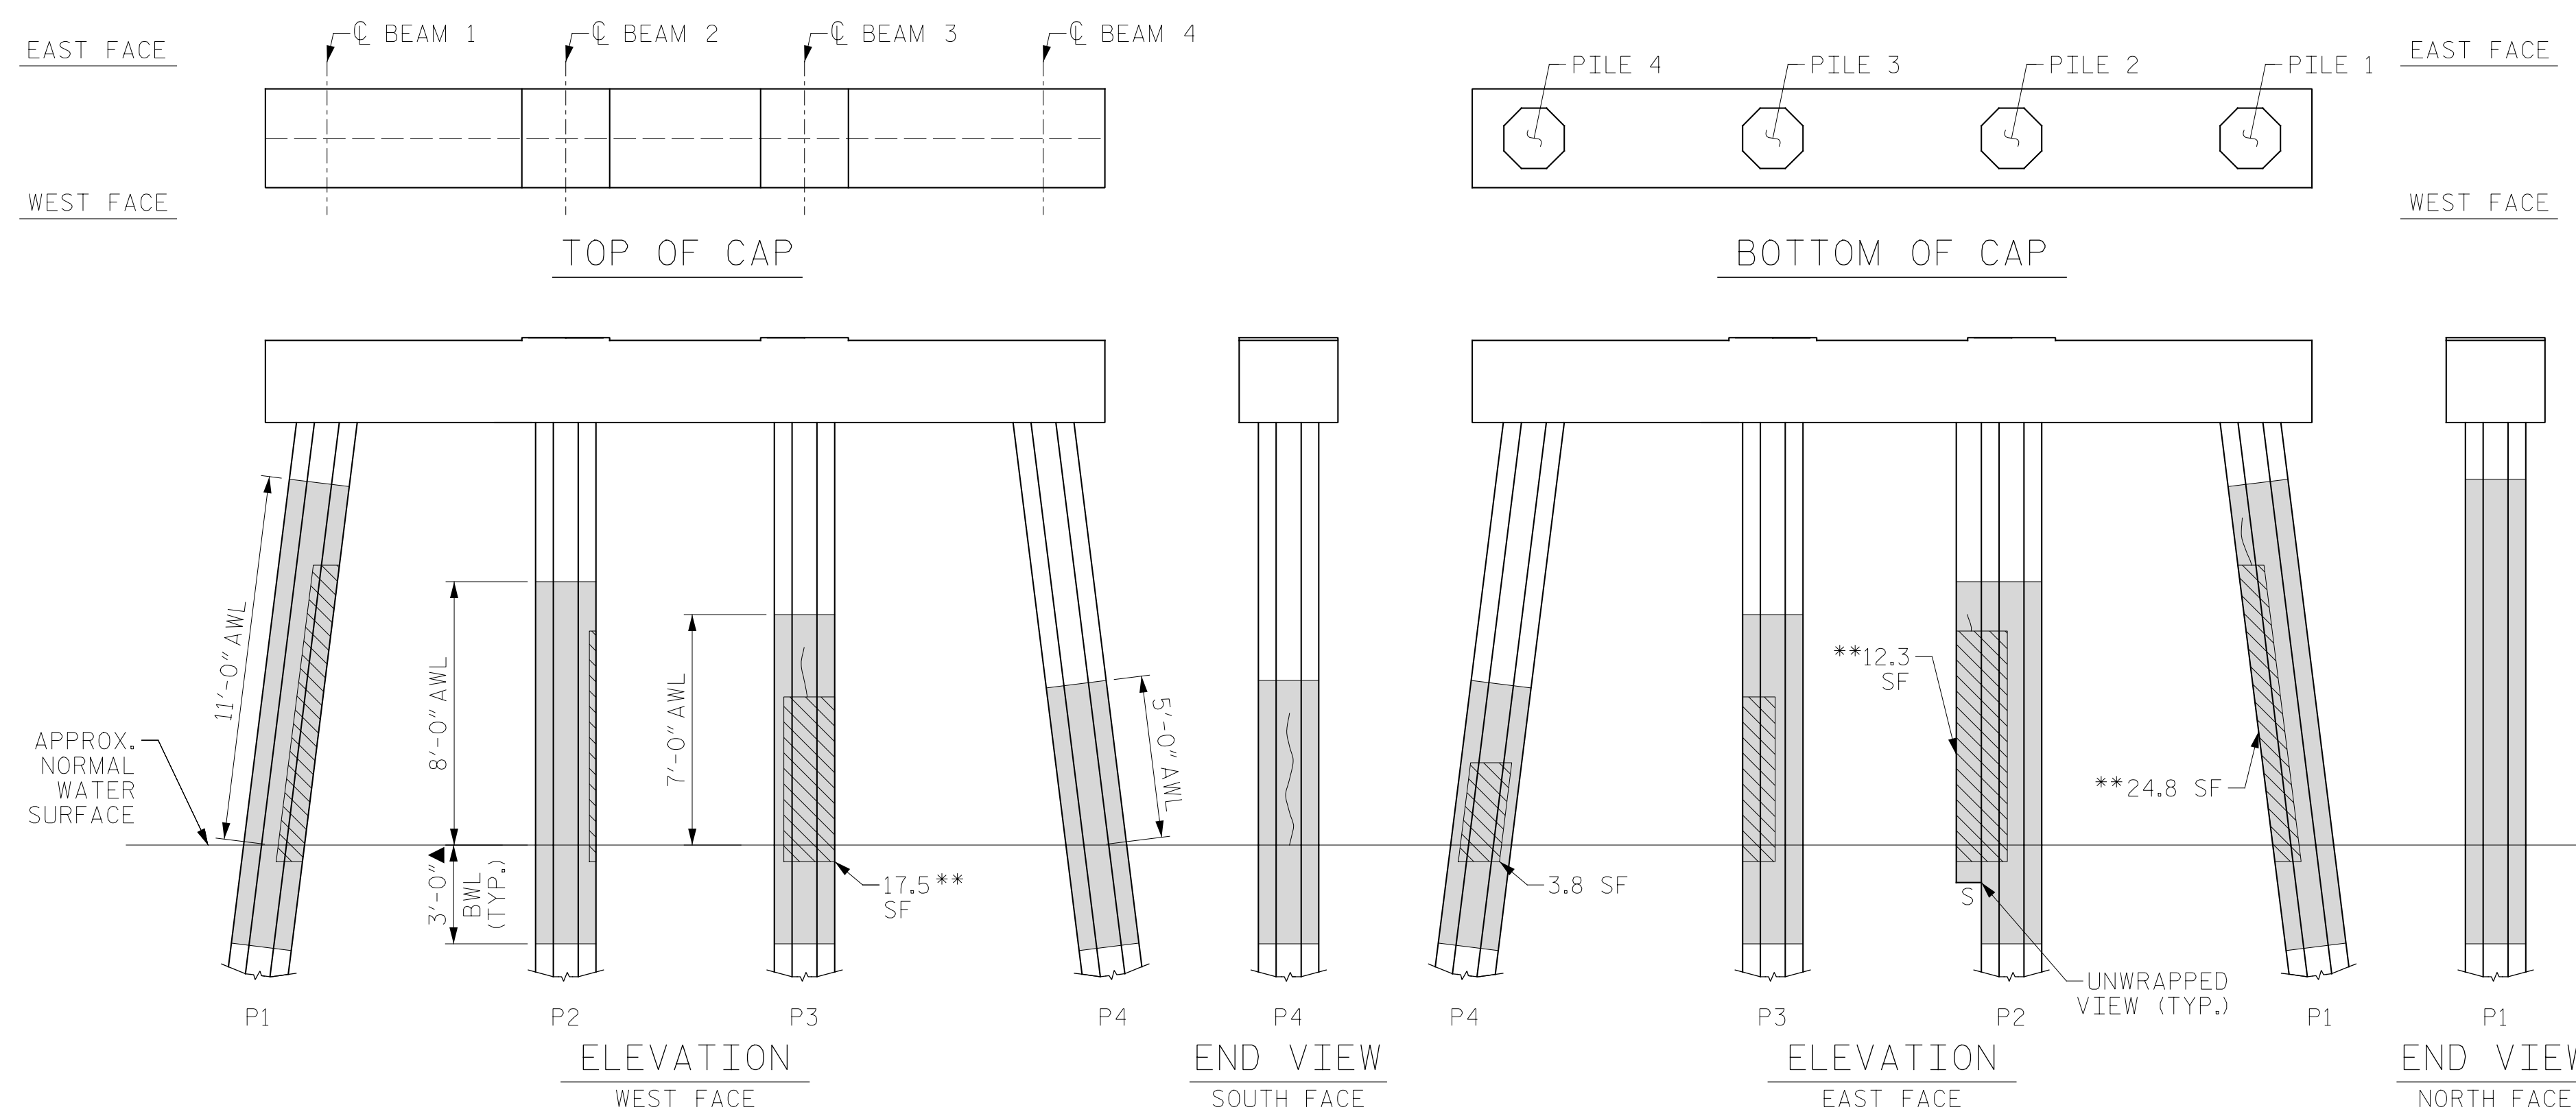
BENT 73

CAP REPAIRS			
SHOTCRETE REPAIRS	- SF	- CF	SF CF
EPOXY RESIN INJECTION	- LF		LF
PILE REPAIRS			
PILE CONCRETE RESTORATION	58.4 SF	23.0 CF	SF CF
FRP PROTECTIVE SYSTEM AWL	170.5 SF		
FRP PROTECTIVE SYSTEM BWL	66.0 SF

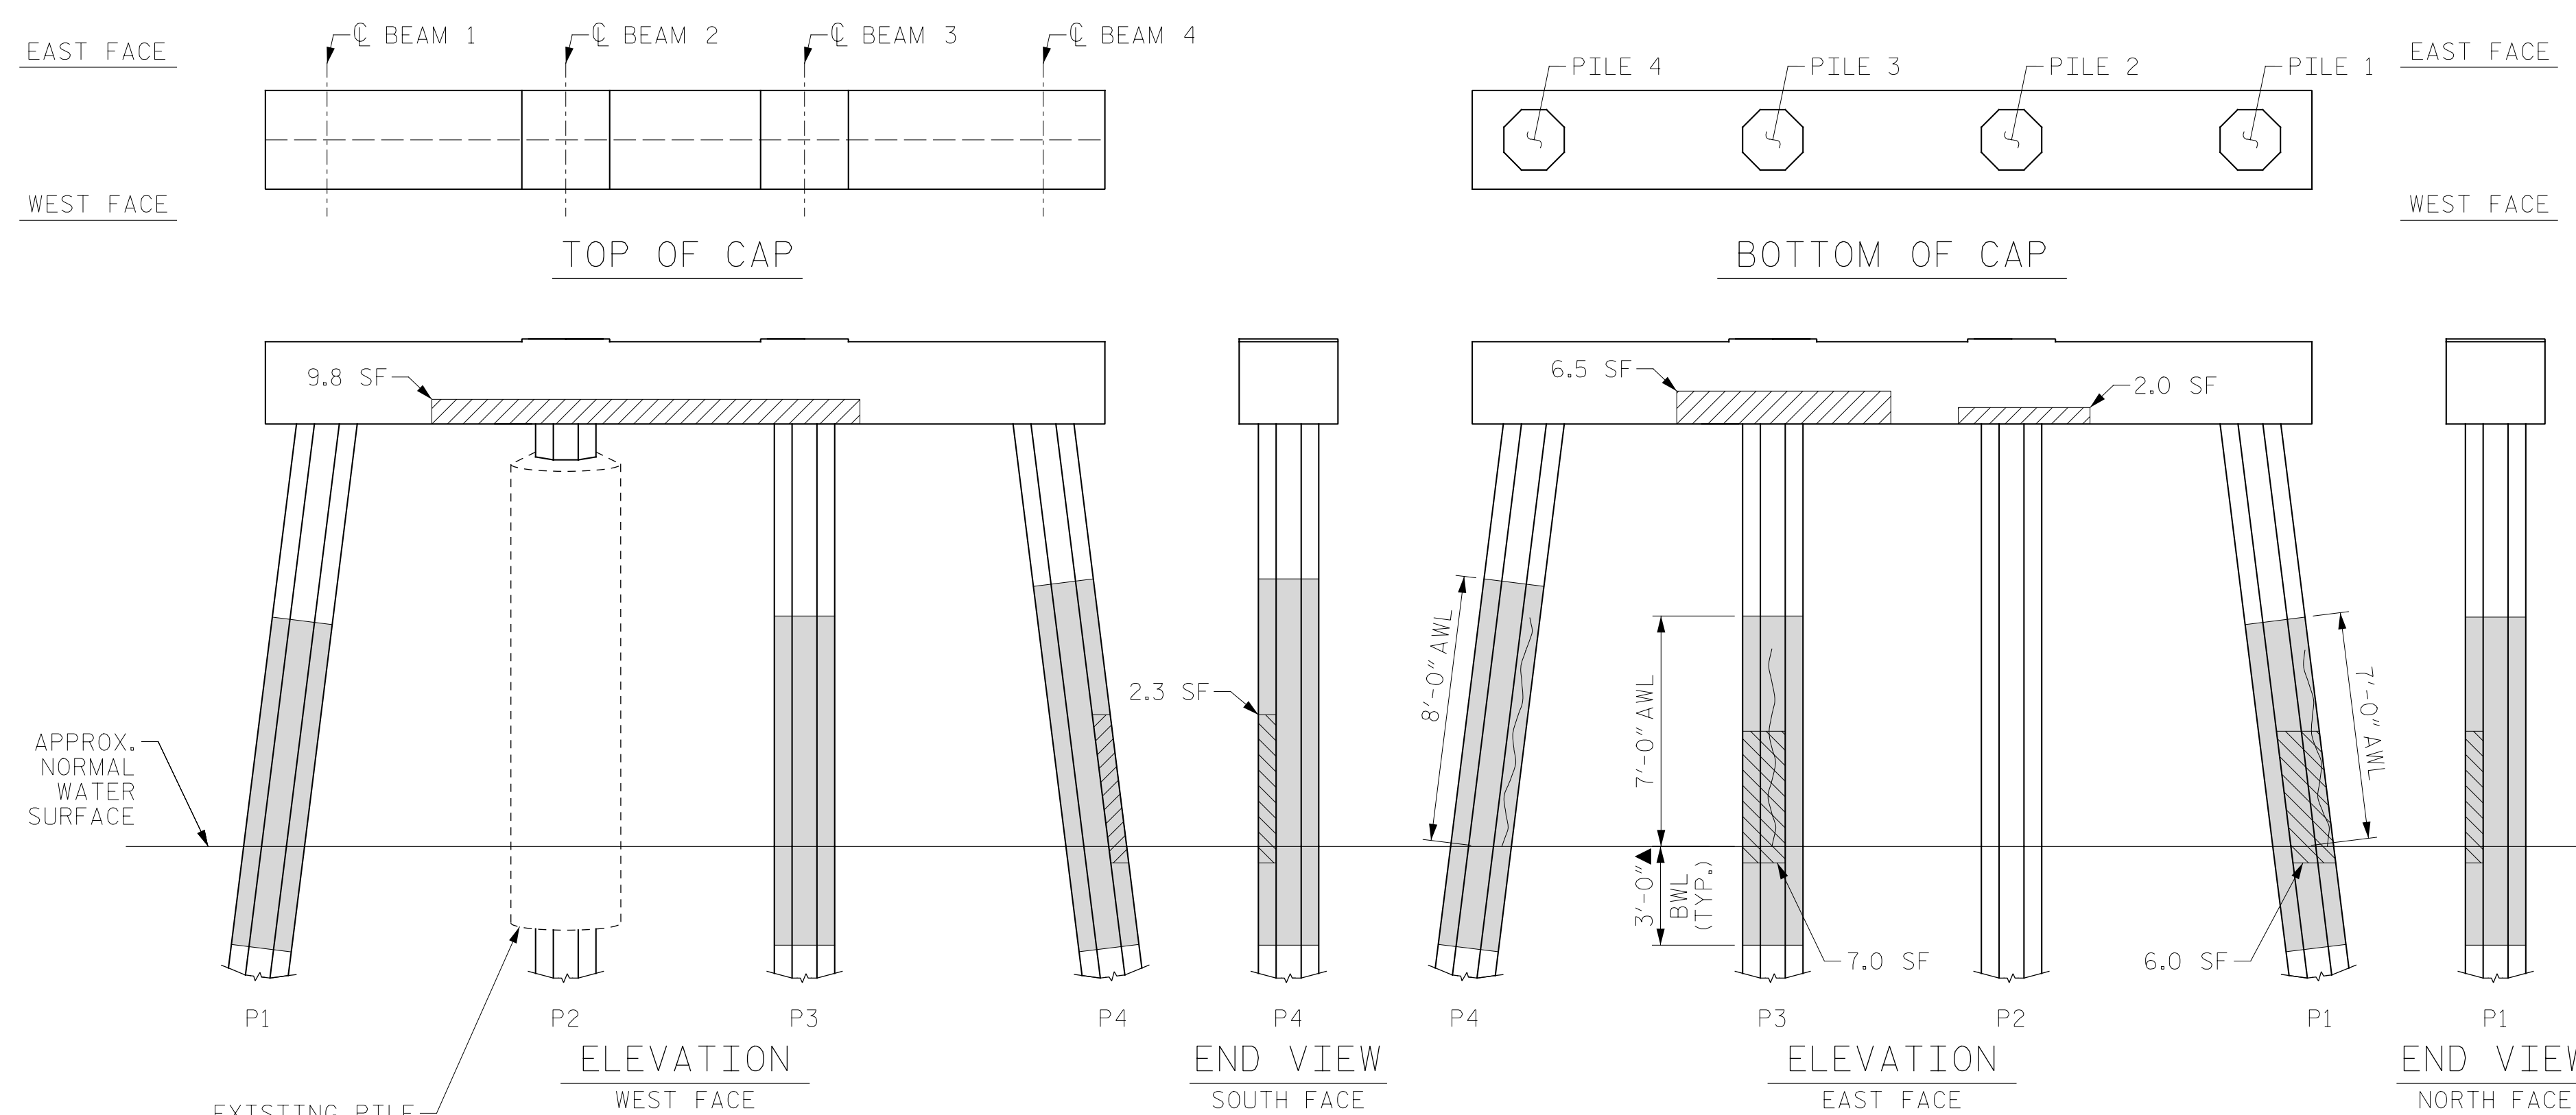
BENT 74

CAP REPAIRS			
SHOTCRETE REPAIRS	18.3 SF	6.6 CF	SF CF
EPOXY RESIN INJECTION	- LF		LF
PILE REPAIRS			
PILE CONCRETE RESTORATION	15.3 SF	7.2 CF	SF CF
FRP PROTECTIVE SYSTEM AWL	121.0 SF		
FRP PROTECTIVE SYSTEM BWL	49.5 SF

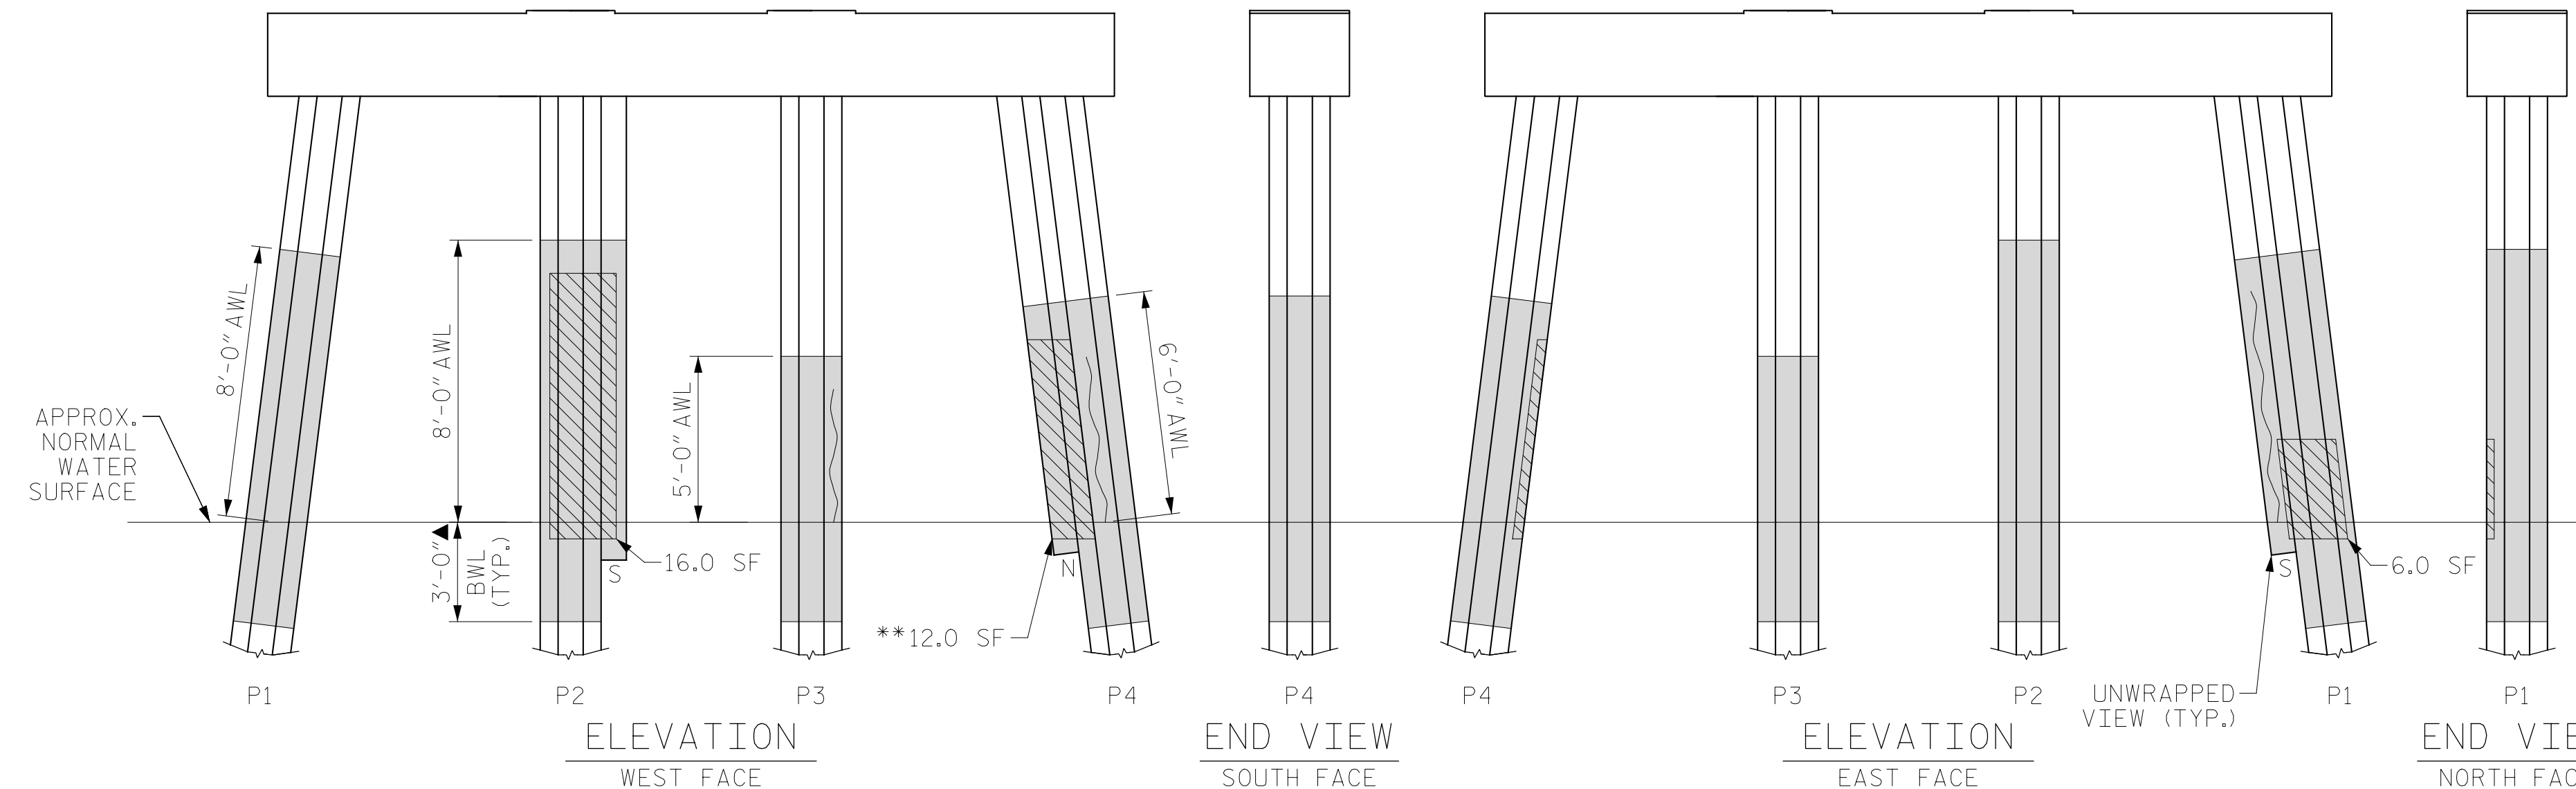
BENT 75

CAP REPAIRS			
SHOTCRETE REPAIRS	- SF	- CF	SF CF
EPOXY RESIN INJECTION	- LF		LF
PILE REPAIRS			
PILE CONCRETE RESTORATION	34.0 SF	13.4 CF	SF CF
FRP PROTECTIVE SYSTEM AWL	148.5 SF		
FRP PROTECTIVE SYSTEM BWL	66.0 SF

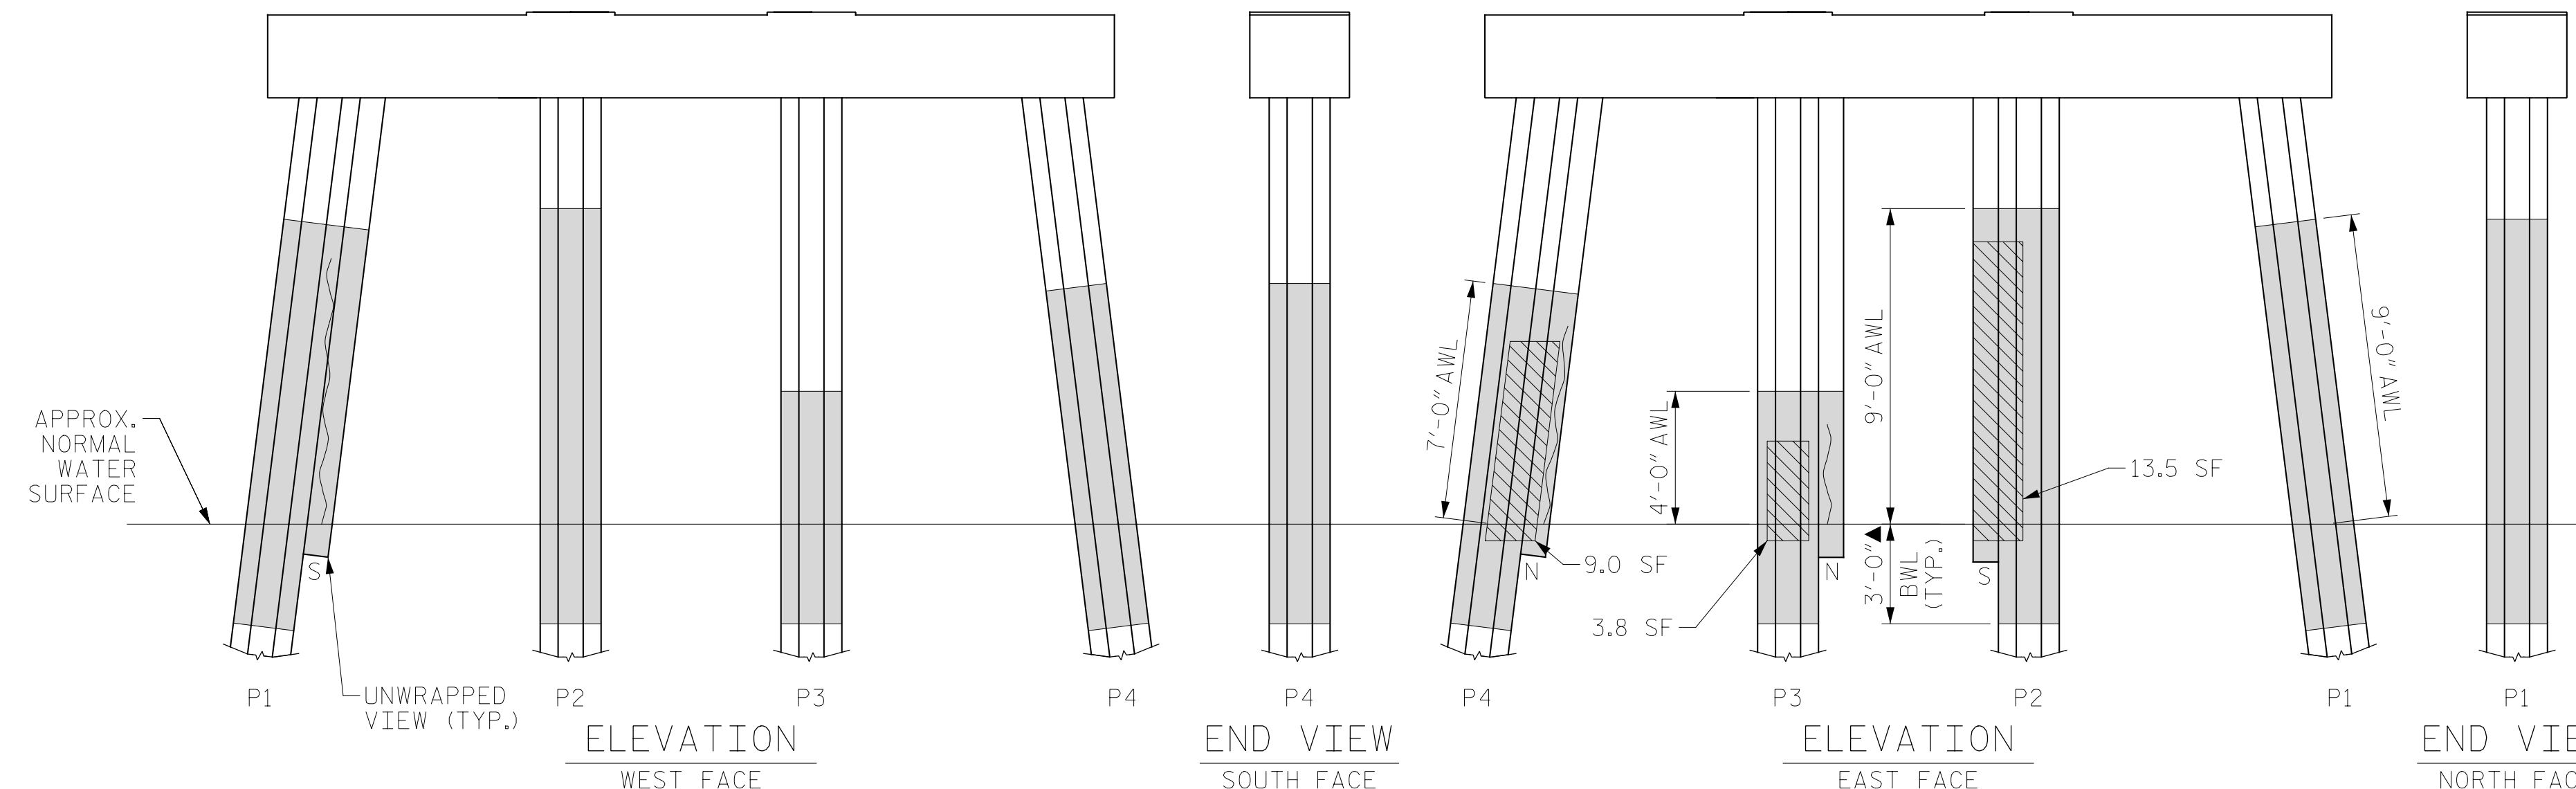
BENT 76

CAP REPAIRS			
SHOTCRETE REPAIRS	- SF	- CF	SF CF
EPOXY RESIN INJECTION	- LF		LF
PILE REPAIRS			
PILE CONCRETE RESTORATION	26.3 SF	11.5 CF	SF CF
FRP PROTECTIVE SYSTEM AWL	159.5 SF		
FRP PROTECTIVE SYSTEM BWL	66.0 SF

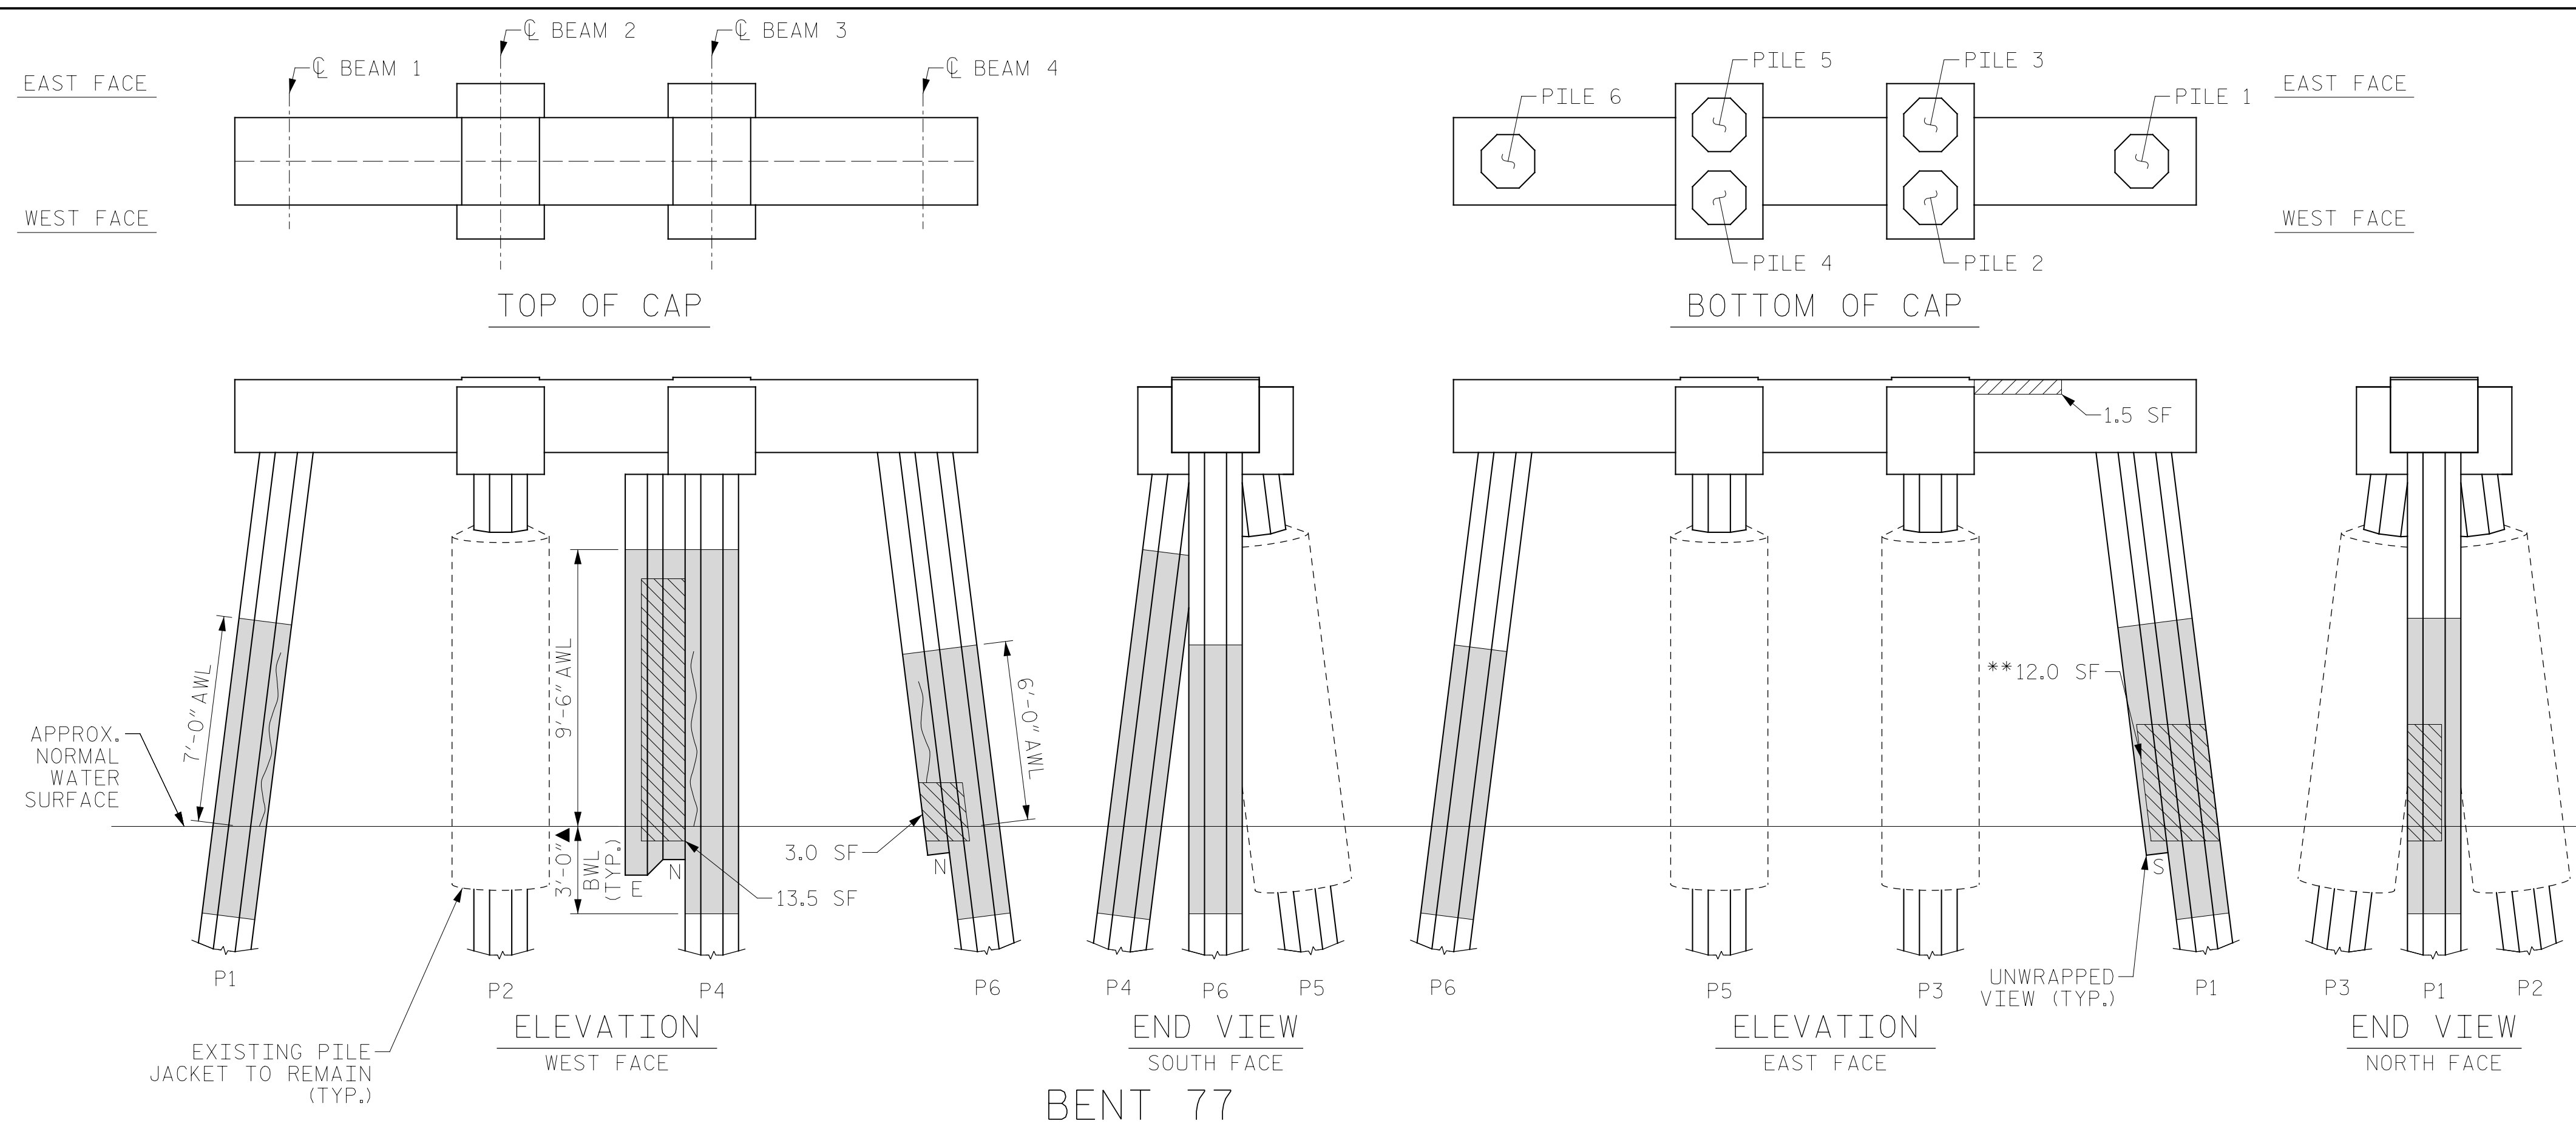
BENT 77
 (AWL = ABOVE WATERLINE)
 (BWL = BELOW WATERLINE)
 (**QUANTITY INCLUDES ADJACENT REPAIRS)

BENT 77			
CAP REPAIRS			
SHOTCRETE REPAIRS	1.5 SF	0.8 CF	
EPOXY RESIN INJECTION	- LF		
PILE REPAIRS			
PILE CONCRETE RESTORATION	28.5 SF	12.1 CF	
FRP PROTECTIVE SYSTEM AWL	121.0 SF		
FRP PROTECTIVE SYSTEM BWL	49.5 SF

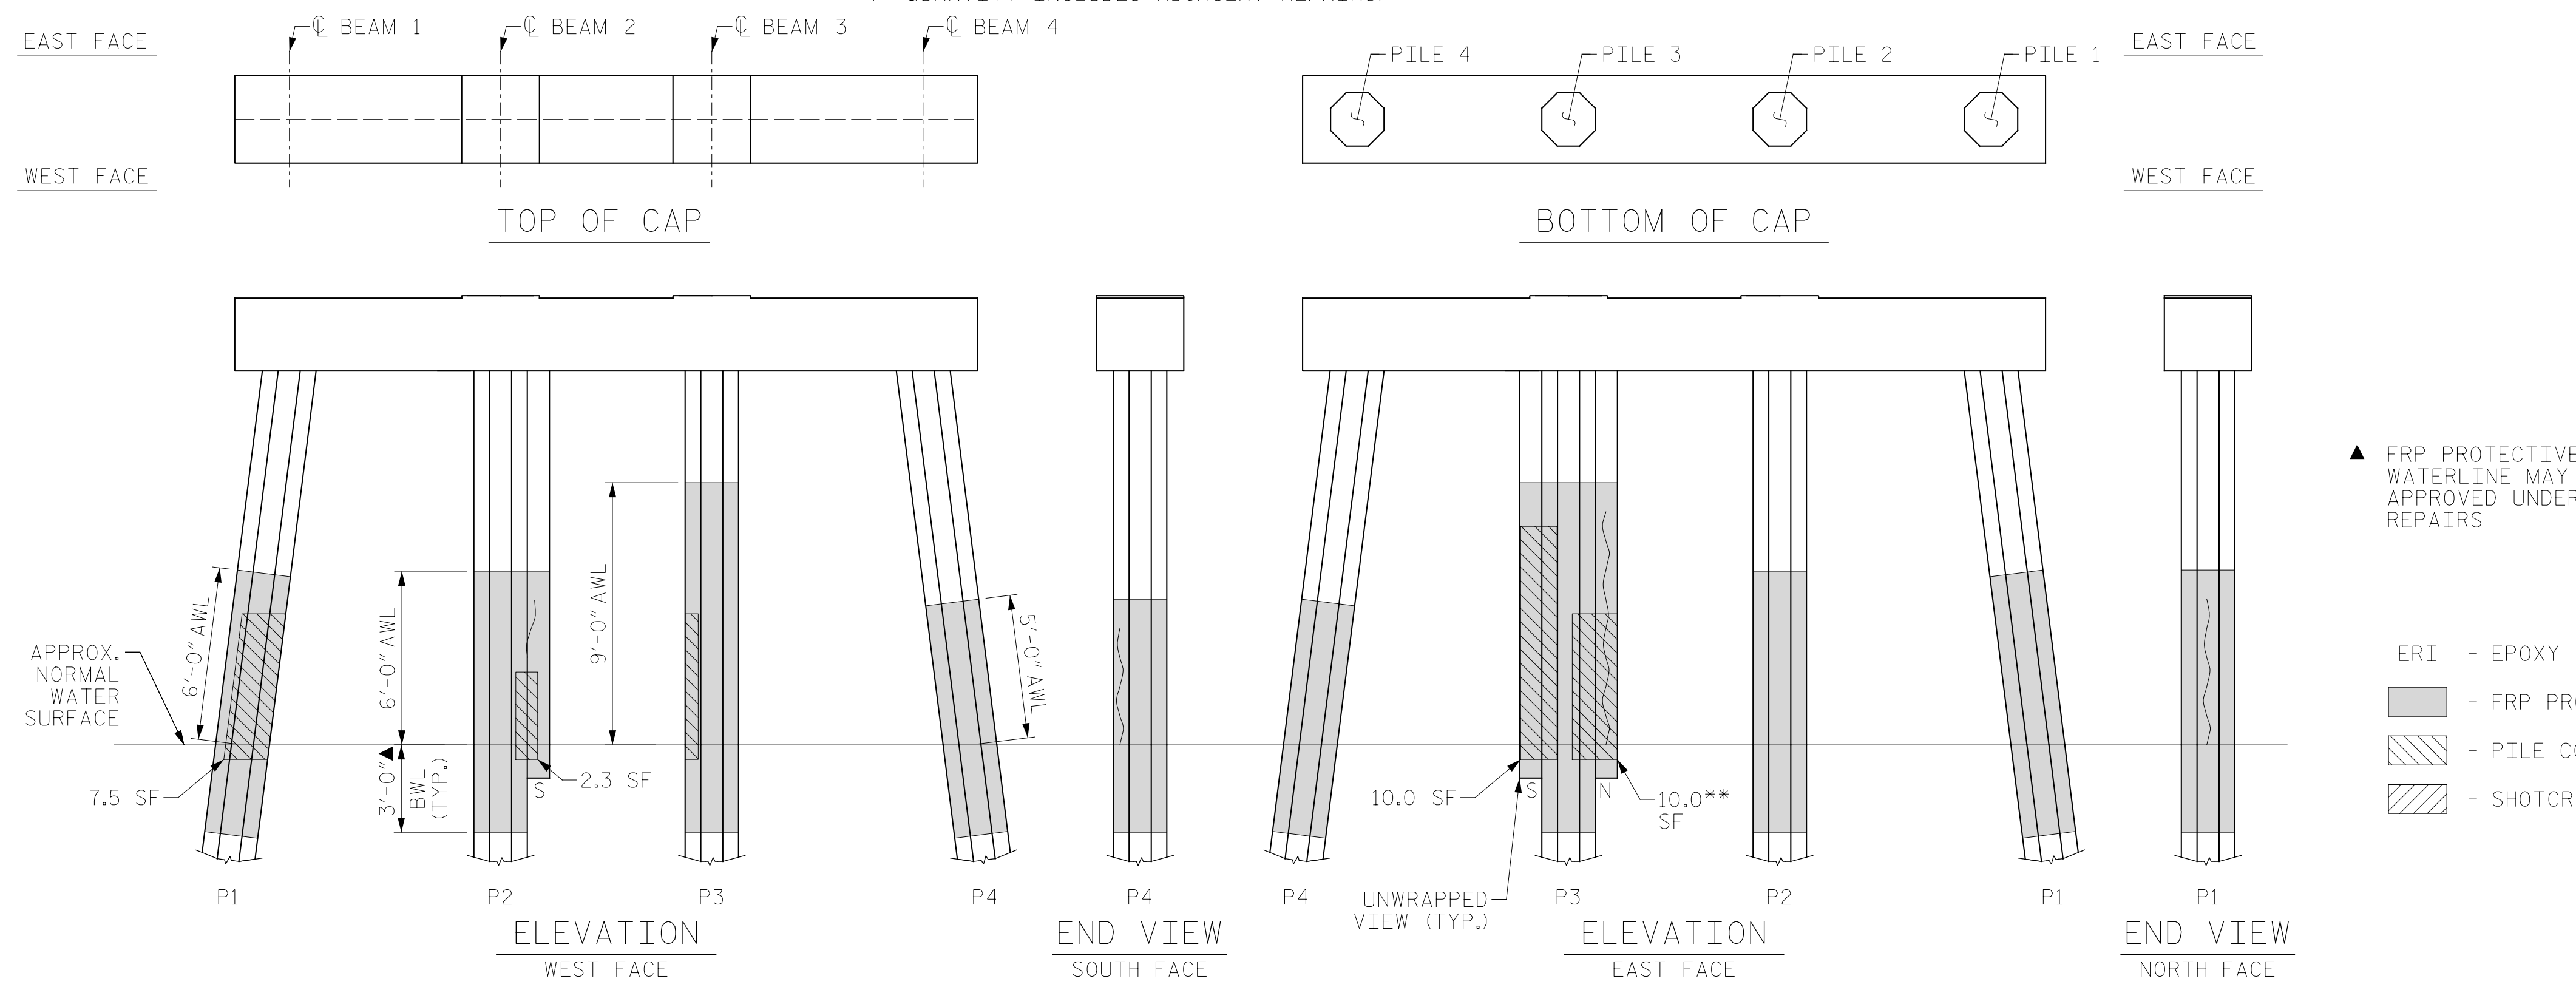
BENT 78
 (AWL = ABOVE WATERLINE)
 (BWL = BELOW WATERLINE)
 (**QUANTITY INCLUDES ADJACENT REPAIRS)

BENT 78			
CAP REPAIRS			
SHOTCRETE REPAIRS	- SF	- CF	
EPOXY RESIN INJECTION	- LF		
PILE REPAIRS			
PILE CONCRETE RESTORATION	29.8 SF	12.6 CF	
FRP PROTECTIVE SYSTEM AWL	143.0 SF		
FRP PROTECTIVE SYSTEM BWL	66.0 SF

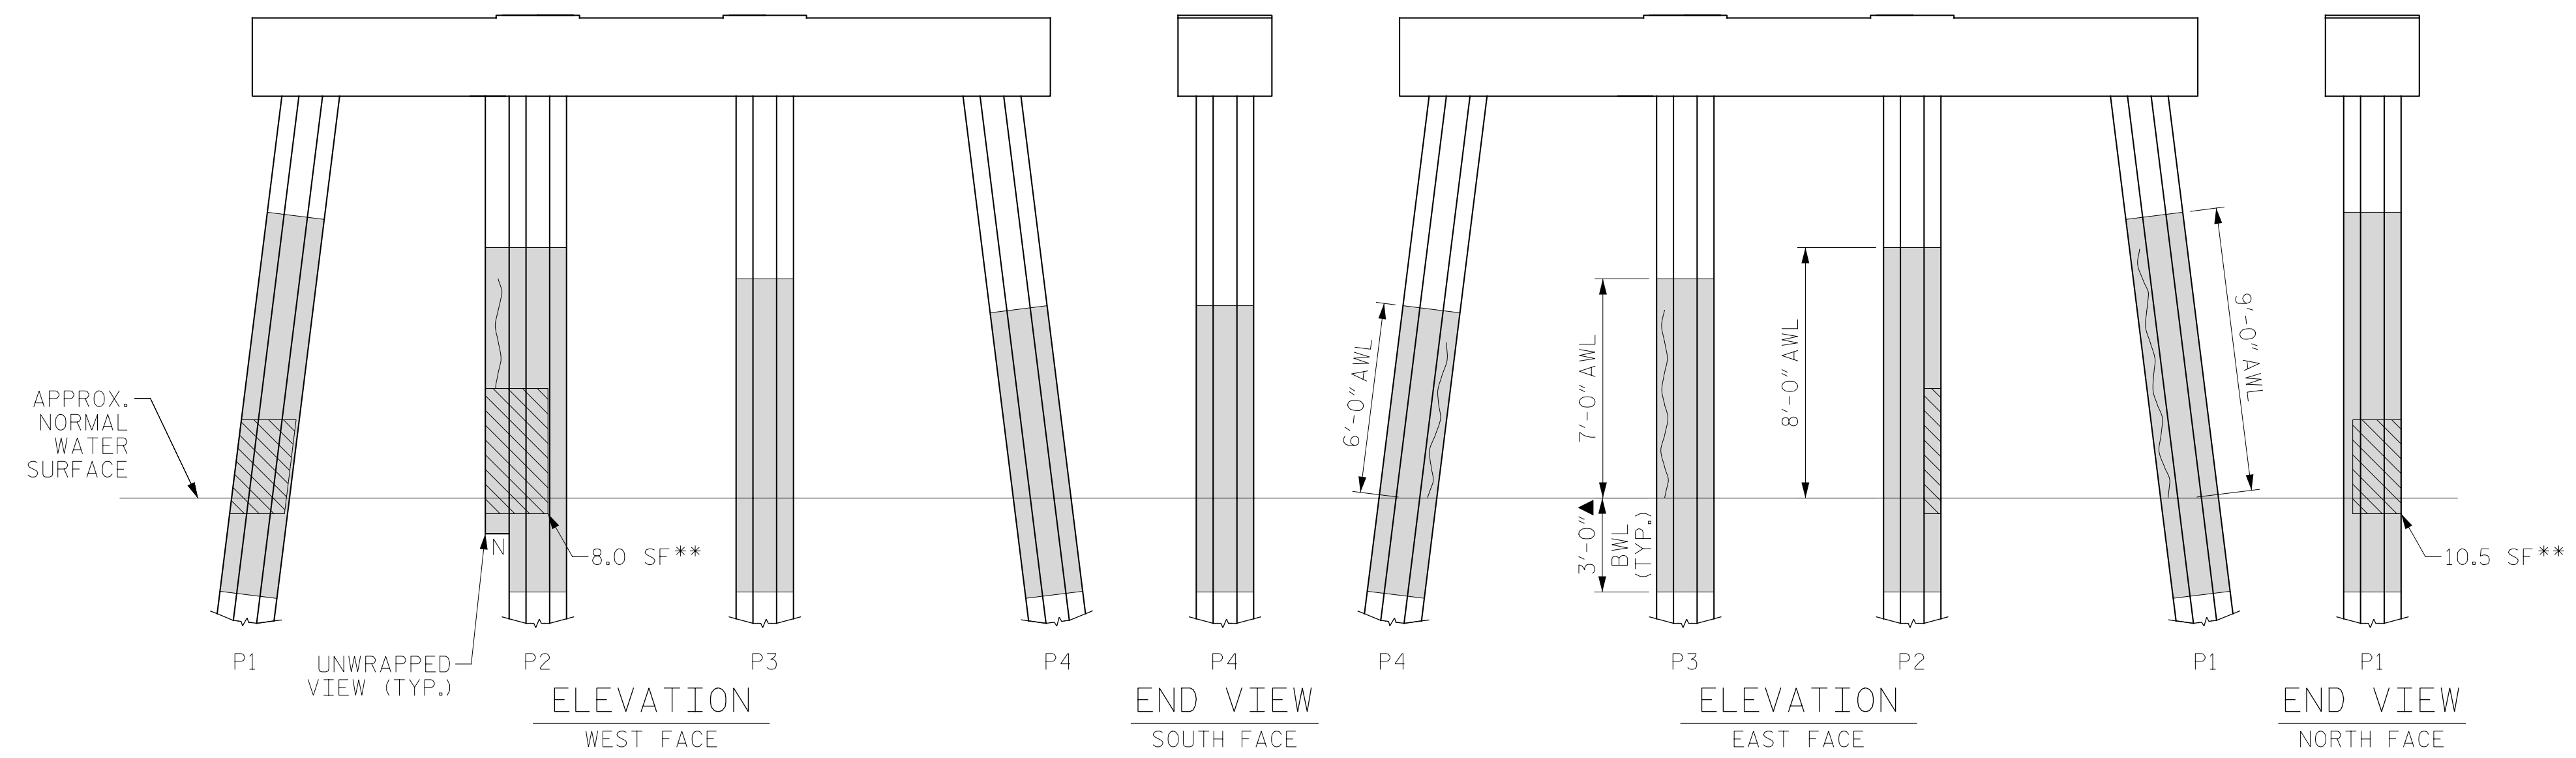
BENT 79

CAP REPAIRS			
SHOTCRETE REPAIRS	- SF	- CF	SF CF
EPOXY RESIN INJECTION	- LF		LF
PILE REPAIRS			
PILE CONCRETE RESTORATION	18.5 SF	7.0 CF	SF CF
FRP PROTECTIVE SYSTEM AWL	165.0 SF		
FRP PROTECTIVE SYSTEM BWL	66.0 SF

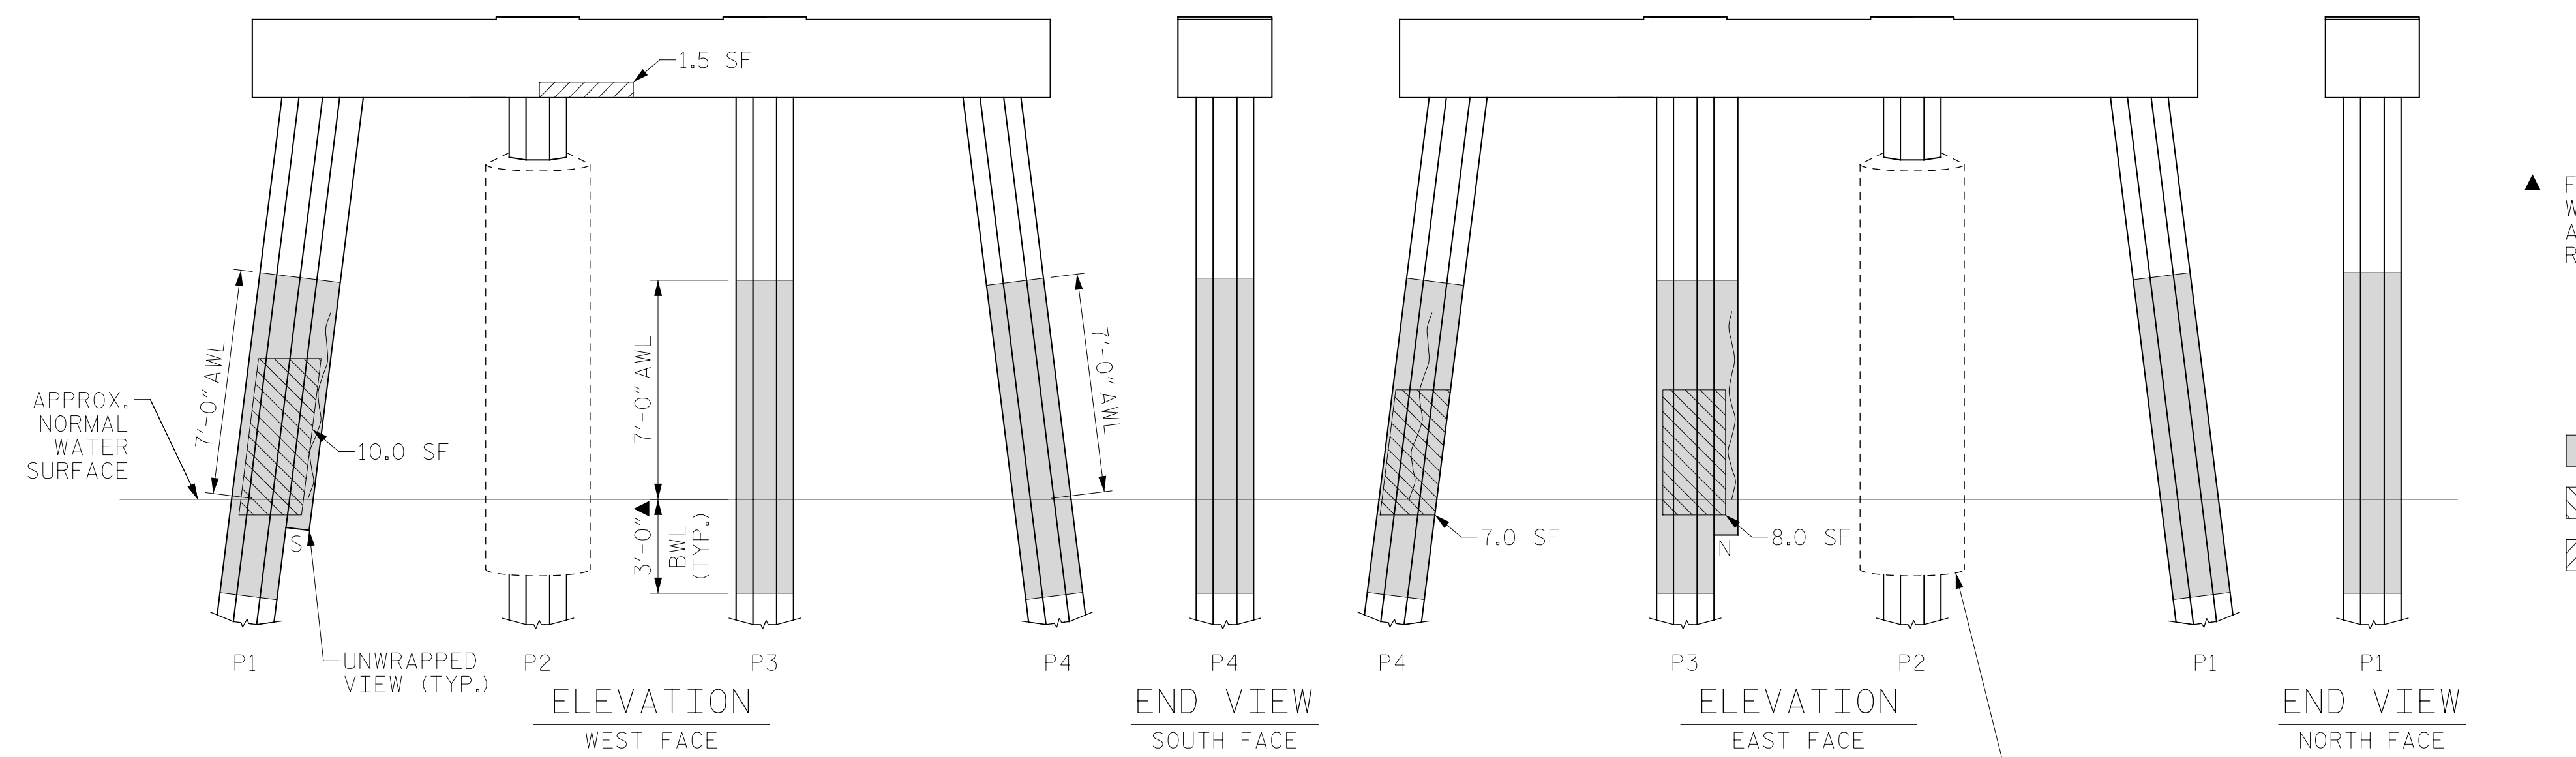
BENT 80

CAP REPAIRS			
SHOTCRETE REPAIRS	1.5 SF	0.8 CF	SF CF
EPOXY RESIN INJECTION	- LF		LF
PILE REPAIRS			
PILE CONCRETE RESTORATION	25.0 SF	10.0 CF	SF CF
FRP PROTECTIVE SYSTEM AWL	115.5 SF		
FRP PROTECTIVE SYSTEM BWL	49.5 SF

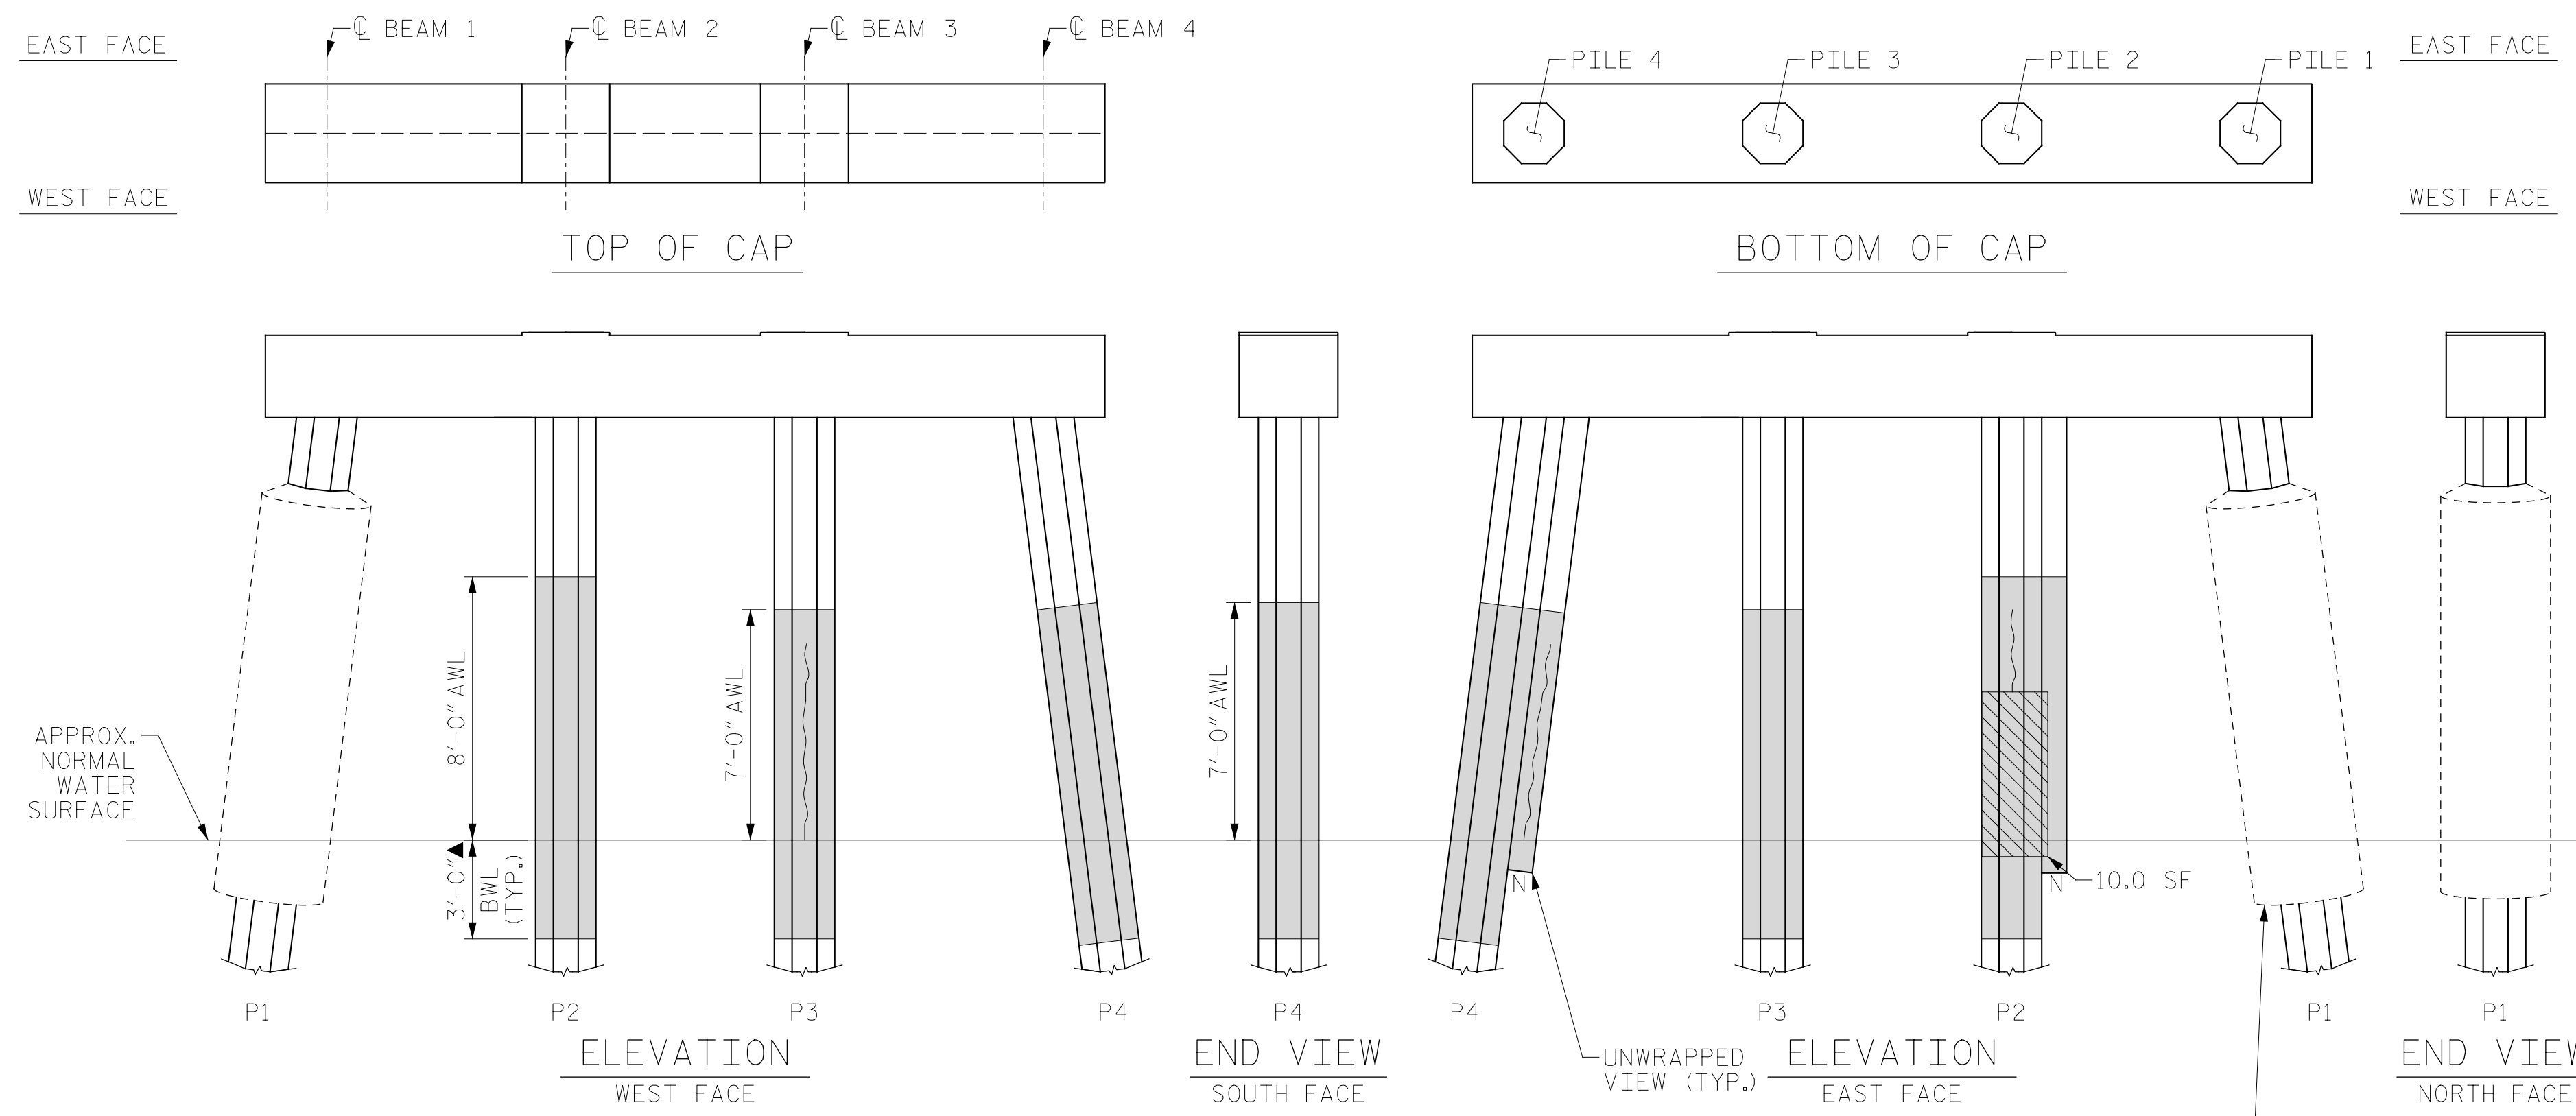
BENT 81				
CAP REPAIRS				
SHOTCRETE REPAIRS	- SF	- CF	SF	CF
EPOXY RESIN INJECTION	- LF			LF
PILE REPAIRS				
PILE CONCRETE RESTORATION	10.0 SF	4.0 CF	SF	CF
FRP PROTECTIVE SYSTEM AWL	121.0 SF			
FRP PROTECTIVE SYSTEM BWL	49.5 SF
