AS-BUILT REPAIR QUANTITY TABLE

PROJECT NO. HB-0017
DARE COUNTY
BRIDGE NO. 270009

BENT 73 & BENT 74

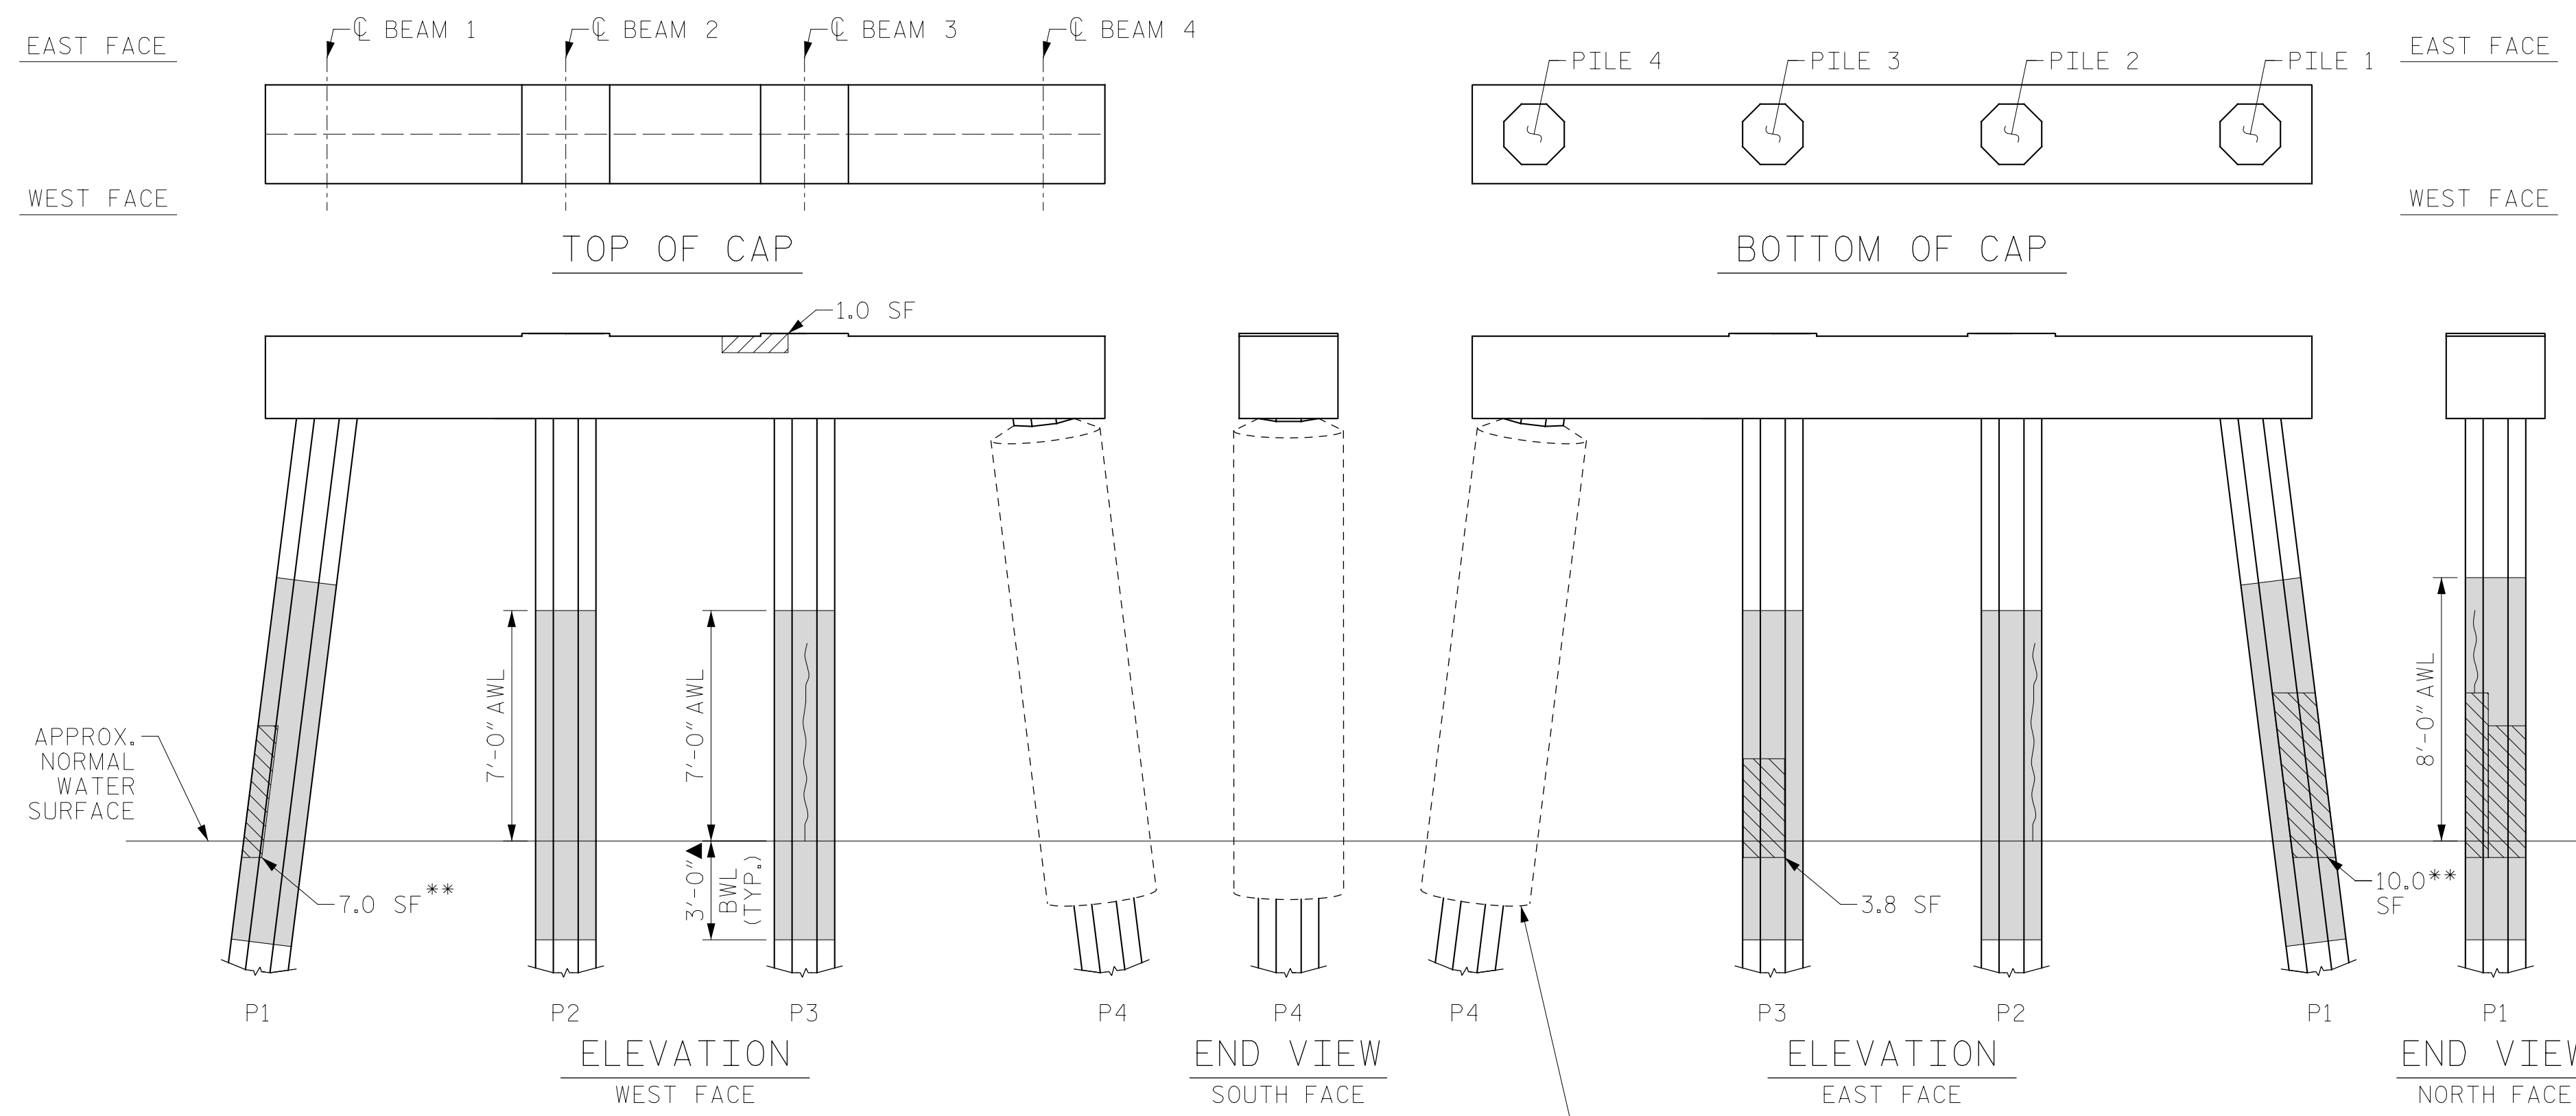
BENT 82				
CAP REPAIRS				
SHOTCRETE REPAIRS	1.0 SF	0.5 CF	SF	CF
EPOXY RESIN INJECTION	- LF			LF
PILE REPAIRS				
PILE CONCRETE RESTORATION	20.8 SF	8.7 CF	SF	CF
FRP PROTECTIVE SYSTEM AWL	121.0 SF			
FRP PROTECTIVE SYSTEM BWL	49.5 SF

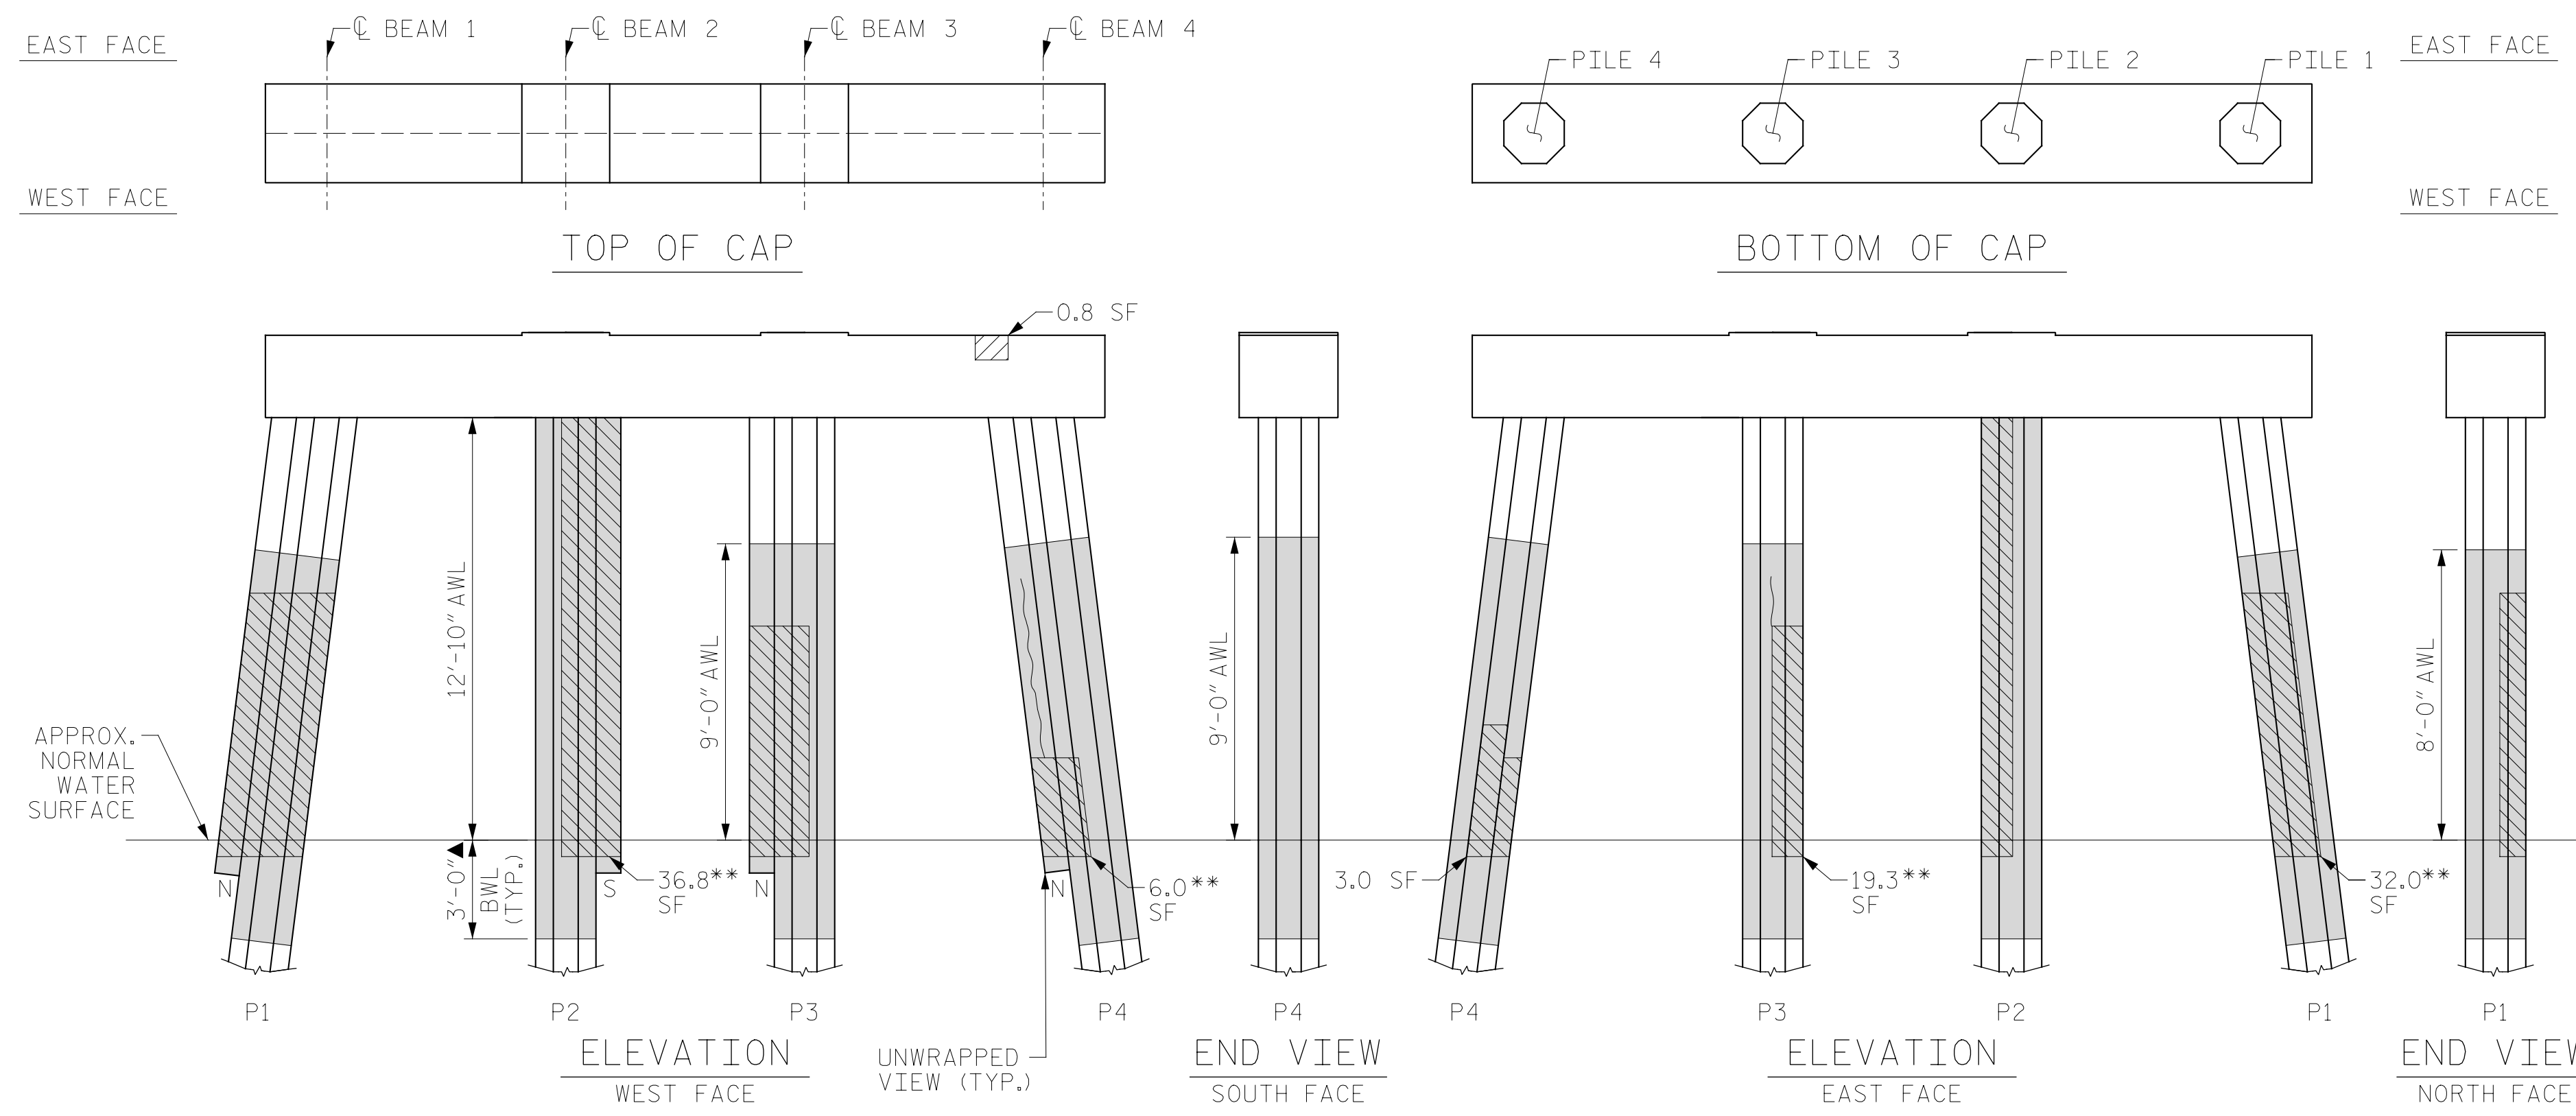
BENT 83

CAP REPAIRS			
SHOTCRETE REPAIRS	0.8 SF	0.4 CF	
EPOXY RESIN INJECTION	- LF		
PILE REPAIRS			
PILE CONCRETE RESTORATION	97.1 SF	37.8 CF	
FRP PROTECTIVE SYSTEM AWL	213.6 SF		
FRP PROTECTIVE SYSTEM BWL	66.0 SF

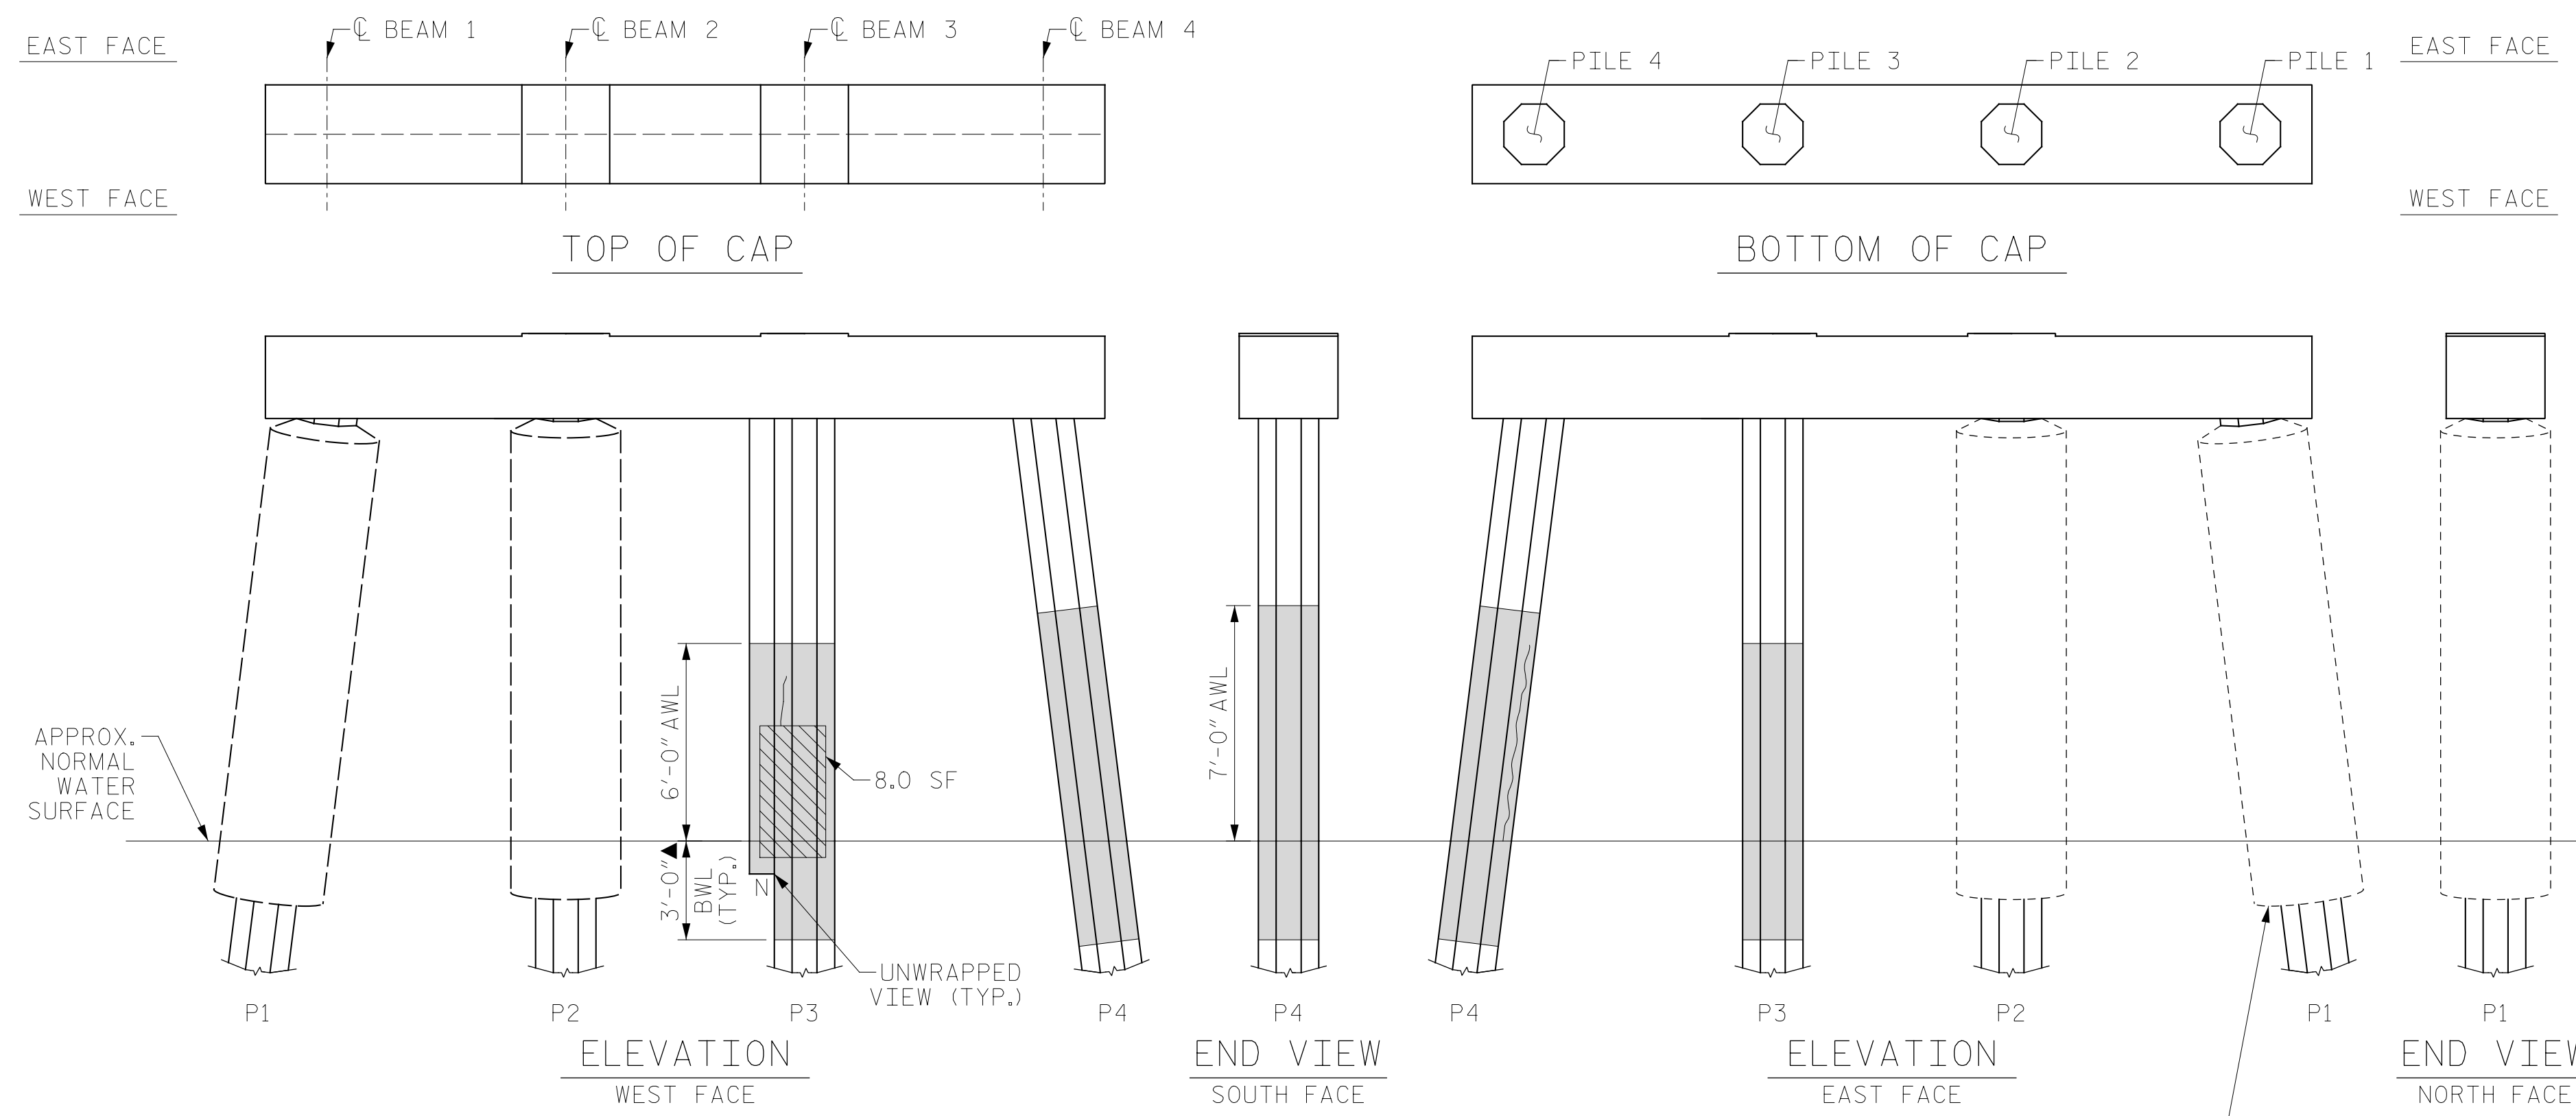
BENT 84

CAP REPAIRS			
SHOTCRETE REPAIRS	- SF	- CF	
EPOXY RESIN INJECTION	- LF		
PILE REPAIRS			
PILE CONCRETE RESTORATION	8.0 SF	3.2 CF	
FRP PROTECTIVE SYSTEM AWL	71.5 SF		
FRP PROTECTIVE SYSTEM BWL	33.0 SF

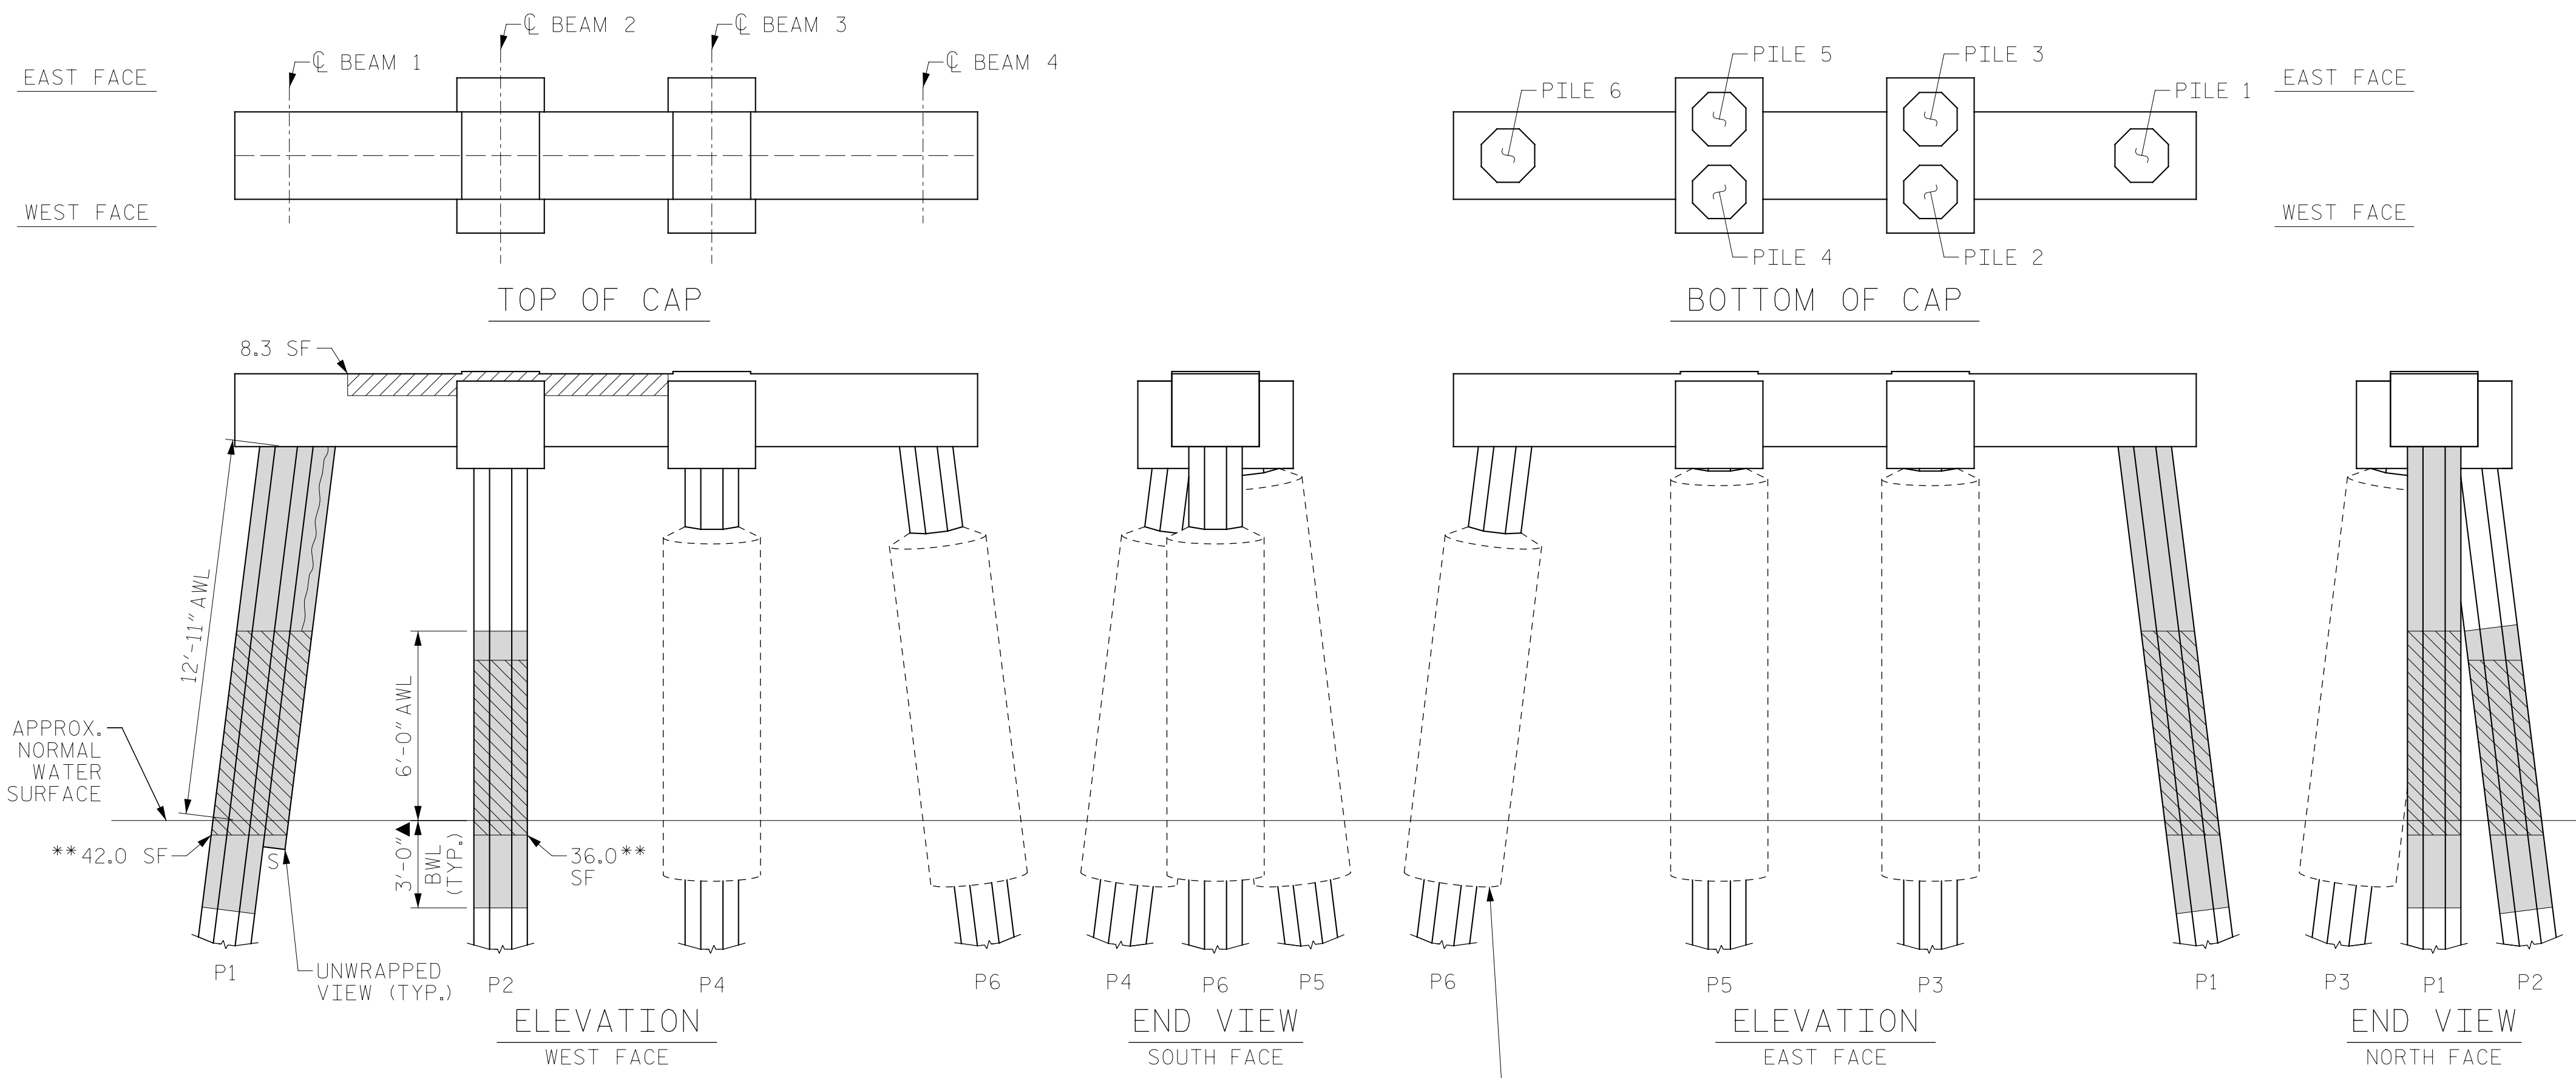
BENT 85

CAP REPAIRS			
SHOTCRETE REPAIRS	8.3 SF	4.1 CF	SF CF
EPOXY RESIN INJECTION	- LF		LF
PILE REPAIRS			
PILE CONCRETE RESTORATION	78.0 SF	28.7 CF	SF CF
FRP PROTECTIVE SYSTEM AWL	104.0 SF		
FRP PROTECTIVE SYSTEM BWL	33.0 SF
