PROJECT NO. **I-5950 DAVIDSON** _ COUNTY 280146

STATE OF NORTH CAROLINA DEPARTMENT OF TRANSPORTATION

SUBSTRUCTURE REPAIR END BENT 1

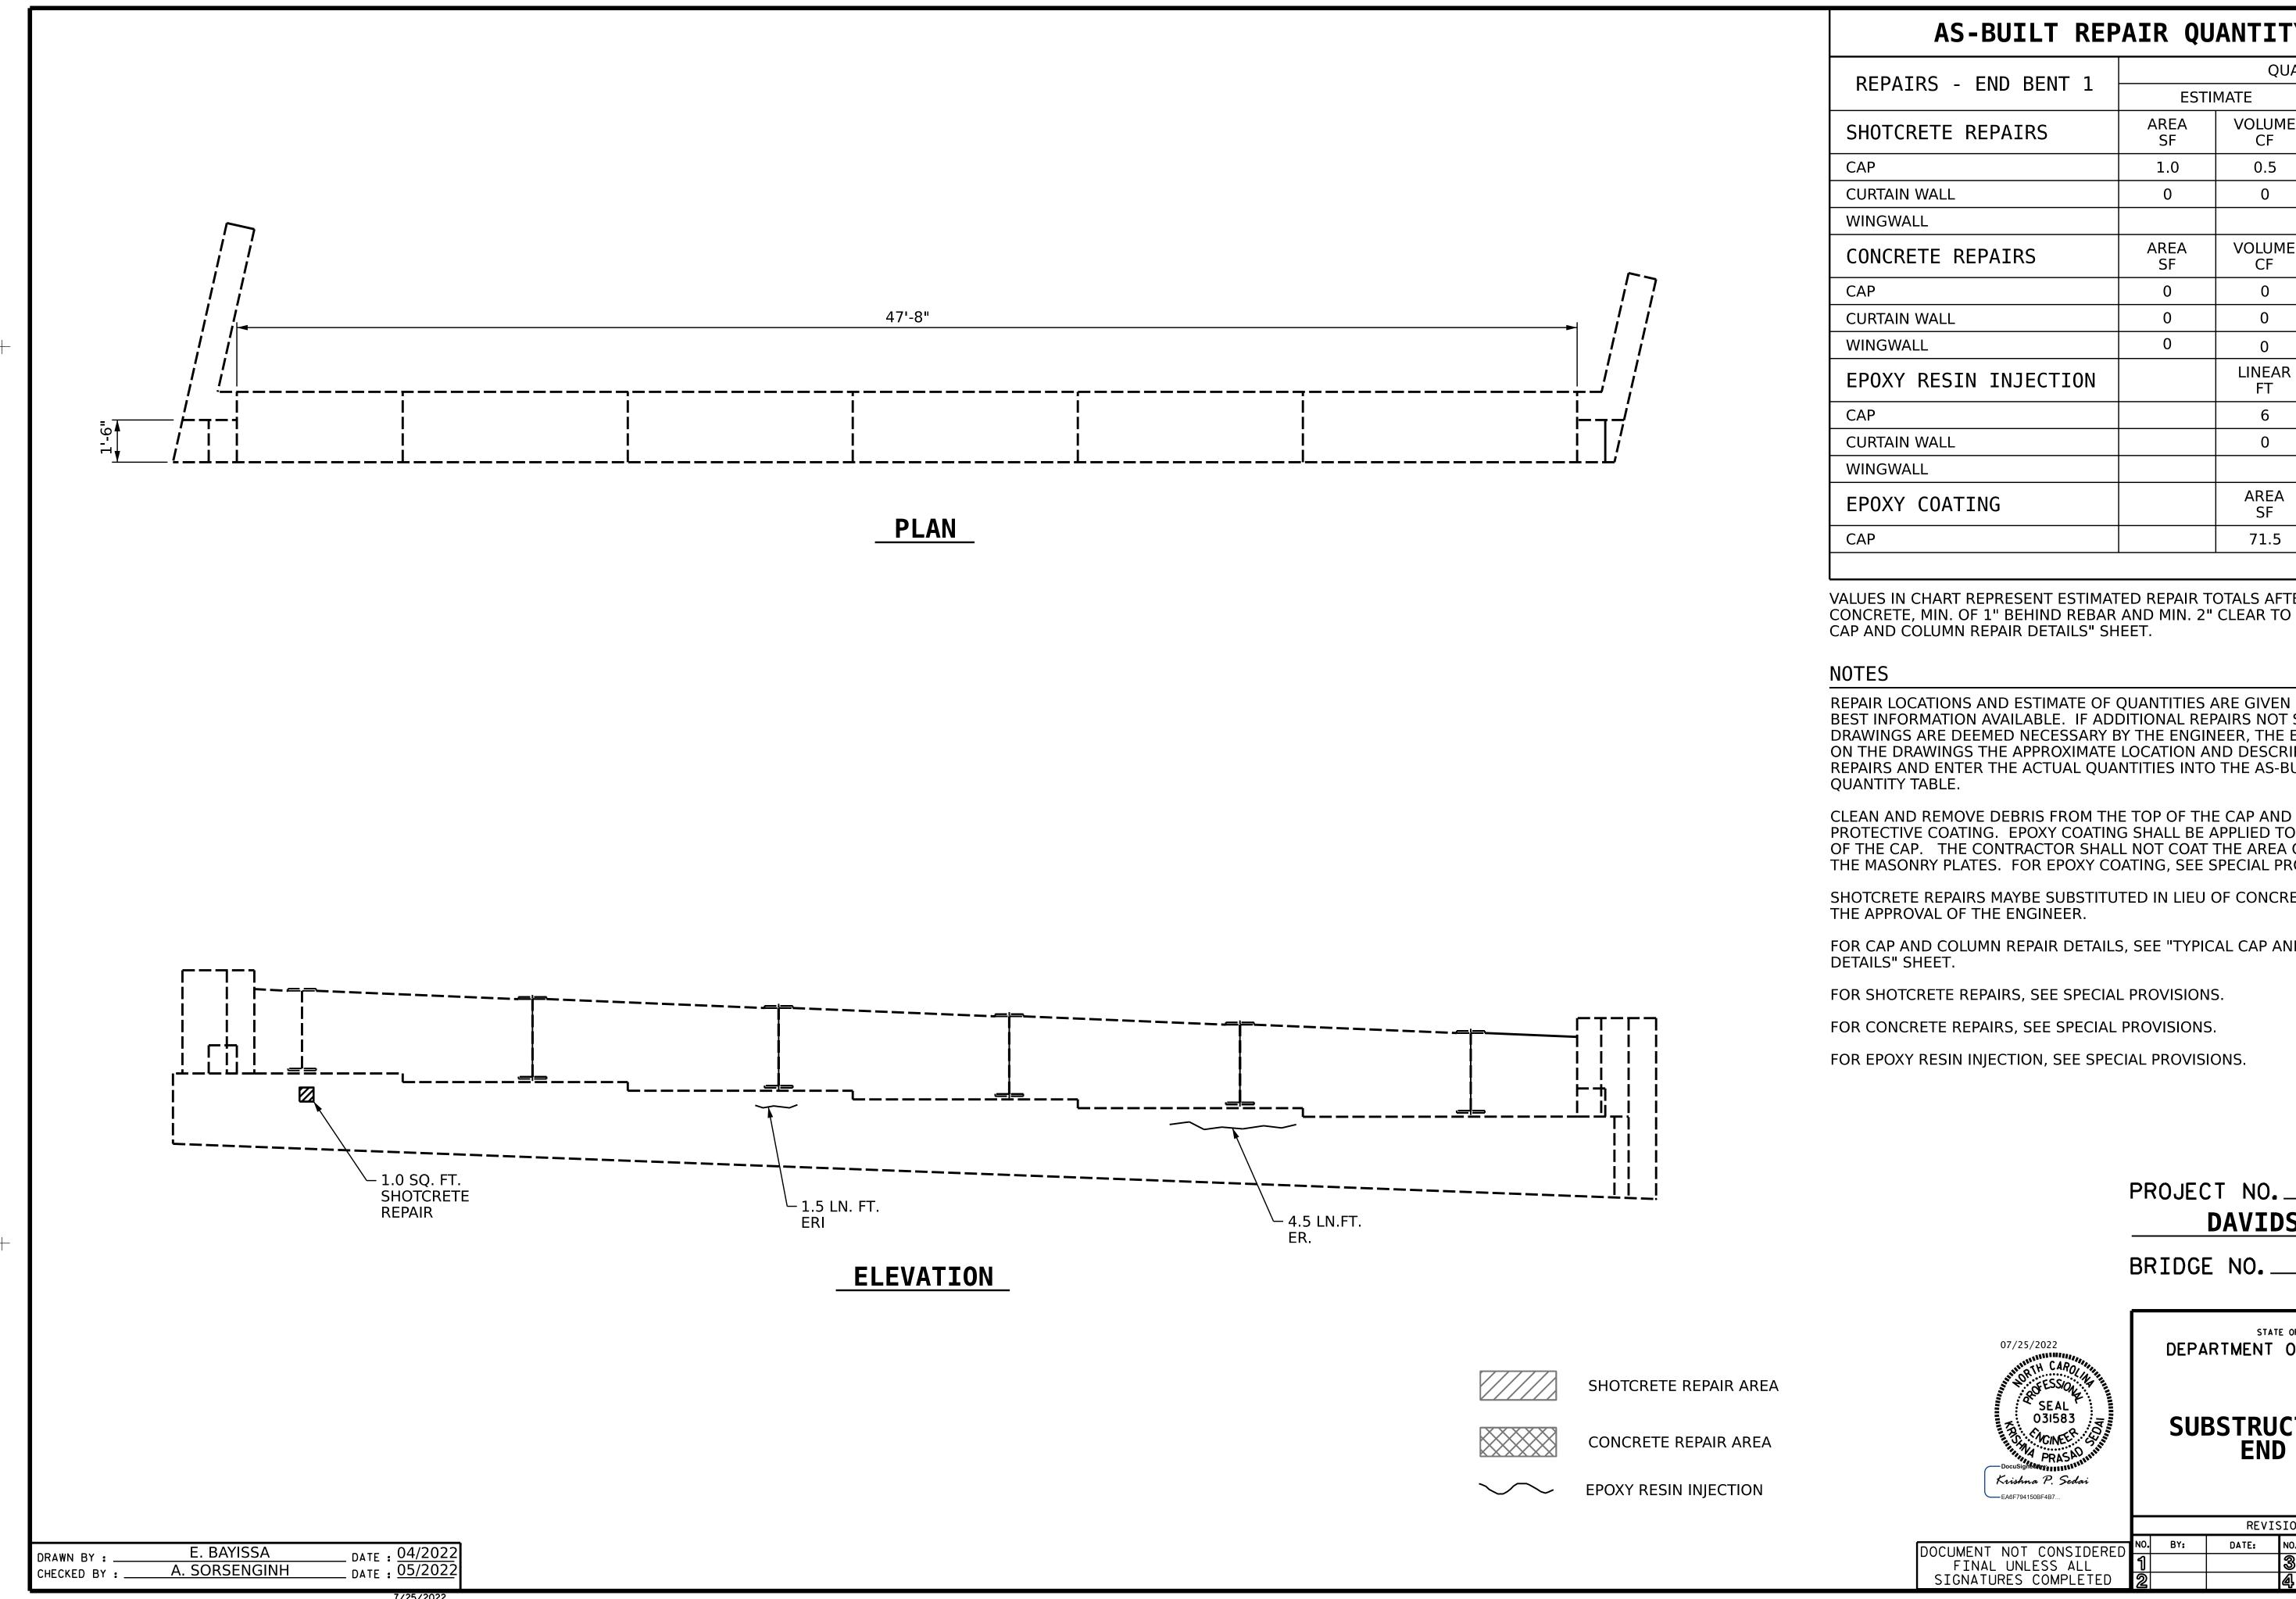
REVISIONS SHEET NO. S3-08 NO. BY: DATE: DATE:

VALUES IN CHART REPRESENT ESTIMATED REPAIR TOTALS AFTER REMOVAL OF UNSOUND CONCRETE, MIN. OF 1" BEHIND REBAR AND MIN. 2" CLEAR TO SAWCUT. SEE "TYPICAL

REPAIR LOCATIONS AND ESTIMATE OF QUANTITIES ARE GIVEN BASED ON THE BEST INFORMATION AVAILABLE. IF ADDITIONAL REPAIRS NOT SHOWN ON THE DRAWINGS ARE DEEMED NECESSARY BY THE ENGINEER, THE ENGINEER SHALL NOTE ON THE DRAWINGS THE APPROXIMATE LOCATION AND DESCRIPTION OF THE REPAIRS AND ENTER THE ACTUAL QUANTITIES INTO THE AS-BUILT REPAIR

CLEAN AND REMOVE DEBRIS FROM THE TOP OF THE CAP AND APPLY EPOXY PROTECTIVE COATING. EPOXY COATING SHALL BE APPLIED TO THE TOP SURFACE OF THE CAP. THE CONTRACTOR SHALL NOT COAT THE AREA OF THE CAP BENEATH THE MASONRY PLATES. FOR EPOXY COATING, SEE SPECIAL PROVISIONS.

SHOTCRETE REPAIRS MAYBE SUBSTITUTED IN LIEU OF CONCRETE REPAIRS WITH

FOR CAP AND COLUMN REPAIR DETAILS, SEE "TYPICAL CAP AND COLUMN REPAIR
