NC DEPARTMENT OF TRANSPORTATION  
 DIVISION OF HIGHWAYS  
 STRUCTURE MANAGEMENT UNIT

ATTENTION: Supplemental Inspection for Left rail in spans 3 and 4 only. Priority Action Request Submitted

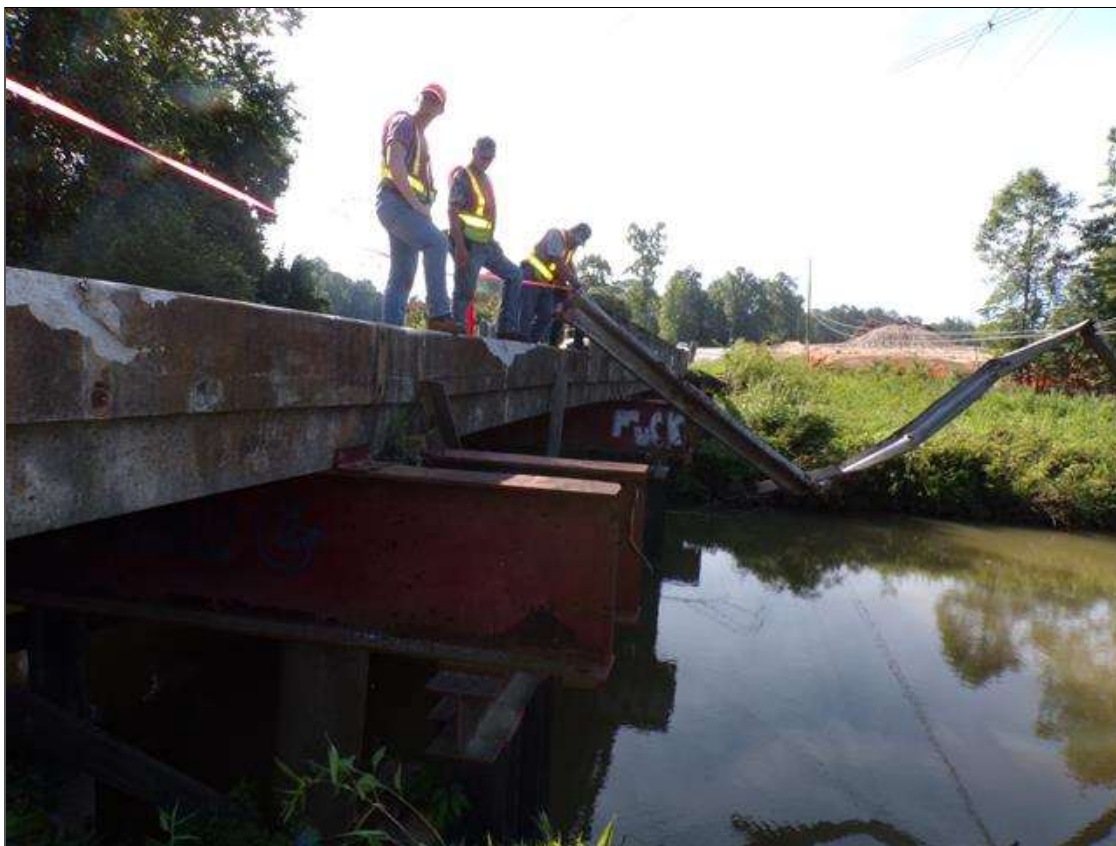
Span 3 Left Bridge Rail: PAR-Left rail in span 3 has impact damage and has completely separated from structure from midspan to bent 3. All post are missing in this area with spalling up to 1foot wide x 4 inches deep at post connections to curbing.

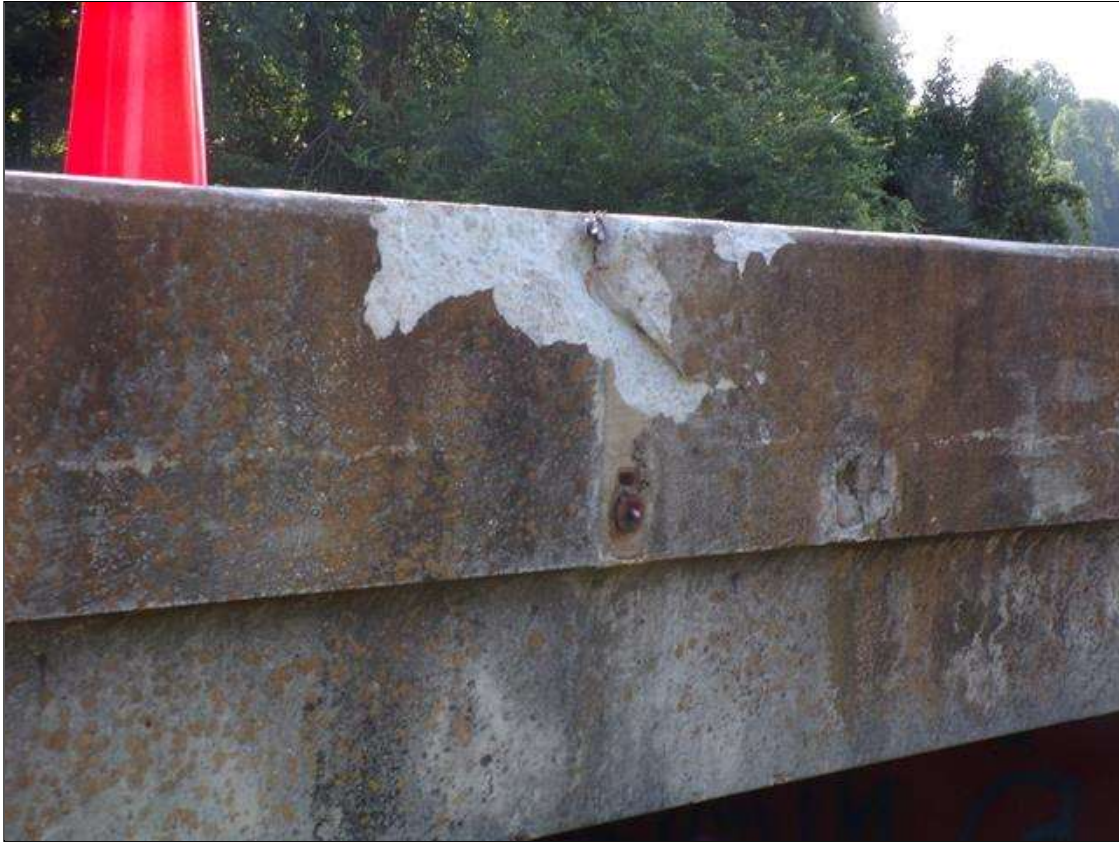
Span 3 Left Bridge Rail: PAR-Left rail in span 3 has impact damage and has completely separated from structure from midspan to bent 3. All post are missing in this area with spalling up to 1foot wide x 4 inches deep at post connections to curbing.

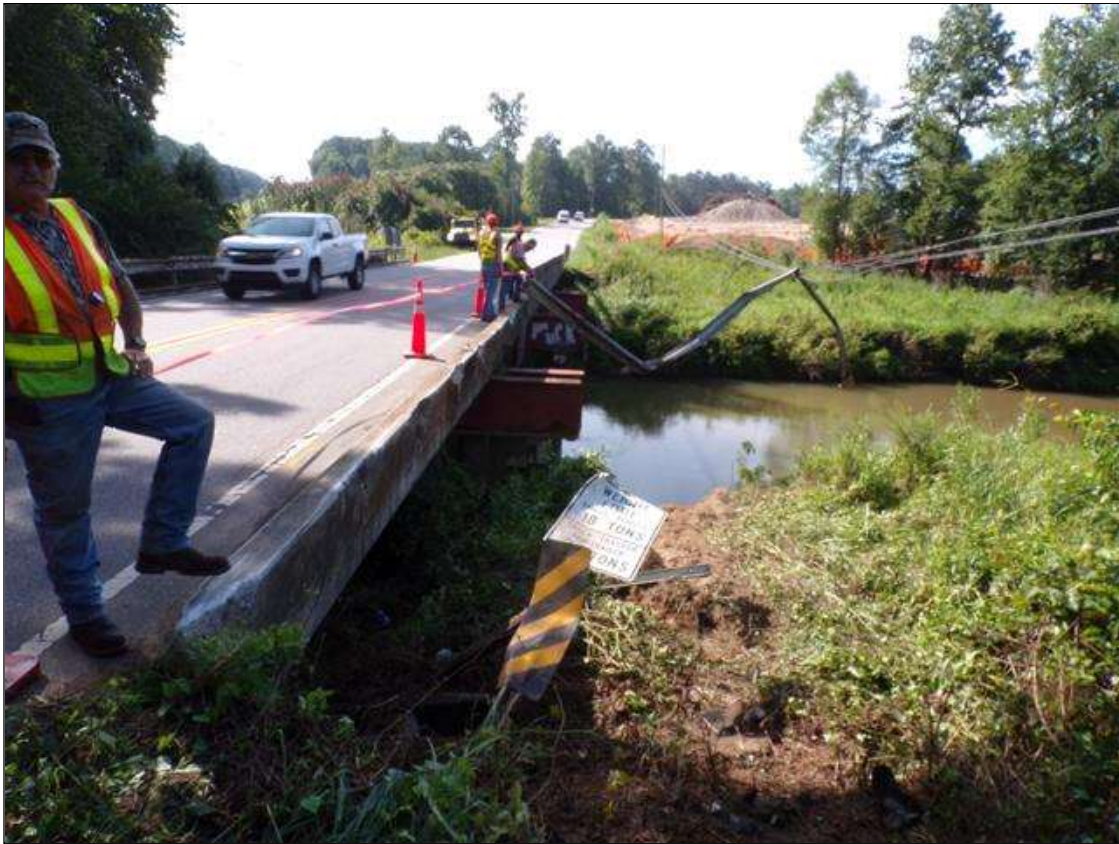
Span 4 Left Bridge Rail: PAR-Left rail in span 4 has impact damage and has completely separated from structure along length. All post are missing with spalling up to 1 foot wide x 4 inches deep at post connections to curbing.

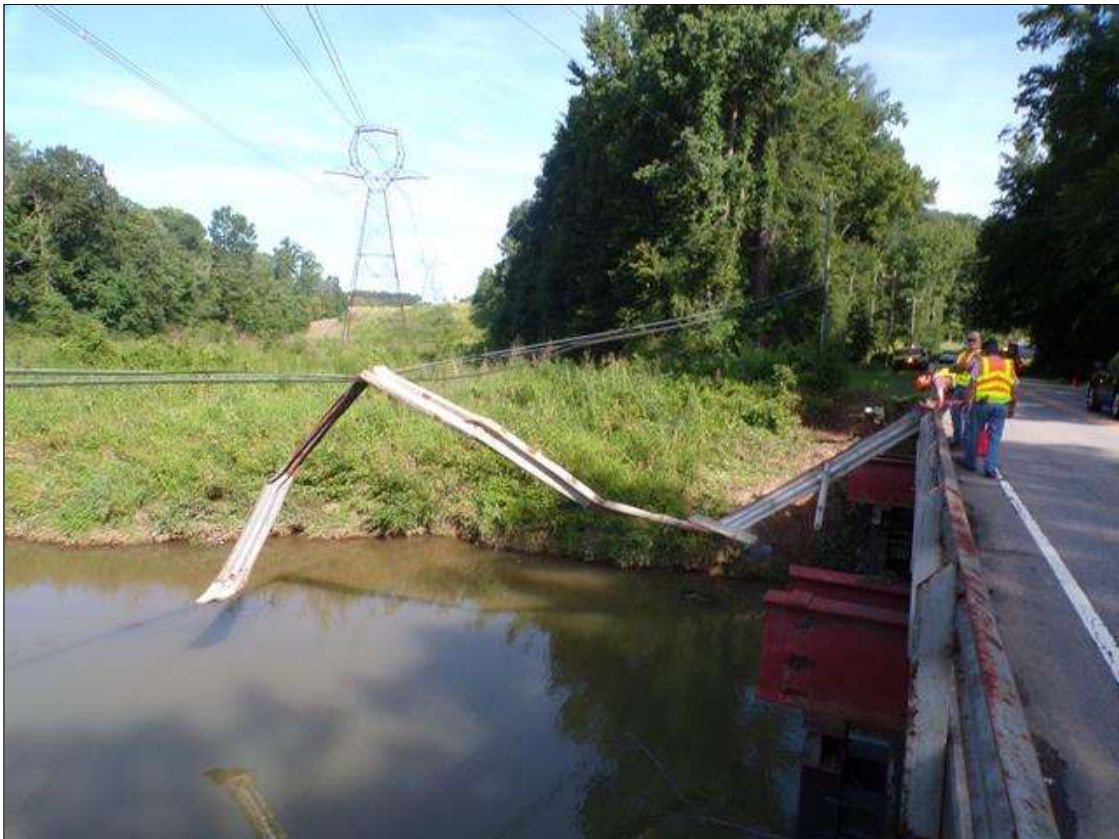
Span 4 Left Bridge Rail: PAR-Left rail in span 4 has impact damage and has completely separated from structure along length. All post are missing with spalling up to 1 foot wide x 4 inches deep at post connections to curbing.

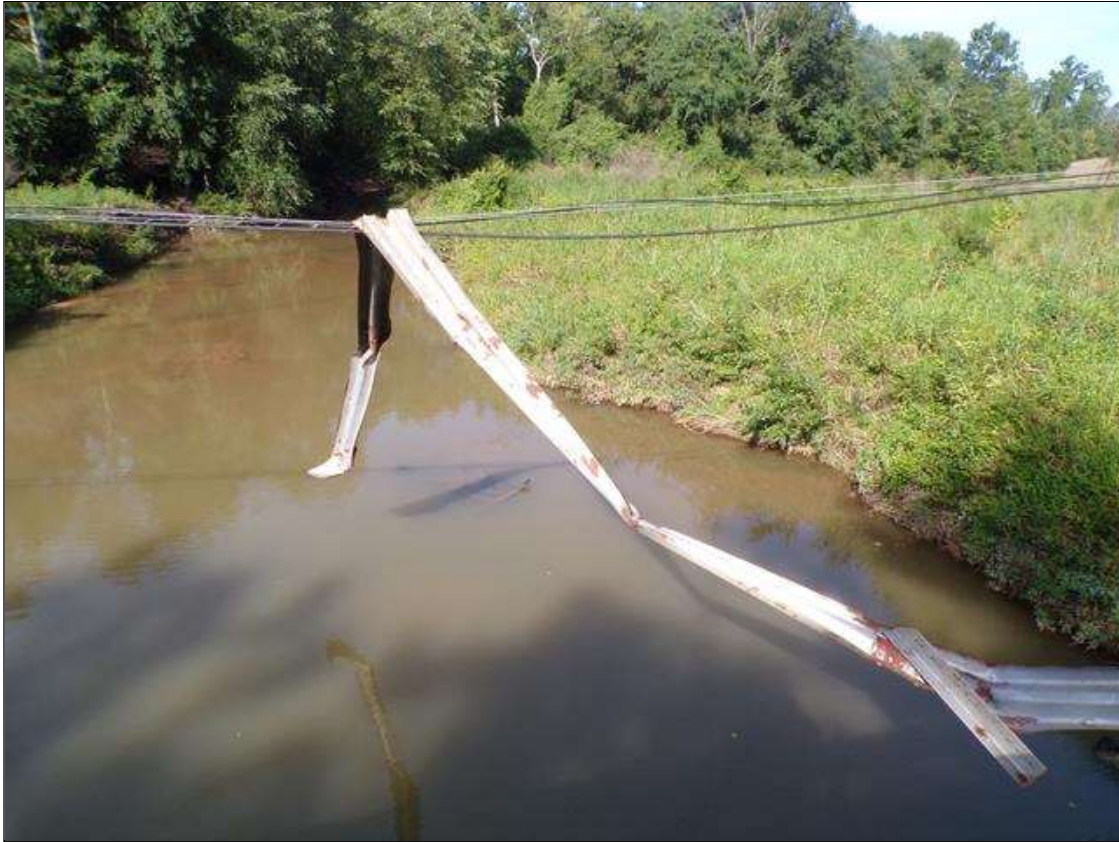
Span 4 Left Bridge Rail: PAR-Left rail in span 4 has impact damage and has completely separated from structure along length. All post are missing with spalling up to 1 foot wide x 4 inches deep at post connections to curbing.

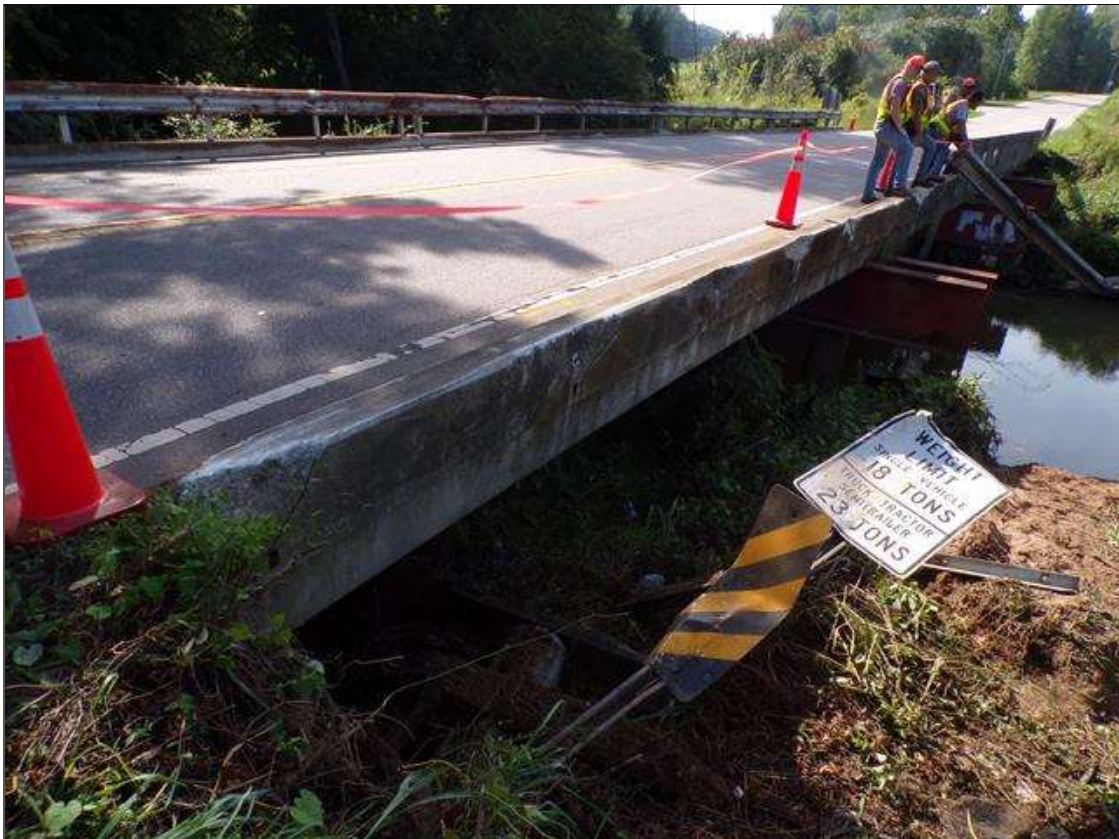
Span 4 Left Bridge Rail: PAR-Left rail in span 4 has impact damage and has completely separated from structure along length. All post are missing with spalling up to 1 foot wide x 4 inches deep at post connections to curbing.

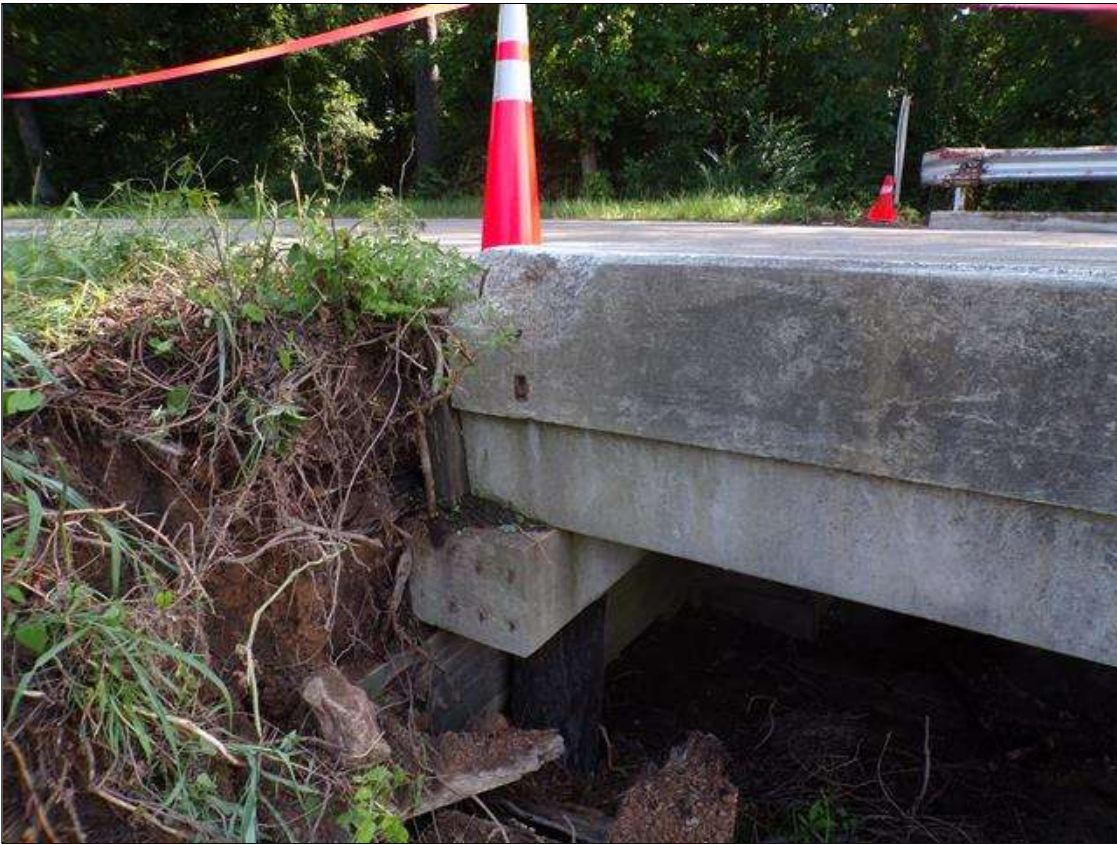
Span 4 Left Bridge Rail: PAR-Left rail in span 4 has impact damage and has completely separated from structure along length. All post are missing with spalling up to 1 foot wide x 4 inches deep at post connections to curbing.

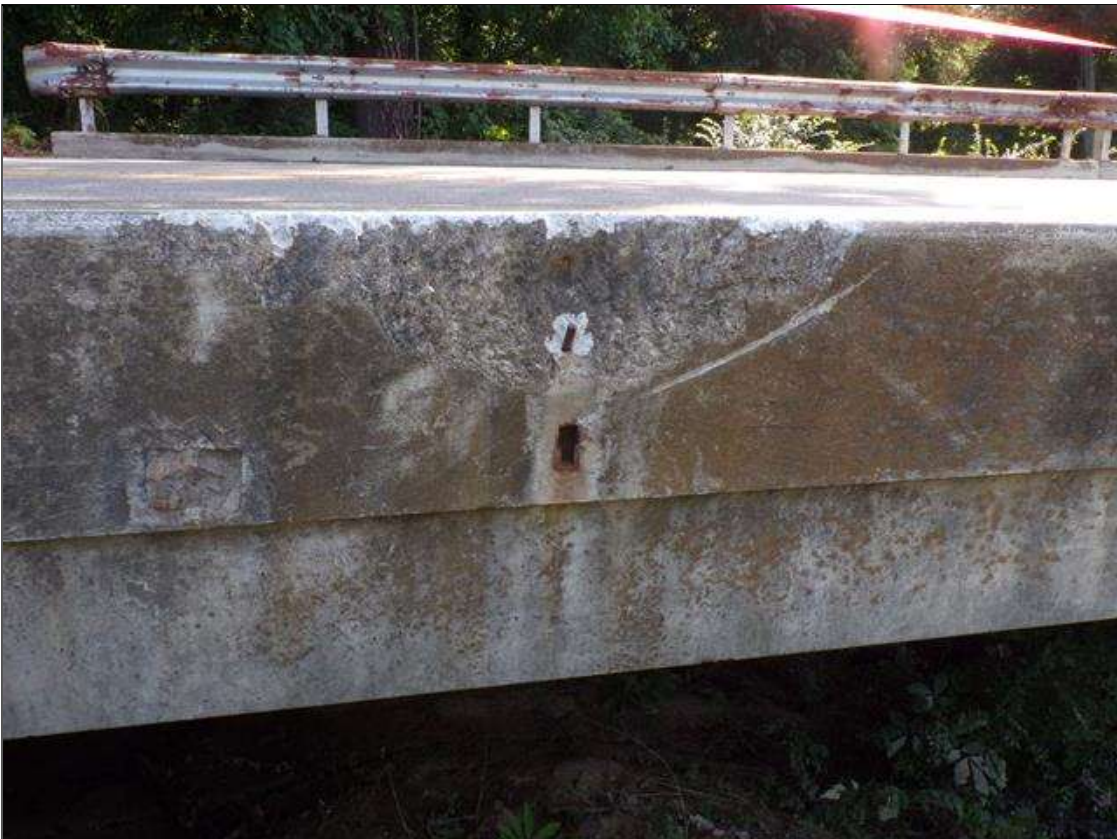
Span 4 Left Bridge Rail: PAR-Left rail in span 4 has impact damage and has completely separated from structure along length. All post are missing with spalling up to 1 foot wide x 4 inches deep at post connections to curbing.

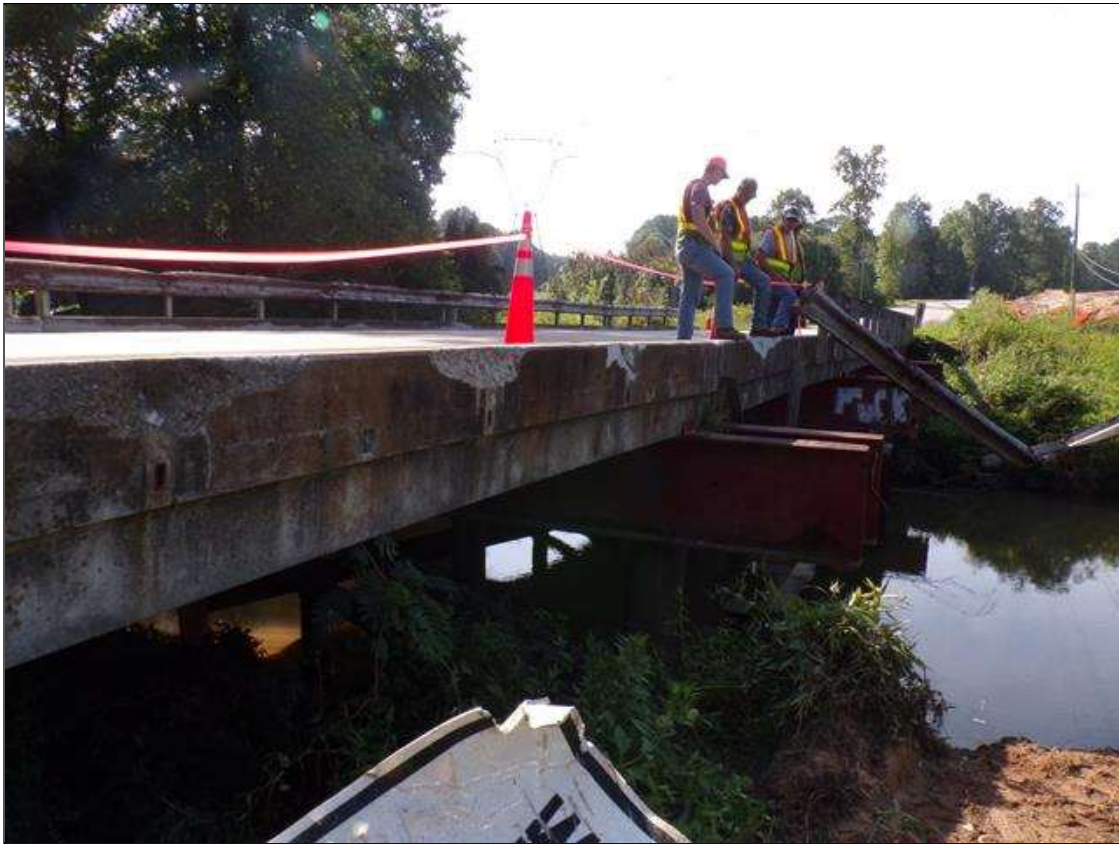
Span 4 Left Bridge Rail: PAR-Left rail in span 4 has impact damage and has completely separated from structure along length. All post are missing with spalling up to 1 foot wide x 4 inches deep at post connections to curbing.

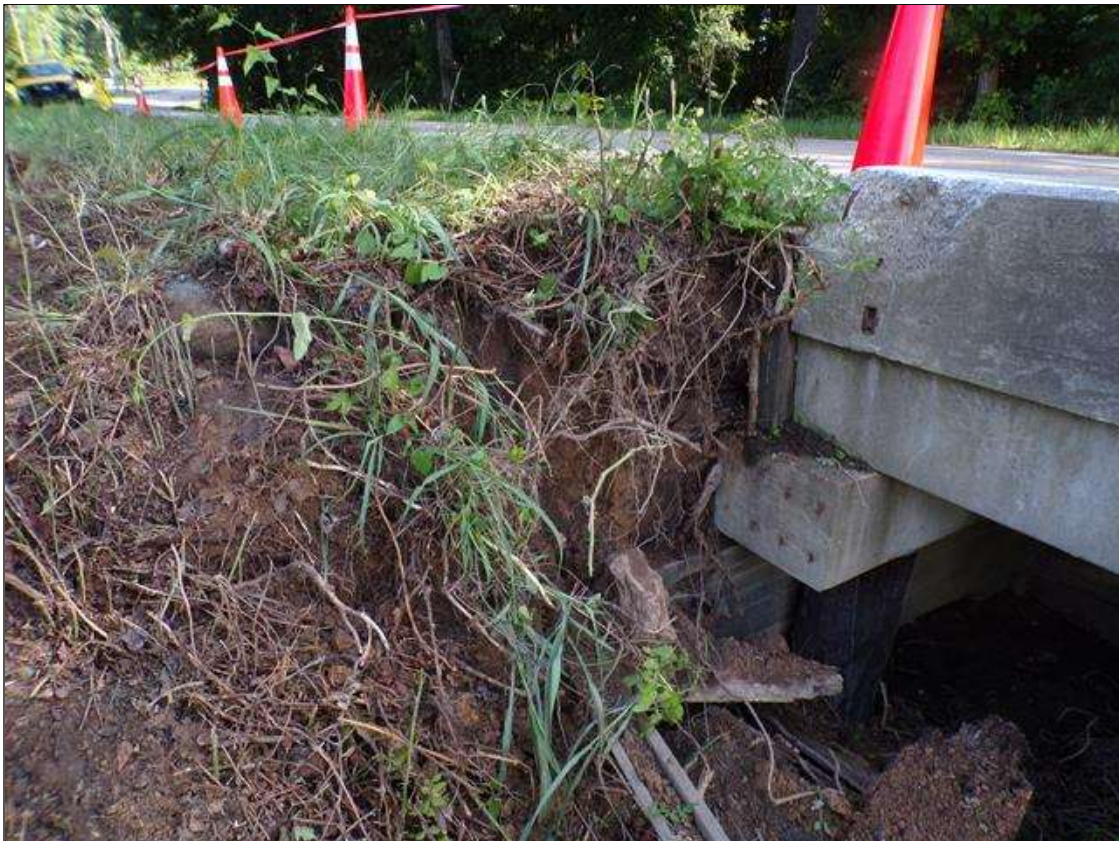
End Bent 2 Abutment: PAR- End Bent 2 bulkhead is broken and missing in a 5 foot long area at left end due to impact damage.

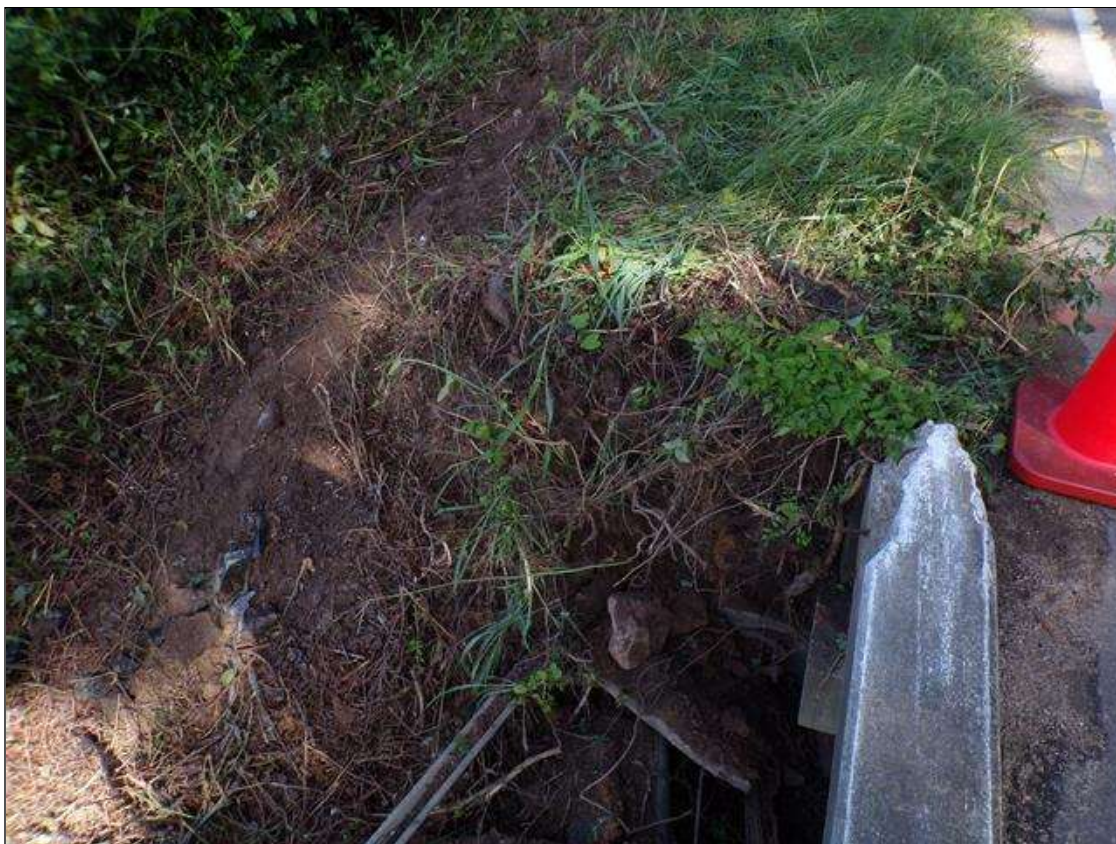
End Bent 2 Abutment: PAR- End Bent 2 bulkhead is broken and missing in a 5 foot long area at left end due to impact damage.

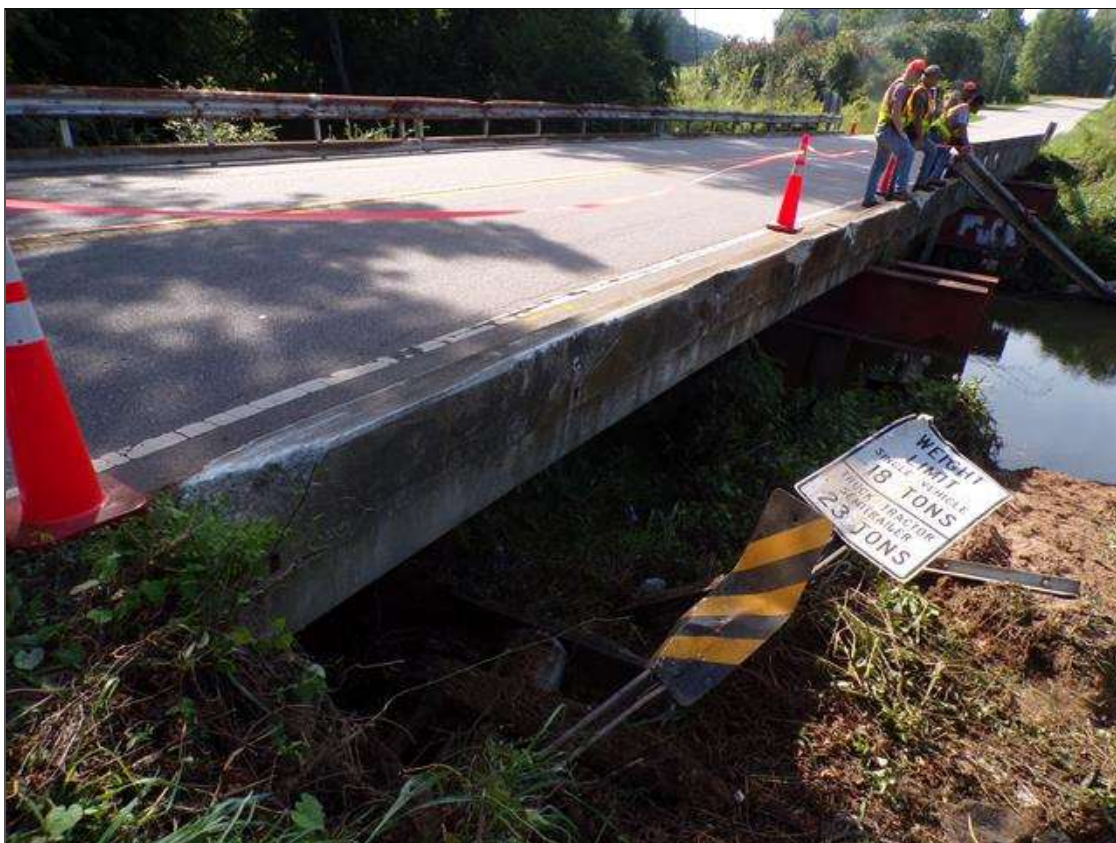
PAR-Posting sign SV 18 TTST 23 and Delineator missing from right shoulder at north approach.
