NC DEPARTMENT OF TRANSPORTATION
 DIVISION OF HIGHWAYS
 STRUCTURE MANAGEMENT UNIT

Structure Safety Report

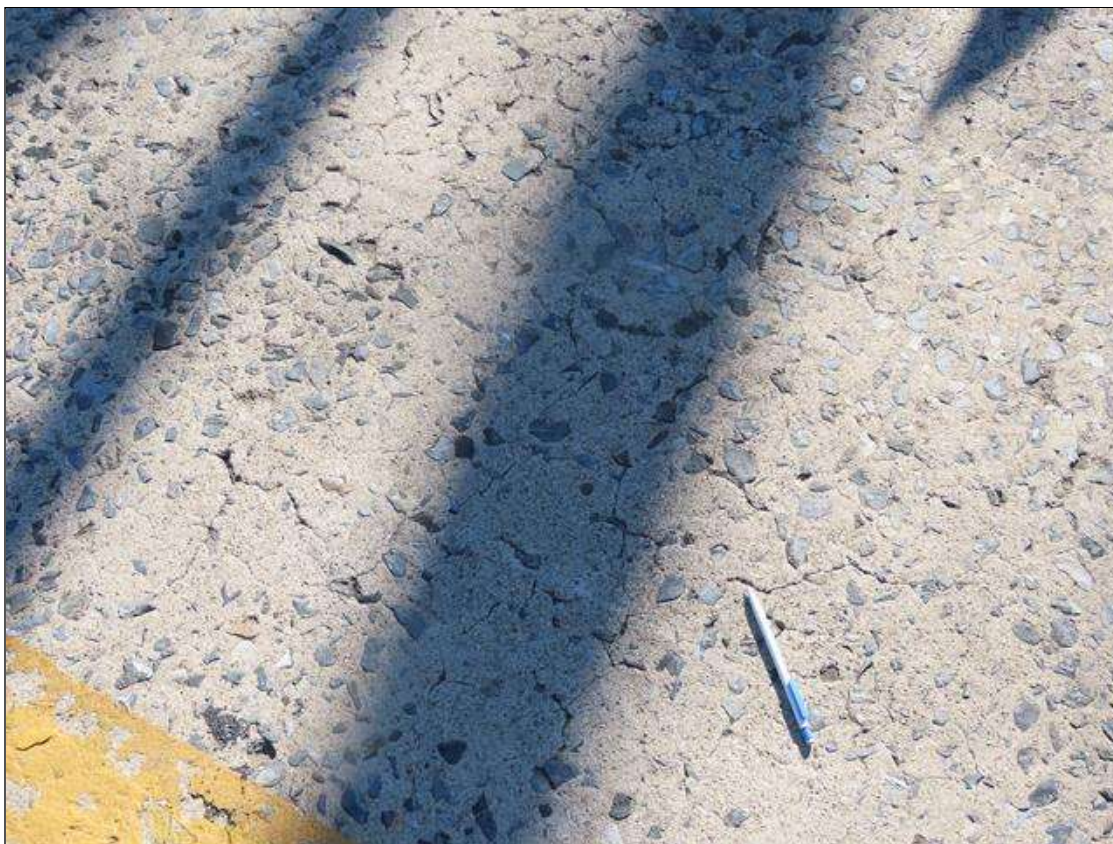
TYPICAL 1/32IN MAP CRACKING & MODERATE TO HEAVY WEAR WITH EXPOSED AGGREGATE THROUGHOUT SPAN 1 RIGHT LANE

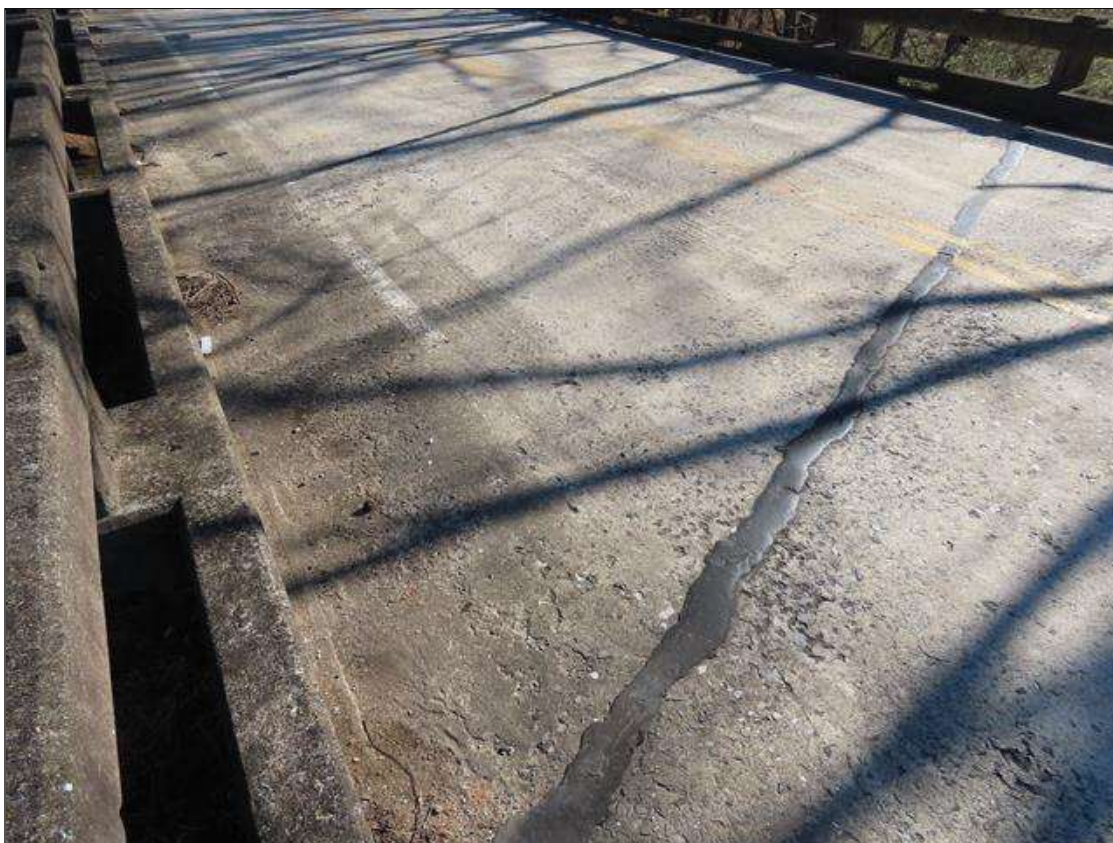
TYPICAL TRANSVERSE SEALED CRACKING (FULL W.) THROUGHOUT TOP OF DECK, SPAN 1 LOOKING AHEAD

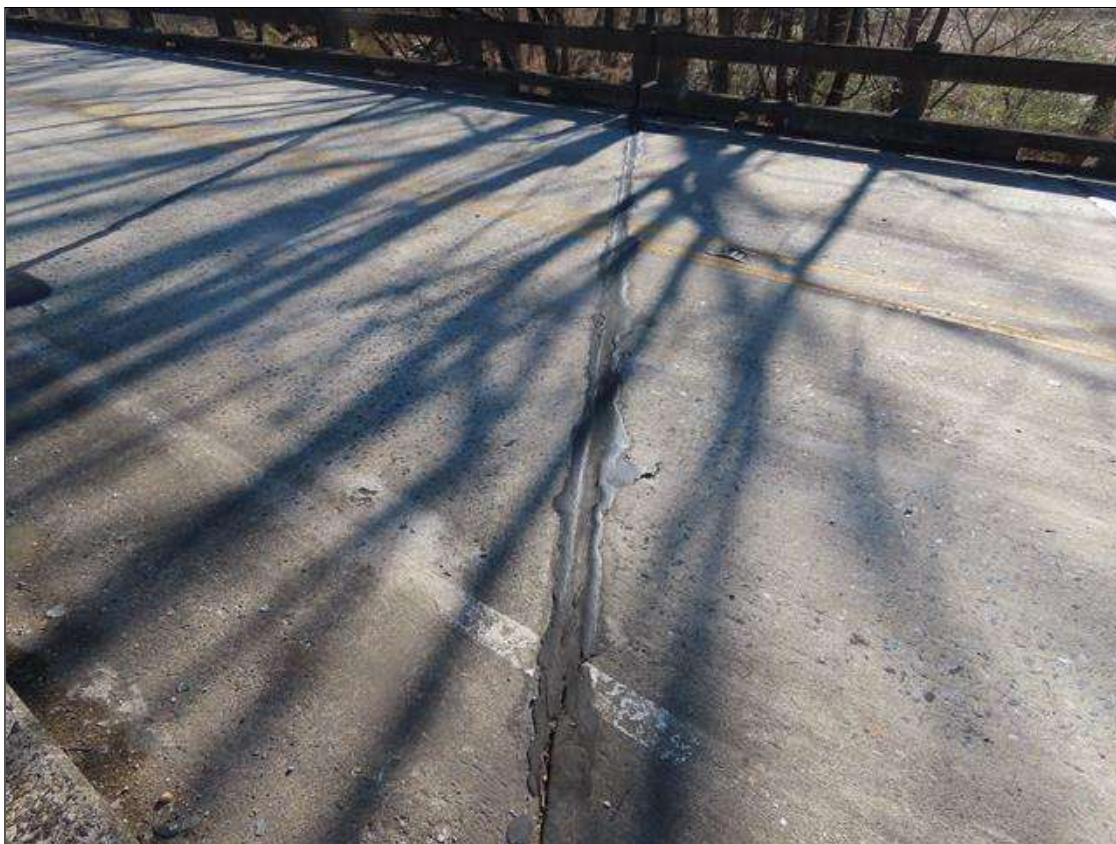
JOINT OVER BENT 1 - INTERMITTENT CRACKING (UP TO 1/4IN W.) THROUGHOUT SEAL

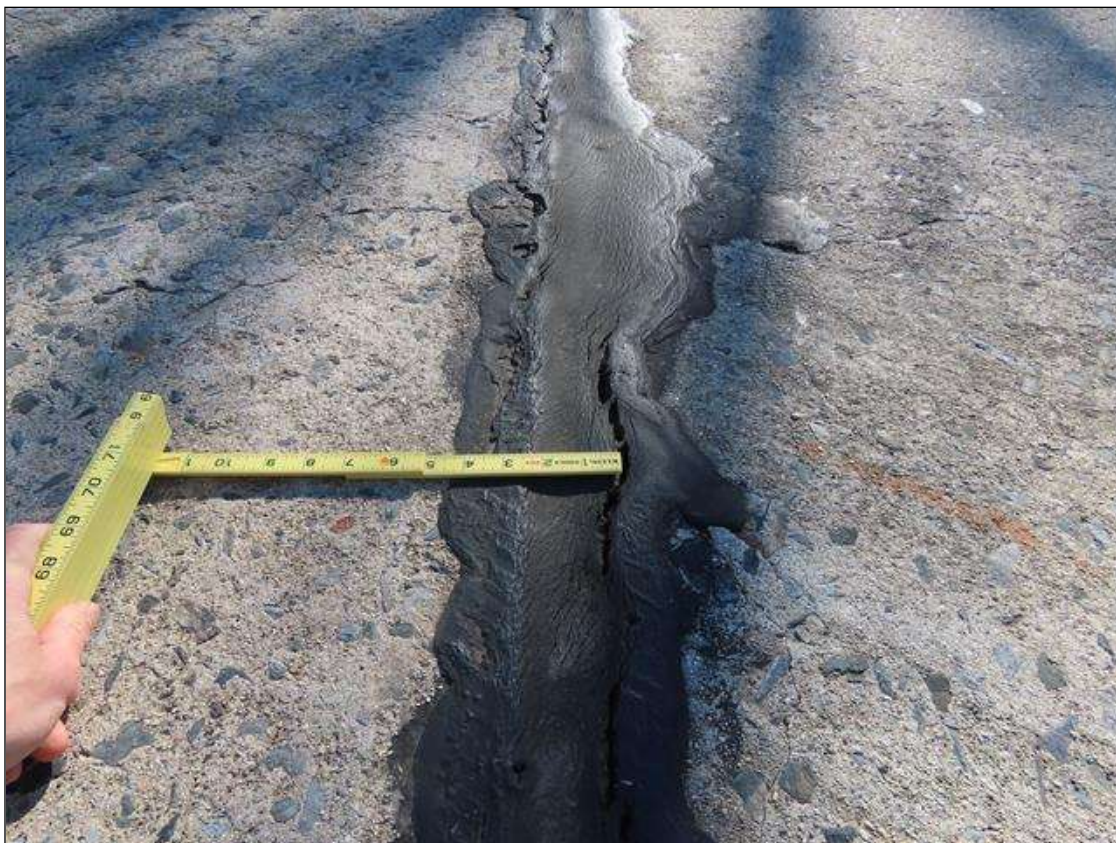
TYPICAL AREA OF CRACKING (UP TO 1/4IN W.) THROUGHOUT SEAL, JOINT OVER BENT 1 LEFT LANE

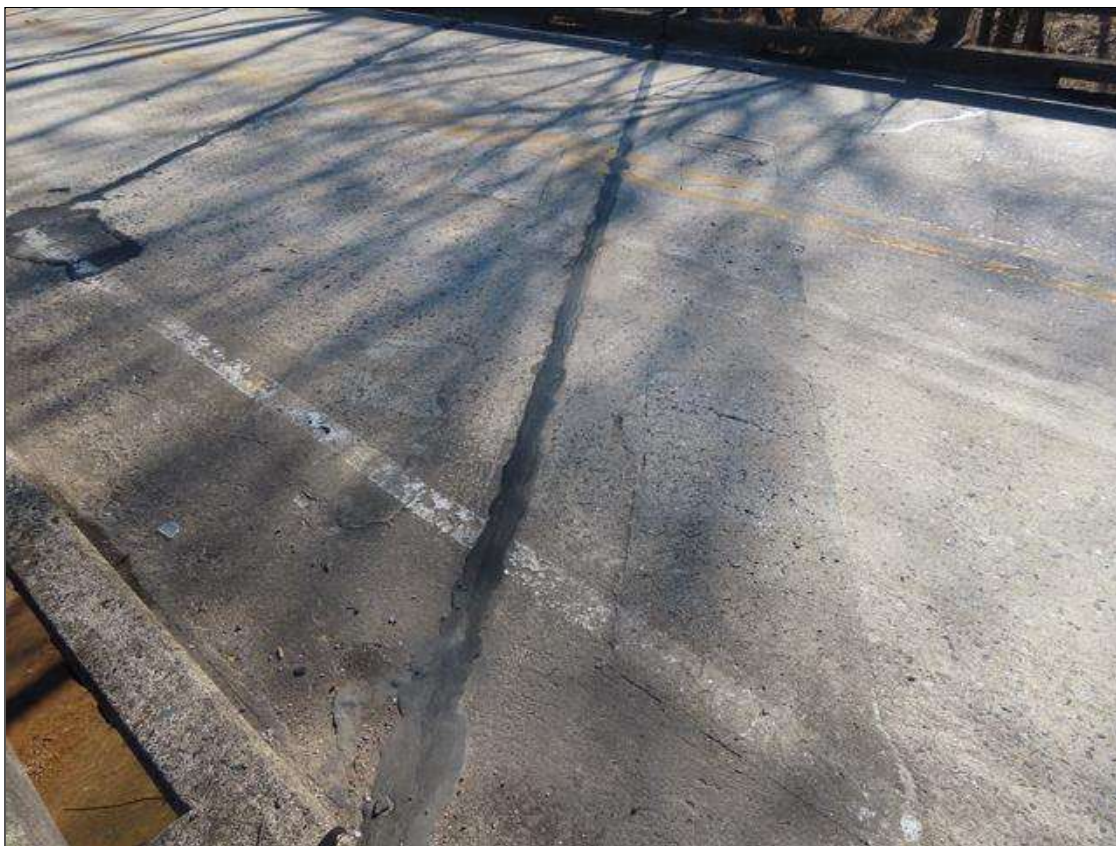
TYPICAL SOUND PATCHING (UP TO 5FT L. X 2FT W.) WITH HAIRLINE MAP CRACKING THROUGHOUT ENDS OF DECK ADJACENT TO JOINT OVER BENT 2

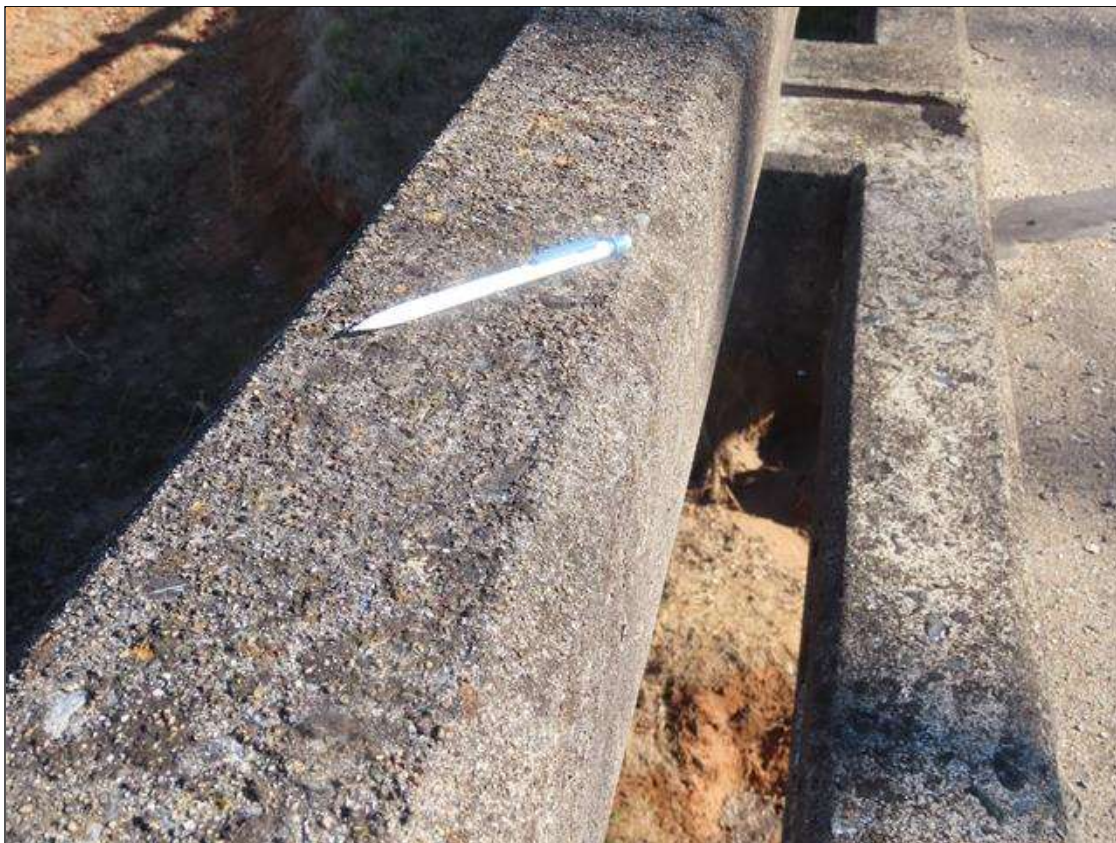
TYPICAL MINOR TO MODERATE WEAR WITH EXPOSED AGGREGATE THROUGHOUT RAILS, SPAN 3 LEFT SIDE

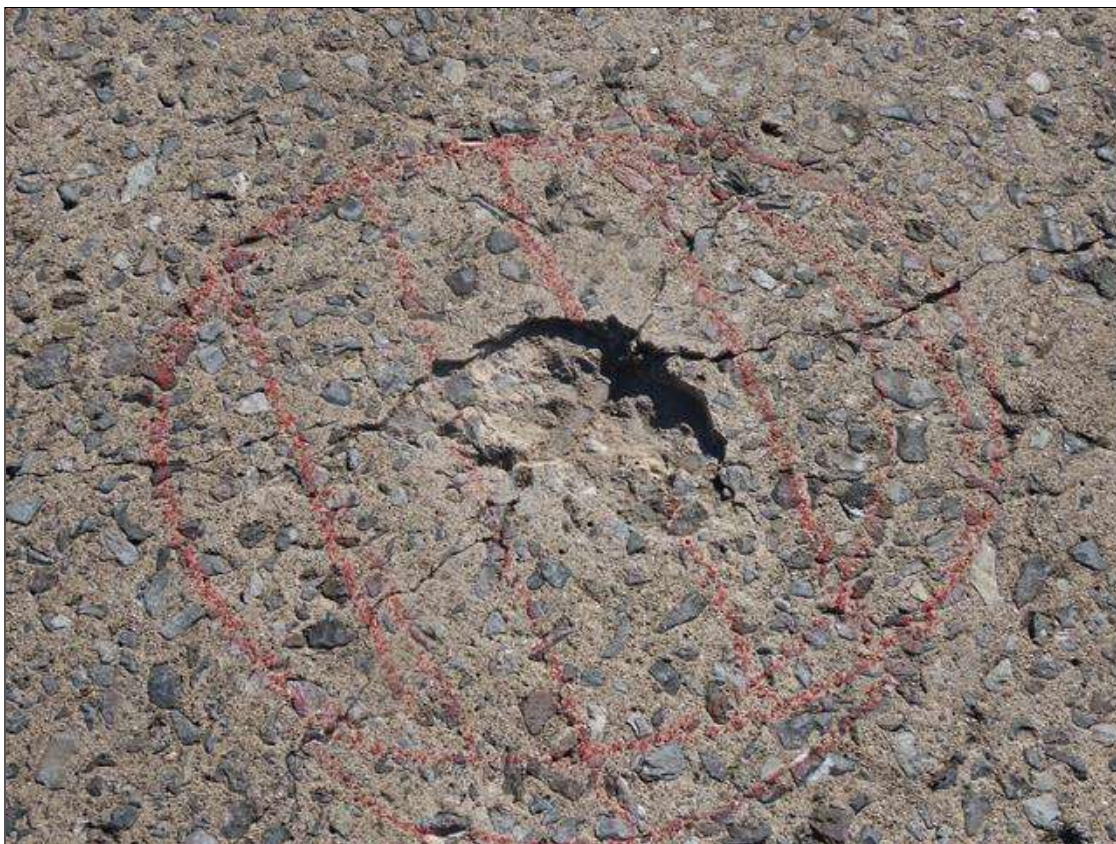
SPAN 5 DECK - SPALL/DELAM (2SF X 1/2IN D.) WITH EXPOSED REBAR IN LEFT LANE 18IN FROM NEAR END. (PAR)

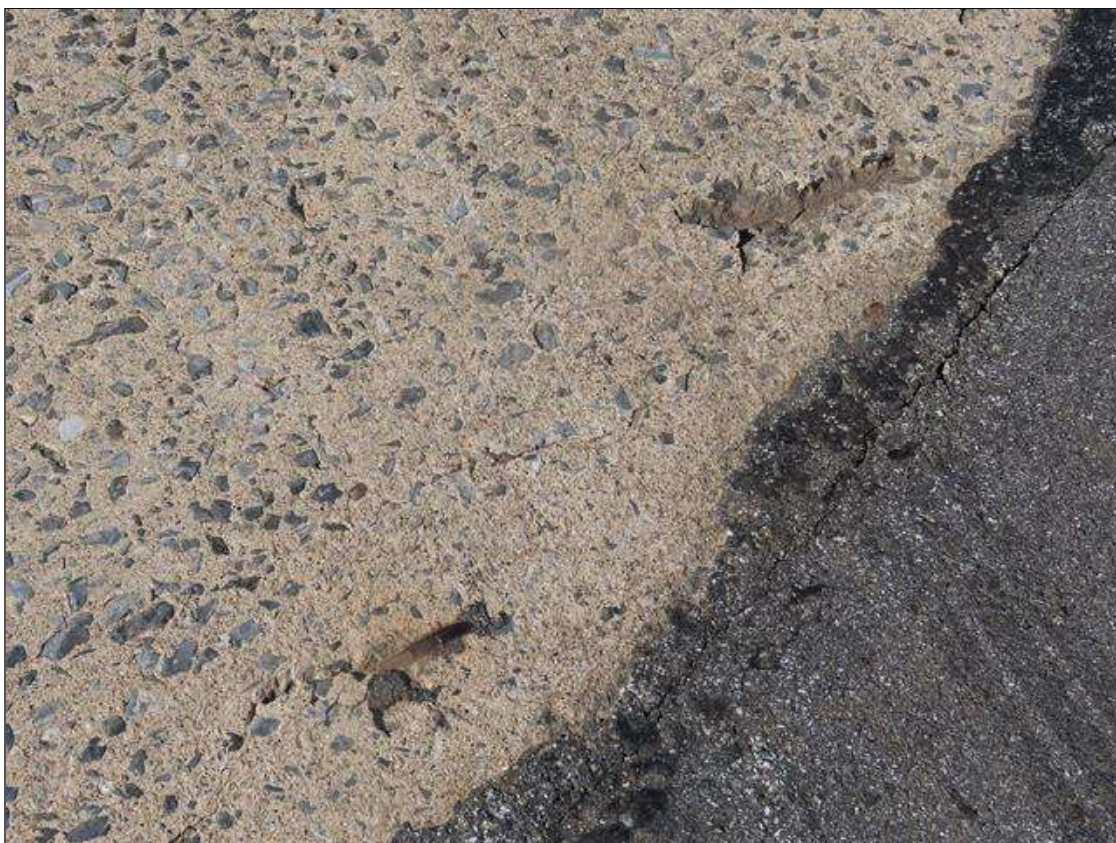
TYPICAL INTERMITTENT SPALLING/DELAM (UP TO 12IN L. X 5IN W. X 1/2IN D.) WITH EXPOSED REBAR TO TOP OF DECK THROUGHOUT FAR END, RIGHT LANE SHOWN. (PAR)

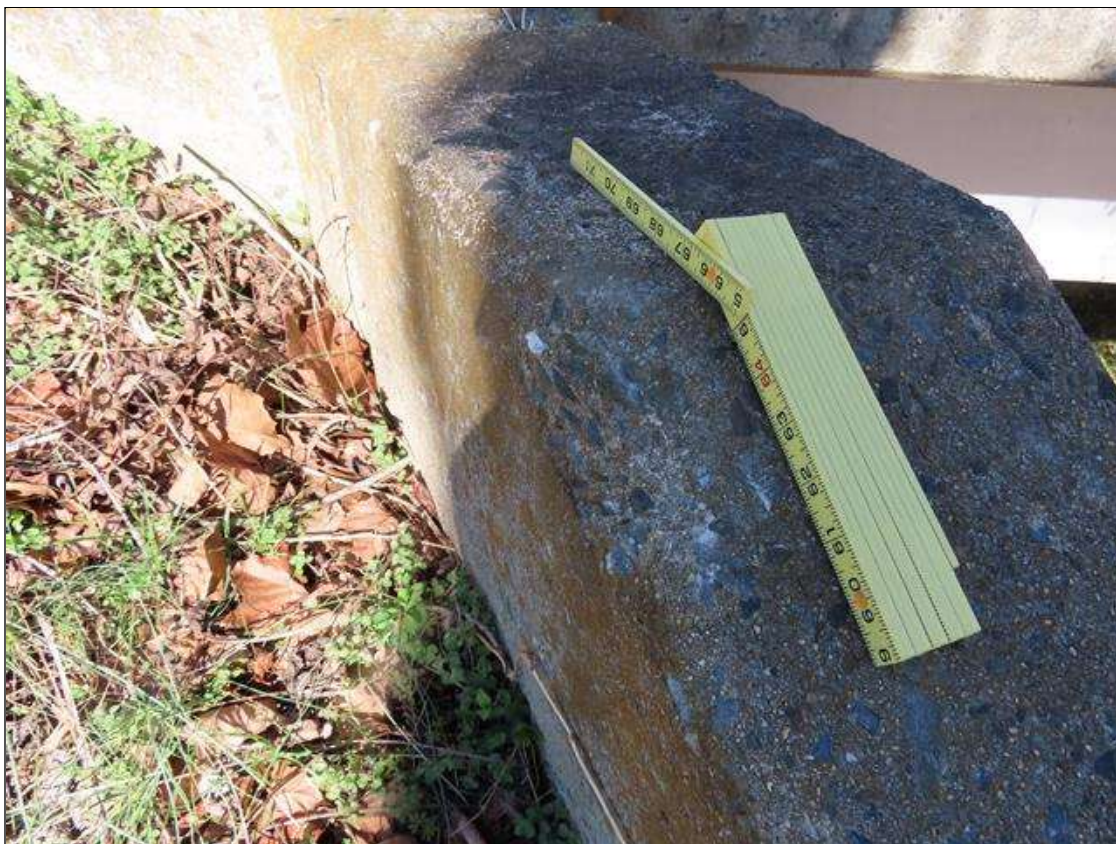
NEAR RIGHT (SW) WINGWALL - SPALL (5IN L. X 4IN W. X 1/2IN D.) TO NEAR SIDE AT TOP

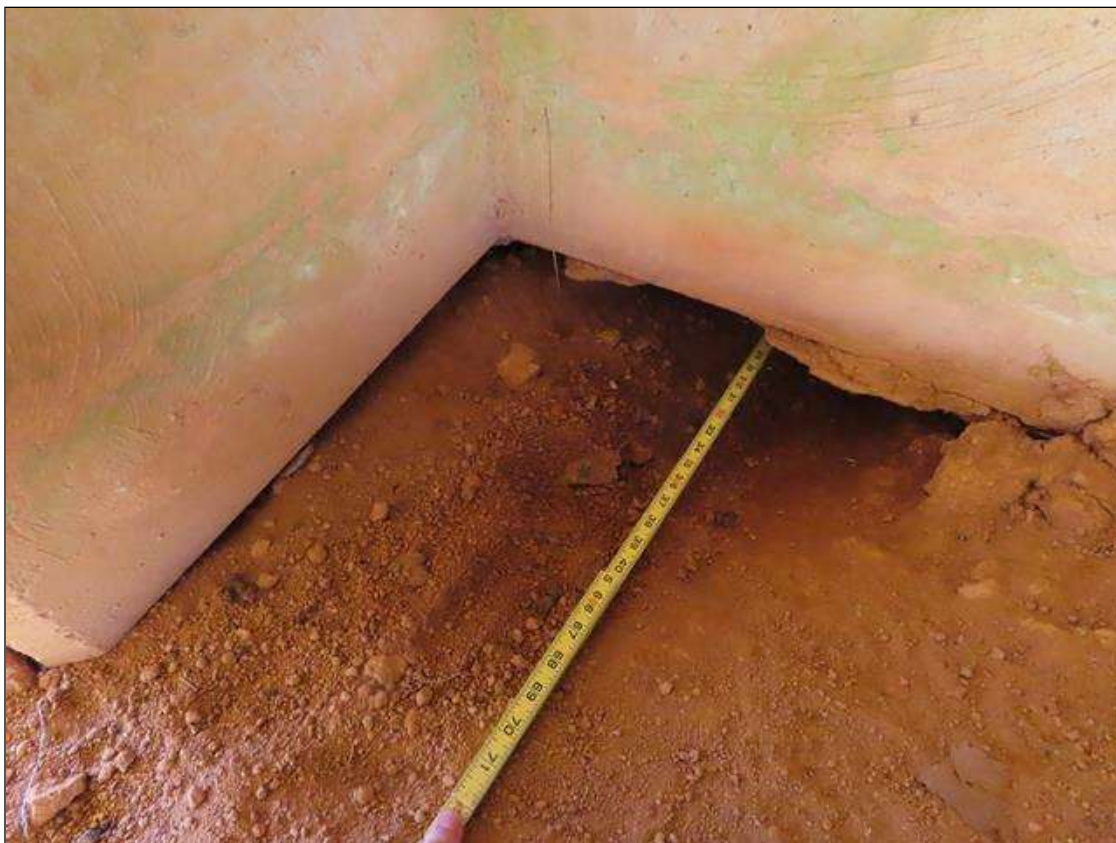
END BENT 1 CAP - EROSION UNDER CAP (2FT L. X 30IN D.) BELOW BAY 3. (PAR)

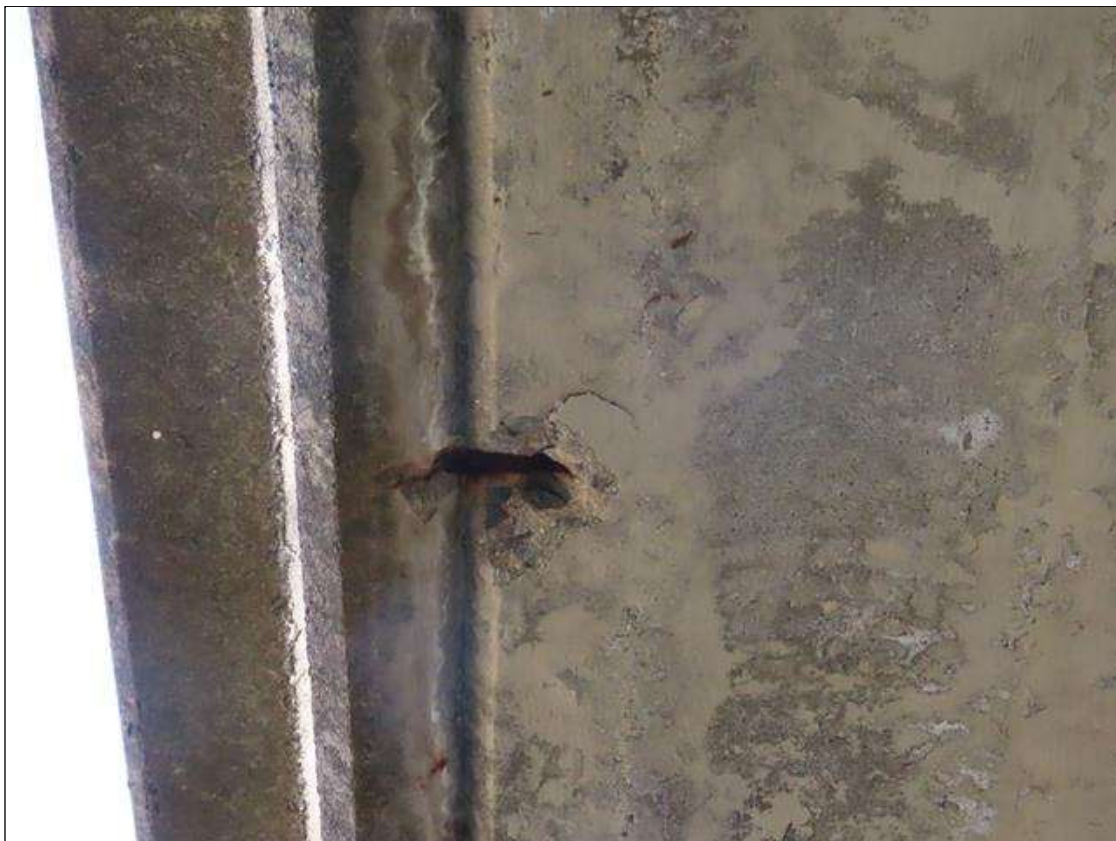
SPAN 1 DECK - SPALL (4IN DIAM. X 1/2IN D.) WITH EXPOSED REBAR TO BOTTOM OF LEFT OVERHANG AT MID-SPAN

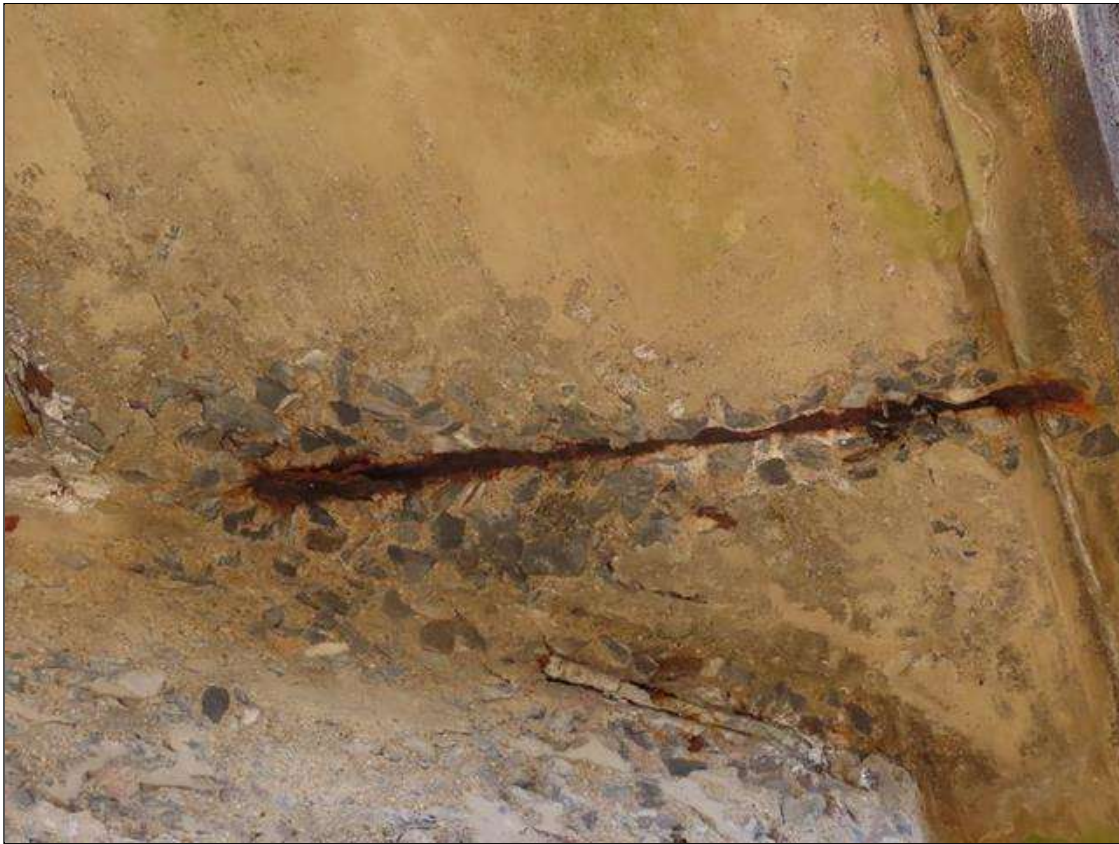
SPAN 1 DECK - SPALLING (18IN L. X 6IN W. X 1IN D.) WITH EXPOSED & CORRODED (1/16IN SL) REBAR TO BOTTOM OF RIGHT SIDE OVERHANG AT FAR END. (PAR)

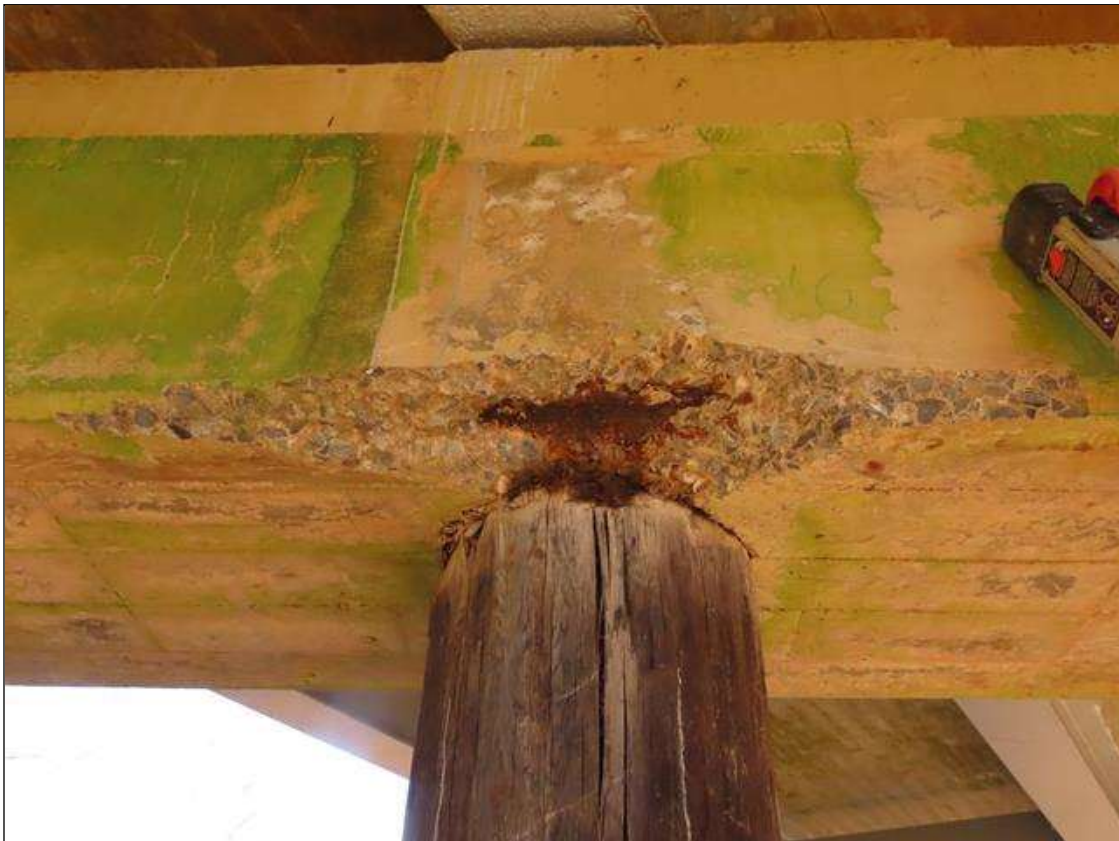
BENT 1 CAP - SPALL (30IN L. X 8IN W. X 2.5IN D.) WITH EXPOSED & CORRODED (1/16IN SL) REBAR TO NEAR SIDE OVER PILE 3. (PAR)

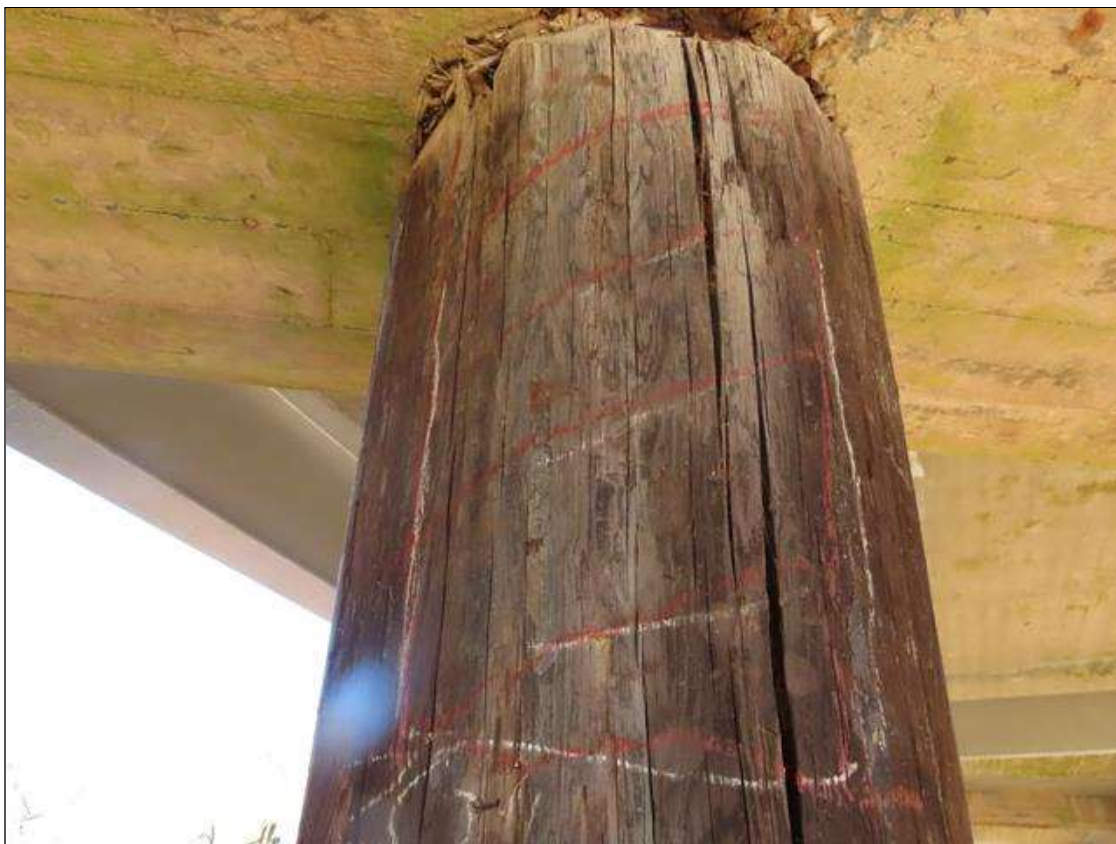
BENT 1 PILE 3 - DELAM/HOLLOW WHEN SOUNDED (20IN L. X 8IN W.) TO NEAR SIDE AT TOP. (PAR)

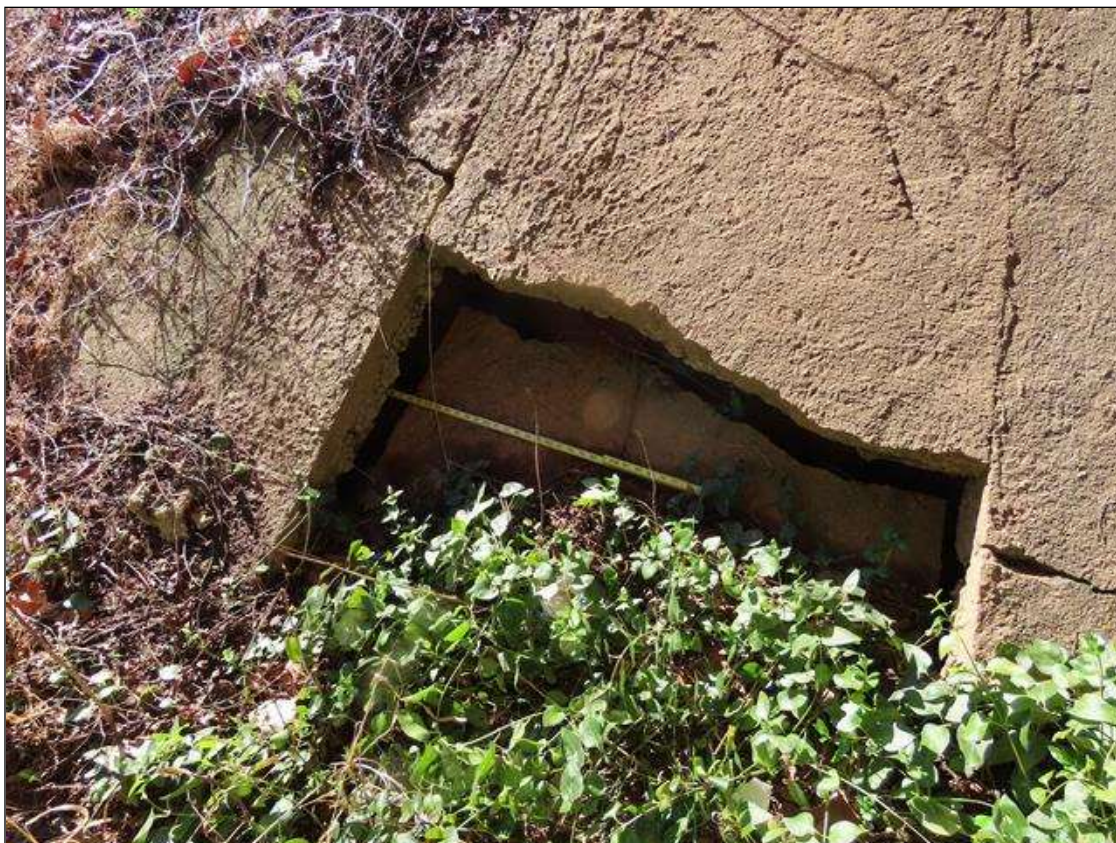
END BENT 1 SLOPE PROTECTION - SPALLED/BROKEN AREA (3FT L. X 3FT W.) WITH EROSION (UP TO 2FT D.) UNDER CONCRETE SLOPE PROTECTION AROUND BROKEN AREA, BELOW BAY 4. (PAR)

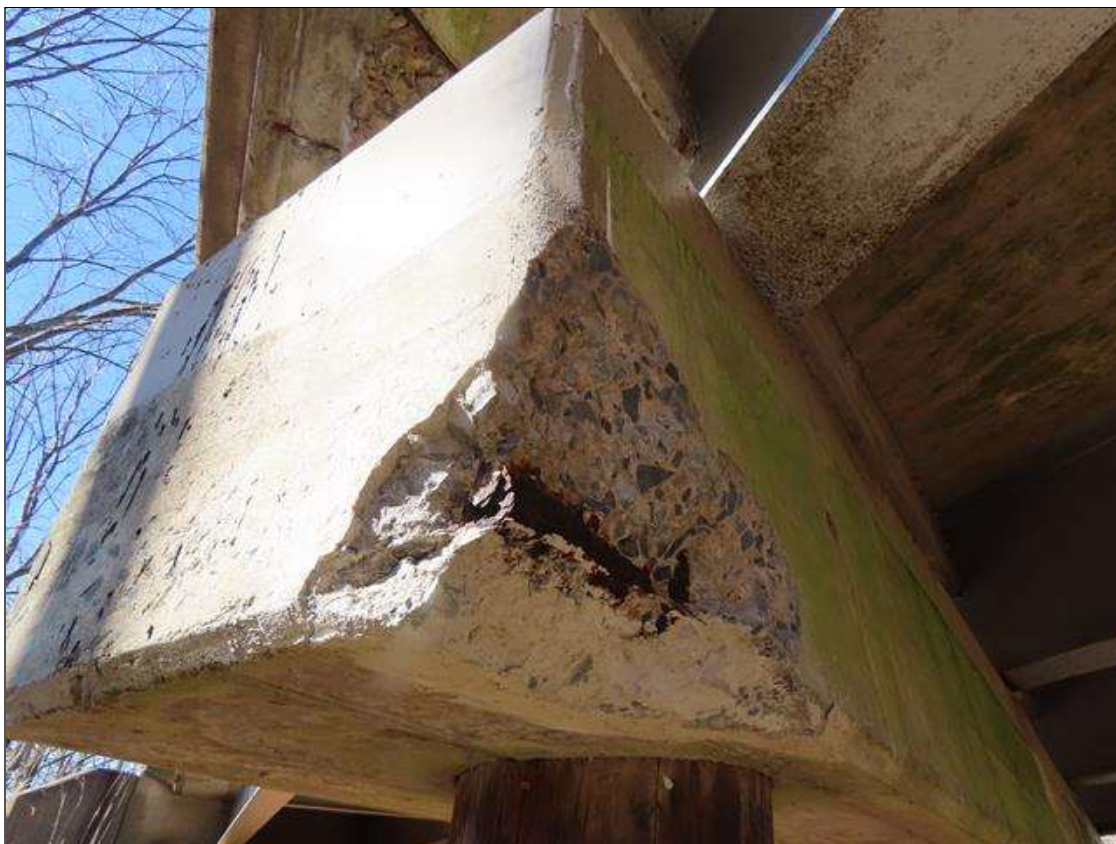
BENT 1 CAP - SPALLED PATCH (16IN L. X 12IN W. X 2.5IN D.) WITH EXPOSED & CORRODED (1/16IN SL) REBAR TO FAR RIGHT CORNER AT BOTTOM. (PAR)

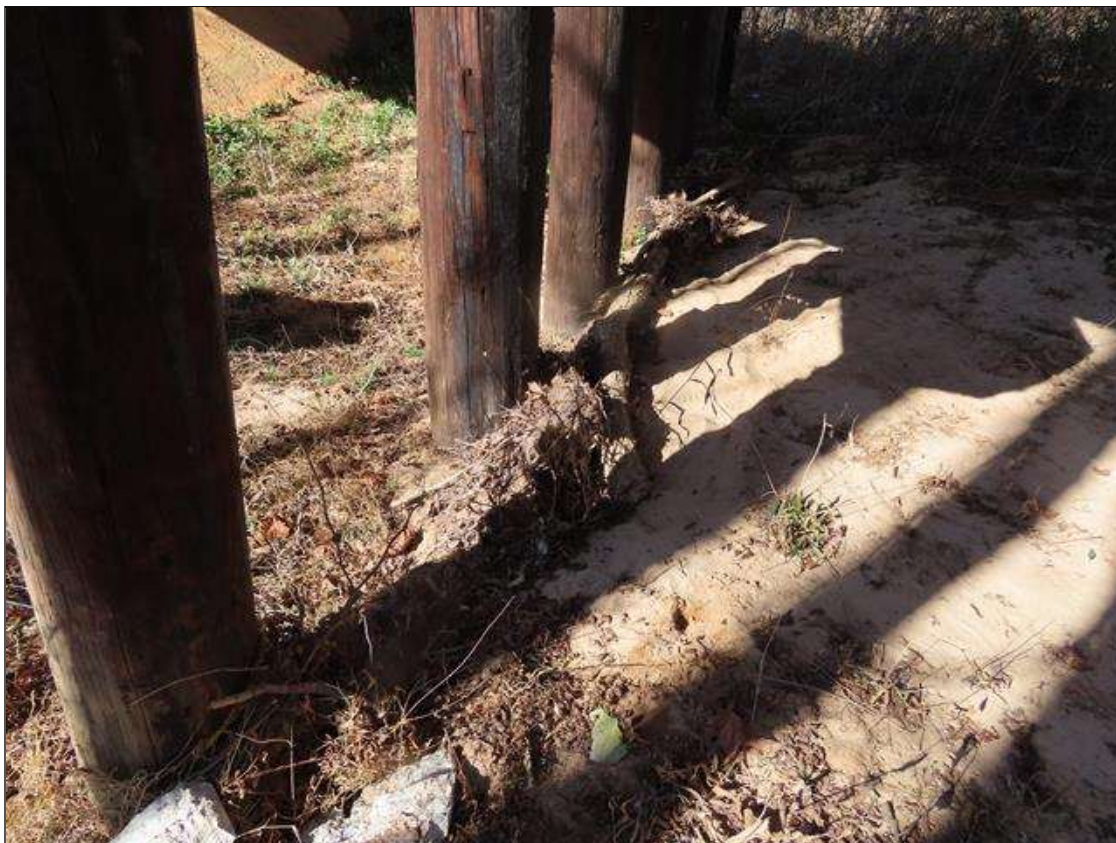
DRIFT (20FT L. X 2FT DIAM.) AT FAR SIDE OF BENT 1 AT GROUND

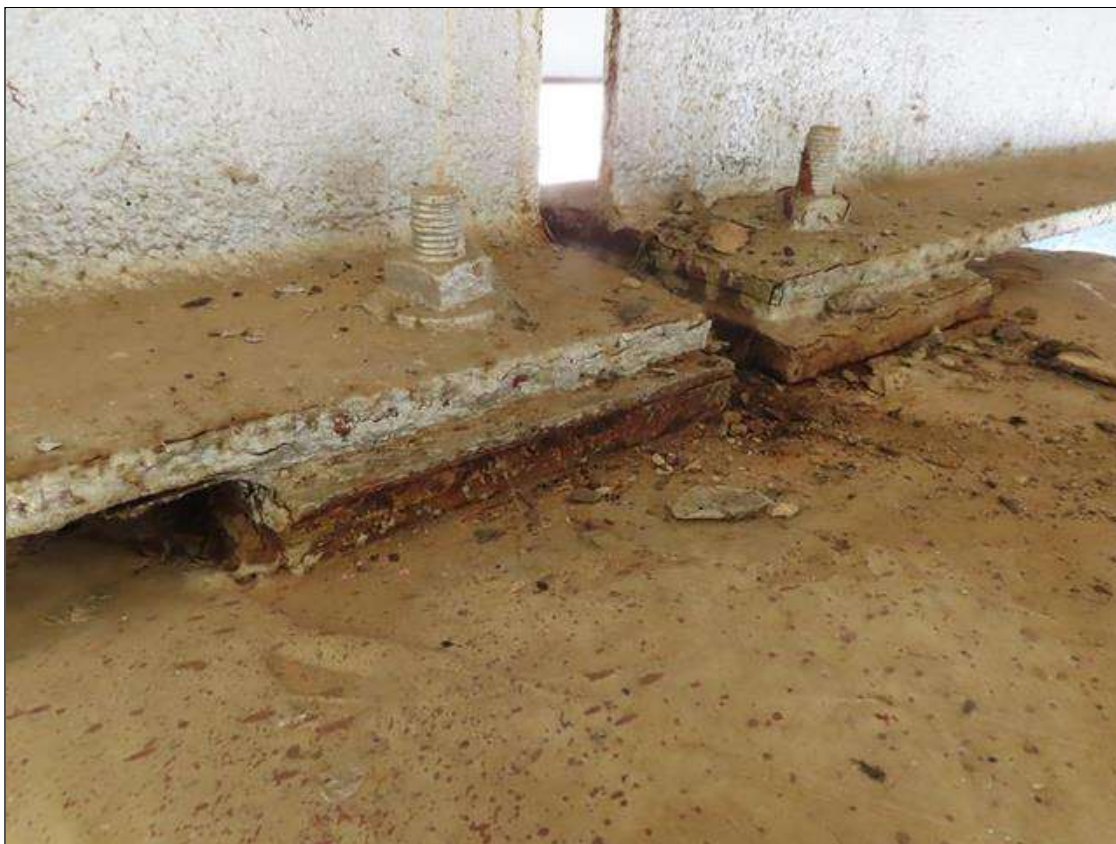
TYPICAL BEARINGS AT BENT 1, BEAMLIN 2 - MINOR SURFACE SCALE & CORROSION

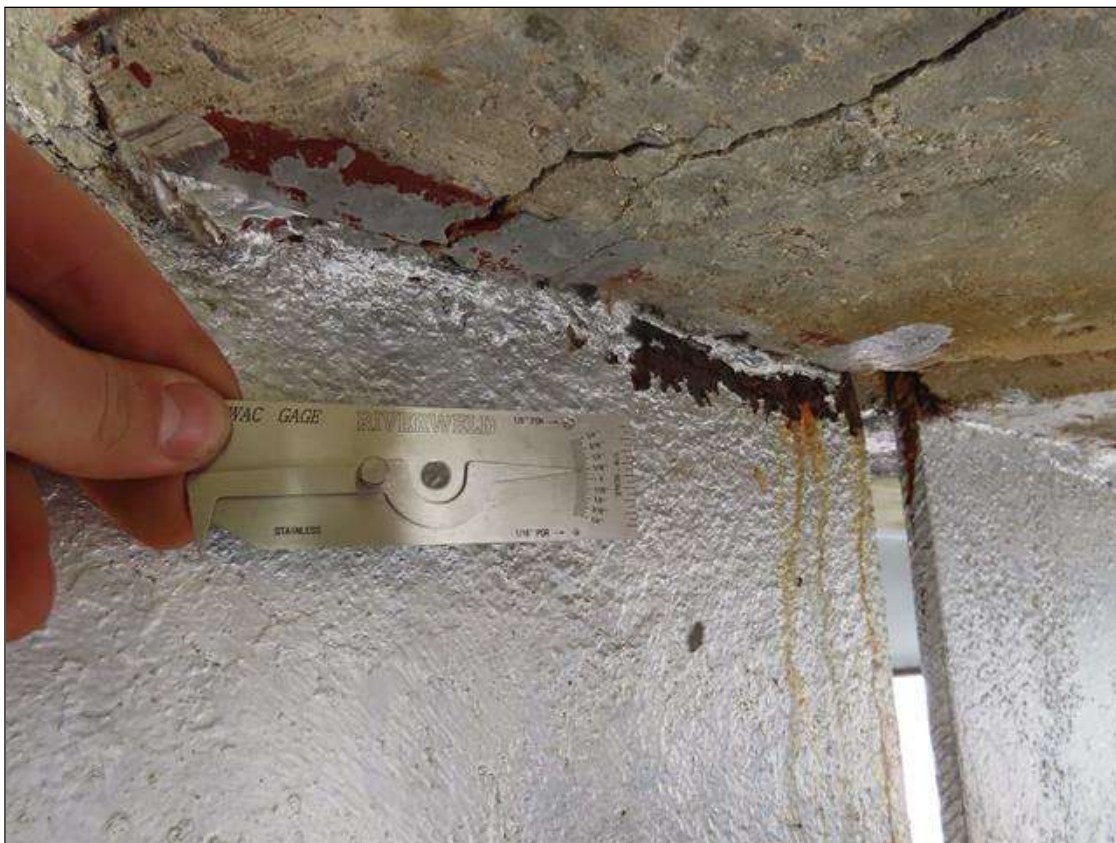
SPAN 1 BEAM 2 - WEB SECTION LOSS (UP TO 1/8IN SL, 3/8IN REMAIN) 1/16IN SL TO BOTH SIDES, 4IN L. X 1IN H. AT FAR END DIAPHRAGM. (PAR)

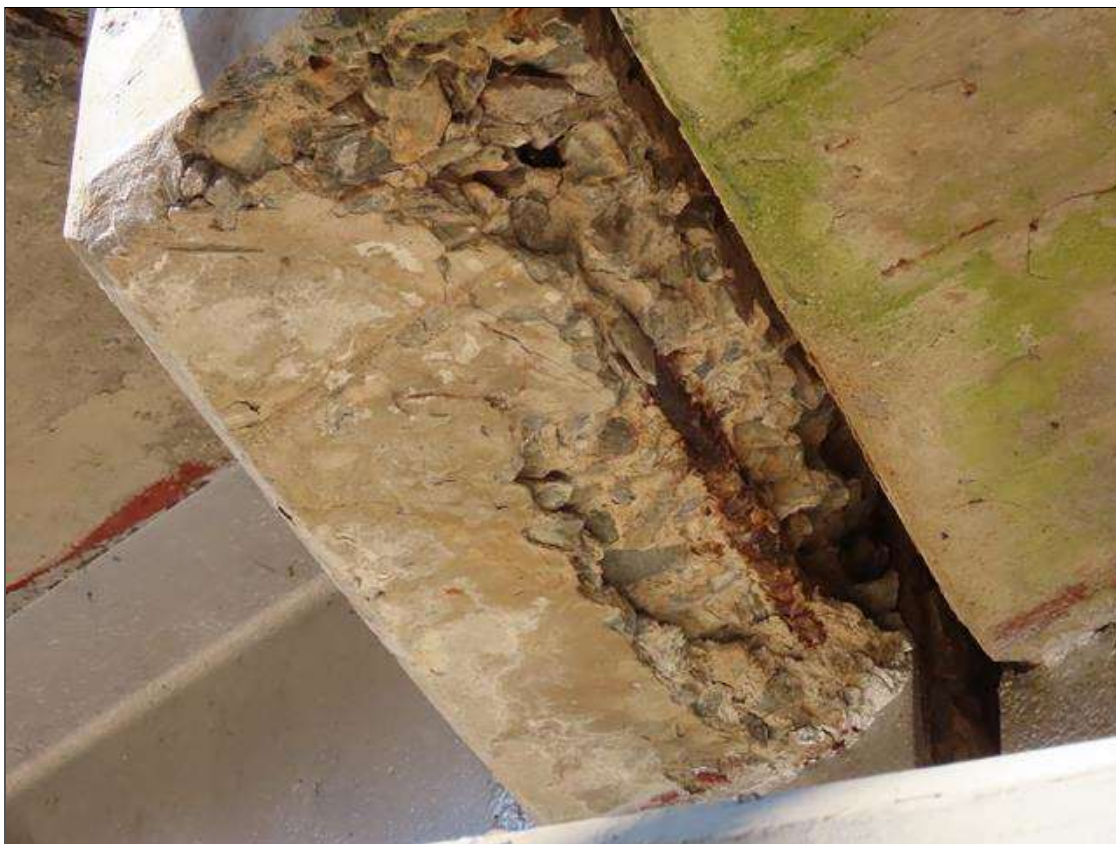
SPAN 1 BEAM 4, FAR END DIAPHRAGM - SPALL (2FT L. X 8IN W. X 2.5IN D.) WITH EXPOSED & CORRODED (1/16IN SL) REBAR AT RIGHT SIDE OF BEAM. (PAR)

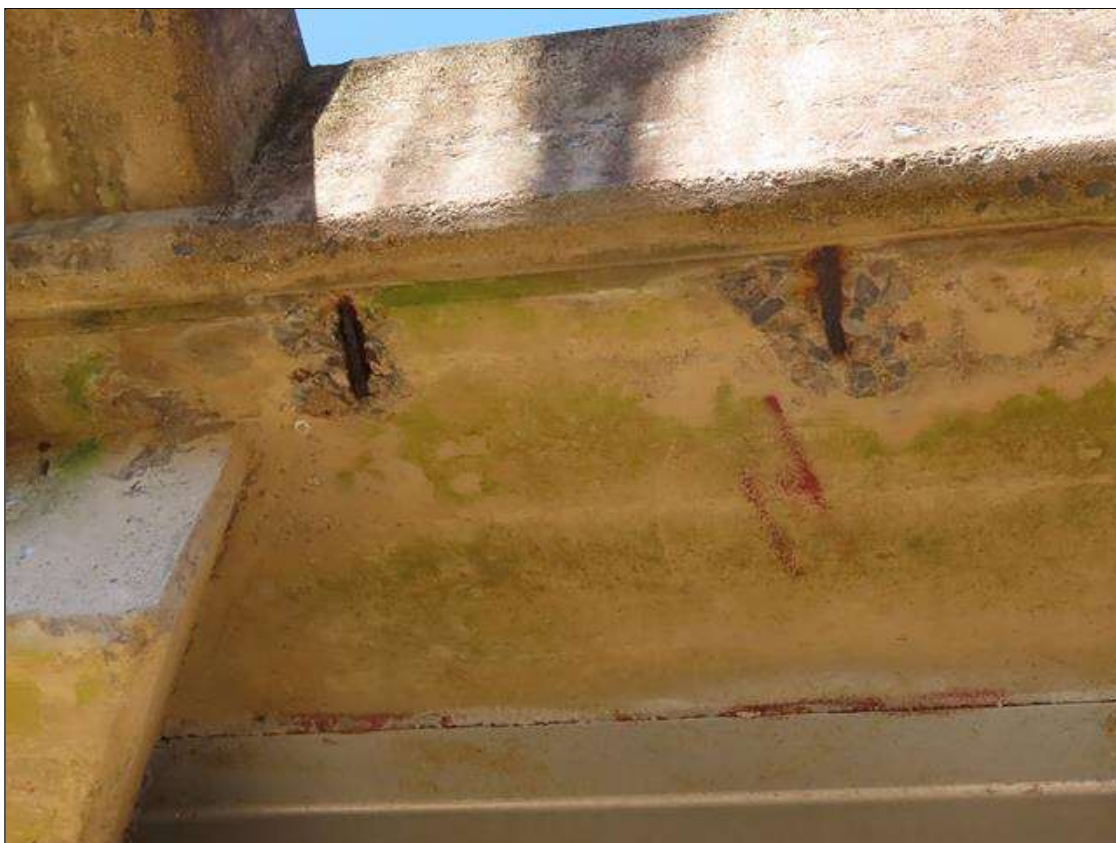
SPAN 2 DECK - X2 SPALLS (6IN DIAM. X 3/4IN D.) WITH EXPOSED & SCALING REBAR TO BOTTOM OF RIGHT SIDE OVERHANG AT NEAR END, (SIMILAR X2 AT FAR END).

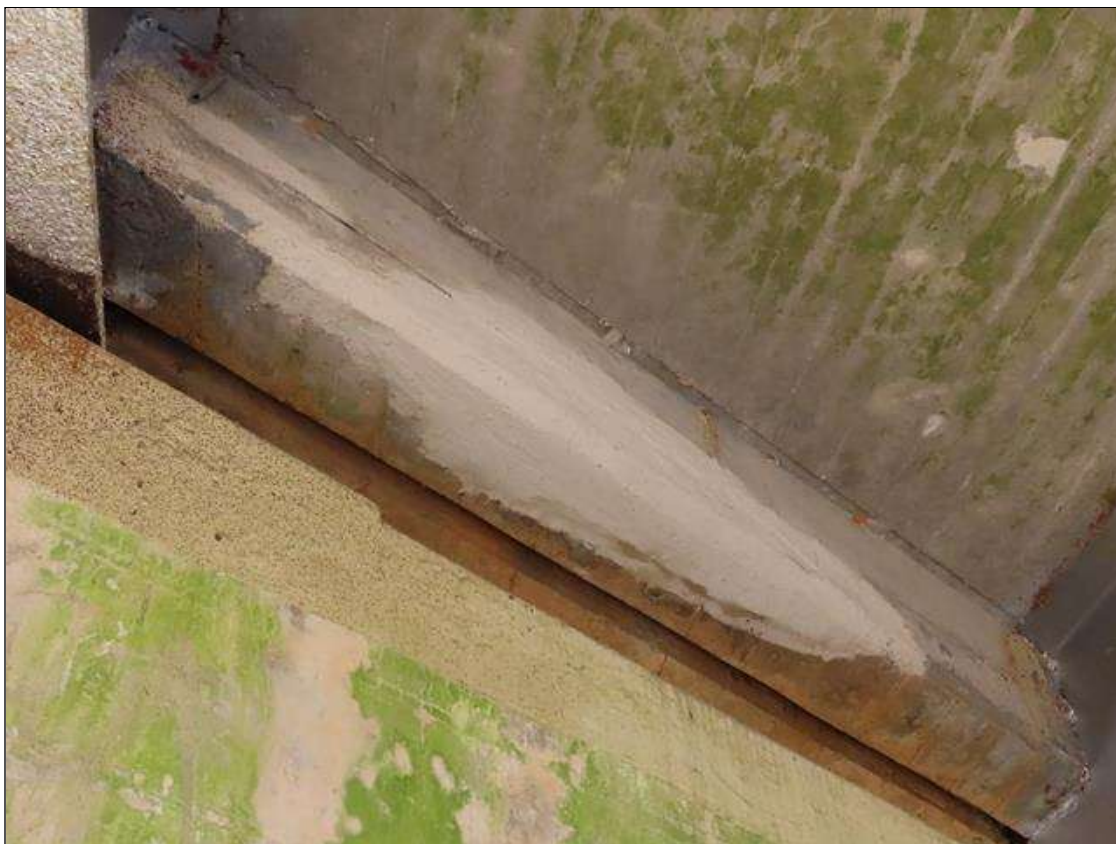
SPAN 2 BEAM 2, NEAR END DIAPHRAGM - SOUND PATCH (4FT L. X 10IN W.) AT RIGHT SIDE OF BEAM

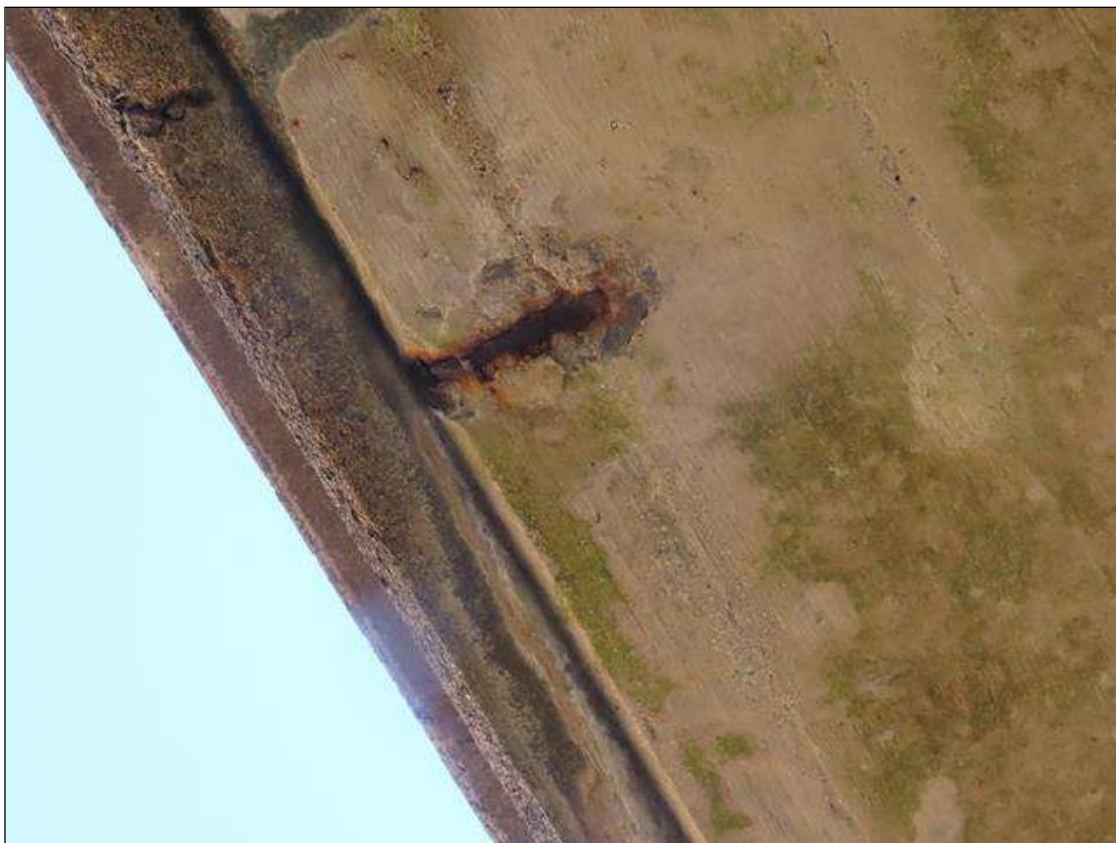
SPAN 2 DECK - SPALL (6IN DIAM. X 1/2IN D.) WITH EXPOSED REBAR TO BOTTOM OF LEFT OVERHANG 10FT FROM NEAR END

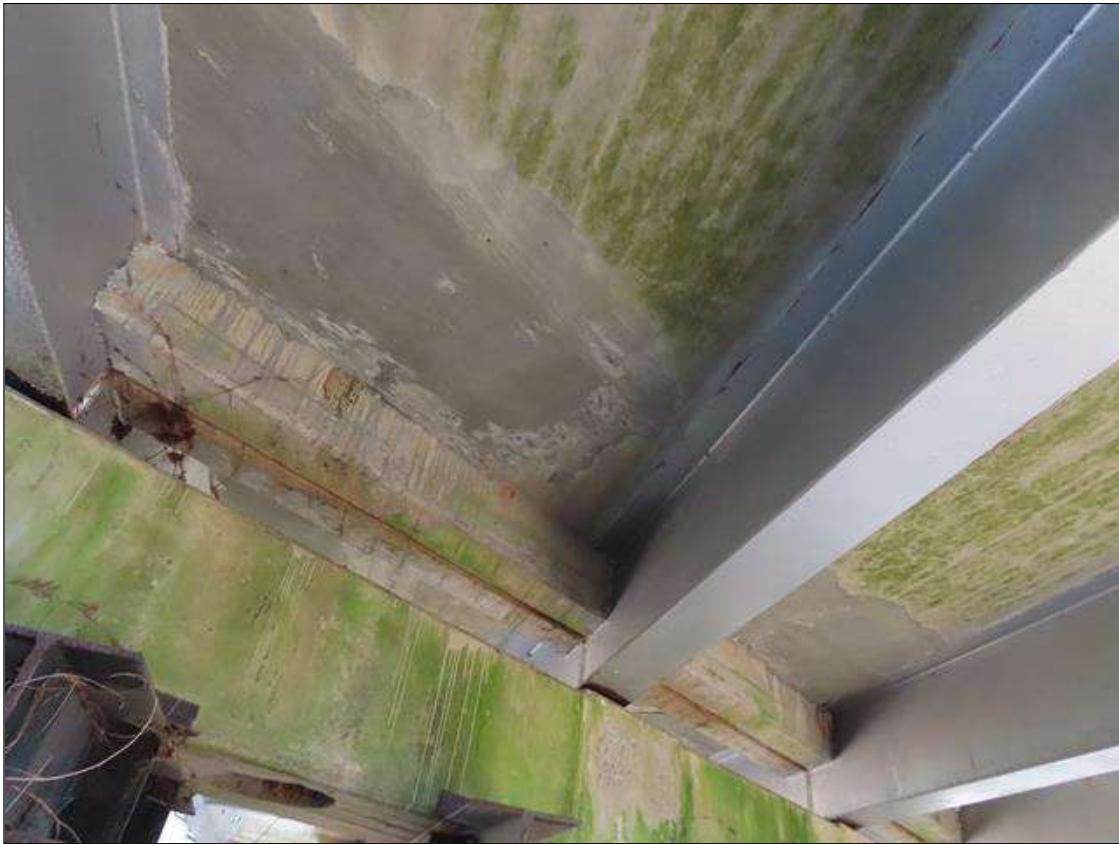
TYPICAL SOUND PATCHING (UP TO 5FT L. X 2FT W.) TO DECK ADJACENT TO BENT 2, SPAN 2 BAY 1 & 2 AT FAR END.
