NC DEPARTMENT OF TRANSPORTATION
 DIVISION OF HIGHWAYS
 STRUCTURE MANAGEMENT UNIT

Structure Safety Report

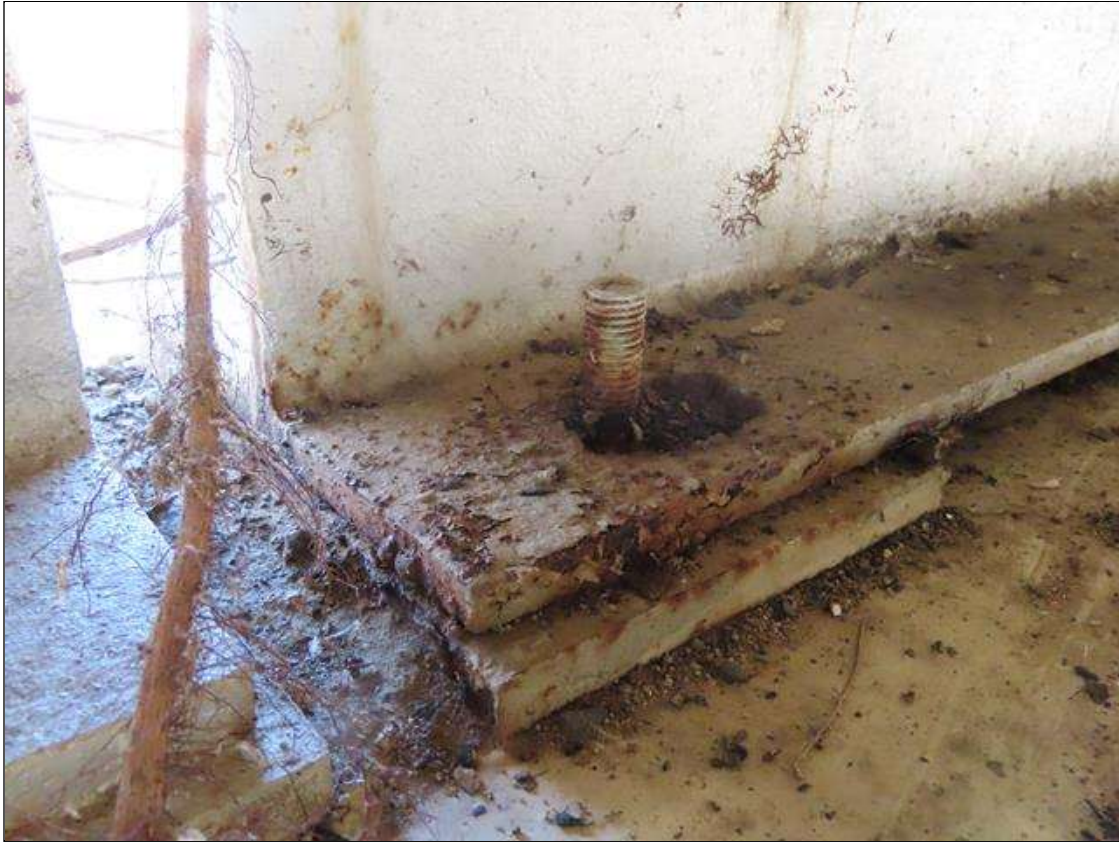
SPAN 3 BEAM 1, NEAR END BEARING - RIGHT ANCHOR NUT MISSING. (PAR)

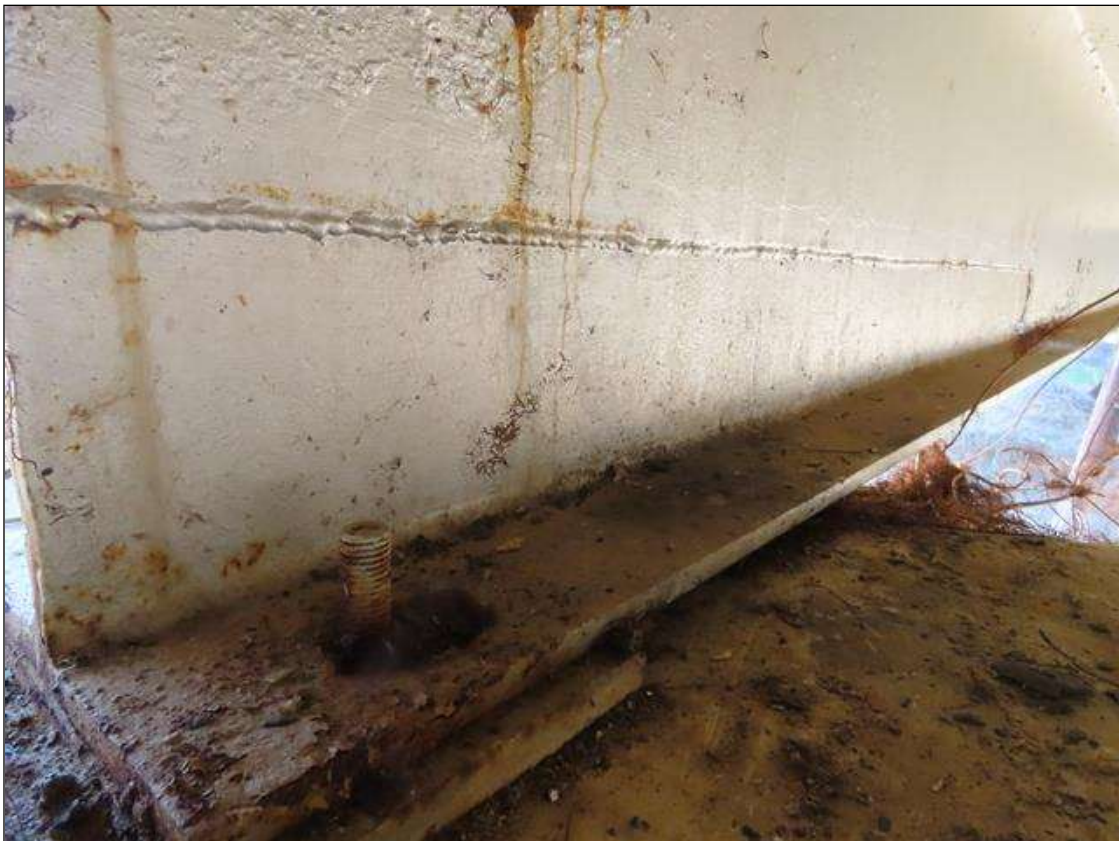
SPAN 3 BEAM 1 - BOTTOM FLANGE & WEB REPAIR (72IN L. X 6IN H.) AT NEAR END, WITH 2IN DIAM. HOLE AT FAR END OF REPAIR.

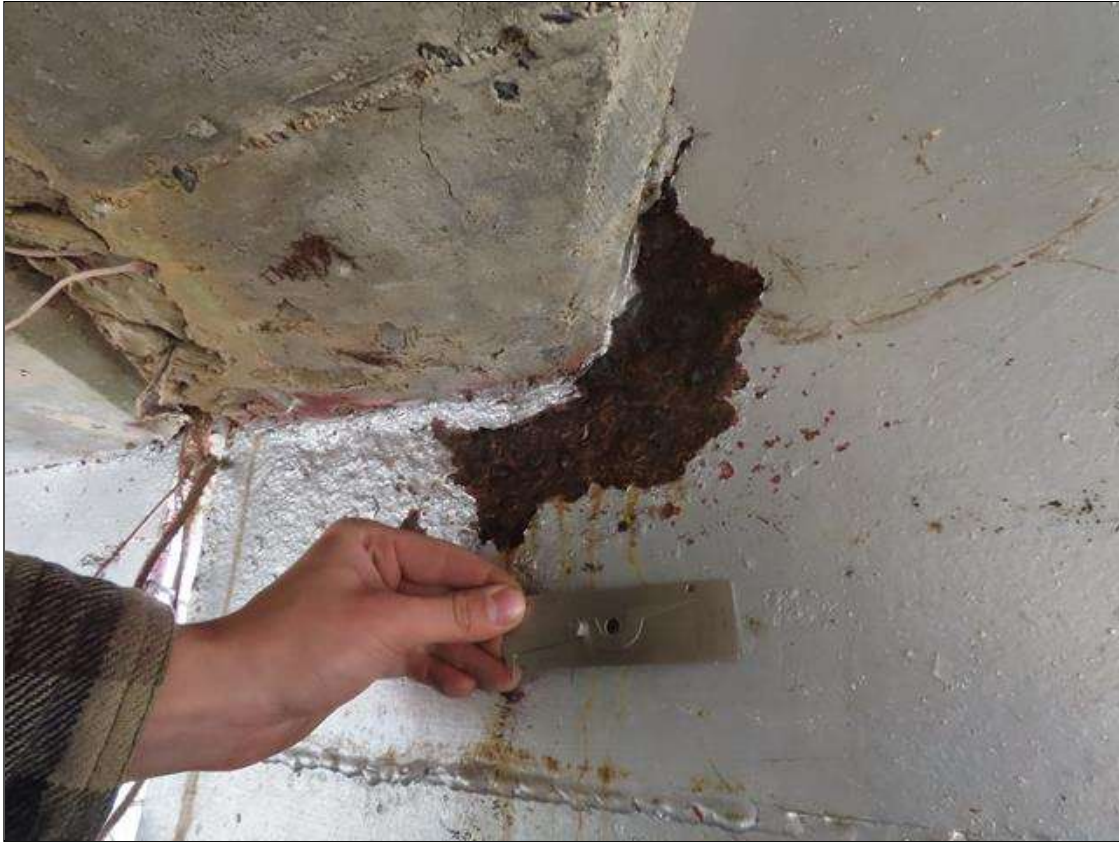
SPAN 3 BEAM 1 - WEB SECTION LOSS (UP TO 1/4IN SL, 1/4IN REMAIN) 3IN H. FOR 6IN H. AT NEAR END DIAPHRAGM. (PAR)

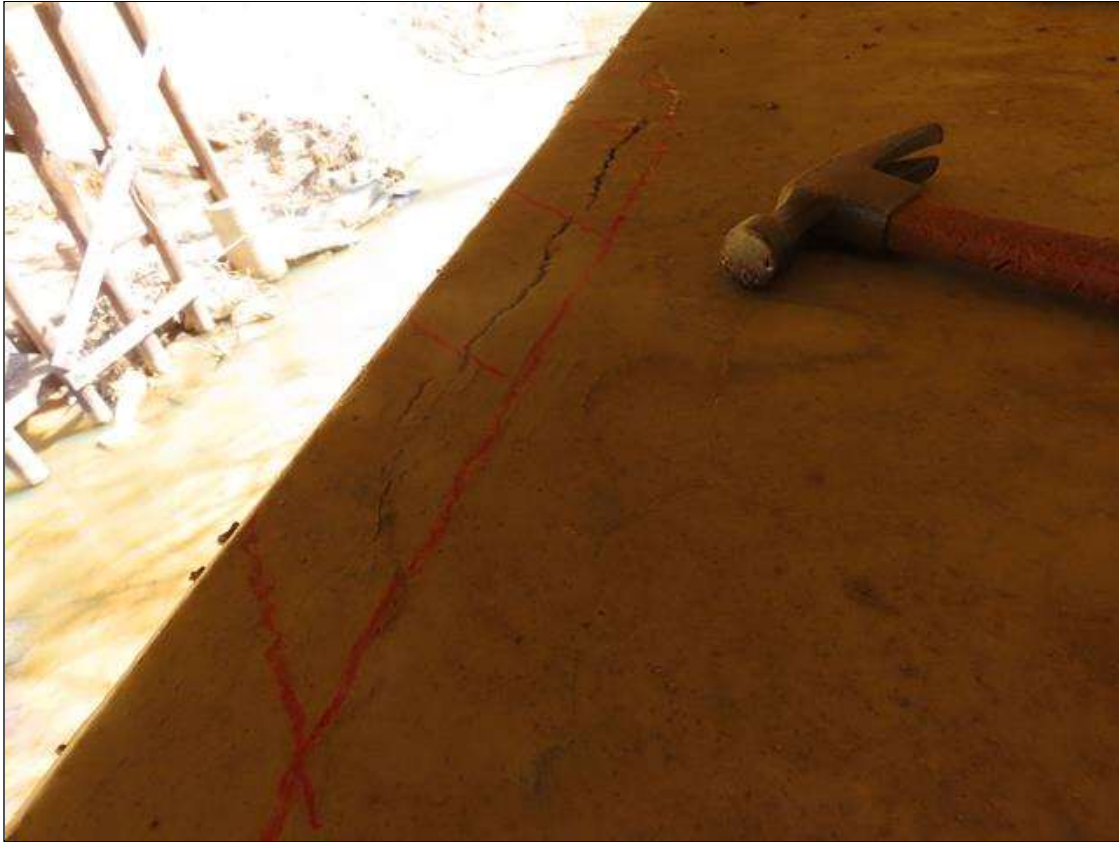
BENT 2 CAP - DELAM (4FT L. X 6IN W.) WITH 1/8IN OPEN CRACKING TO FAR SIDE AT TOP IN BAY 2. (NOT UNDER BEARING)

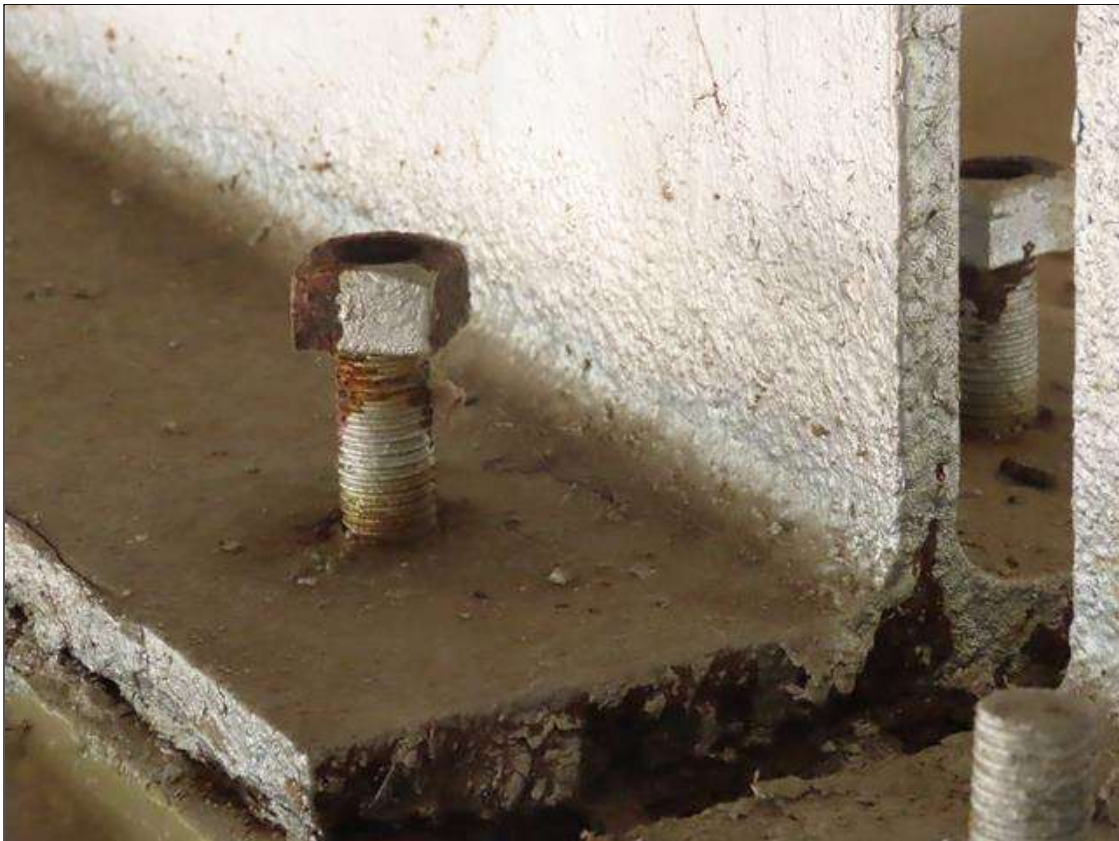
SPAN 3 BEAM 3, NEAR BEARING - BOTH ANCHOR NUTS NOT ENGAGED. (BEAM 2 & 4 AT NEAR END SIMILAR)

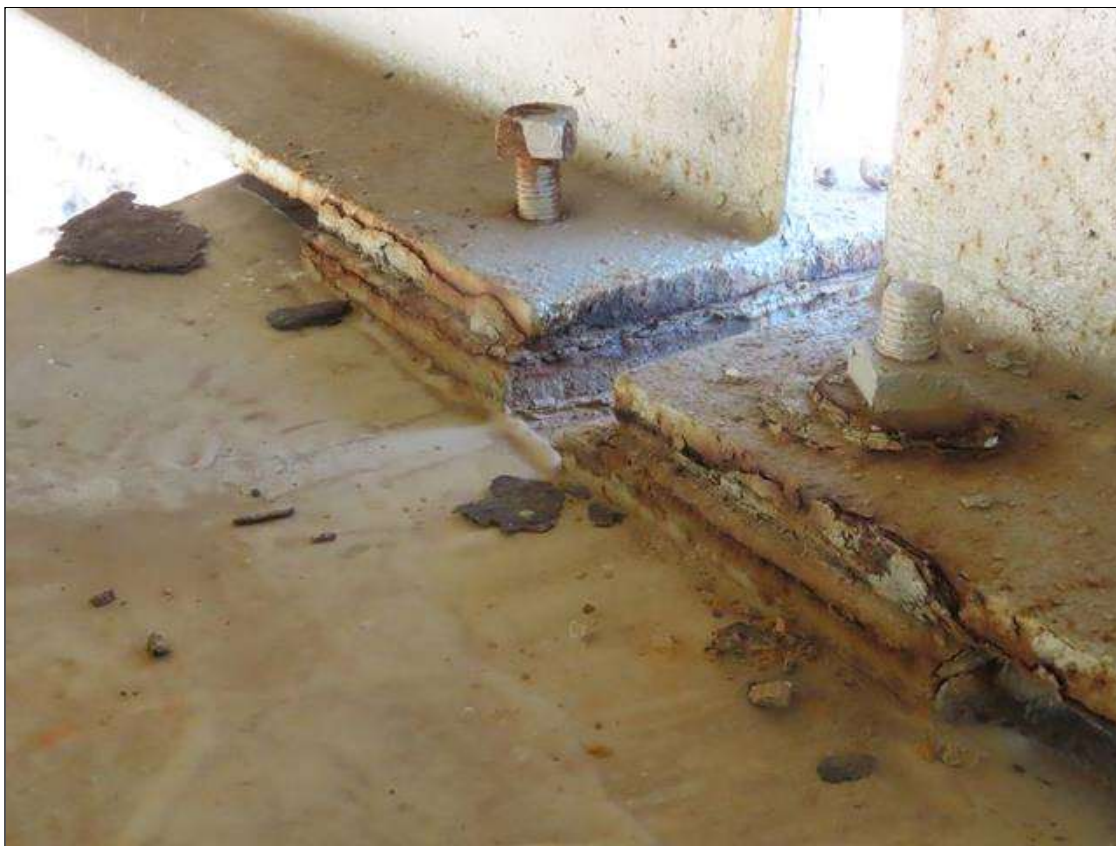
TYPICAL BEARINGS AT BENT 2, BEAMLIN 4 - MINOR TO MODERATE SCALE & CORROSION

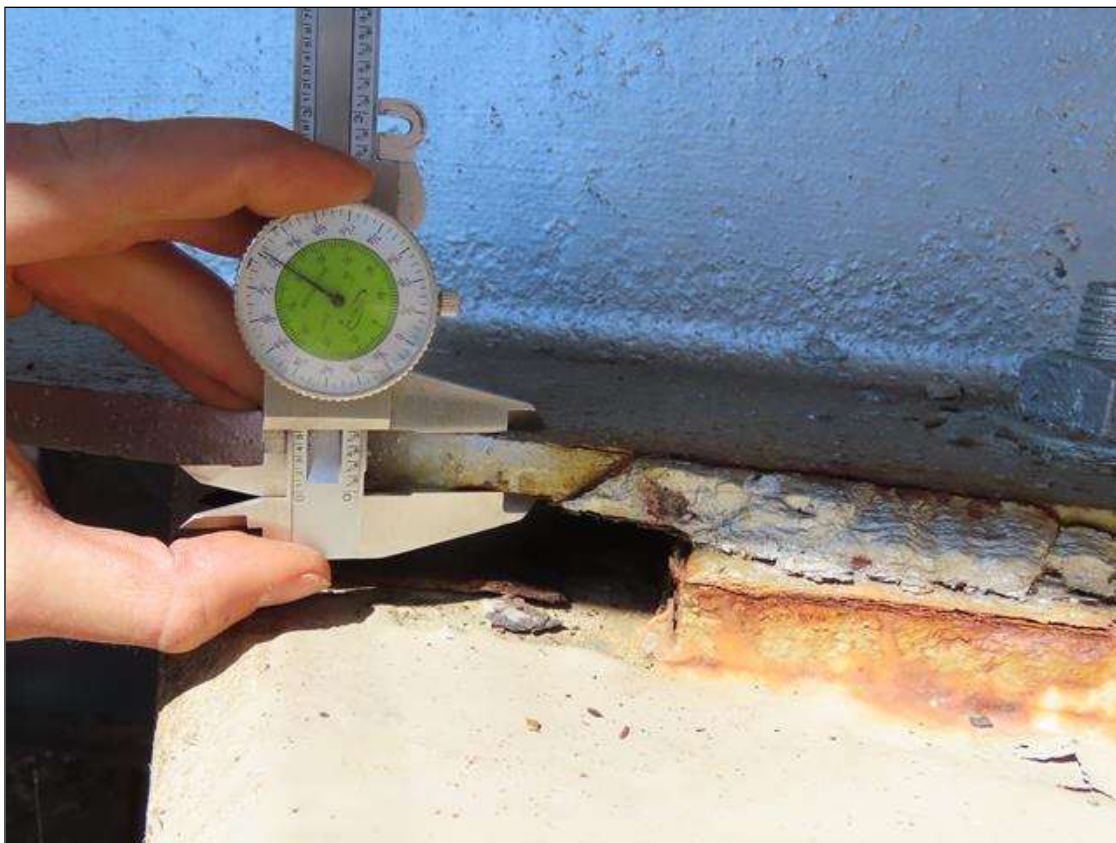
SPAN 2 BEAM 4 - BOTTOM FLANGE SECTION LOSS (UP TO 20%, 1/8IN SL, 1/2IN REMAIN) FULL W. FOR 6IN L. AT FAR END

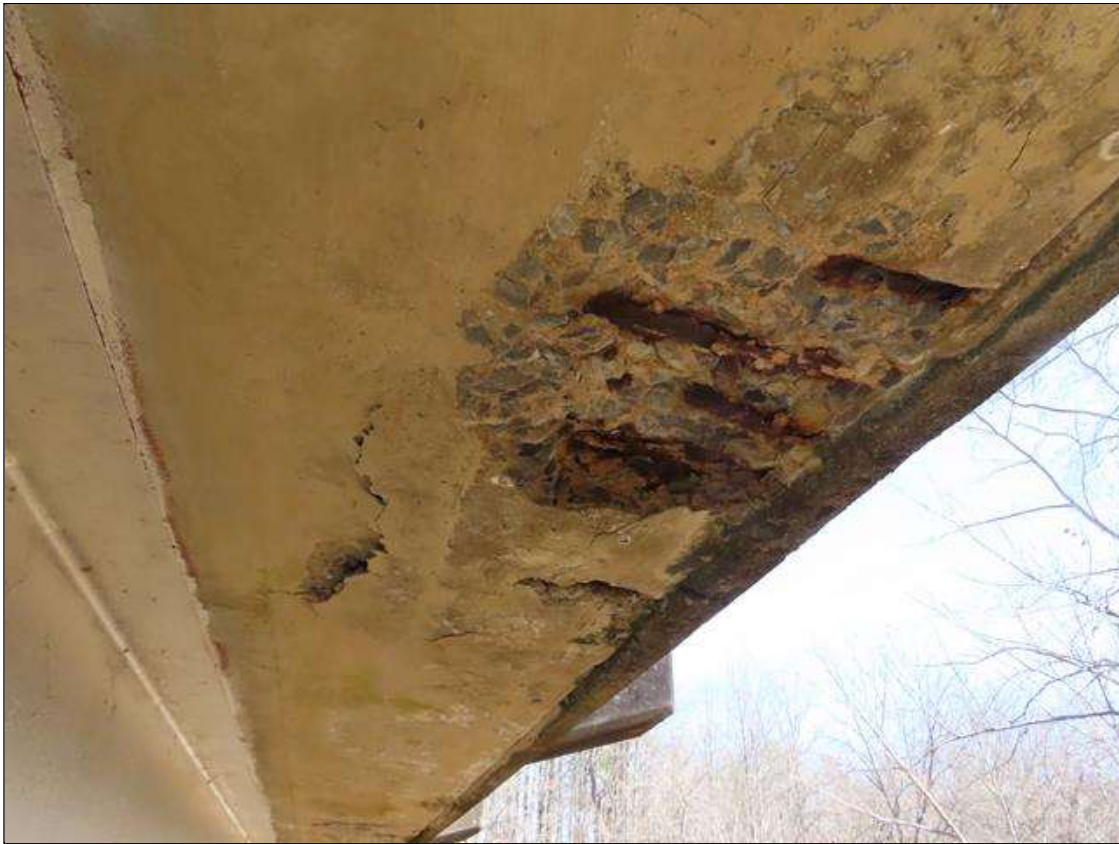
SPAN 3 DECK - SPALLING/DELAM (4.5FT L. X 14IN W. X 2IN D.) WITH EXPOSED & CORRODED (1/16IN SL) REBAR TO BOTTOM OF RIGHT OVERHANG, 2FT FROM NEAR END. (PAR)

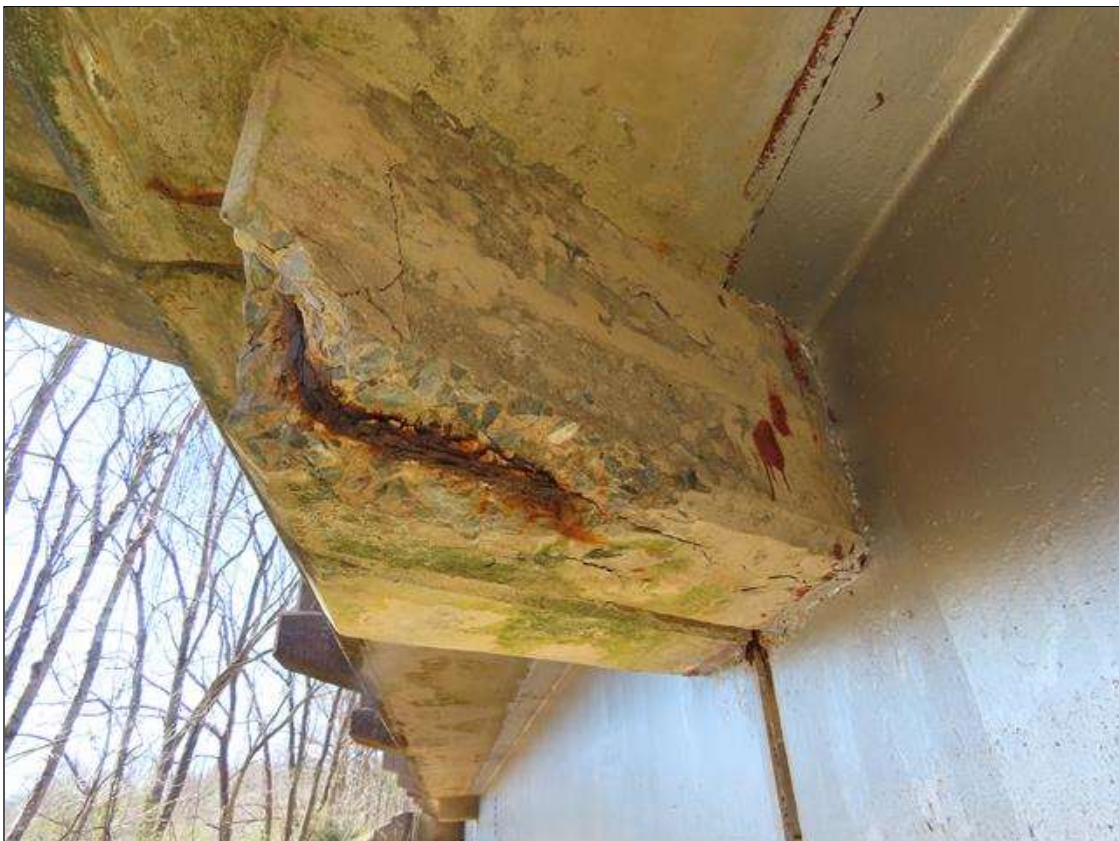
SPAN 3 BEAM 4, NEAR END DIAPHRAGM - SPALL (16IN L. X 8IN W. X 2IN D.) WITH EXPOSED & CORRODED REBAR (1/16IN SL) AT RIGHT SIDE OF BEAM. (PAR)

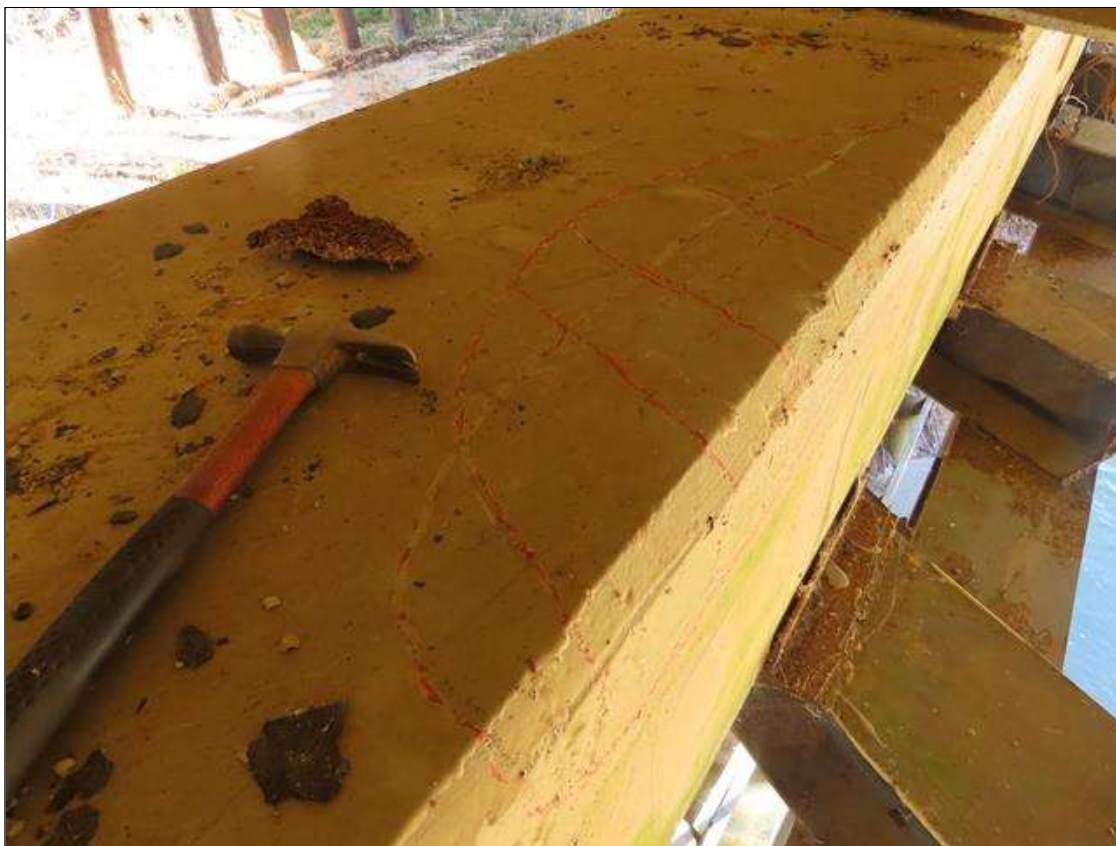
BENT 2 CAP - DELAM (3FT L. X 14IN W.) TO FAR SIDE TOP EDGE IN BAY 3. (NOT UNDER BEARING)

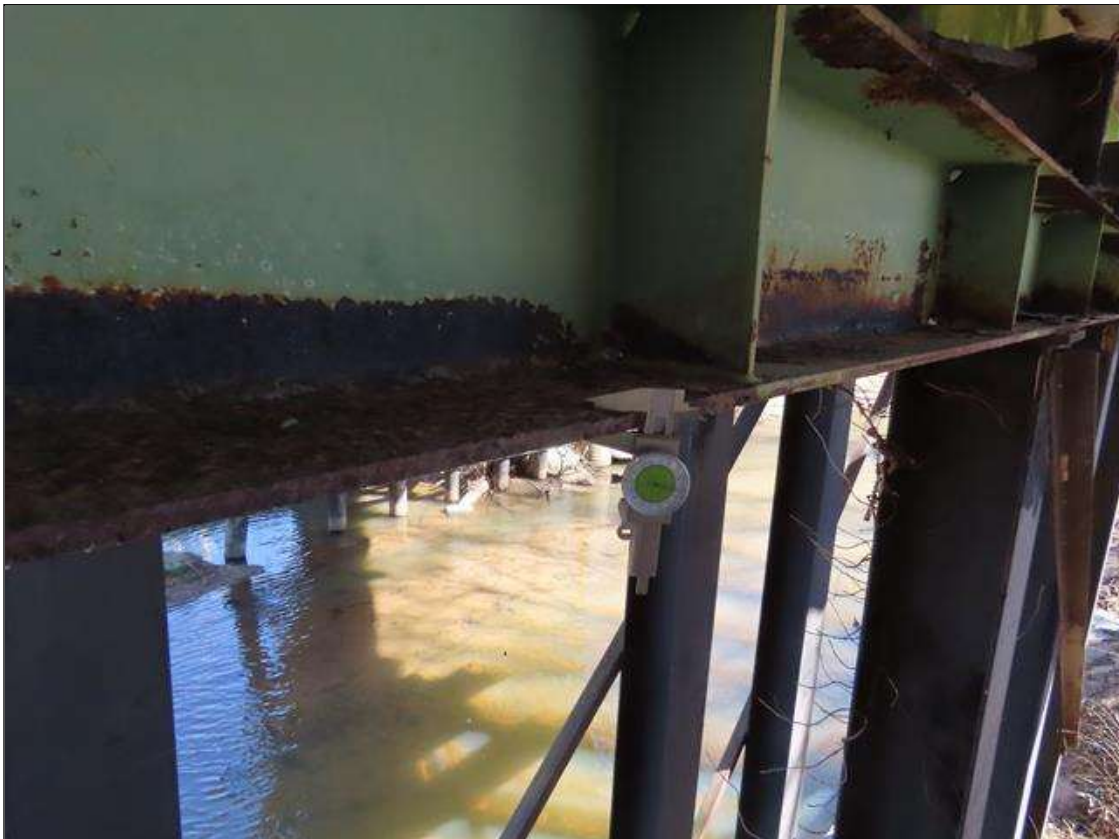
TYPICAL INTERMITTENT MODERATE TO HEAVY SCALE & CORROSION, NO MEASURABLE SECTION LOSS, THROUGHOUT STEEL CAP & BEAMS AT BENT 2, NEAR SIDE BELOW BEAM 2

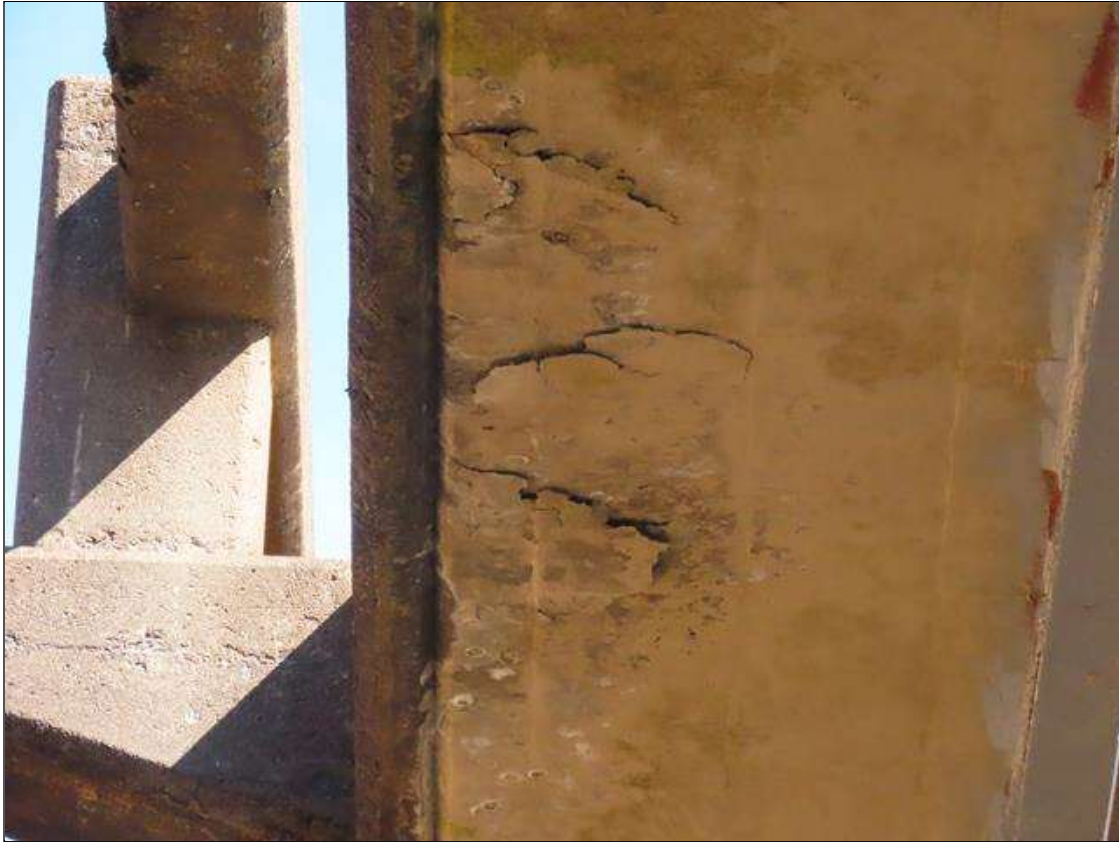
SPAN 3 DECK - DELAM (3SF) TO BOTTOM OF LEFT OVERHANG AT MID-SPAN

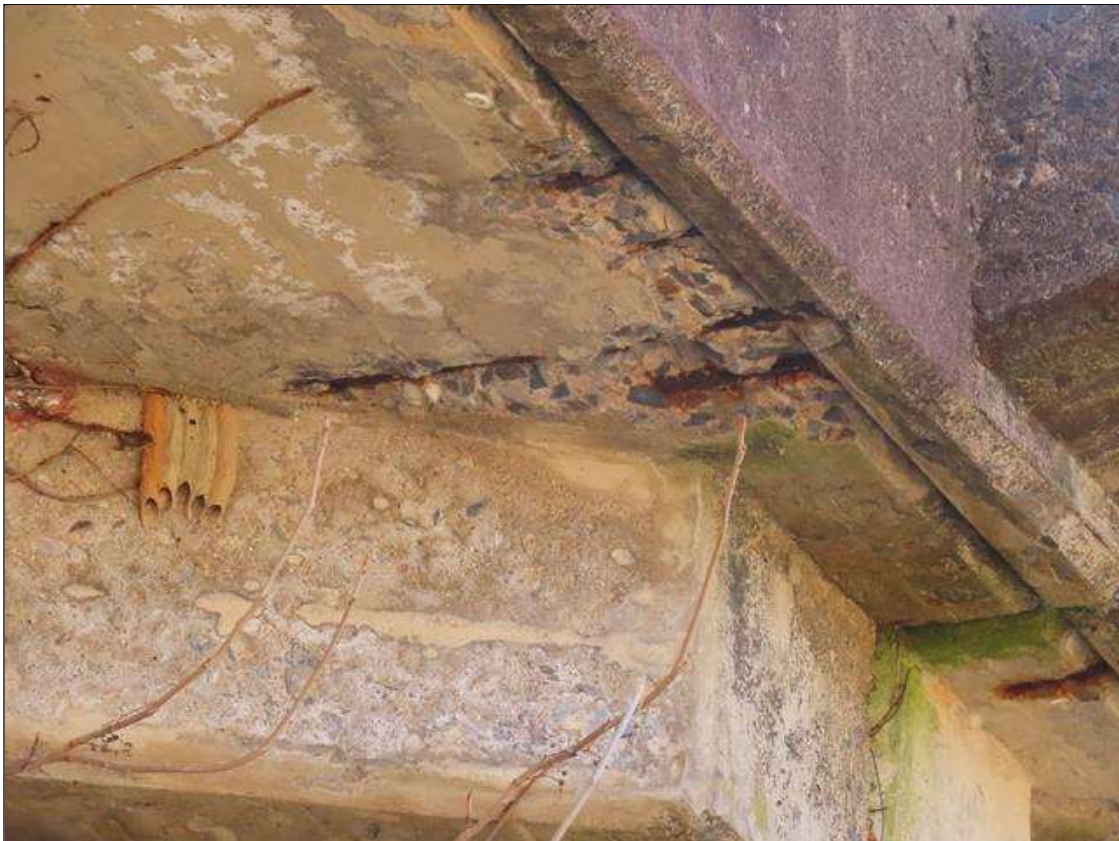
SPAN 3 DECK - SPALLING (2SF X 1IN D.) WITH EXPOSED & SCALING REBAR TO BOTTOM OF LEFT OVERHANG AT NEAR END

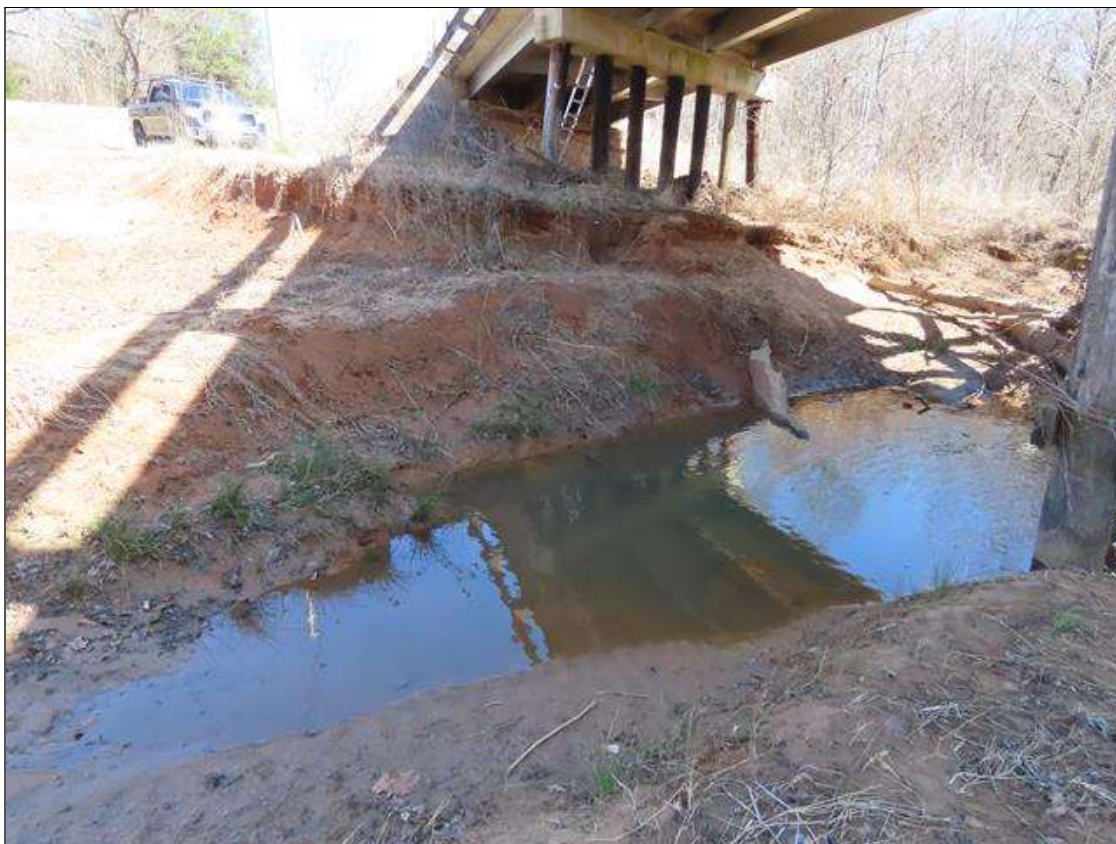
STREAM BANK BELOW SPAN 4 - BANK EROSION (UP TO 6FT H. X 20FT W. X 50FT L.) AT FAR SIDE OF BENT 3

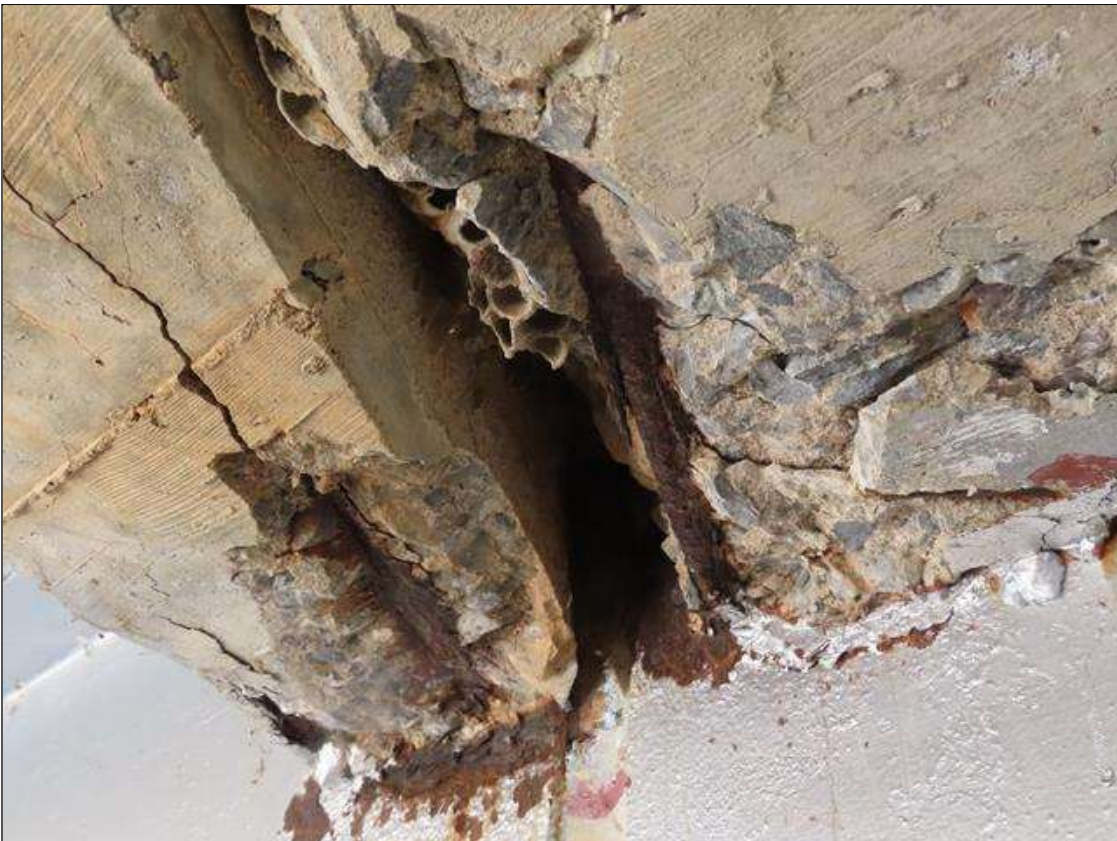
SPAN 3 & 4 DIAPHRAGMS AT BENT 3, BEAMLIN 2 - SPALLING (16IN L. X 6IN W. X 2IN D.) WITH EXPOSED & CORRODED (1/16IN SL) REBAR AT LEFT SIDE OF BEAMS (PAR)

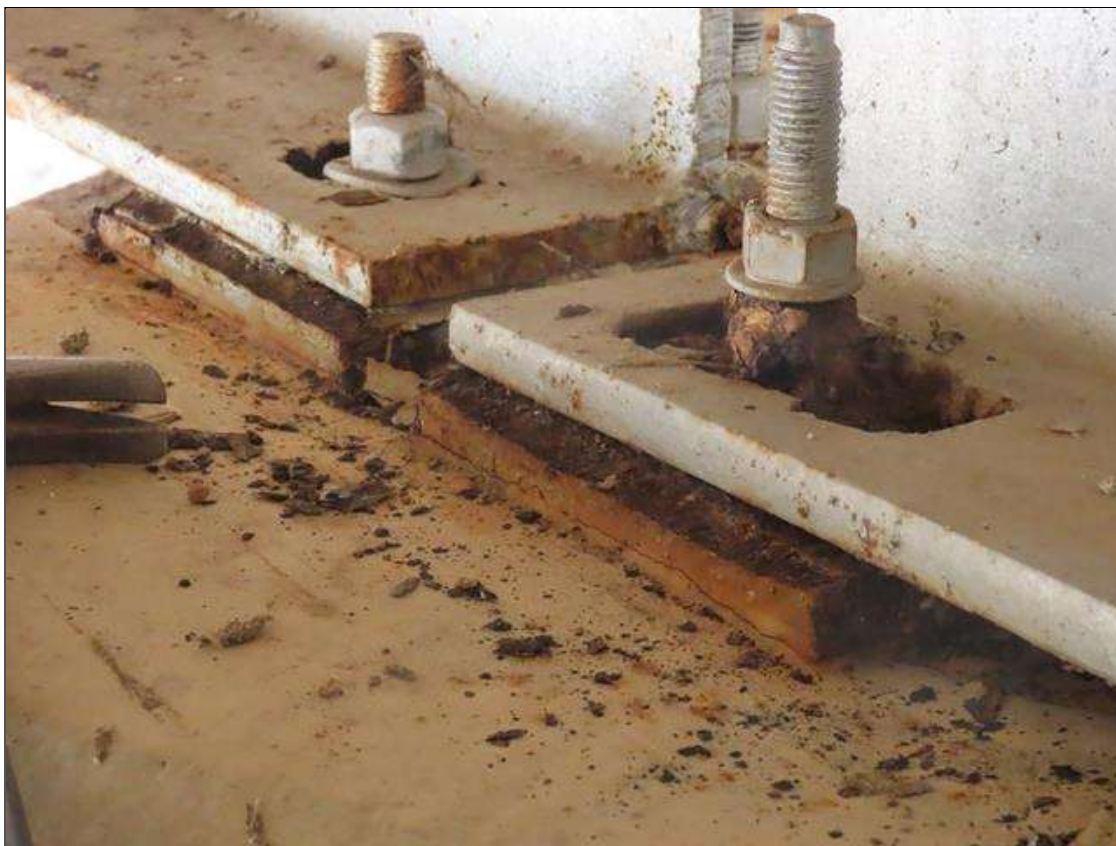
TYPICAL BEARINGS AT BENT 3, BEAMLINE 3 - MINOR TO MODERATE SCALE & CORROSION

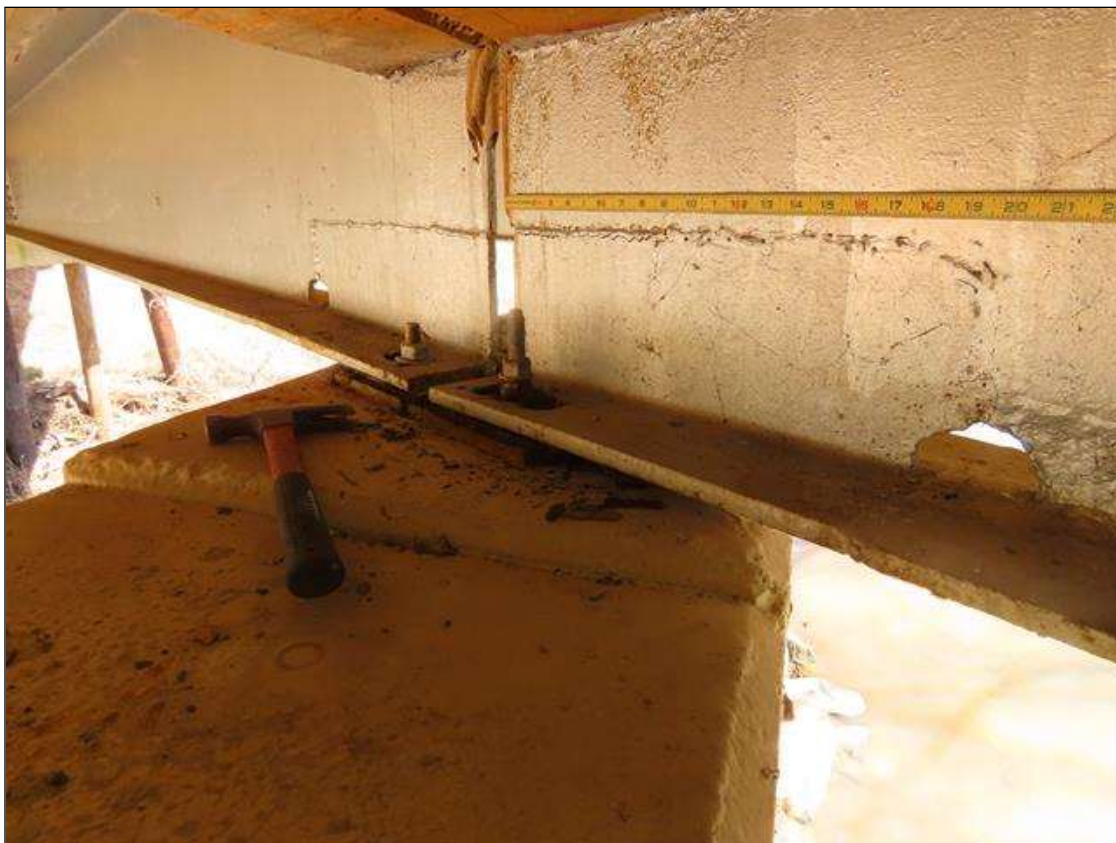
BEAMLINE 3 AT BENT 3 - BOTTOM FLANGE & WEB REPAIRS (20IN L. X 6IN H.) WITH 2IN DIAM. HOLE IN WEB AT END OF REPAIR.

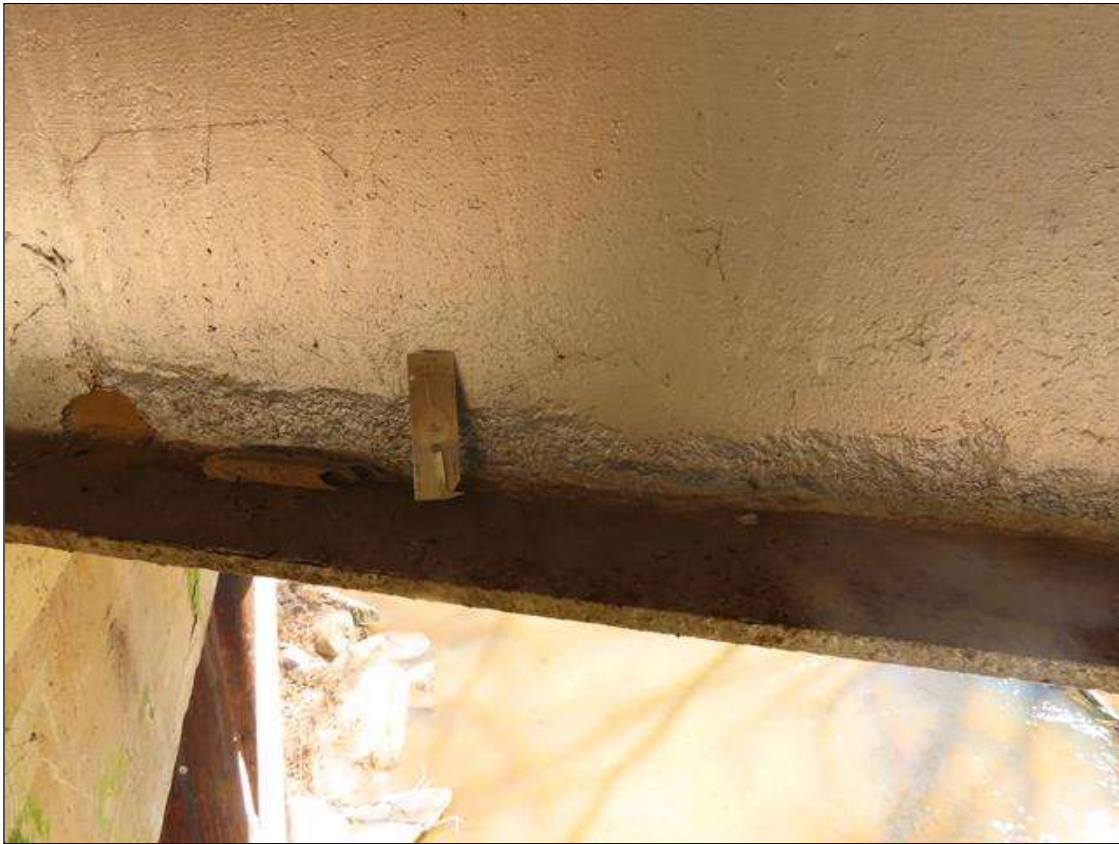
SPAN 3 BEAM 3 - ARRESTED WEB SECTION LOSS (UP TO 1/8IN SL, 3/8IN REMAIN) 2.5IN H. X 2.5FT L. TO BOTTOM AT NEAR END OF REPAIR

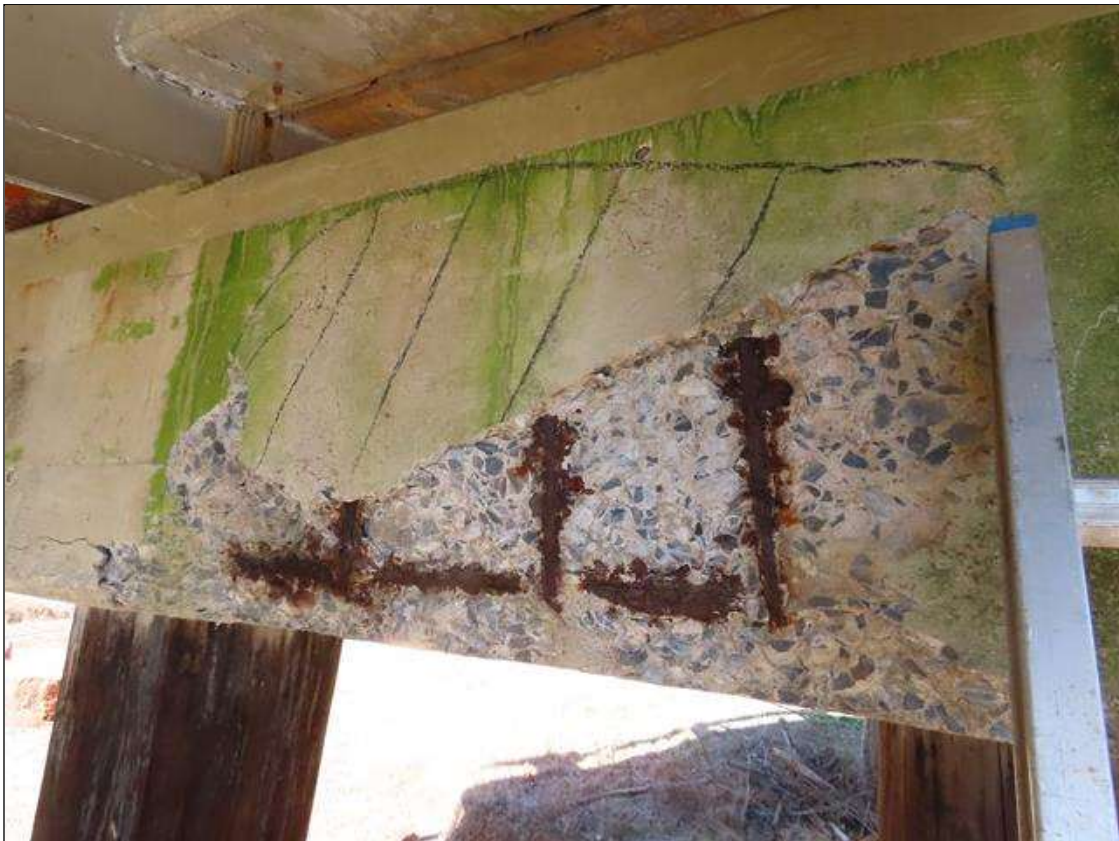
BENT 3 CAP - SPALLING/DELAM (40IN L. X 24IN . X 2IN D.) WITH EXPOSED & CORRODED (1/16IN SL) REBAR TO NEAR SIDE BELOW BAY 3. (PAR)

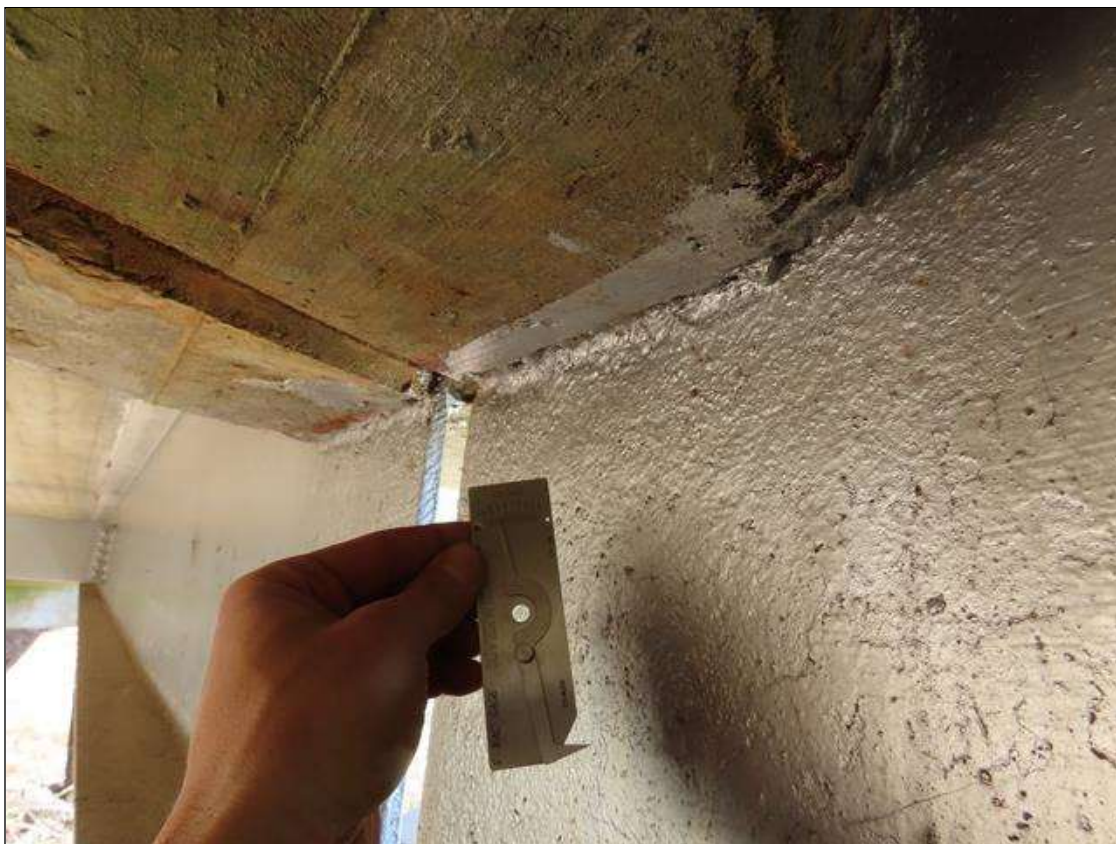
BEAMLINE 4 AT BENT 3 - ARRESTED WEB SECTION LOSS (UP TO 1/8IN SL, 3/8IN REMAIN) 6IN L. X 1IN H.) AT DIAPHRAGMS. (BEAMLINE 1 AT BENT 4 SIMILAR)

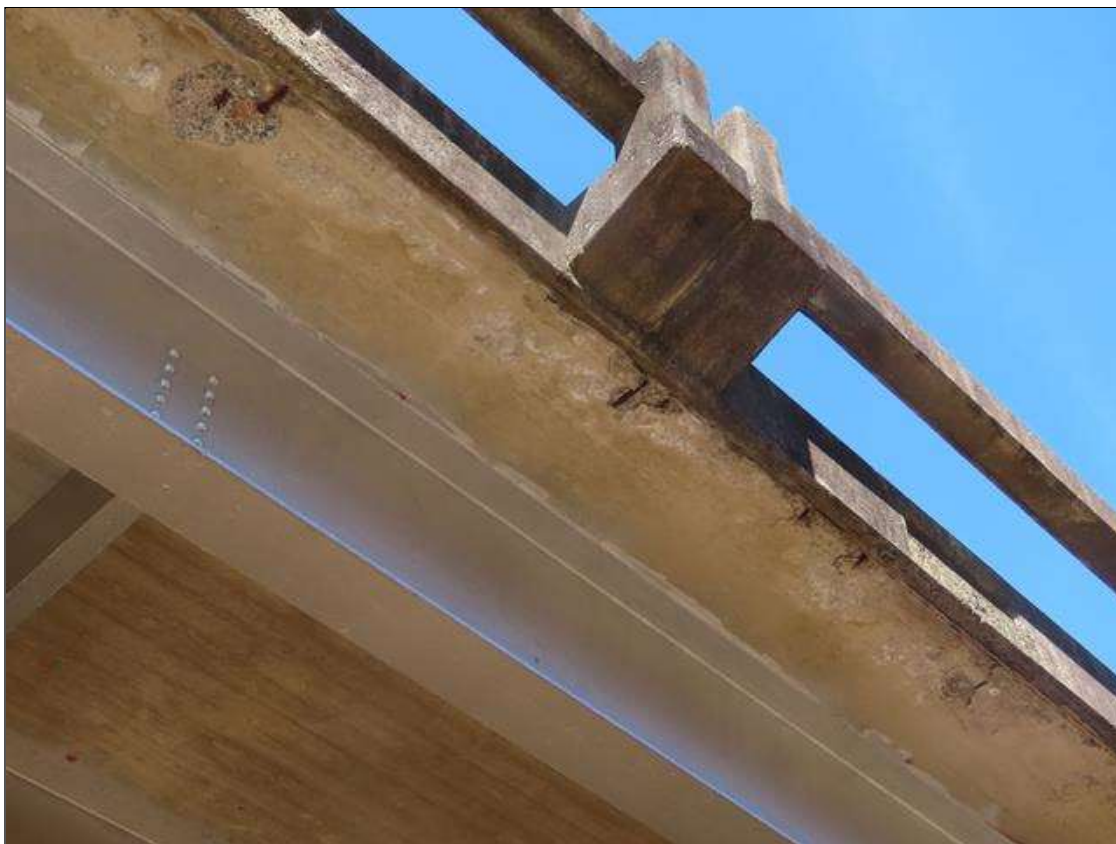
SPAN 4 DECK - X5 SPALLS/DELAM (UP TO 1SF X 1IN D.) WITH EXPOSED & SCALING REBAR TO BOTTOM OF RIGHT SIDE OVERHANG AT MID-SPAN

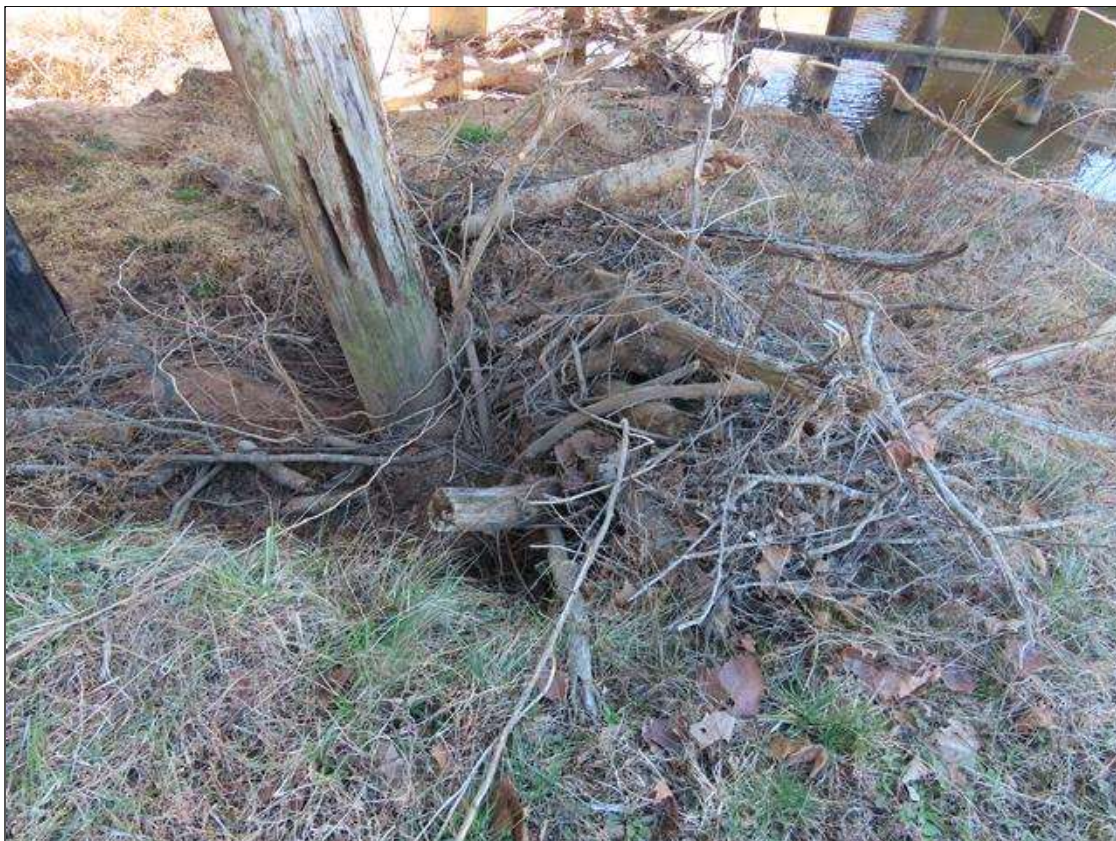
DRIFT (12CUFT) AT LEFT SIDE OF BENT 4 PILE 1

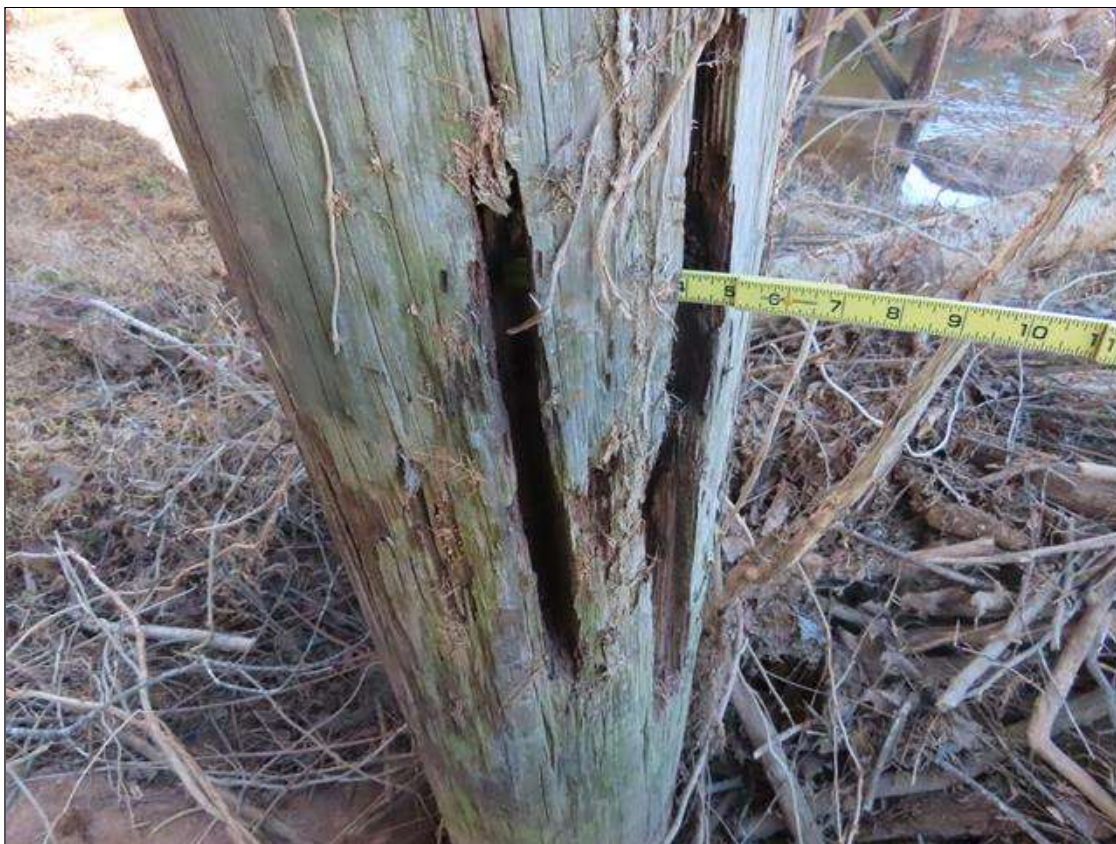
BENT 4 PILE 1 - DECAY/SECTION LOSS (UP TO 4IN D. X 12IN W. X 3FT L.) TO LEFT SIDE STARTING 2FT FROM GROUND. (PAR)

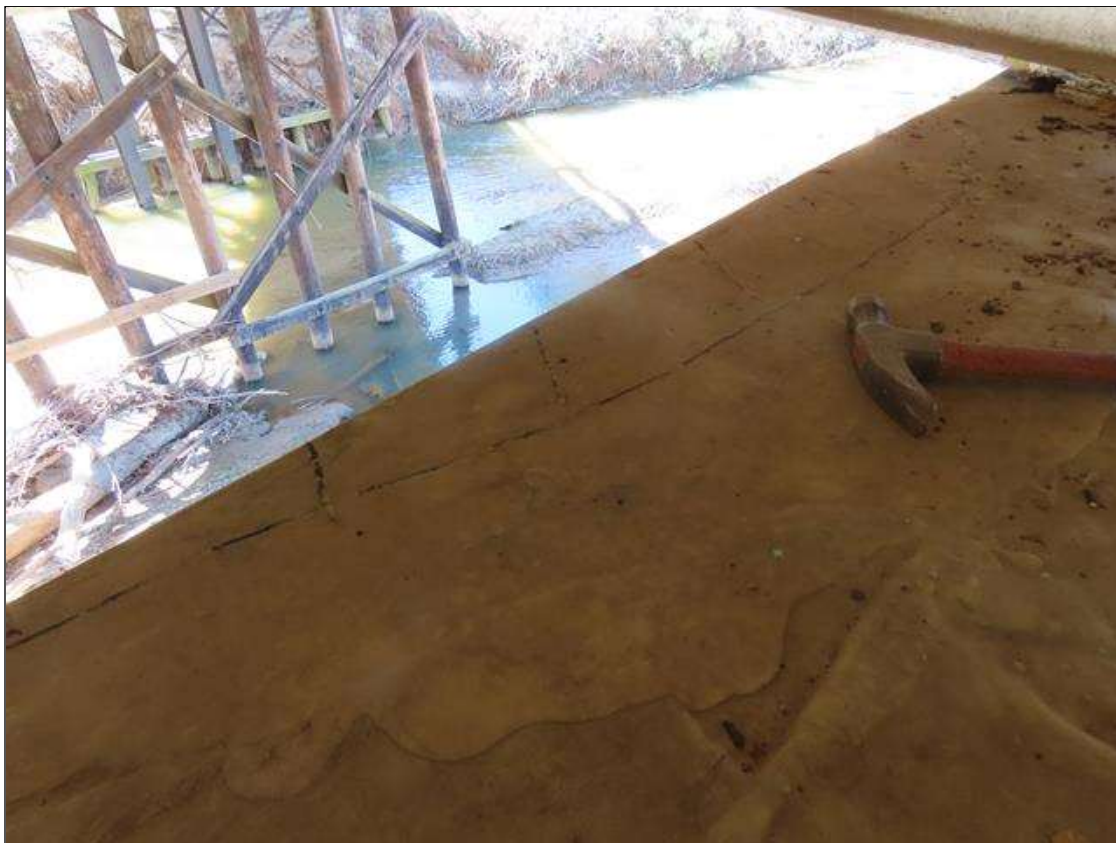
BENT 4 CAP - DELAM (3FT L. X 8IN W.) TO NEAR SIDE AT TOP EDGE IN BAY 1. (NOT UNDER BEARINGS)
