NC DEPARTMENT OF TRANSPORTATION
 DIVISION OF HIGHWAYS
 STRUCTURE MANAGEMENT UNIT

Structure Safety Report

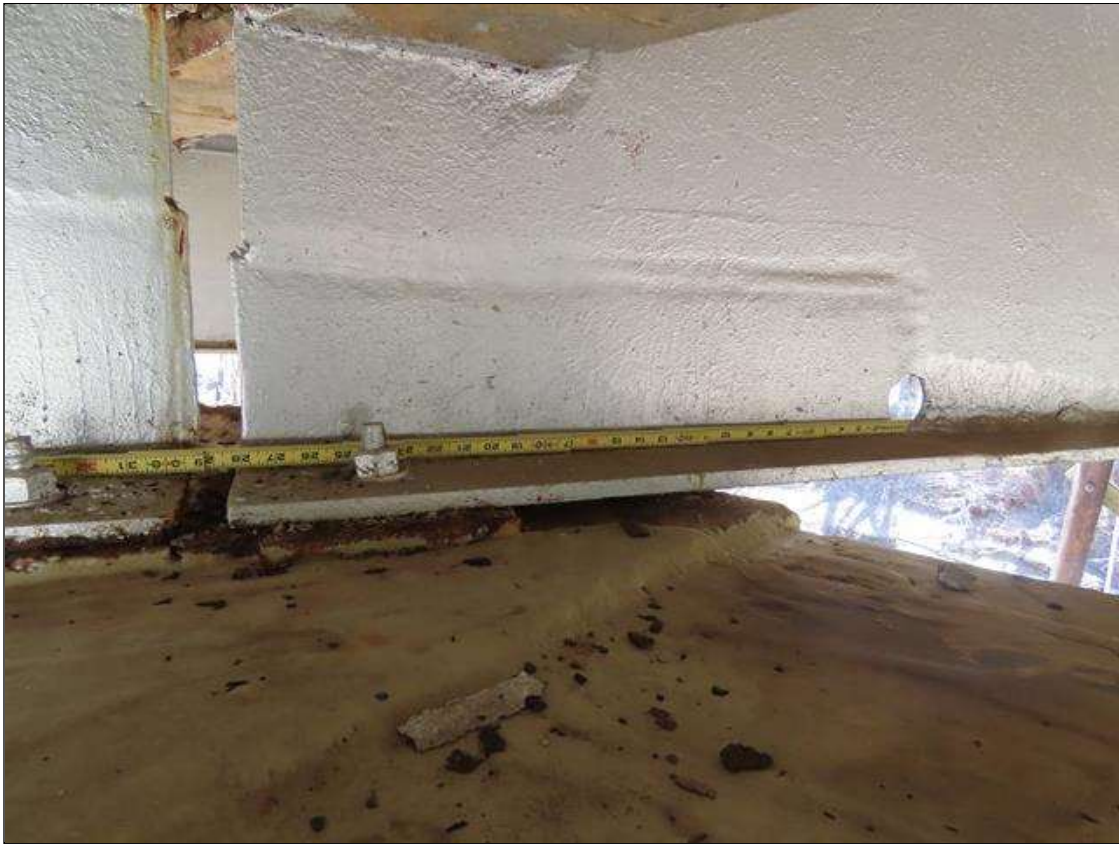
SPAN 4 BEAM 2 - BOTTOM FLANGE & WEB REPAIR (28IN L. X 6IN H.) AT FAR END WITH 2IN DIAM. HOLE IN WEB AT NEAR END OF REPAIR

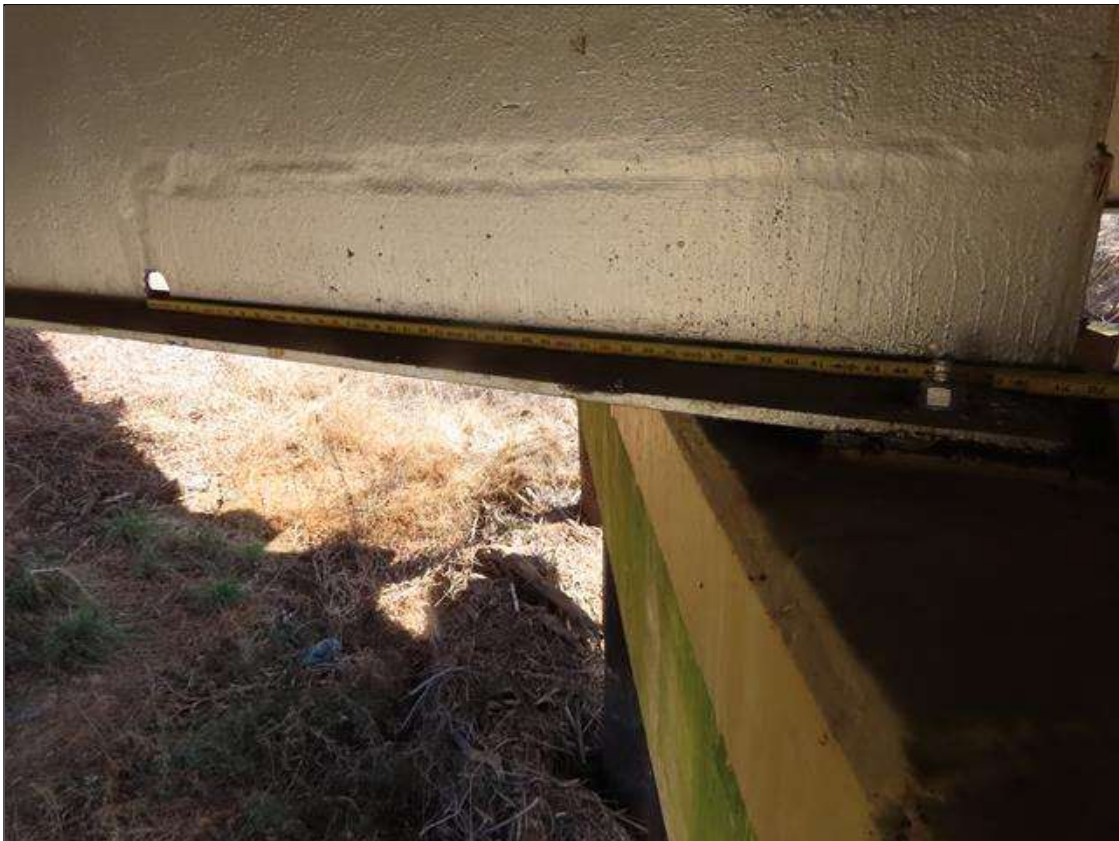
SPAN 5 BEAM 2 - BOTTOM FLANGE & WEB REPAIR (48IN L. X 6IN H.) AT NEAR END WITH 2IN DIAM. HOLE AT FAR END OF REPAIR

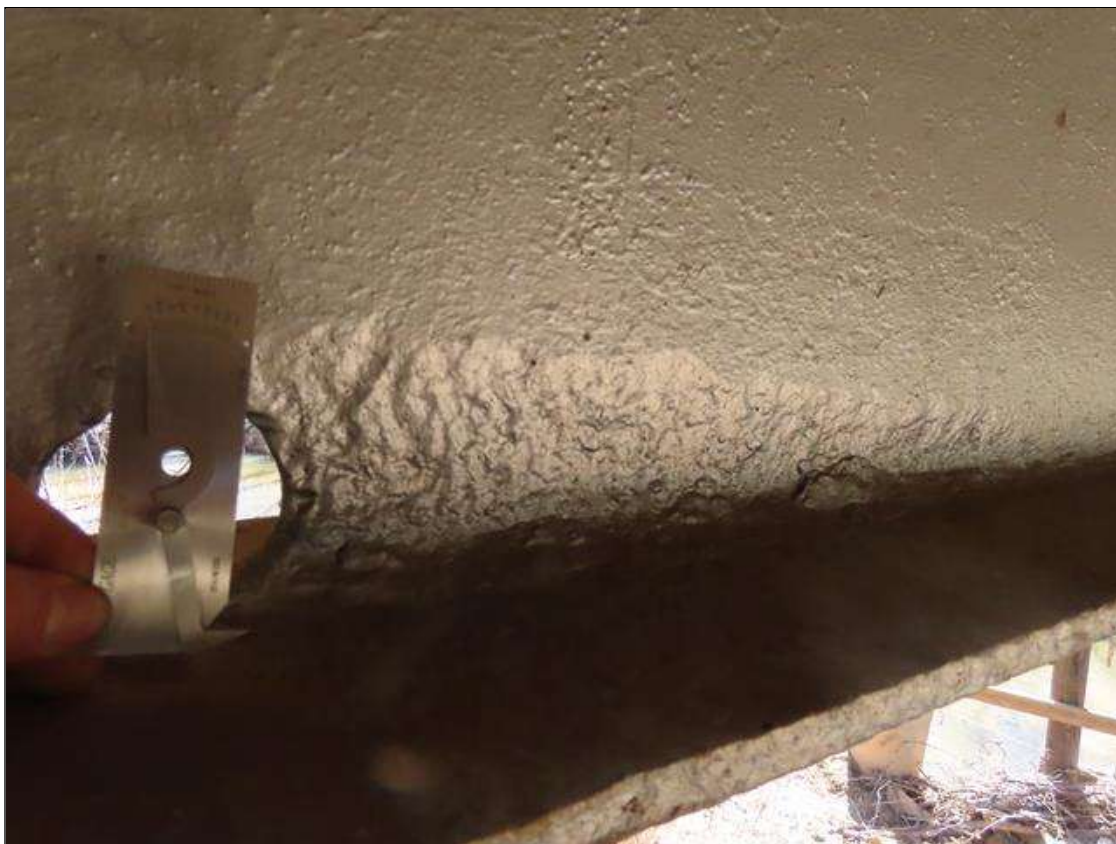
SPAN 4 BEAM 2 - ARRESTED WEB SECTION LOSS (UP TO 1/4IN SL, 1/4IN REMAIN) 2.5IN H. X 2FT L. STARTING 28IN FROM FAR END. (PAR)

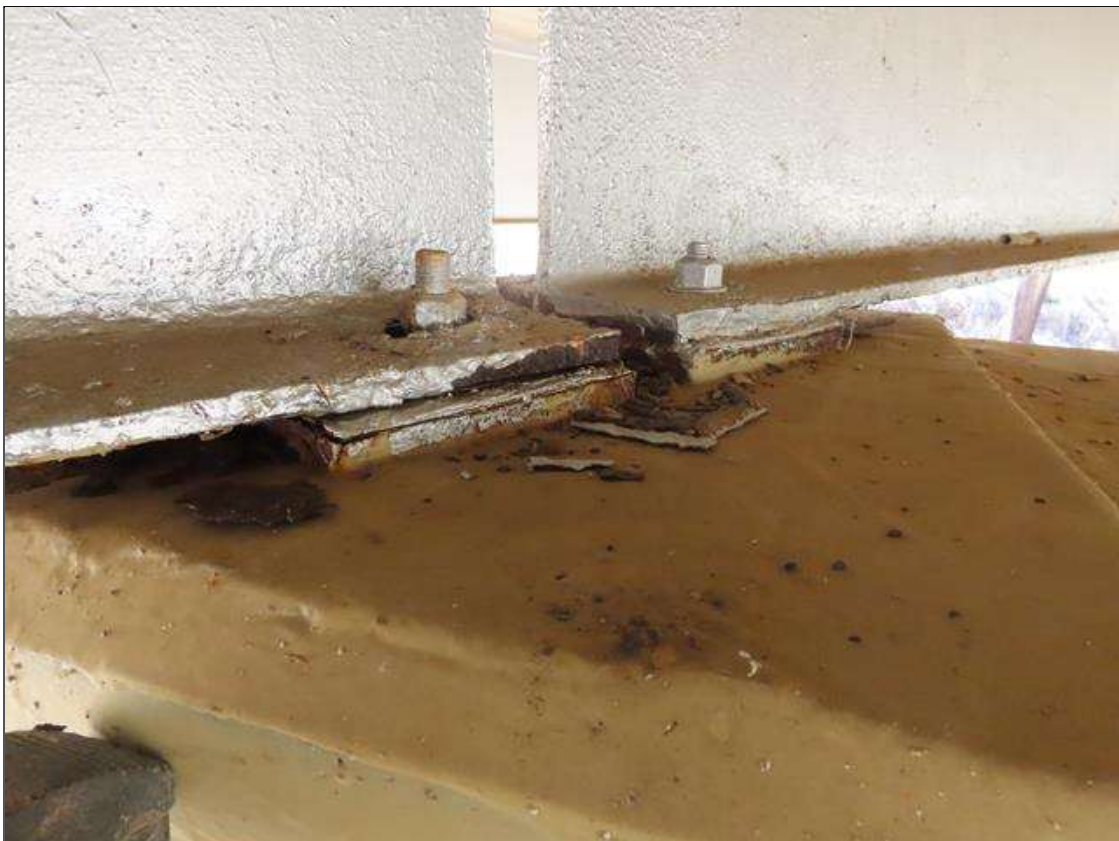
TYPICAL BEARINGS AT BENT 4, BEAMLIN 3 - MINOR TO MODERATE SCALE & CORROSION

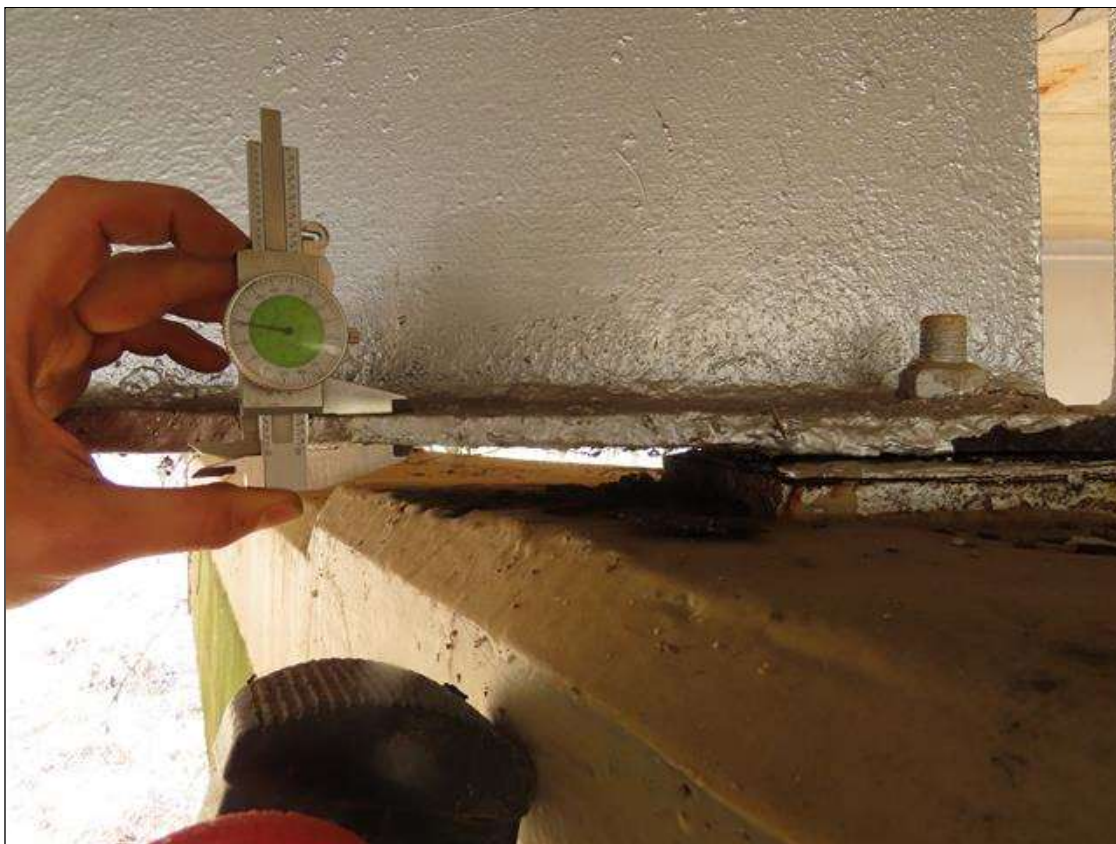
SPAN 5 BEAM 3 - BOTTOM FLANGE SECTION LOSS (UP TO 30%, 3/16IN SL, 7/16IN REMAIN) FULL W. FOR 6IN L. AT NEAR END. (PAR)

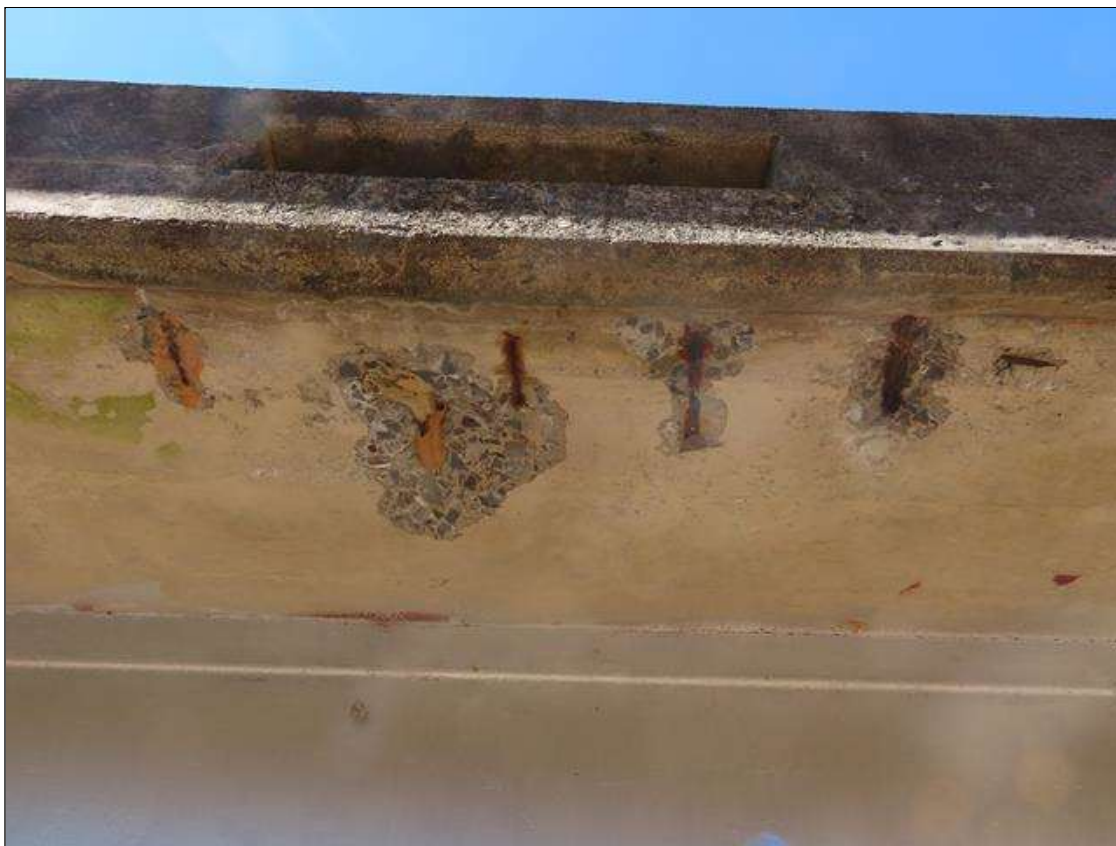
SPAN 5 DECK - SPALLING (UP TO 12IN DIAM. X 1IN D.) WITH EXPOSED & CORRODED (1/16IN SL) REBAR TO BOTTOM OF RIGHT SIDE OVERHANG 10FT FROM END BENT 2. (PAR)

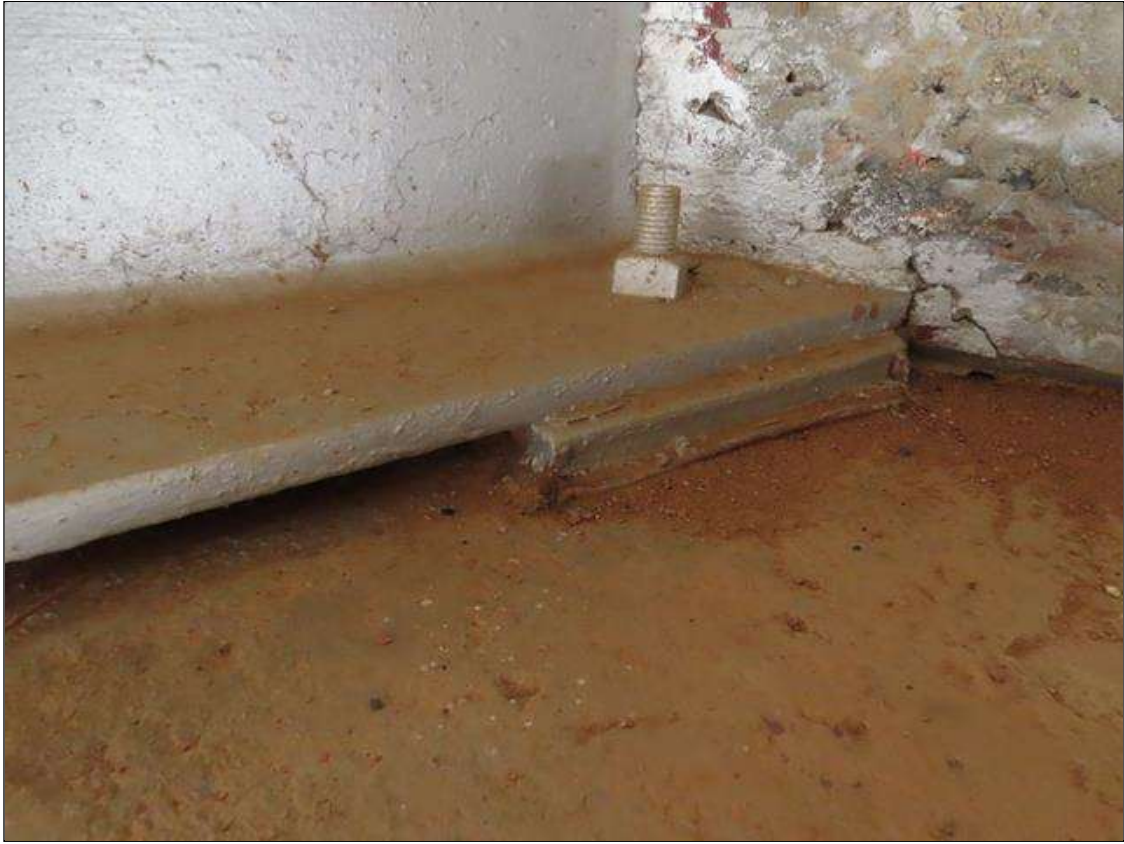
TYPICAL BEARING AT END BENT 2, BEAM 3

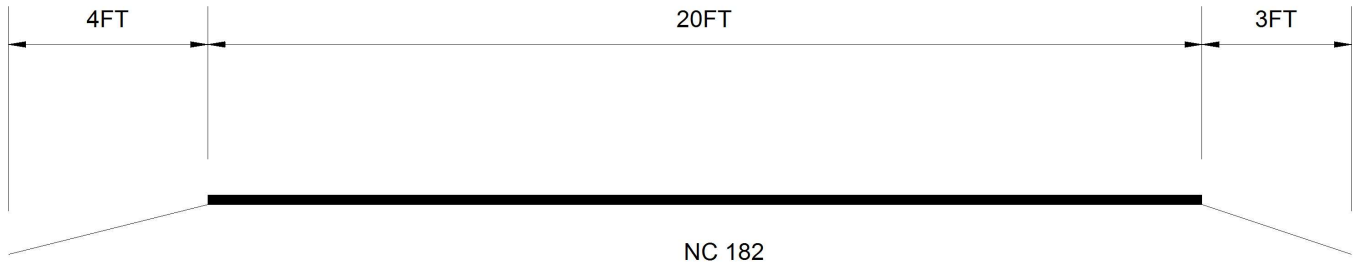
MEASUREMENTS TAKEN 130FT FROM NEAR END OF BRIDGE

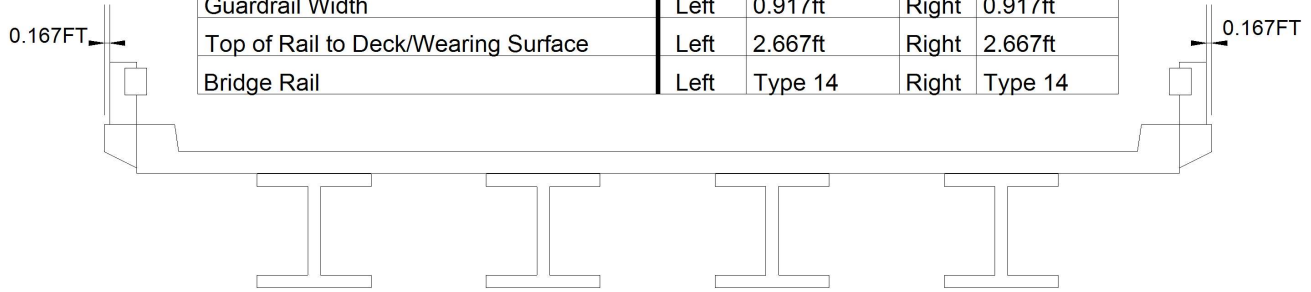
Measurements for Span #	1		
Deck Thickness	0.542	Left Overhang	4
Top of Rail to Bottom of Beam	5.4	Right Overhang	4

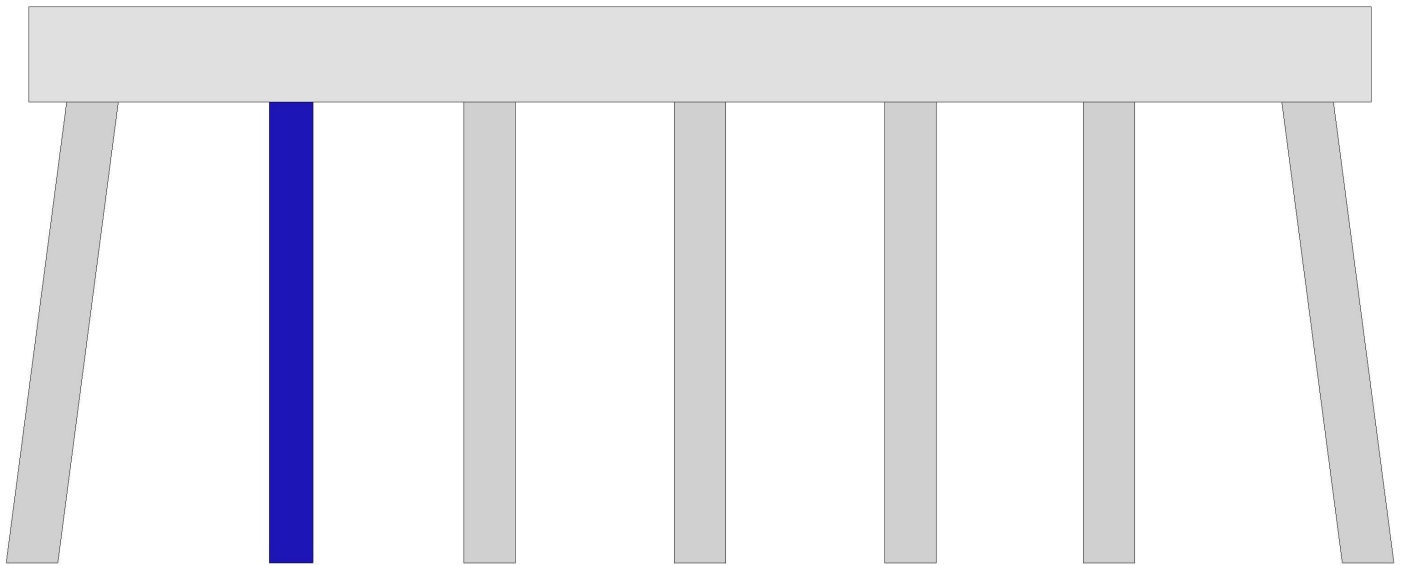
Cap Information			Material Cast-in-Place Concrete							
Length	Width	Height	Left Overhang	Right Overhang	Left Beam to End of Cap.	Right Beam to End of Cap.

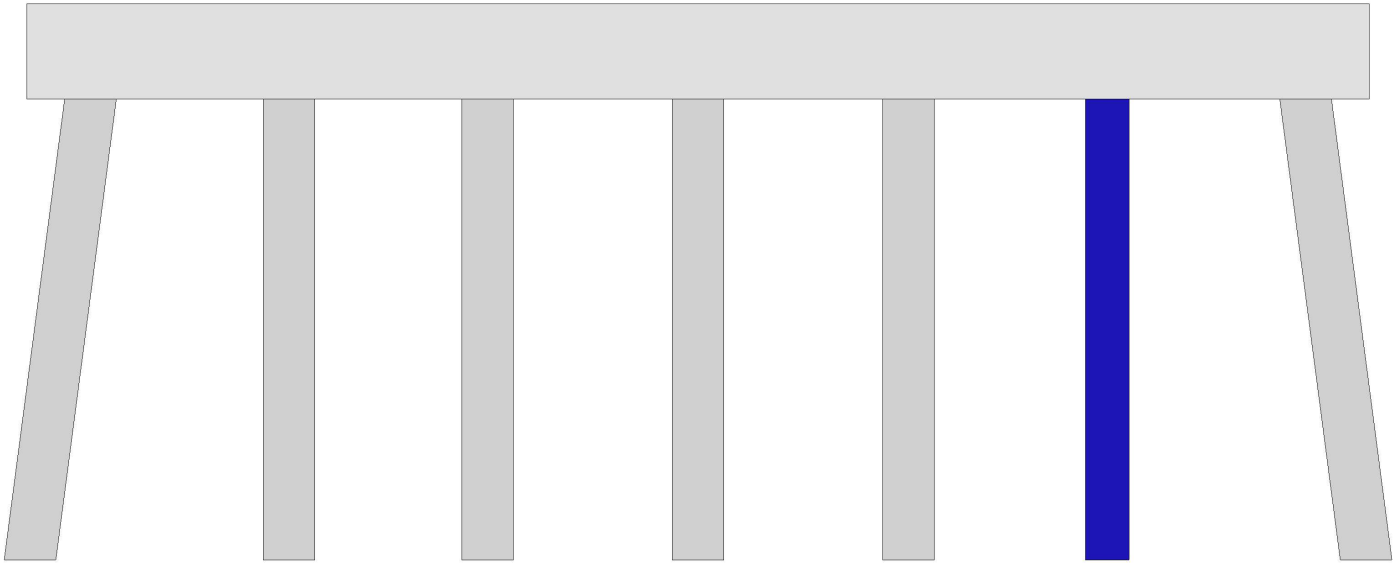
Cap Information			Material Cast-in-Place Concrete							
Length	Width	Height	Left Overhang	Right Overhang	Left Beam to End of Cap.	Right Beam to End of Cap.

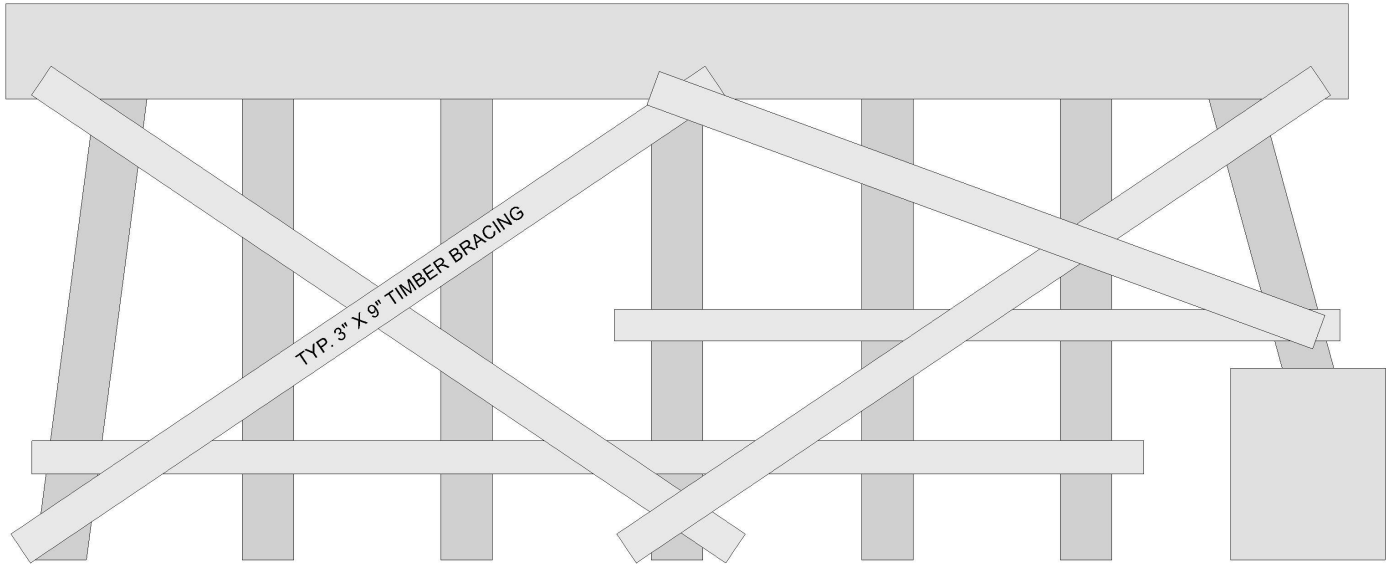
Cap Information			Material Cast-in-Place Concrete							
Length	Width	Height	Left Overhang	Right Overhang	Left Beam to End of Cap.	Right Beam to End of Cap.

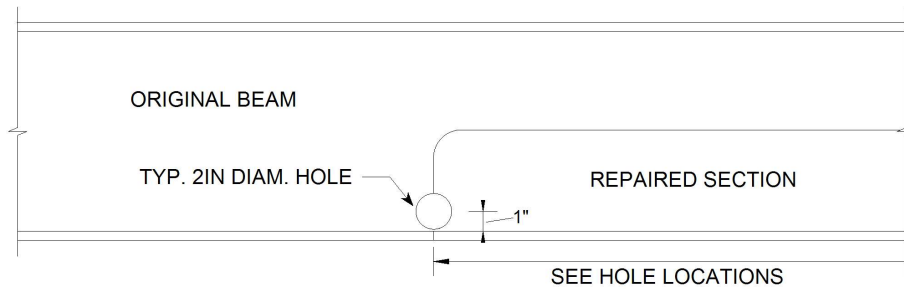
TYP. HOLE IN BEAM WEBS AT END OF REPAIRED SECTION
