NC DEPARTMENT OF TRANSPORTATION  
 DIVISION OF HIGHWAYS  
 STRUCTURE MANAGEMENT UNIT

ATTENTION: **BOAT USED FOR INSPECTION / LADDER USED FOR INSPECTION / "PAR"s ISSUED**

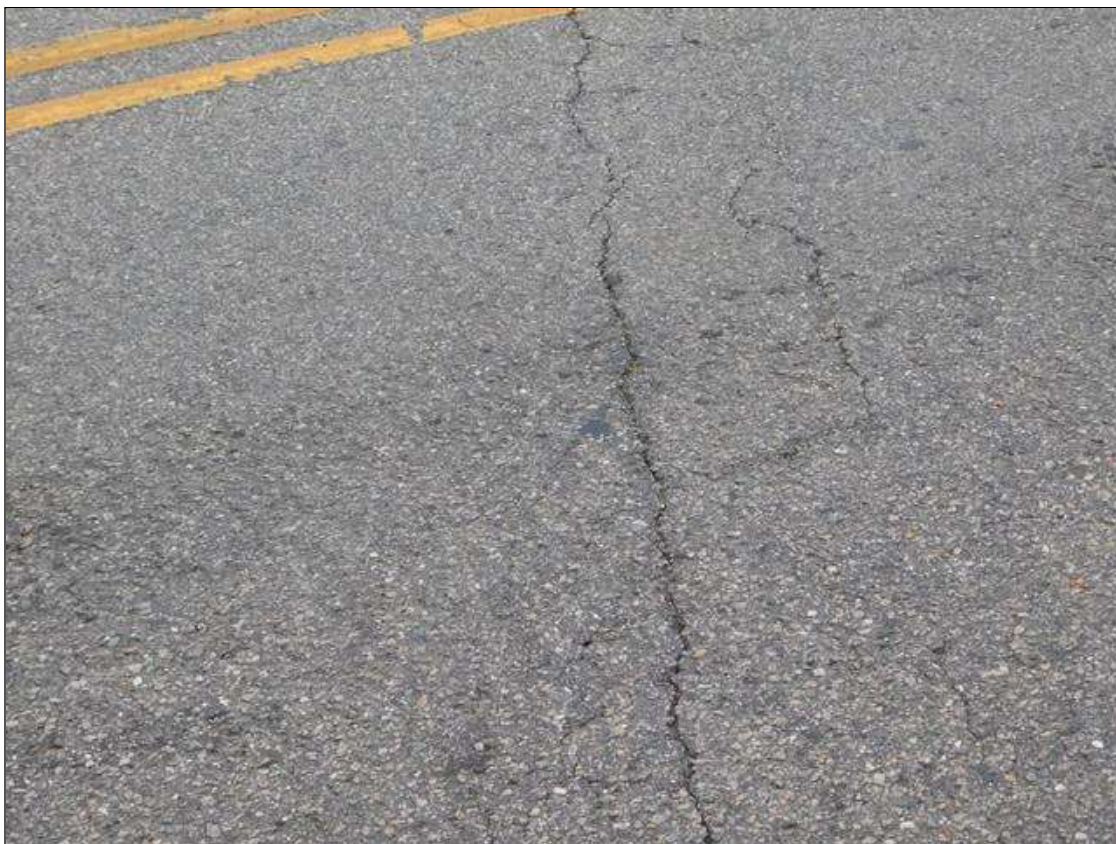
Span 1 Wearing Surface: at End Bent 1, transverse crack [full width x 1/8in]

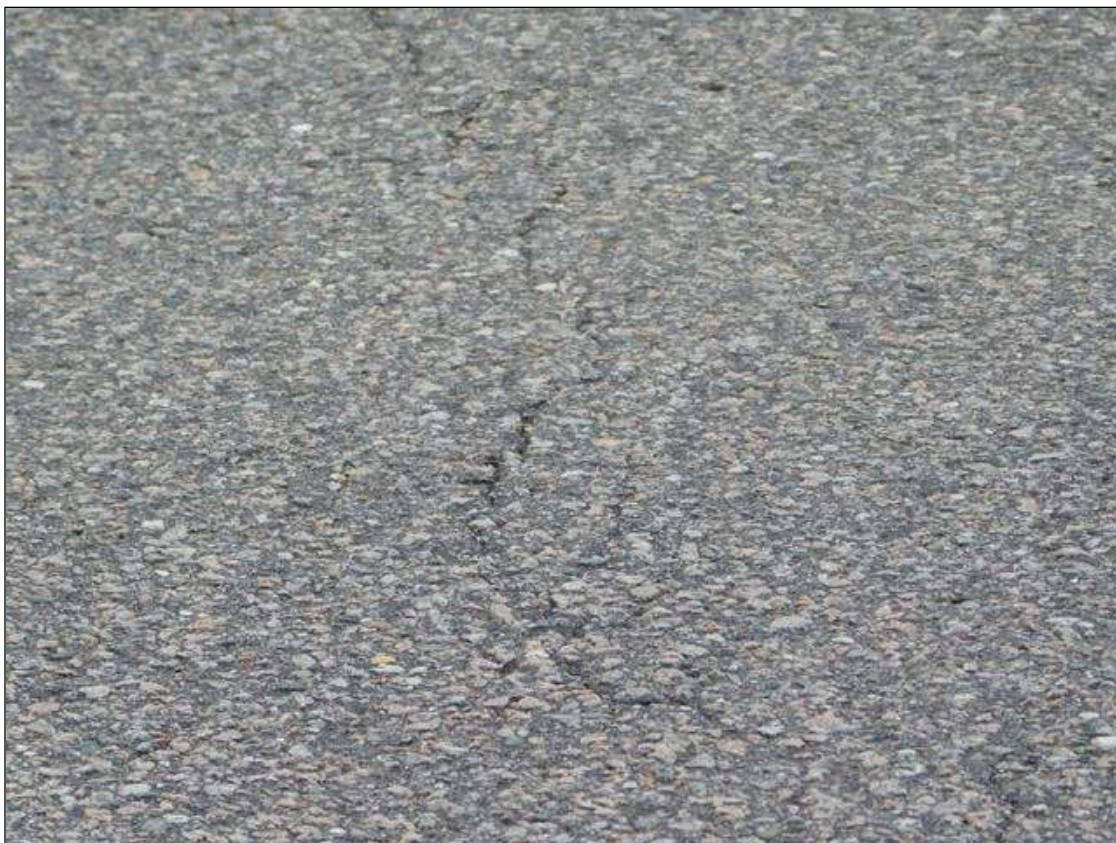
Span 1 Wearing Surface: throughout span, multiple transverse cracks [full width x up to 0.02in]

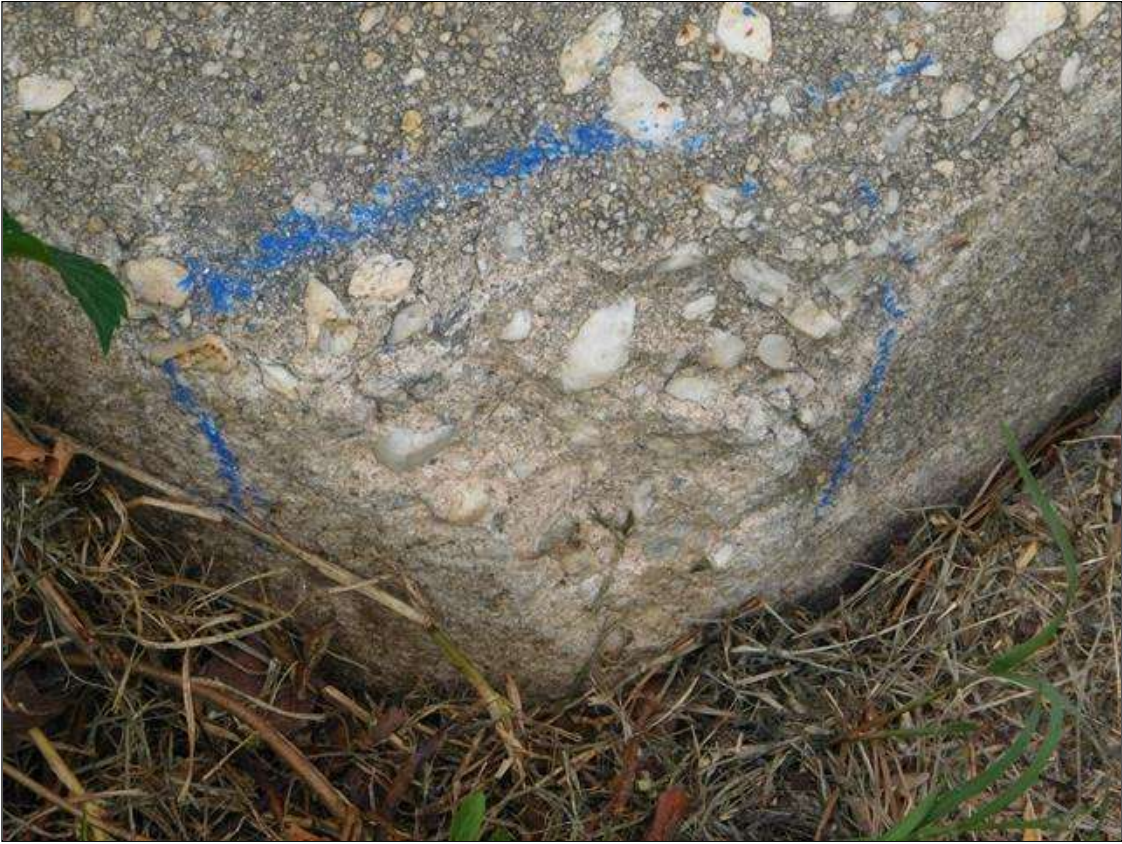
Span 1 Left Bridge Rail: 4" X UP TO 4" X 1/2" SPALL, SOUTHEAST CORNER OF BOTTOM RAIL, AT END BENT 1.

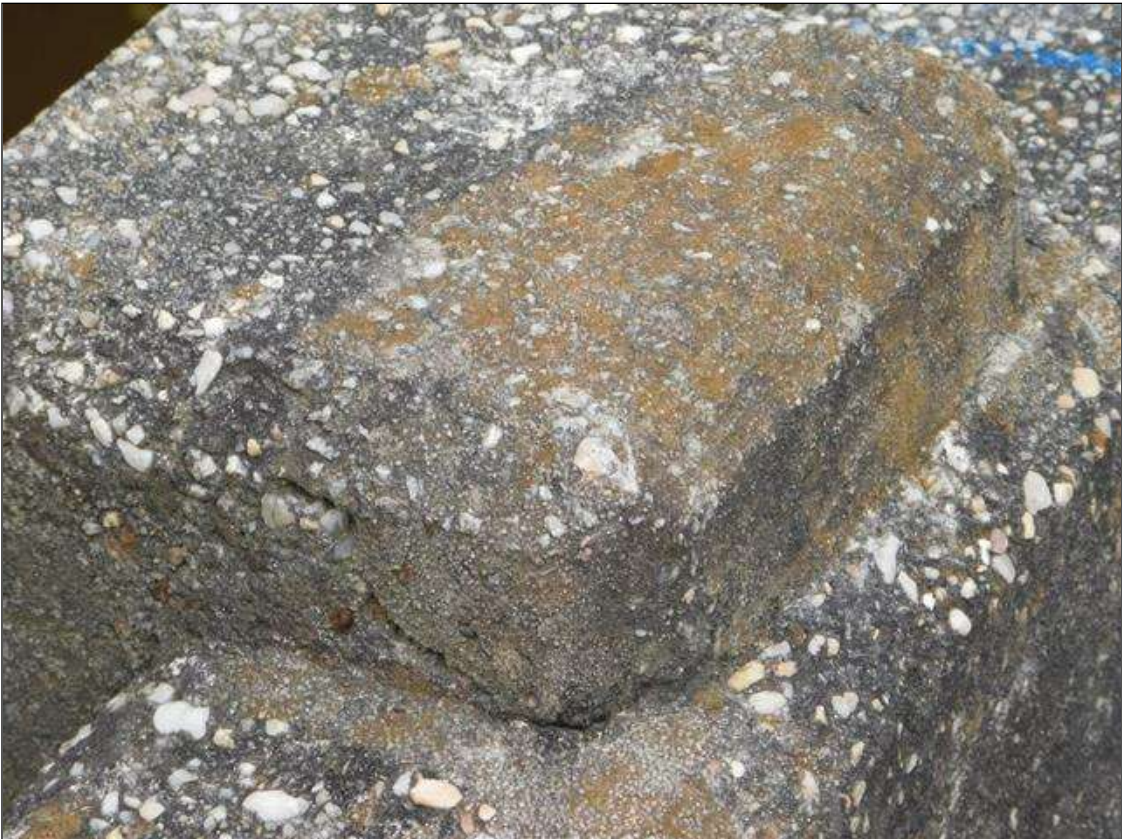
Span 1 Left Bridge Rail: at top of rail post 2 and 3, delamination [7in x 3in]

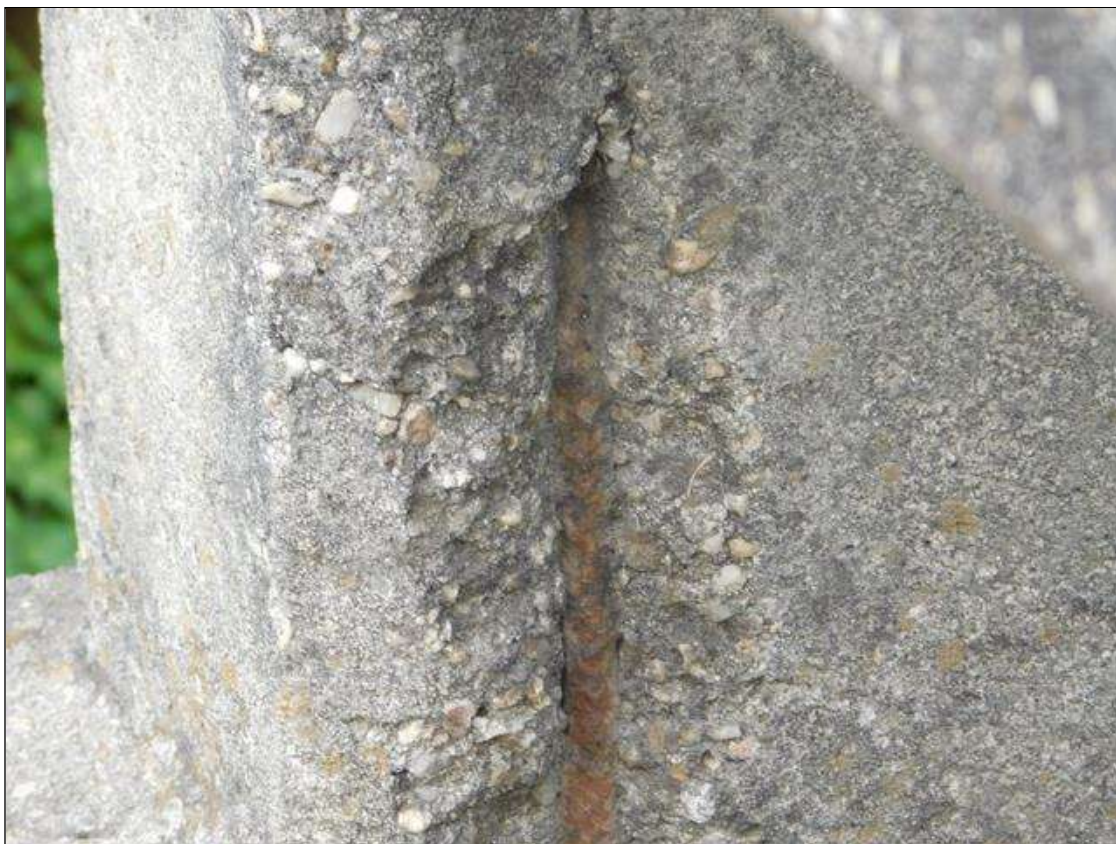
Span 1 Left Bridge Rail: at base of rail post 2, spall [8in x 2in x 3/4in deep] with exposed rusted reinforcing no section loss noted

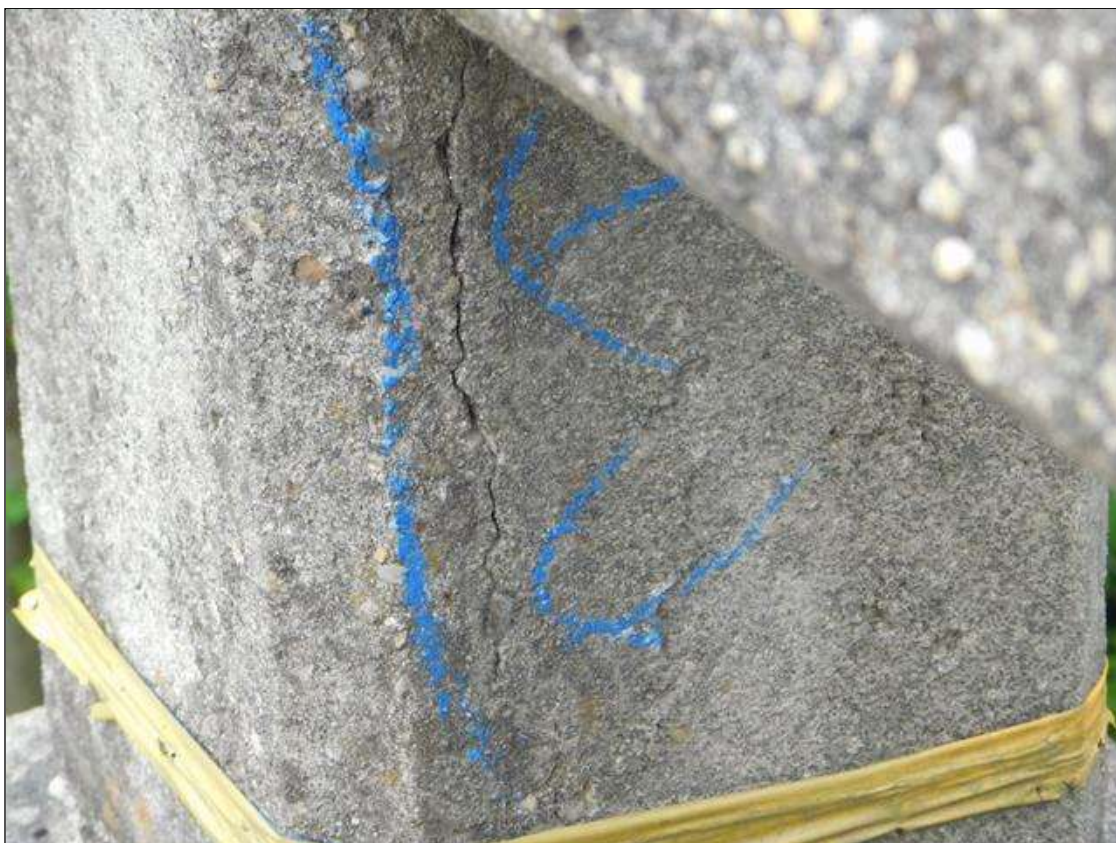
Span 1 Left Bridge Rail: NORTH FACE OF POST 1 HAS A 1/16" WIDE x 8" HIGH VERTICAL CRACK.

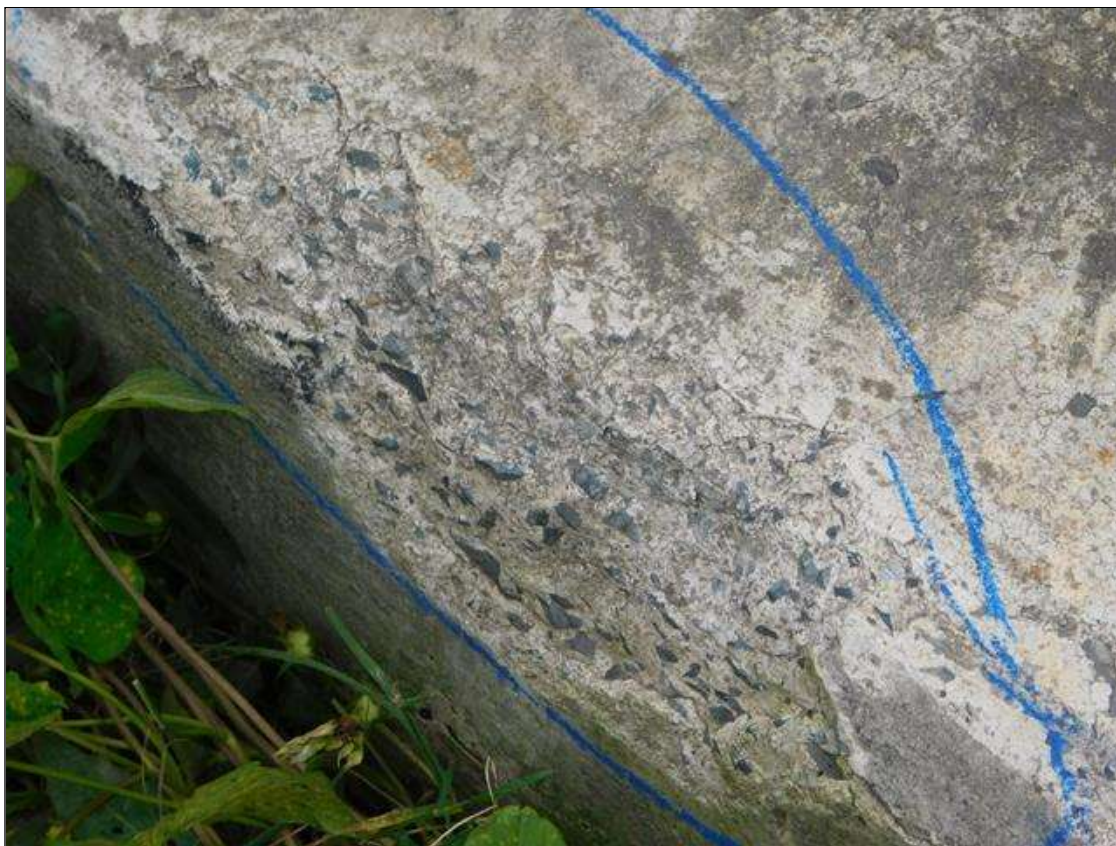
Span 1 Right Bridge Rail: top of curb at End Bent 1, spall [8in x 6in x 3/4in]

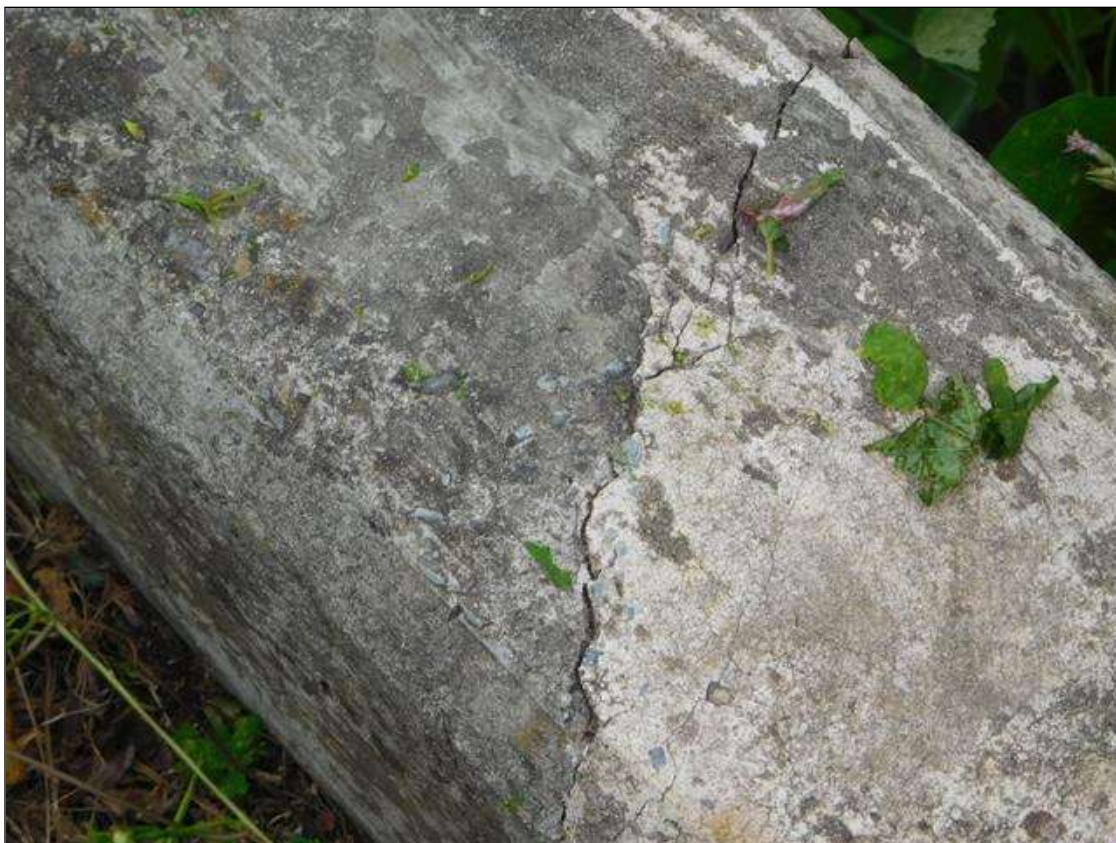
Span 1 Right Bridge Rail: top face of curb at End Bent 1, diagonal crack [8in x 0.02in]

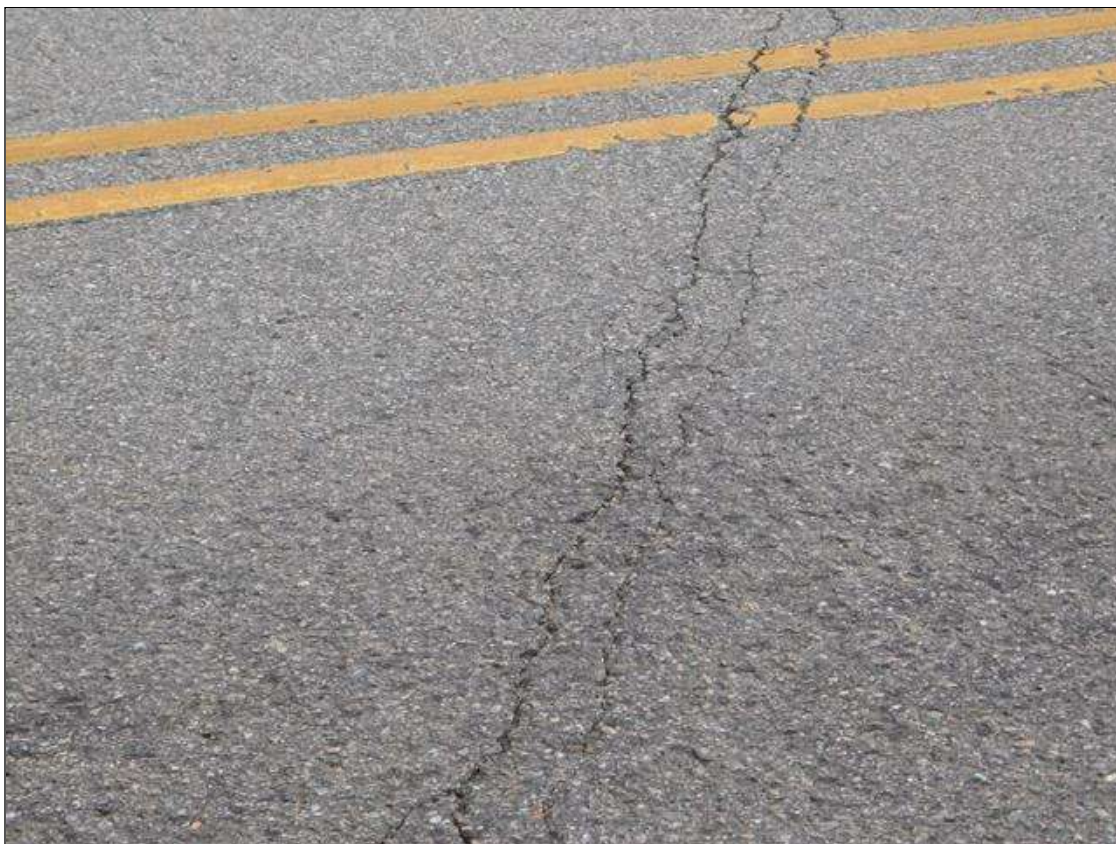
Span 2 Wearing Surface: at bent 1 and End Bent 2, transverse crack [full width x 1/8in]

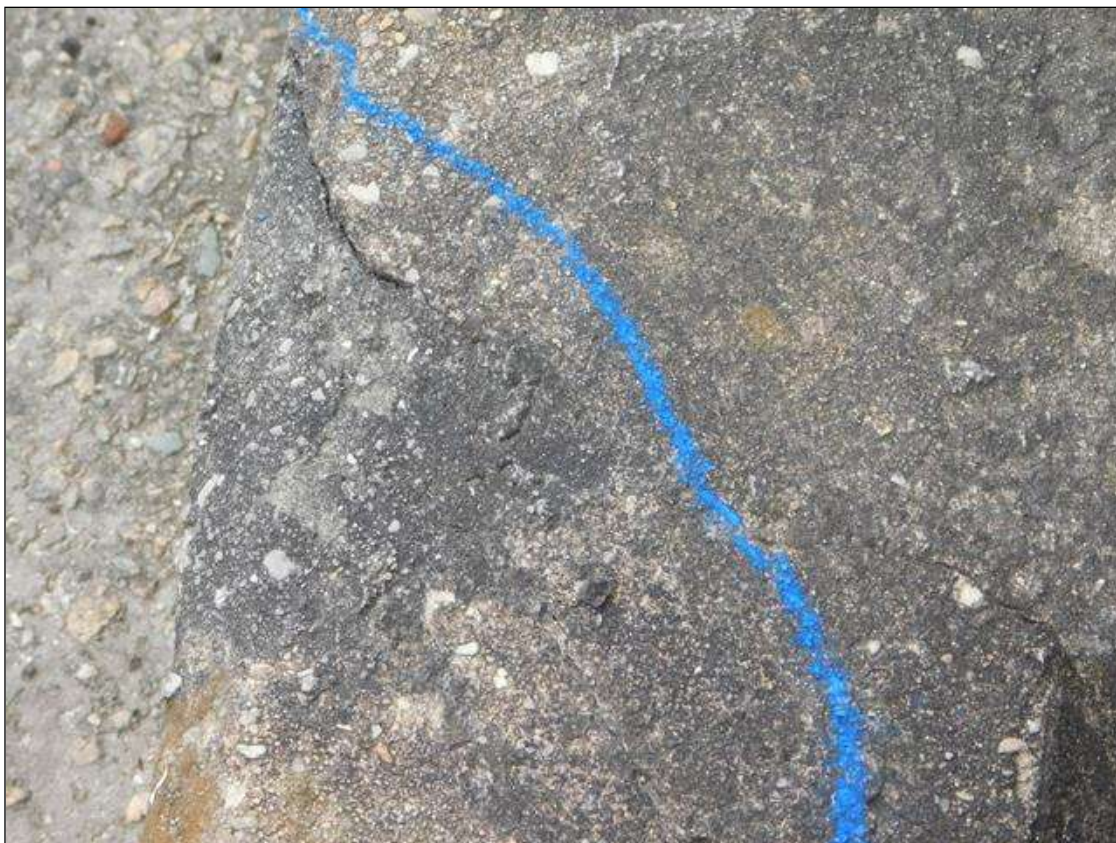
Span 2 Left Bridge Rail: top face of curb at bent 1, diagonal crack [14in x 0.02in]

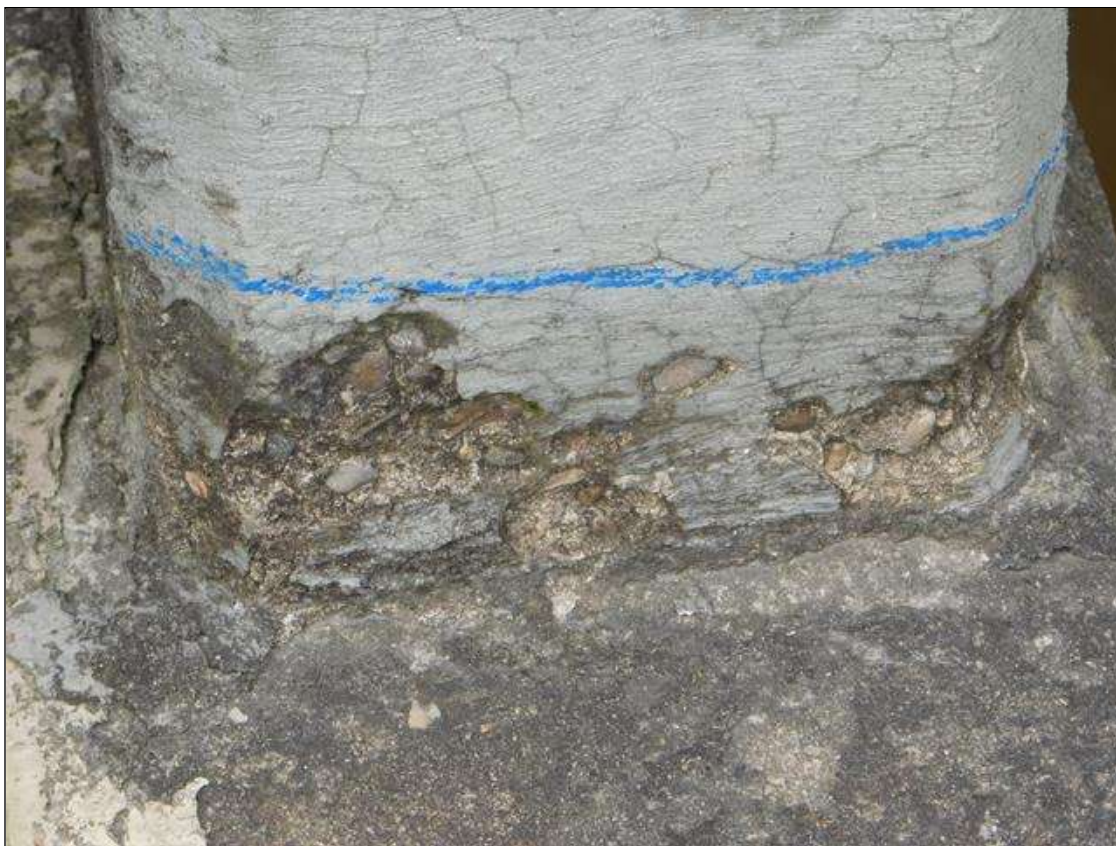
Span 2 Left Bridge Rail: LEFT RAIL POST 1 EAST FACE NEAR BOTTOM. HAS A 10" x 4" x 1/4" DEEP SPALL.

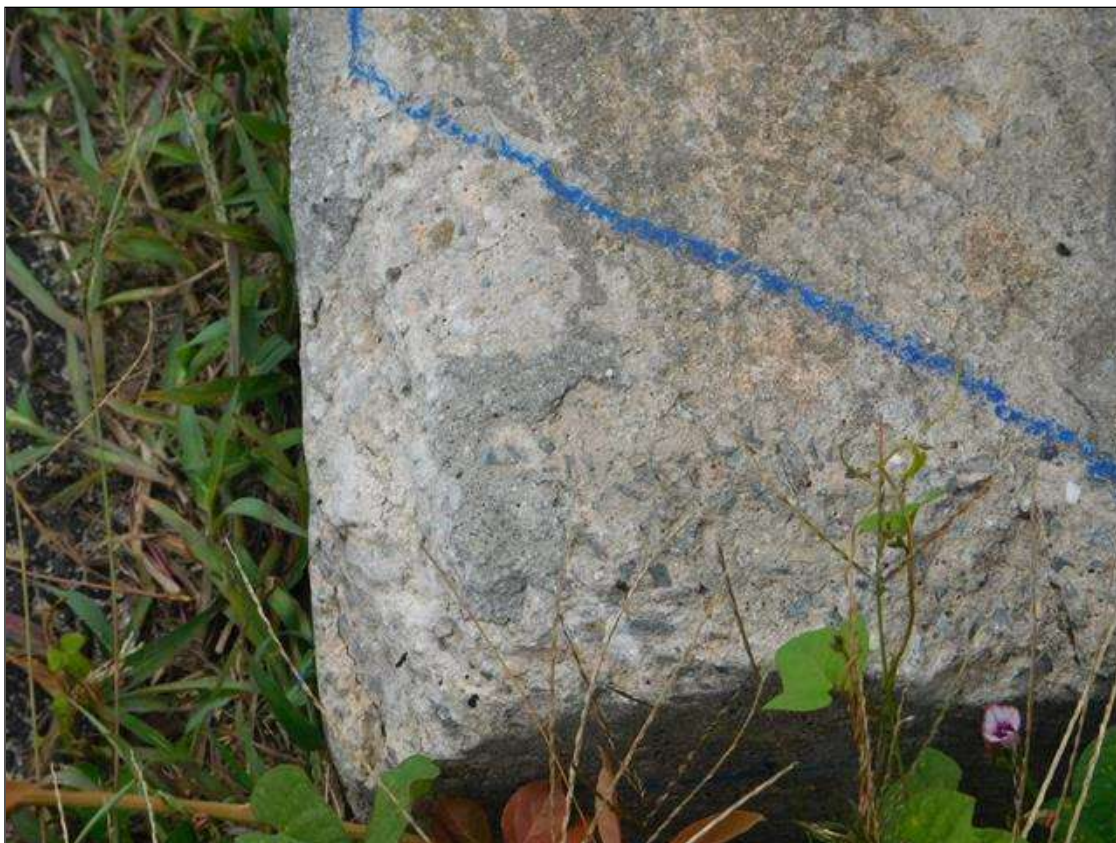
Span 2 Left Bridge Rail: LEFT RAIL NORTHEAST CORNER OF CURB. HAS A 10" x 8" x 1/2" DEEP SPALL.

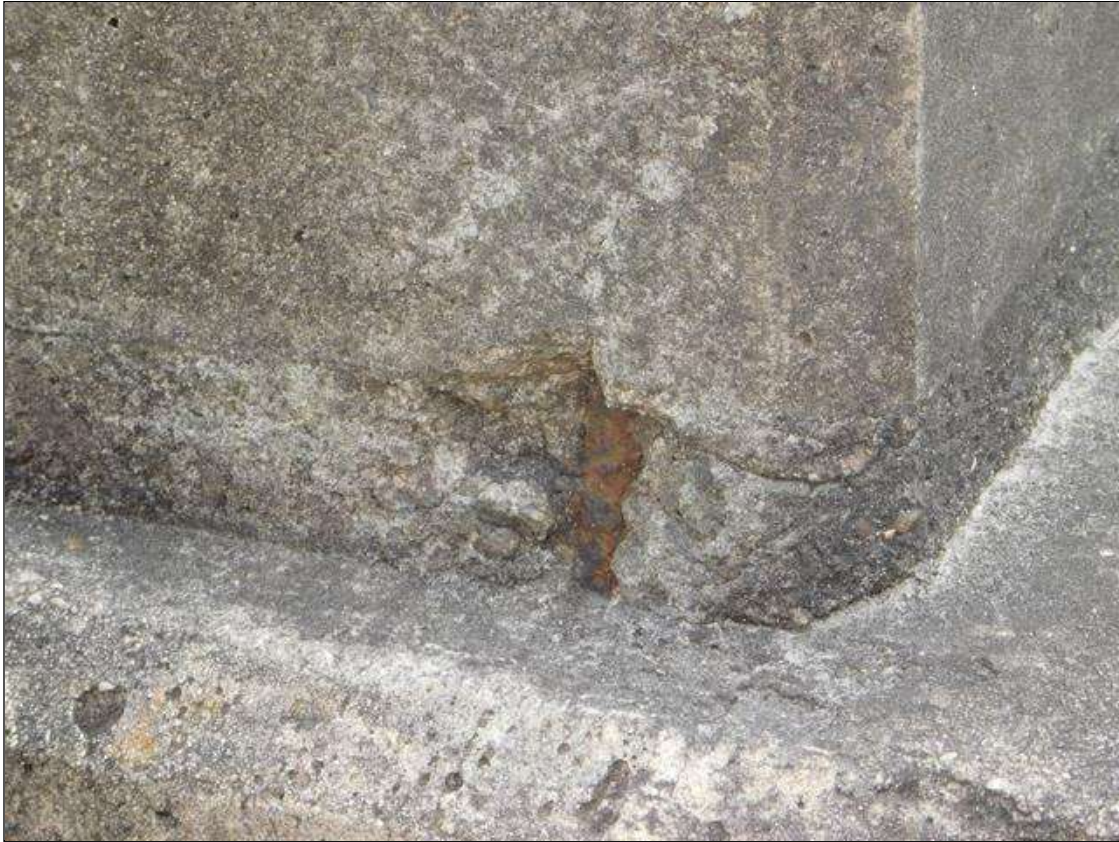
Span 2 Right Bridge Rail: at base of rail post 1, spall [2in x 2in x 1/2in deep] with exposed rusted reinforcing no section loss noted

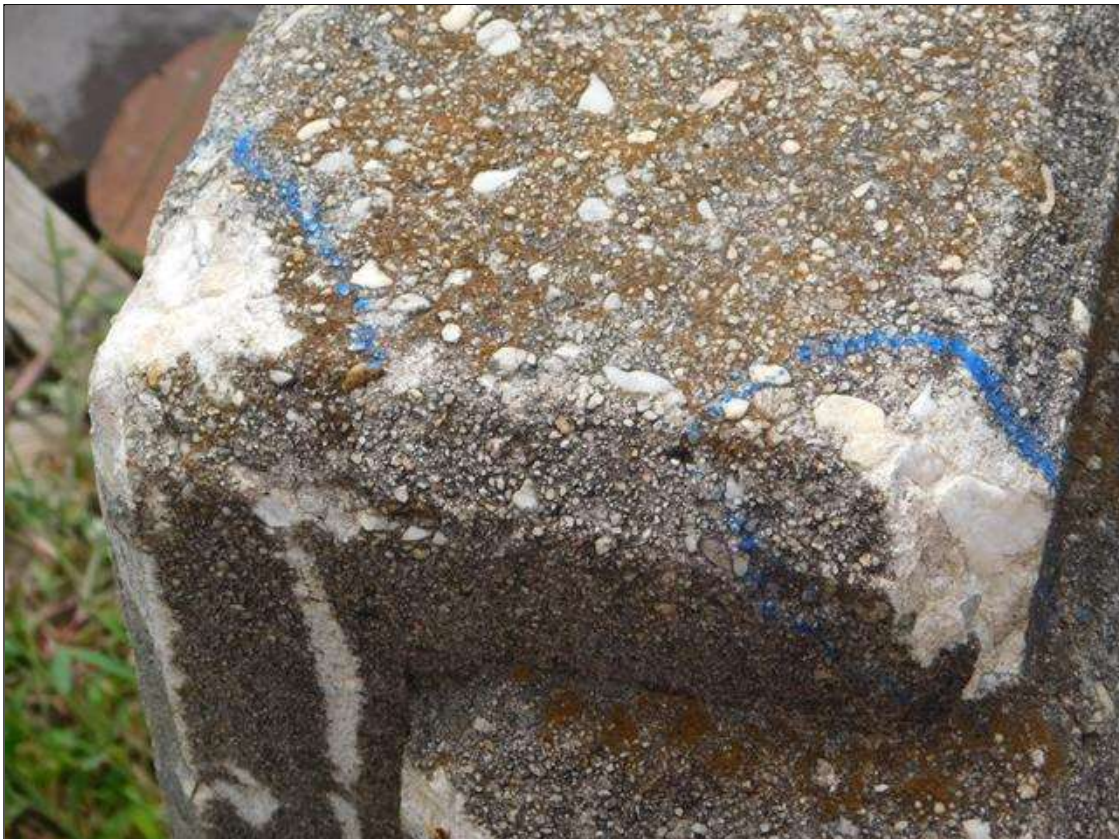
Span 2 Right Bridge Rail: RIGHT RAIL TOP OF END POST AT NORTH END. HAS (2) SPALLED AREAS. AREAS ARE: 2" x 1" x 1/4" DEEP AND 3" x 2" x 1/4" DEEP.

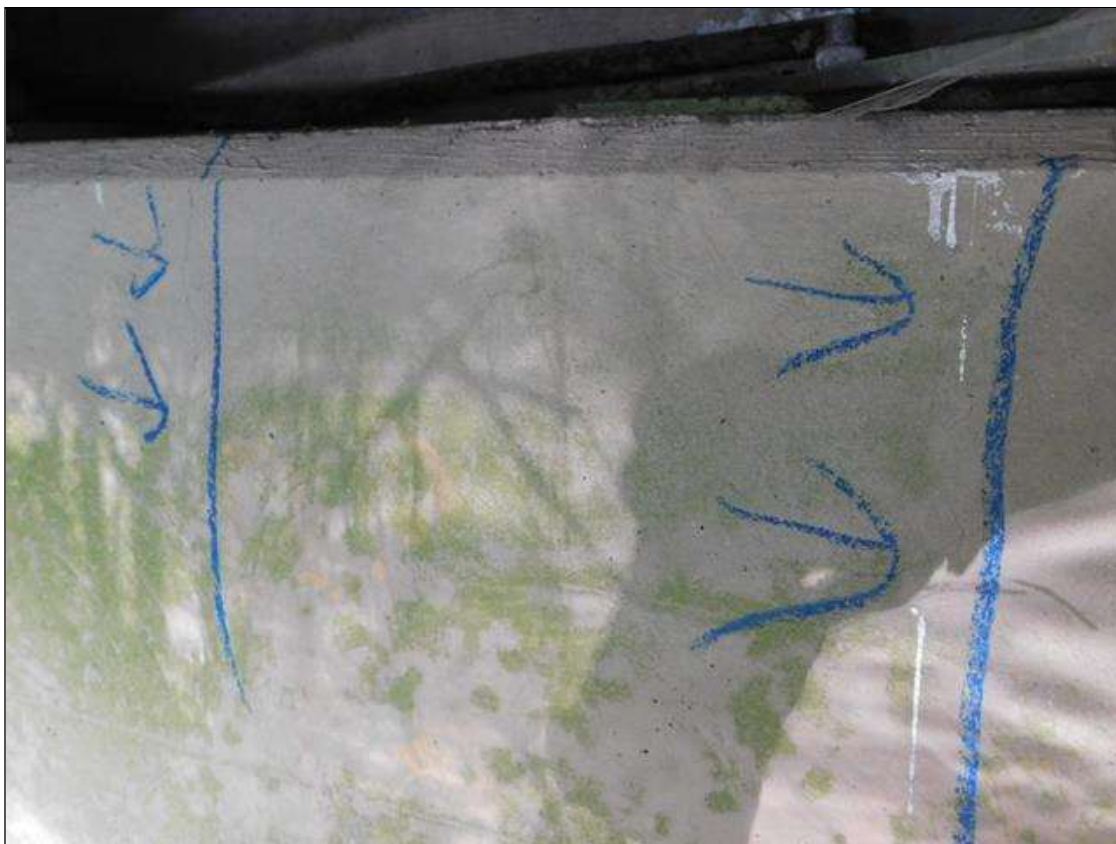
End Bent 1 Cap 1: at bay 9, (2) vertical cracks [1ft x 0.02in]

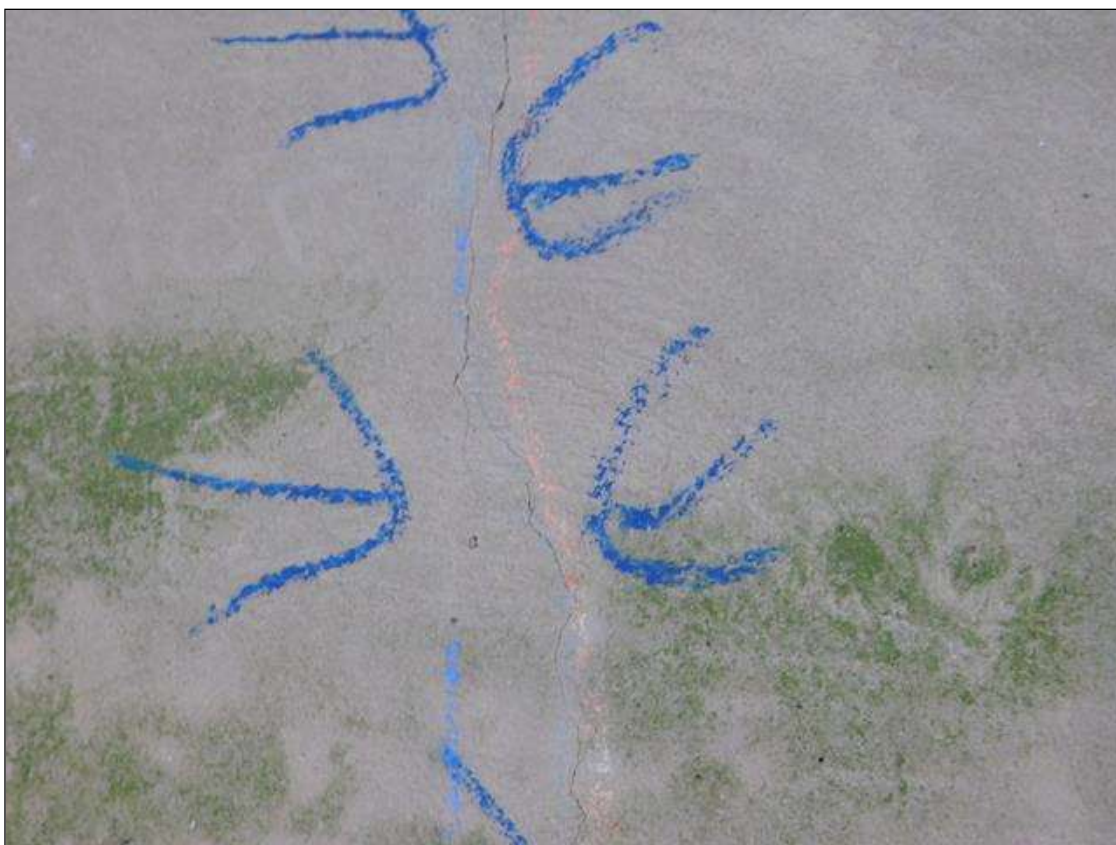
End Bent 1 Cap 1: (8) UP TO 16" X 1/16" VERTICAL CRACKS, NORTH FACE, AT RANDOM THROUGHOUT.

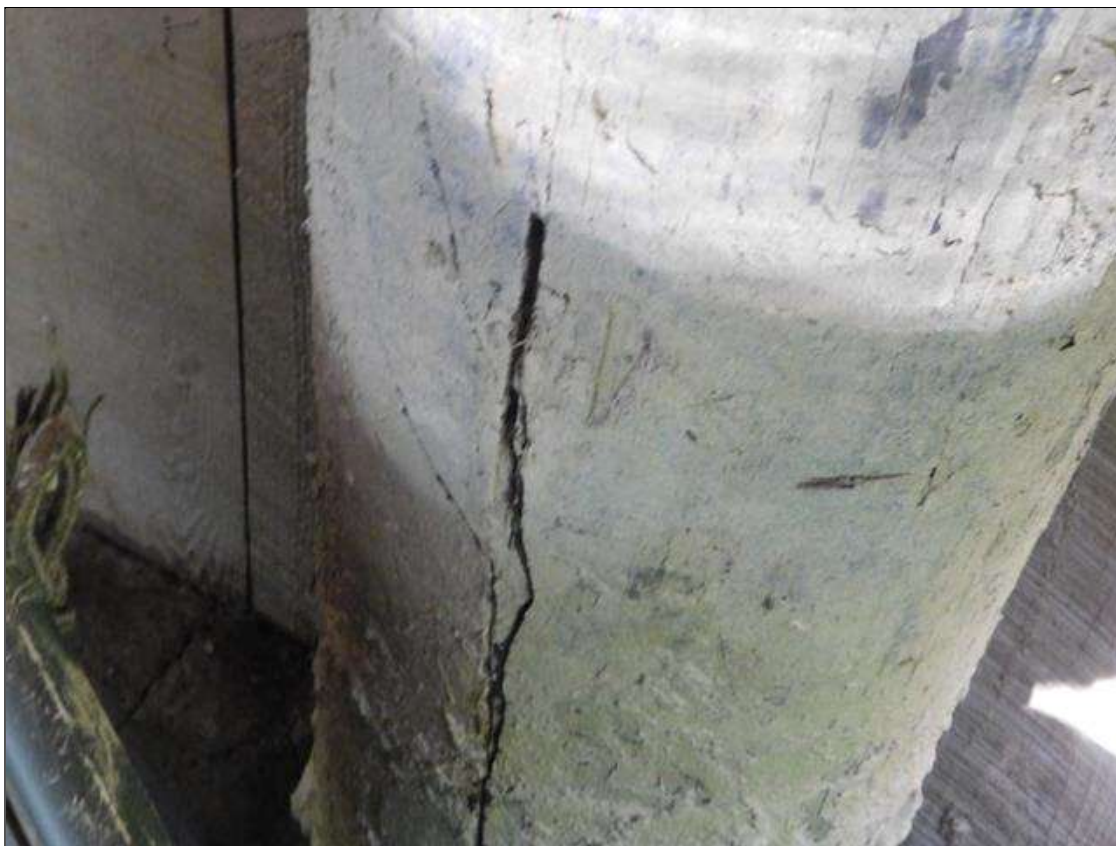
End Bent 1 Pile 2: UP TO 2' X 1/8" X 1/2" CHECKS, AT RANDOM THROUGHOUT.

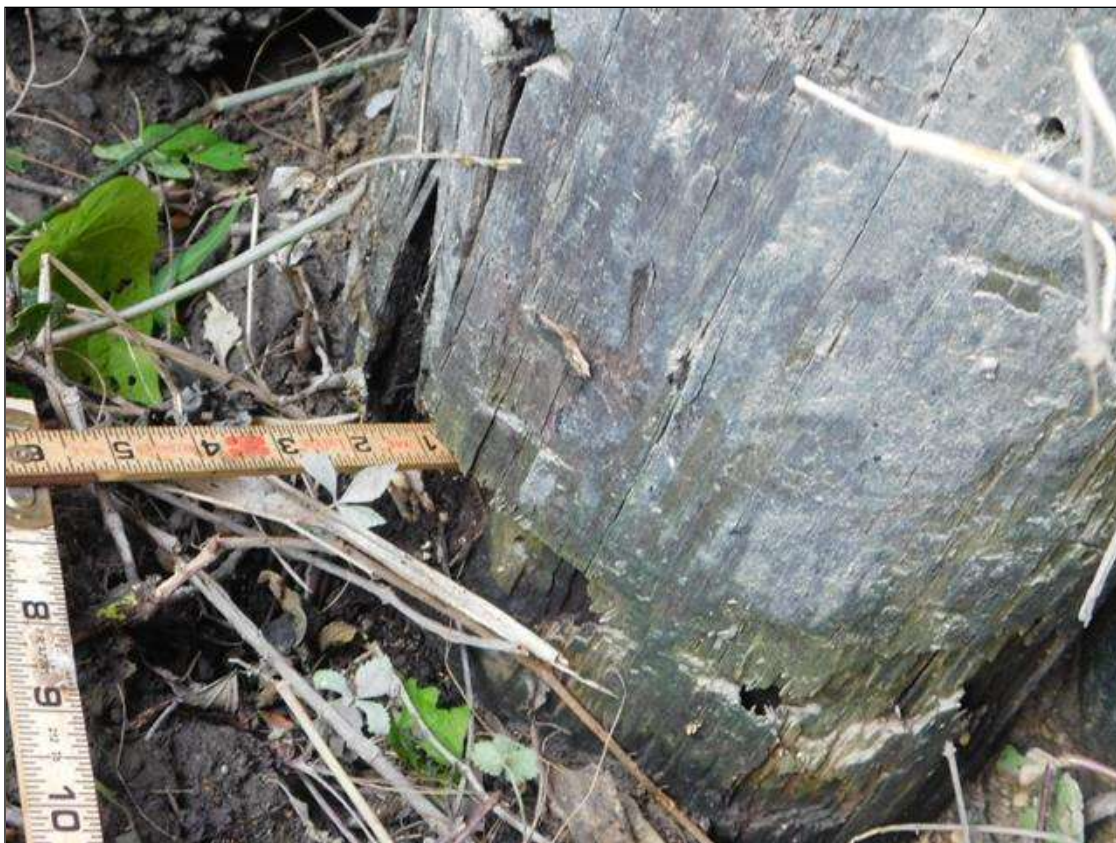
End Bent 1 Pile 5: END BENT 1 PILE 5 NORTH FACE. HAS A 12" x 10" x 1" DEEP AREA OF HEAVY DECAY AT GROUND LINE.

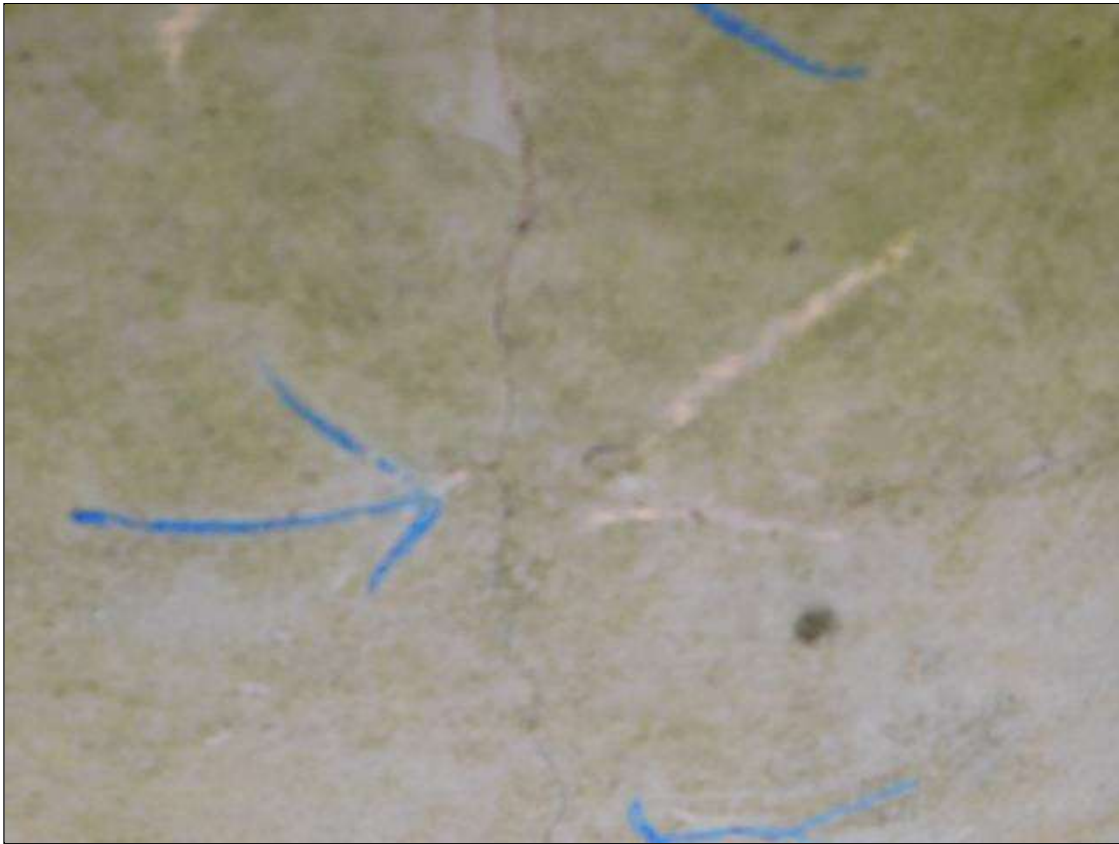
Span 1 Deck: along underside of deck, multiple transverse cracks [up to 8ft x 0.02in]

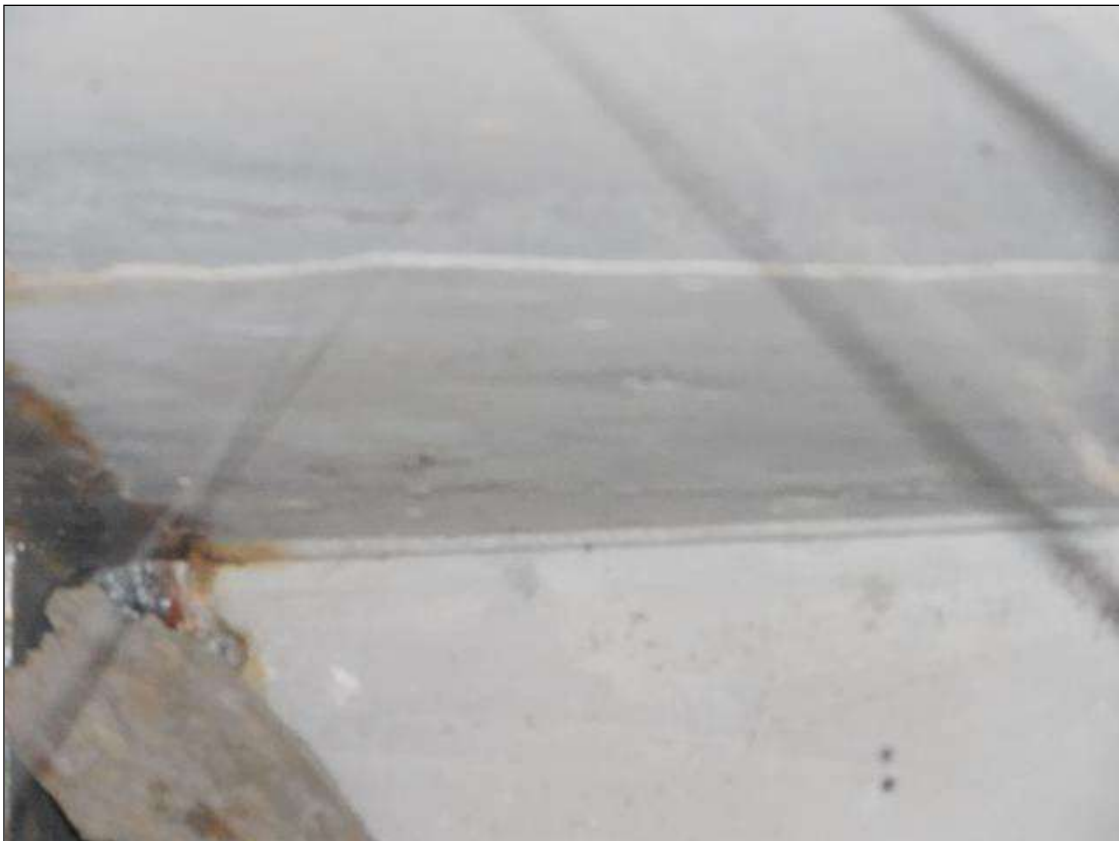
Span 1 Deck: 2.5' X 2' PATCHED AREA, DECK UNDERSIDE, BAY 4, AT BENT 1.

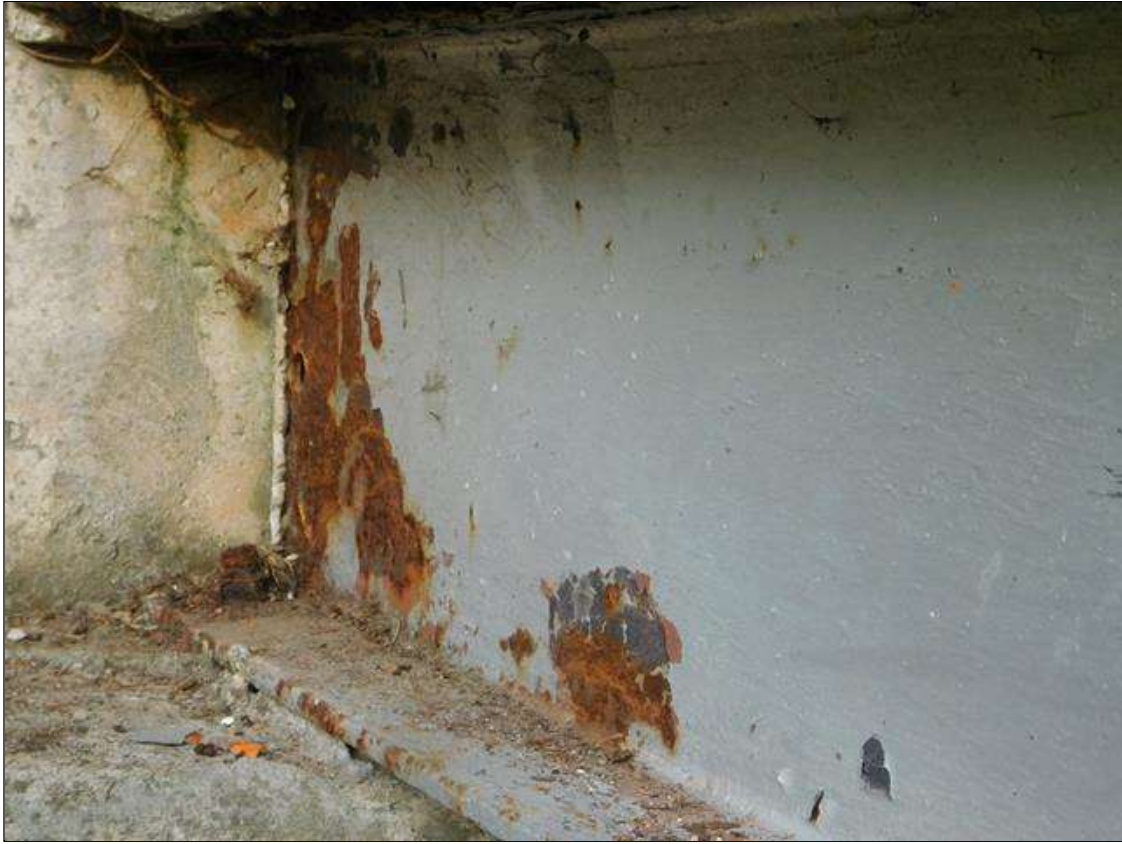
Span 1 Beam 11: at near and far ends, surface corrosion [up to full height x full width]

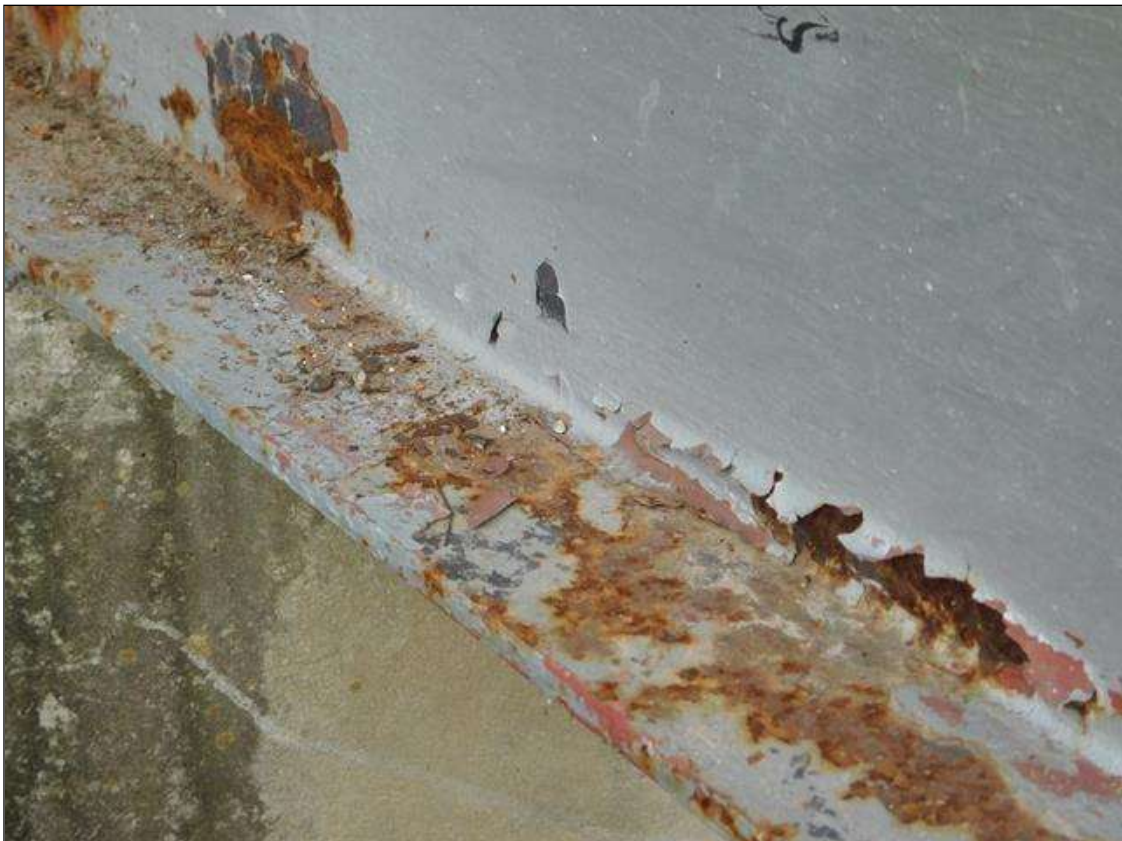
Span 1 Beam 11: 6" OF RUST SCALE, BOTTOM FLANGE, UP TO 2" IN THE WEB, AT END BENT 1.

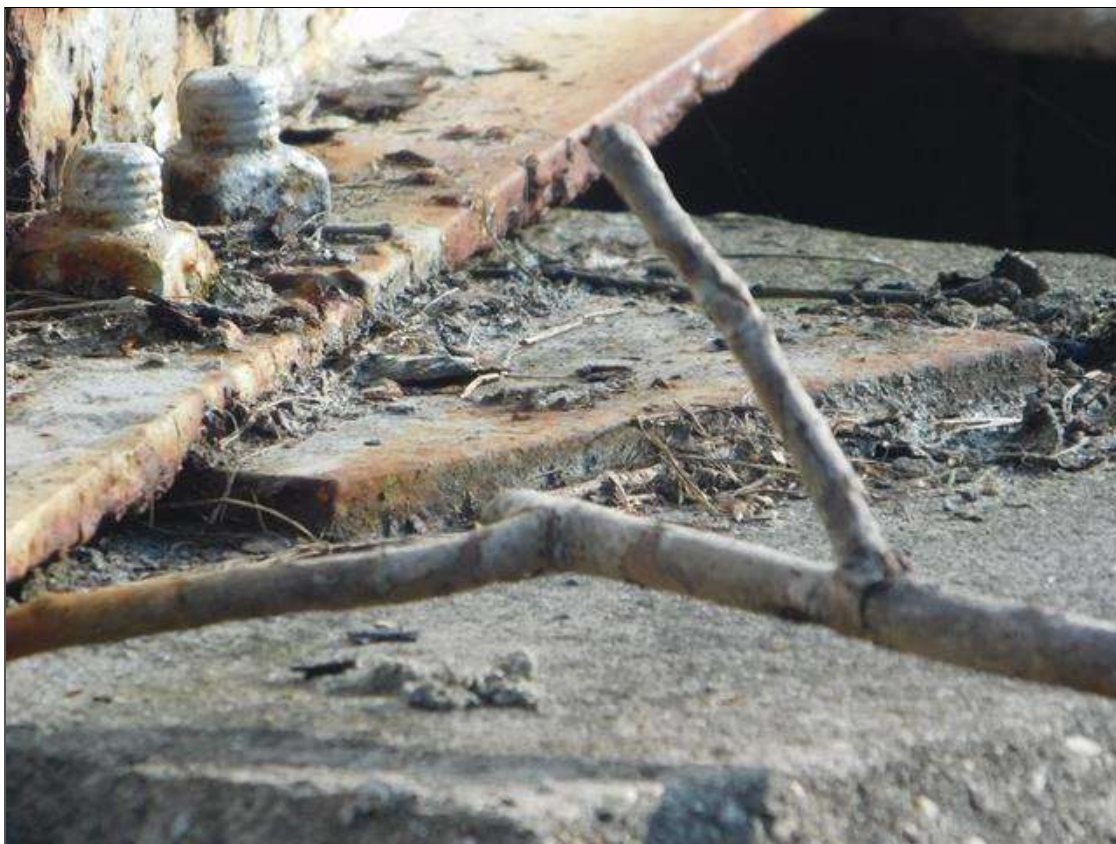
Span 1 Beam 11 - Span 1 Beam 11 Far Bearing: SURFACE RUST, BEARING ASSEMBLY.

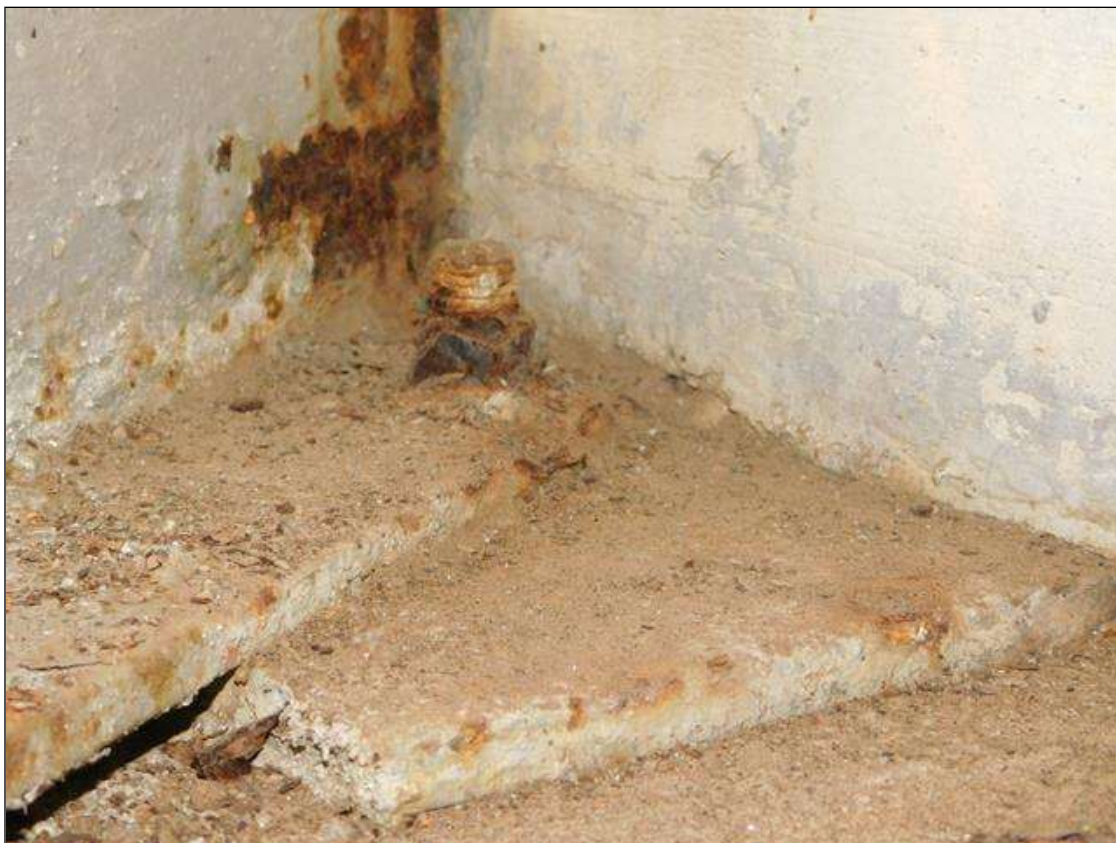
Span 1 Beam 11 - Span 1 Beam 11 Near Bearing: surface corrosion in bearing plate with a 1/16" section loss anchor bolt nut on left and right side.
