NC DEPARTMENT OF TRANSPORTATION  
 DIVISION OF HIGHWAYS  
 STRUCTURE MANAGEMENT UNIT

ATTENTION: **BOAT USED FOR INSPECTION / LADDER USED FOR INSPECTION / "PAR"s ISSUED**

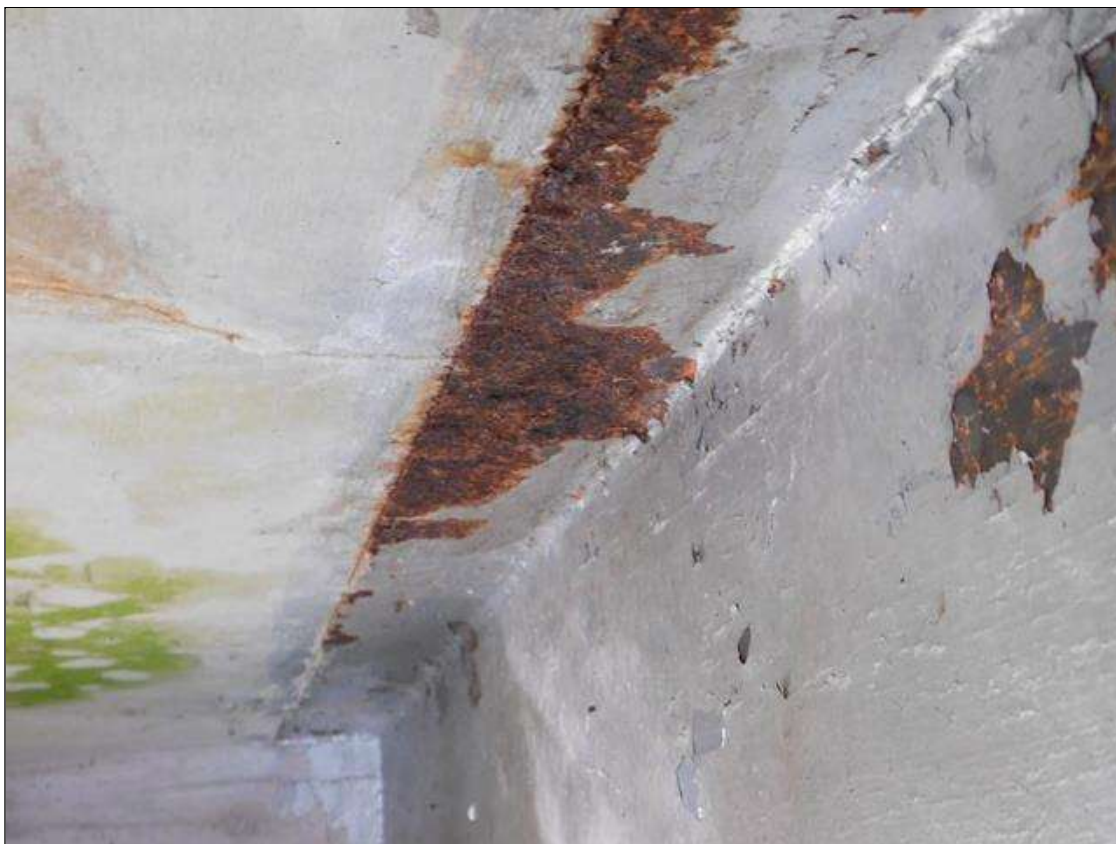
Span 1 Beam 10: BEAM 10 TOP FLANGE. HAS SCATTERED AREAS OF RUST AND FLAKING WITH NO MEASURABLE SECTION LOSS.

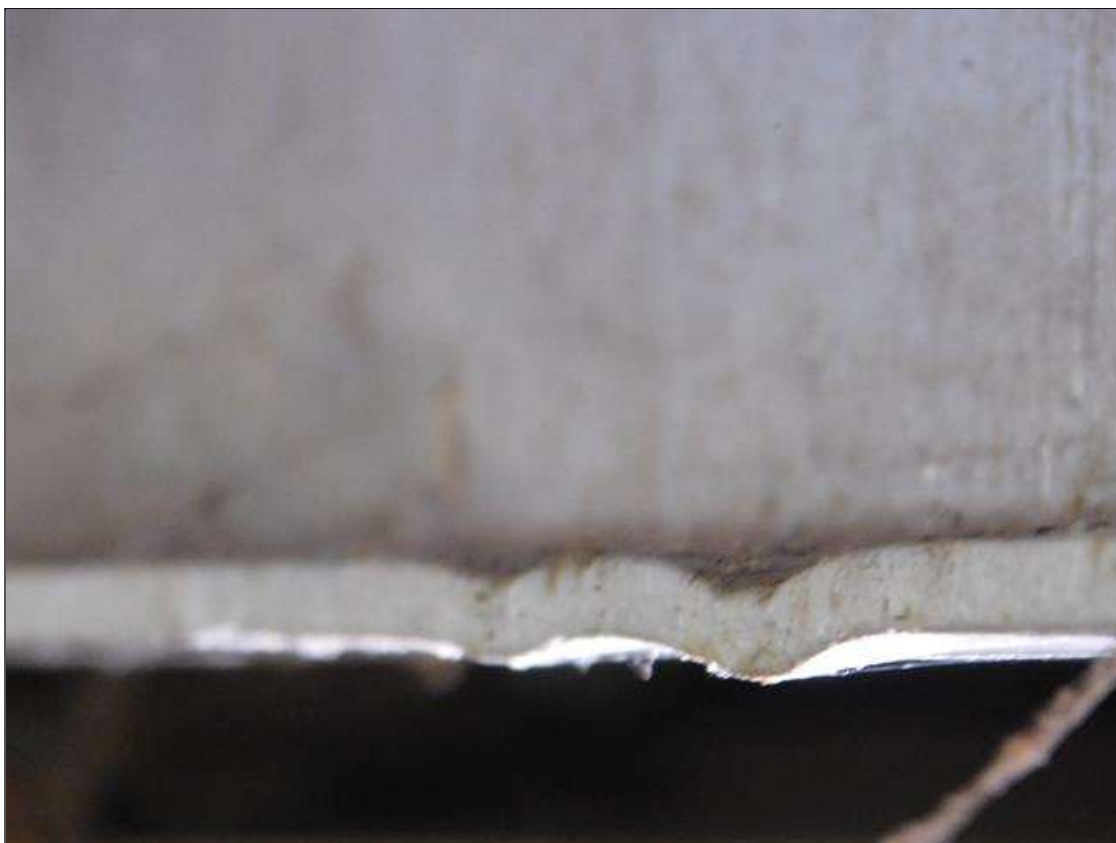
Span 1 Beam 6: West bottom flange near Mid-Span, distortion [6in x 1/4in]

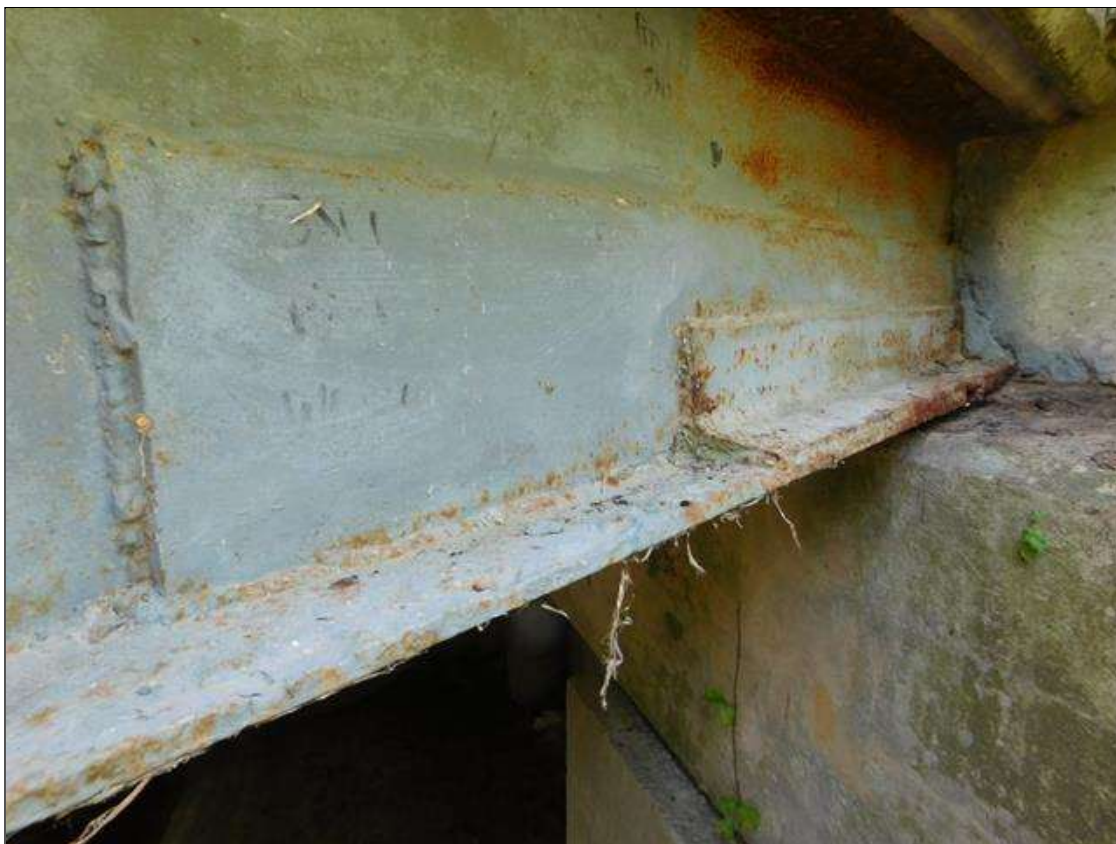
Span 1 Beam 1: 1' OF RUST SCALE, BOTTOM FLANGE, WITH 3/8" REMAINING IN THE BOTTOM FLANGE, WITH 3' X 7" WEB PLATE AND 2' X 3" REPAIR ANGLE ON WEST FACE, AT END BENT 1.

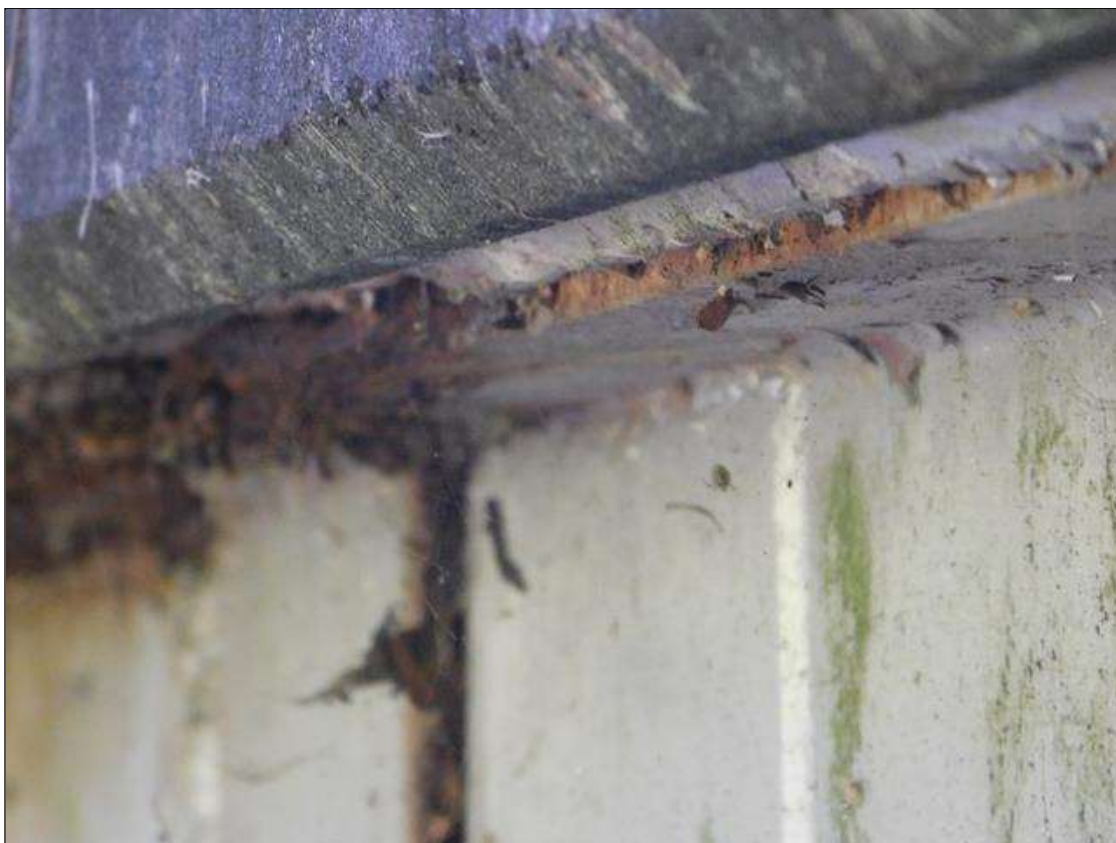
Span 1 Beam 1: at near and far ends, surface corrosion [up to full height x full width]

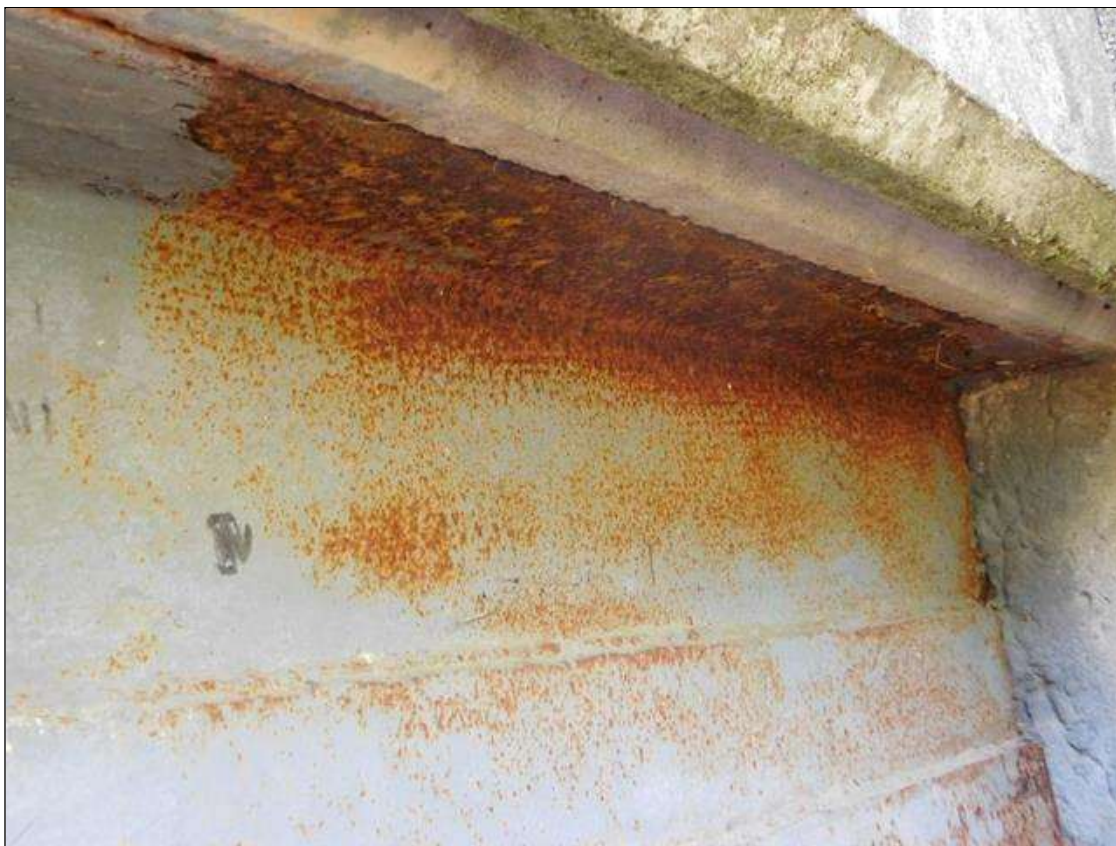
Span 1 Beam 1: 2' OF FRECKLED RUST, TOP AND BOTTOM FLANGE AND WEB, WEST FACE, AT END BENT 1.

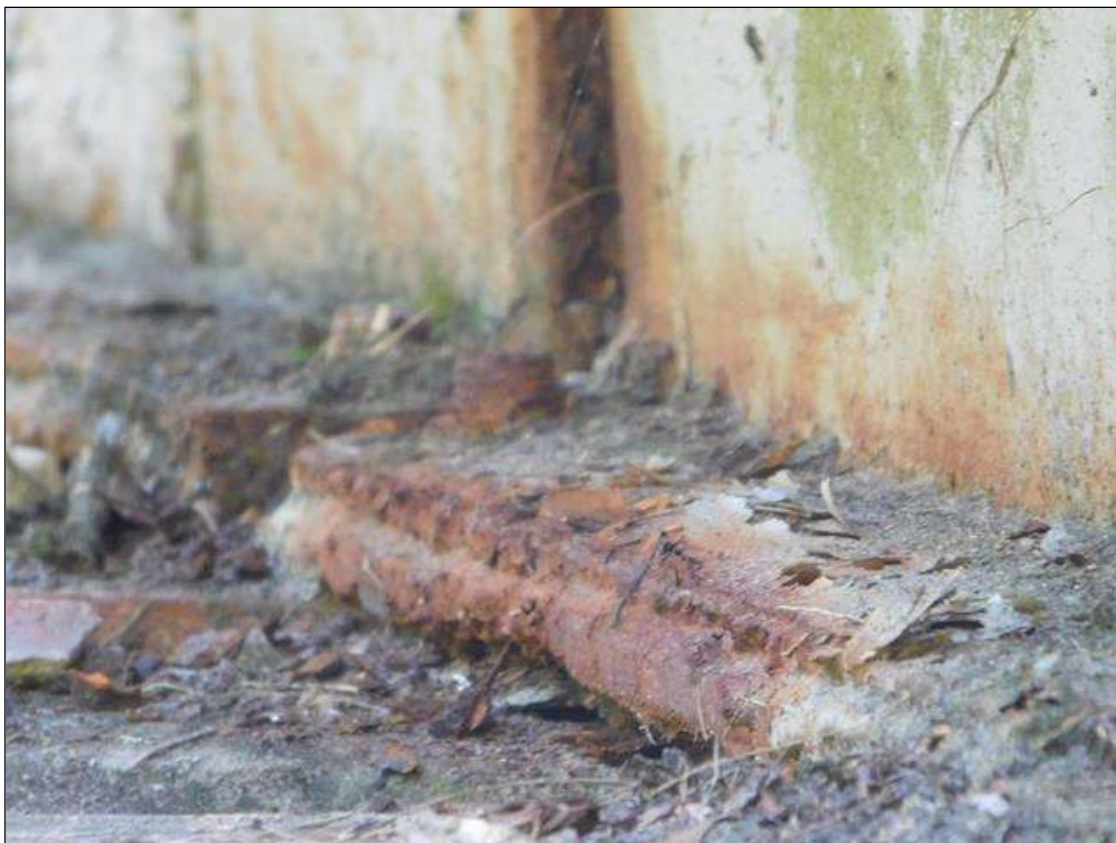
Span 1 Beam 1 - Span 1 Beam 1 Far Bearing: at West side anchor bolt nut is missing

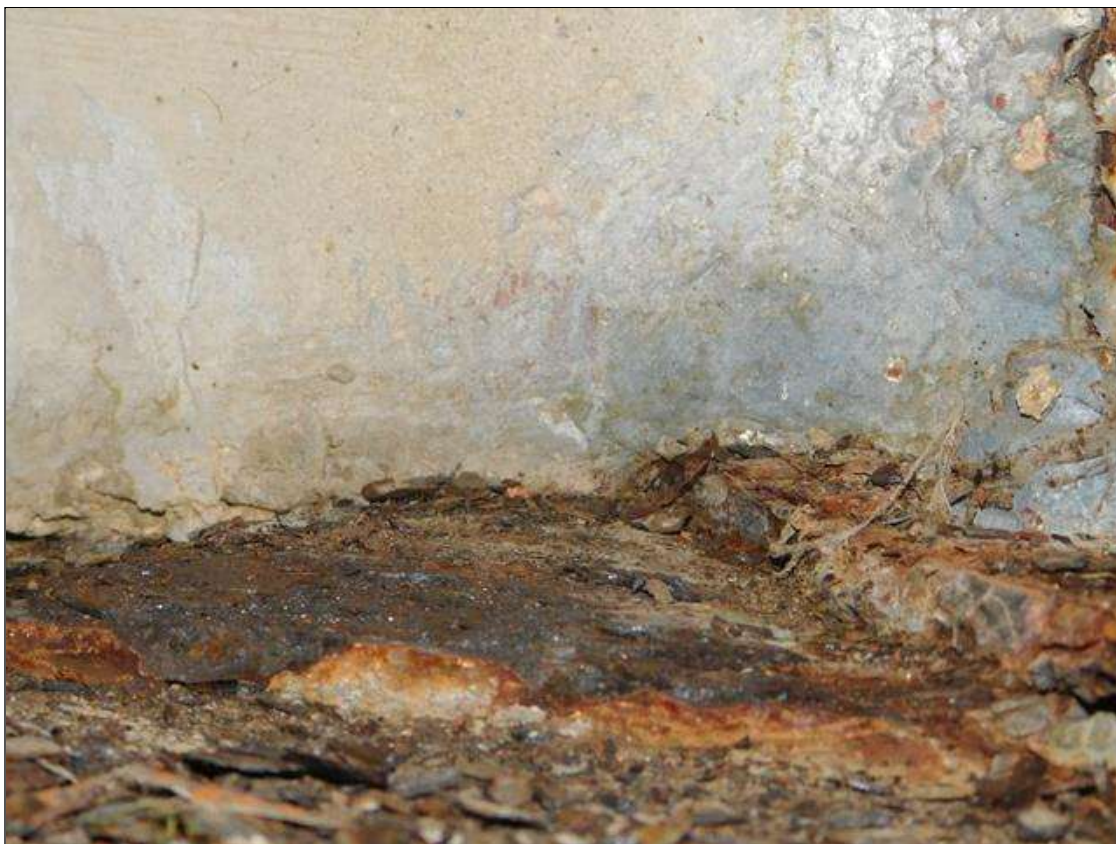
Span 1 Beam 1 - Span 1 Beam 1 Near Bearing: surface corrosion with section loss [1/16in]

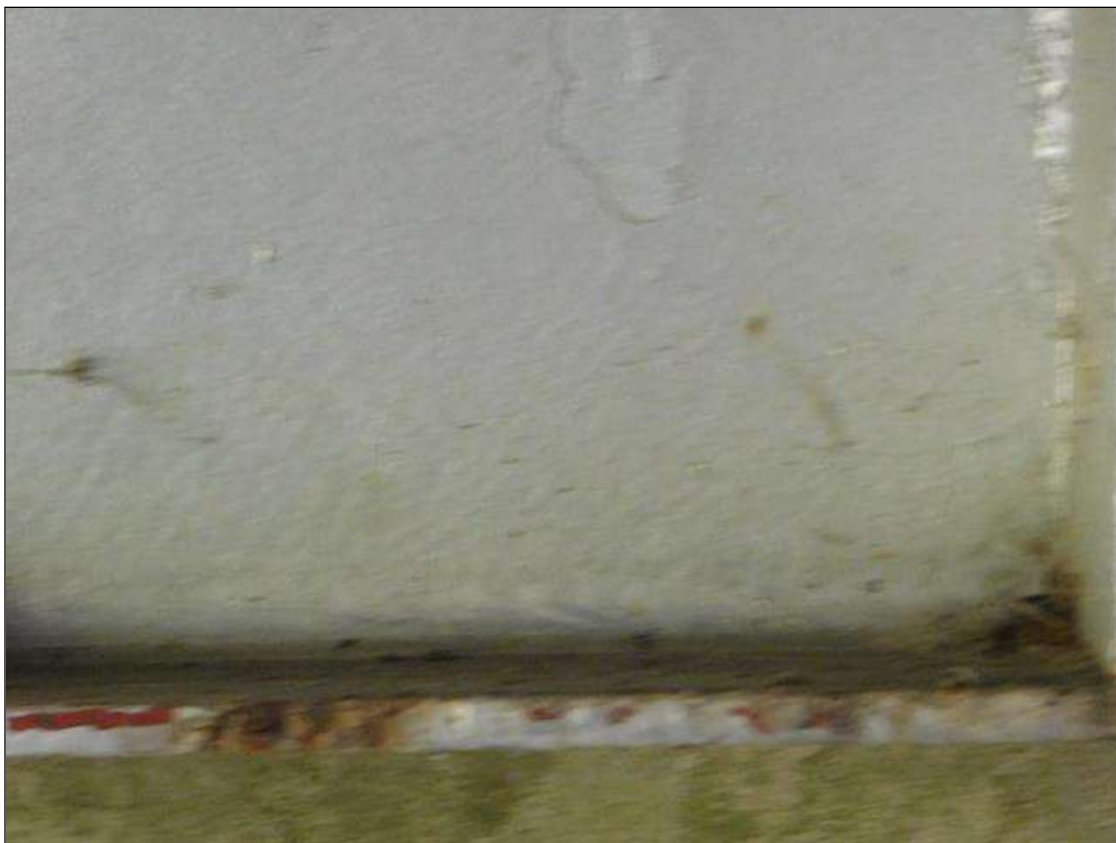
Span 1 Crutch Bent 1 Cap 1: along length of cap, random areas of surface corrosion with no section loss

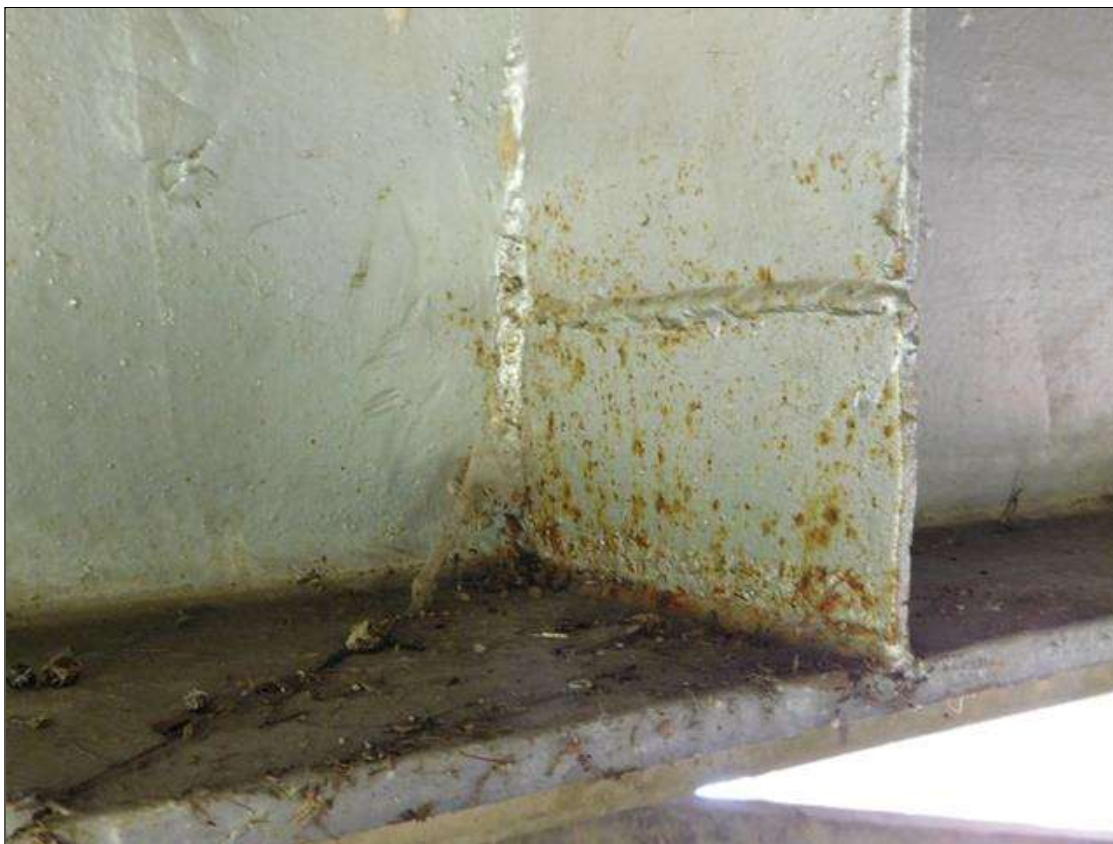
Span 1 Crutch Bent 1 Cap 1: 7" X 2" AREA OF RUST SCALE, WITH 1" X 1" HOLE, SOUTH BEARING STIFFENER, 4' WEST OF PILE 2. / THIS AREA HAS BEEN REPAIRED

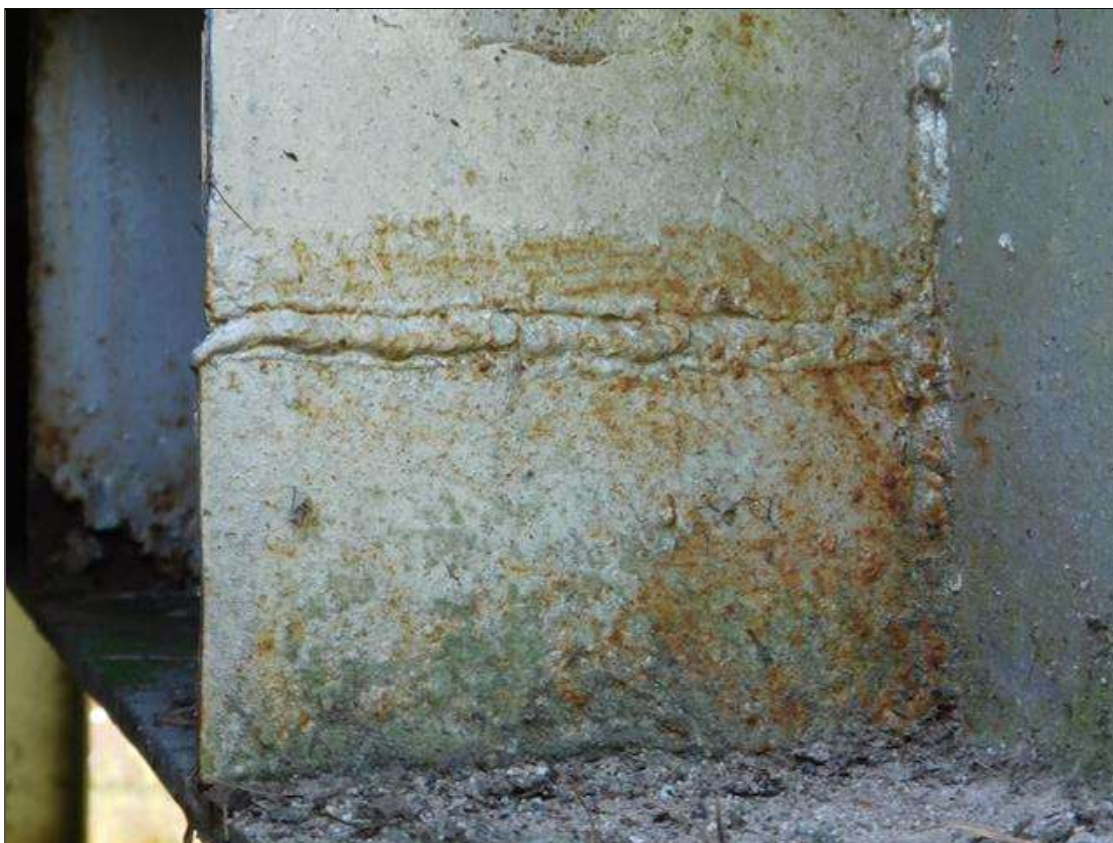
Span 1 Crutch Bent 1 Cap 1: 7" X 3" AREA OF RUST SCALE, WITH 2" DIAMETER HOLE, NORTH BEARING STIFFENER, ABOVE PILE 1. / THIS AREA HAS BEEN REPAIRED

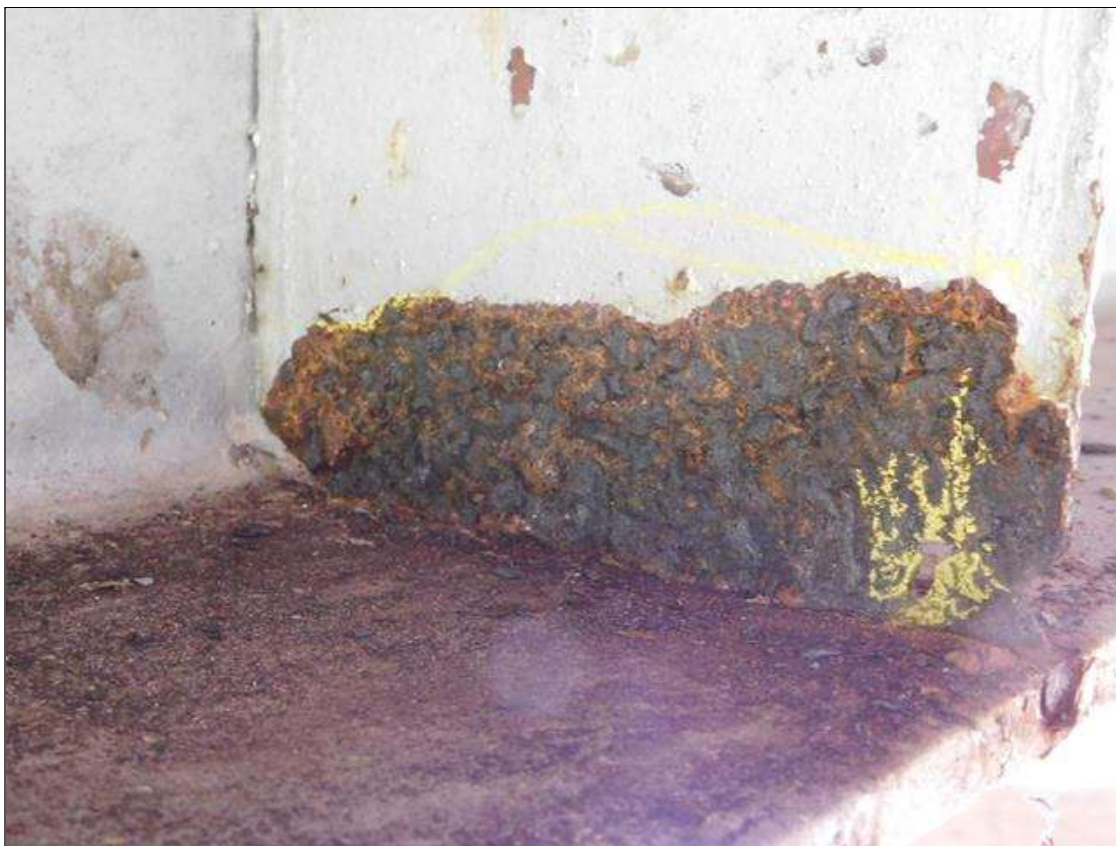
Span 1 Crutch Bent 1 Cap 1: BEARING STIFFNER UNDER BEAM 5. HAS A 7" x 2" AREA OF SECTION LOSS DOWN TO A KNIFE EDGE REMAINING. WITH A 1/2" DIAMETER HOLE. A "PAR" HAS BEEN ISSUED FOR THIS CONDITION.

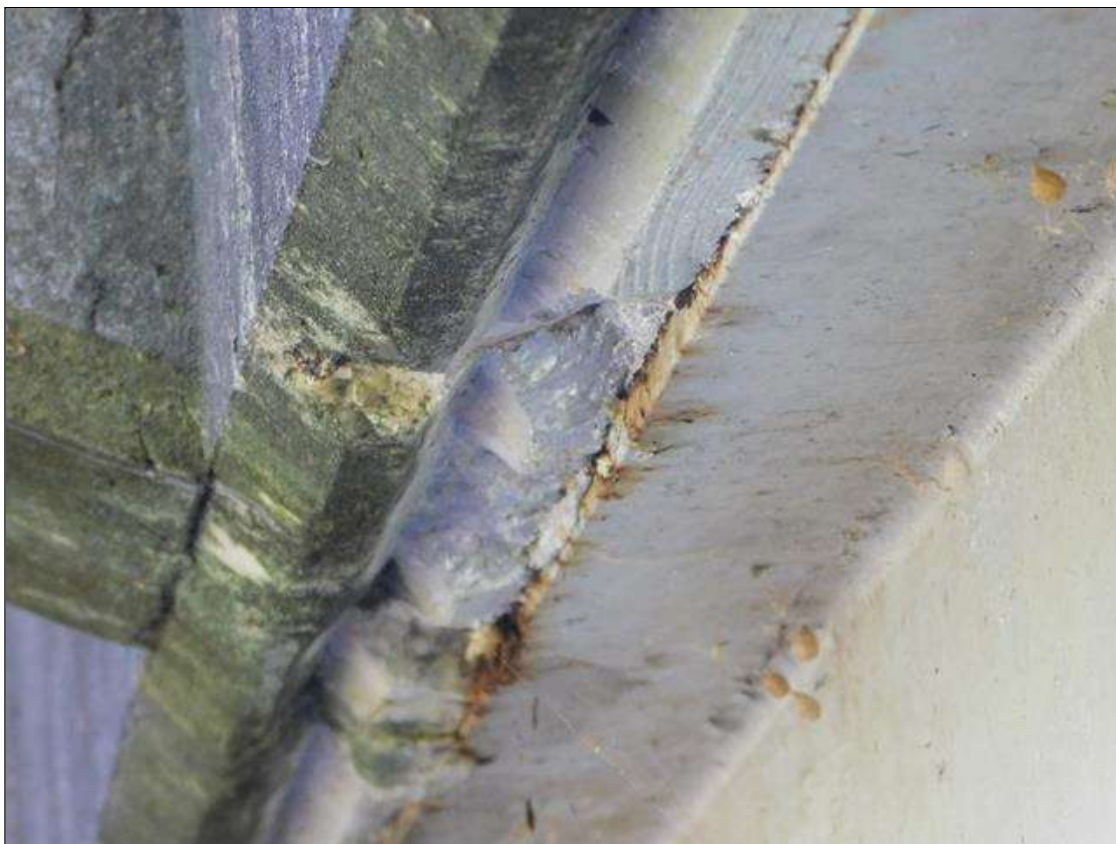
Span 1 Deck: 1' X 2" X 1" SPALL, DECK UNDERSIDE, LEFT OVERHANG, AT BENT 1.

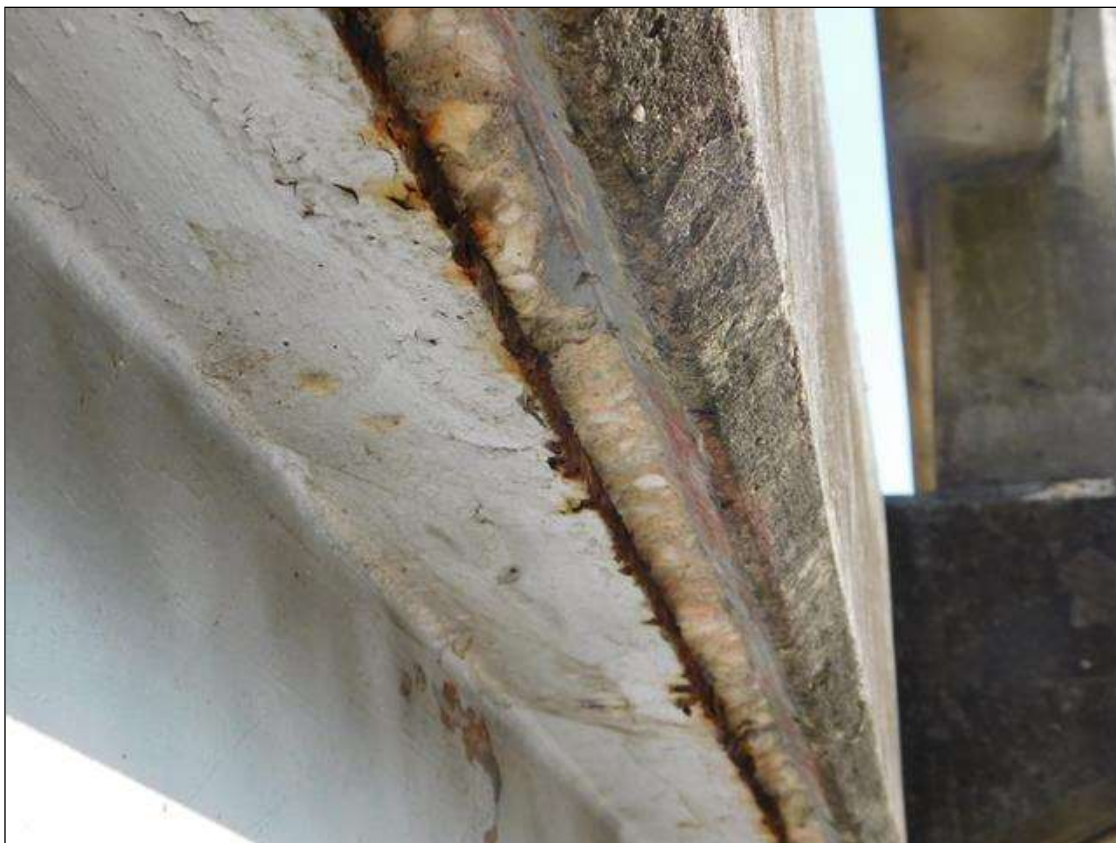
Span 1 Deck: 21' X 2" X 1" SPALL, DECK UNDERSIDE, RIGHT OVERHANG, AT BENT 1.

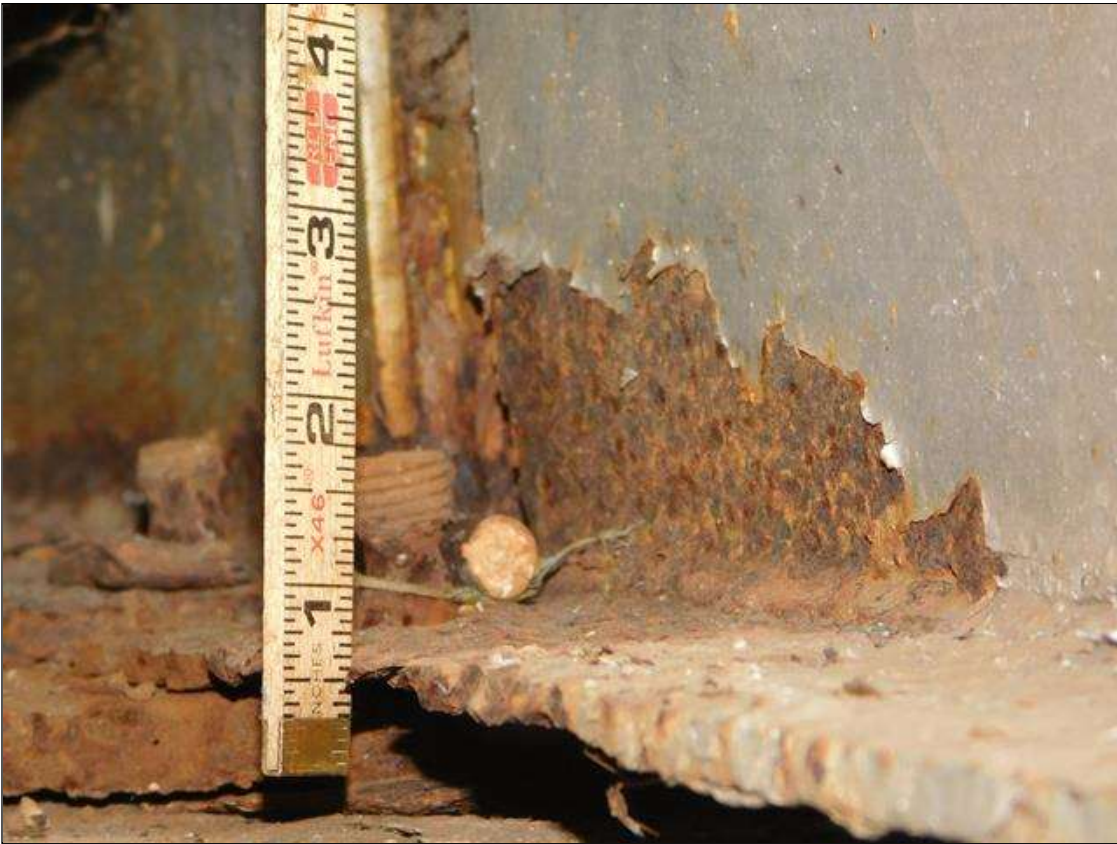
Span 1 Beam 2: 6" OF RUST SCALE, BOTTOM FLANGE, UP TO 2" IN THE WEB, WITH 1/16" REMAINING IN THE BOTTOM FLANGE, AT BENT 1. A "PAR" HAS BEEN ISSUED FOR THIS CONDITION.

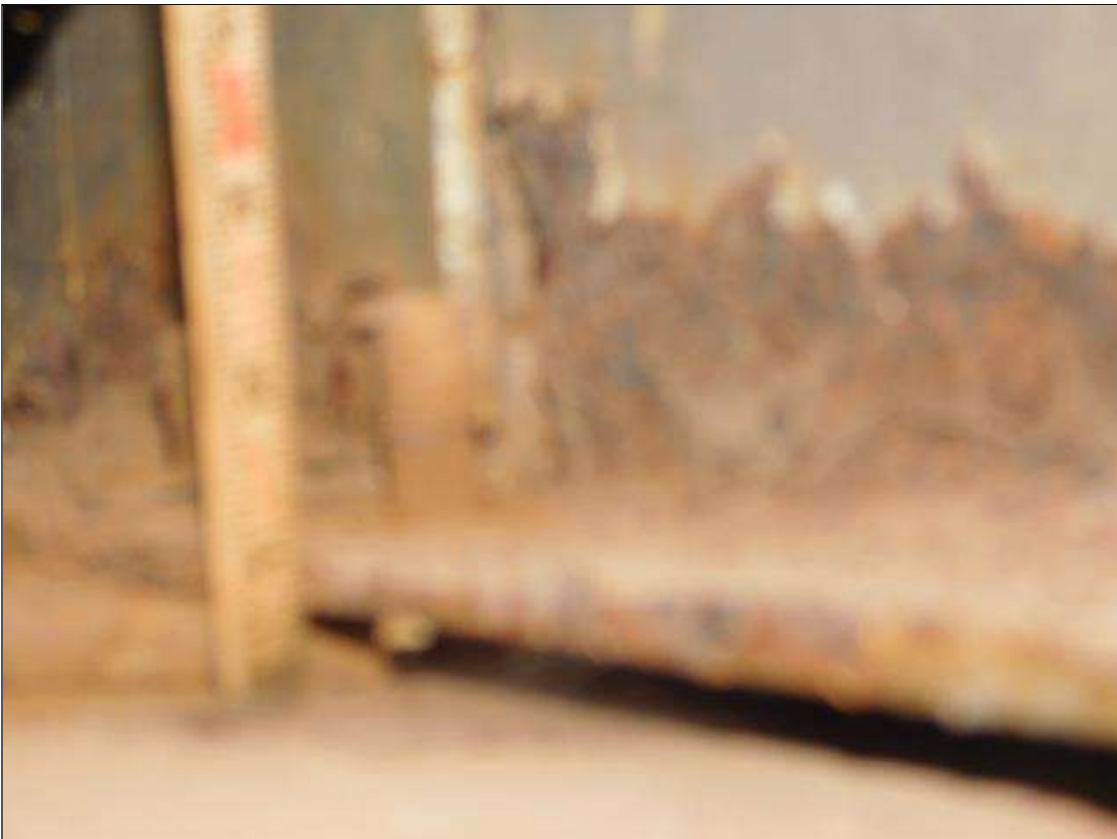
Span 1 Beam 3: 1' OF RUST SCALE, BOTTOM FLANGE, UP TO 3" IN THE WEB, WITH 1/4" REMAINING IN THE BOTTOM FLANGE, AT BENT 1. A "PAR" HAS BEEN ISSUED FOR THIS CONDITION.

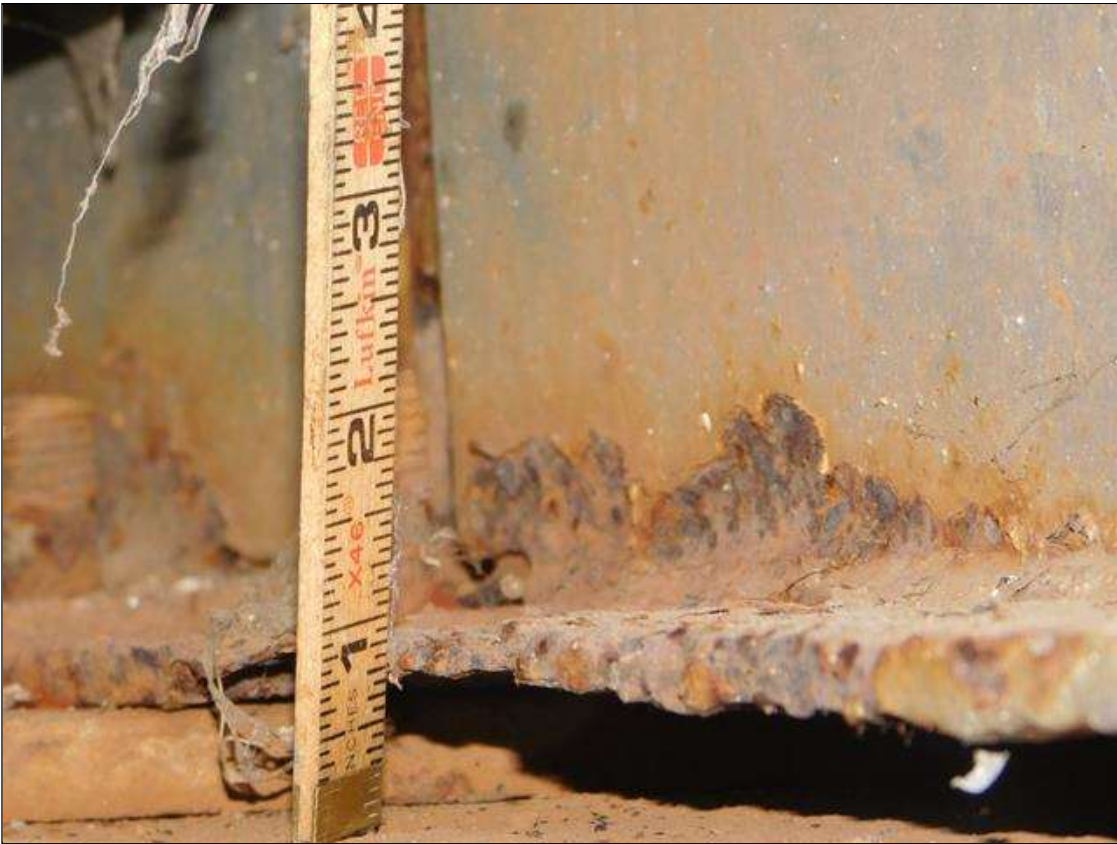
Span 1 Beam 4: 6" OF RUST SCALE, BOTTOM FLANGE, UP TO 3" IN THE WEB DOWN TO A KNIFE EDGE REMAINING IN THE BOTTOM FLANGE, AT BENT 1. A "PAR" HAS BEEN ISSUED FOR THIS CONDITION.

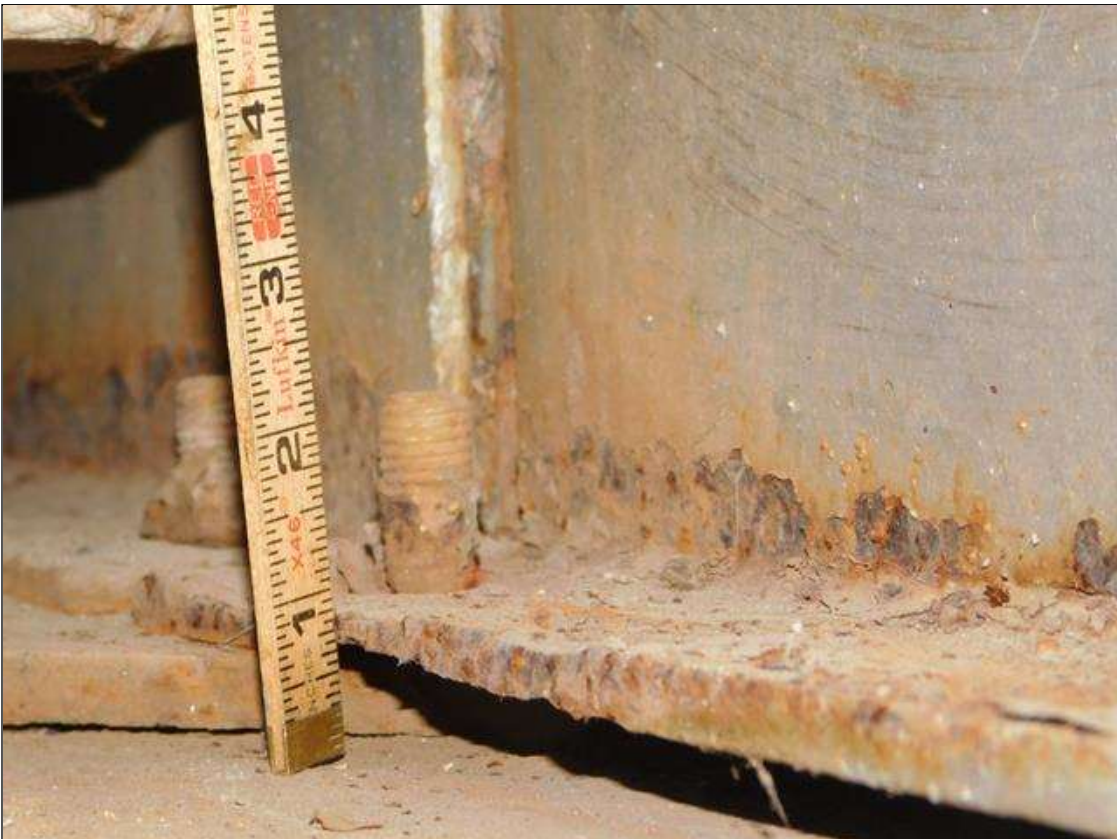
Span 1 Beam 5: 18" OF RUST SCALE, BOTTOM FLANGE, UP TO 4" IN THE WEB, WITH 1/4" REMAINING IN THE BOTTOM FLANGE, AT BENT 1. A "PAR" HAS BEEN ISSUED FOR THIS CONDITION.

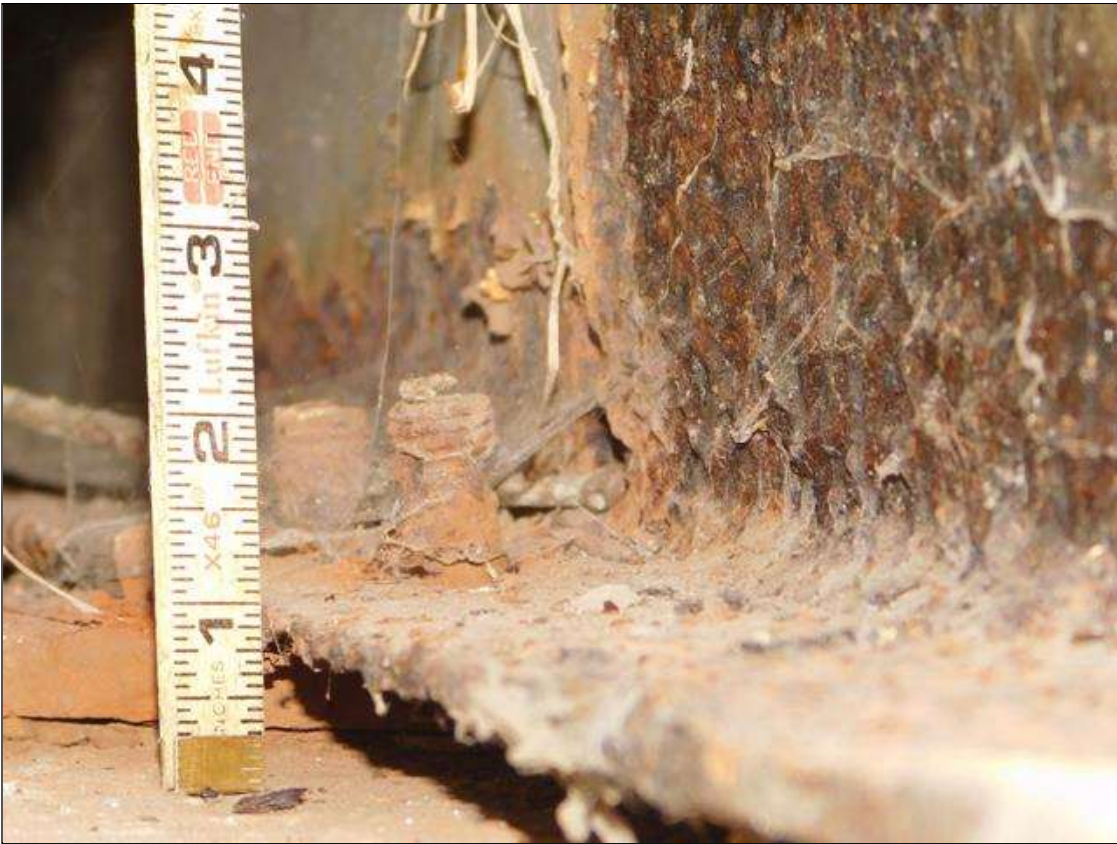
Span 1 Beam 6: 1' OF RUST SCALE, BOTTOM FLANGE, UP TO 5" IN THE WEB, WITH 1/8" REMAINING IN THE BOTTOM FLANGE, AT BENT 1. A "PAR" HAS BEEN ISSUED FOR THIS CONDITION.

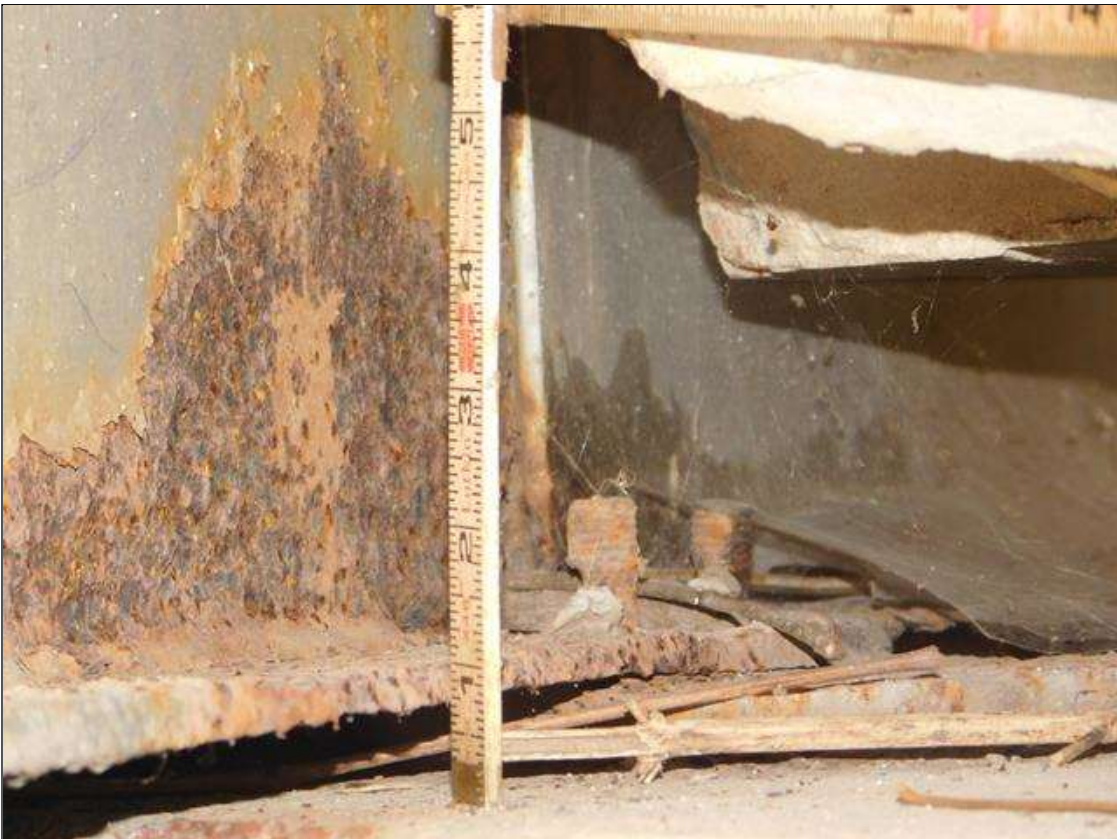
Span 1 Beam 7: 18" OF RUST SCALE, BOTTOM FLANGE, UP TO 5" IN THE WEB, 1/4" REMAINING IN THE BOTTOM FLANGE, AT BENT 1. A "PAR" HAS BEEN ISSUED FOR THIS CONDITION.

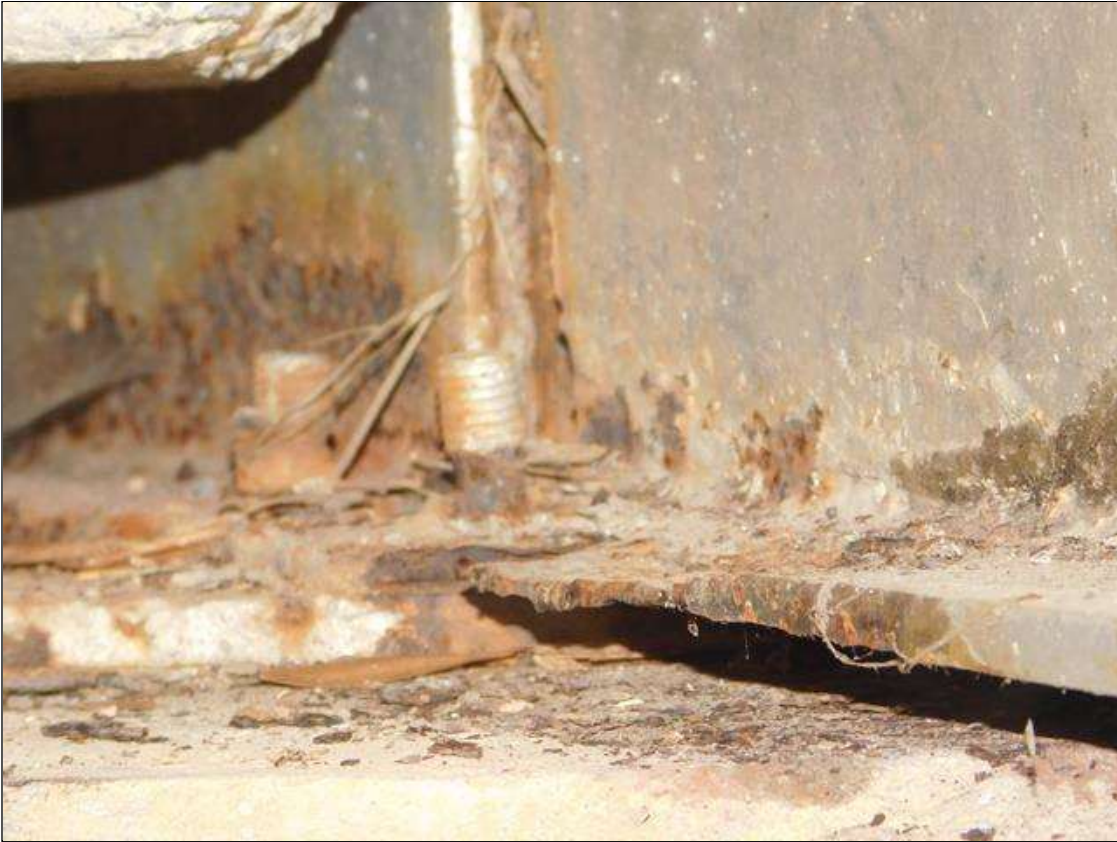
Span 1 Beam 8: 18" OF RUST SCALE, BOTTOM FLANGE, UP TO 5" IN THE WEB, 1/4" REMAINING IN THE BOTTOM FLANGE. WITH A 2" DIAMETER AREA WITH 100% SECTION LOSS AT BENT 1. A "PAR" HAS BEEN ISSUED FOR THIS CONDITION.

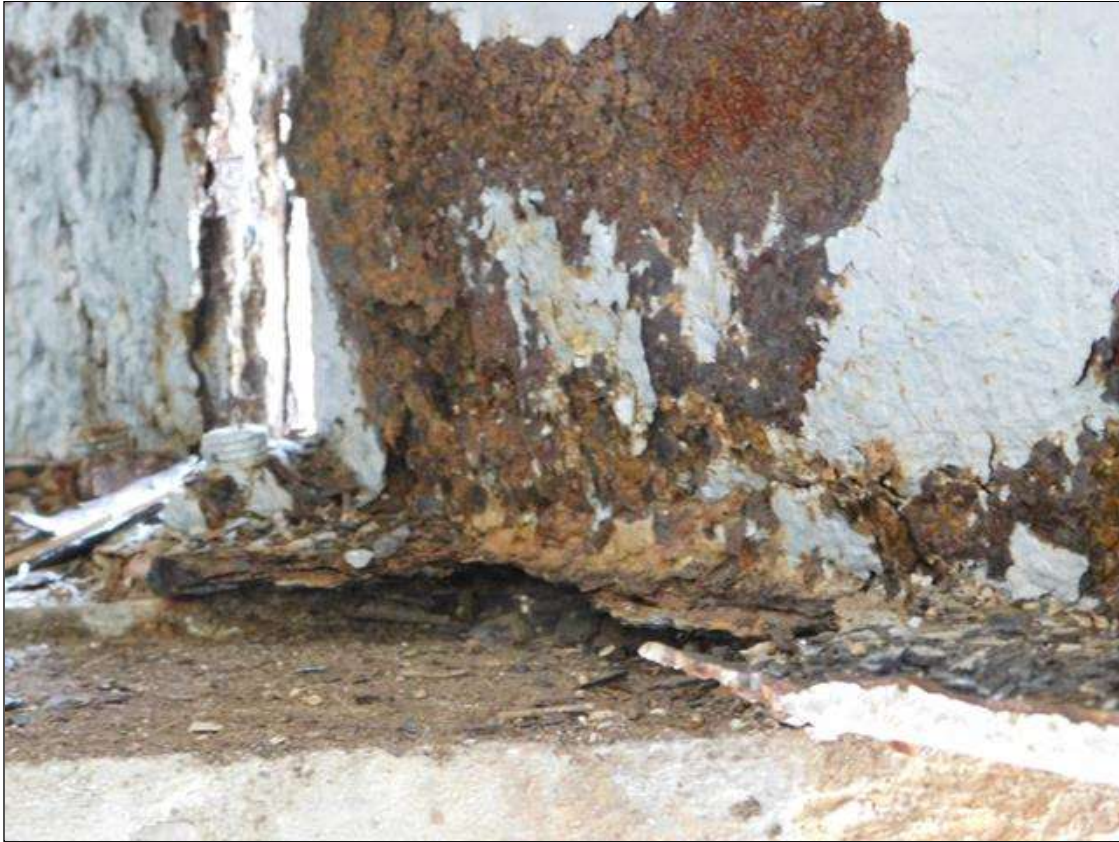
Span 1 Beam 11: 3' OF RUST SCALE, TOP AND BOTTOM FLANGE, UP TO 6" IN THE WEB, WITH 6" X UP TO 3" HOLE IN THE BOTTOM FLANGE, WITH 3/8" REMAINING IN THE WEB, WITH 5/16" REMAINING IN THE BOTTOM FLANGE, AT BENT 1. A "PAR" HAS BEEN ISSUED FOR THIS CONDITION.

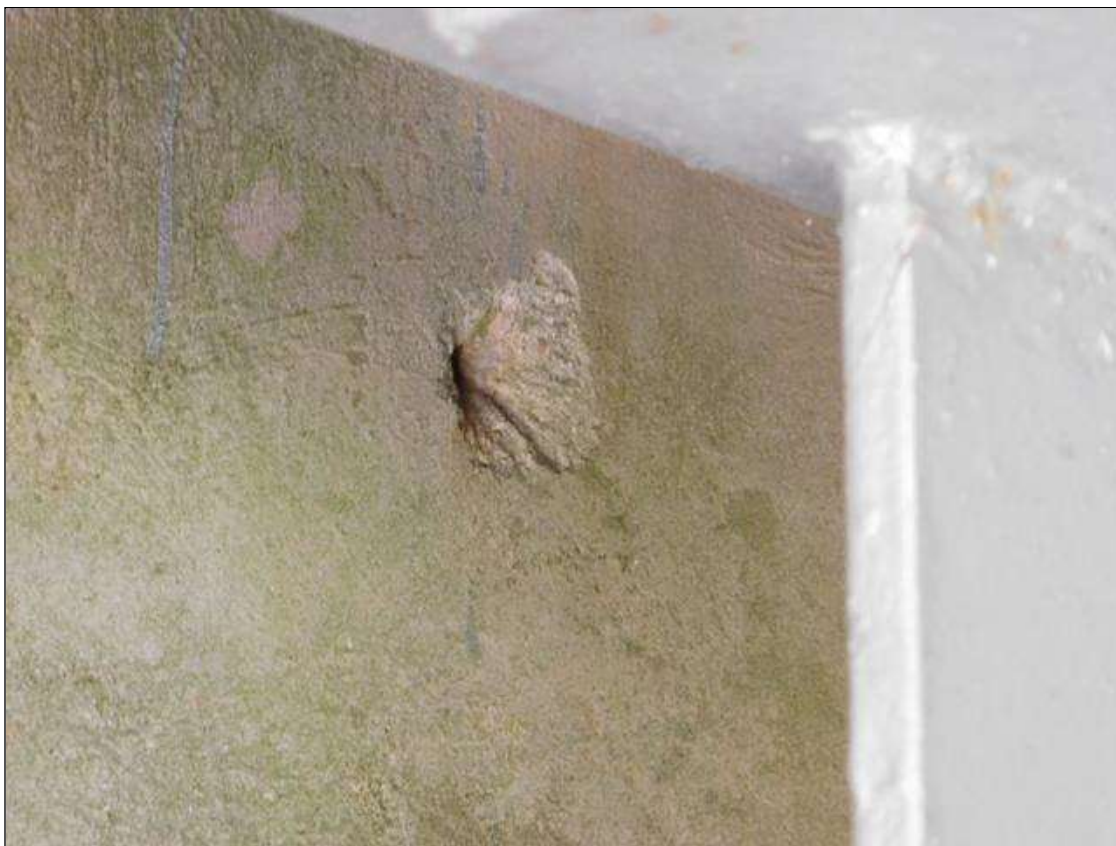
Bent 1 Cap 1: 2" DIAMETER X 3/4" SPALL, WITH EXPOSED REINFORCING, NORTH FACE OF CAP, 3' EAST OF PILE 3.

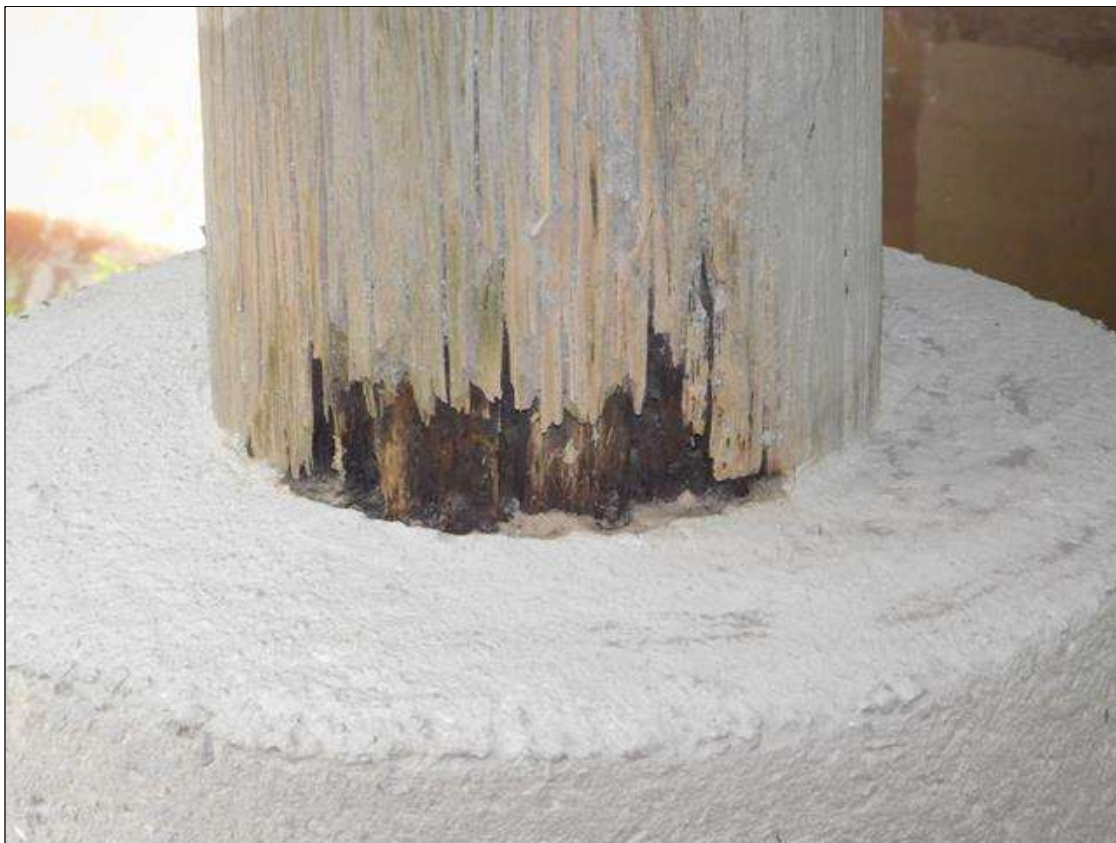
Bent 1 Pile 4: Northwest quadrant at top of collar, decay [7in x 4in x 3/4in]
