NC DEPARTMENT OF TRANSPORTATION  
 DIVISION OF HIGHWAYS  
 STRUCTURE MANAGEMENT UNIT

ATTENTION: **BOAT USED FOR INSPECTION / LADDER USED FOR INSPECTION / "PAR"s ISSUED**

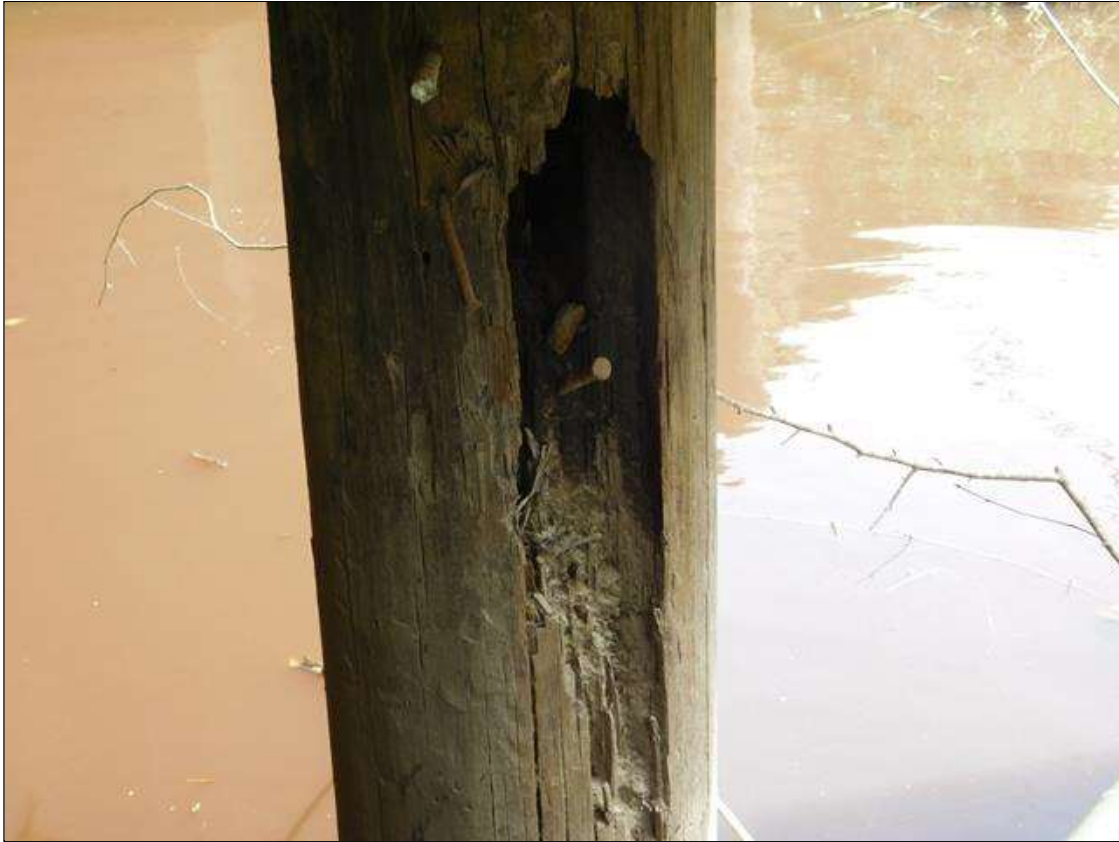
Bent 1 Pile 5: at Southeast quadrant from cap down 3ft, decay [3ft x 7in x up to 9in deep] crutch bent installed at both sides of bent 1

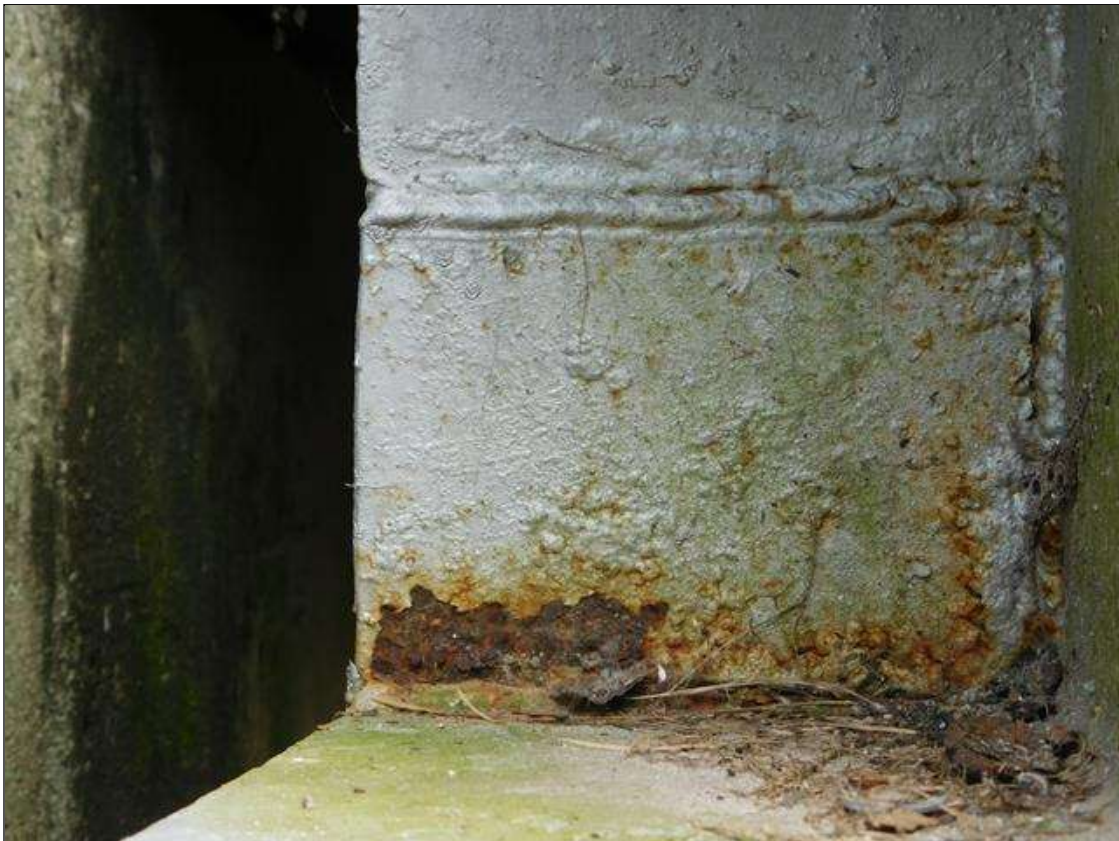
Span 2 Crutch Bent 2 Cap 1: 7" X 3" AREA OF RUST SCALE, WITH 3" X 2" HOLE, SOUTH BEARING STIFFENER, ABOVE PILE 4. / THIS AREA HAS BEEN REPAIRED

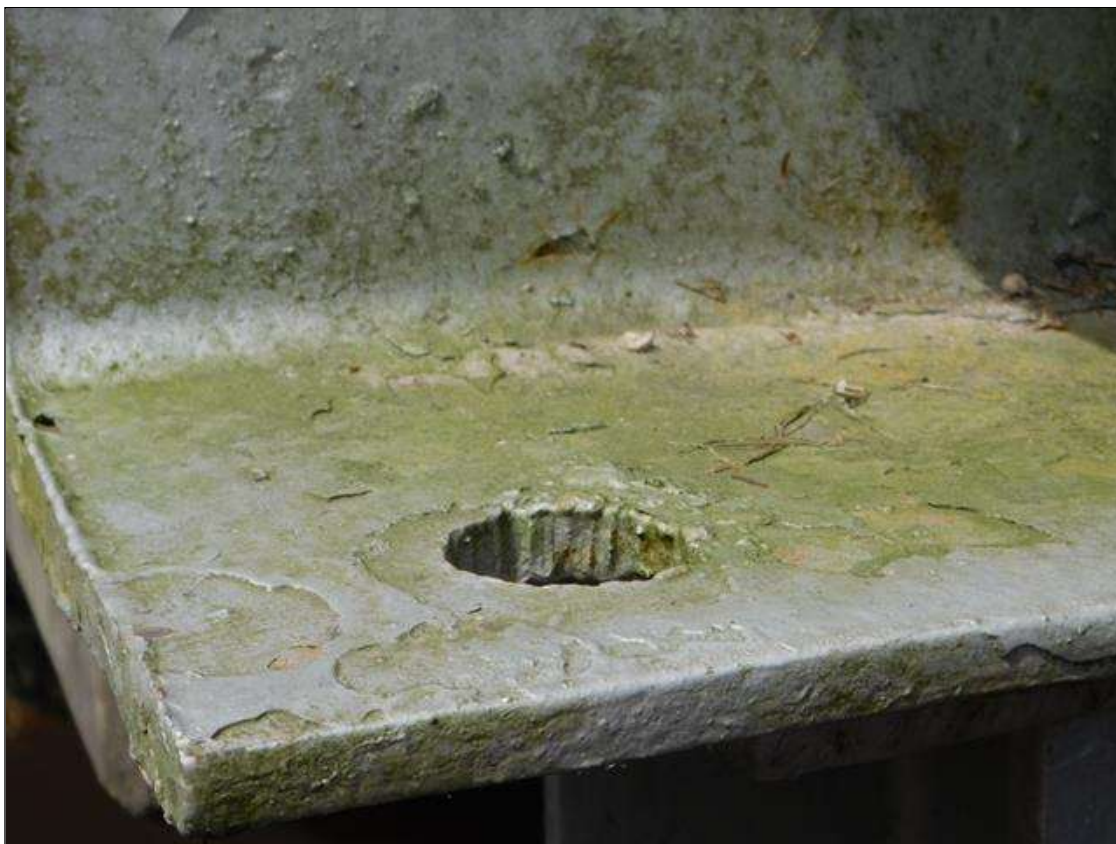
Span 2 Crutch Bent 2 Cap 1: 1" DIAMETER HOLE, BOTTOM FLANGE, EAST END OF CAP.

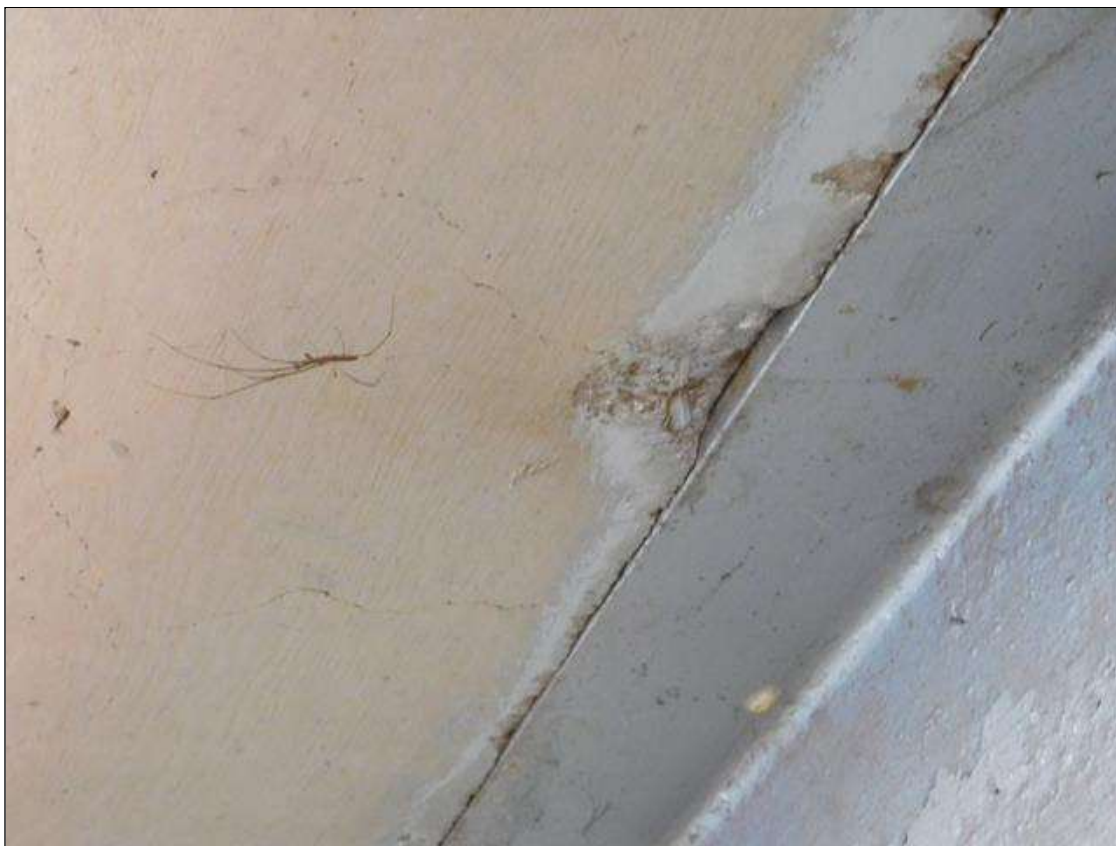
Span 2 Deck: 1" DIAMETER X 1/2" SPALL, WITH EXPOSED REINFORCING, DECK UNDERSIDE, BAY 7, ADJACENT TO BEAM 8, NEAR MID-SPAN.

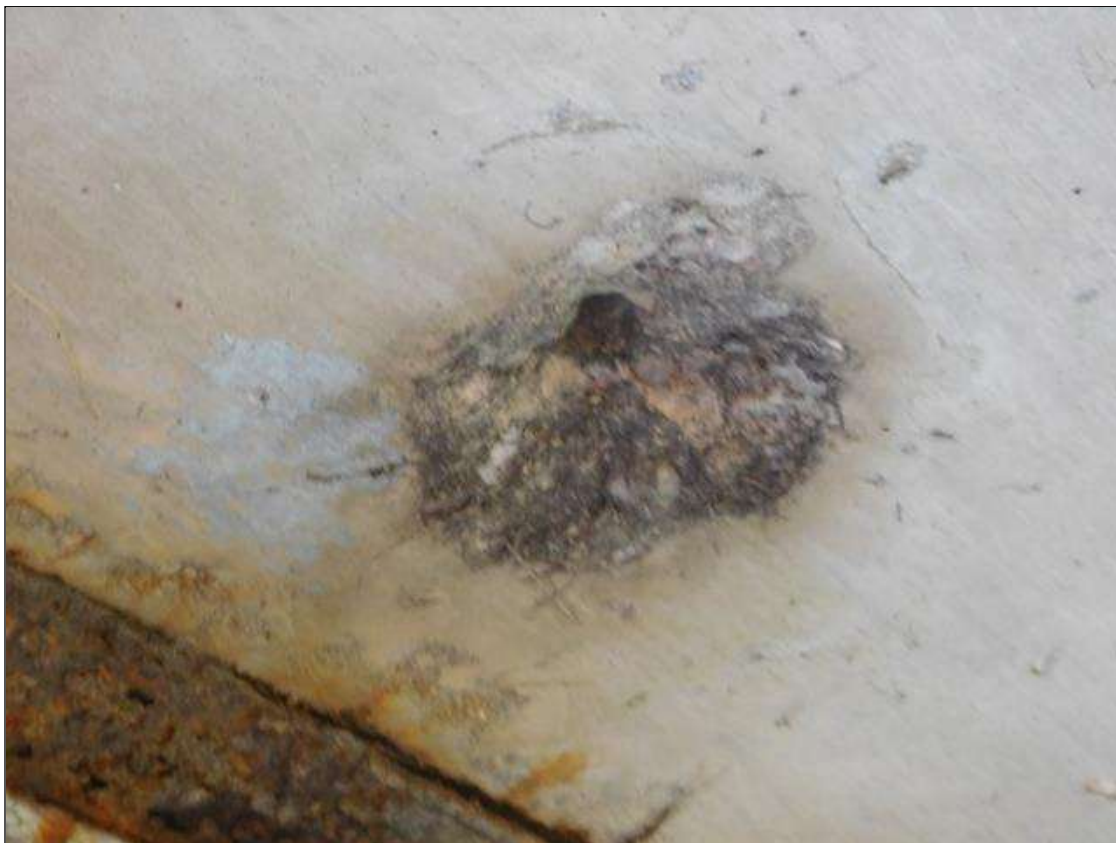
Span 2 Deck: 4" DIAMETER X 1" SPALL, WITH EXPOSED REINFORCING, DECK UNDERSIDE, BAY 1, 3' FROM END BENT 2.

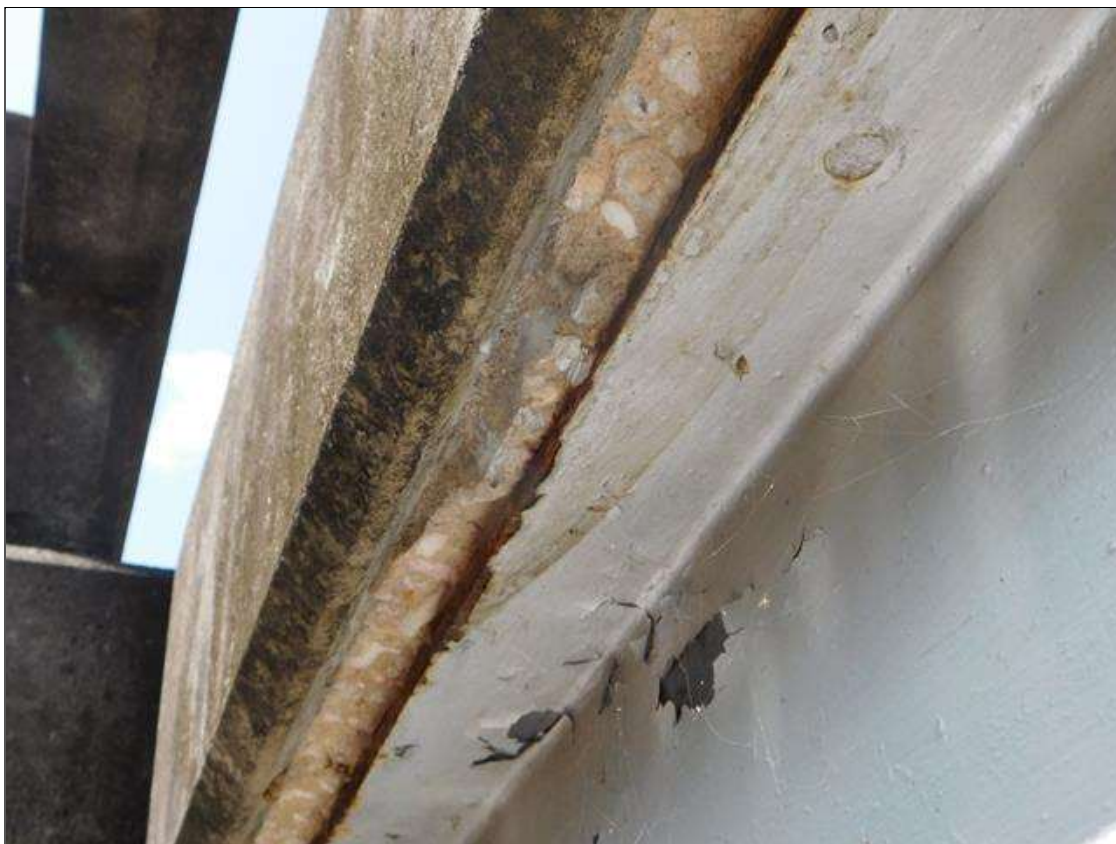
Span 2 Deck: 10' X UP TO 2" X 1" SPALL, DECK UNDERSIDE, RIGHT OVERHANG, BEGINNING AT BENT 1.

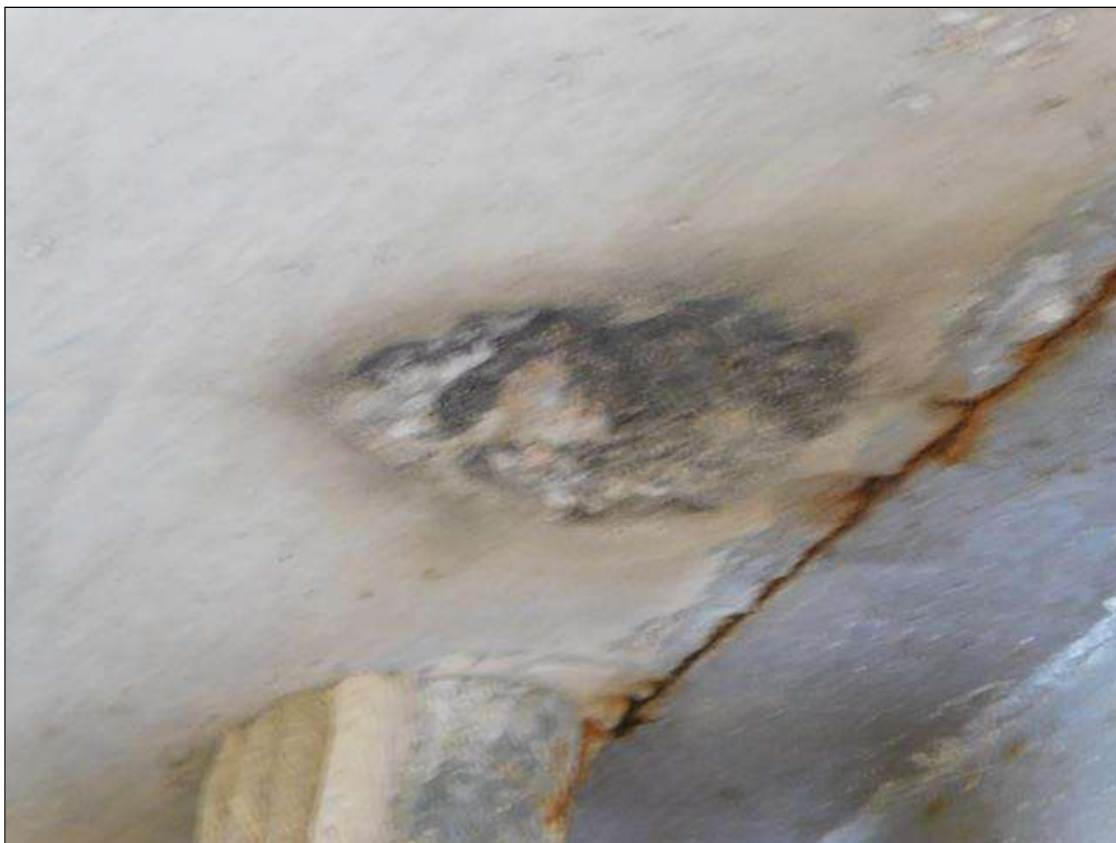
Span 2 Deck: 3" DIAMETER X 1" SPALL, WITH EXPOSED REINFORCING, DECK UNDERSIDE, BAY 1, 2' FROM BENT 1.

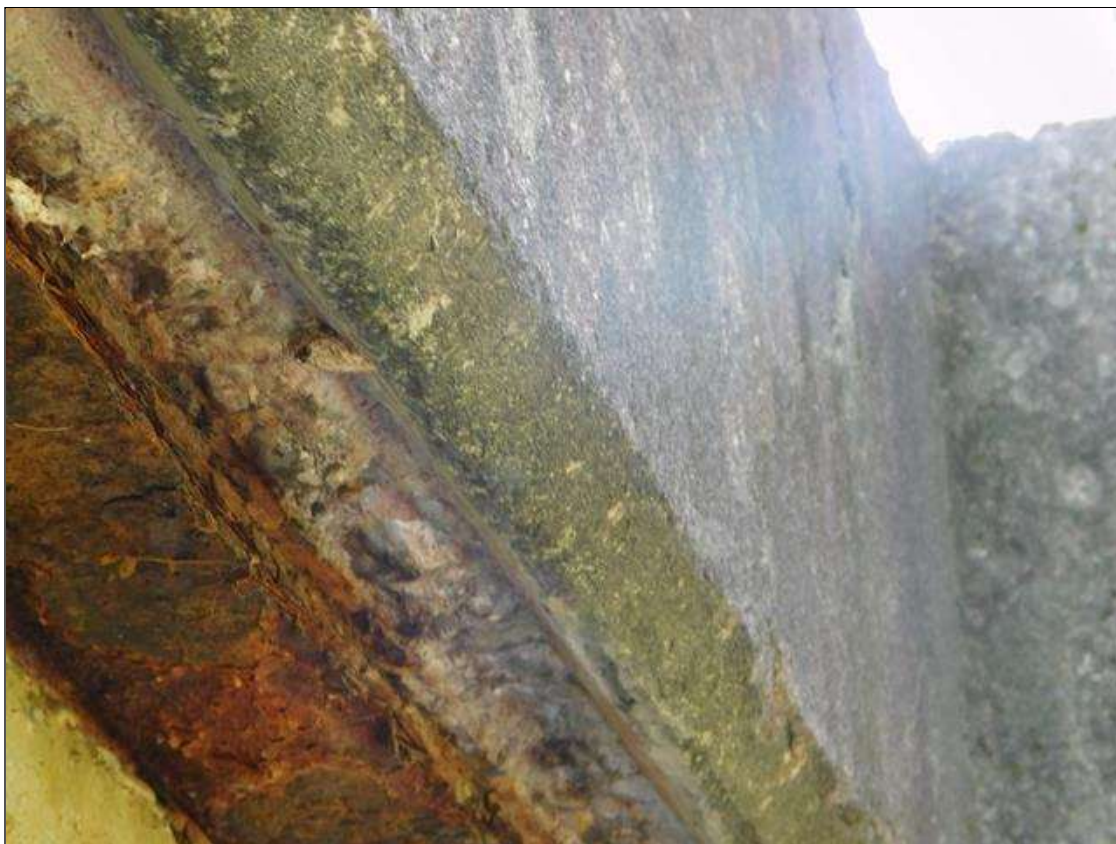
Span 2 Deck: 3' X 2" X 1" SPALL, DECK UNDERSIDE, LEFT OVERHANG, AT BENT 1.

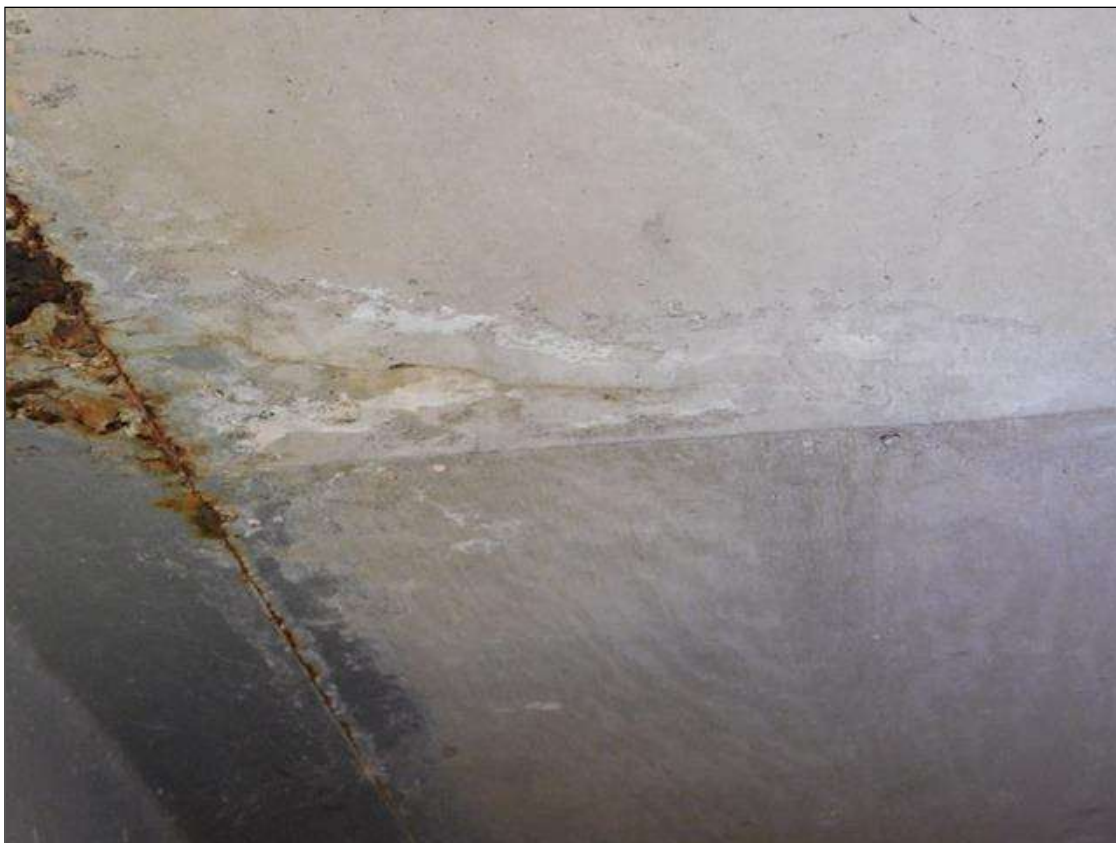
Span 2 Deck: 2' X 1/16" CRACK, WITH EFFLORESCENCE, DECK UNDERSIDE, BAY 2, AT END BENT 2.

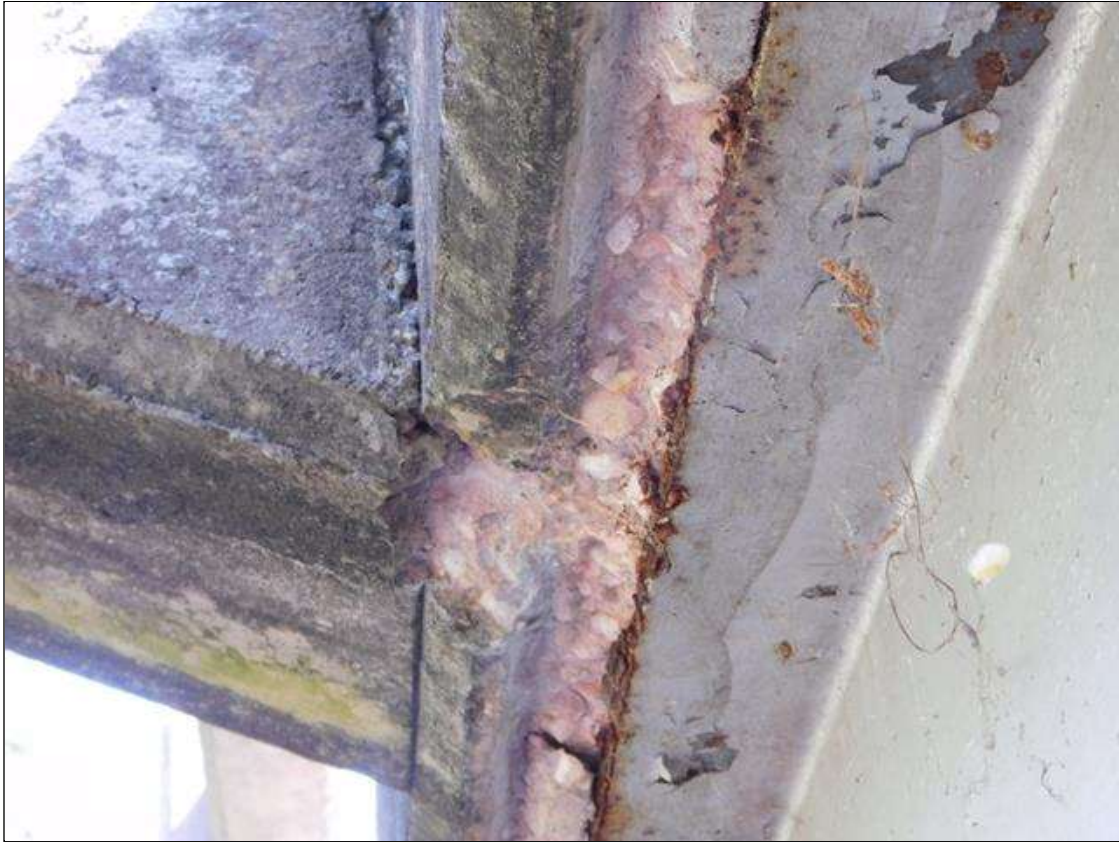
Span 2 Deck: 18" x 3" x 1" DEEP SPALL IN LEFT OVERHANG. LOCATED 4' FROM END BENT 2.

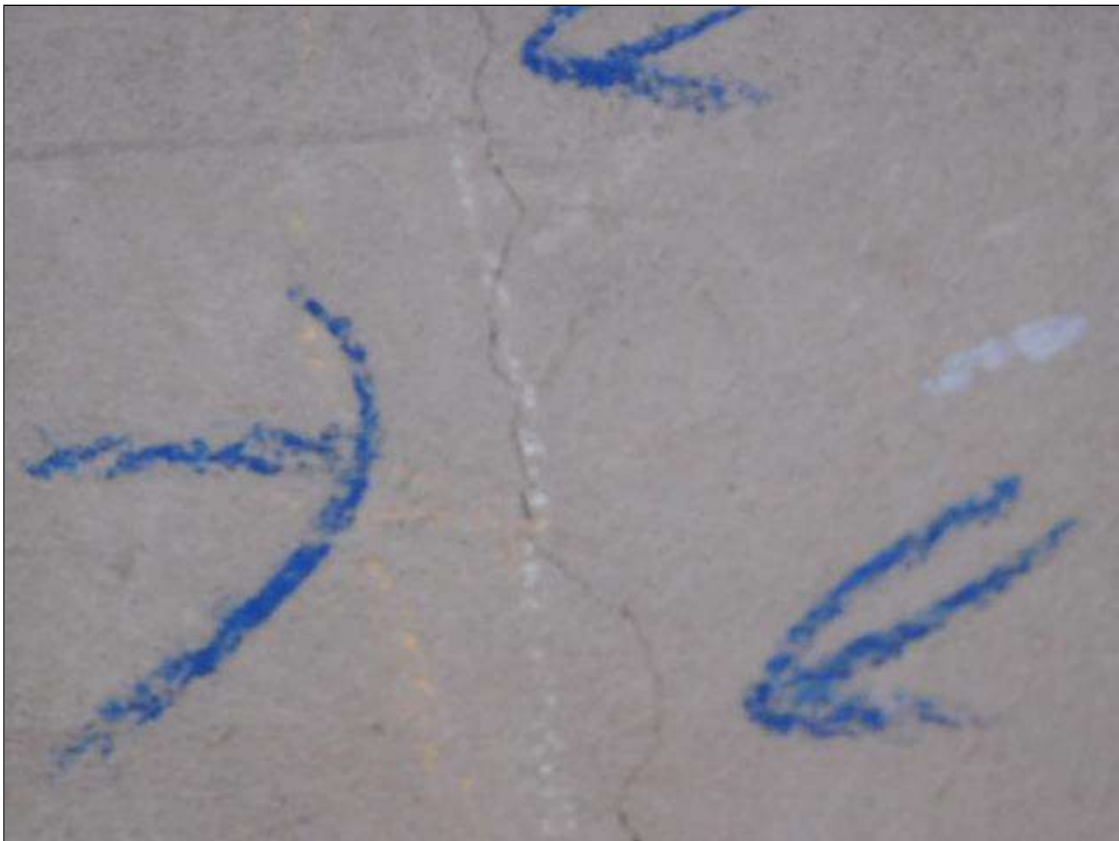
End Bent 2 Cap 1: along length of cap, multiple vertical cracks [1ft x 0.02in]

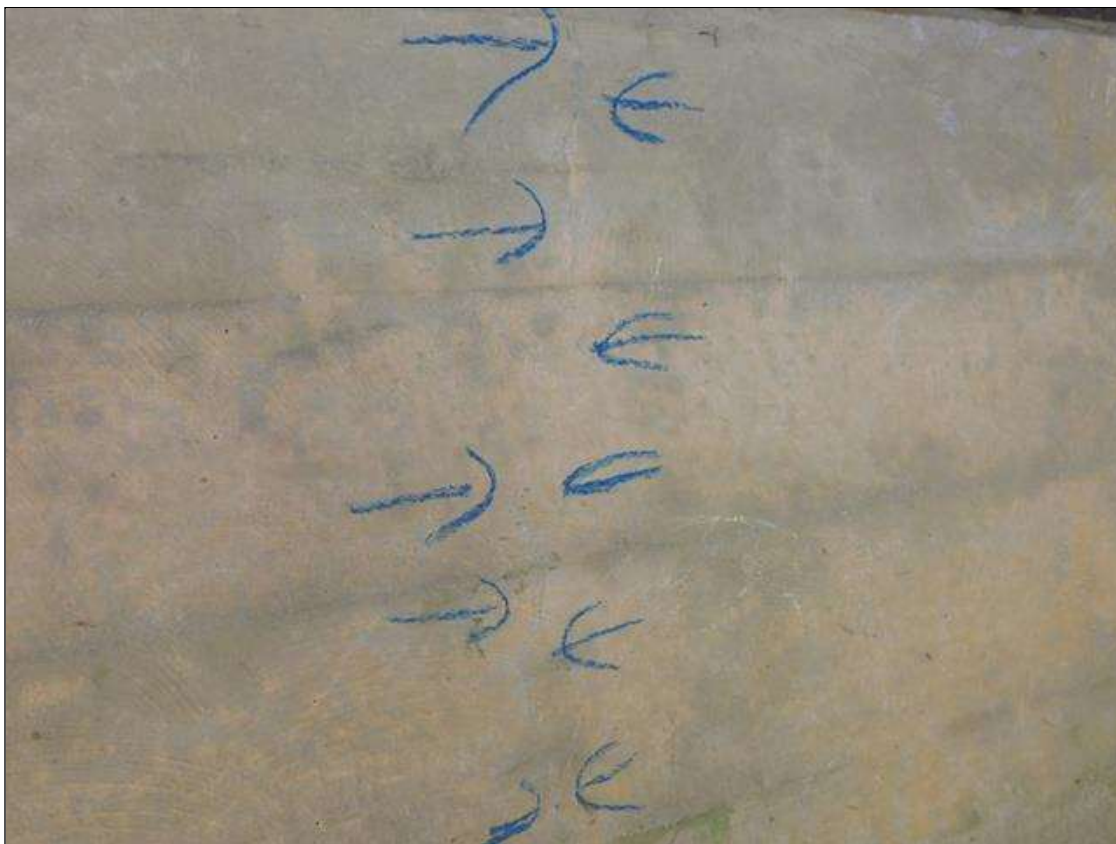
End Bent 2 Cap 1: (9) UP TO 18" X 1/16" VERTICAL CRACKS, SOUTH FACE, AT RANDOM THROUGHOUT.

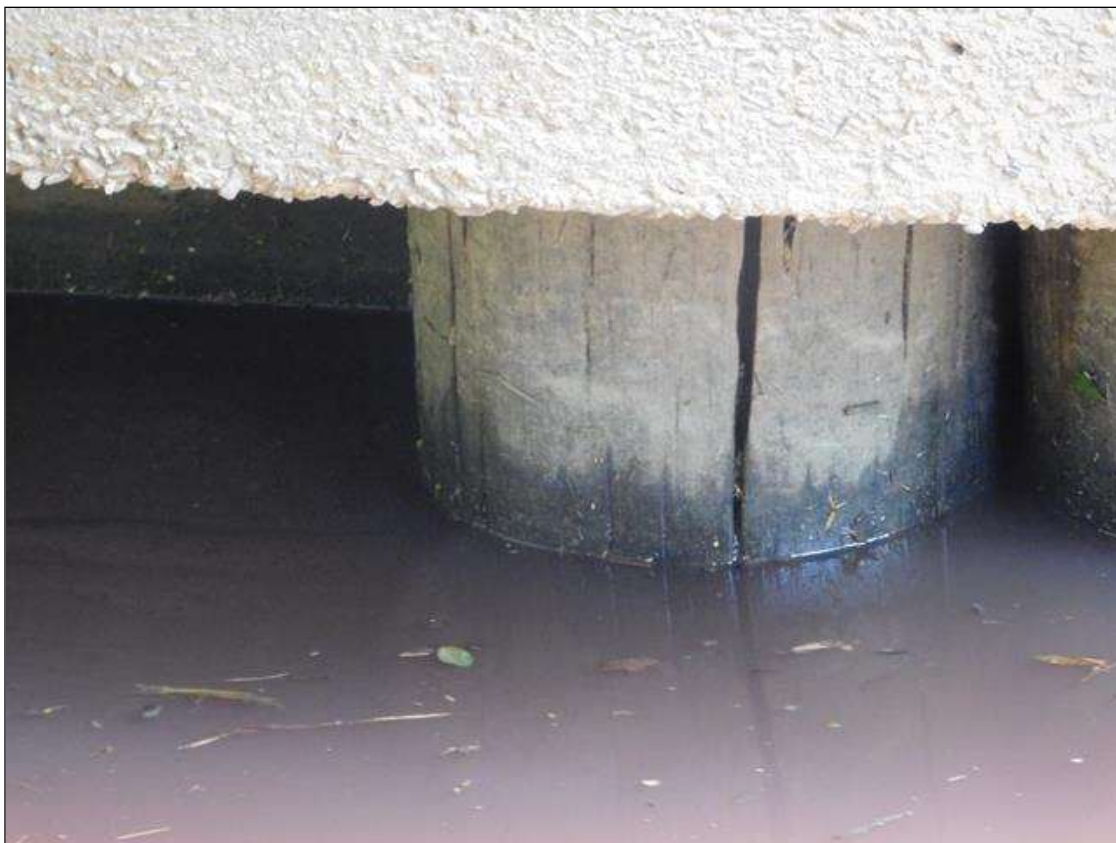
End Bent 2 Pile 5: at exposed pile below concrete collar, checks [3/8in x 3/4in deep]

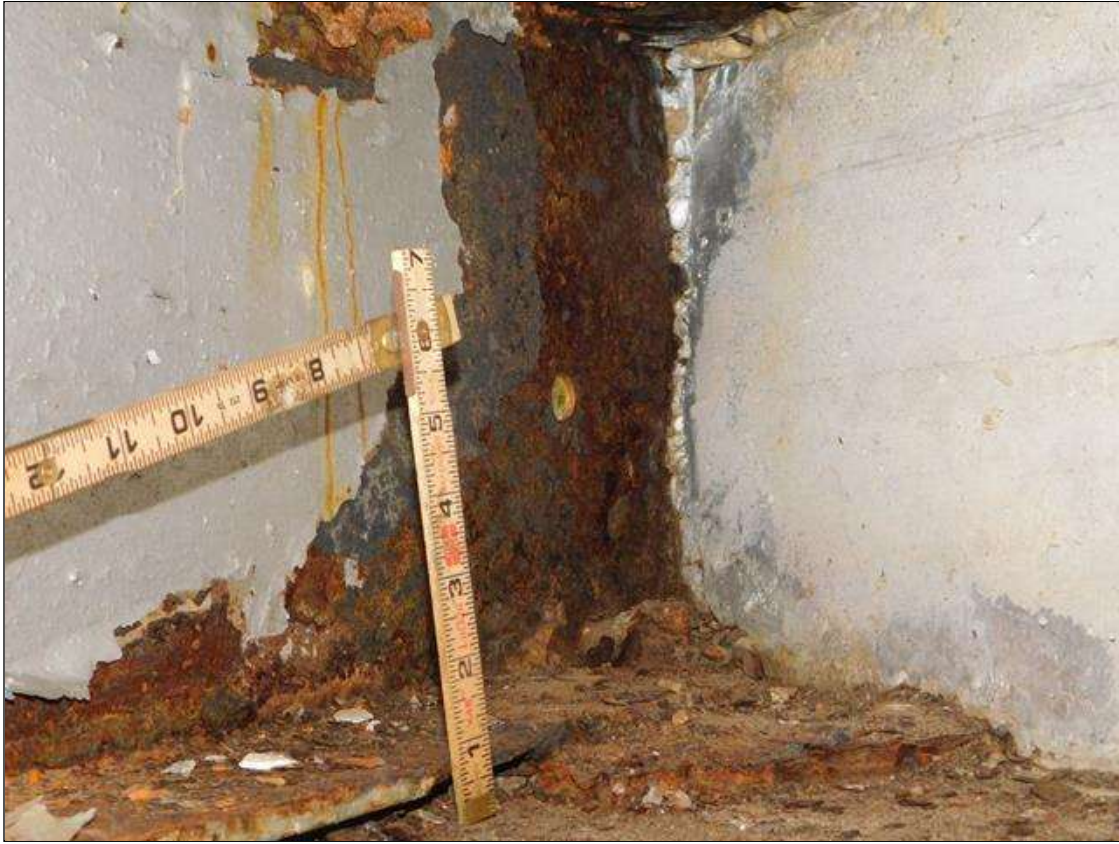
Span 2 Beam 1: SPAN 2 BEAM 1 OVER END BENT 1. WEB AND FLANGES HAVE AREAS OF SECTION LOSS WITH 1/8" REMAINING IN BOTTOM FLANGE AND 3/16" REMAINING IN WEB. AREA IS: FROM END OF BEAM OUT 18" x FULL WIDTH OF FLANGE AND FROM END OF BEAM OUT 12" x FULL HEIGHT OF WEB. A "PAR" HAS BEEN ISSUED FOR THESE CONDITIONS.

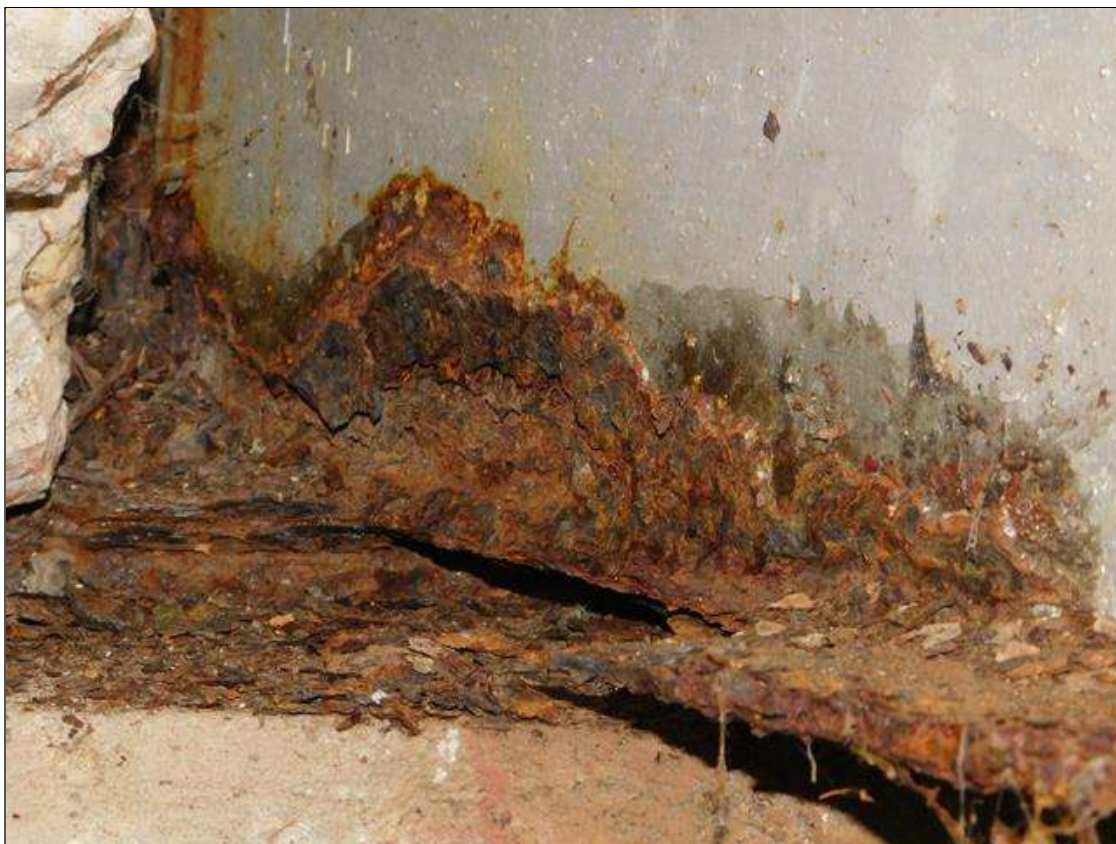
Span 2 Beam 1: RIGHT WEB AND BOTTOM FLANGE OVER BENT 1. HAS A 10" x 3" AREA OF 100% SECTION LOSS. A "PAR" HAS BEEN ISSUED FOR THIS CONDITION.

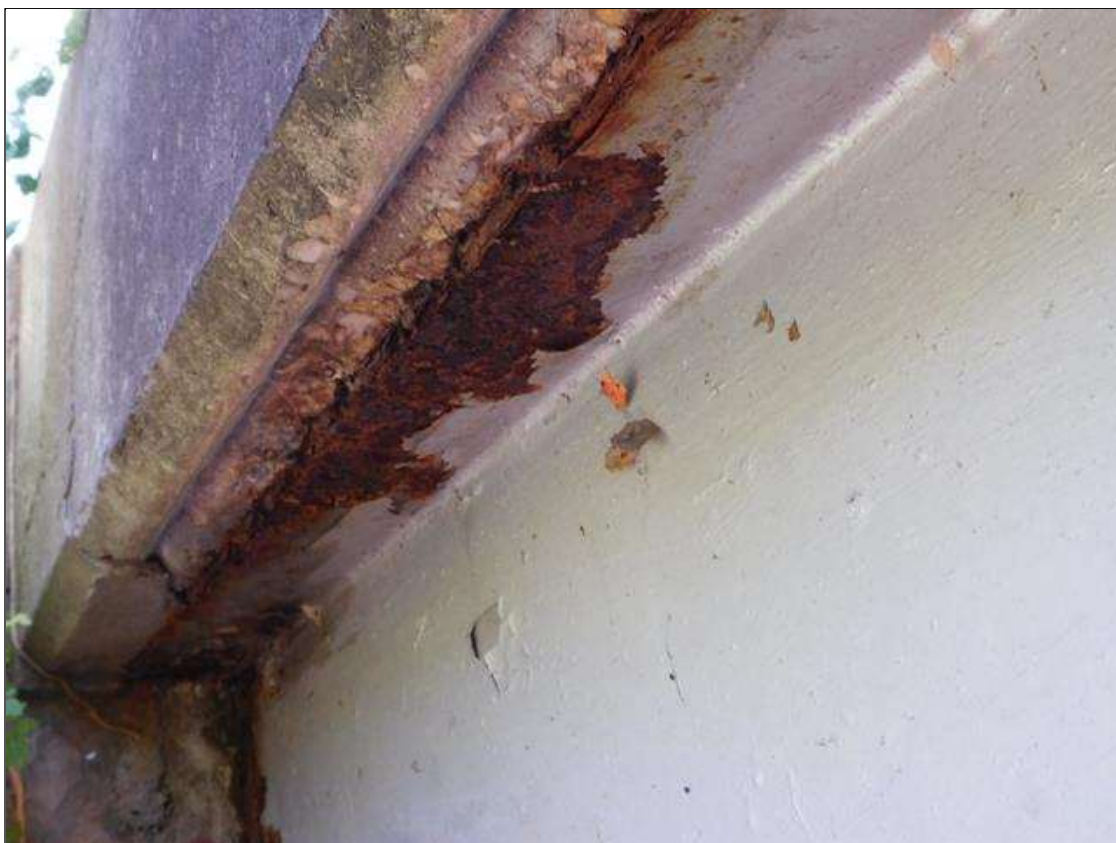
Span 2 Beam 1: at near and far ends, surface corrosion [2ft x up to full height x full width]

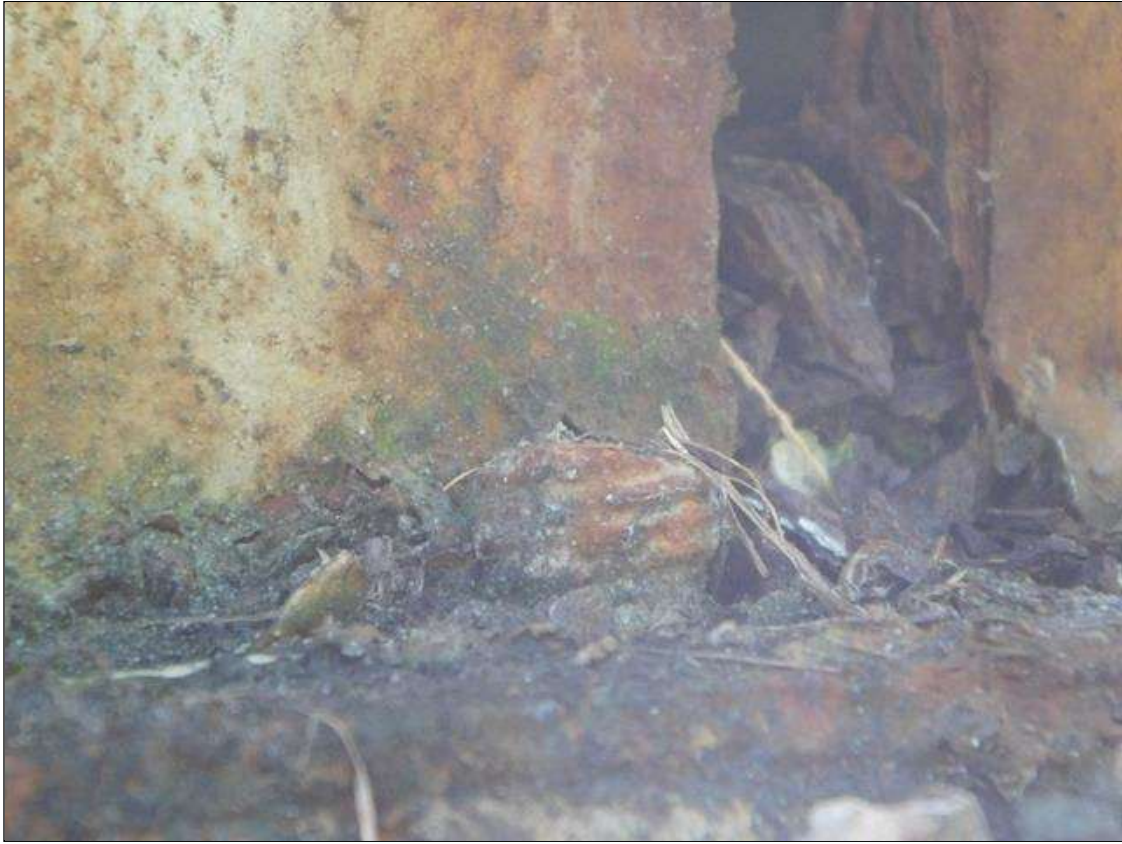
Span 2 Beam 1: West side at near end, anchor bolt nut is missing

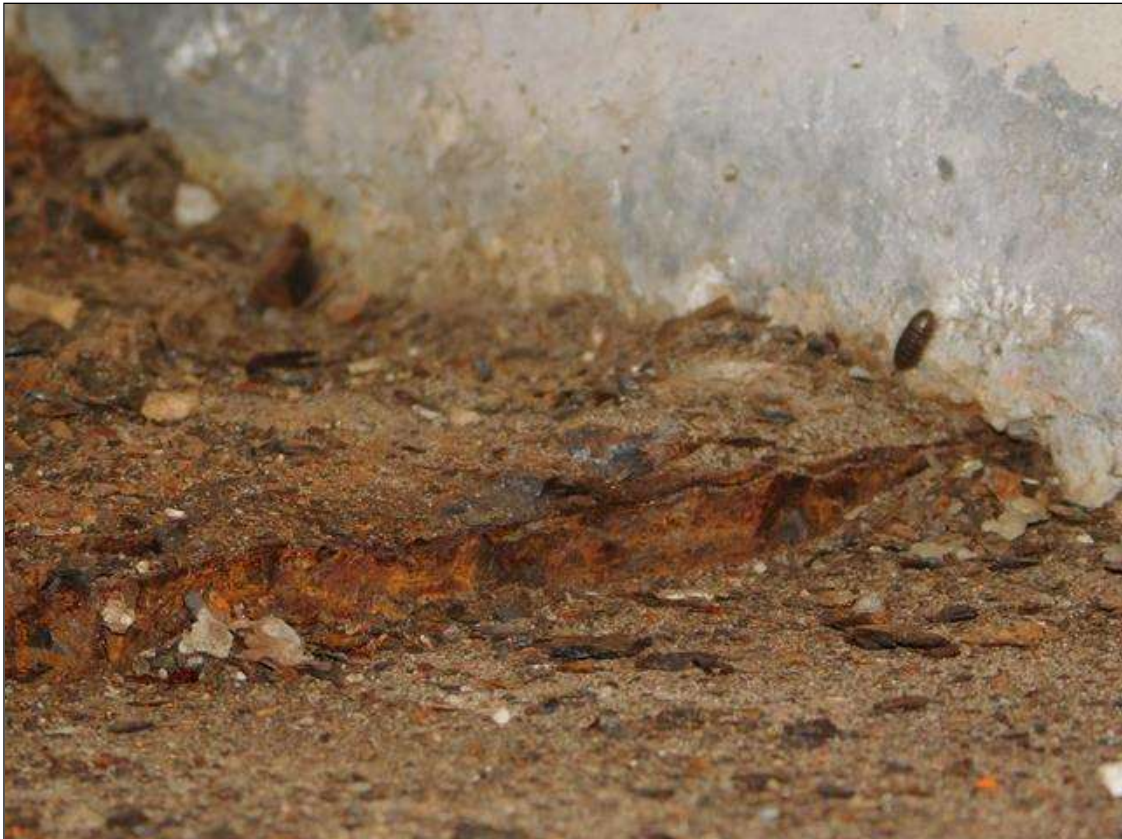
Span 2 Beam 1 - Span 2 Beam 1 Far Bearing: surface corrosion with no section loss noted

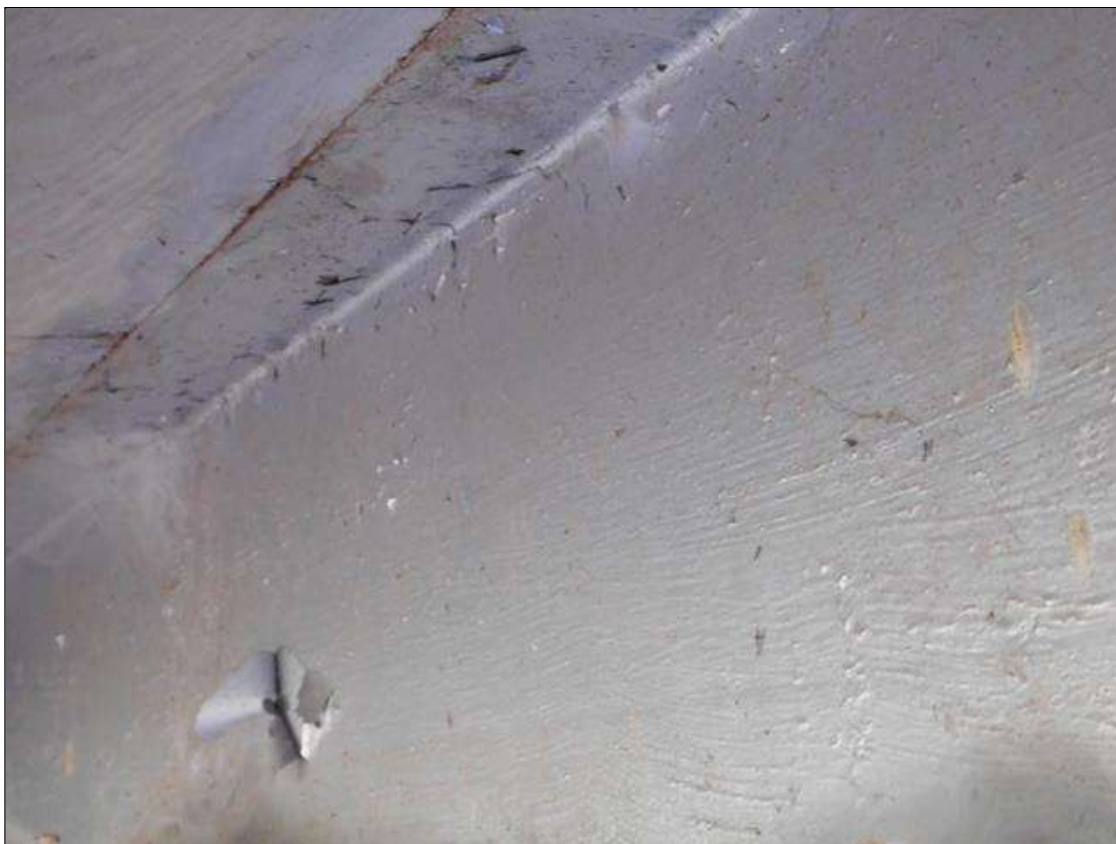
Span 2 Beam 3 - Protective System: along length of beam, bubbling paint in surface coat only

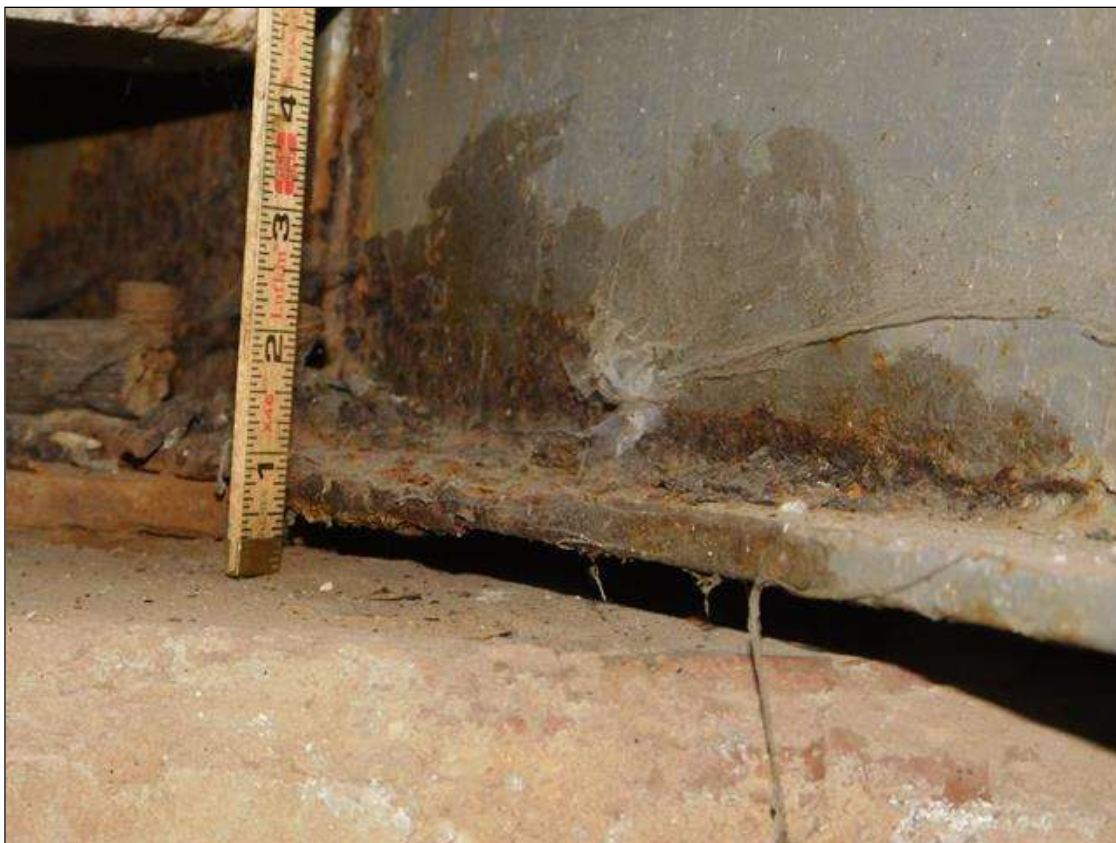
Span 2 Beam 5: 1' OF RUST SCALE, BOTTOM FLANGE, UP TO 2" IN THE WEB, WITH 1/4" REMAINING IN THE BOTTOM FLANGE, AT BENT 1. A "PAR" HAS BEEN ISSUED FOR THIS CONDITION.

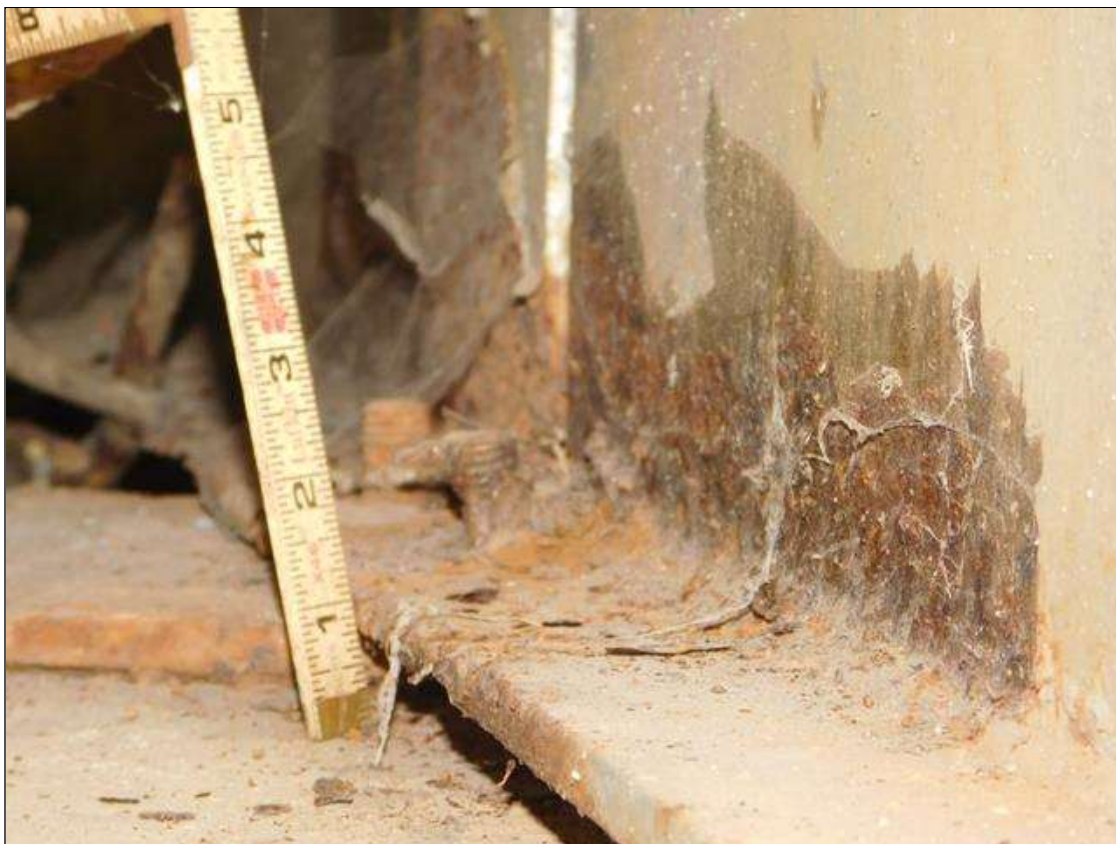
Span 2 Beam 6: 3' OF RUST SCALE, TOP AND BOTTOM FLANGE, UP TO 3" IN THE WEB, WITH 1/4" REMAINING IN THE BOTTOM FLANGE, AT BENT 1. BOTTOM FLANGE HAS A 1" DIAMETER HOLE. A "PAR" HAS BEEN ISSUED FOR THIS CONDITION.

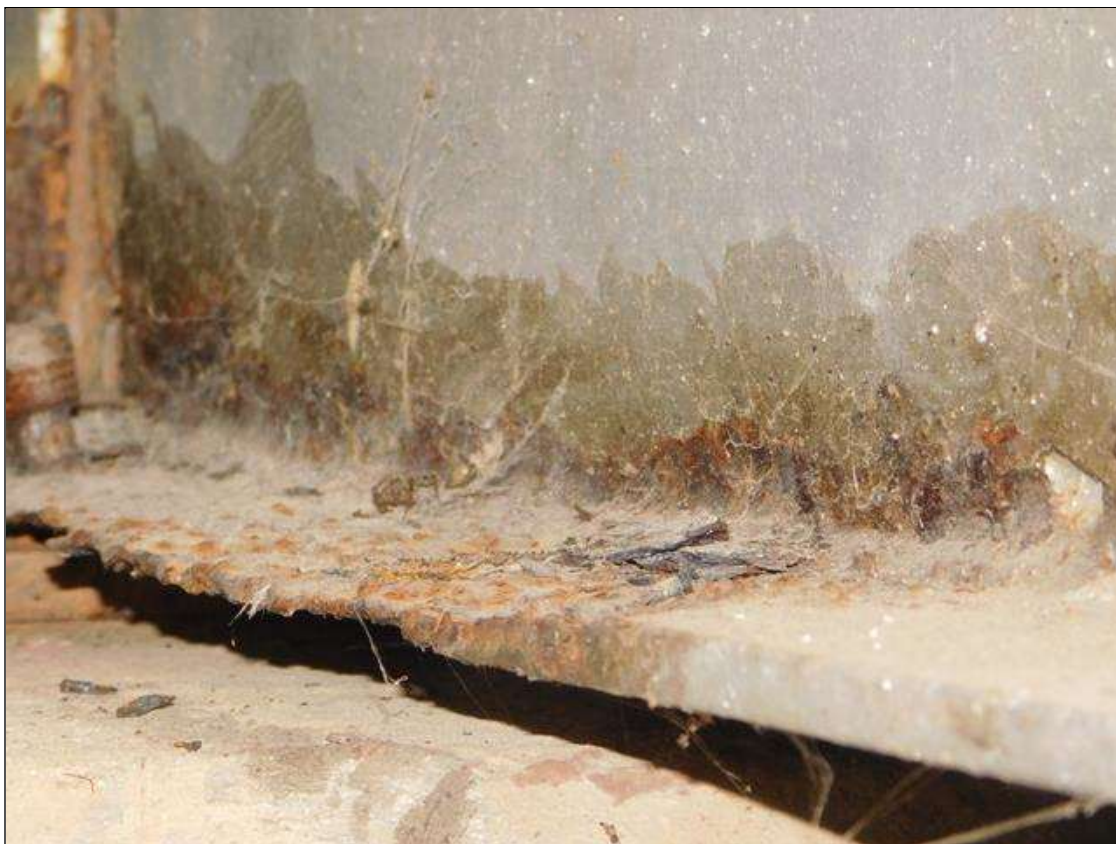
Span 2 Beam 7: 1' OF RUST SCALE, BOTTOM FLANGE, UP TO 2" IN THE WEB, WITH A KNIFE EDGE REMAINING IN THE BOTTOM FLANGE, AT BENT 1. A "PAR" HAS BEEN ISSUED FOR THIS CONDITION.

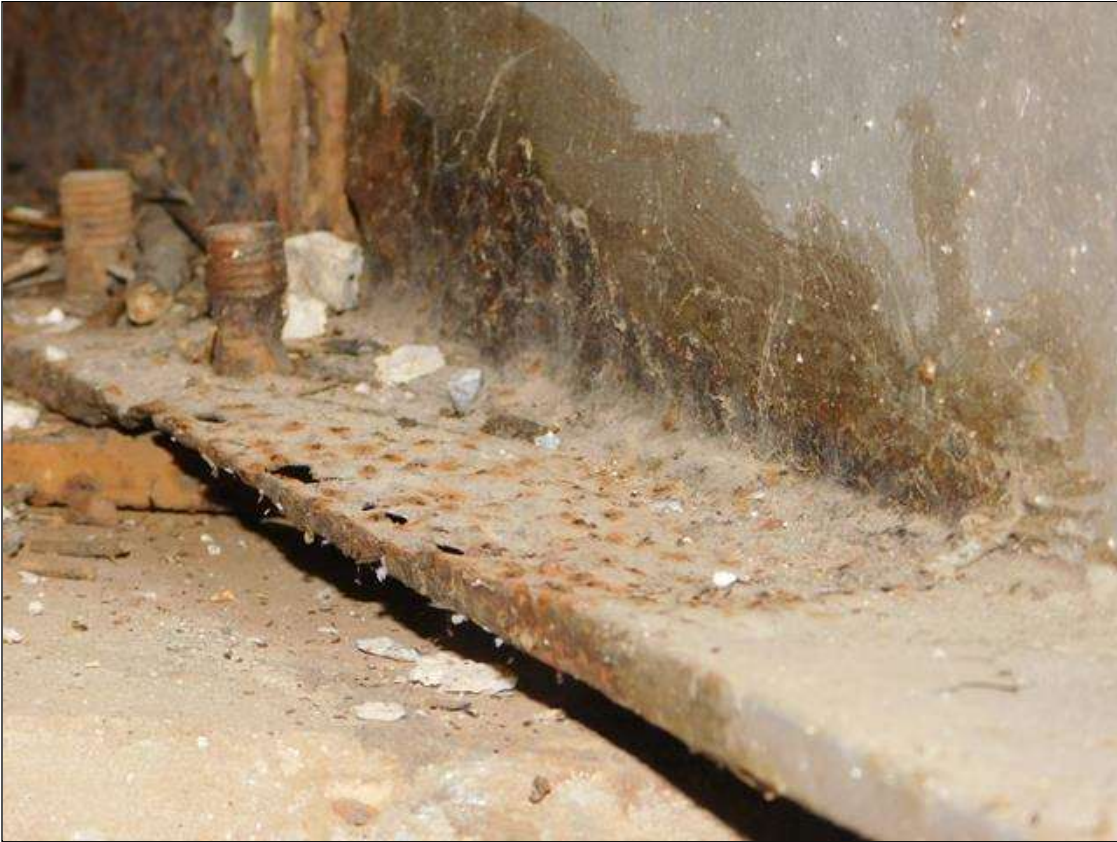
Span 2 Beam 8: 1' OF RUST SCALE, BOTTOM FLANGE, UP TO 2" IN THE WEB, WITH 1/16" REMAINING IN THE BOTTOM FLANGE, AT BENT 1. BOTTOM FLANGE HAS (3) 1" DIAMETER HOLES. A "PAR" HAS BEEN ISSUED FOR THIS CONDITION.
