NC DEPARTMENT OF TRANSPORTATION  
 DIVISION OF HIGHWAYS  
 STRUCTURE MANAGEMENT UNIT

ATTENTION: **BOAT USED FOR INSPECTION / LADDER USED FOR INSPECTION / "PAR"s ISSUED**

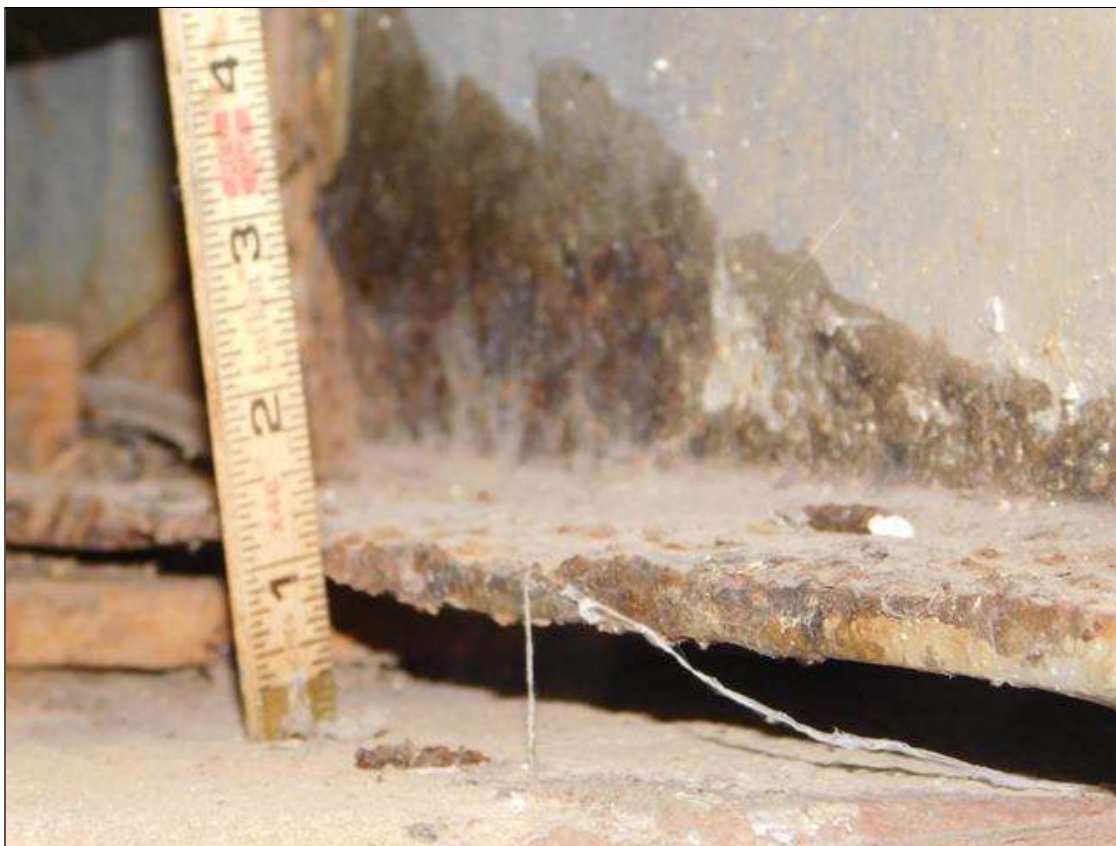
Span 2 Beam 9: 1' OF RUST SCALE, BOTTOM FLANGE, UP TO 2" IN THE WEB, WITH 1/8" REMAINING IN THE BOTTOM FLANGE, AT BENT 1. A "PAR" HAS BEEN ISSUED FOR THIS CONDITION.

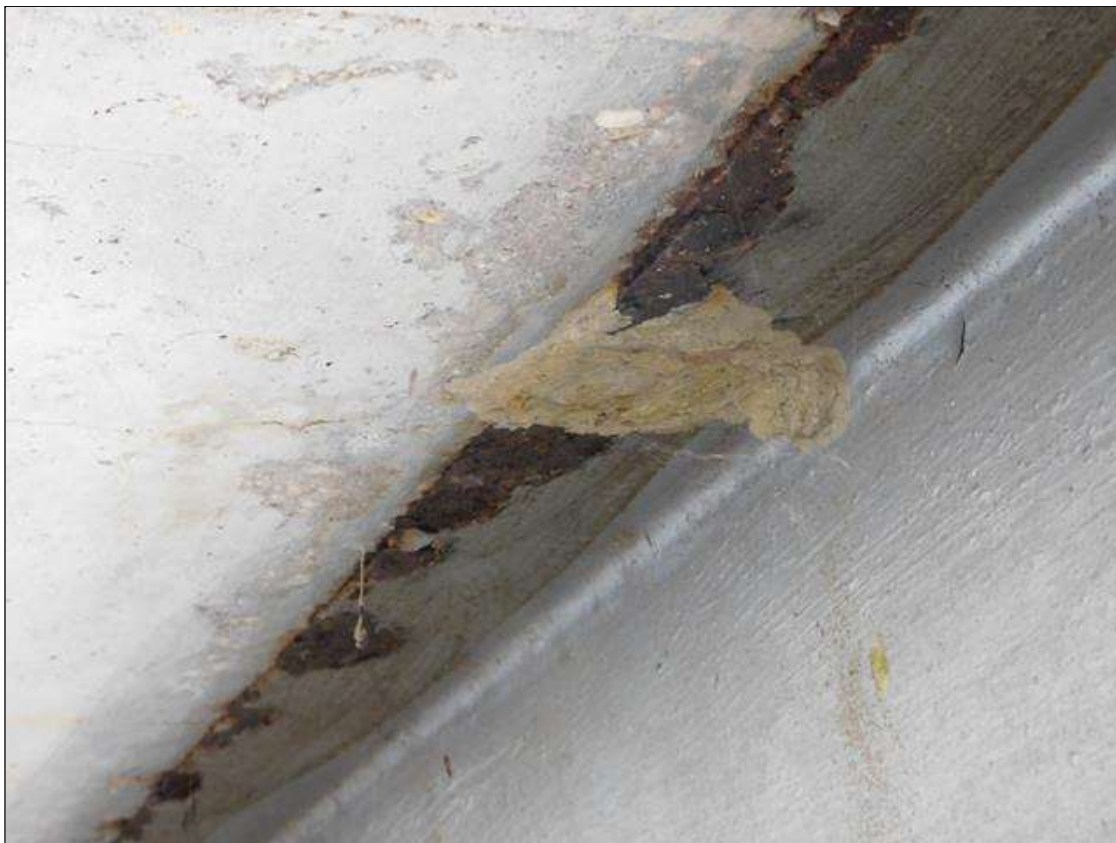
Span 2 Beam 10: 5' OF RUST SCALE, TOP FLANGE, NEAR MID-SPAN.

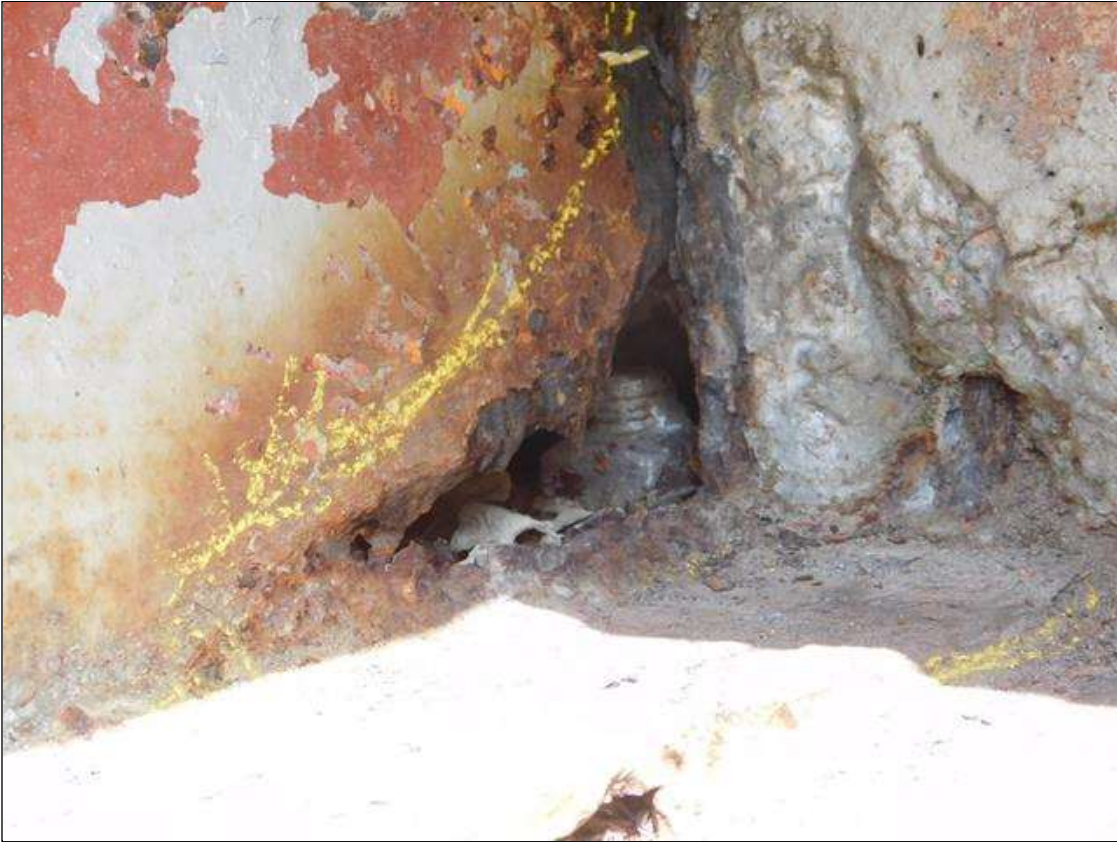
Span 2 Beam 11: SPAN 2 BEAM 11 RIGHT WEB AND BOTTOM FLANGE OVER END BENT 2. WEB HAS A 5" x 3" AREA OF 100% SECTION LOSS. BOTTOM FLANGE HAS A 7" x 3" AREA OF SECTION LOSS WITH 1/4" REMAINING. A "PAR" HAS BEEN ISSUED FOR THIS CONDITION.

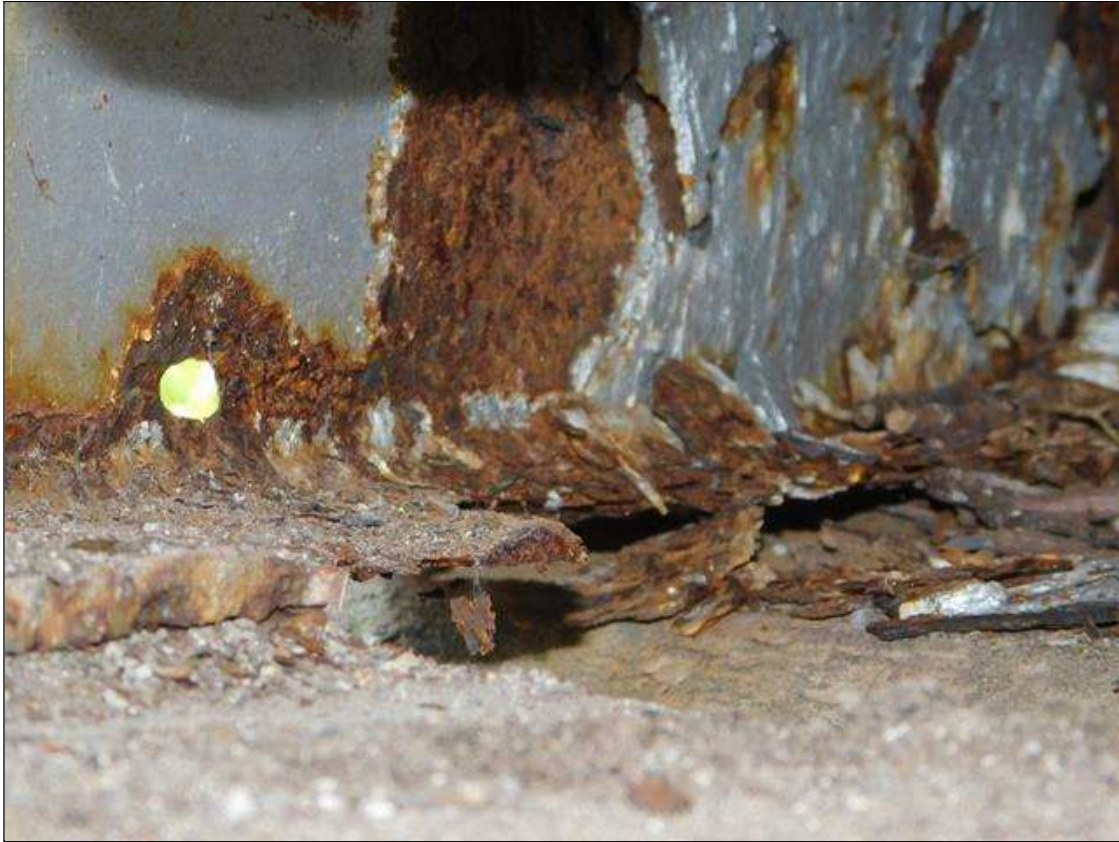
Span 2 Beam 11: 3' OF RUST SCALE IN TOP FLANGE WITH 5/16" REMAINING. BOTTOM FLANGE HAS A 12" x 3" AREA OF 100% SECTION LOSS. WEB HAS A 1 1/2" DIAMETER HOLE. THESE AREAS ARE OVER BENT 1. A "PAR" HAS BEEN ISSUED FOR THESE CONDITIONS.

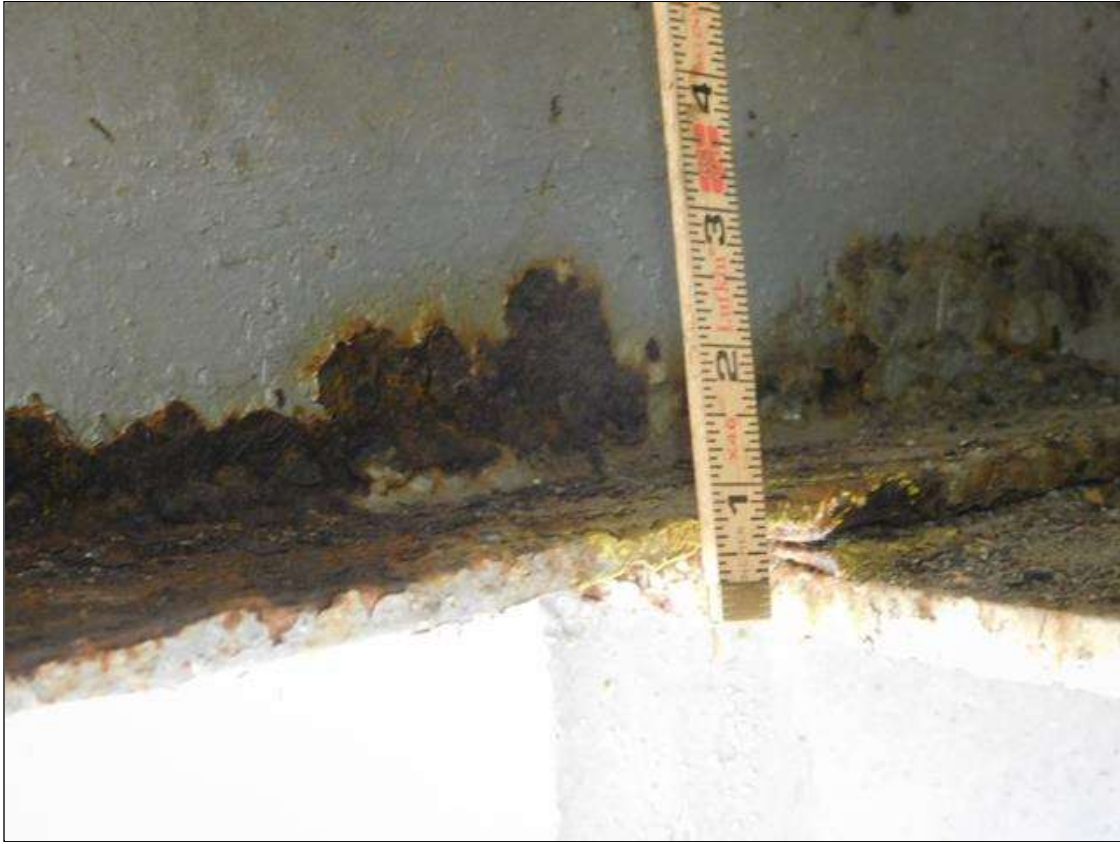
Span 2 Beam 11: BEAM 11 LEFT BOTTOM FLANGE AT CRUTCH BENT. HAS A AREA OF SECTION LOSS WITH 1/4" REMAINING. AREA IS: 3" WIDE x 10" LONG. A "PAR" HAS BEEN ISSUED FOR THIS CONDITION.

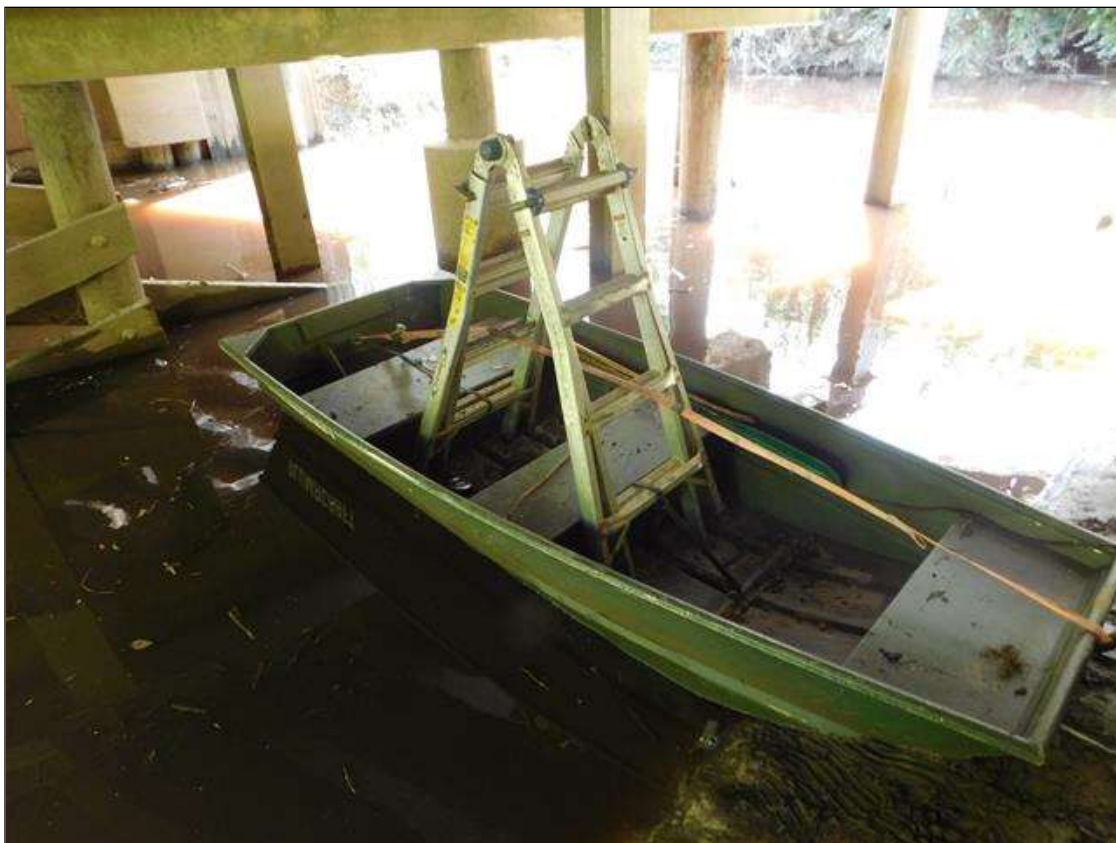
BOAT AND LADDER USED FOR INSPECTION

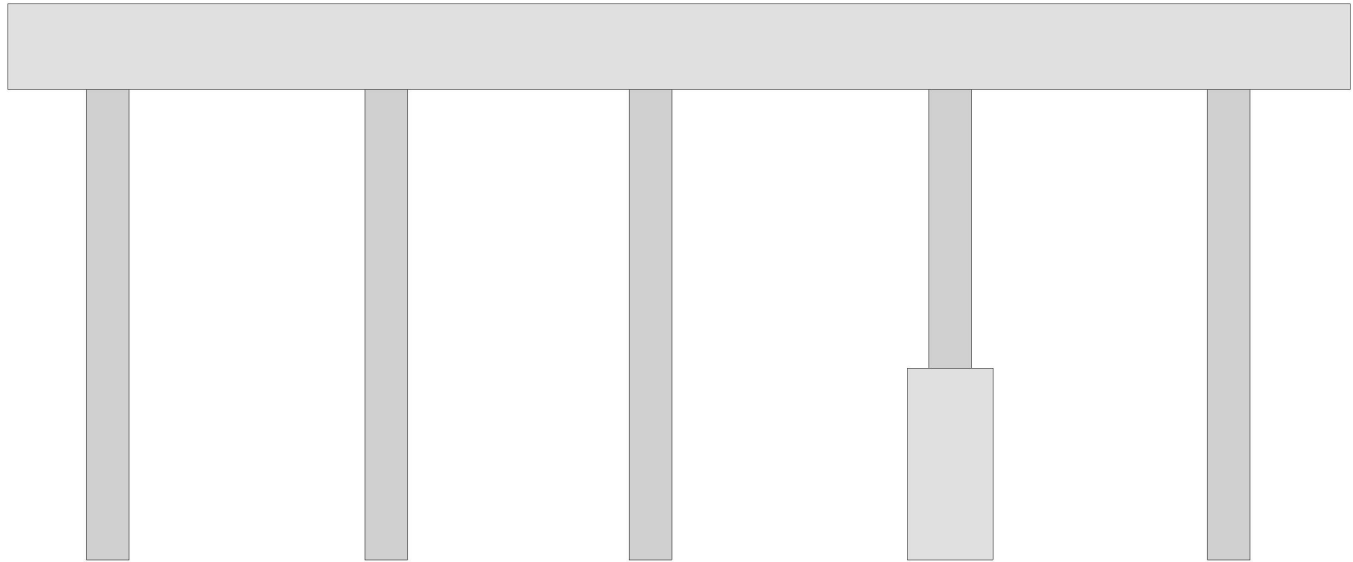
<b>Cap Information</b>			<b>Material</b> Cast-in-Place Concrete							
Length	Width	Height	Left Overhang	Right Overhang	Left Beam to End of Cap.	Right Beam to End of Cap.				
31.333 ft.	2.000 ft.	2.000 ft.	2.330 ft.	2.830 ft.	2.000 ft.	1.000 ft.				
<b>Subcap Information</b>			<b>Material</b>							
Length	Width	Height	Left Overhang	Right Overhang	Left Pile to Splice.					
<b>Sill Information</b>			<b>Material</b>							
Length	Width	Height								
Pile #	Material	Spacing	Width/Dia.	Height	Length	Orientation	Driven?	Replacement?	Removed?	Collar?
1	Timber	6.5 ft.	1 ft.			Vertical	Yes	No	No	No
2	Timber	6.167 ft.	1 ft.			Vertical	Yes	No	No	No
3	Timber	7 ft.	1 ft.			Vertical	Yes	No	No	No
4	Timber	6.5 ft.	1 ft.			Vertical	Yes	Yes	No	Yes
5	Timber		1 ft.			Vertical	Yes	No	No	No
<b>Bent/Abutment #:</b> 1			<b>Similar Bents:</b>

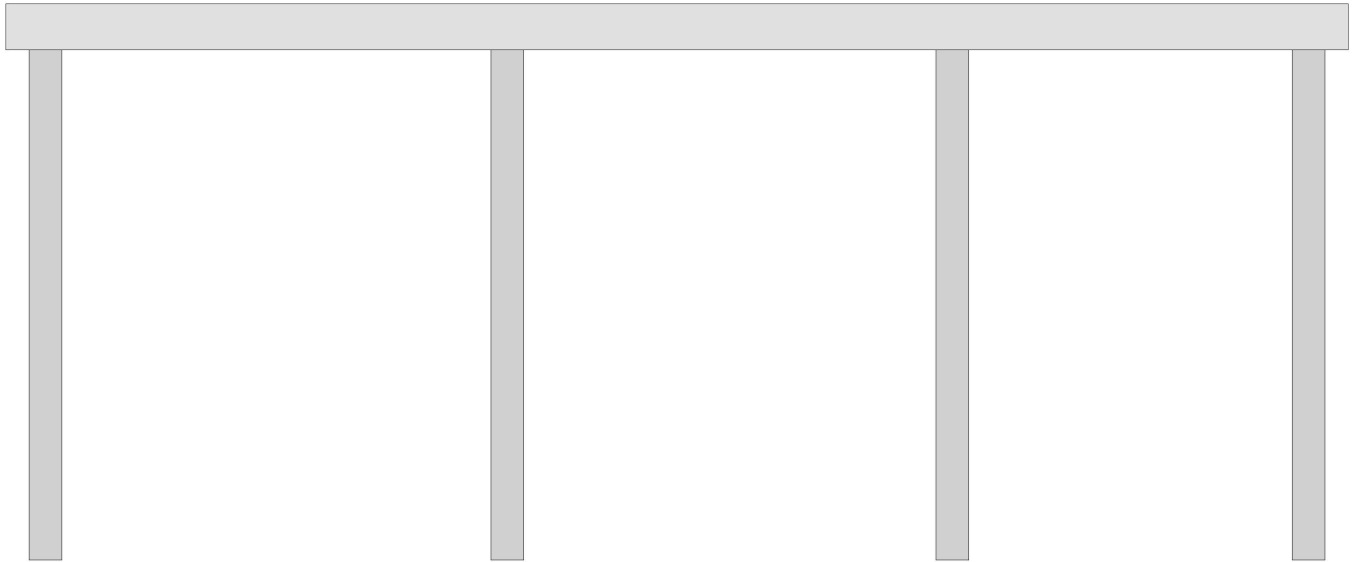
<b>Cap Information</b>			<b>Material</b> Steel							
Length	Width	Height	Left Overhang	Right Overhang	Left Beam to End of Cap.	Right Beam to End of Cap.				
33.920 ft.	1.208 ft.	1.125 ft.	1.000 ft.	1.000 ft.	3.167 ft.	2.833 ft.				
<b>Subcap Information</b>			<b>Material</b>							
Length	Width	Height	Left Overhang	Right Overhang	Left Pile to Splice.					
<b>Sill Information</b>			<b>Material</b>							
Length	Width	Height								
Pile #	Material	Spacing	Width/Dia.	Height	Length	Orientation	Driven?	Replacement?	Removed?	Collar?
1	Steel	11.67 ft.	0.833 ft.	0.833 ft.		Vertical	Yes	No	No	No
2	Steel	11.25 ft.	0.833 ft.	0.833 ft.		Vertical	Yes	No	No	No
3	Steel	9.0 ft.	0.833 ft.	0.833 ft.		Vertical	Yes	No	No	No
4	Steel		0.833 ft.	0.833 ft.		Vertical	Yes	No	No	No
<b>Crutch Bent #:</b> 1

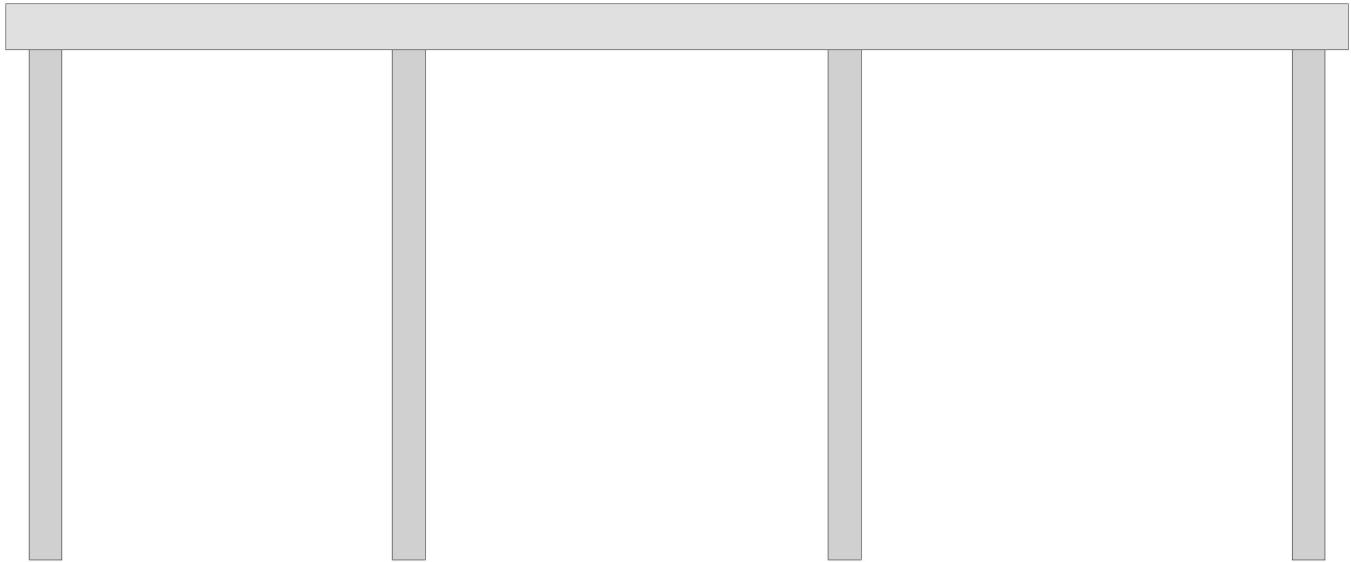
<b>Cap Information</b>			<b>Material</b> Steel							
Length	Width	Height	Left Overhang	Right Overhang	Left Beam to End of Cap.	Right Beam to End of Cap.				
33.875 ft.	1.208 ft.	1.125 ft.	1.000 ft.	1.000 ft.	2.750 ft.	3.427 ft.				
<b>Subcap Information</b>			<b>Material</b>							
Length	Width	Height	Left Overhang	Right Overhang	Left Pile to Splice.					
<b>Sill Information</b>			<b>Material</b>							
Length	Width	Height								
Pile #	Material	Spacing	Width/Dia.	Height	Length	Orientation	Driven?	Replacement?	Removed?	Collar?
1	Steel	9.167 ft.	0.833 ft.	0.833 ft.		Vertical	Yes	No	No	No
2	Steel	11.0 ft.	0.833 ft.	0.833 ft.		Vertical	Yes	No	No	No
3	Steel	11.708 ft.	0.833 ft.	0.833 ft.		Vertical	Yes	No	No	No
4	Steel		0.833 ft.	0.833 ft.		Vertical	Yes	No	No	No
<b>Crutch Bent #:</b> 2

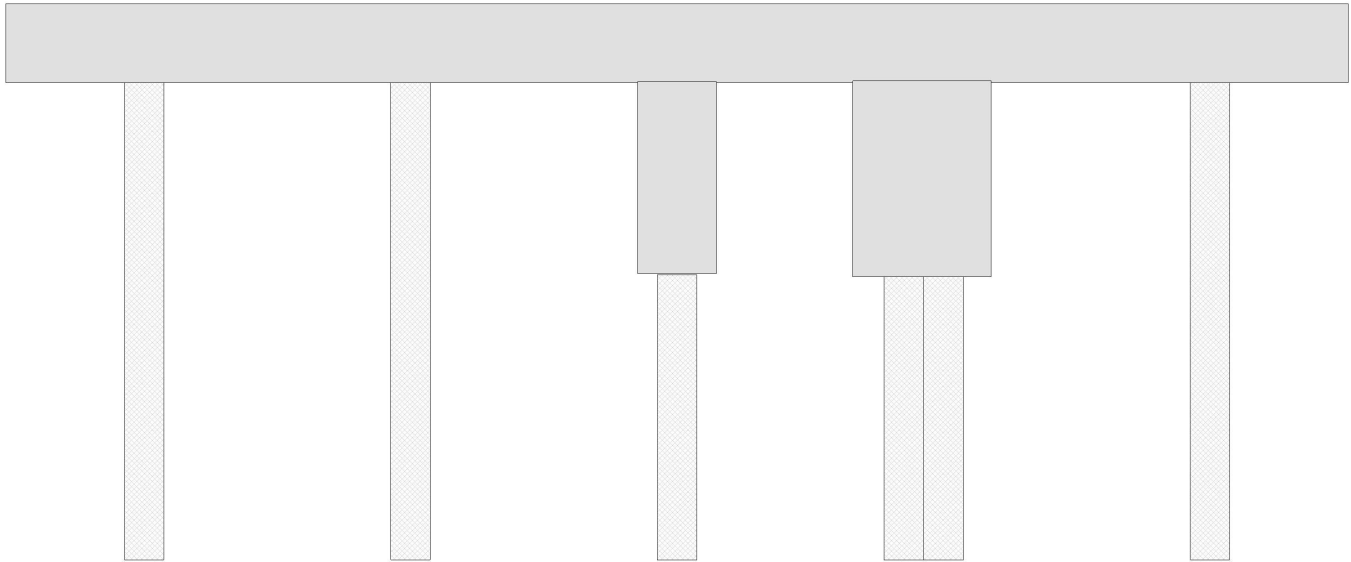
Cap Information			Material							
Length	Width	Height	Left Overhang	Right Overhang	Left Beam to End of Cap.	Right Beam to End of Cap.				
34.000 ft.	2.000 ft.	2.000 ft.	3.500 ft.	3.500 ft.	2.000 ft.	3.330 ft.				
Subcap Information			Material							
Length	Width	Height	Left Overhang	Right Overhang	Left Pile to Splice.					
Sill Information			Material							
Length	Width	Height								
Pile #	Material	Spacing	Width/Dia.	Height	Length	Orientation	Driven?	Replacement?	Removed?	Collar?
1	Concrete	6.75 ft.	3.00 ft.			Vertical	No	No	No	No
2	Timber	6.75 ft.	1.00 ft.			Vertical	No	No	No	No
3	Concrete	5.75 ft.	1.00 ft.			Vertical	No	No	No	Yes
4	Timber	1.00 ft.	1.00 ft.			Vertical	No	No	No	Yes
5	Timber	6.75 ft.	1.00 ft.			Vertical	No	No	No	Yes
6	Timber		1.00 ft.			Vertical	No	No	No	No
Abutment #: 1

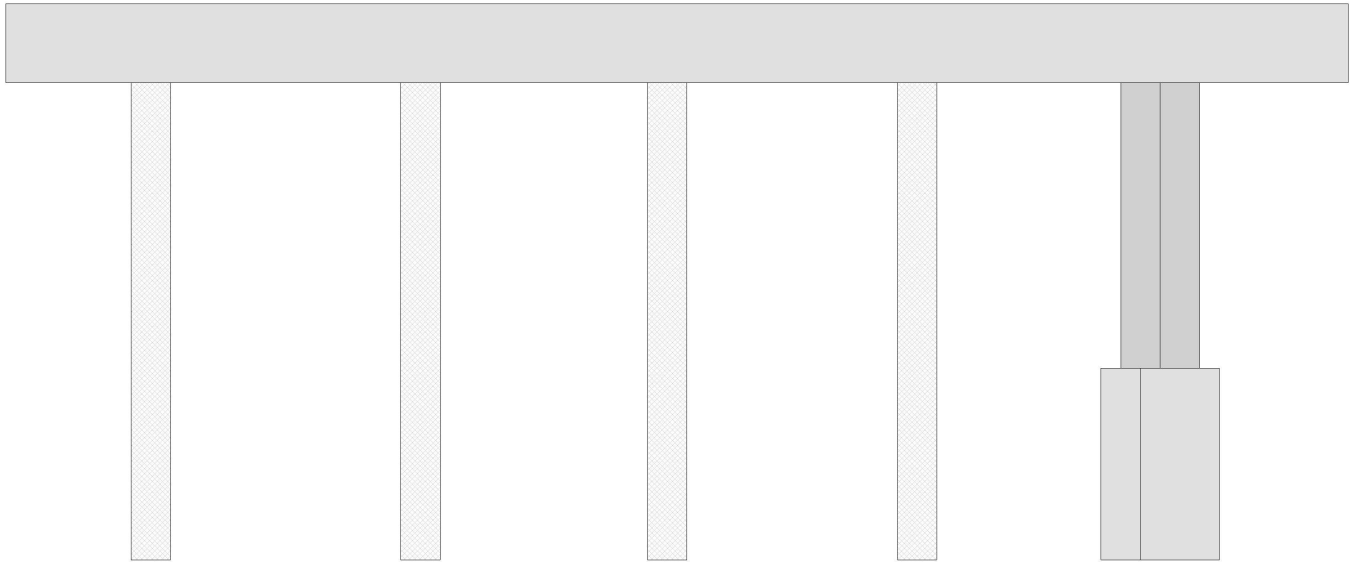
<b>Cap Information</b>			<b>Material</b> Cast-in-Place Concrete							
Length	Width	Height	Left Overhang	Right Overhang	Left Beam to End of Cap.	Right Beam to End of Cap.				
34.000 ft.	2.000 ft.	2.000 ft.	3.670 ft.	3.500 ft.	3.160 ft.	1.500 ft.				
<b>Subcap Information</b>			<b>Material</b>							
Length	Width	Height	Left Overhang	Right Overhang	Left Pile to Splice.					
<b>Sill Information</b>			<b>Material</b>							
Length	Width	Height								
Pile #	Material	Spacing	Width/Dia.	Height	Length	Orientation	Driven?	Replacement?	Removed?	Collar?
1	Concrete	6.83 ft.	1 ft.			Vertical	No	Yes	No	No
2	Concrete	6.25 ft.	1 ft.			Vertical	No	Yes	No	No
3	Concrete	6.33 ft.	1 ft.			Vertical	No	Yes	No	No
4	Concrete	5.66 ft.	1 ft.			Vertical	No	Yes	No	No
5	Timber	1 ft.				Vertical	Yes	No	No	Yes
6	Timber					Vertical	Yes	No	No	Yes
<b>Abutment #:</b>			2
