NC DEPARTMENT OF TRANSPORTATION  
 DIVISION OF HIGHWAYS  
 STRUCTURE MANAGEMENT UNIT

ATTENTION: Prompt Action Request; Typical Section Sketch Modified

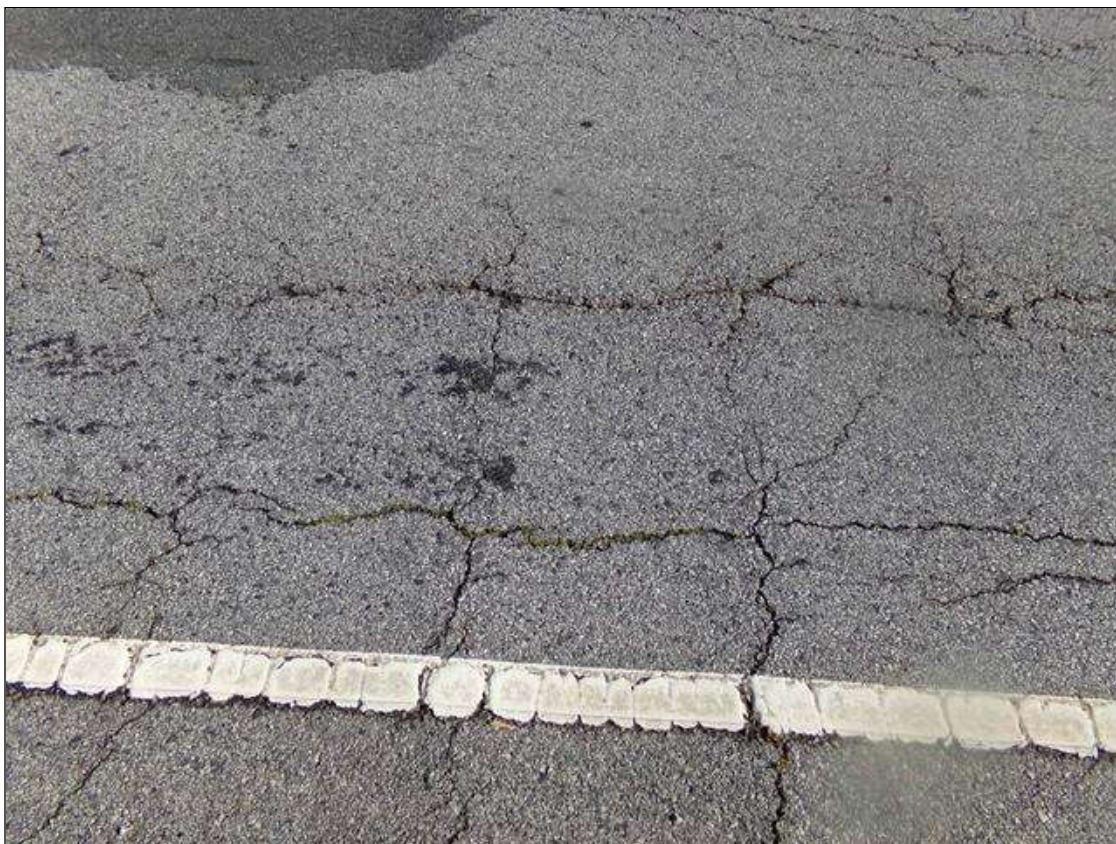
Span 1 Wearing Surface: 45 square feet up to 1/4" transverse cracks

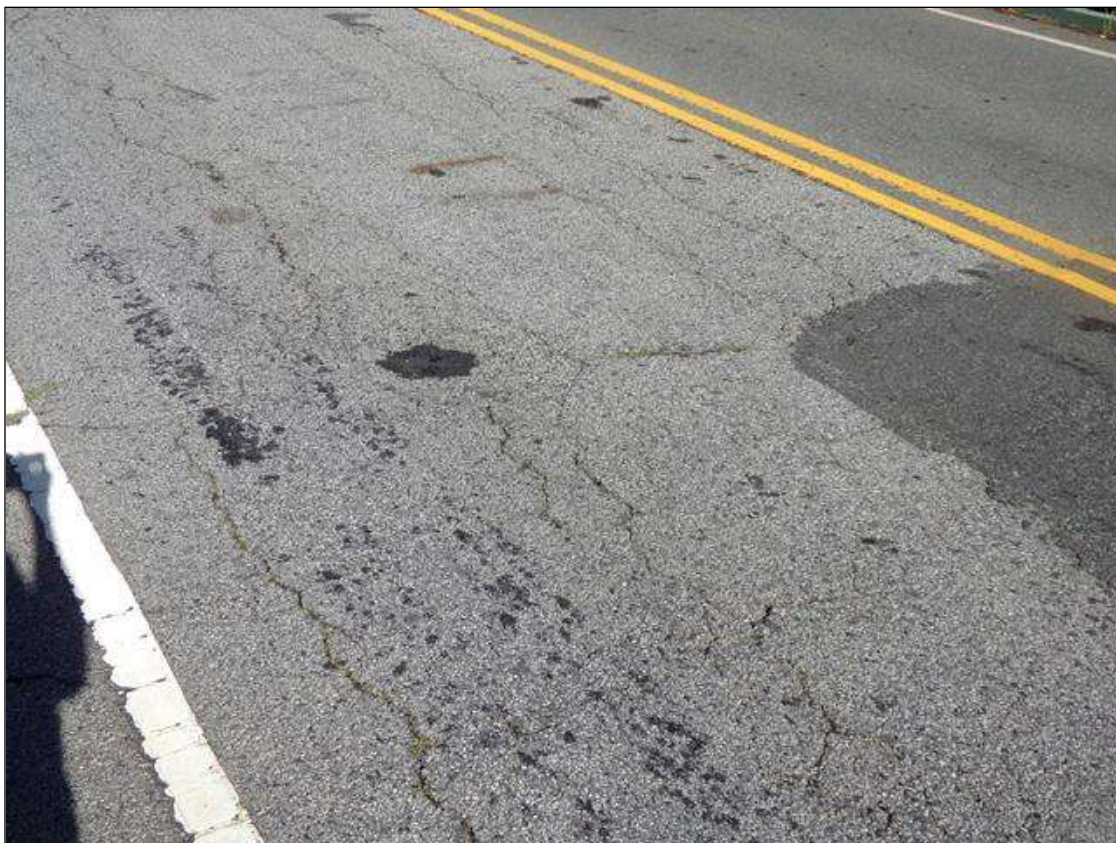
Span 1 Wearing Surface: (2) UP TO 35' x 1/2" LONGITUDINAL CRACKS IN Eastbound LANE.

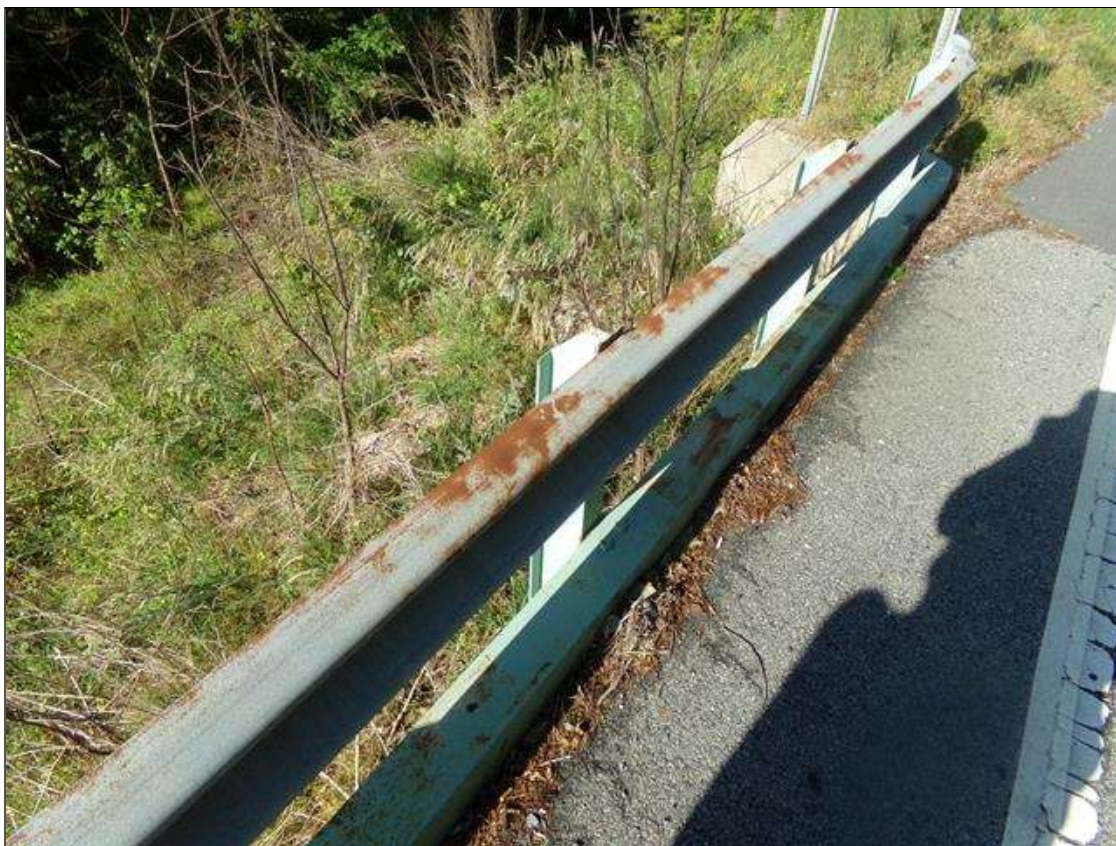
Span 1 Right Bridge Rail: SURFACE RUST AT RANDOM THROUGHOUT GUARDRAIL AND CURB RAIL.

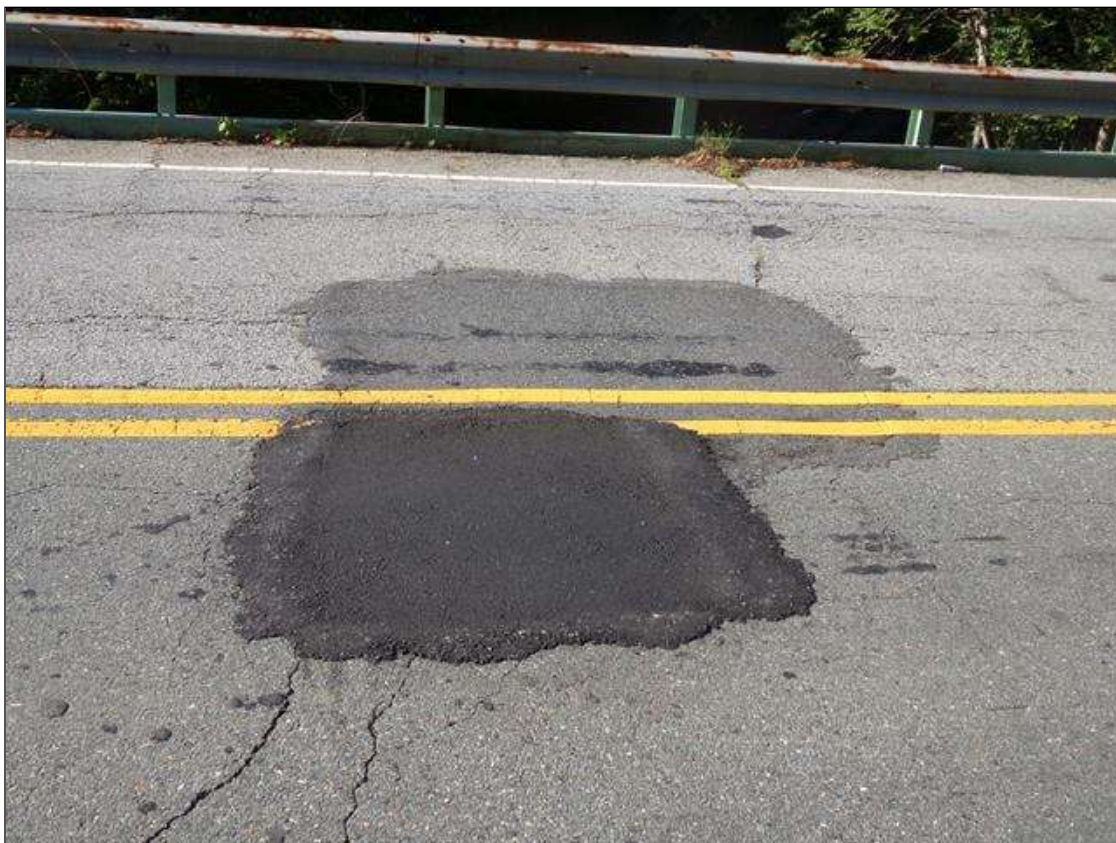
Span 2 Wearing Surface: 7' x 5' PATCHED AREA AT CENTERLINE OF ROADWAY AT BENT 1.

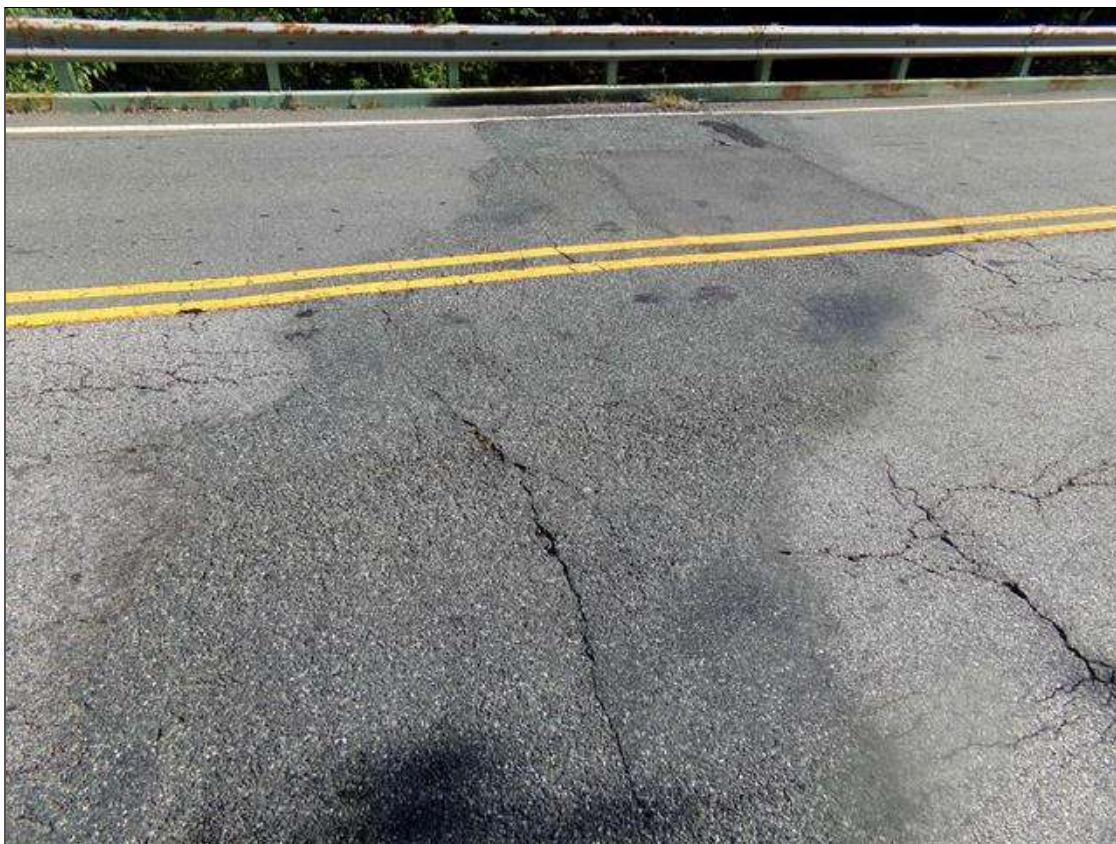
Span 2 Wearing Surface: 27' x UP TO 5' PATCHED AREA AT BENT 2 JOINT.

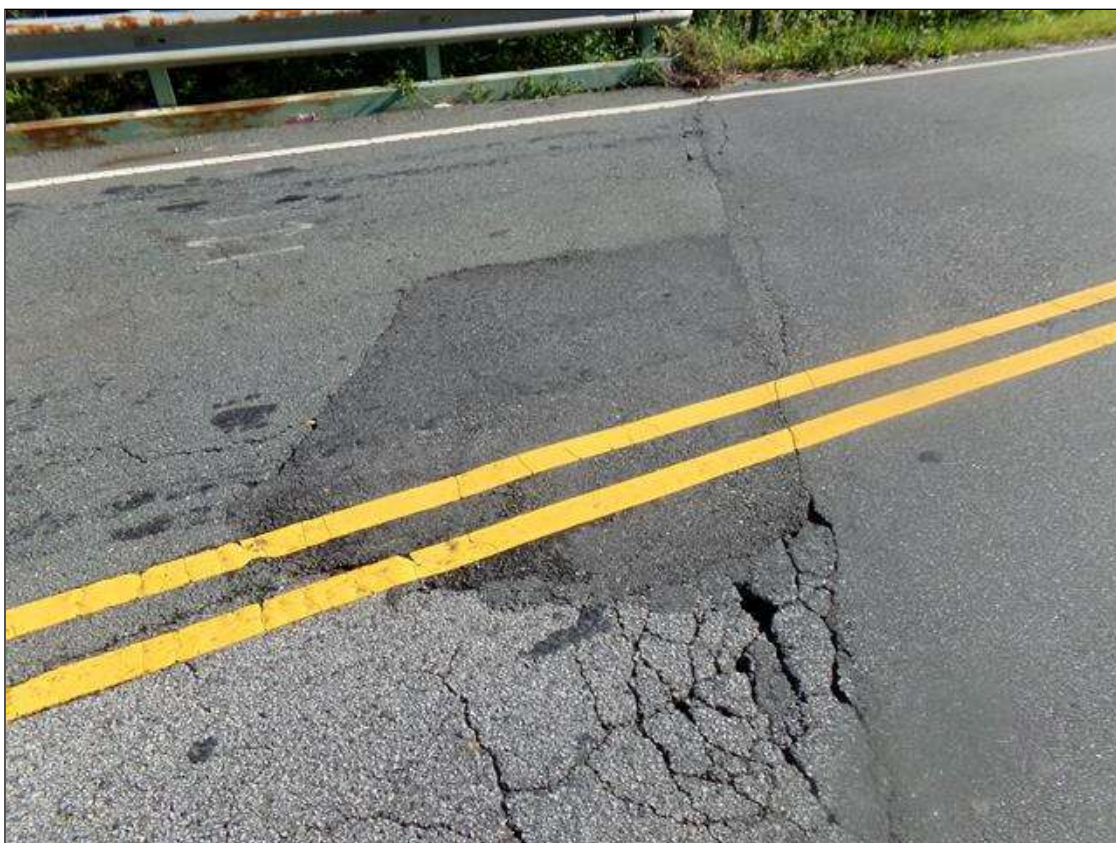
Span 3 Wearing Surface: (2) UP TO 5' x 3' PATCHED AREAS, IN Westbound LANE NEAR CENTERLINE, AT BENT 2 AND END BENT 2. (PHOTO TAKEN AT END BENT 2)

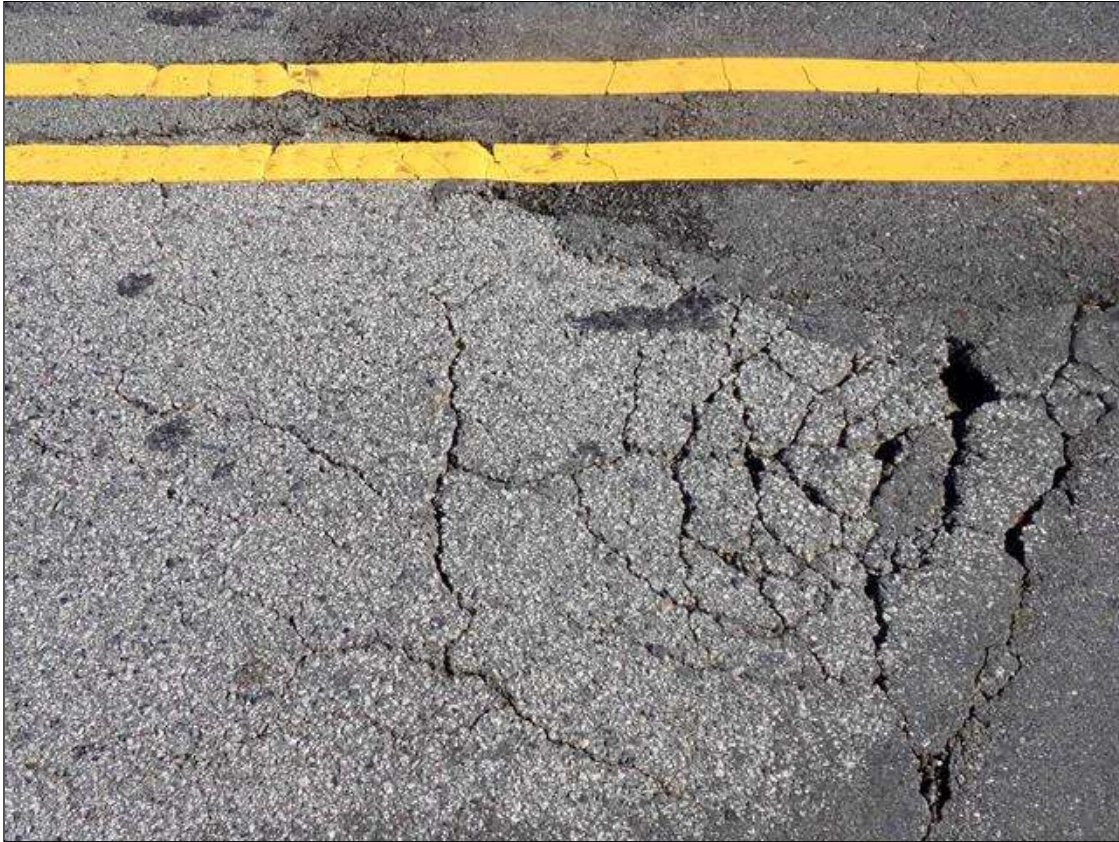
Span 3 Wearing Surface: MAP CRACKING UP TO 1/4" AT RANDOM THROUGHOUT ASPHALT WEARING SURFACE. (PHOTO TAKEN IN Eastbound LANE 1' FROM END BENT 2)

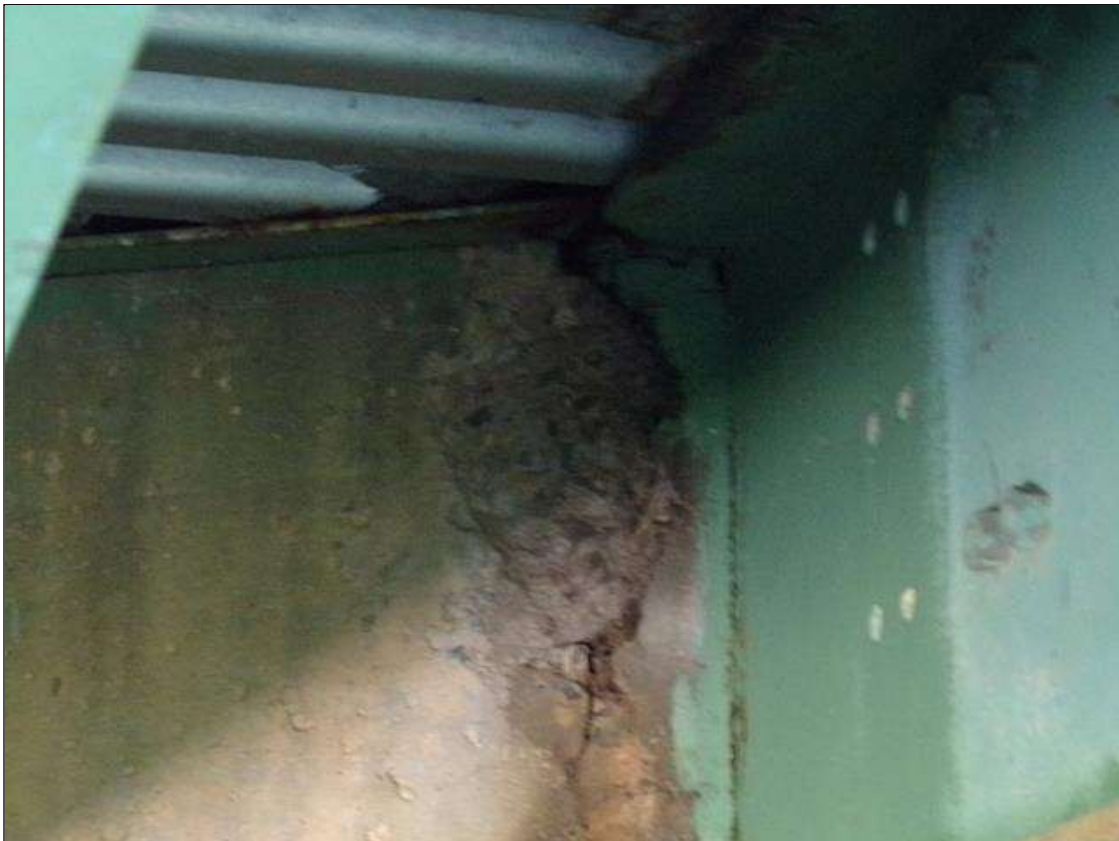
End Bent 2 Abutment: (5) UP TO 9" x 21" x 1 1/2" SPALLS and area of delamination ON NORTH BEAM INTERFACE IN ABUTMENT BACKWALL AT BEAM ENDS BETWEEN BEAMS 8 THROUGH 12.

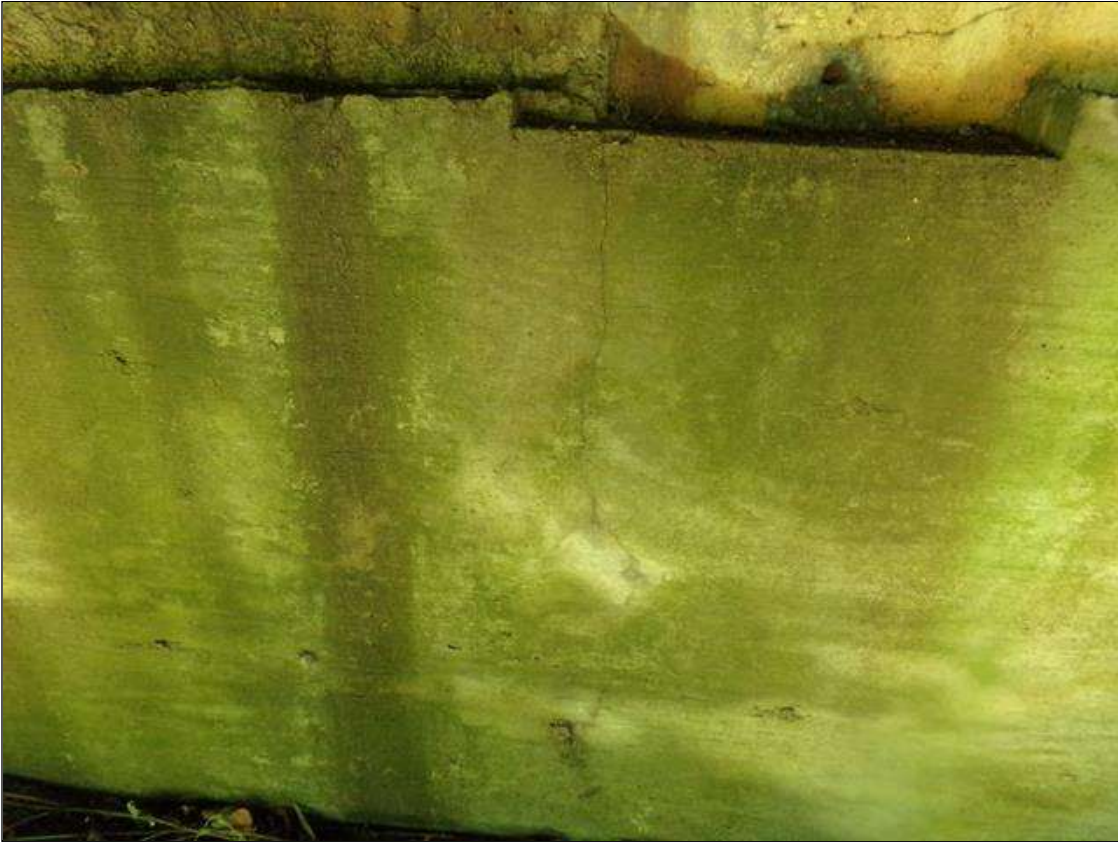
End Bent 2 Abutment: (4) UP TO 2 1/2' x 1/32" VERTICAL CRACKS AT RANDOM THROUGHOUT WEST FACE OF ABUTMENT. (PHOTO TAKEN BENEATH BEAM 10)

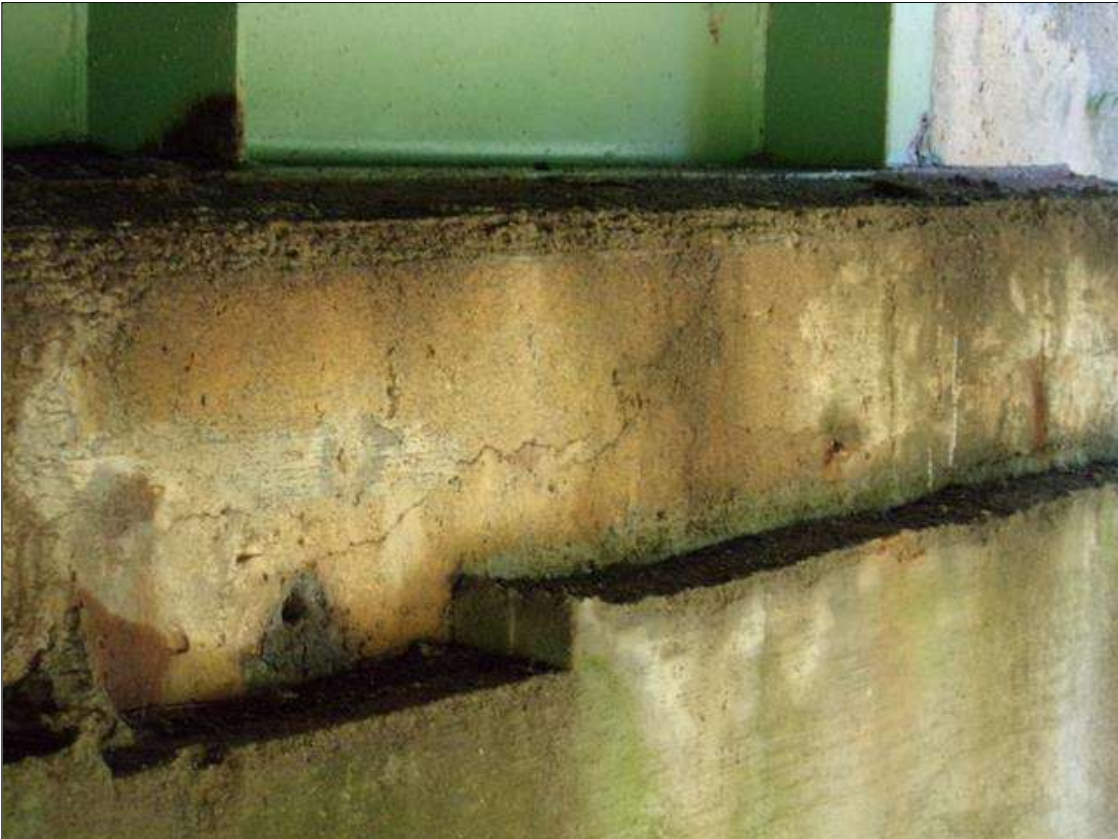
End Bent 2 Abutment: 15' x UP TO 1/32" HORIZONTAL ON WEST FACE OF UPPER ABUTMENT WALL BETWEEN BEAMS 8 THROUGH 11.

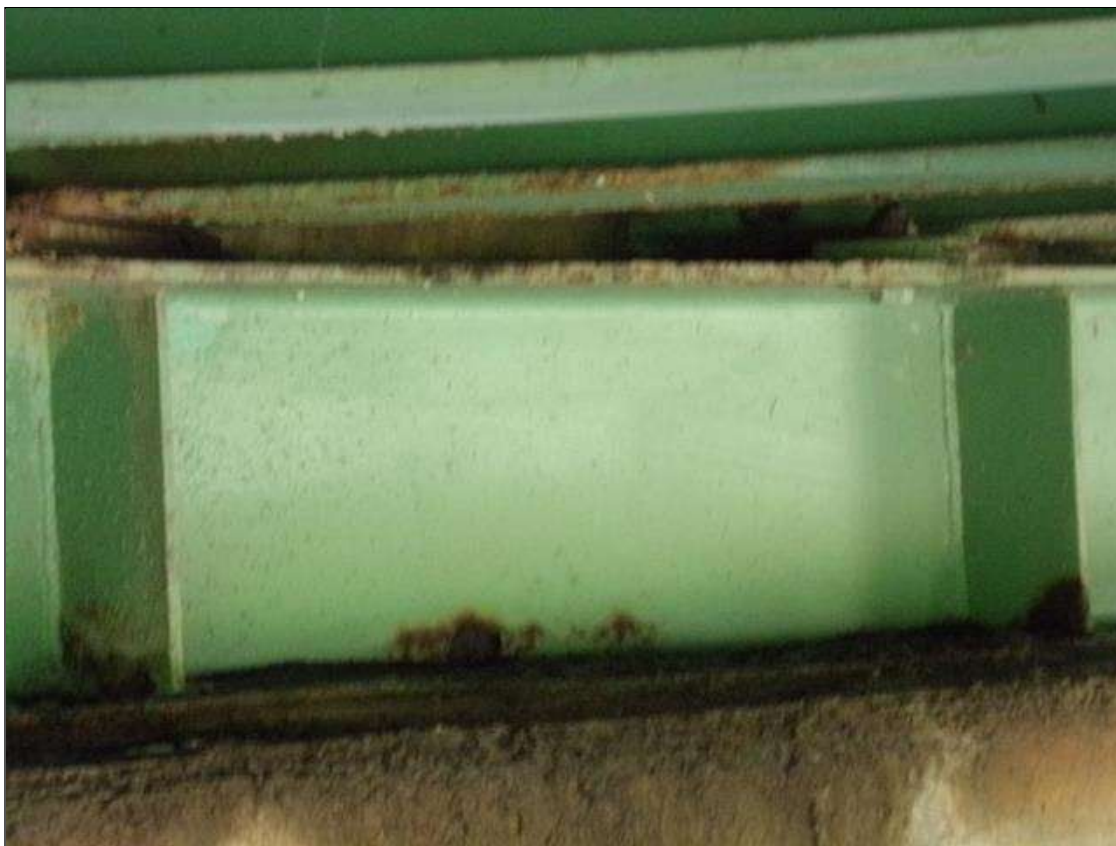
End Bent 2 Cap 1: 15' surface rust on both flanges

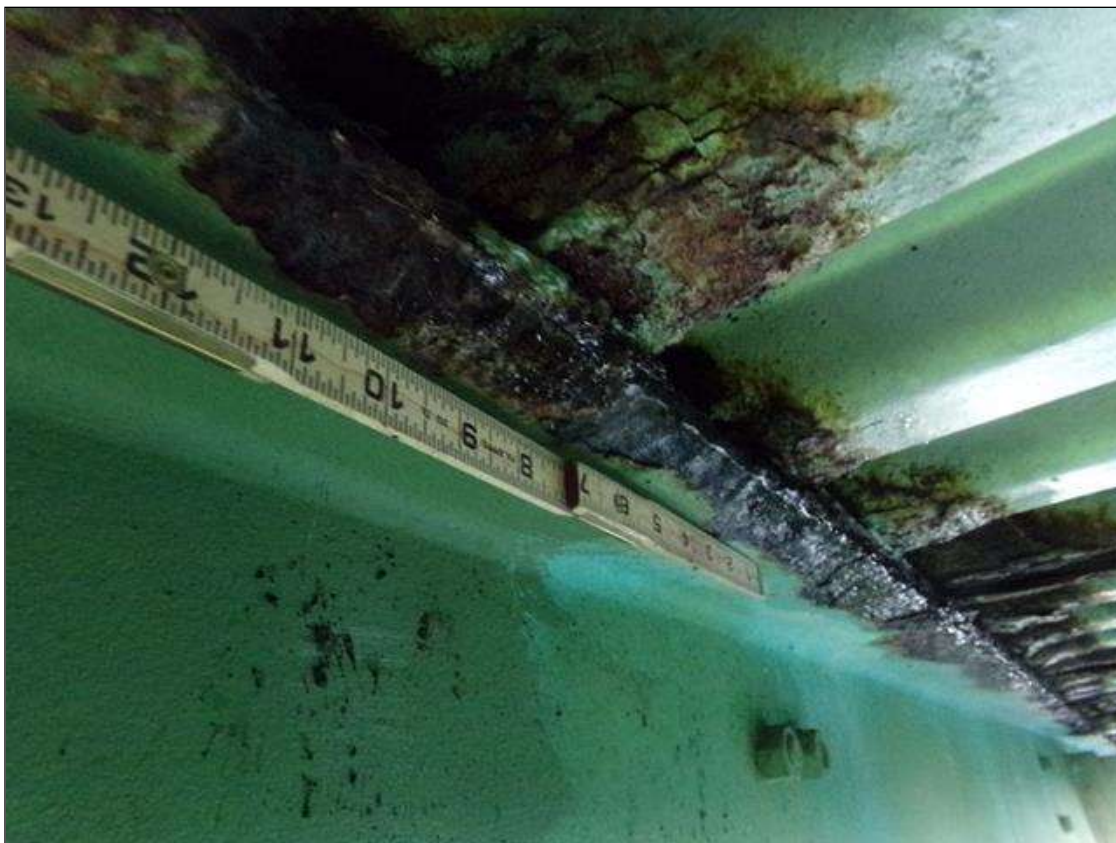
Span 3 Beam 12: 20" x 1 1/2" area of 1/8" section loss (3/8" remaining) on both sides of top flange, 11' from End Bent 2 (PAR)

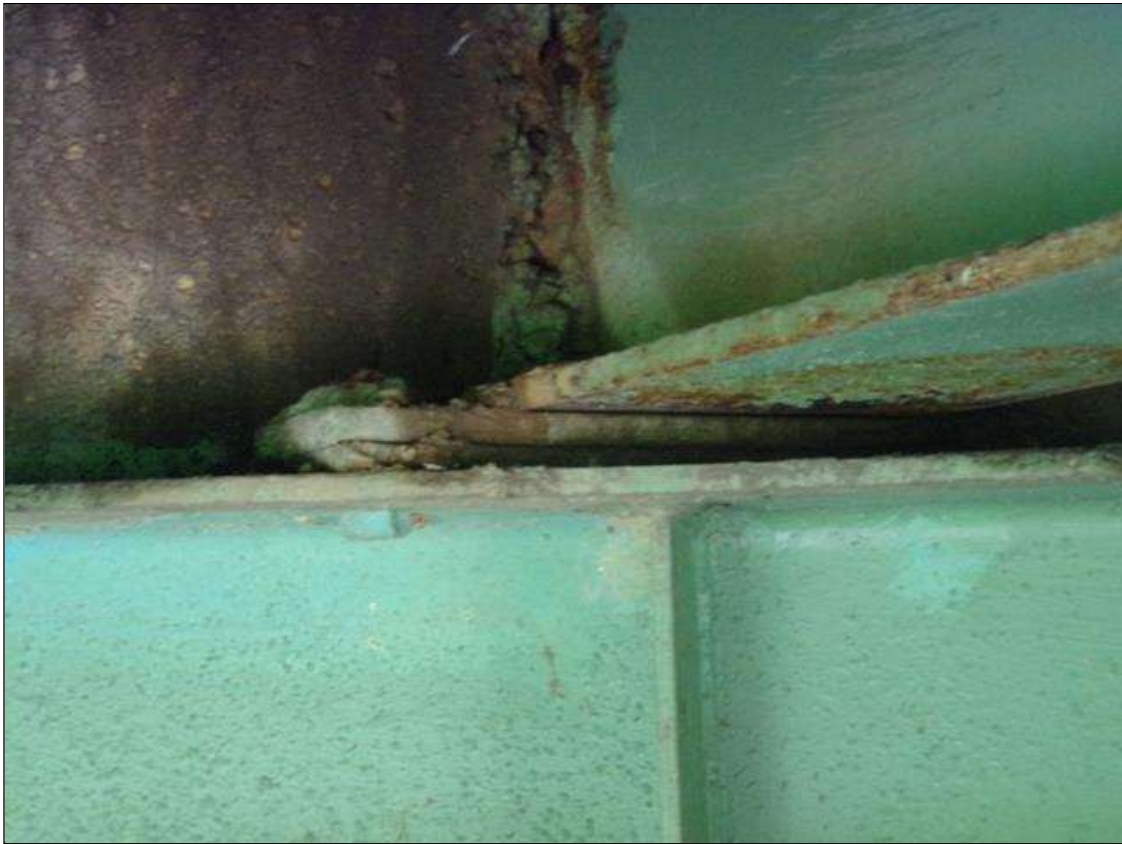
Span 3 Far Bearing: surface rust

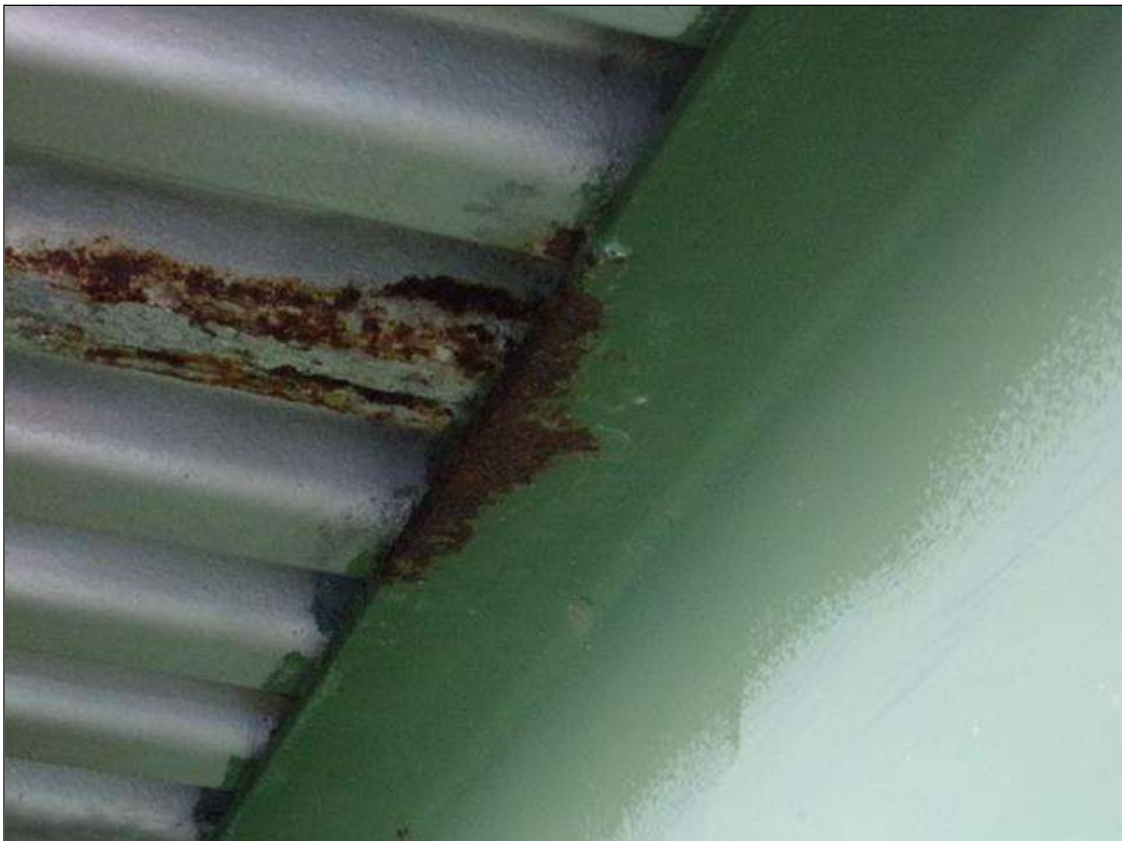
Span 3 Beam 8: 15' OF peeling paint with rust ON TOP AND BOTTOM FLANGES, AT RANDOM THROUGHOUT.

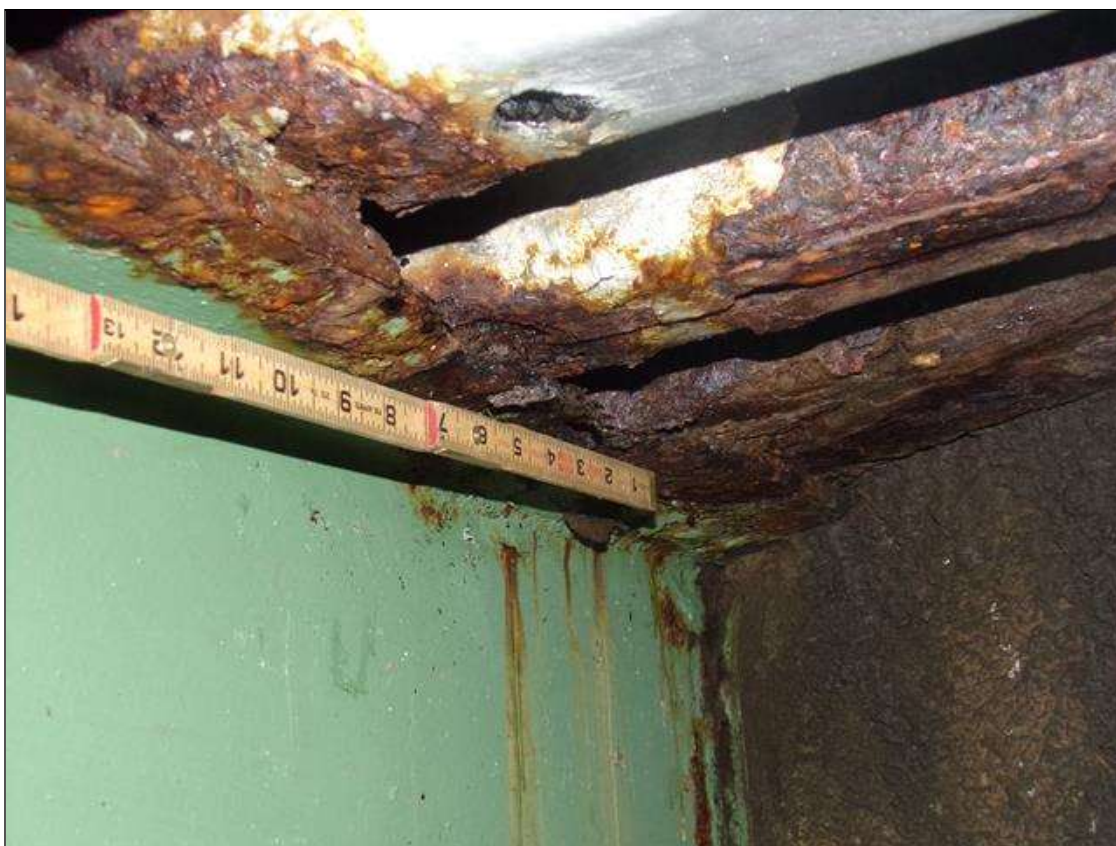
Span 3 Beam 7: 32" RUST SCALE TOP FLANGE WITH SECTION LOSS TO KNIFE'S EDGE AND 9" x 1" area of 100% section loss ON BOTH TOP FLANGES AT END BENT 2. (PAR)

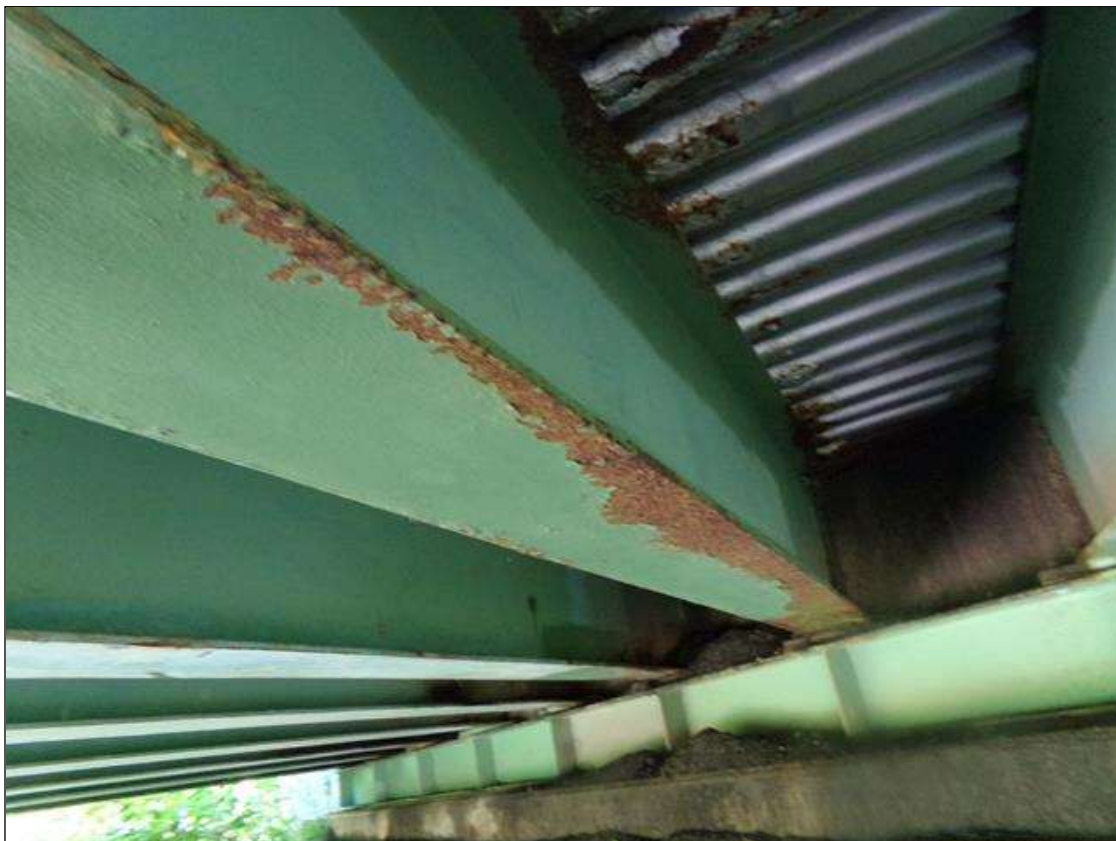
Span 3 Beam 7: 20' peeling paint with rust

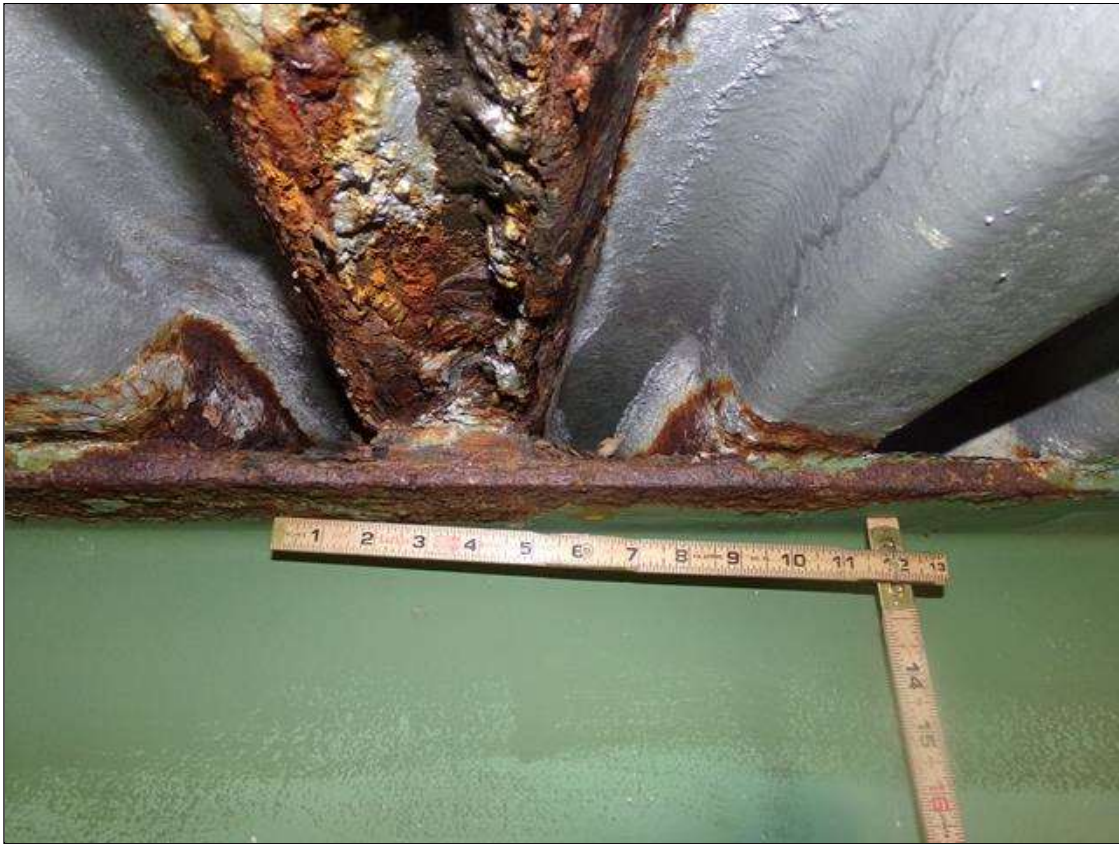
Span 3 Beam 7: 15" x 1" area of 1/8" section loss (3/8" remaining) on left side of top flange, 6' from End Bent 2 (PAR)

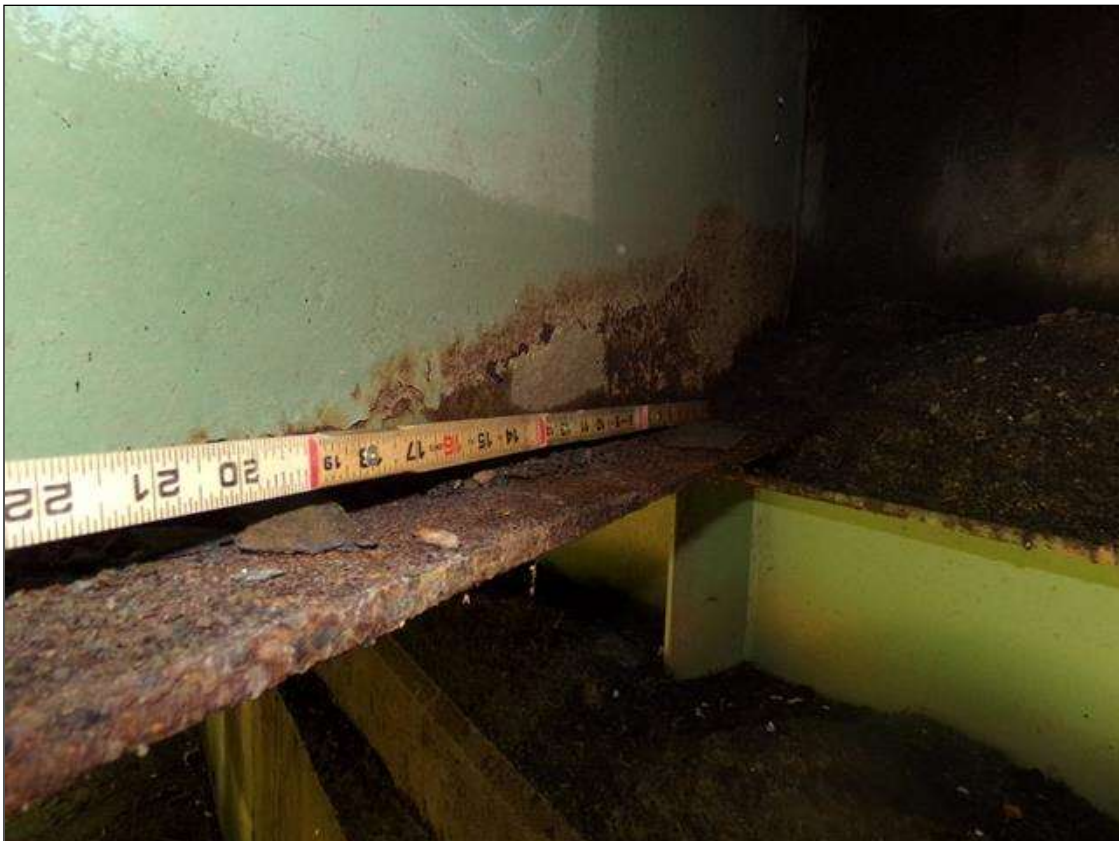
Span 3 Beam 6: 4' RUST SCALE BOTTOM FLANGE UP TO 8" IN WEB WITH 1/4" REMAINING IN BOTTOM FLANGE AT END BENT 2. (PAR)

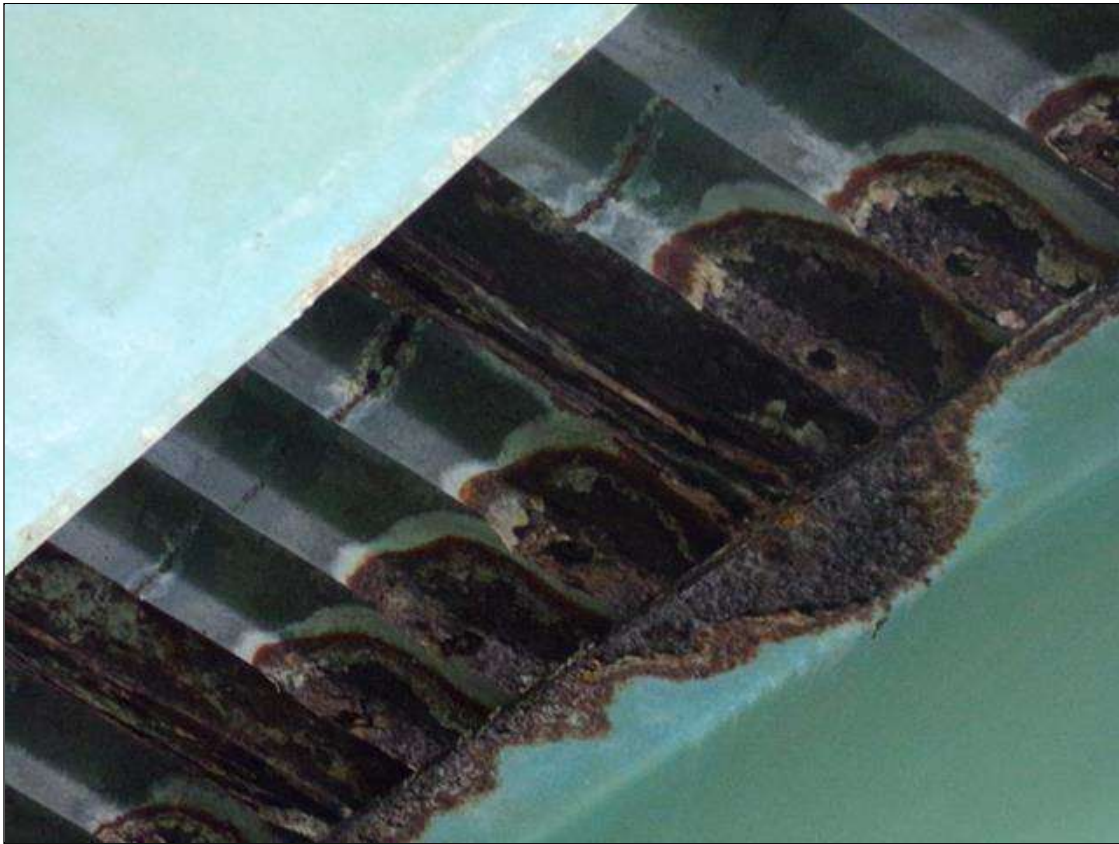
Span 3 Deck: 2 SF OF RUST SCALE WITH UP TO 100% LOSS OF SECTION AND CONCRETE DECK EXPOSED BETWEEN BEAMS 6 AND 7, 6' FROM BENT 2. (PAR)

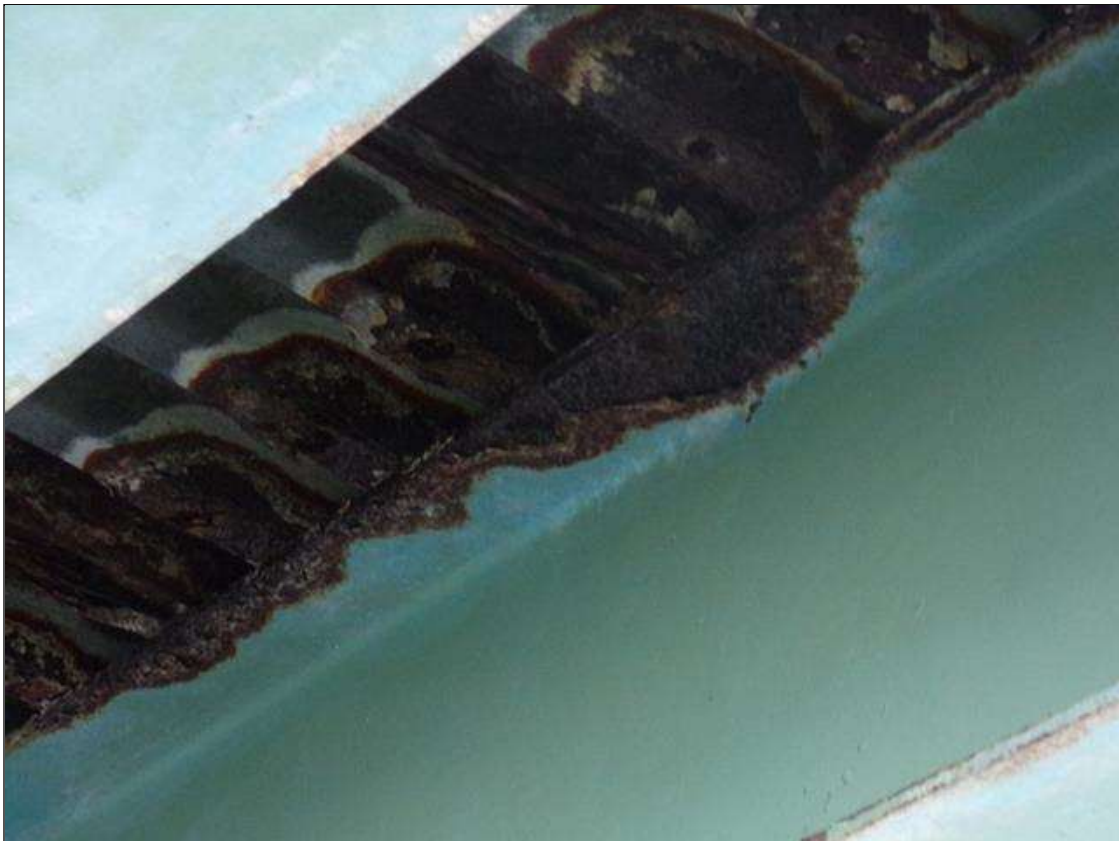
Span 3 Beam 6: 32" x 3" area of 1/8" section loss (3/8" remaining) on right side of top flange, 10' from Bent 2 (PAR)

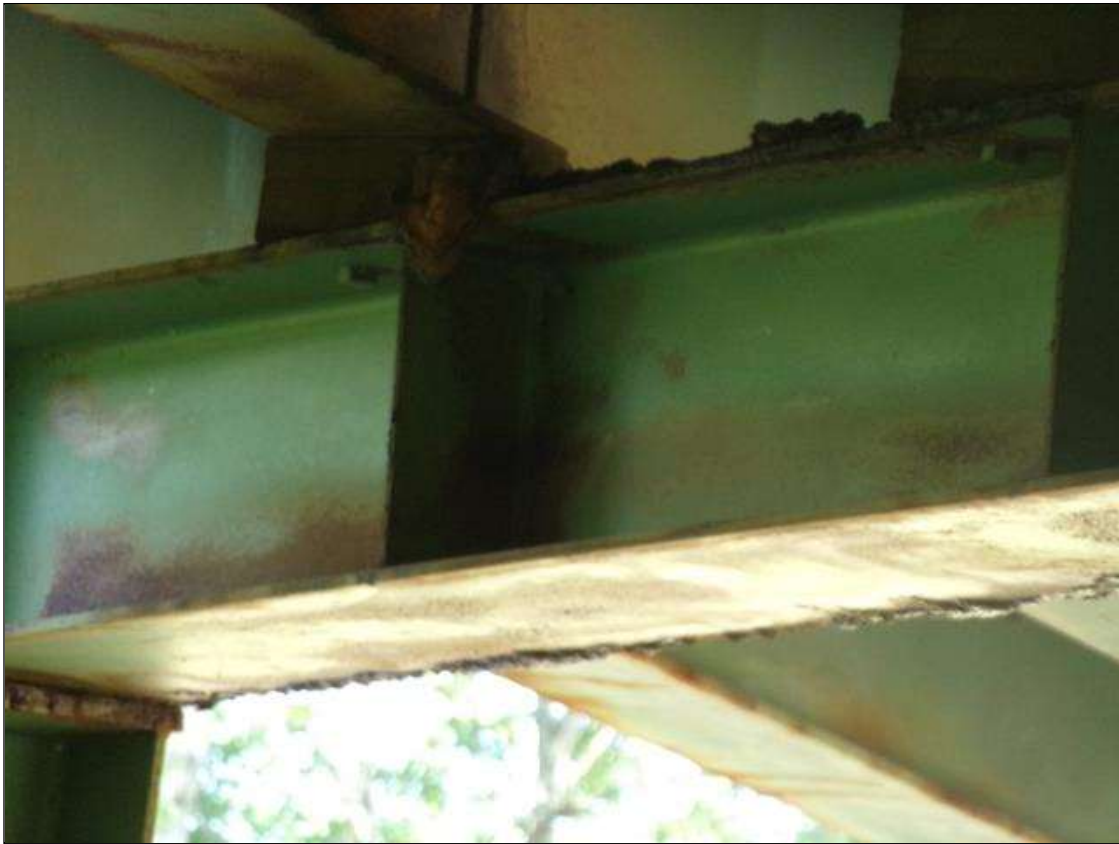
Bent 2 Cap 1: 25' OF SURFACE RUST WITH ISOLATED LOCATIONS FRECKLED RUST ON TOP AND BOTTOM FLANGES AND UP TO 5" IN WEB, AT RANDOM THROUGHOUT EAST AND WEST FACES.

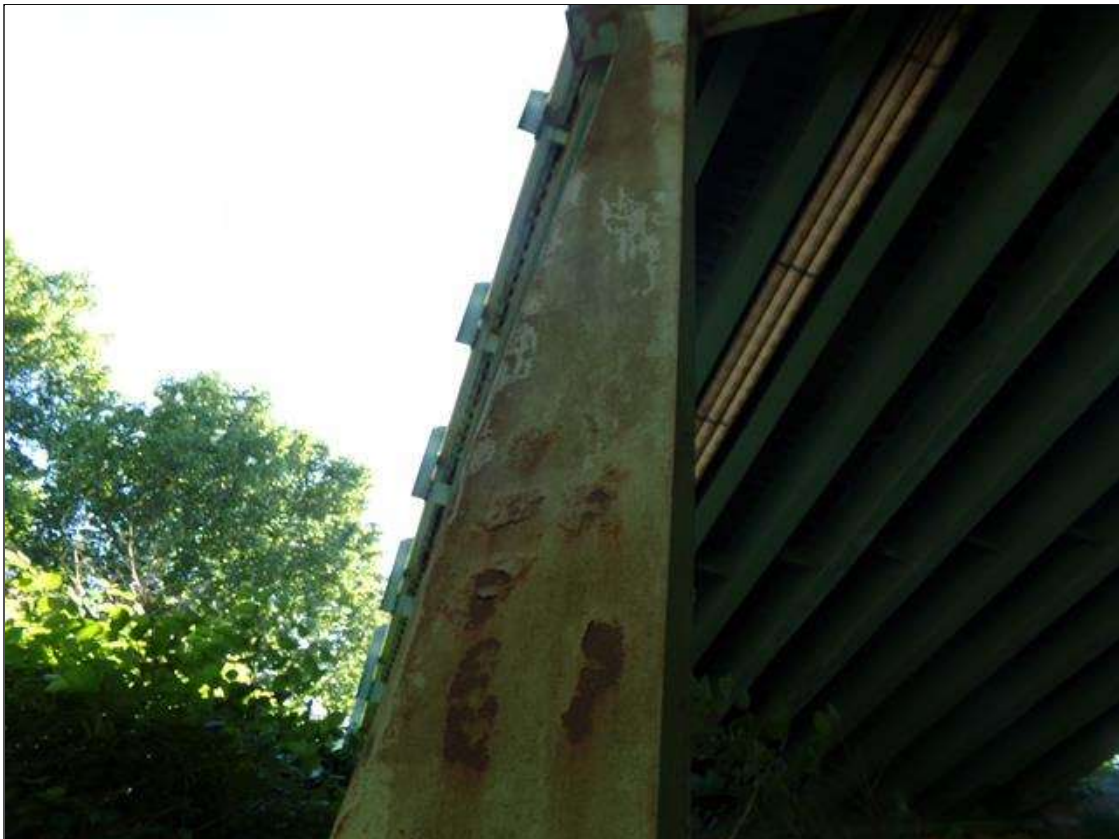
Bent 2 Pile 1: 8' OF FRECKLED RUST WITH ISOLATED LOCATIONS SURFACE RUST ON ALL SURFACES, AT RANDOM THROUGHOUT.

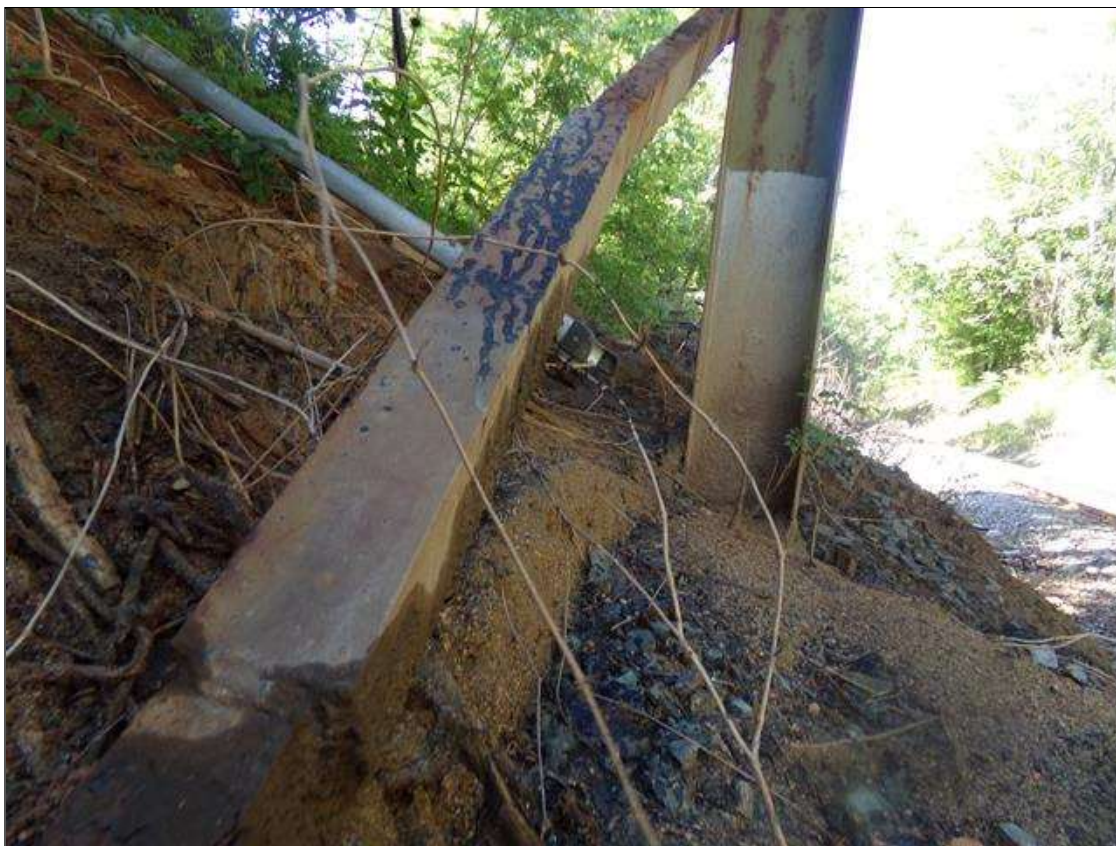
BENT 2 PILE 1: 3' ANGLE PLATE WELDED REPAIR TO CROSS BRACING MEMBER ON EAST FACE AT MID Span.

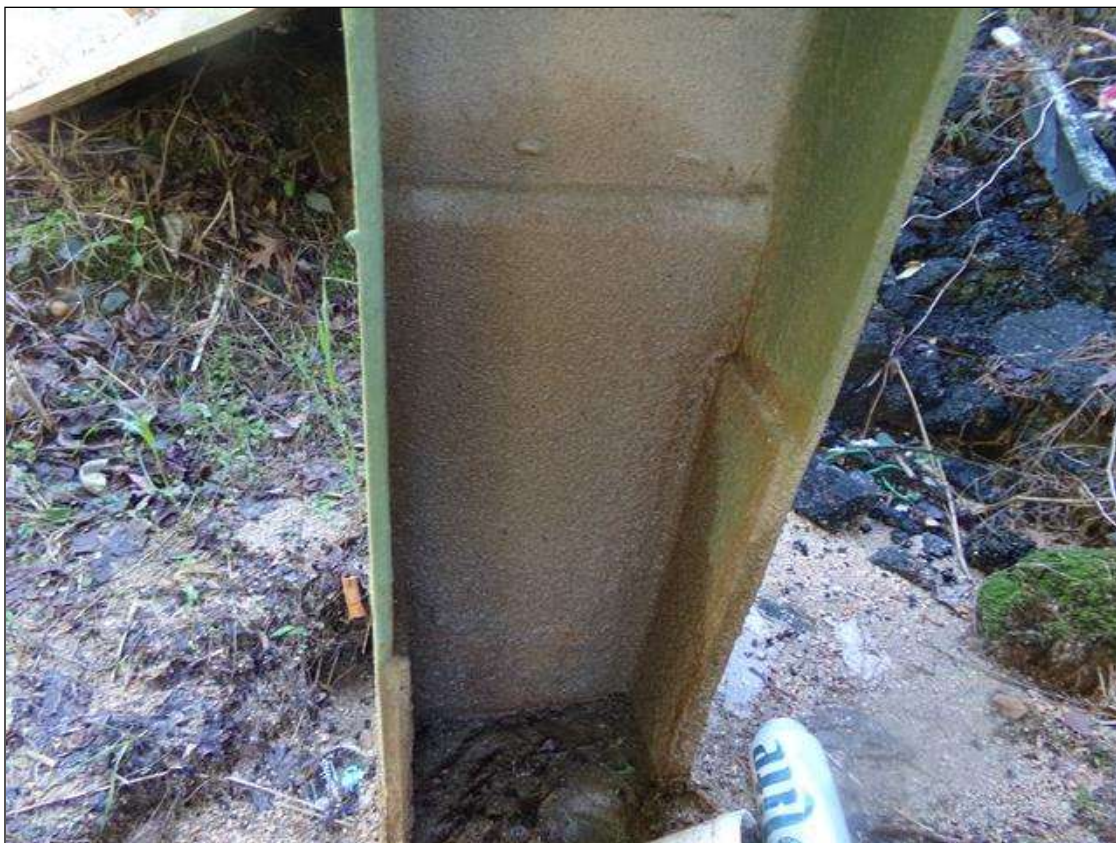
BENT 2 PILE 1: (4) UP TO 2' x 10" x 1/2" WELDED REPAIR PLATES ON NORTH AND SOUTH FACES, AT SOIL INTERFACE. (PHOTO TAKEN NORTH FACE)
