NC DEPARTMENT OF TRANSPORTATION  
 DIVISION OF HIGHWAYS  
 STRUCTURE MANAGEMENT UNIT

ATTENTION: Prompt Action Request; Typical Section Sketch Modified

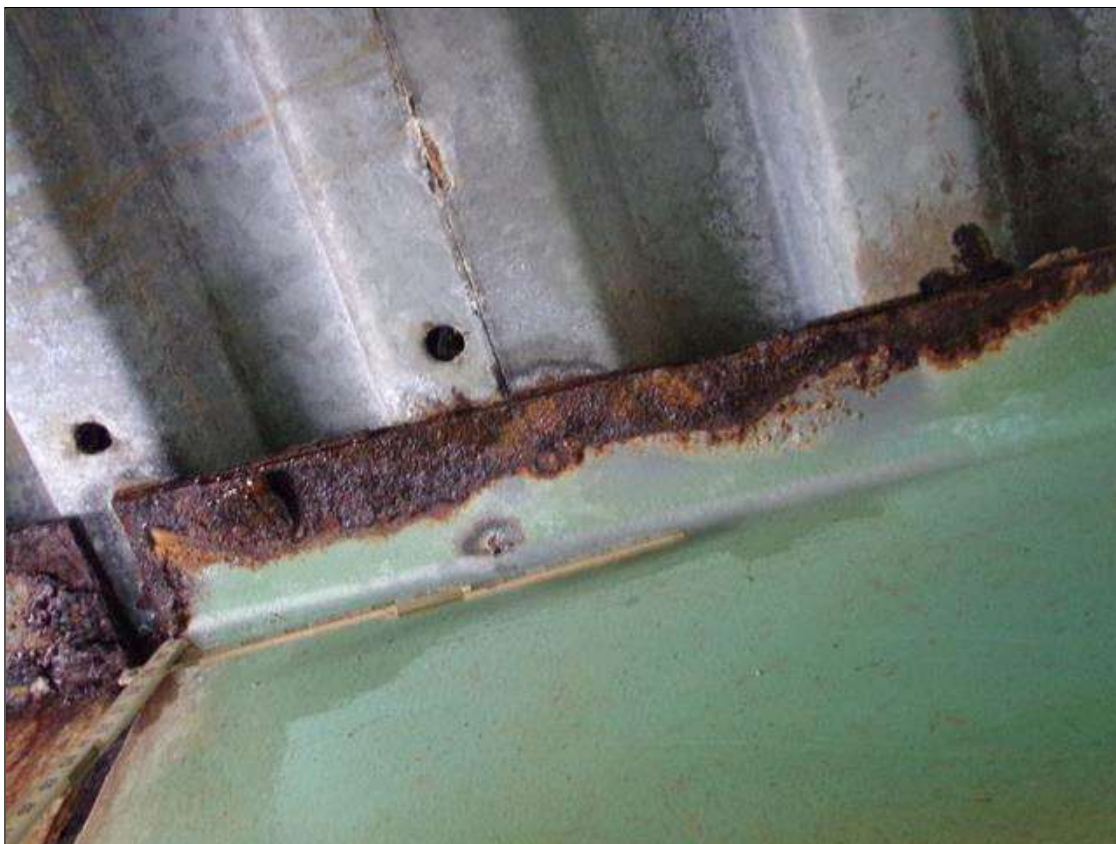
Span 3 Beam 6: 15" x 2 1/2" area of 1/8" section loss (3/8" remaining) on both sides of top flange at Bent 2 (PAR)

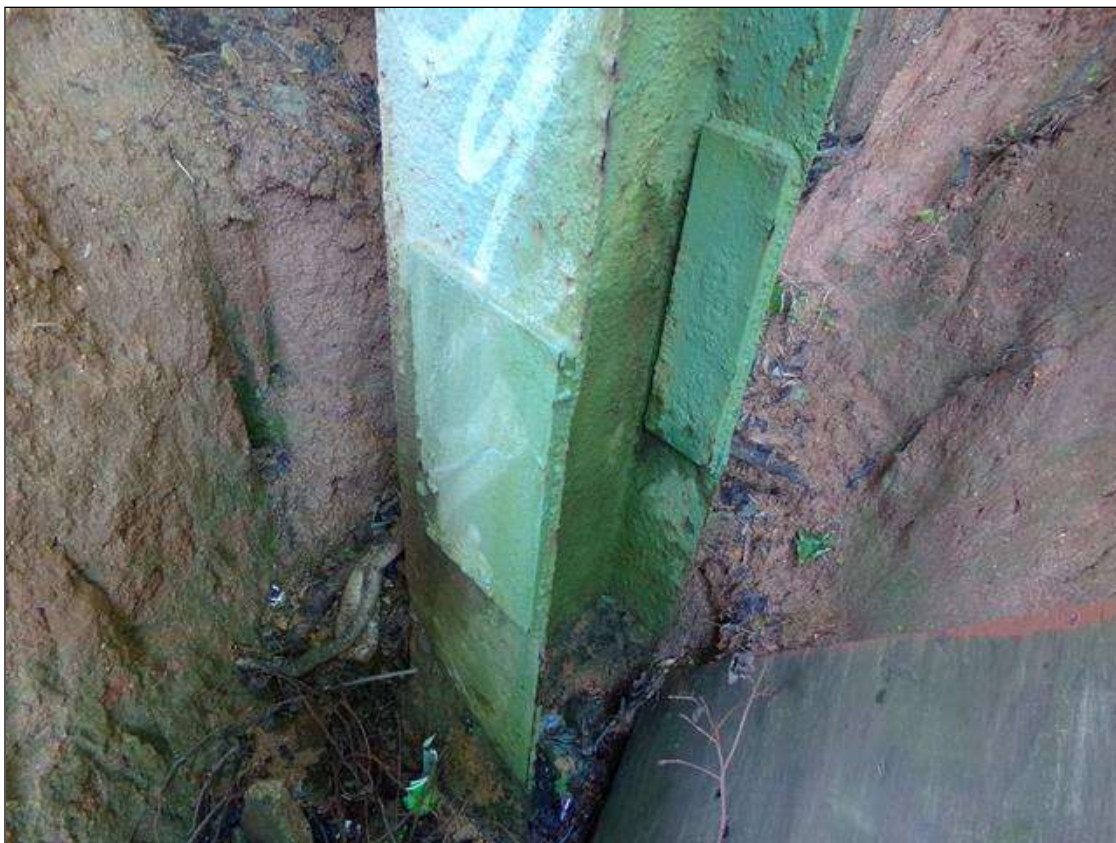
BENT 1 PILE 1: (3) UP TO 16" x 9" x 1/4" WELDED REPAIR PLATES ON EAST AND WEST FLANGES, 14' FROM BOTTOM OF CAP. (PHOTO TAKEN ON EAST FLANGE)

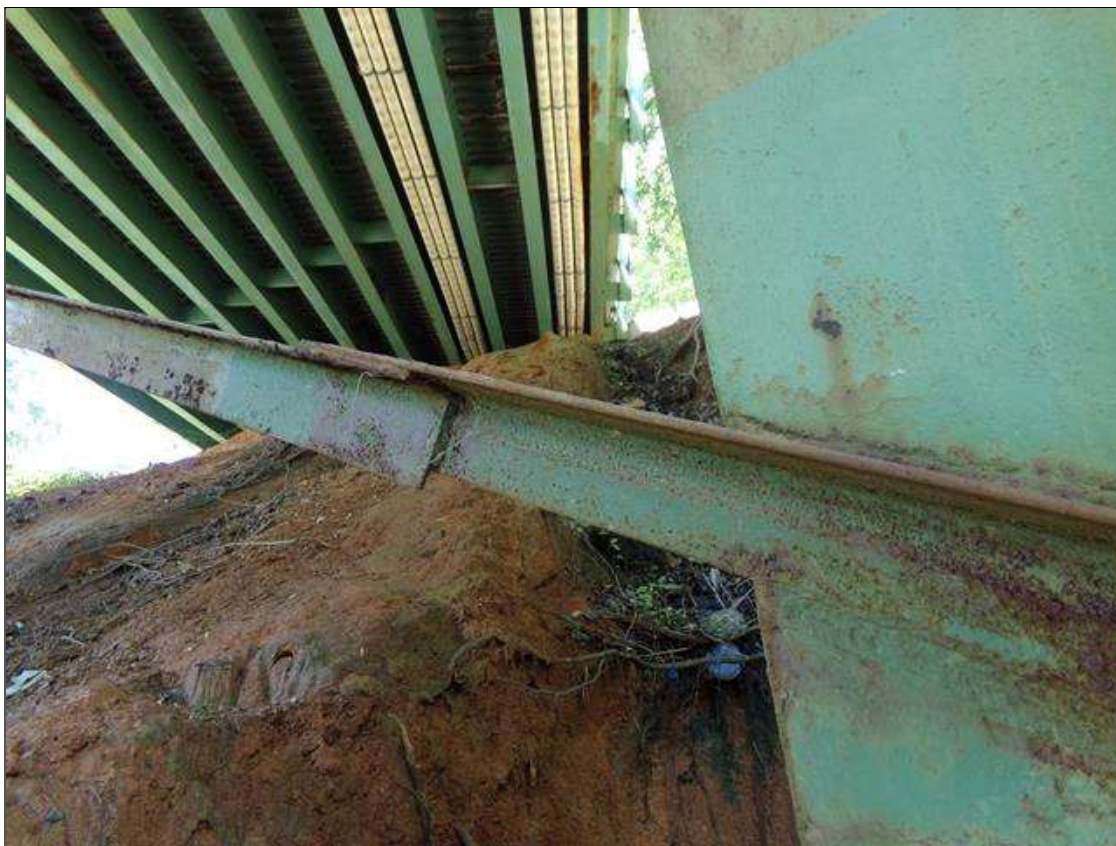
BENT 1 PILE 1: 2' REPAIRED CROSS BRACING ANGLE ON EAST BRACING CONNECTION.

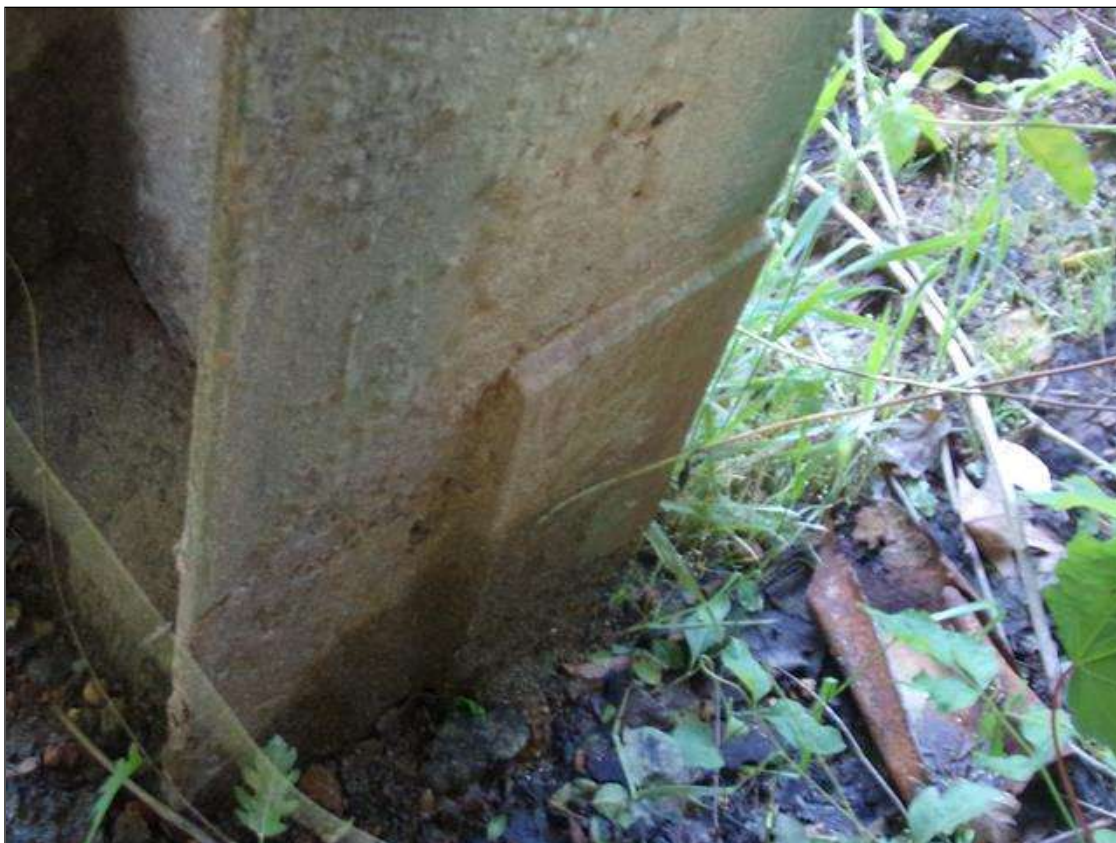
BENT 1 PILE 3: 1' x 6" x 1/4" WELDED REPAIR PLATE ON THE WEST FACE AT BOTTOM OF PILE.

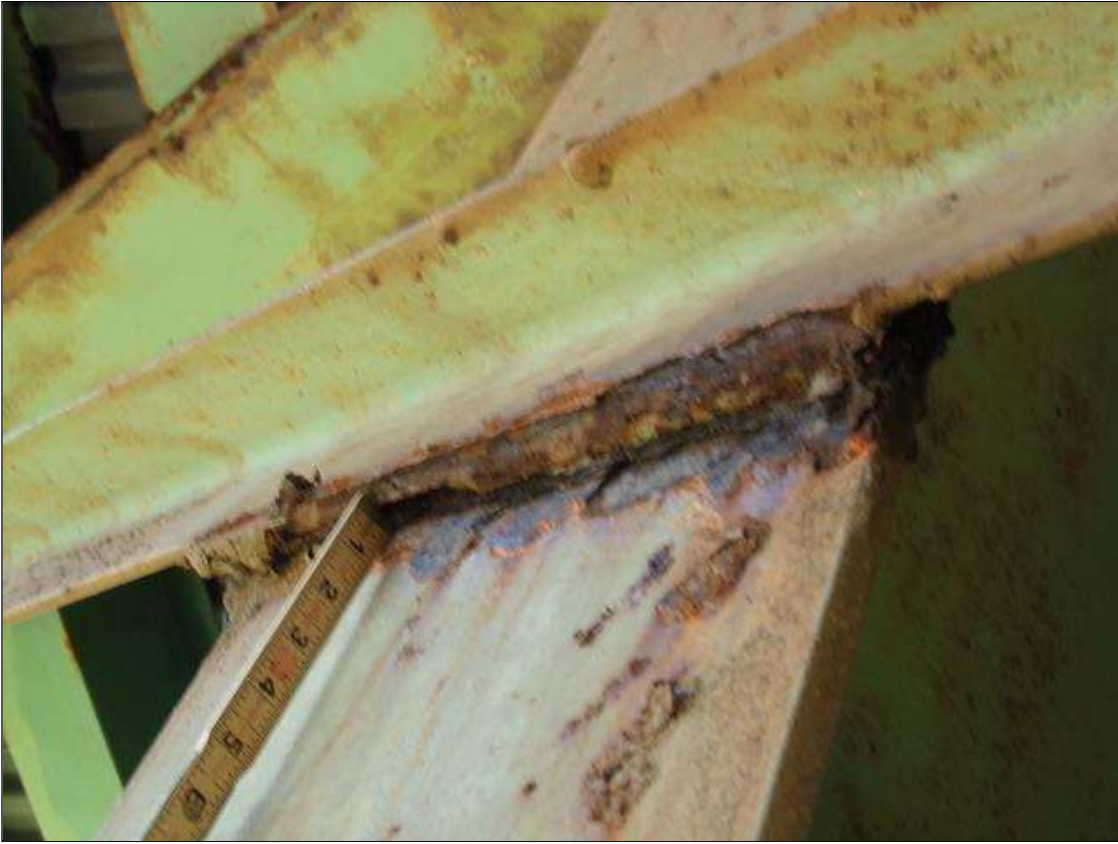
Bent 1 Pile 3: 1" x 10" area of 1/8" section loss (3/8" remaining) on Span 2 flange at diagonal bracing connection (PAR)

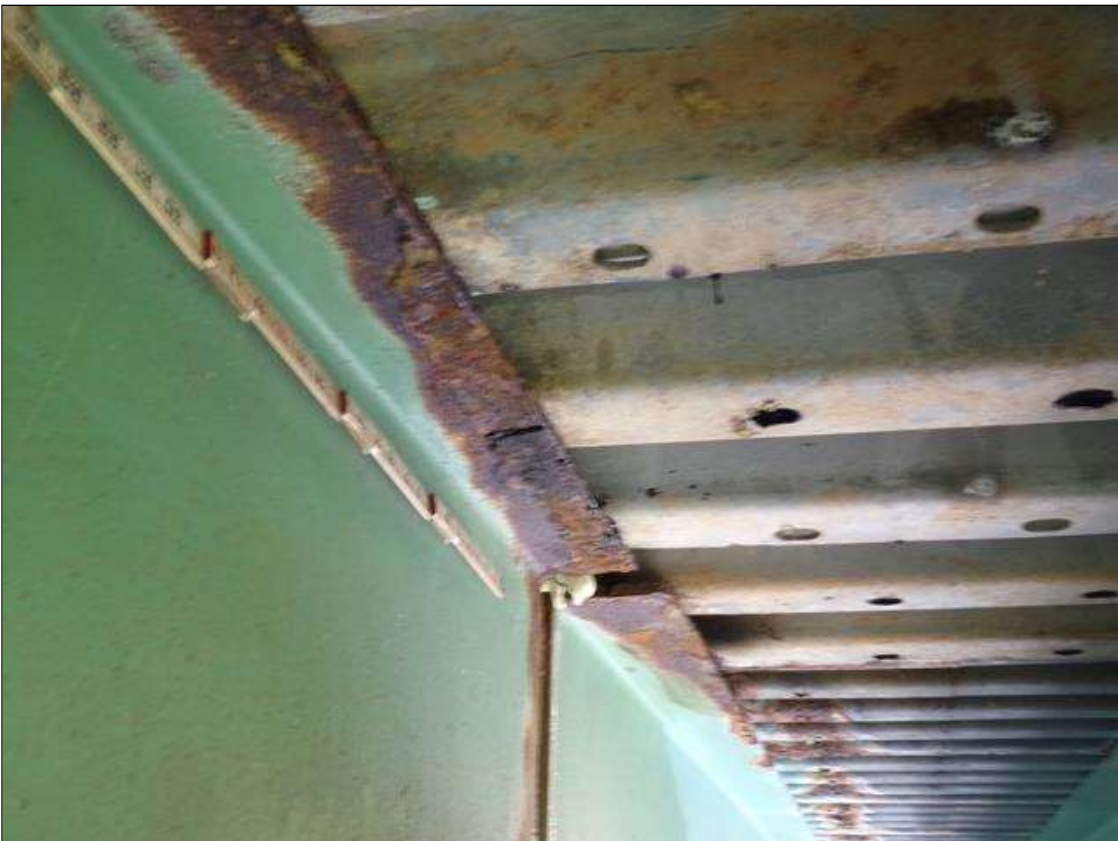
Span 1 Beam 6: 20" OF RUST SCALE ON NORTH AND SOUTH EDGE OF TOP FLANGE WITH 1/8" REMAINING AT BENT 1. (PAR)

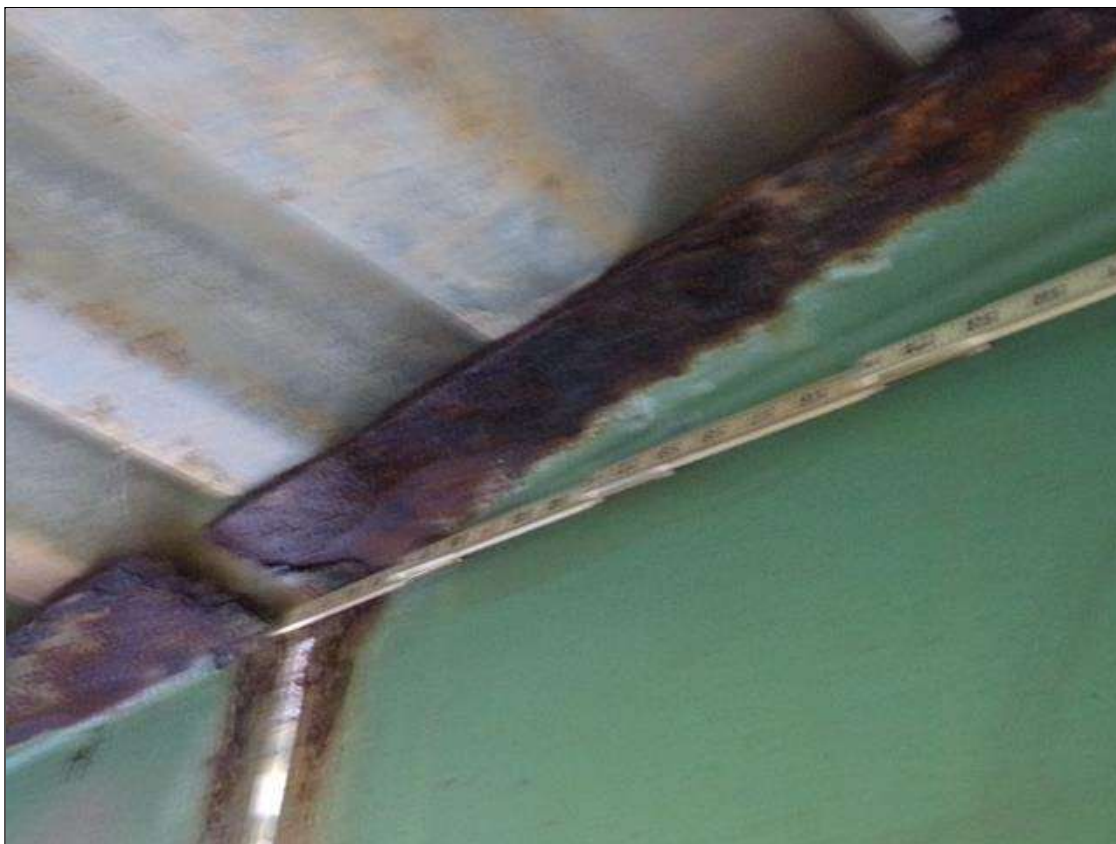
Span 1 Beam 7: 14" x 3" area of 1/4" section loss (1/4" remaining) on both sides of top flange at Bent 1 (PAR)

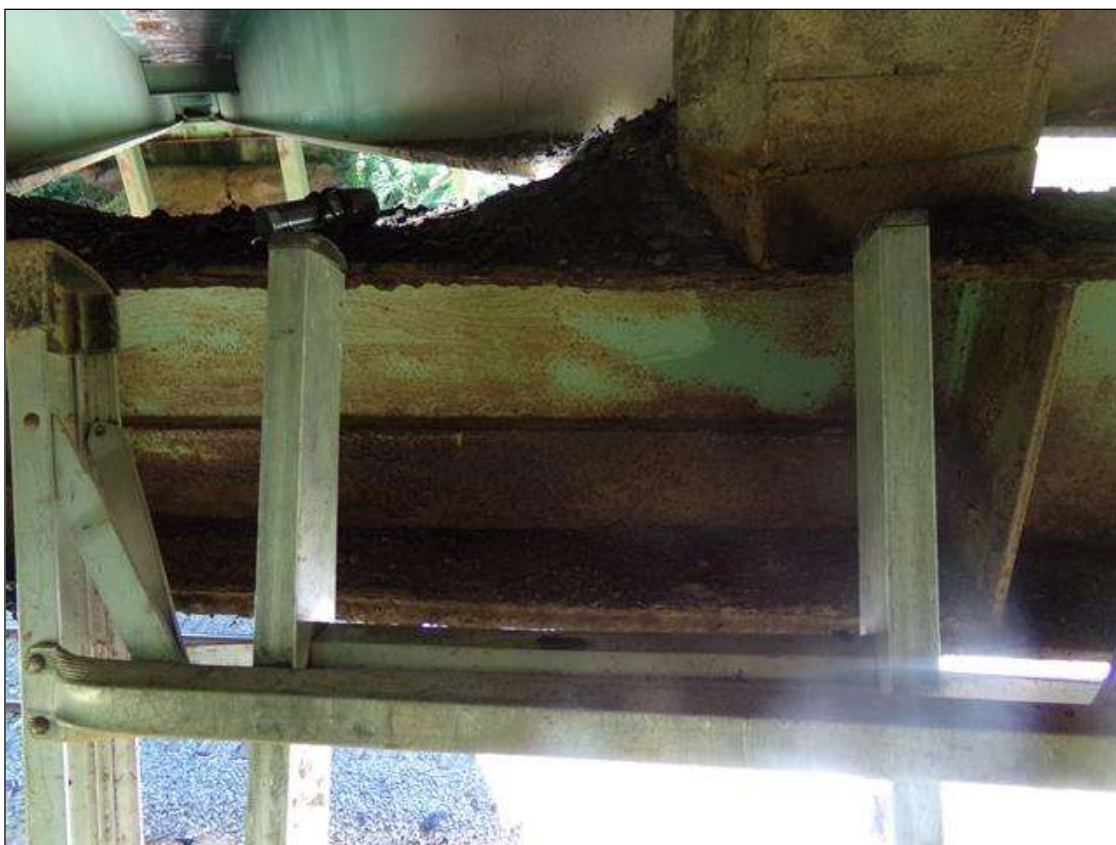
BENT 1 CAP: 29" x 5" x 4.5" x 1/2" THICK CAP REPAIR BETWEEN BEAMS 6 AND 7.

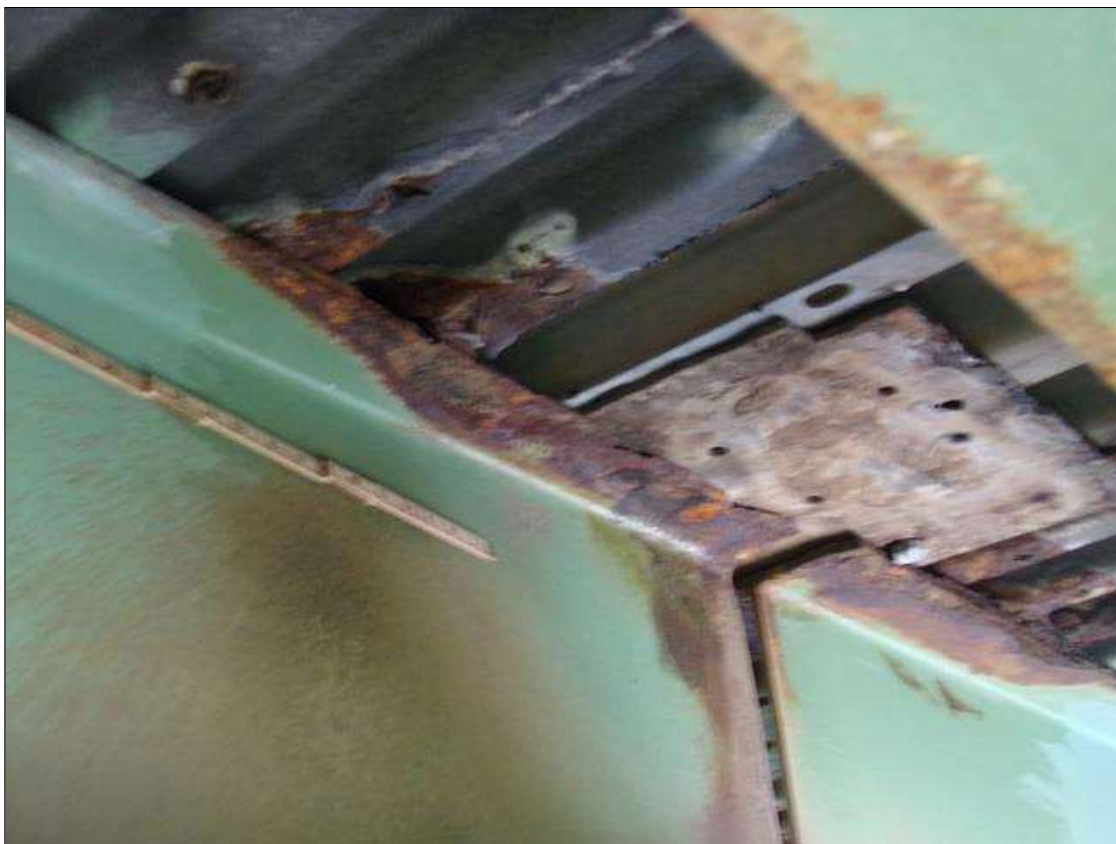
Span 1 Beam 5: 20" x 3 1/2" area of section loss (with knife edge remaining) on right side of top flange at Bent 1 (PAR)

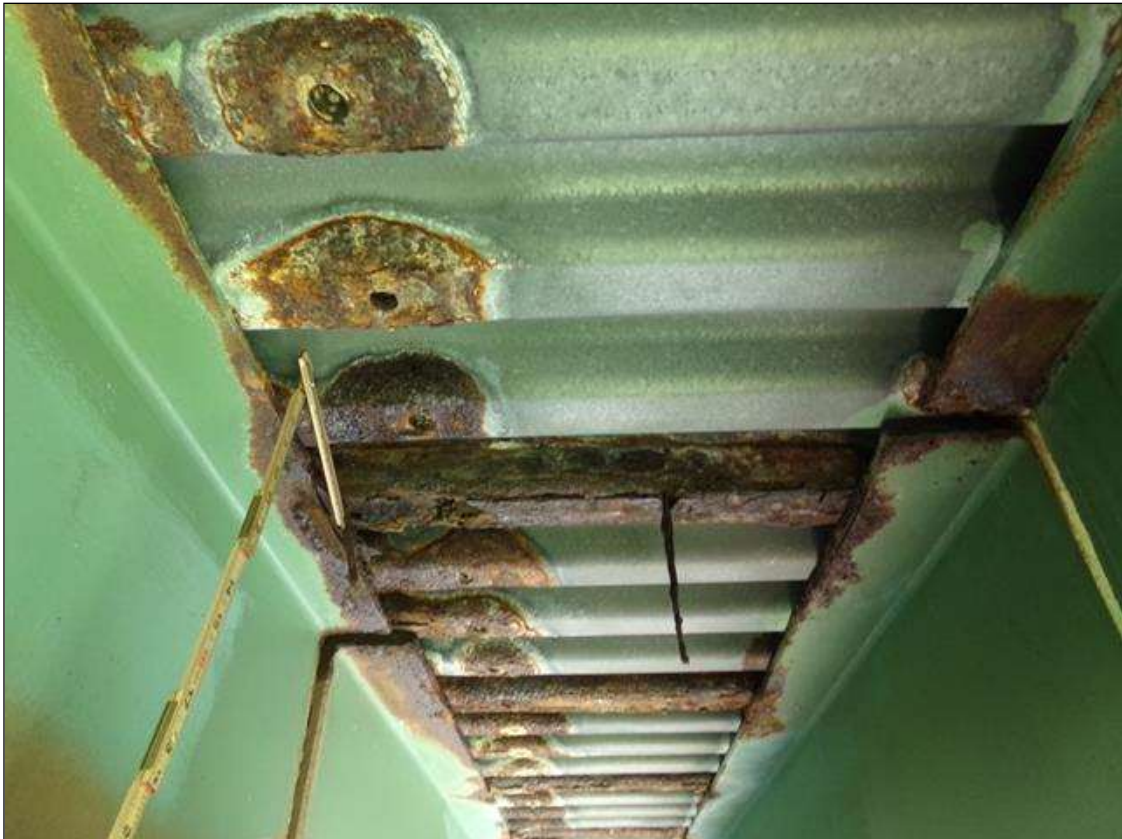
Span 1 Deck: 1 SF RUST SCALE WITH 100% LOSS OF SECTION AND CONCRETE DECK EXPOSED BETWEEN BEAMS 10 AND 11 AT BENT 1. (PAR)

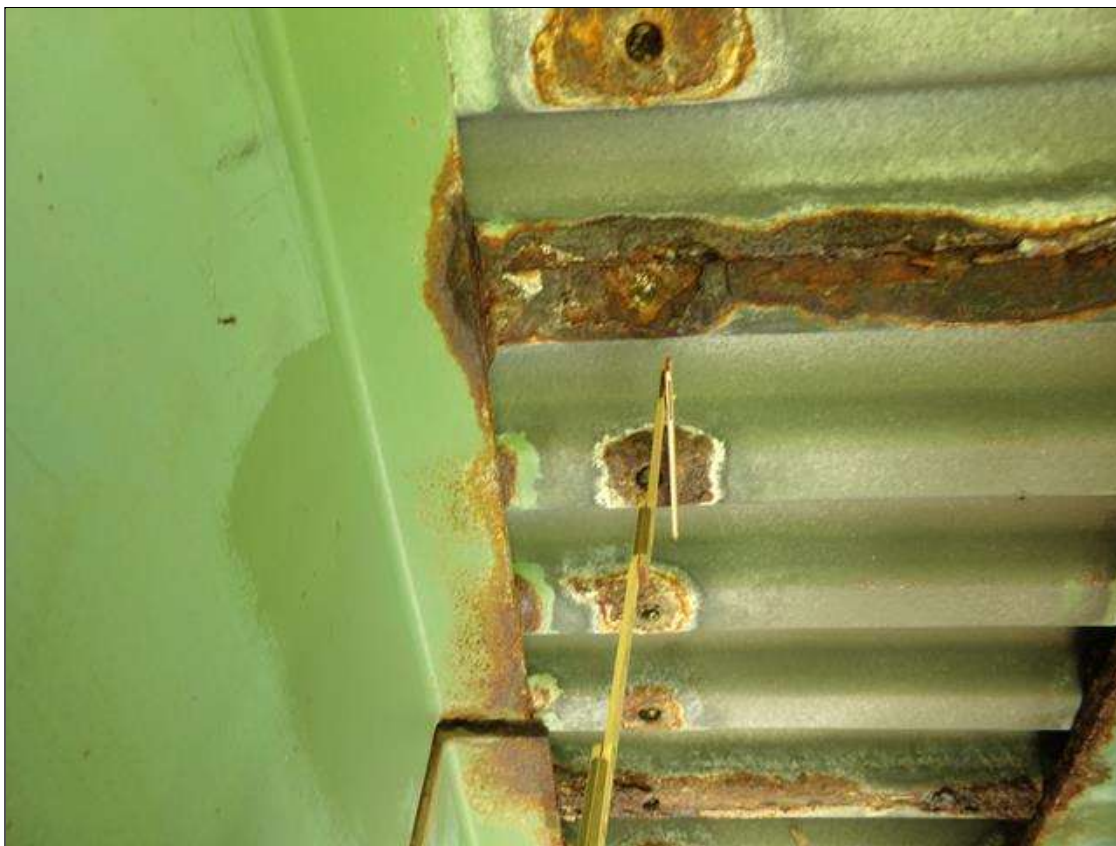
Span 1 Deck: 1/2 SF RUST SCALE WITH 1/8" REMAINING BEAMS 11 AND 12 AT BENT 1. (PAR)

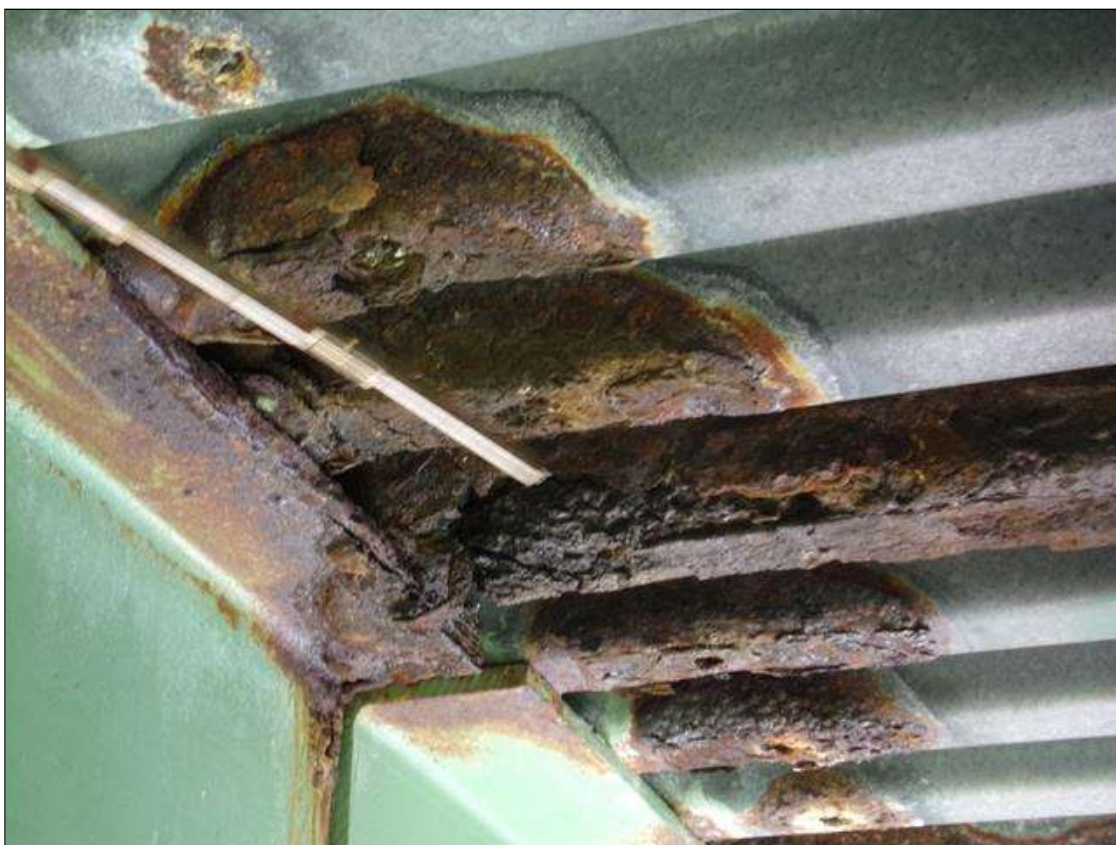
Span 1 Deck: 1 SF RUST SCALE WITH 100% LOSS OF SECTION AND CONCRETE DECK EXPOSED BETWEEN BEAMS 9 AND 10 AT BENT 1. (PAR)

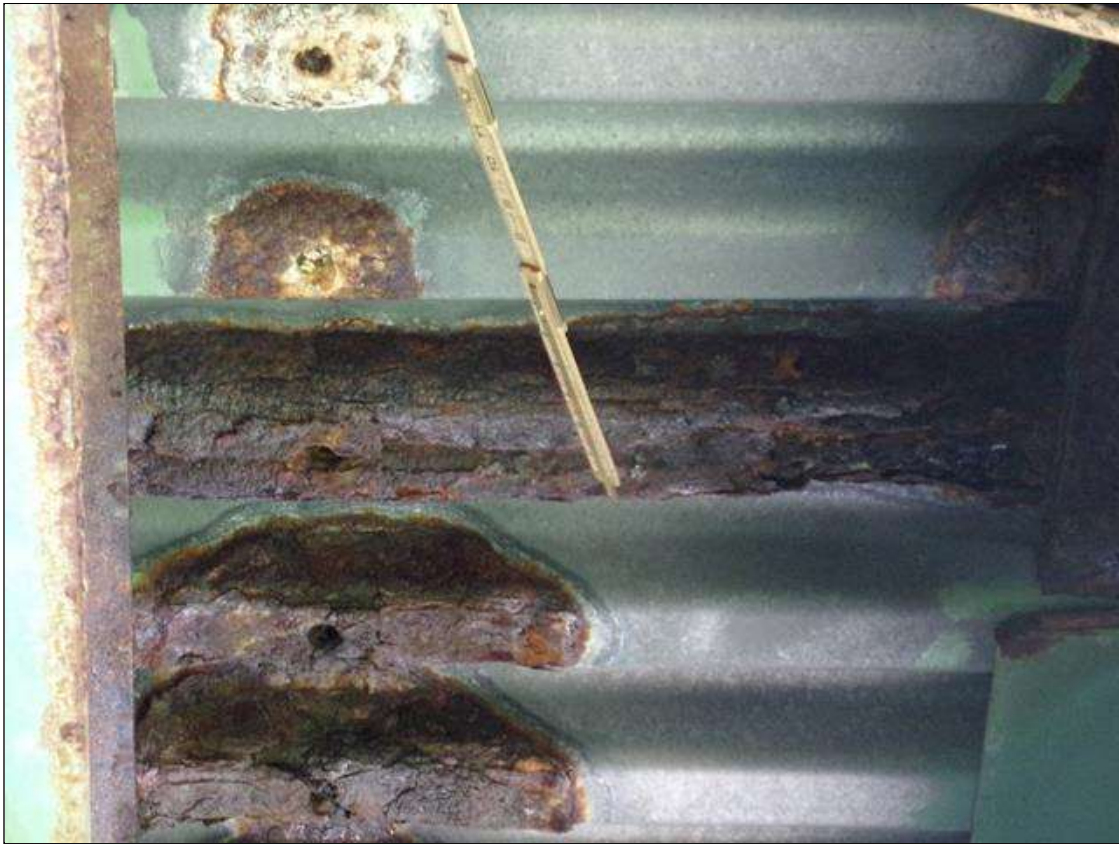
Span 1 Deck: 1/2 SF RUST SCALE WITH 100% LOSS OF SECTION AND CONCRETE DECK EXPOSED BETWEEN BEAMS 8 AND 9 AT BENT 1. (PAR)

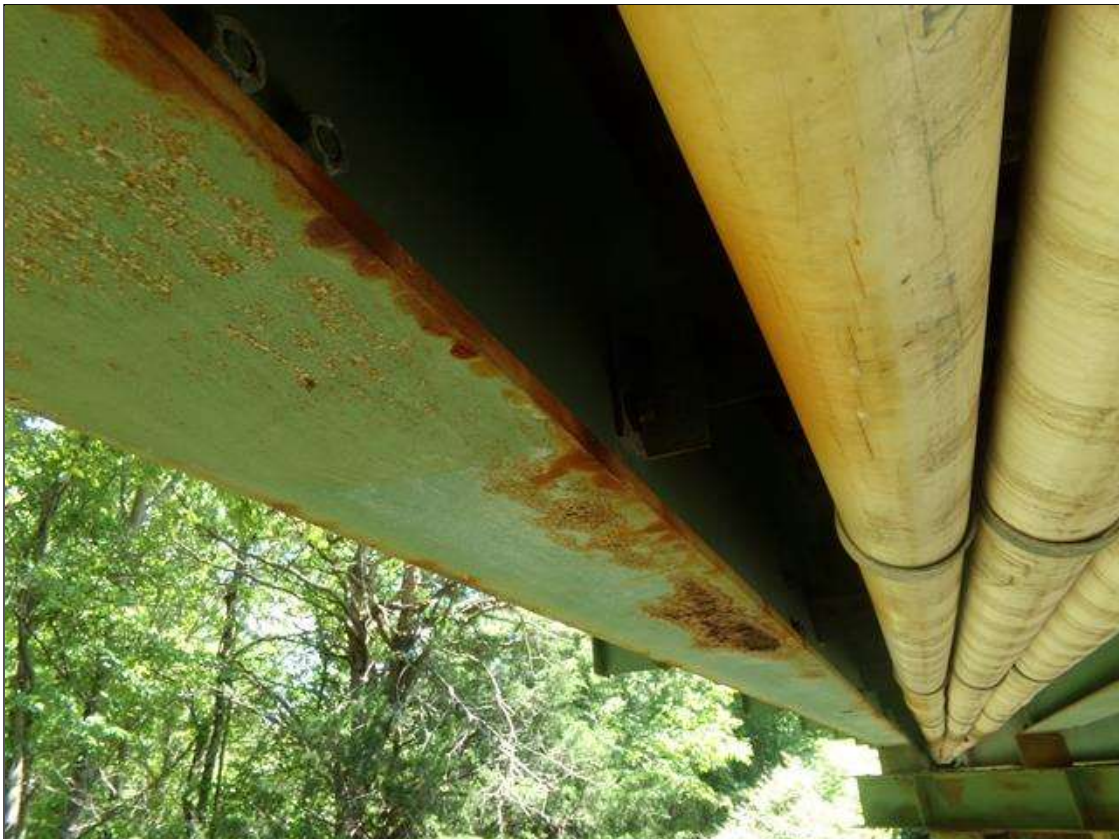
Span 1 Beam 1: 20' OF LIGHT SCALING WITH ISOLATED LOCATIONS SURFACE RUST ON TOP AND BOTTOM FLANGES, AT RANDOM THROUGHOUT. (PHOTO TAKEN NEAR MID Span)

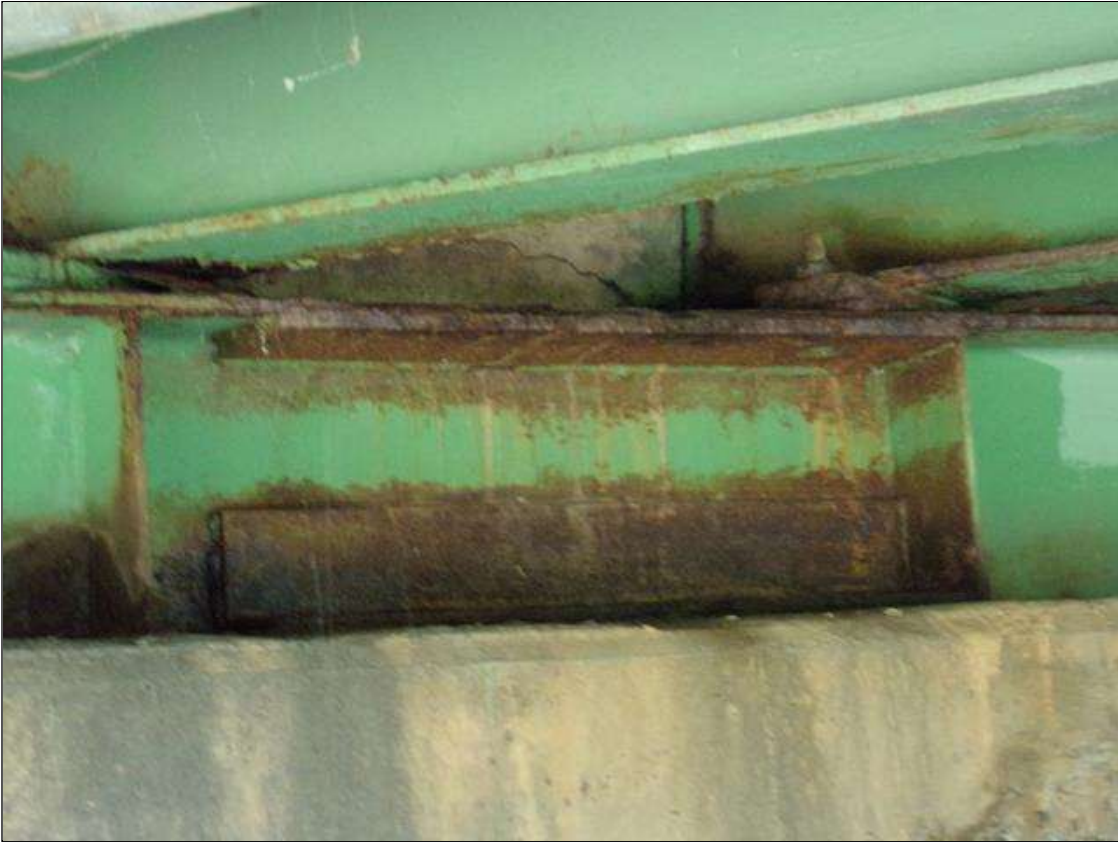
END BENT 1 CAP: 1/4" WELDED PLATE REPAIR TO TOP FLANGE WITH ADDED ANGLE PLATES TO THE BOTTOM FLANGE AND WEB BETWEEN BEAMS 6 AND 7.

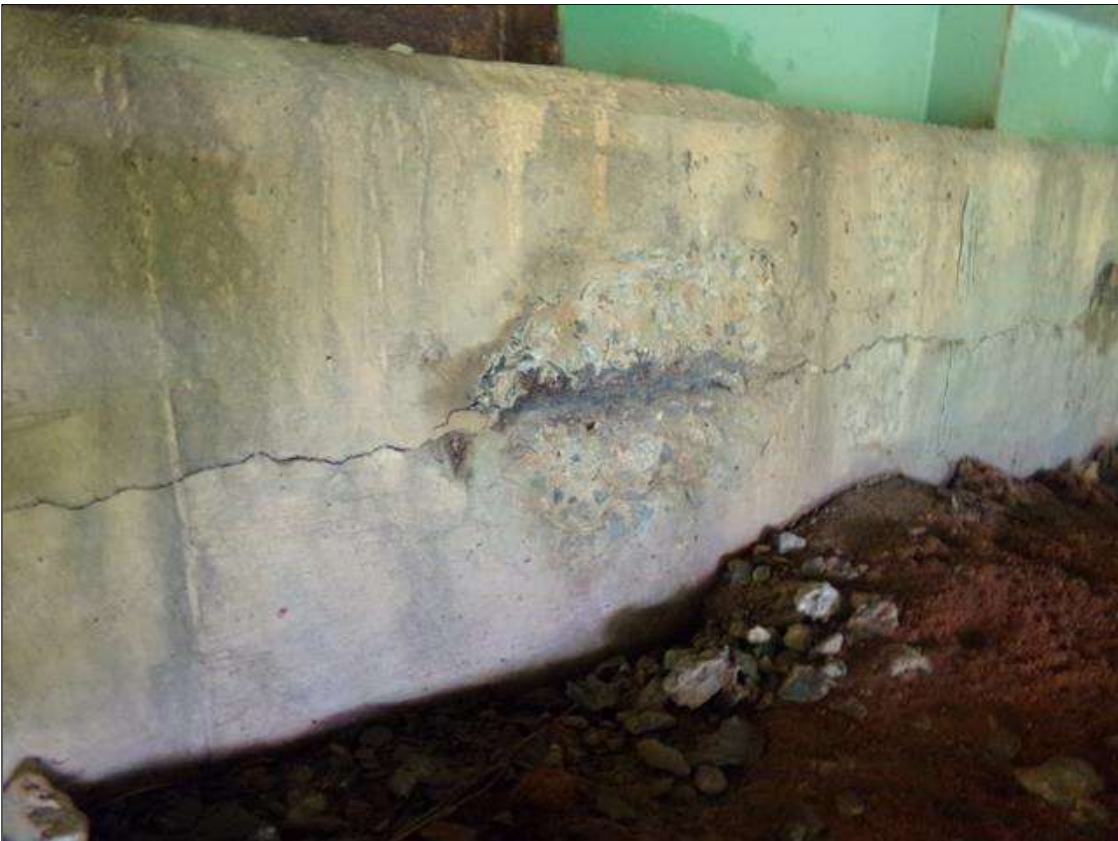
End Bent 1 Abutment: 16" x 9" x UP TO 1 1/2" SPALL, WITH EXPOSED REINFORCING, WITH 20% LOSS OF SECTION OF EXPOSED REINFORCING.

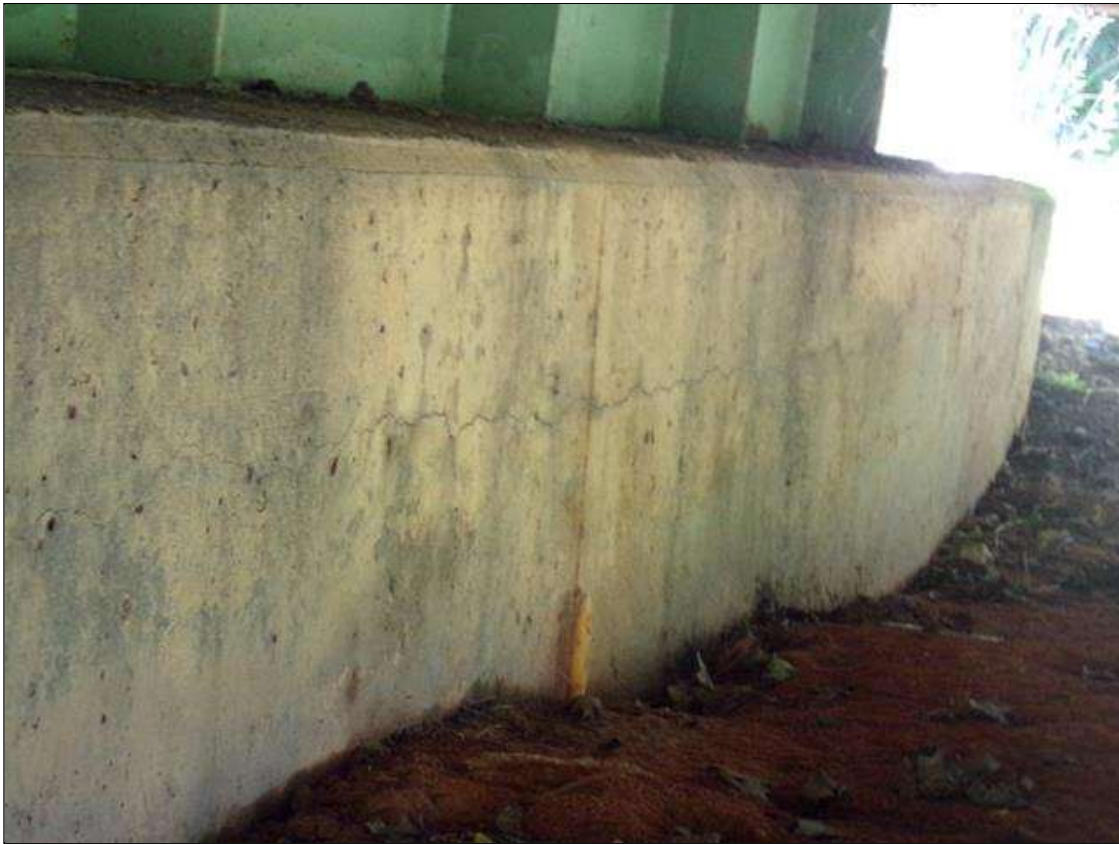
End Bent 1 Abutment: 24' x UP TO 1/16" HORIZONTAL CRACK THROUGHOUT EAST FACE OF ABUTMENT BETWEEN BEAMS 2 THROUGH 10. (PHOTO TAKEN BETWEEN BEAMS 3 AND 4)

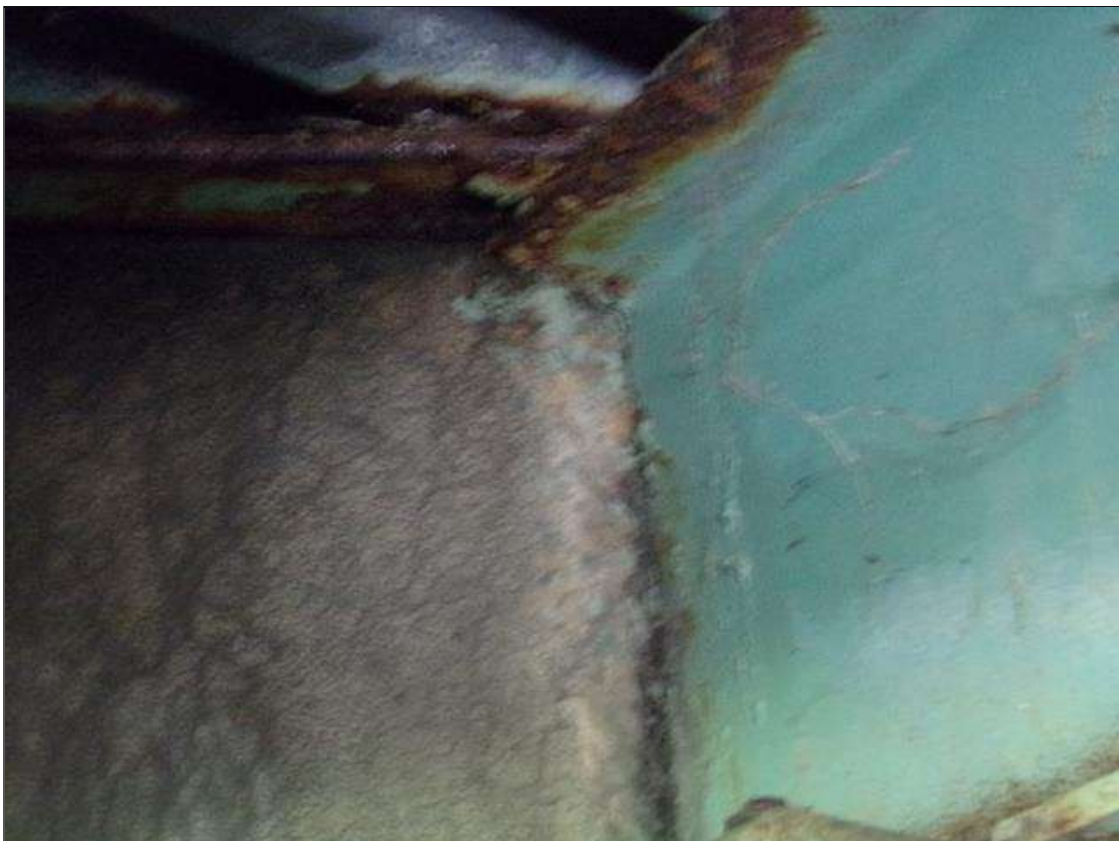
End Bent 1 Abutment: (12) UP TO 18" x UP TO 3" x 1" SPALLS ON SOUTH BEAM INTERFACE IN ABUTMENT BACKWALL AT ALL BEAM ENDS. (PHOTO TAKEN IN BETWEEN BEAMS 5 AND 6)

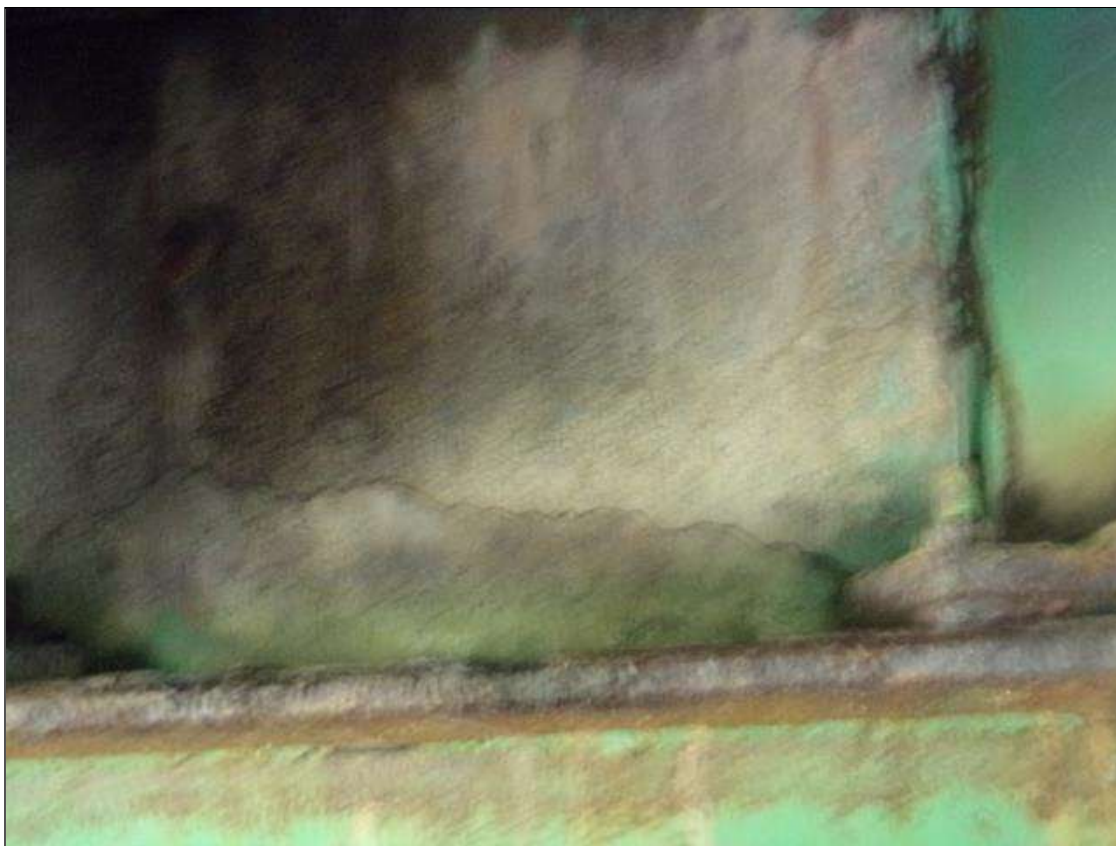
End Bent 1 Abutment: 8' x UP TO 1/16" HORIZONTAL CRACK IN ABUTMENT BACKWALL BETWEEN BEAMS 5 AND 7. (PHOTO TAKEN IN BETWEEN BEAMS 5 AND 6)

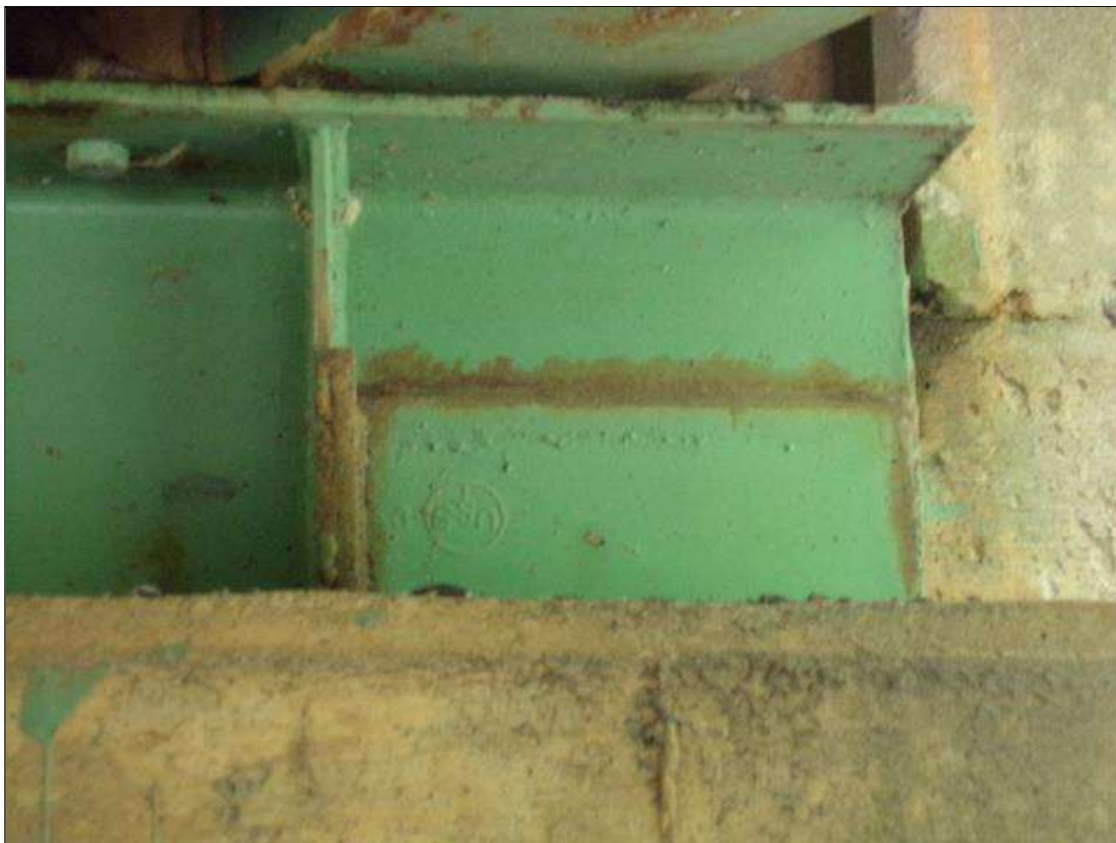
End Bent 1 CAP: 13" x 5" x 6" x 1/2" ANGLE REPAIR AT NORTH END.

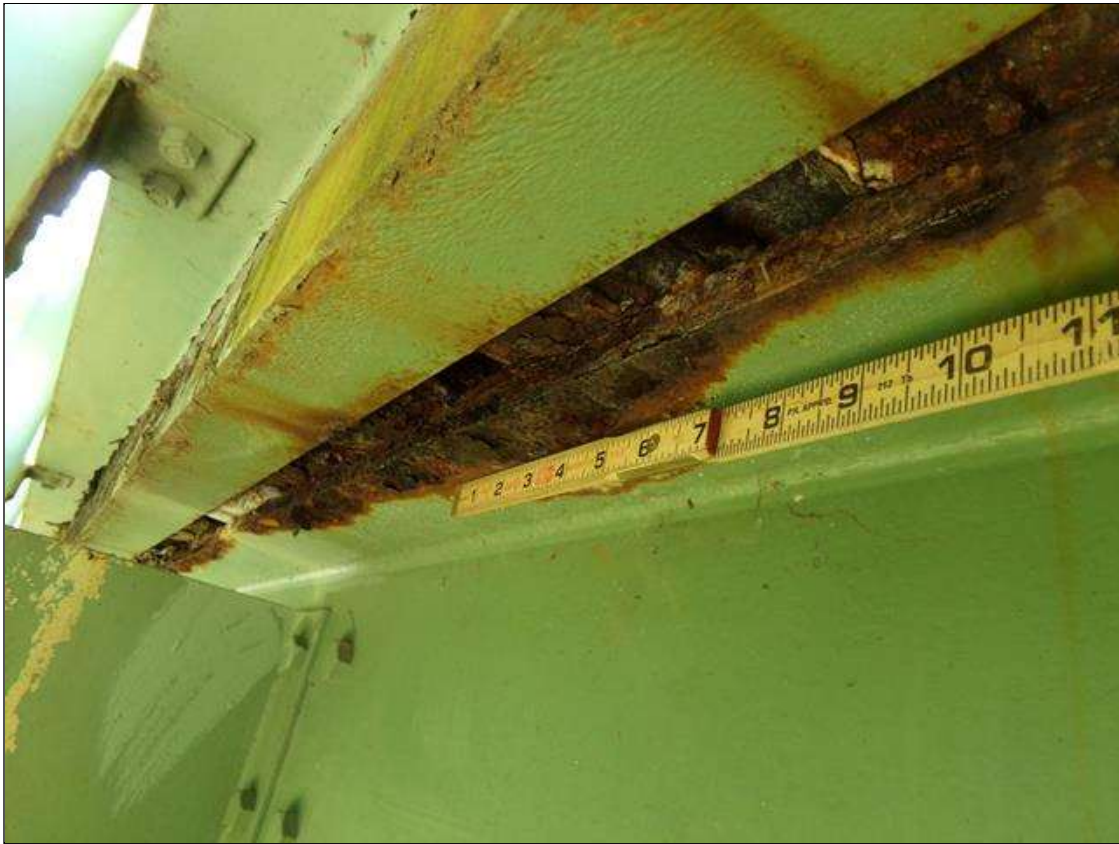
Span 1 Beam 1: 7' x 1" area of 1/16" section loss (7/16" remaining) on left side of top flange near midspan

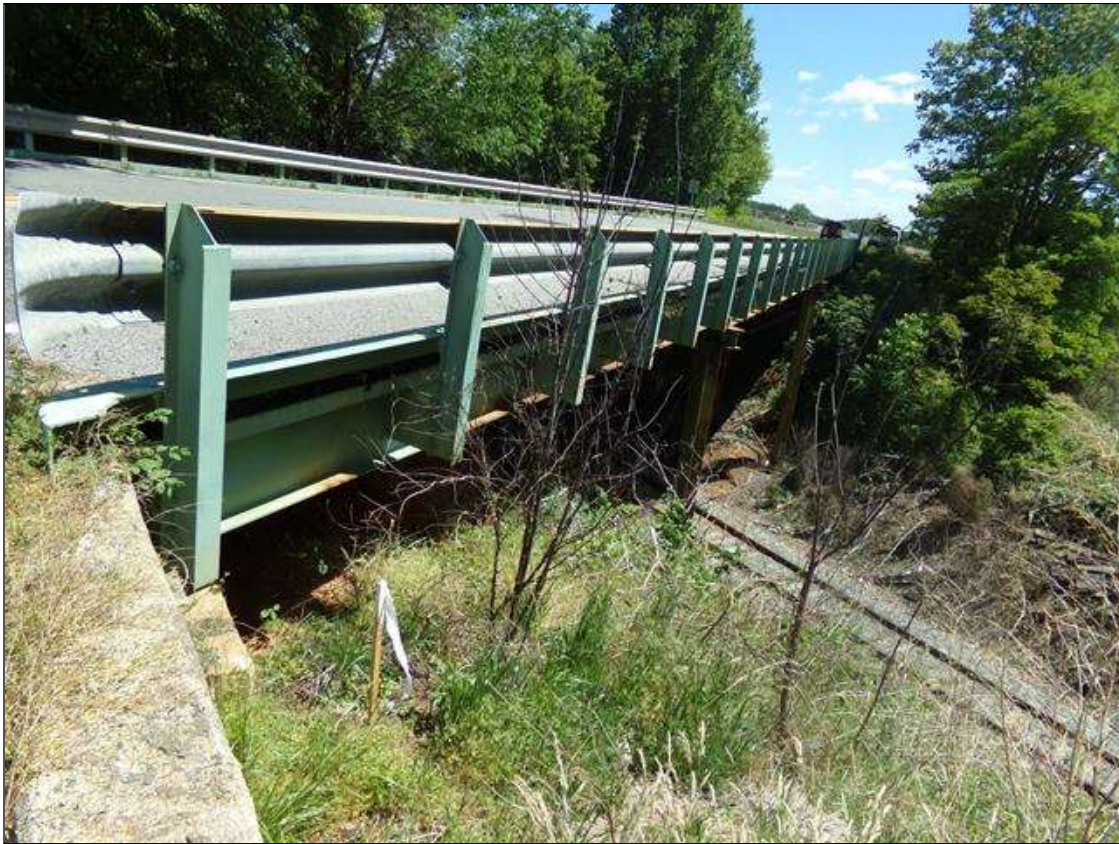
South structure profile

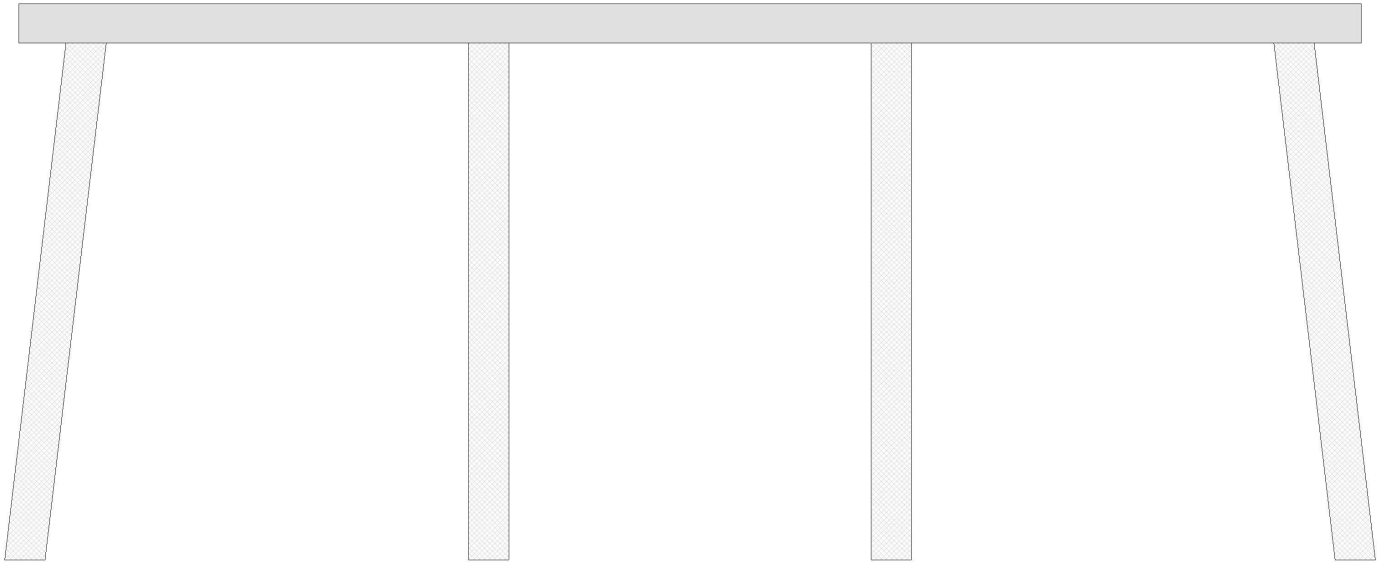
Cap Information			Material							
Length	Width	Height	Left Overhang	Right Overhang	Left Beam to End of Cap.	Right Beam to End of Cap.				
33.333 ft.	1.000 ft.	.980 ft.	1.667 ft.	1.667 ft.	1.083 ft.	1.083 ft.				
			Material							
Length	Width	Height	Left Overhang	Right Overhang	Left Pile to Splice.					
Sill Information			Material							
Length	Width	Height								
Pile #	Material	Spacing	Width/Dia.	Height	Length	Orientation	Driven?	Replacement?	Removed?	Collar?
1	Steel	10.0 ft.	1 ft.		1 ft.	Battered	No	No	No	No
2	Steel	10.0 ft.	1 ft.		1 ft.	Vertical	No	No	No	No
3	Steel	10.0 ft.	1 ft.		1 ft.	Vertical	No	No	No	No
4	Steel		1 ft.		1 ft.	Battered	No	No	No	No
Bent/Abutment #: 2			Similar Bents: 1
