Structure Safety Report

Routine Element Inspection

INSPECTION DATE: 04/29/2019

DIVISION: 6 COUNTY: ROBESON STRUCTURE NUMBER: 770156 FREQUENCY: 24 MONTHS

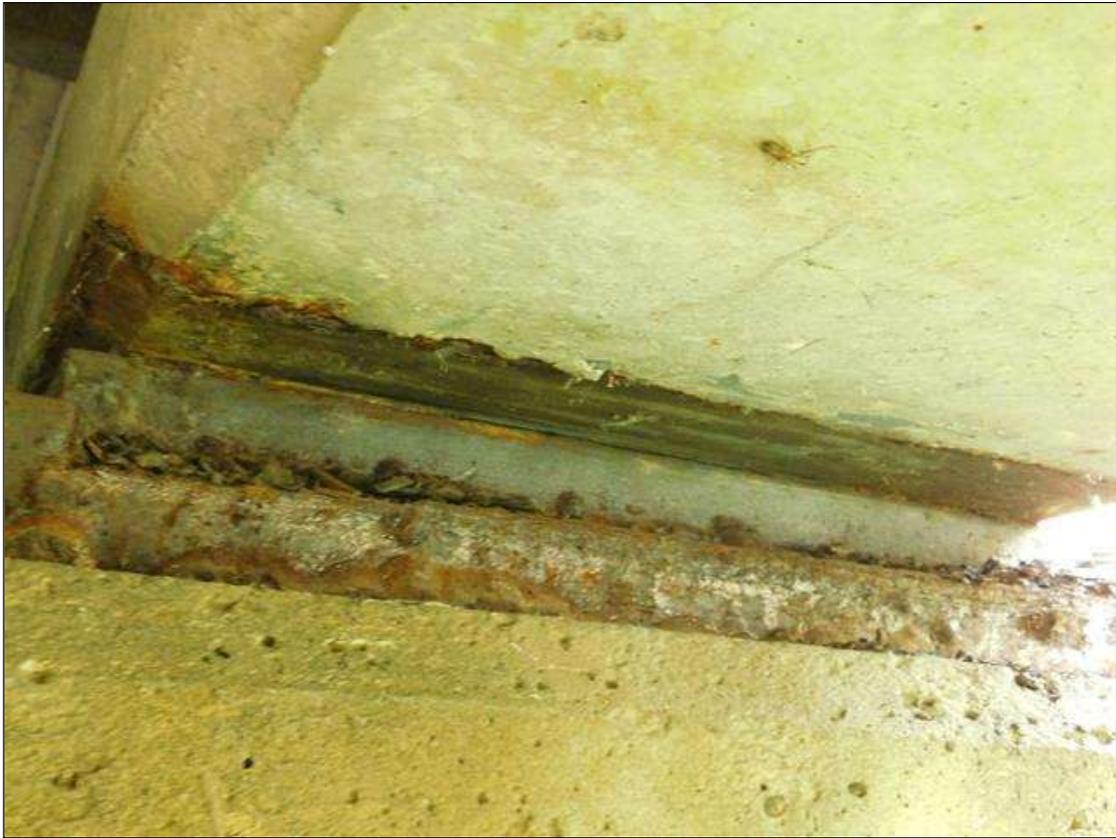
Span 2 Beam 1 Near Bearing: 1/8" OF PACK RUST

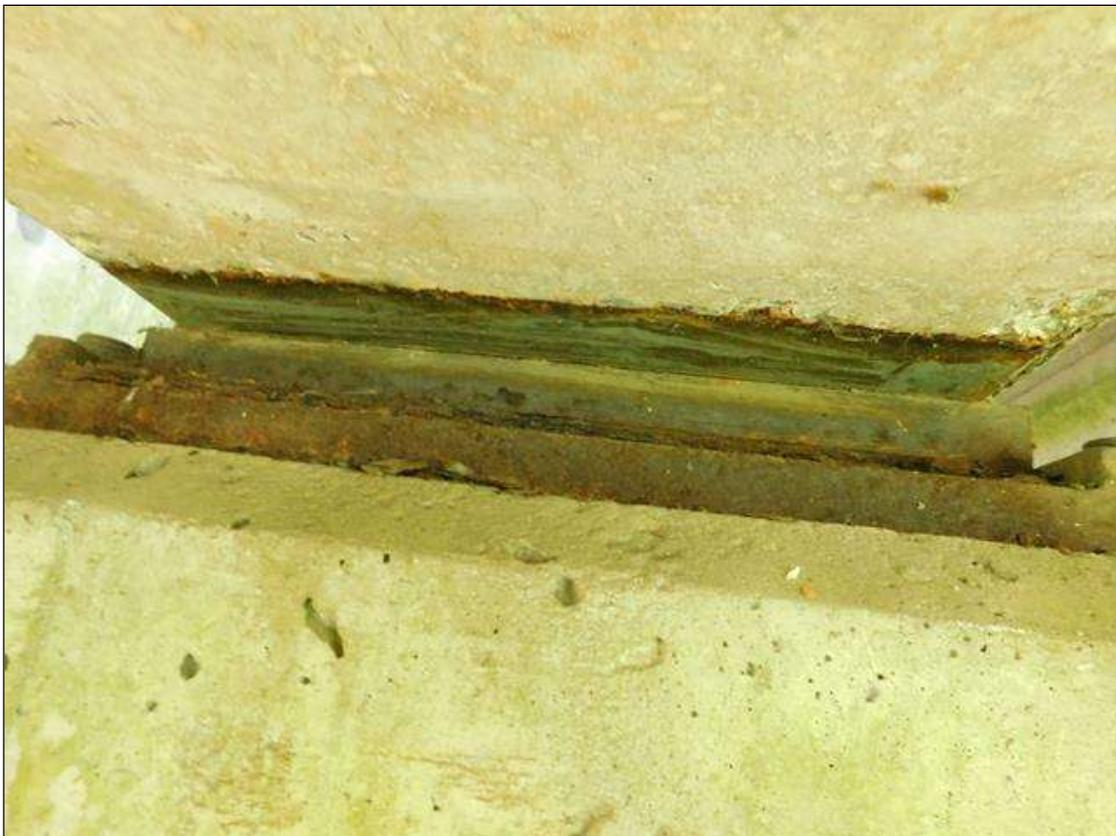
Span 2 Beam 2 Far Bearing: SURFACE RUST

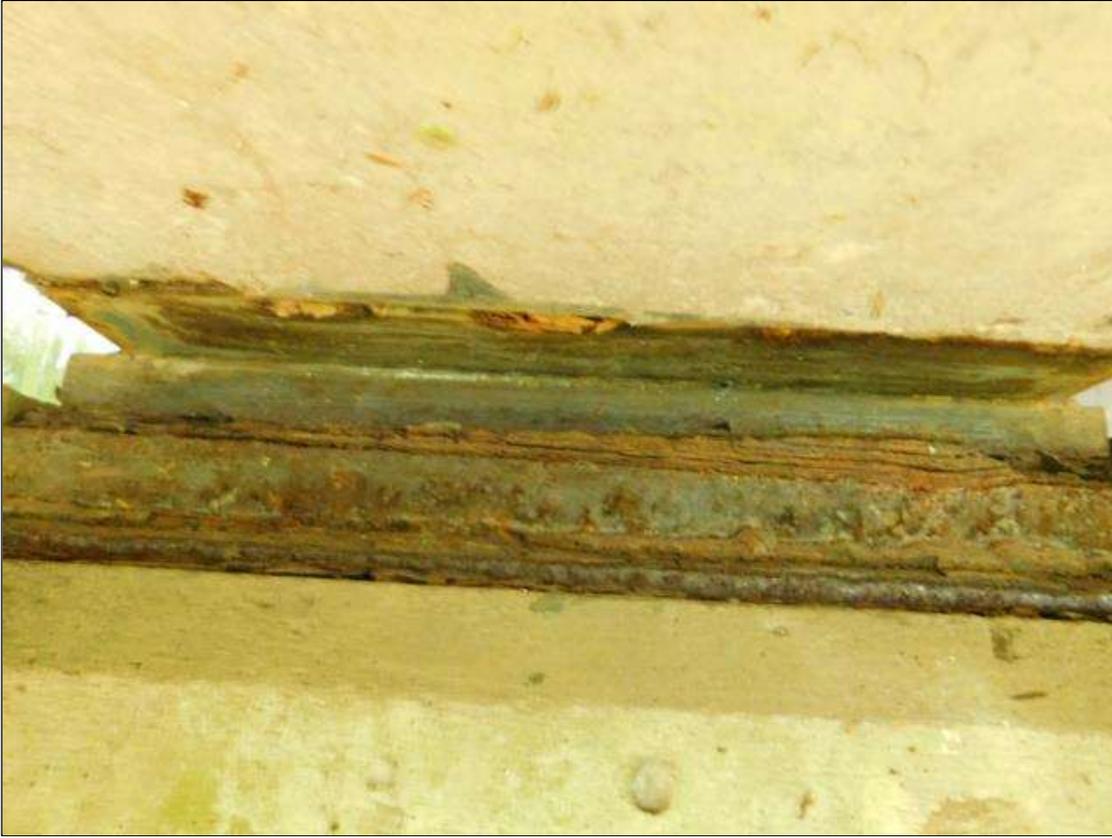
Span 3 Beam 2 Near Bearing: RUST AND FLAKING WITH NO SECTION LOSS

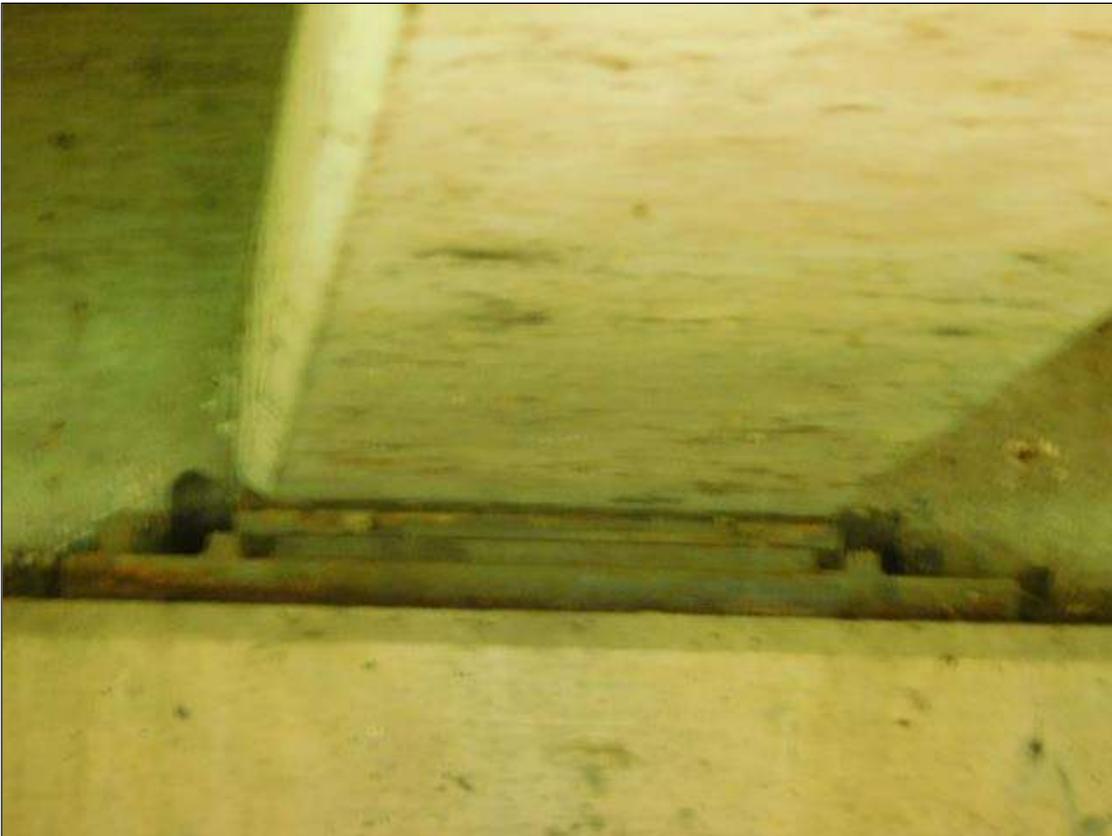
Span 3 Beam 4 Far Bearing: FRECKLED RUST

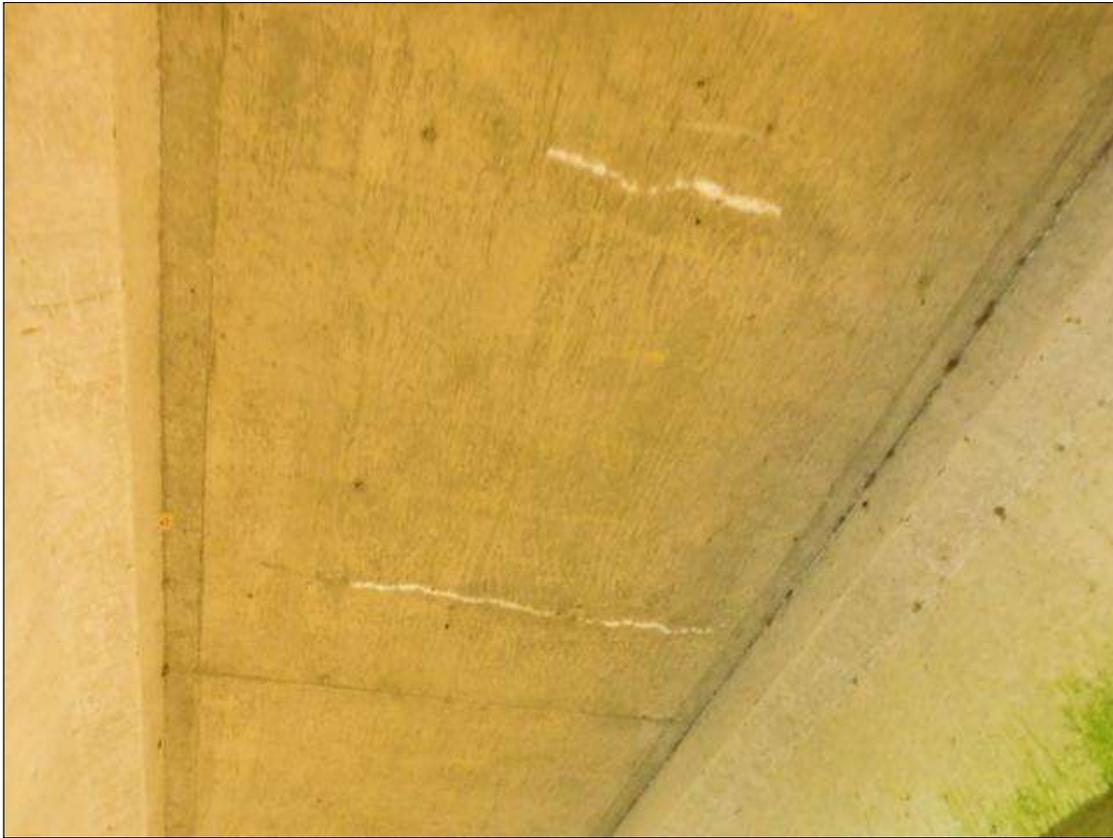
Span 3 Deck: 24" AND 12" TRANSVERSE HAIRLINE CRACKS WITH EFFLORESCENCE IN BOTTOM OF DECK BAY 3, 10 FT. FROM BENT 2

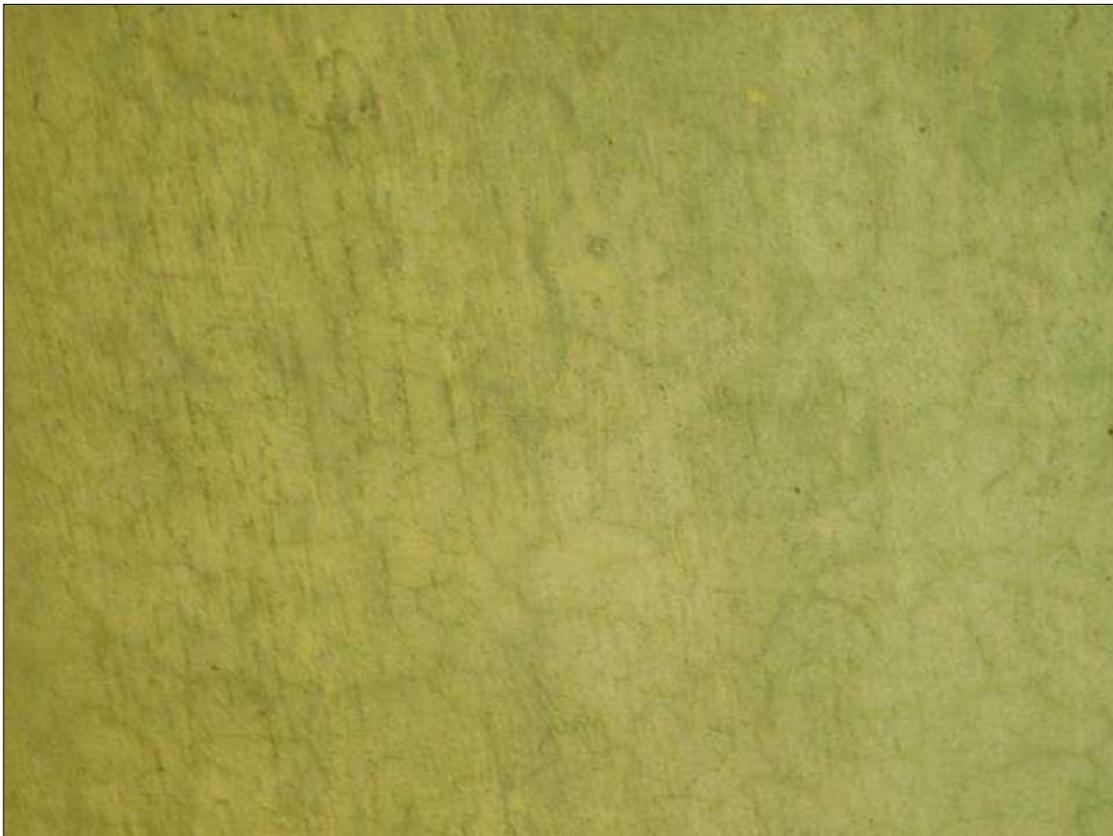
Span 3 Deck: 300 SF. OF HAIRLINE MAP CRACKING IN BOTTOM OF DECK

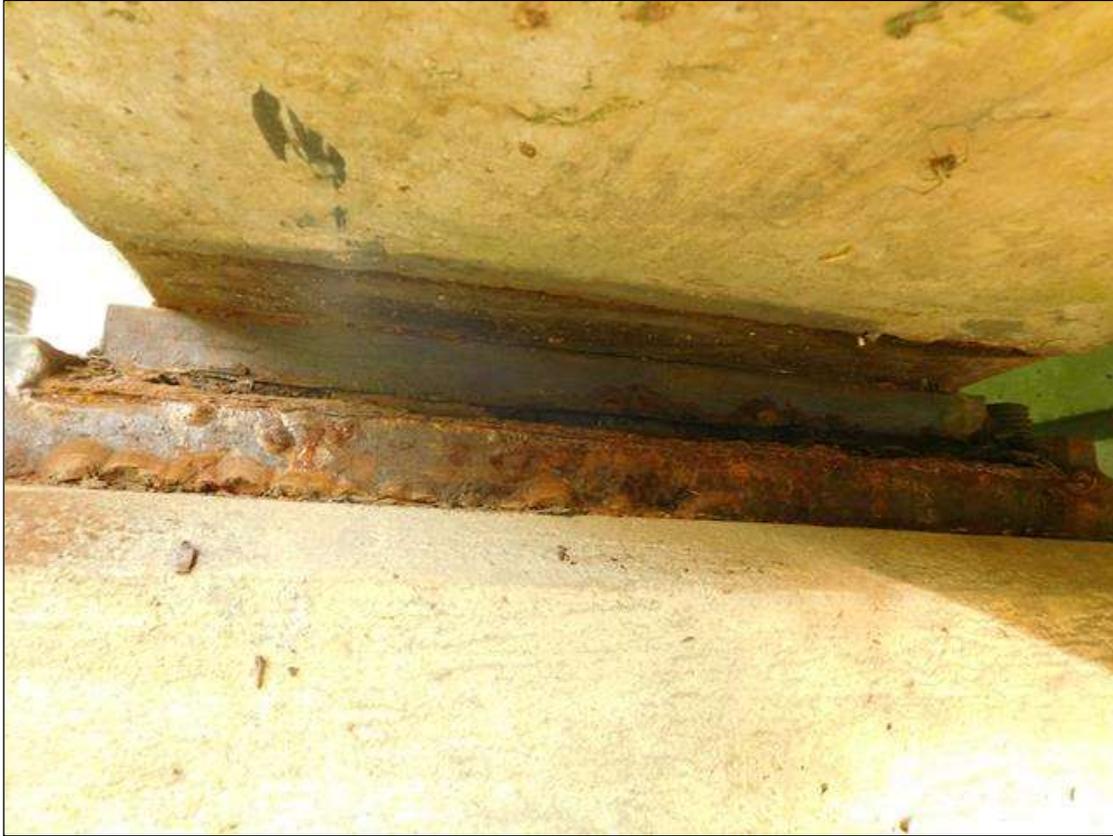
Span 3 Beam 6 Near Bearing: RUST AND FLAKING WITH NO SECTION LOSS

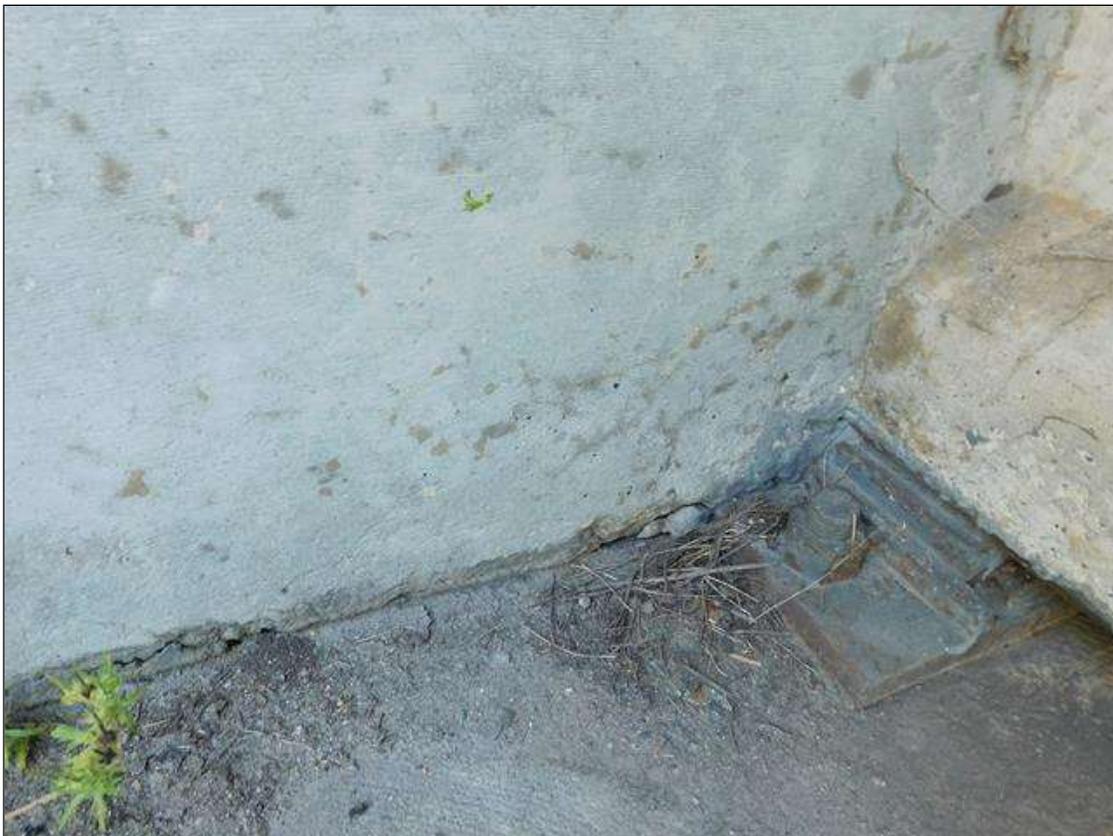
Element Number	Defect Type	Defect Description	CS	CS Qty	Maint Qty
215	Cracking (RC and Other)	HAIRLINE MAP CRACKING AT WEST END , SIMILAR THROUGHOUT ABUTMENT IN ALL BAYS	2	18	Feet

End Bent 2 Abutment/Backwall : HAIRLINE MAP CRACKING AT WEST END , SIMILAR THROUGHOUT ABUTMENT IN ALL BAYS

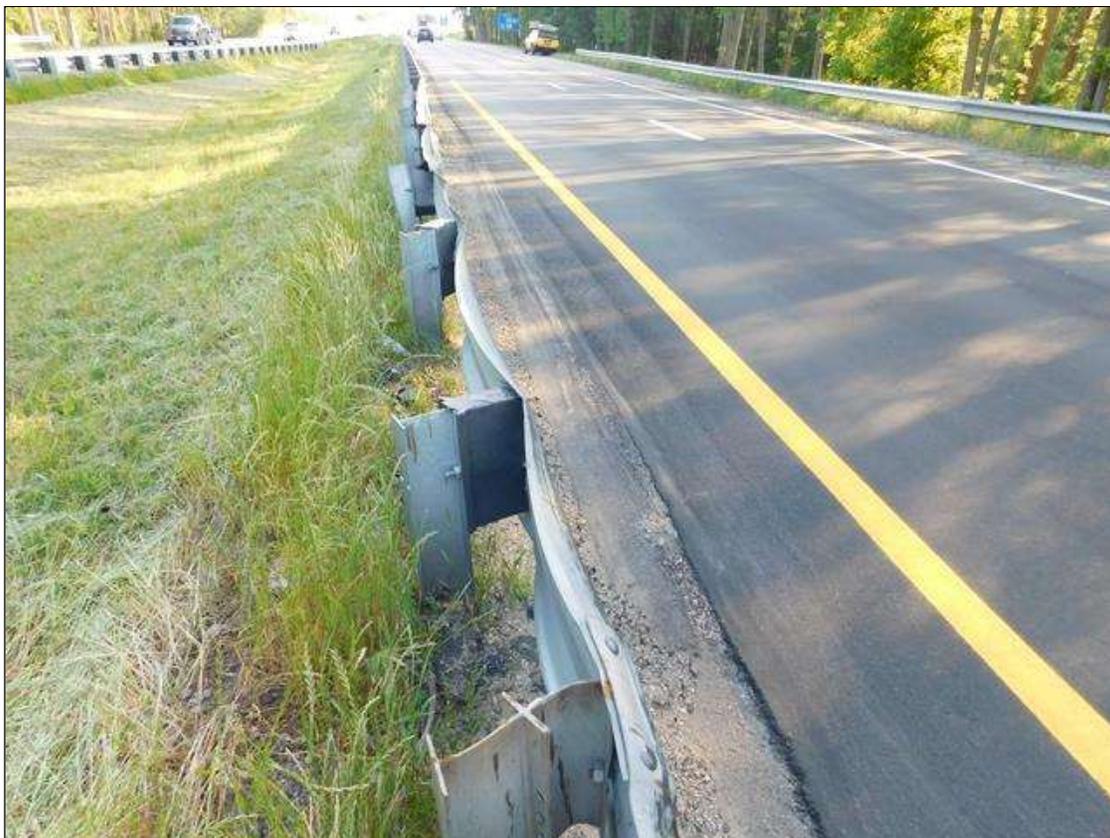
Details DAMAGED GUARDRAIL (40 FT.) IN NORTH WEST CORNER

DAMAGED GUARDRAIL (40 FT.) IN NORTH WEST CORNER

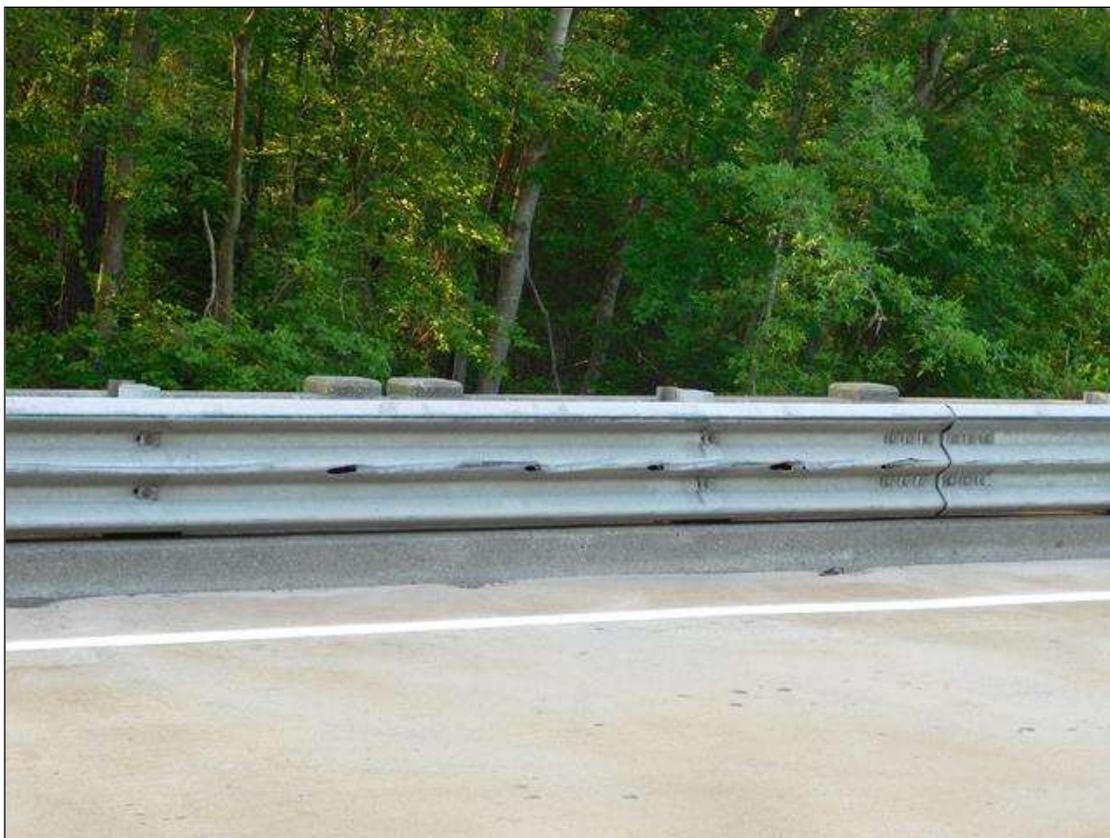
Element Number	Defect Type	Defect Description	CS	CS Qty	Maint Qty
333	Damage	IMPACT GOUGES IN STEEL RAIL	2	8	Feet

Span 3 Right Bridge Rail: IMPACT GOUGES IN STEEL RAIL

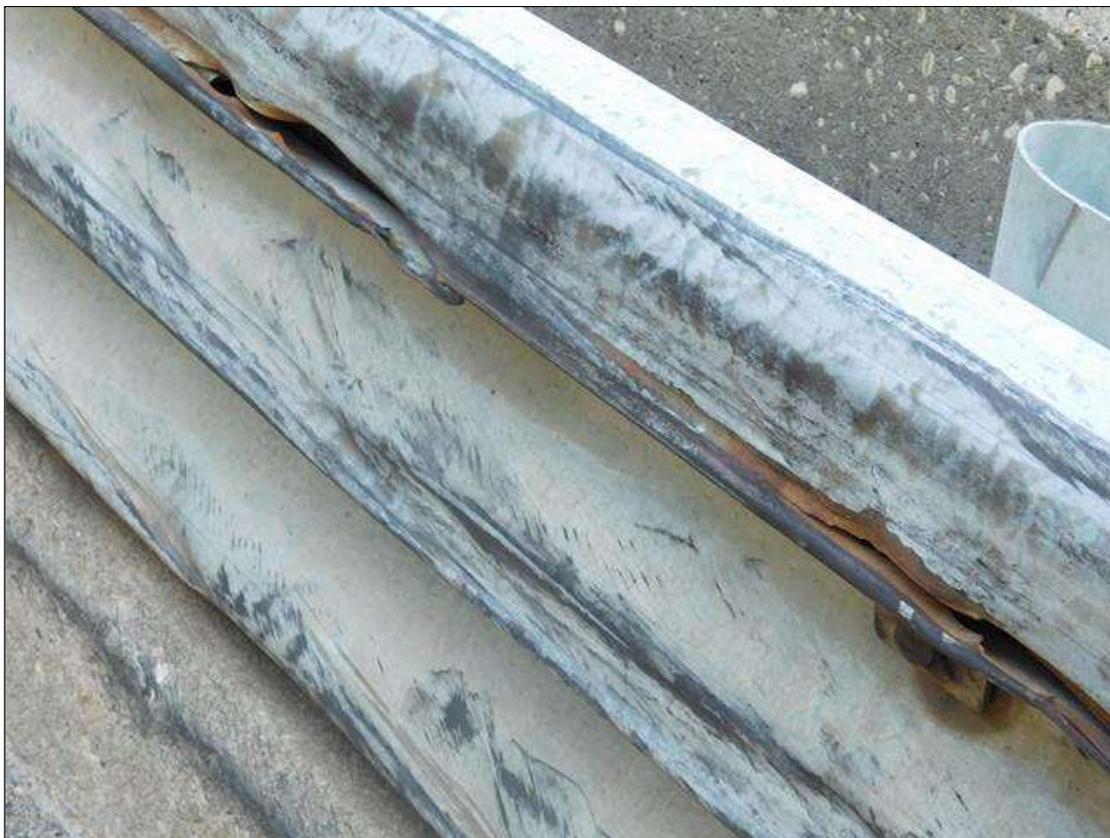
Element Number	Defect Type	Defect Description	CS	CS Qty	Maint Qty
333	Distortion	MULTIPLE GOUGES UP TO 12" X 1" IN RAIL	2	12	Feet

Span 3 Left Bridge Rail: MULTIPLE GOUGES UP TO 12" X 1" IN RAIL

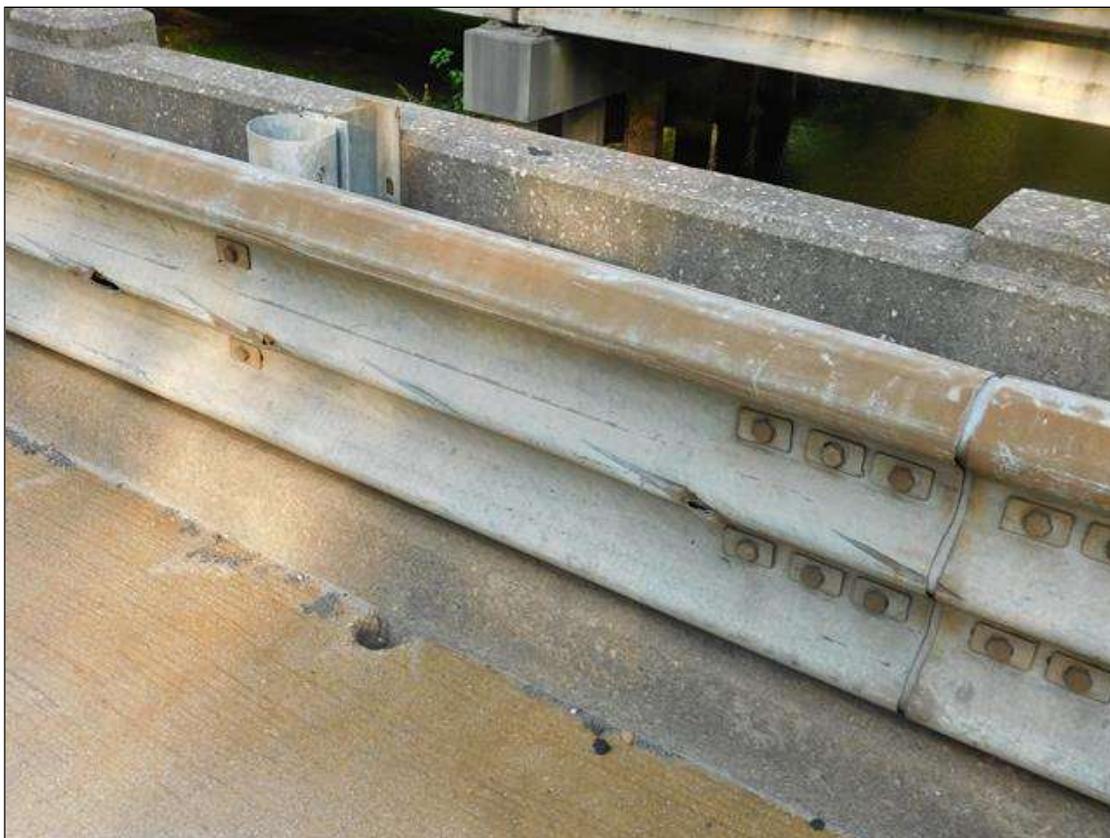
Element Number	Defect Type	Defect Description	CS	CS Qty	Maint Qty
333	Distortion	MULTIPLE GOUGES UP TO 6" X 3" IN RAIL	2	10	Feet

Span 2 Left Bridge Rail: MULTIPLE GOUGES UP TO 6" X 3" IN RAIL

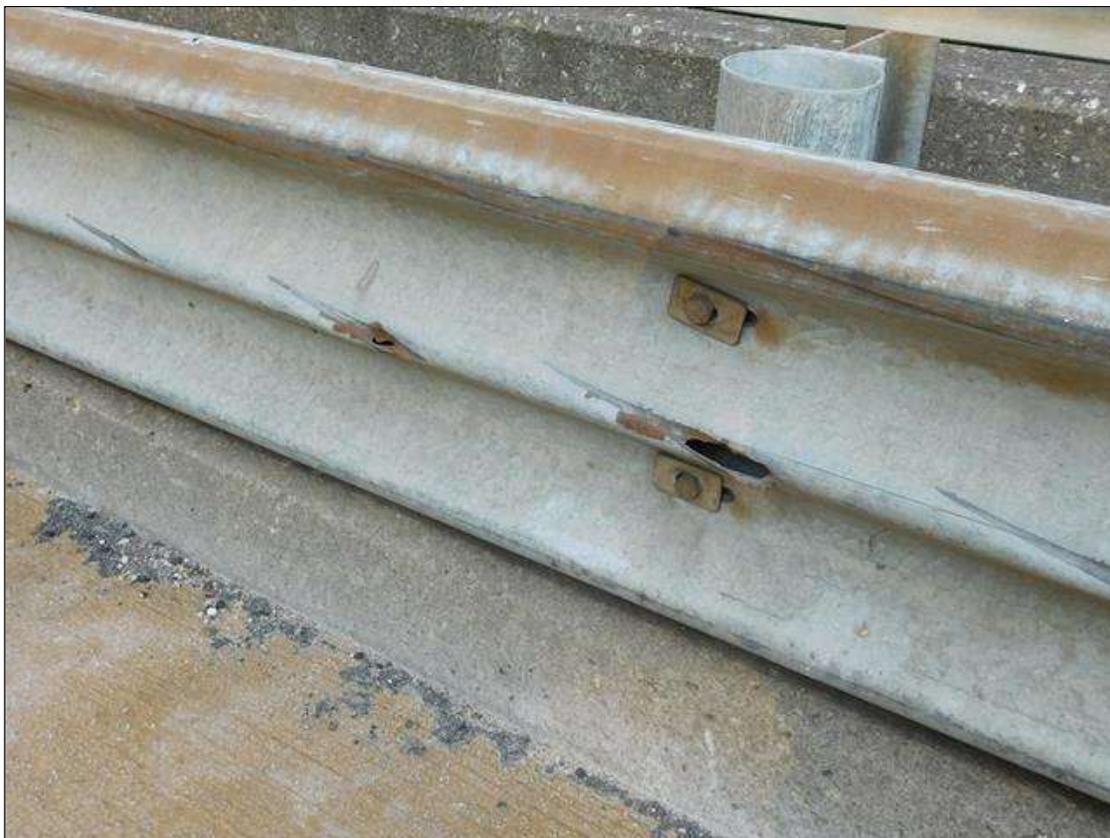
Element Number	Defect Type	Defect Description	CS	CS Qty	Maint Qty
333	Distortion	MULTIPLE GOUGES UP TO 6" X 3" IN RAIL	2	20	Feet

Span 1 Left Bridge Rail: MULTIPLE GOUGES UP TO 6" X 3" IN RAIL

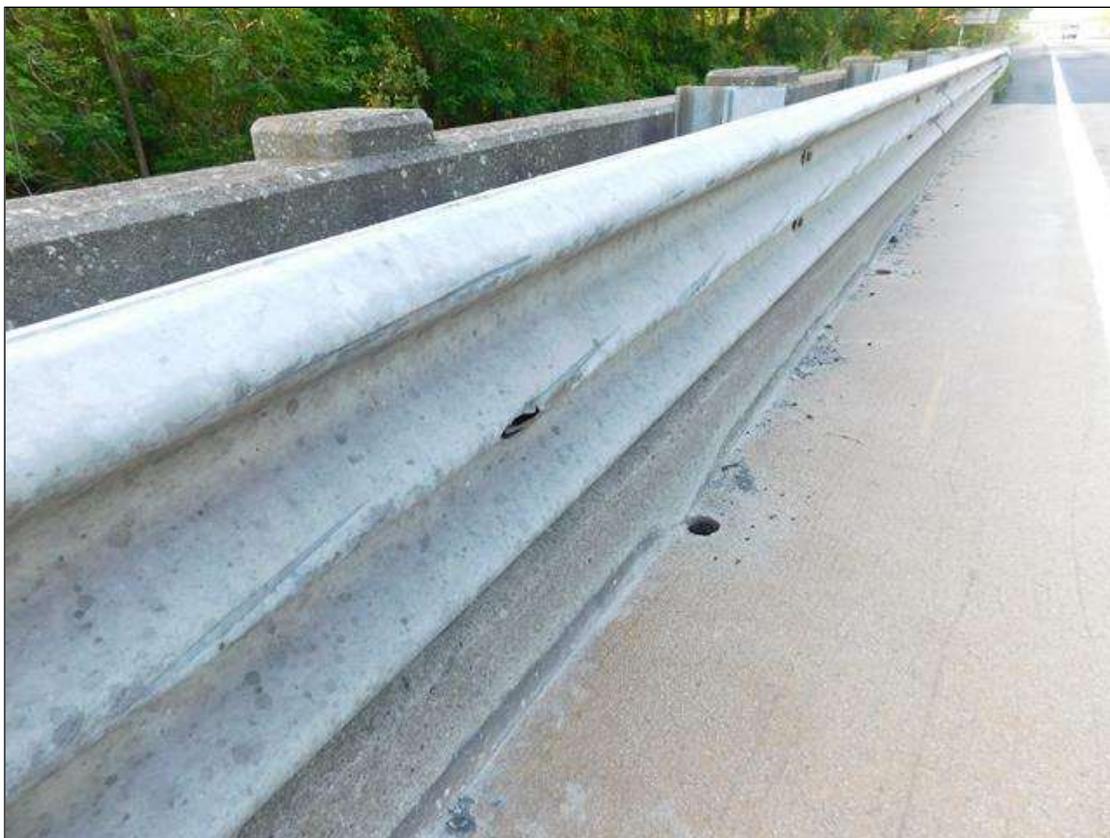
Element Number	Defect Type	Defect Description	CS	CS Qty	Maint Qty
333	Damage	IMPACT GOUGES IN STEEL RAIL	2	10	Feet

Span 1 Right Bridge Rail: IMPACT GOUGES IN STEEL RAIL

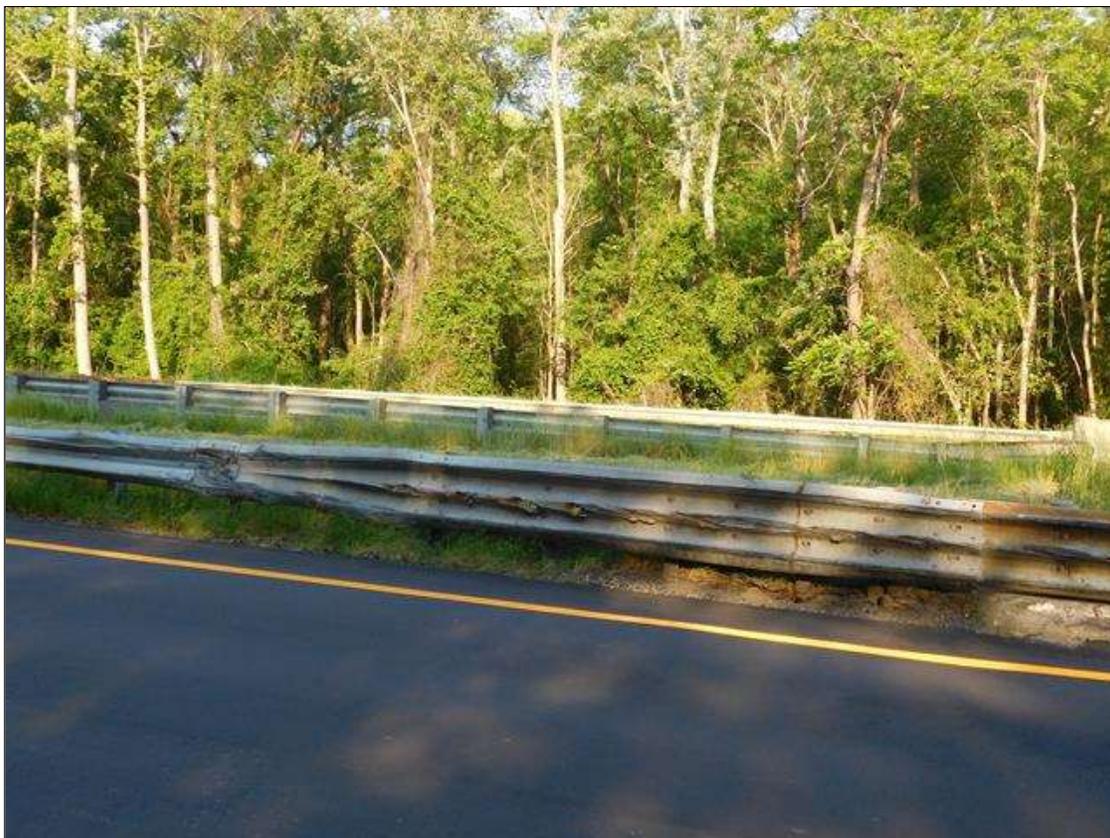
DAMAGED GUARDRAIL AT SOUTHWEST CORNER 20 FT.

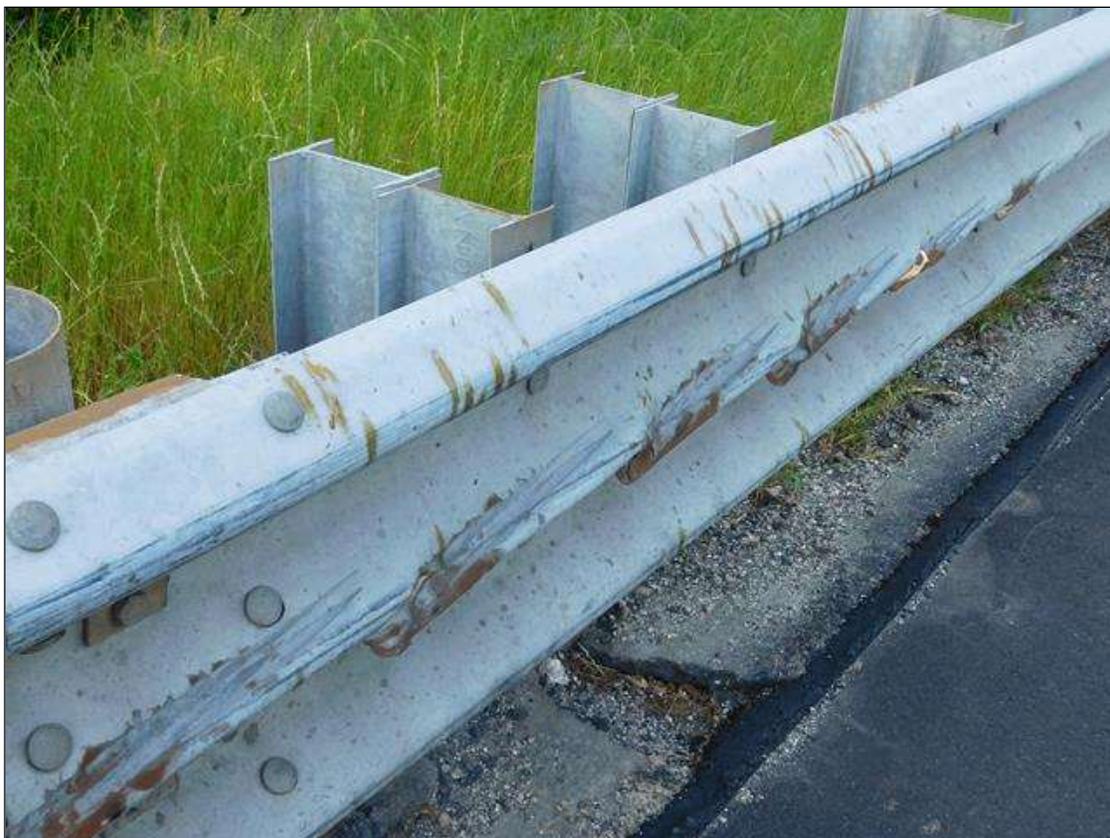
DAMAGED GUARDRAIL AT SOUTHEAST CORNER 20 FT.

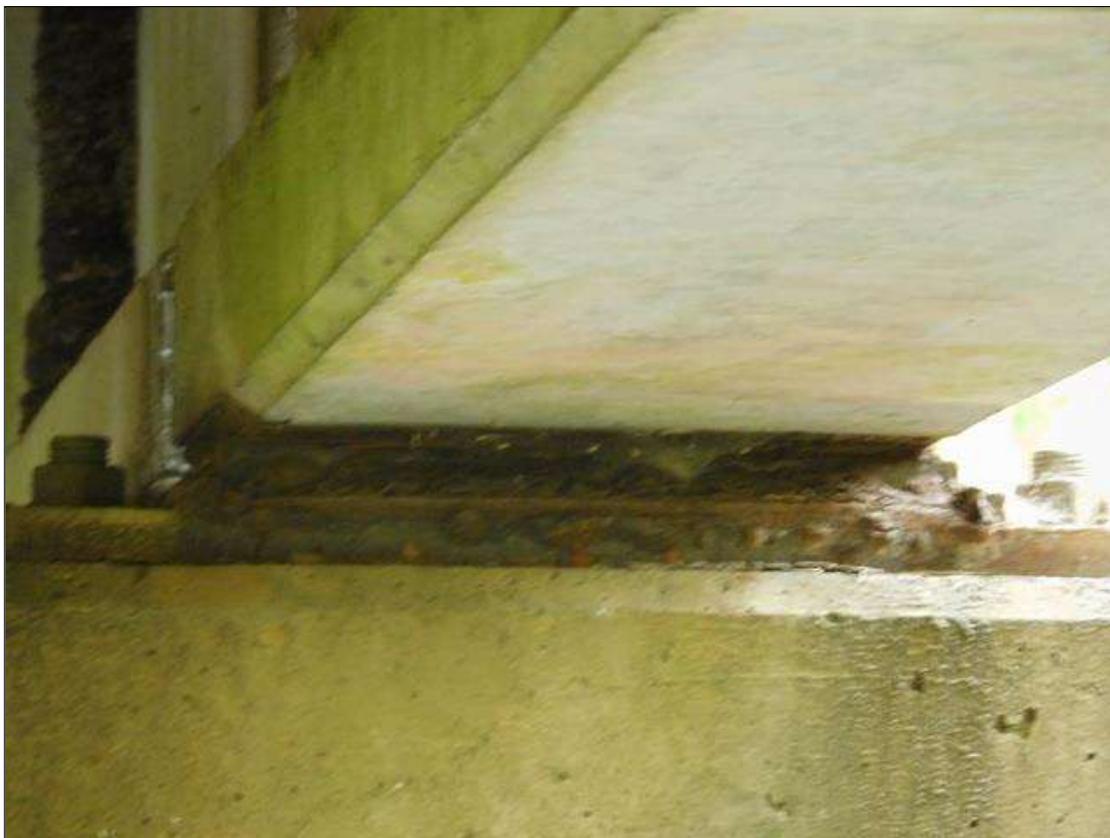
Span 1 Beam 6 Far Bearing: RUST AND FLAKING WITH NO SECTION LOSS

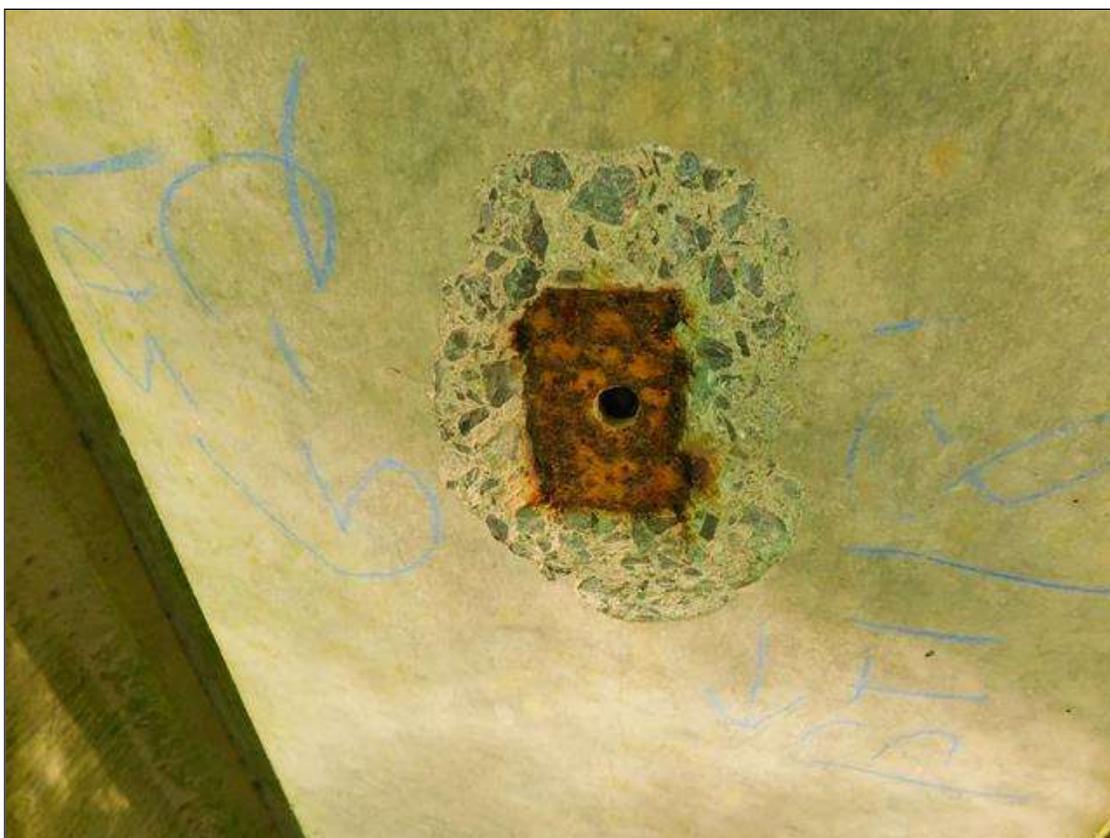
Element Number	Defect Type	Defect Description	CS	CS Qty	Maint Qty
109	Delamination/Spall	4" DIAMETER X 1/2" DEEP SPALL WITH EXPOSED PLATE AT HOLD-DOWN POINT IN BOTTOM FLANGE	2	1	1 Feet

Span 1 Beam 2: 4" DIAMETER X 1/2" DEEP SPALL WITH EXPOSED PLATE AT HOLD-DOWN POINT IN BOTTOM FLANGE
