NC DEPARTMENT OF TRANSPORTATION ATTENTION:
 DIVISION OF HIGHWAYS
 STRUCTURE MANAGEMENT UNIT

Structure Safety Report

Routine Element Inspection

DIVISION: 6 COUNTY: ROBESON STRUCTURE NUMBER: 770158 FREQUENCY: 24 MONTHS

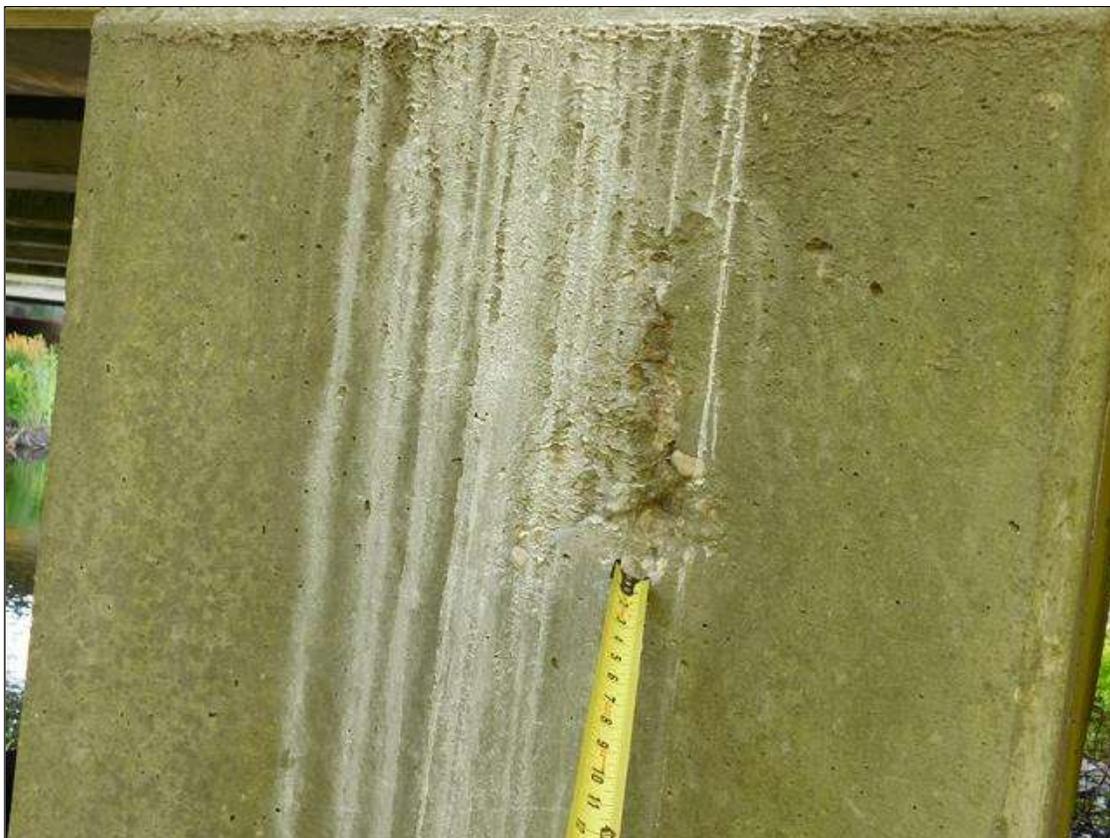
Element Number	Defect Type	Defect Description	CS	CS Qty	Maint Qty
234	Delamination/Spall	SURFACE SPALL 6" DIAMETER X 1" DEEP ON WEST END	2	1	1 Feet

Bent 1 Cap 1: SURFACE SPALL 6" DIAMETER X 1" DEEP ON WEST END

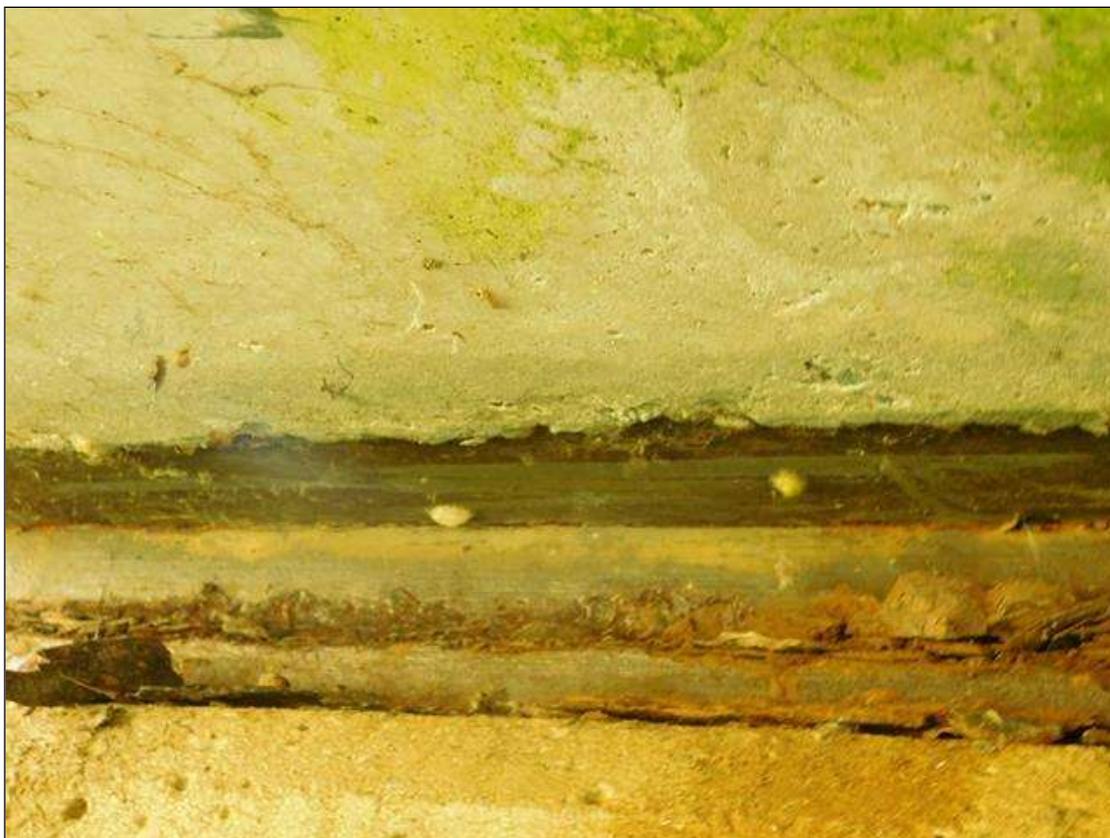
Element Number	Defect Type	Defect Description	CS	CS Qty	Maint Qty
316	Corrosion	RUST AND FLAKING WITH NO SECTION LOSS	2	1	Each
515	Effectiveness (Steel Protective Coatings)	2 SF. OF INEFFECTIVE PROTECTIVE COATING	4	2	2 Square Feet

Span 1 Beam 1 Far Bearing: RUST AND FLAKING WITH NO SECTION LOSS

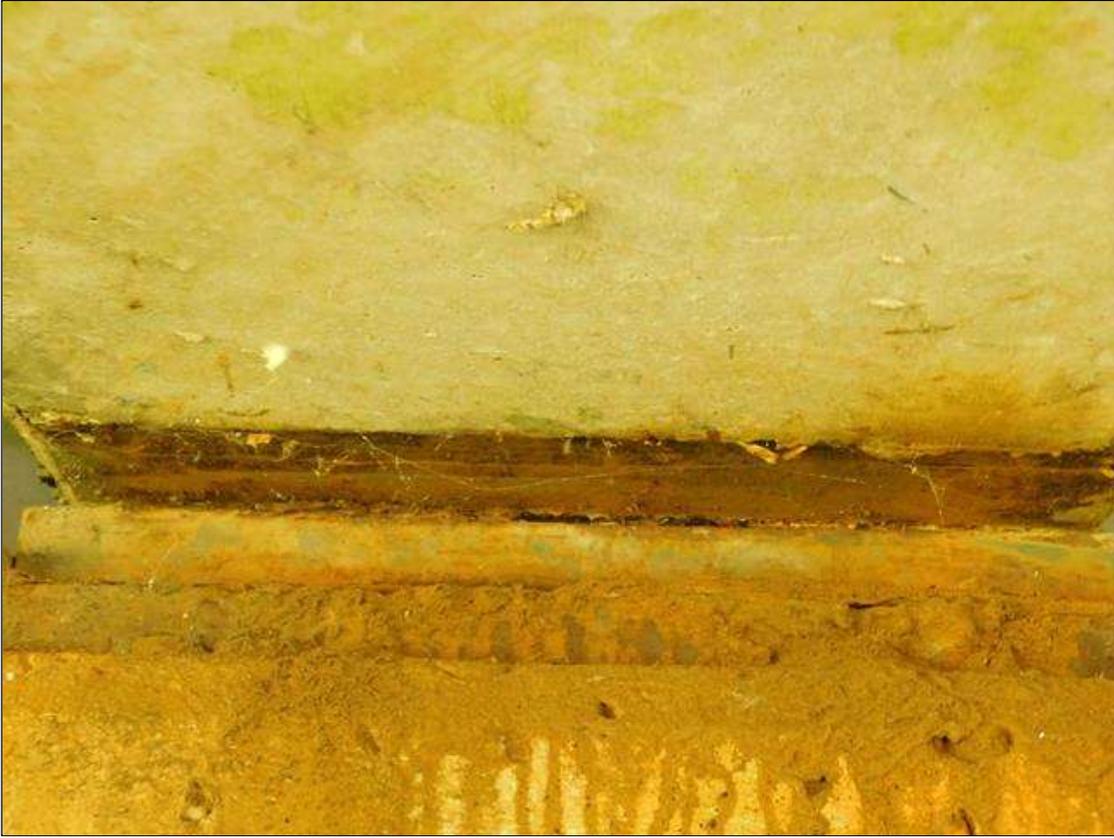
Element Number	Defect Type	Defect Description	CS	CS Qty	Maint Qty
316	Corrosion	RUST WITH FLAKING , NO SECTION LOSS	2	1	Each
515	Effectiveness (Steel Protective Coatings)	2 SF. OF INEFFECTIVE PROTECTIVE COATING	4	2	2 Square Feet

Span 1 Beam 2 Far Bearing: RUST WITH FLAKING , NO SECTION LOSS

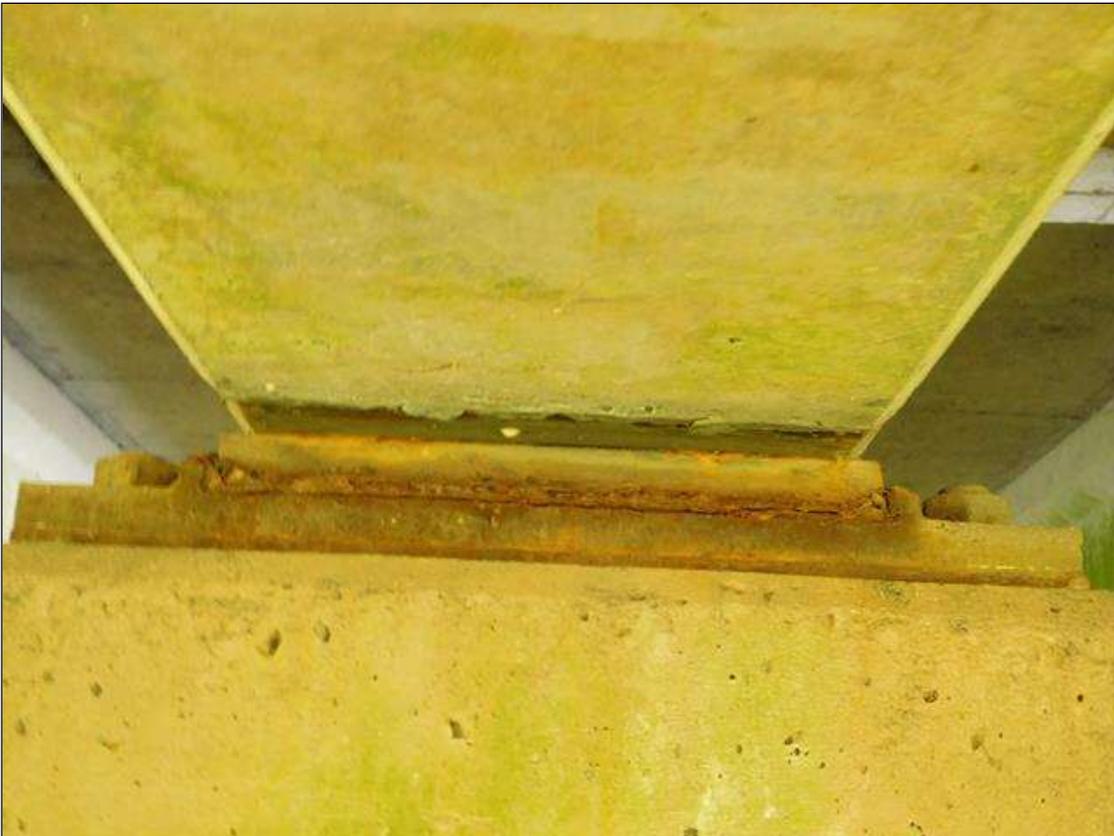
Element Number	Defect Type	Defect Description	CS	CS Qty	Maint Qty
316	Corrosion	RUST WITH FLAKING , NO SECTION LOSS	2	1	Each
515	Effectiveness (Steel Protective Coatings)	2 SF. OF INEFFECTIVE PROTECTIVE COATING	4	2	2 Square Feet

Span 1 Beam 3 Far Bearing: RUST WITH FLAKING , NO SECTION LOSS

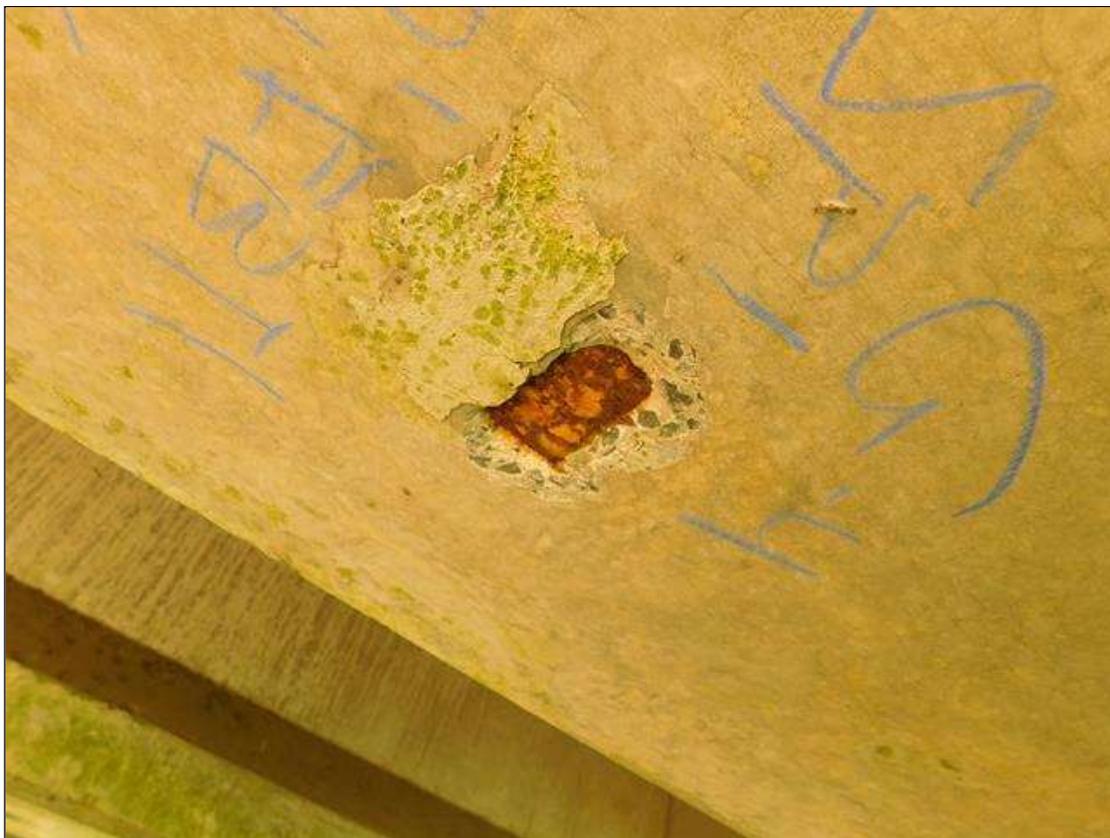
Element Number	Defect Type	Defect Description	CS	CS Qty	Maint Qty	
109	Delamination/Spall	SURFACE SPALL 4" DIAMETER X 1/2" DEEP IN BOTTOM FLANGE AT 20 FT. FROM END BENT 1 CAP	2	1	1	Feet

Span 1 Beam 4: SURFACE SPALL 4" DIAMETER X 1/2" DEEP IN BOTTOM FLANGE AT 20 FT. FROM END BENT 1 CAP

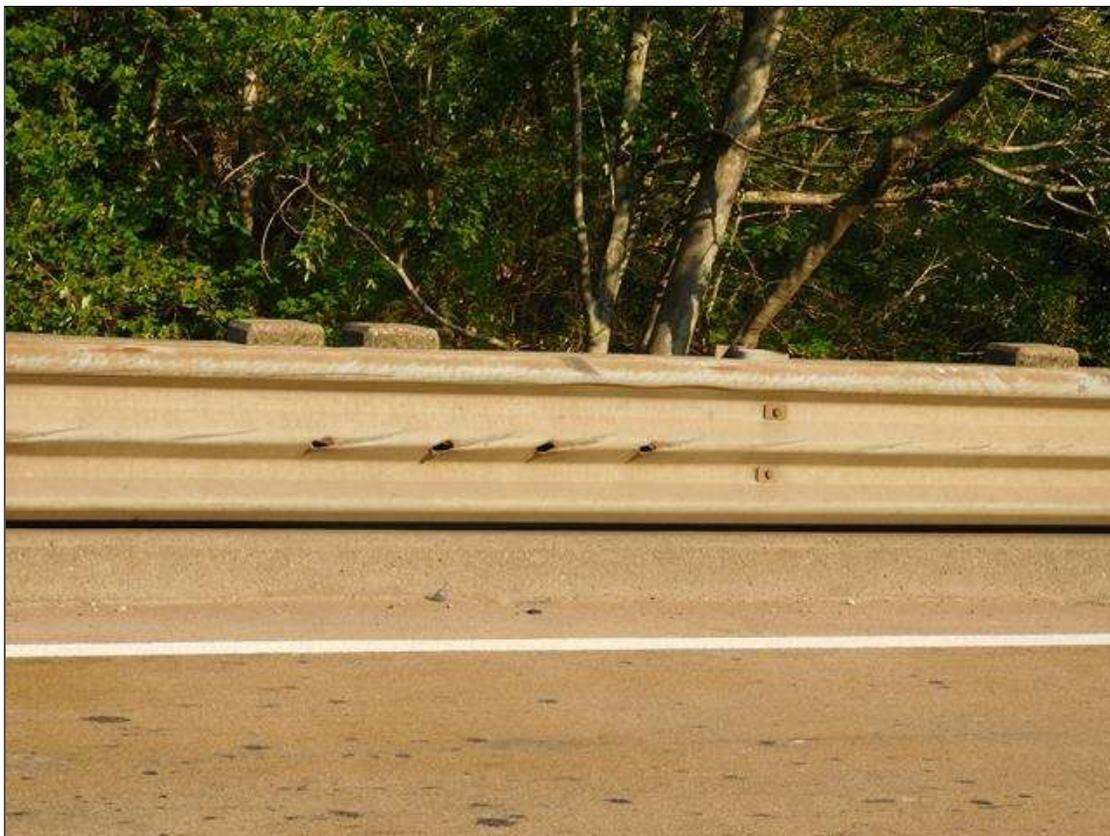
Element Number	Defect Type	Defect Description	CS	CS Qty	Maint Qty	
333	Distortion	MULTIPLE GOUGES UP TO 3" X 1" IN RAIL	2	10		Feet

Span 1 Left Bridge Rail: MULTIPLE GOUGES UP TO 3" X 1" IN RAIL

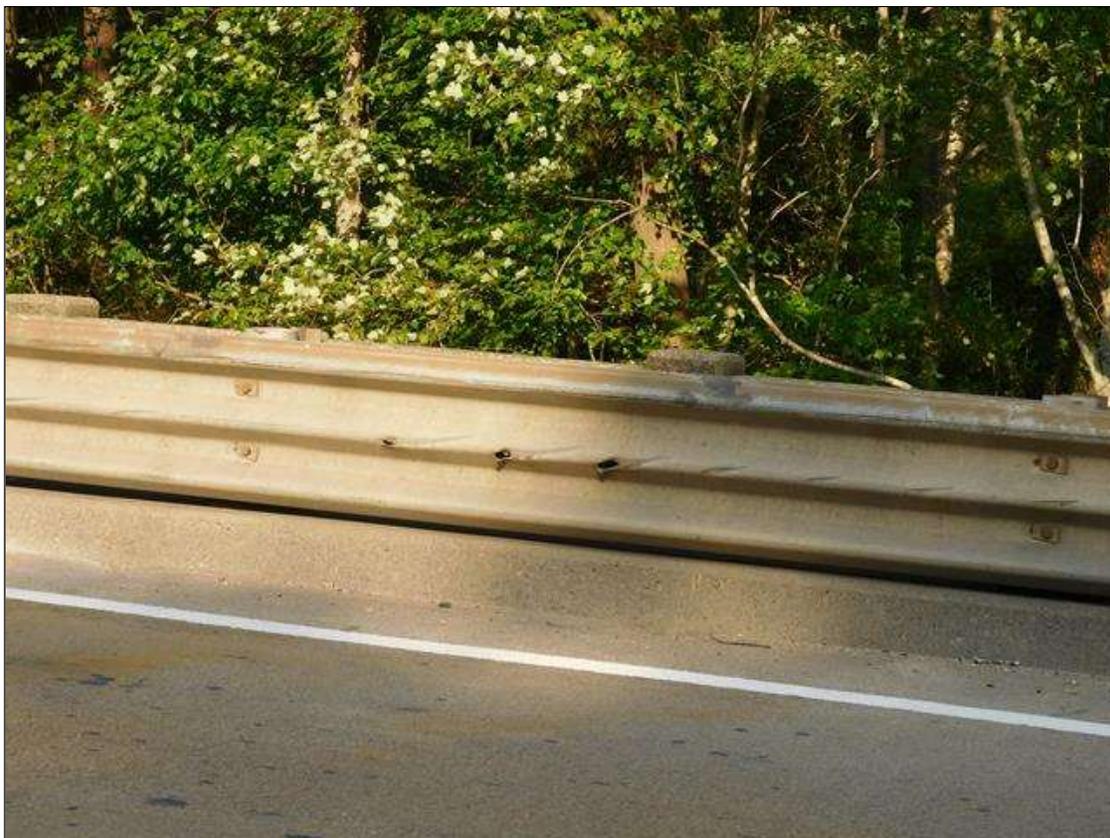
Element Number	Defect Type	Defect Description	CS	CS Qty	Maint Qty
333	Distortion	MULTIPLE GOUGES UP TO 3" X 1" IN RAIL	2	20	Feet

Span 2 Left Bridge Rail: MULTIPLE GOUGES UP TO 3" X 1" IN RAIL

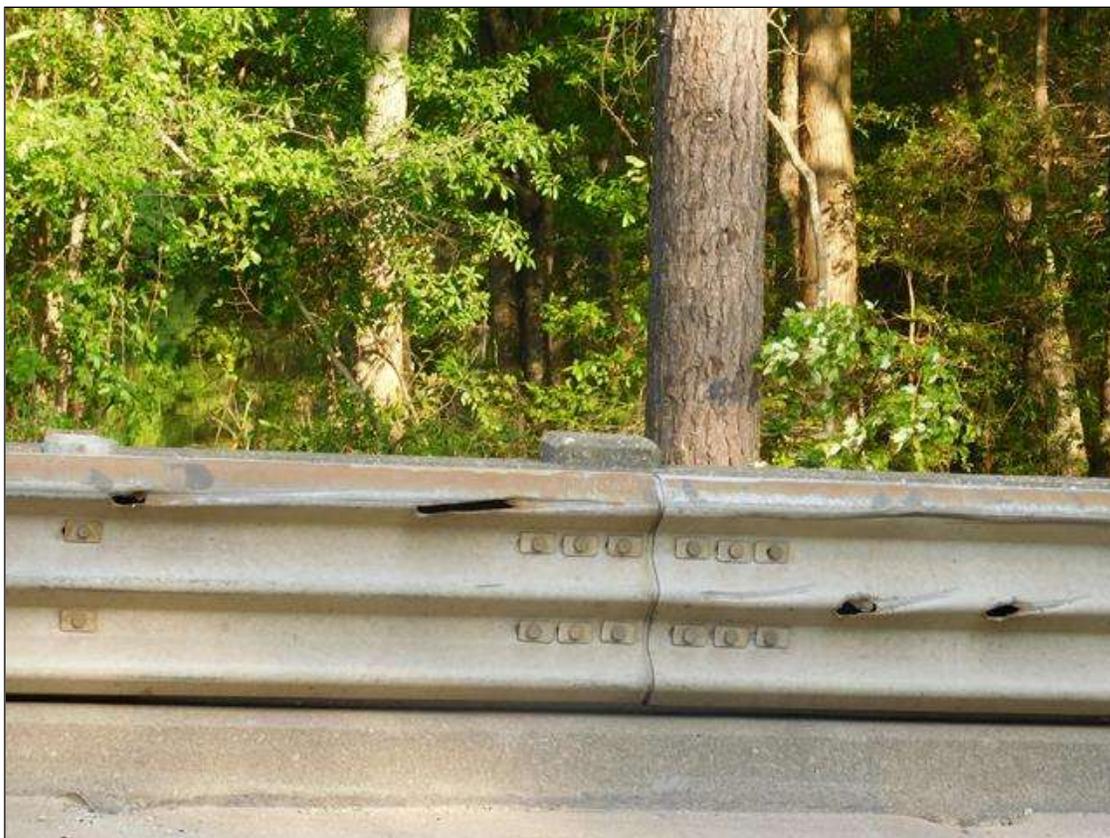
Element Number	Defect Type	Defect Description	CS	CS Qty	Maint Qty
333	Distortion	MULTIPLE GOUGES UP TO 8" X 1" IN RAIL	2	20	Feet

Span 3 Left Bridge Rail: MULTIPLE GOUGES UP TO 8" X 1" IN RAIL

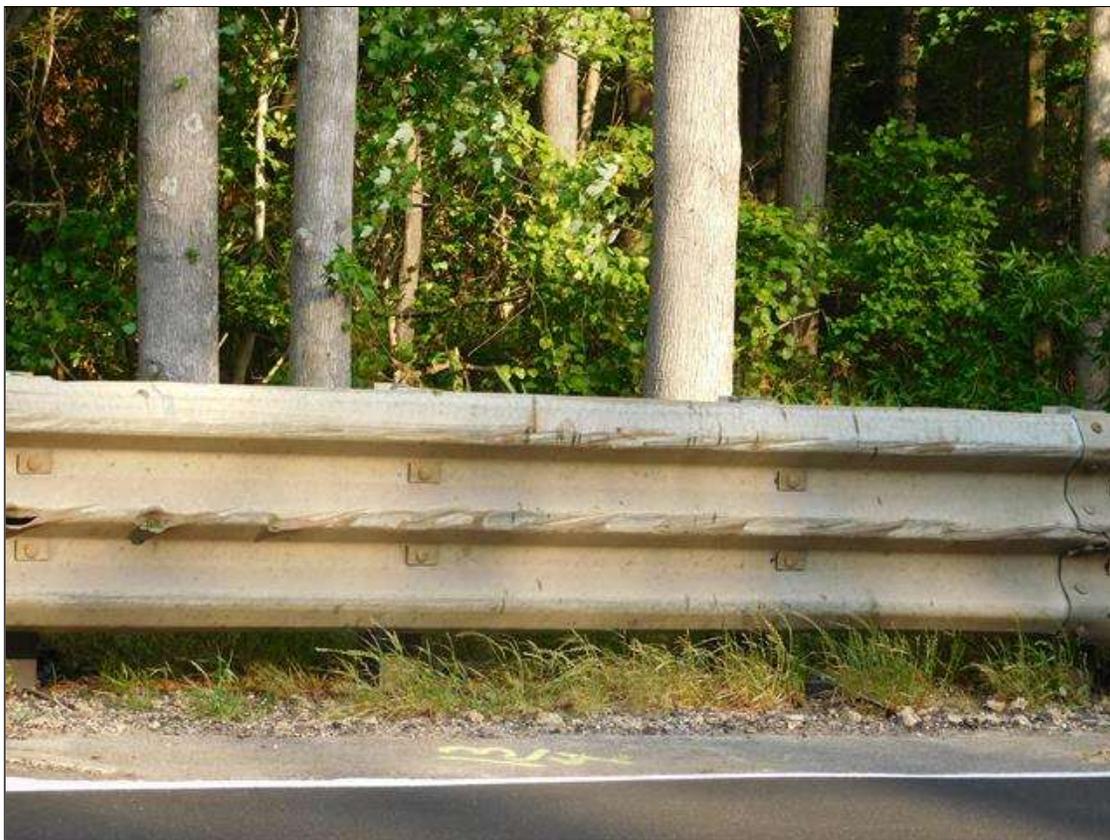
Details DAMAGED APPROACH GUARDRAIL AT NORTHWEST CORNER 20 FT.

DAMAGED APPROACH GUARDRAIL AT NORTHWEST CORNER 20 FT.

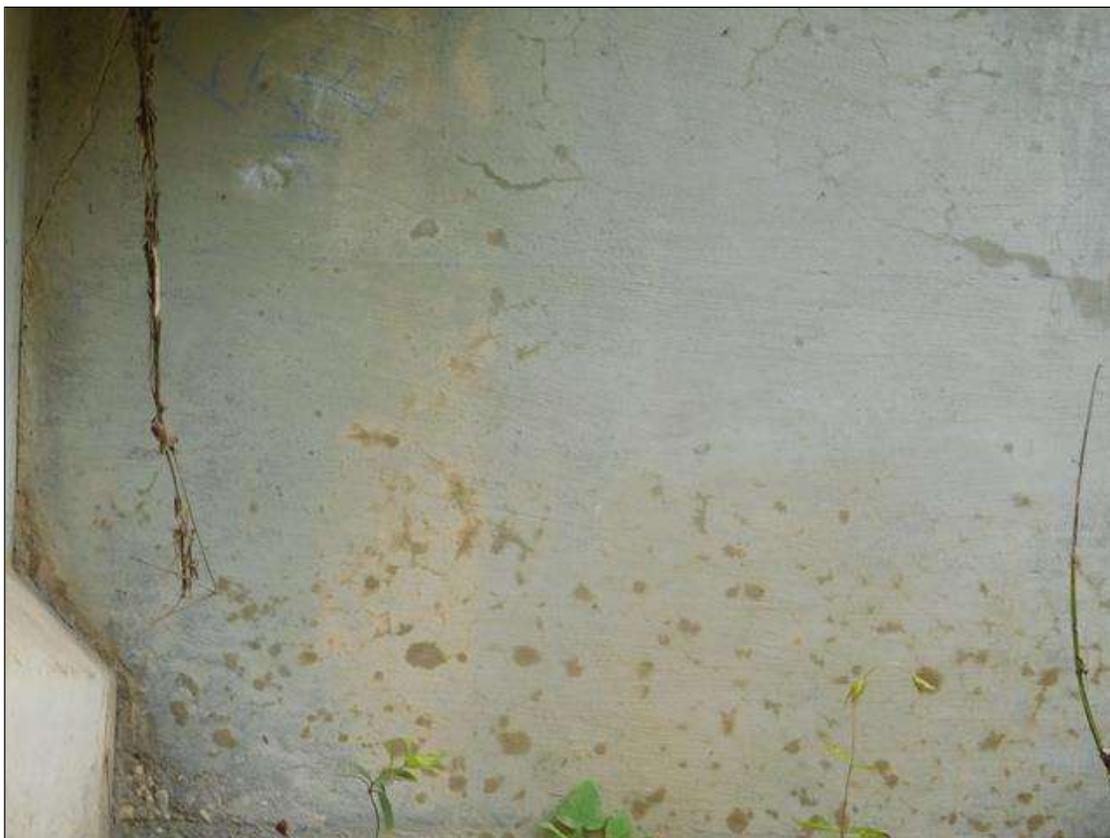
Element Number	Defect Type	Defect Description	CS	CS Qty	Maint Qty
215	Cracking (RC and Other)	6 SF. OF HAIRLINE MAP CRACKING AT EAST END	2	3	Feet

End Bent 2 Abutment/Backwall : 6 SF. OF HAIRLINE MAP CRACKING AT EAST END

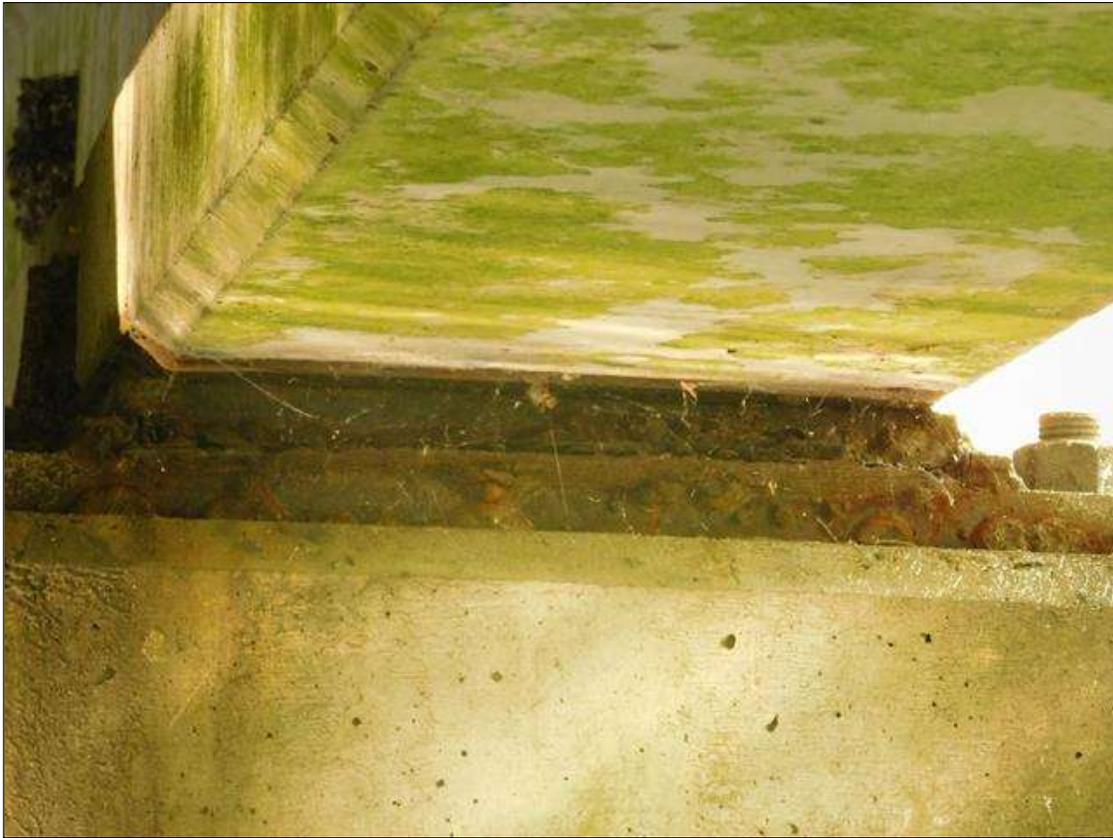
Span 3 Beam 1 Near Bearing: SURFACE CORROSION

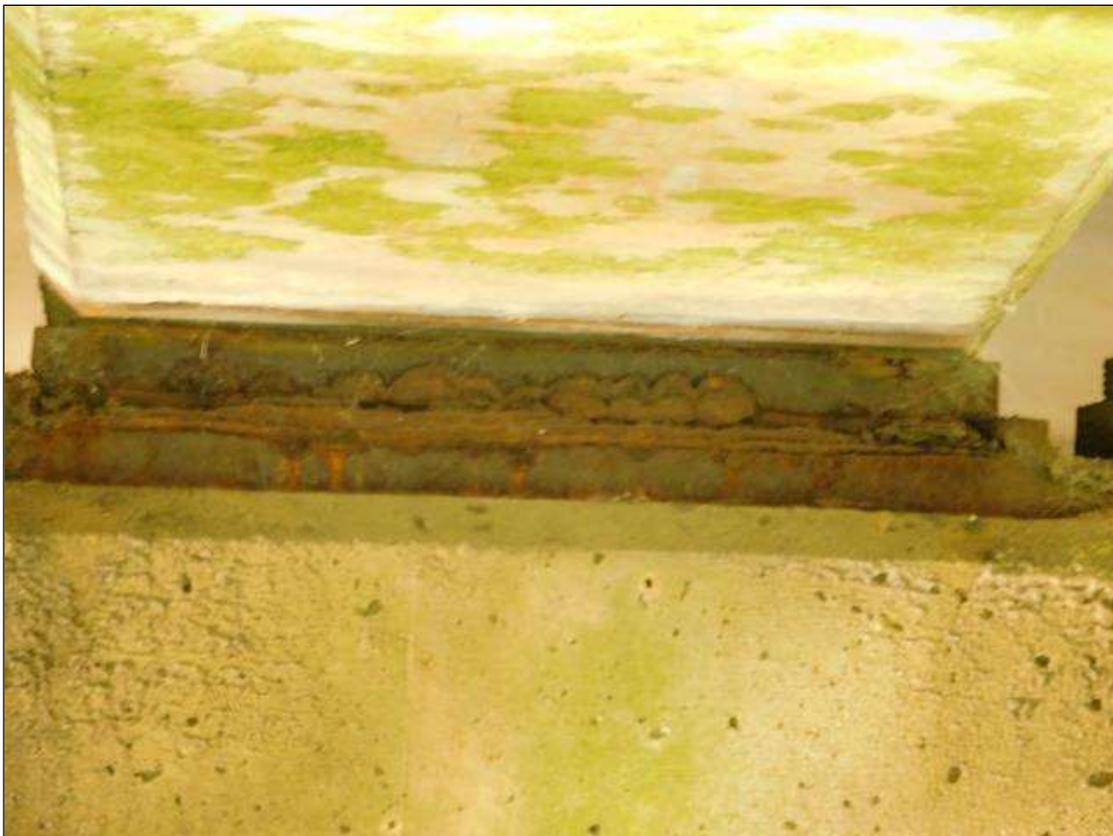
Span 3 Beam 2 Near Bearing: SURFACE CORROSION

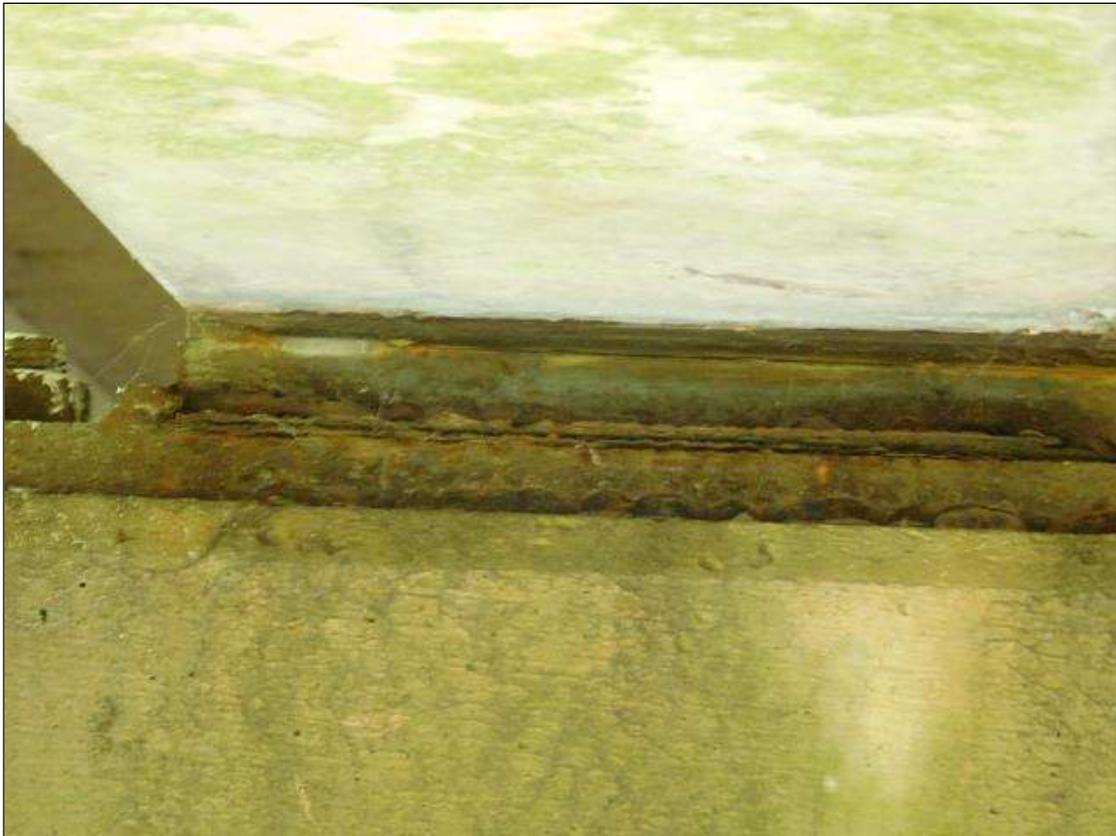
Span 3 Beam 5 Near Bearing: SURFACE CORROSION

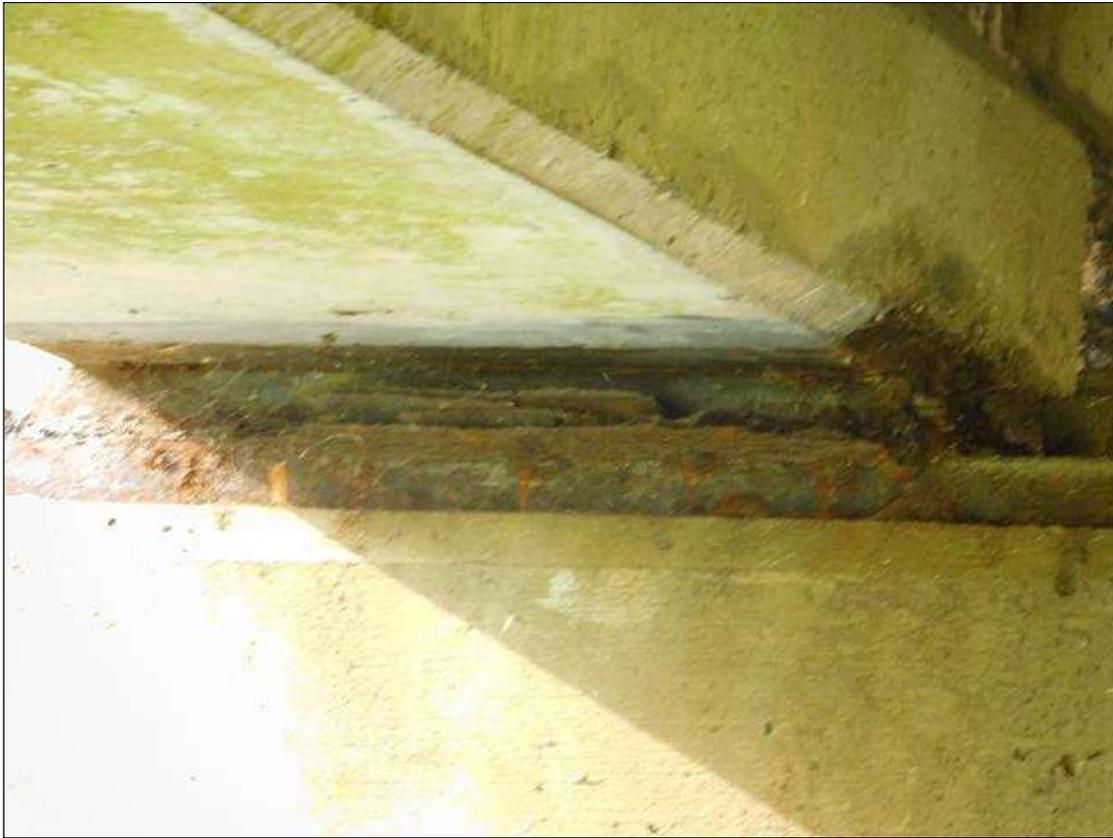
Span 3 Beam 6 Near Bearing: SURFACE CORROSION

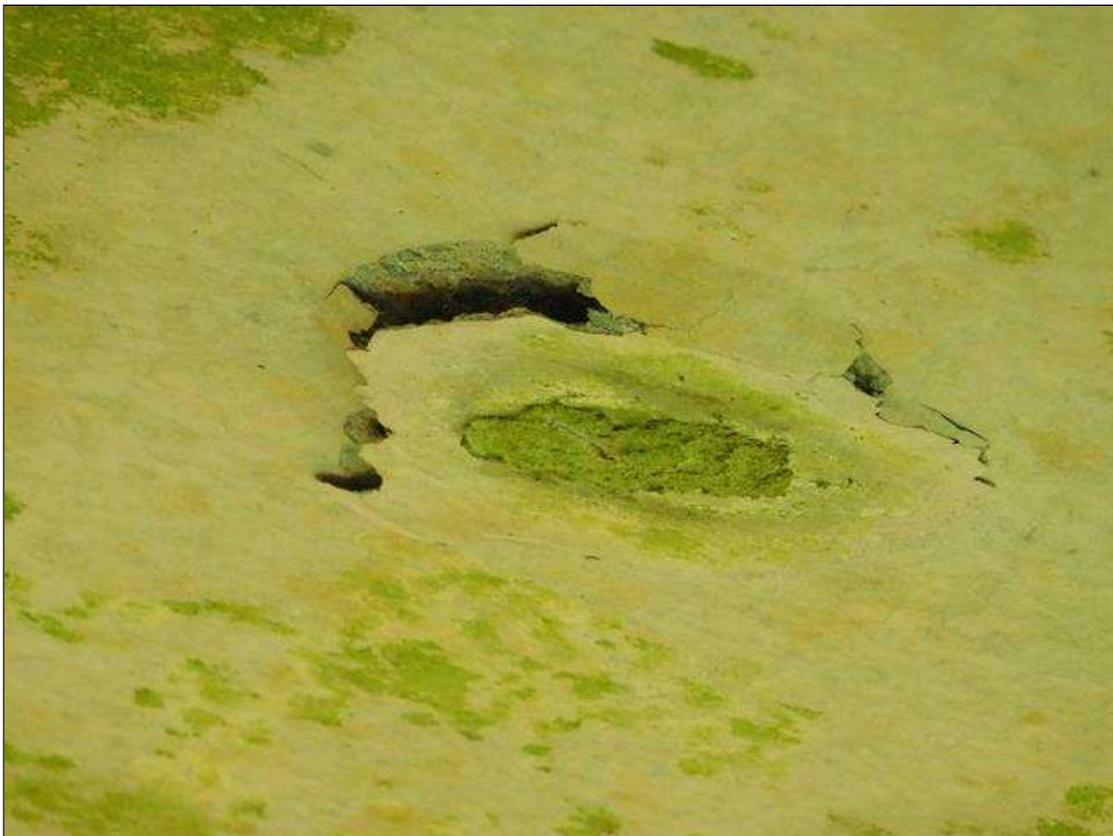
Element Number	Defect Type	Defect Description	CS	CS Qty	Maint Qty
109	Delamination/Spall	DELAMINATION IN BOTTOM FLANGE 4" DIAMETER AT 20 FT. FROM END BENT 2	2	1	1 Feet

Span 3 Beam 5: DELAMINATION IN BOTTOM FLANGE 4" DIAMETER AT 20 FT. FROM END BENT 2

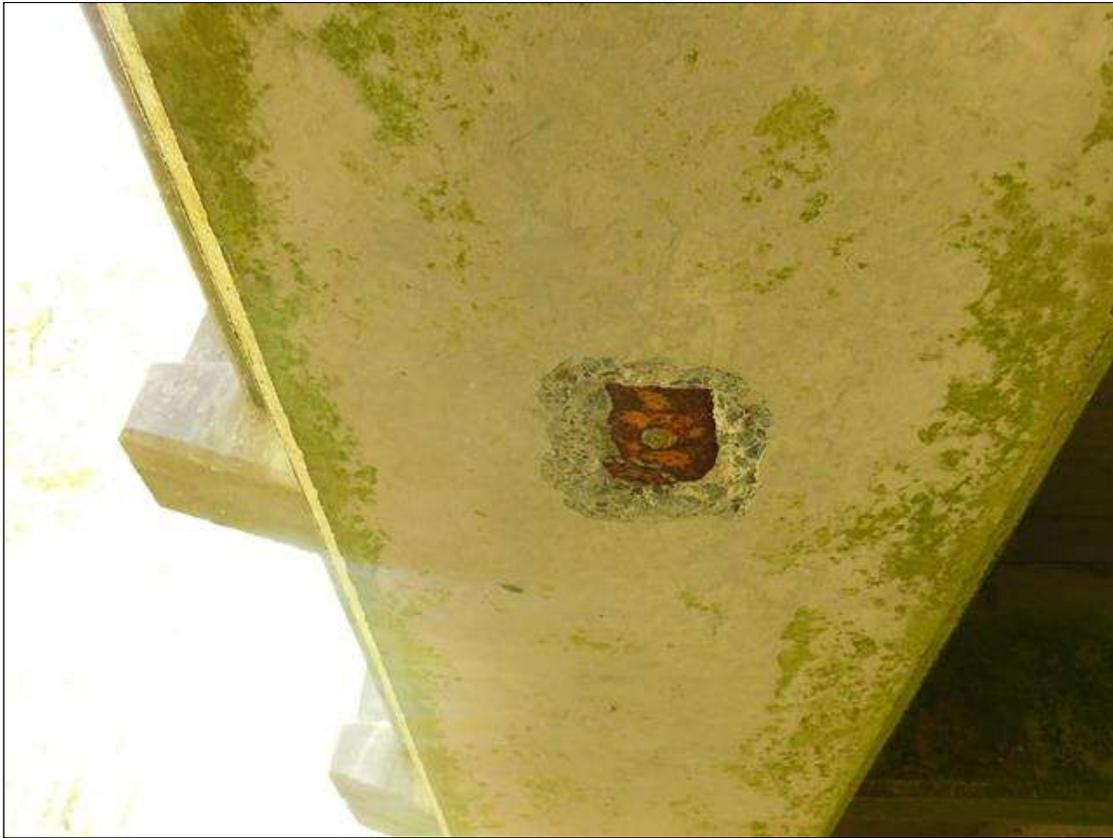
Span 3 Beam 1: 4" DIAMETER X 1/2" DEEP SPALL WITH EXPOSED PLATE AT HOLD-DOWN POINT IN BOTTOM FLANGE
