NC DEPARTMENT OF TRANSPORTATION  
 DIVISION OF HIGHWAYS  
 STRUCTURE MANAGEMENT UNIT

ATTENTION: PAR SUBMITTED, NEWLY INSTALLED WEIGHT LIMITS, LOW UNDERCLEARANCE SIGNS, STRUCTURAL DATA MODIFIED, BEAMS SHAPES ADDED

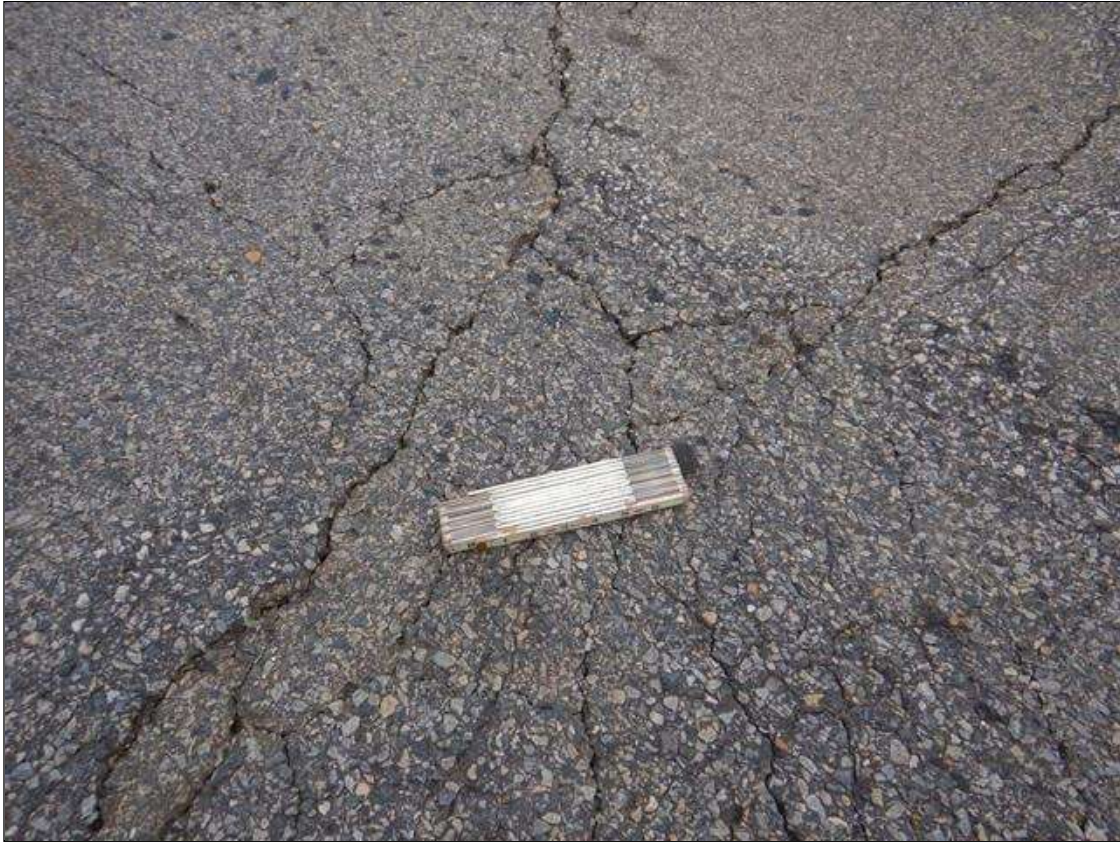
EAST APPROACH HAS MAP CRACKING UP TO 1/4 IN WIDE WITH SOME AREAS OF SUNKEN PAVEMENT

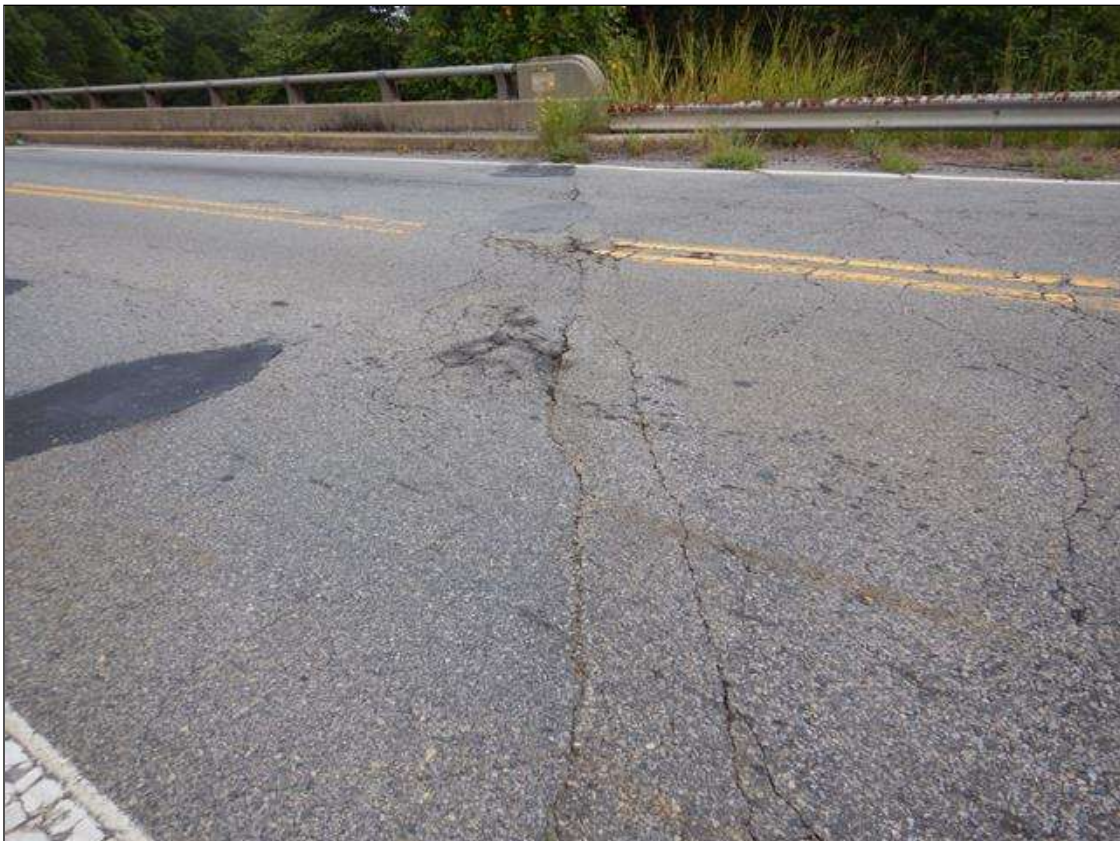
Span 4 Expansion Joint: Top of joint sealed with an Asphalt sealer on wearing surface. CRACKING UP TO 1/4 IN FULL WIDTH WITH PATCHED POTHOLES

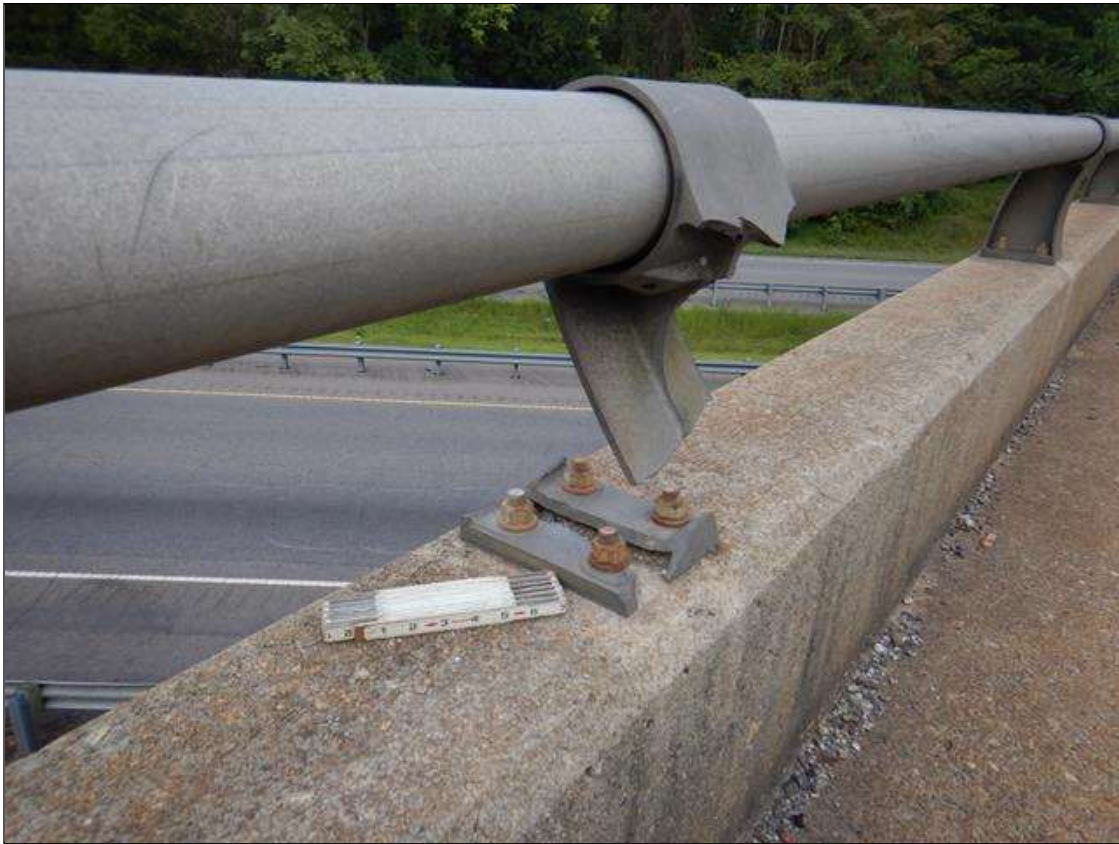
Span 4 Right Bridge Rail: ALUMINUM POST # 4 IS BROKEN AND COMPLETELY DETACHED FROM ITS BASE.  
(PAR)

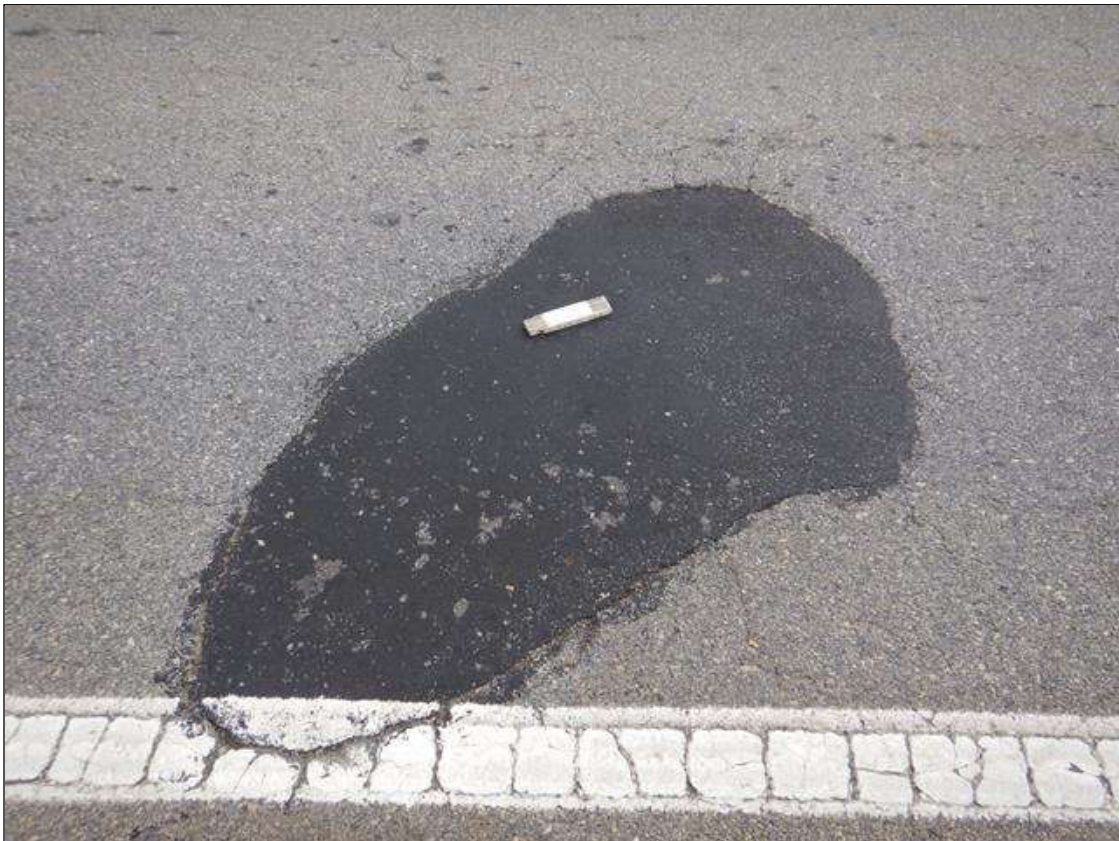
Span 4 Wearing Surface: BOTH LANES OF TRAVEL HAVE SEVERAL SCATTERED PATCHED AREAS THAT ARE SOUND, PERIMETER OF PATCHES ARE DELAMINATED

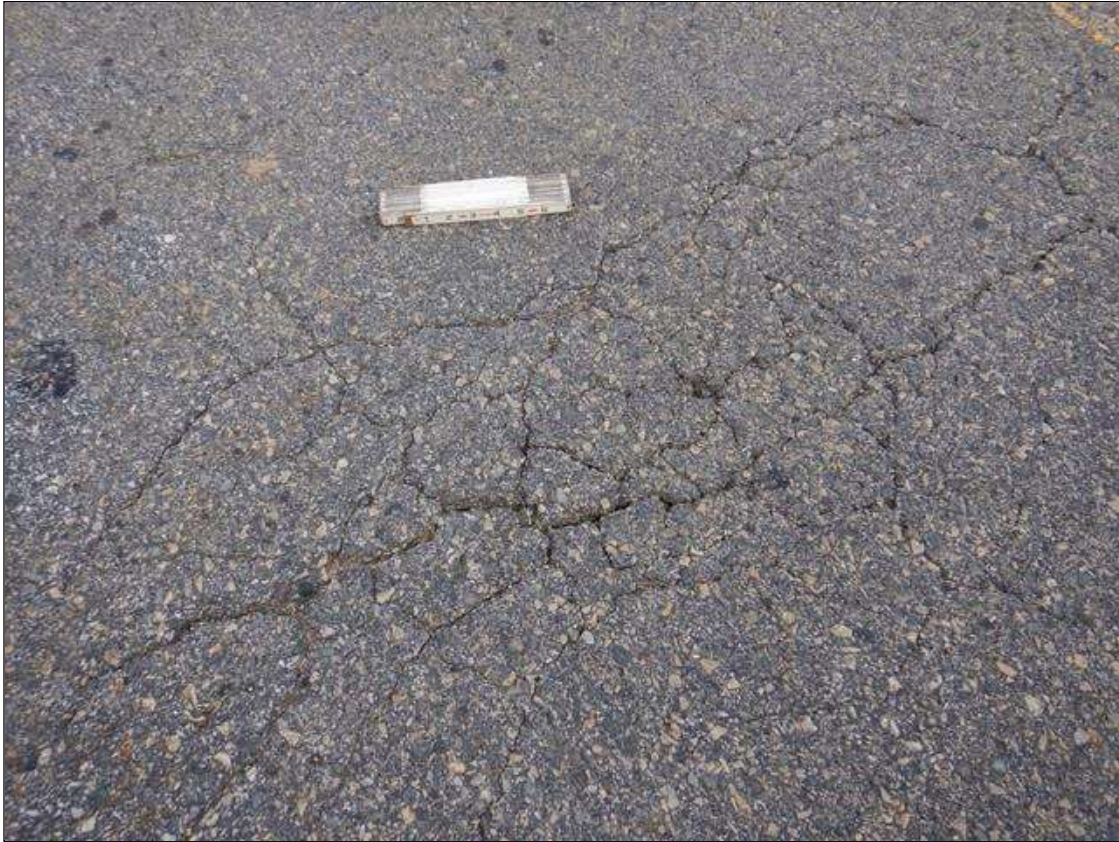
Span 4 Wearing Surface: Map Cracking (up to 1/4" wide) scattered across span in both lanes., SIMILAR CONDITION THROUGH OTHER SPANS IN BOTH TRAVEL LANES

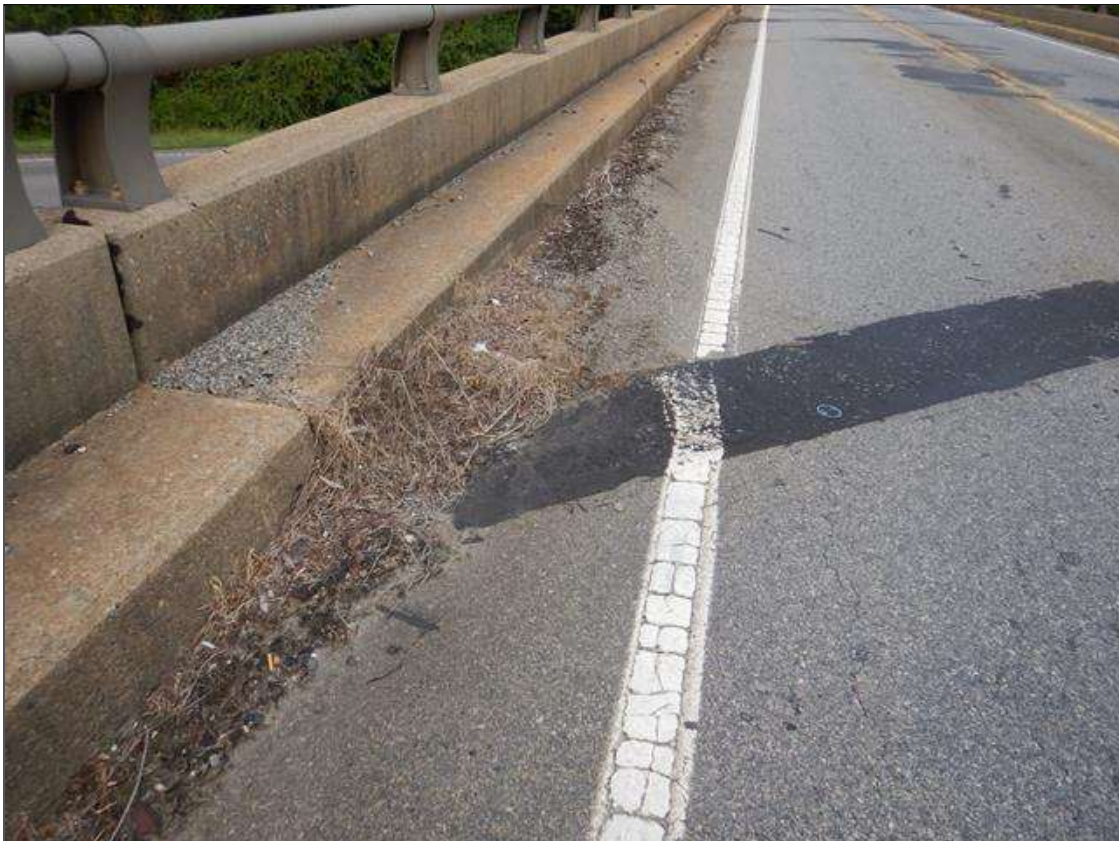
RIGHT BRIDGE RAIL HAS MODERATE DEBRIS IMPACTION THROUGHT ALL SPANS, SPAN 3

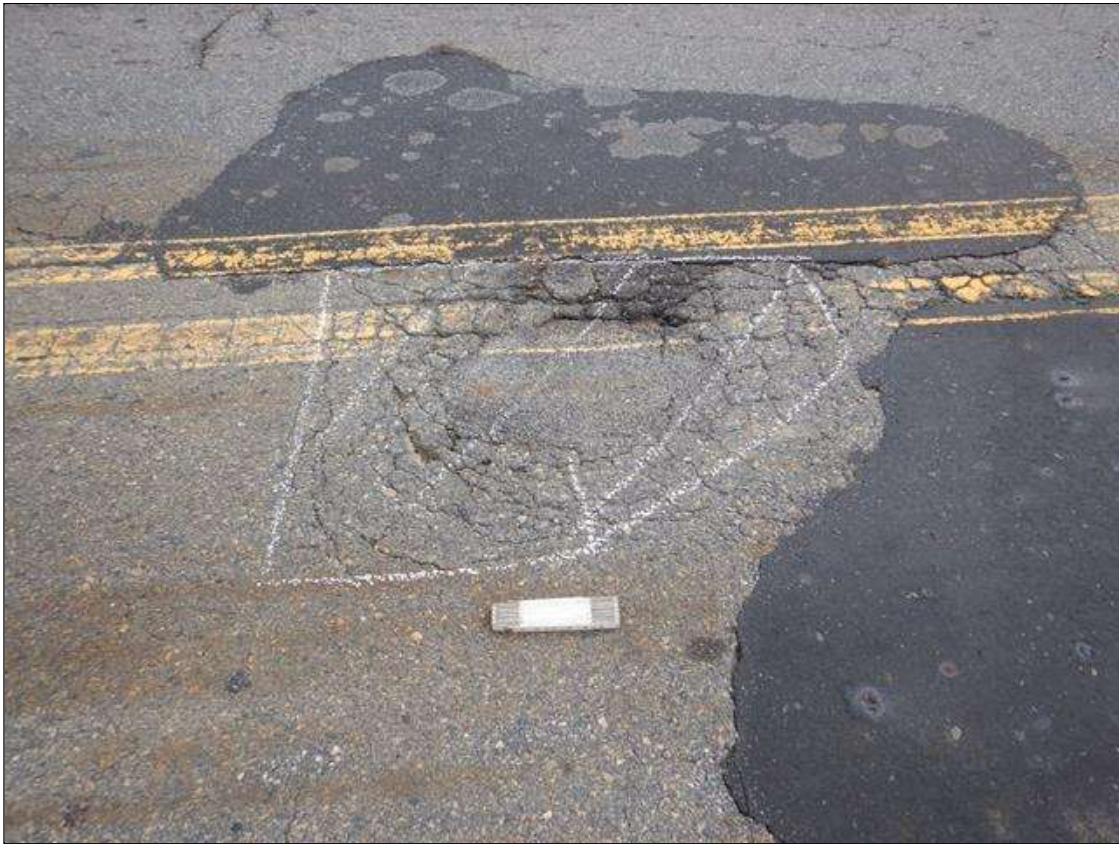
Span 3 Wearing Surface: DELAMINATED SPALLED AREA IN MIDDLE OF SPAN 3 CENTER LINE FOR 4 FT LONG X 3 FT WIDE X UP TO 1 IN DEEP. POTHOLES HAVE TYPICAL PERIMETER AREA OF DELAMINATION

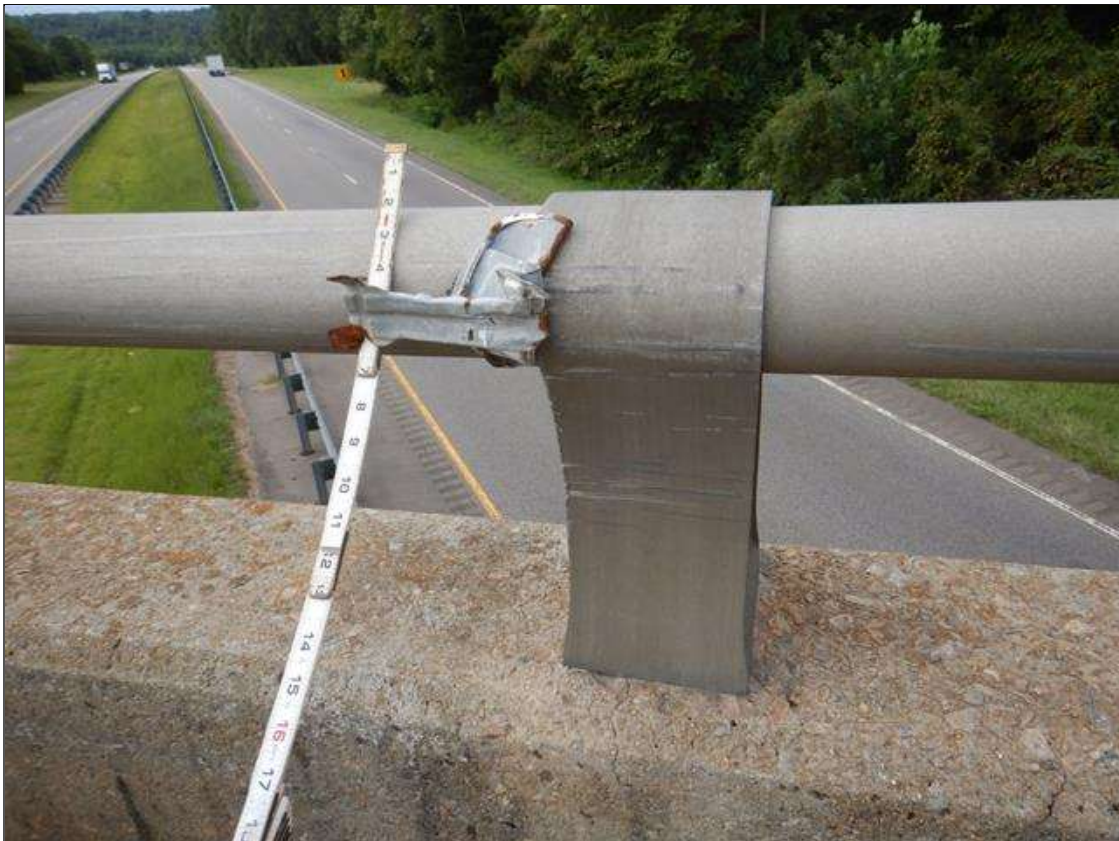
Span 2 Right Bridge Rail: Aluminum Post #9, scrapes to traffic side. Connections intact, post functioning as intended.

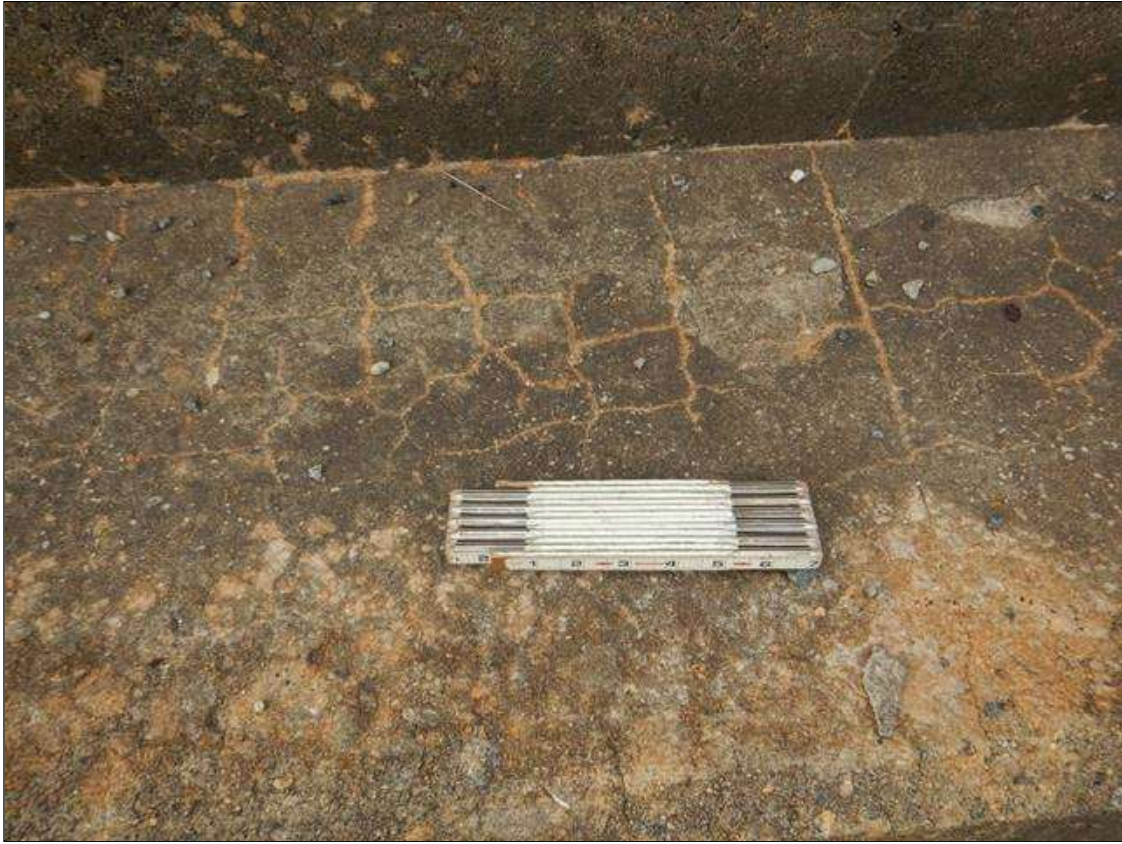
Span 2 Right Bridge Rail: SCATTERED MAP CRACKING ON CONCRETE BASE OF RIGHT BRIDGE RAIL

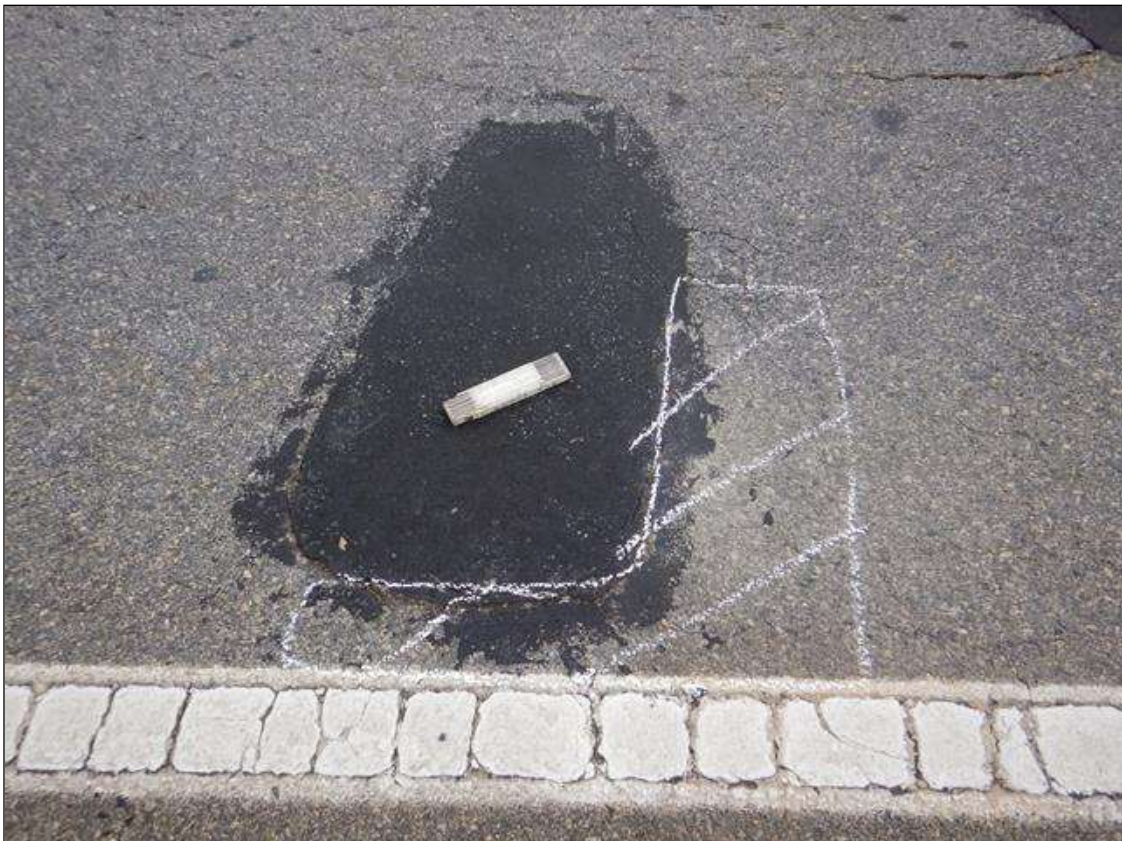
Span 2 Wearing Surface: DELAMINATED AREA IN MIDDLE OF SPAN 2 IN RIGHT TRAVEL LANE 2 FT X 2 FT. TYPICAL FOR MOST PATCHED POTHOLES

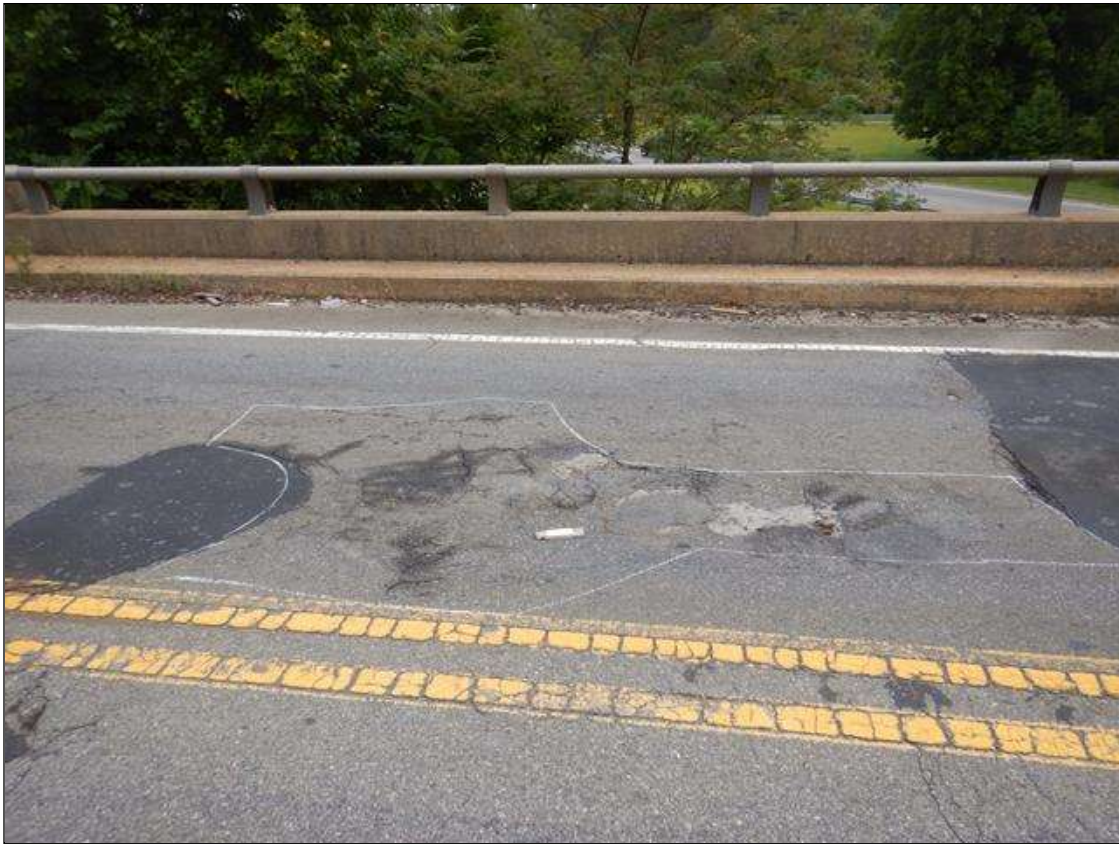
Span 1 Wearing Surface: LEFT TRAVEL LANE AT BEGIN OF SPAN 1 HAS DELAMINATED SPALLED AREA FOR 14 FT LONG X 6 FT WIDE X UP TO 1 IN DEEP

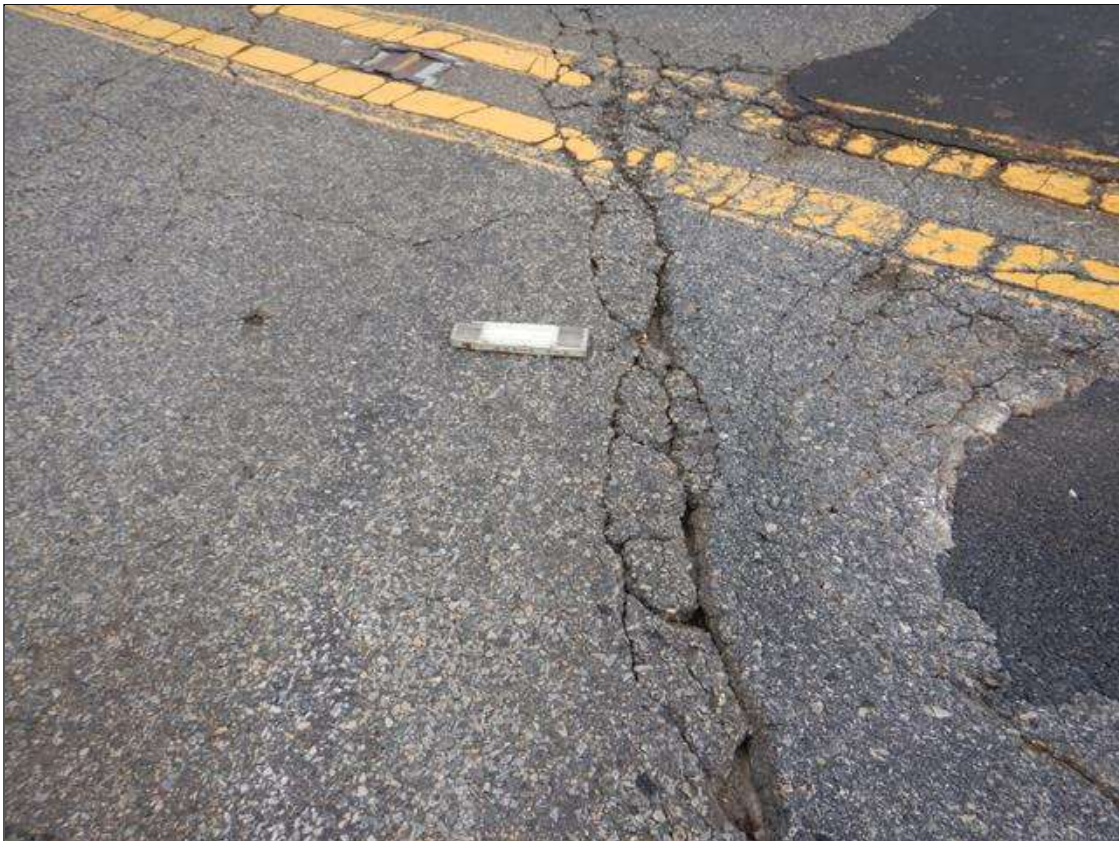
END BENT 1 JOINT HAS TRANSVERSE CRACKING FOR 5 FT WIDE X 1 FT LONG X 2 IN DEEP, AREA OF DETERIORATED ASPHALT

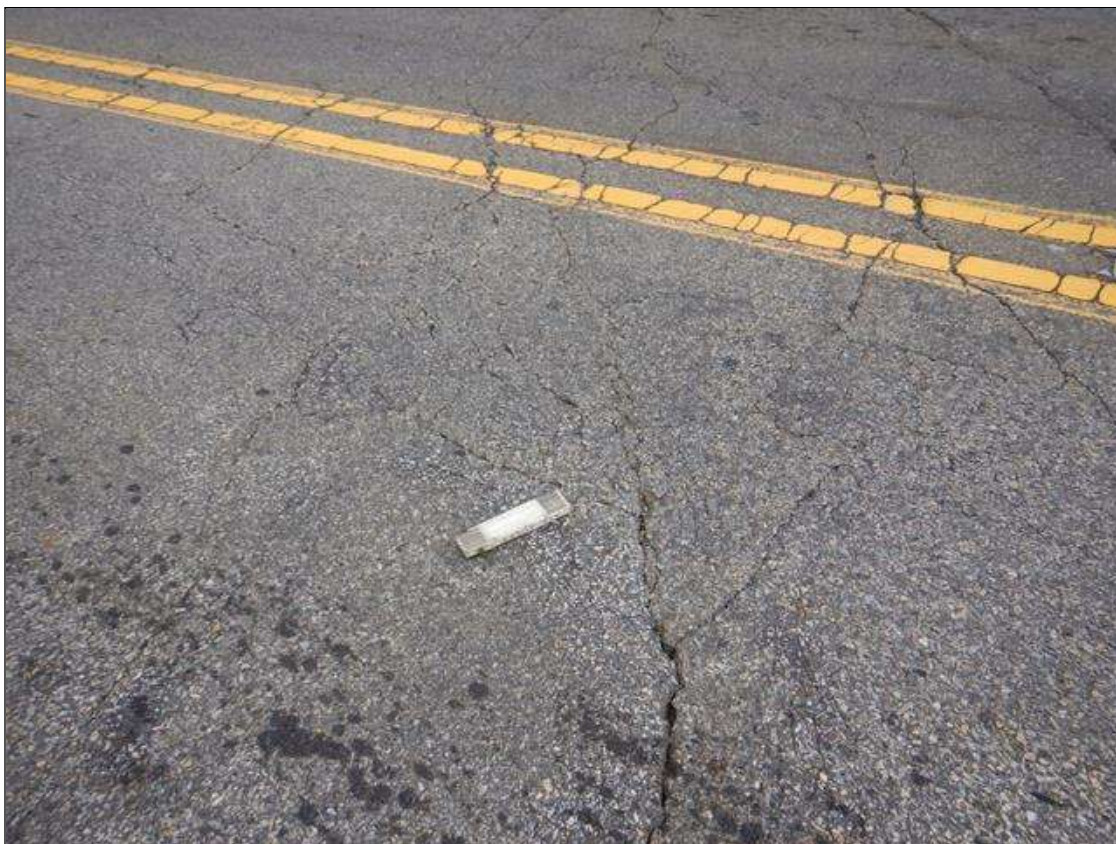
WEST APPROACH HAS HEAVY AREA OF MAP CRACKING UP TO 1/2 IN WIDE

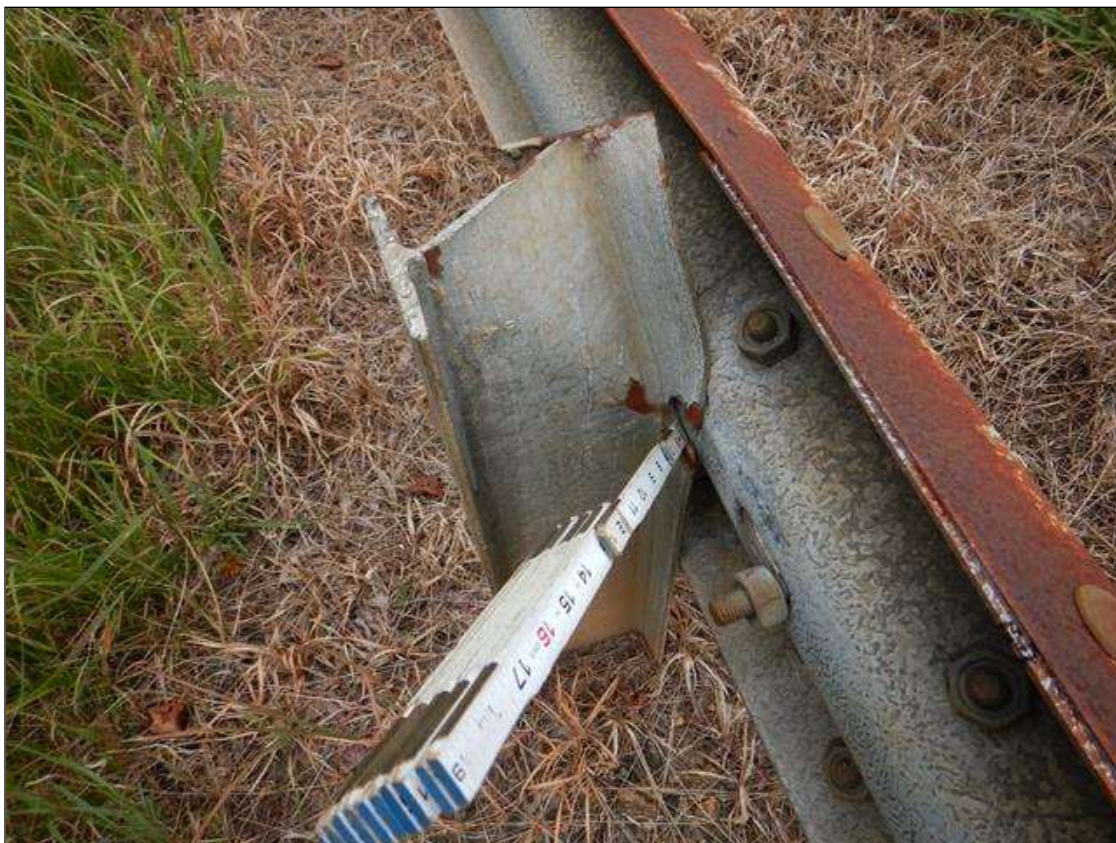
THIRD POST FROM END BENT 1 ON RIGHT GUARDRAIL IS DAMAGED AND DETACHED FROM RAIL. (PAR)

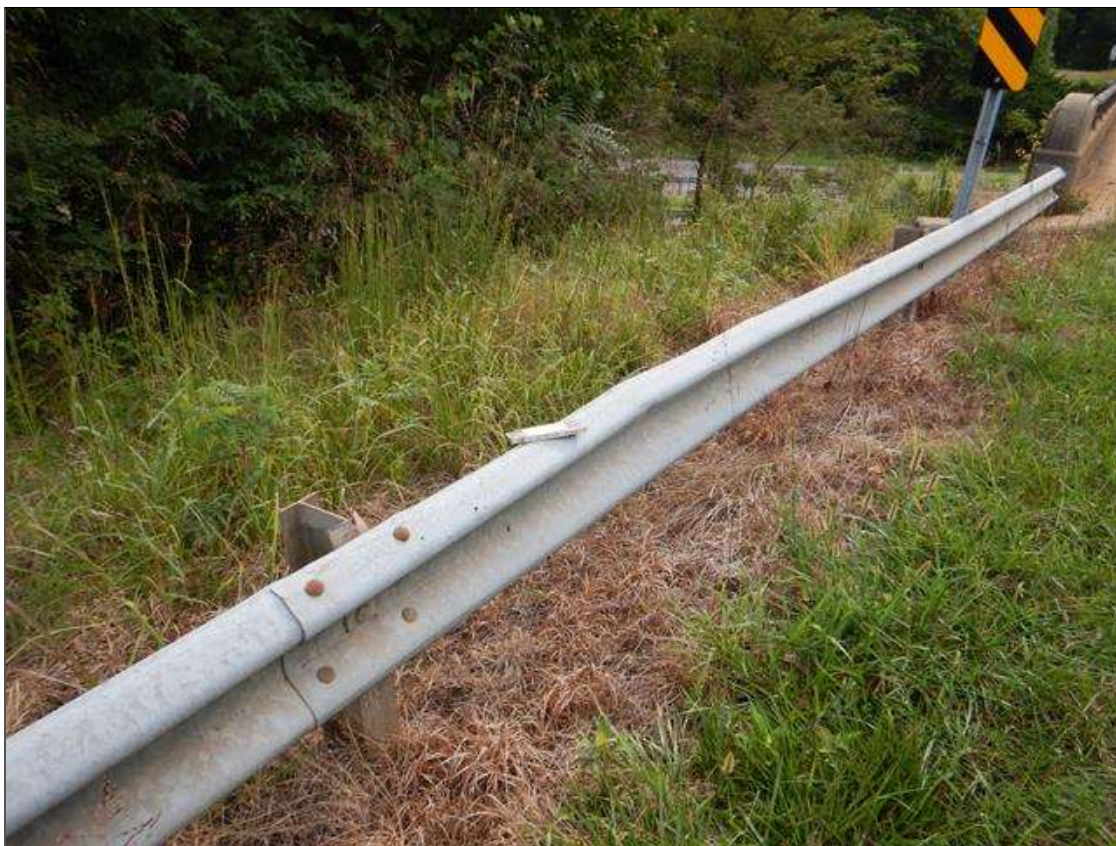
LEFT GUARDRAIL AT WEST APPROACH HAS AREA OF IMPACT DAMAGE FOR 10 FT LONG

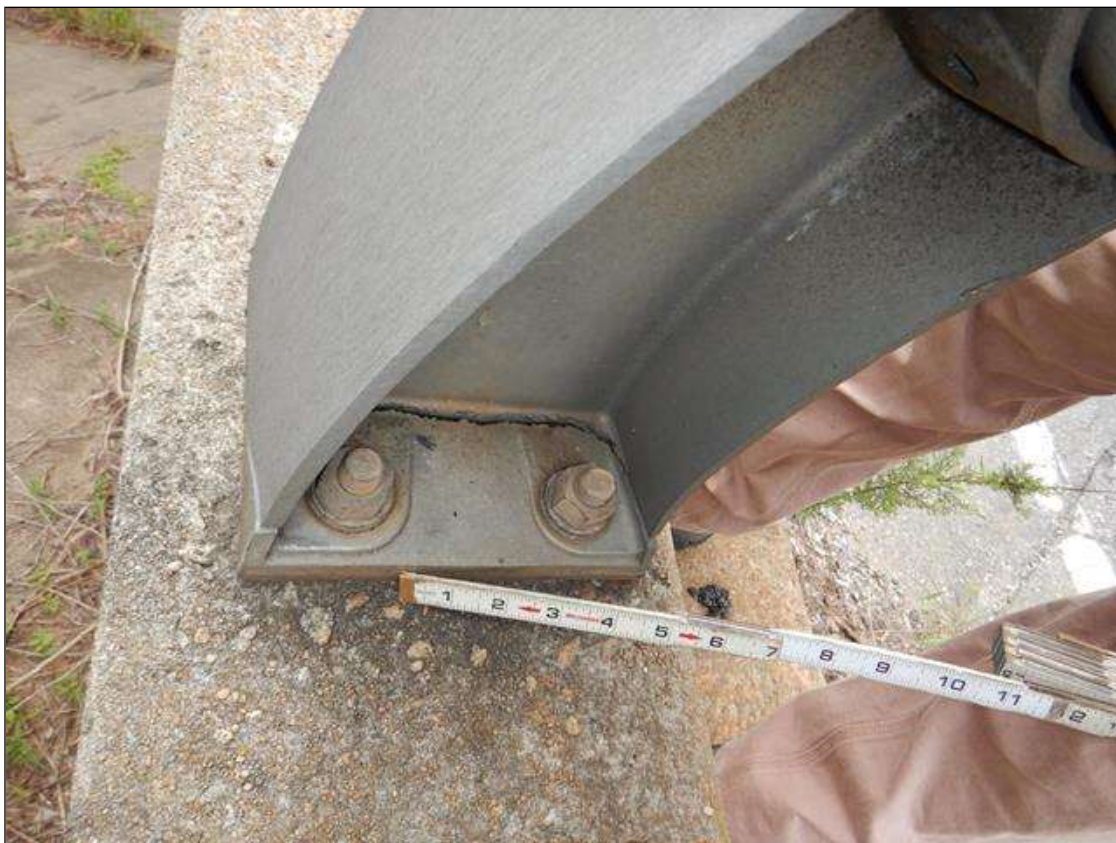
Span 1 Left Bridge Rail: Aluminum Post #1, crack thru web to base plate weld, propagated through flange plates.  
(PAR)

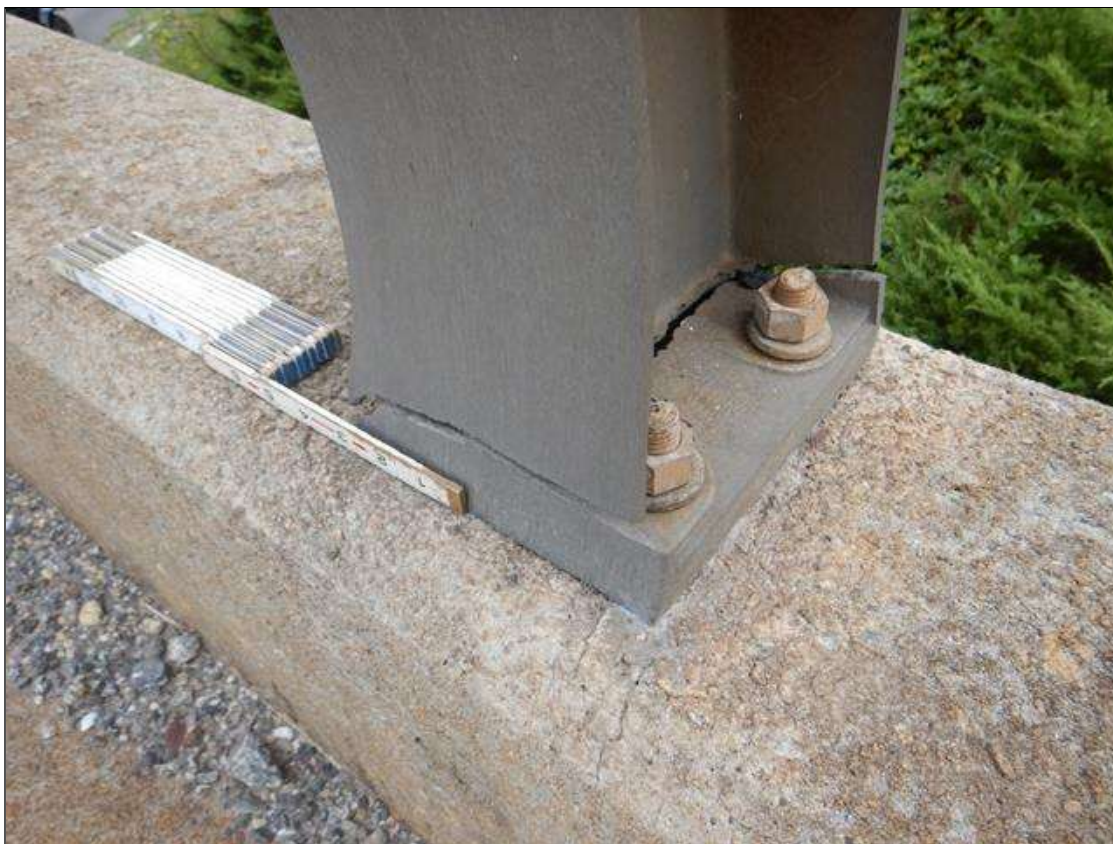
Span 4 Left Bridge Rail: ALUMINUM POST # 5 IS CRACKED AT BASE. (PAR)

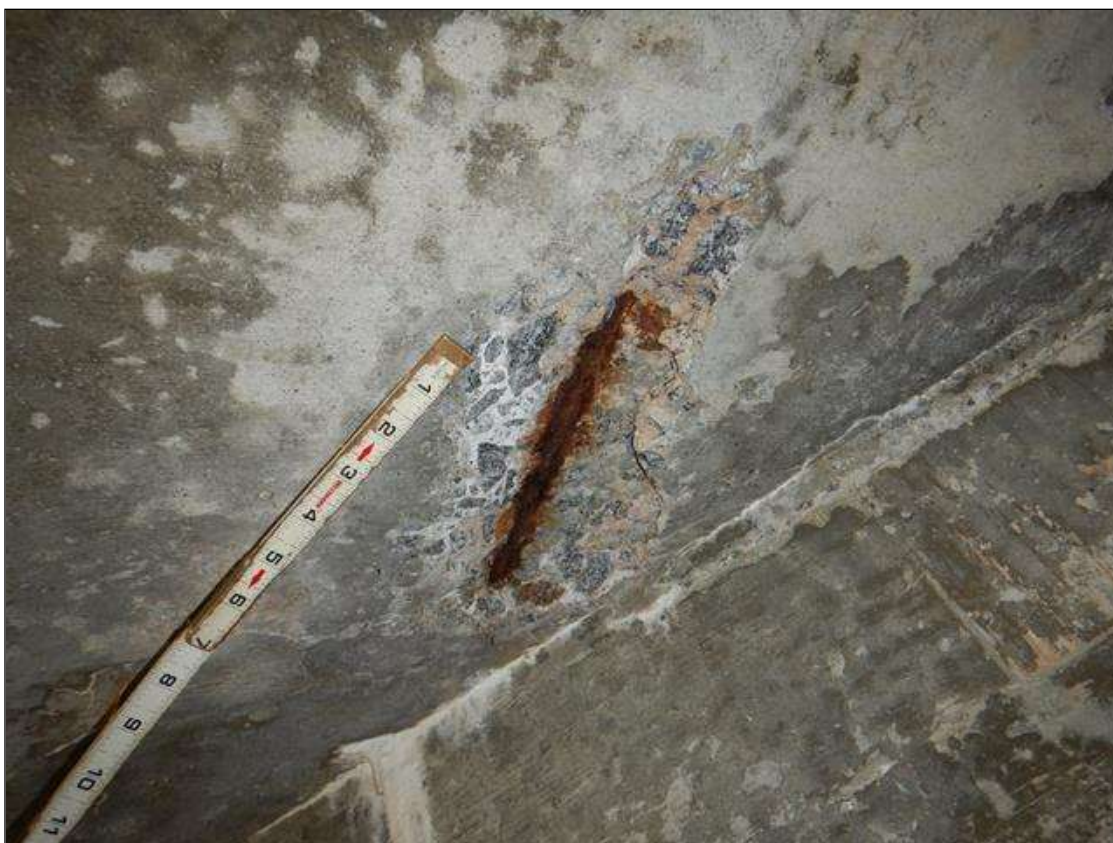
End Bent 1 Abutment: DELAMINATION AND SPALLED AREA IN BAY 3 1 FT DIAMETER X 1 IN DEEP WITH EXPOSED REBAR, 90% SECTION REMAINING IN EXPOSED REBAR

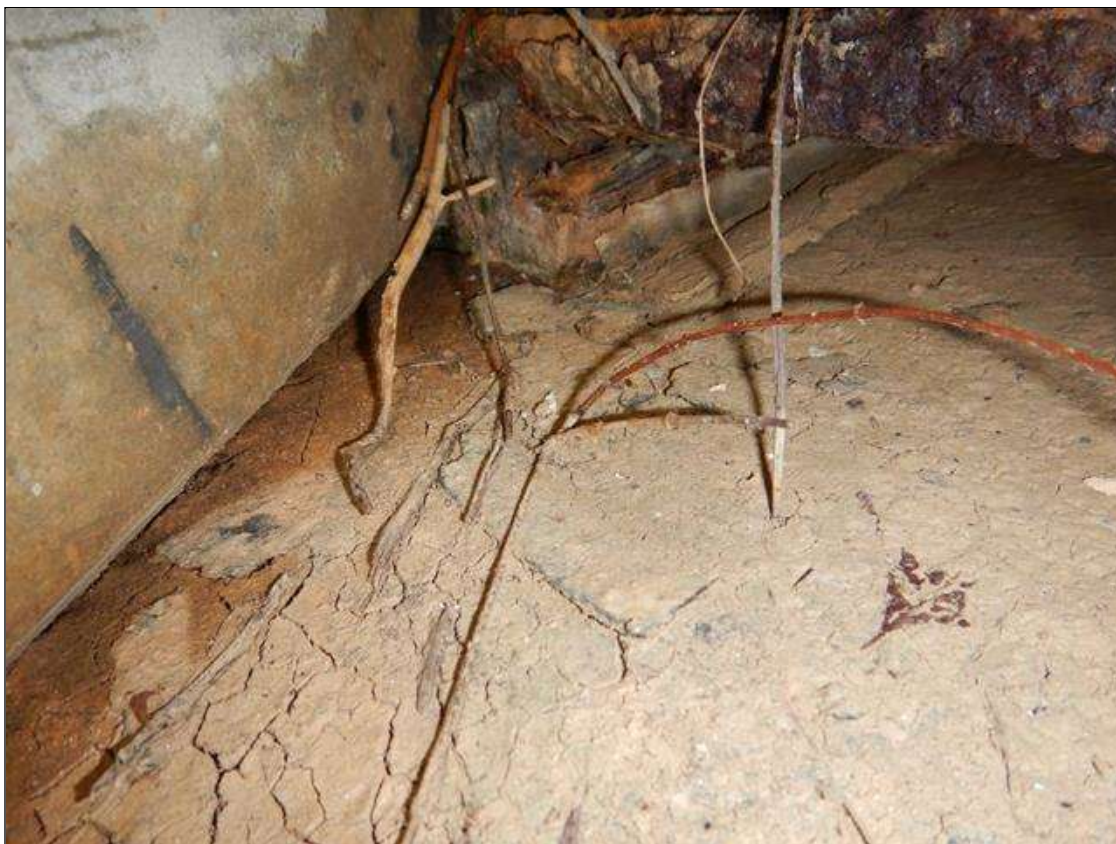
Span 1 Beam 4 - Near Bearing: 1 Each of Corrosion: Freckled rust. Corrosion of the steel has initiated.

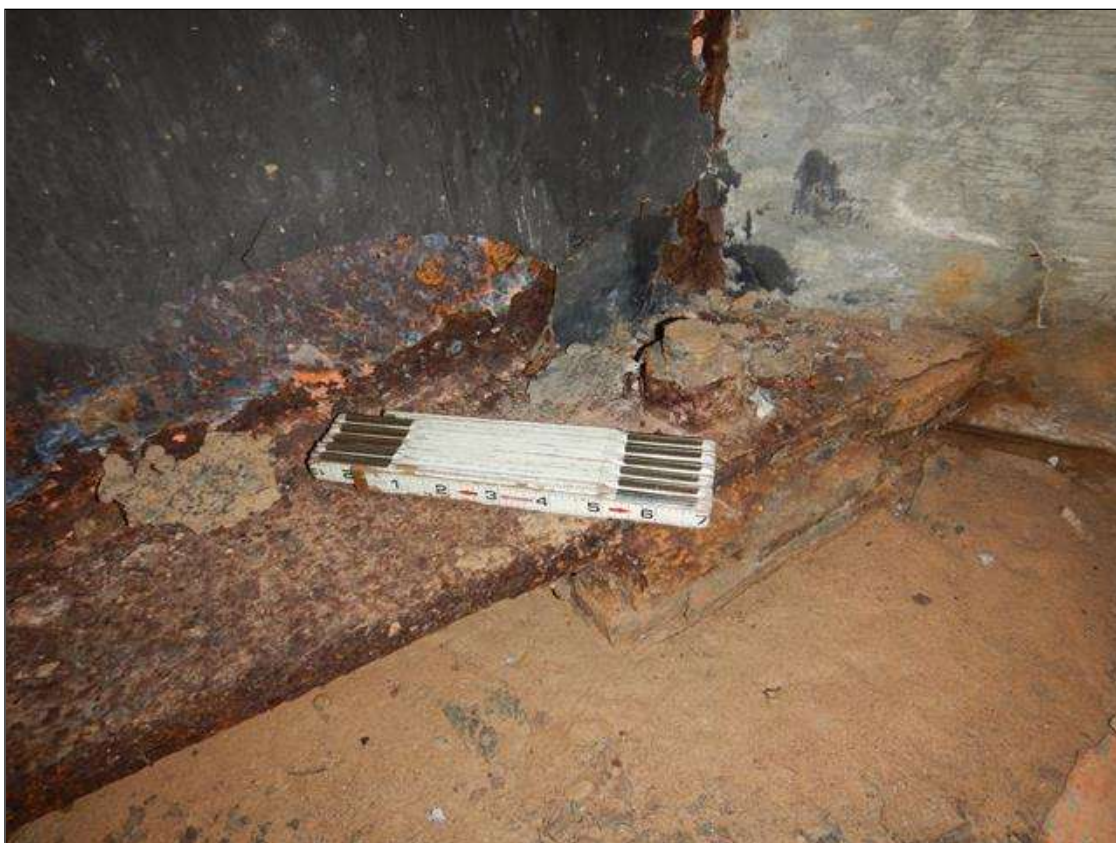
Span 1 Beam 4: at End Bent 1, Rust and Scale no measurable Section Loss in bottom flange and lower web.

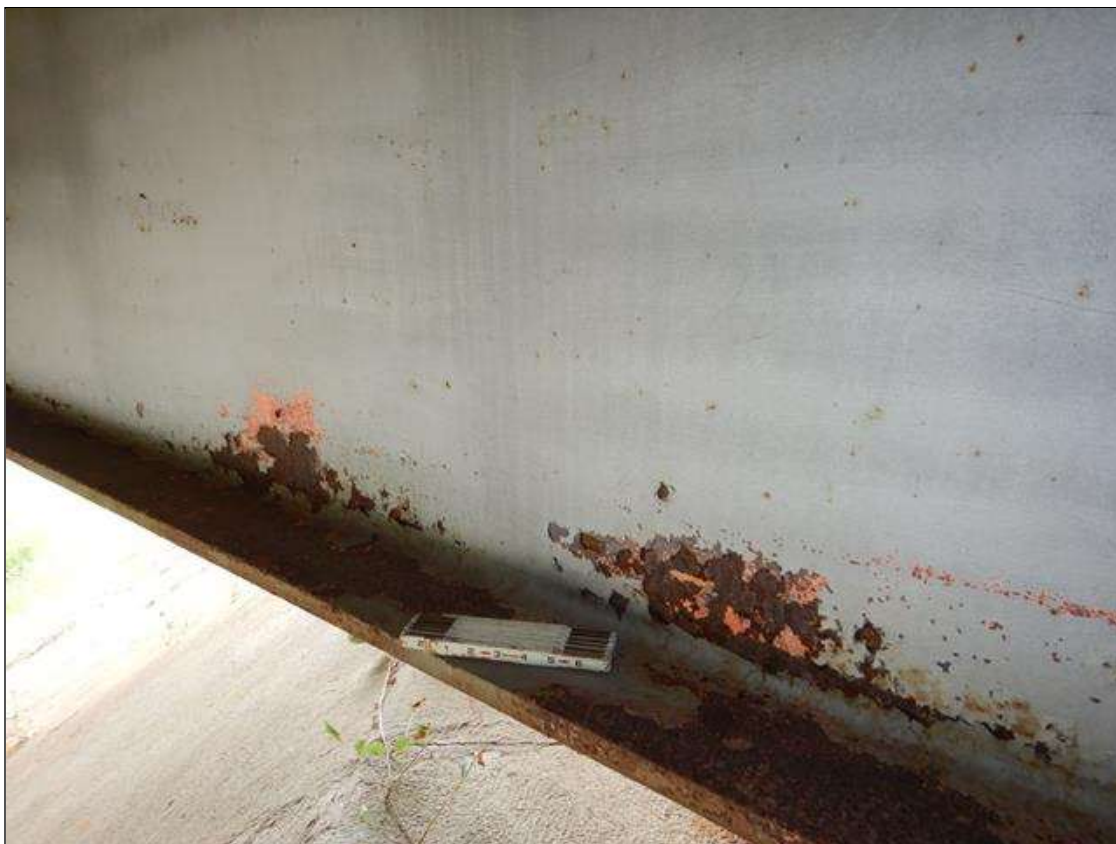
Span 1 Beam 4: Surface Corrosion/ Freckled Rust in flanges and web along length of beam.

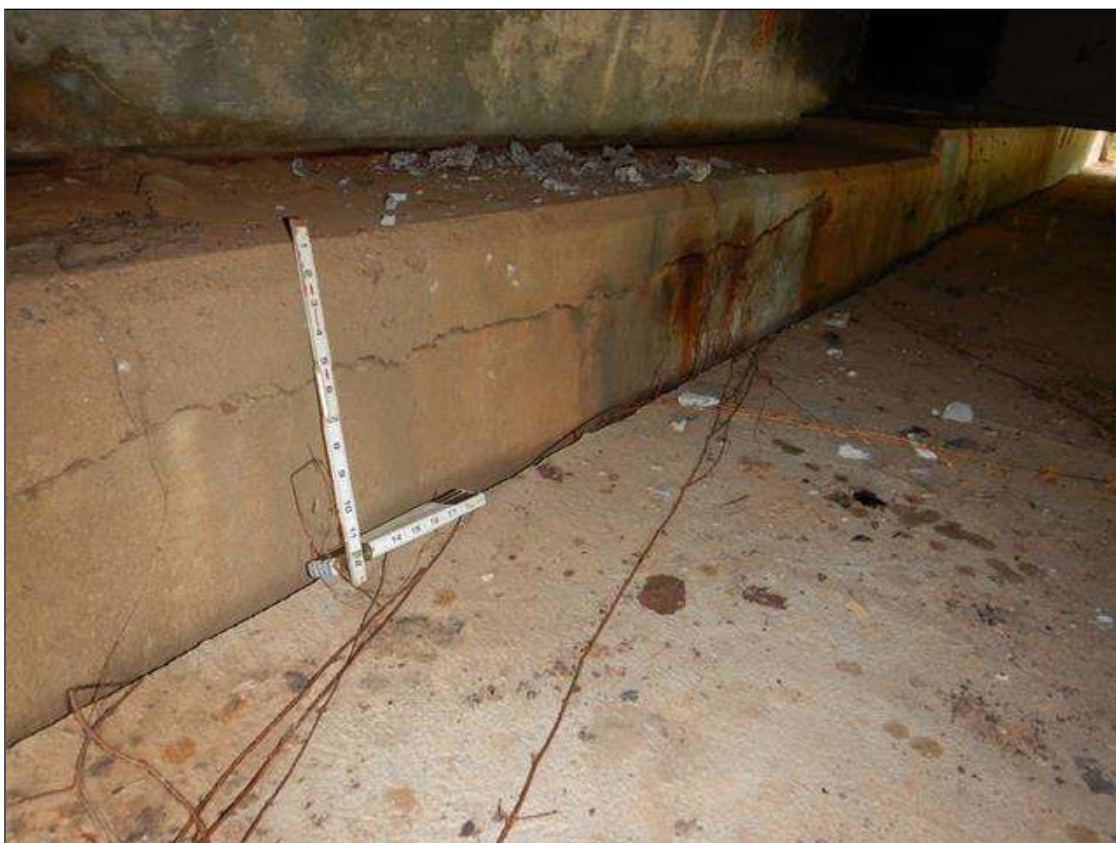
End Bent 1 Cap 1: CRACKING GOING ACROSS CAP SEAT FOR FULL WIDTH UP TO 1/2 IN WIDE WITH AREAS OF DELAMINATION

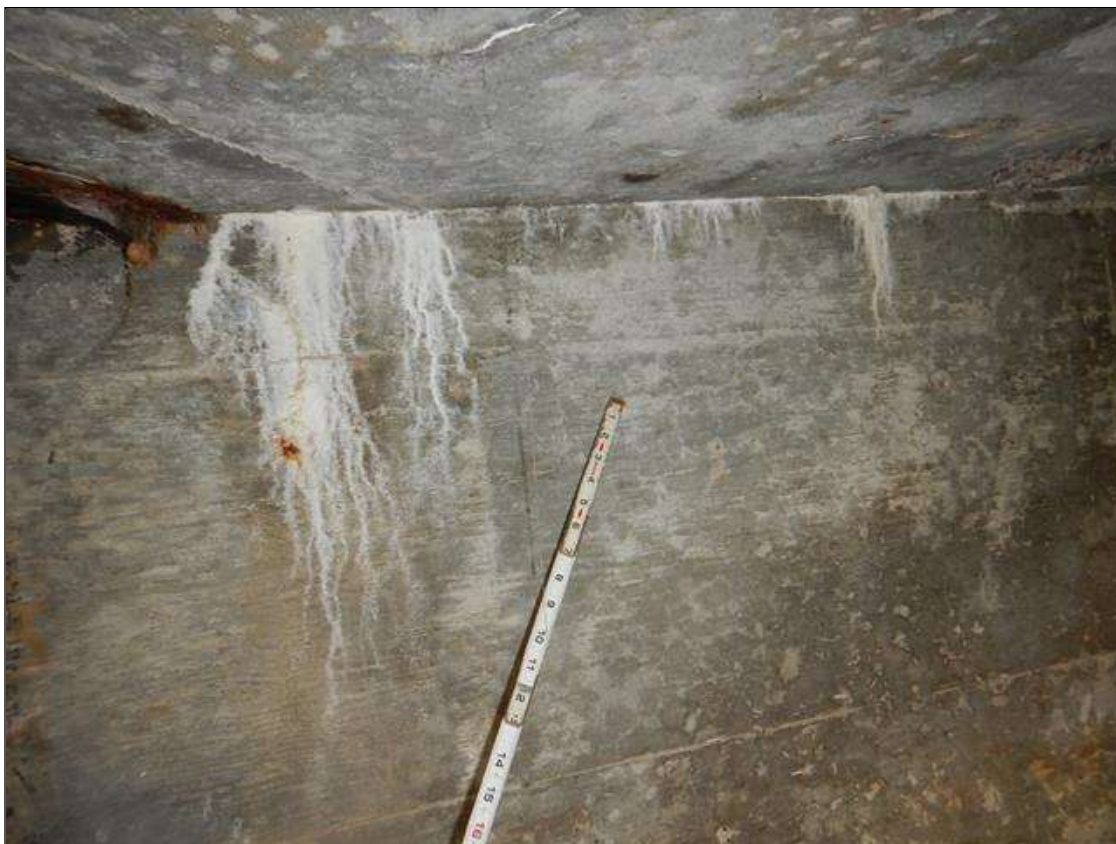
End Bent 1 Abutment: AREAS OF EFFLORESCENCE AT TOP OF BACK WALL IN BAY 3

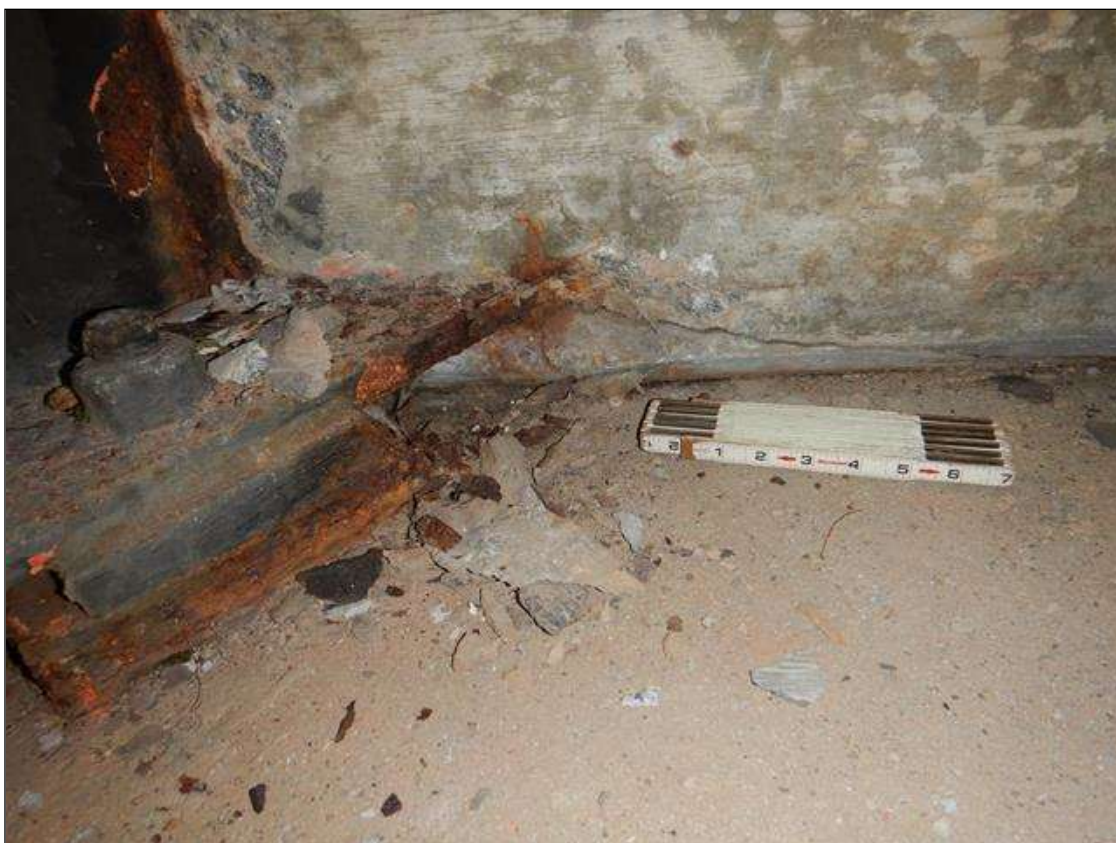
Span 1 Beam 3: AREA WHERE BEAM 3 GOES INTO END BENT 1 CRACKING UP TO 1 FT LONG AND SMALL SPALL UP TO 3 IN DIAMETER X 3/4 IN DEEP
