NC DEPARTMENT OF TRANSPORTATION  
 DIVISION OF HIGHWAYS  
 STRUCTURE MANAGEMENT UNIT

ATTENTION: PAR SUBMITTED, NEWLY INSTALLED WEIGHT LIMITS, LOW UNDERCLEARANCE SIGNS, STRUCTURAL DATA MODIFIED, BEAMS SHAPES ADDED

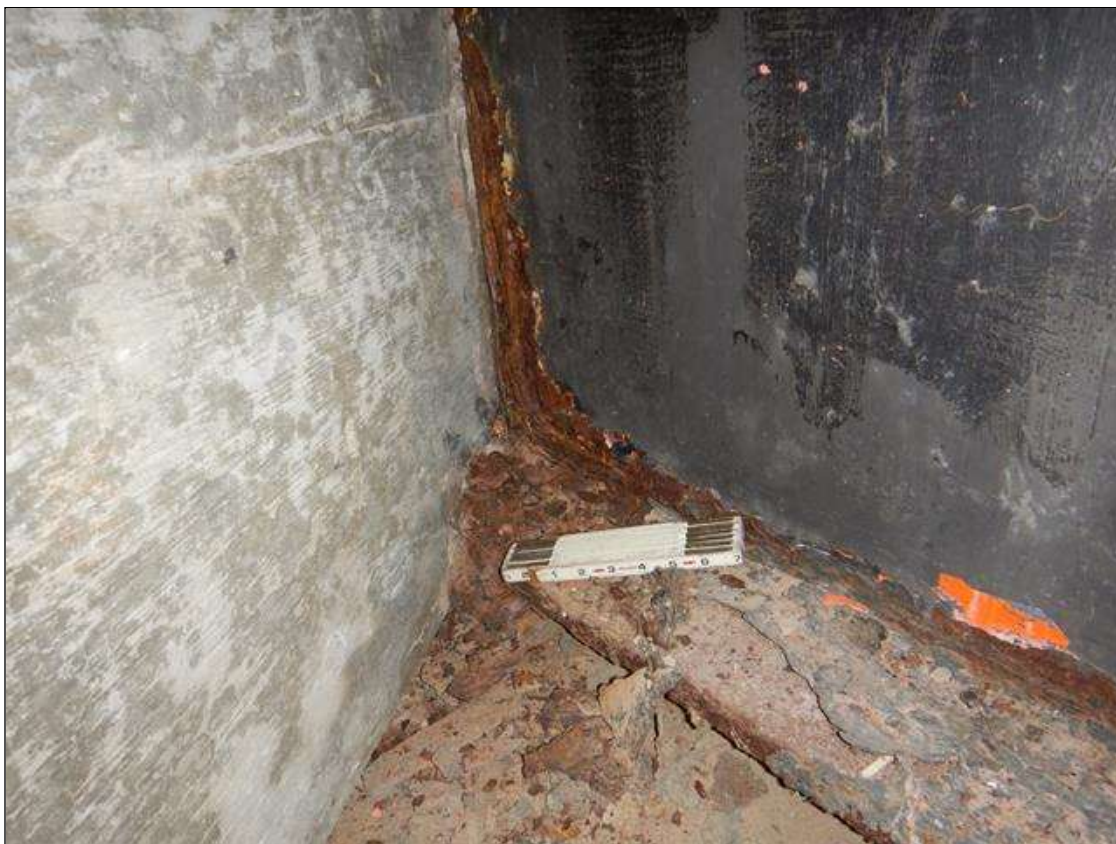
Span 1 Beam 1: at End Bent 1, Rust and Scale no measurable Section Loss in bottom flange and lower web.

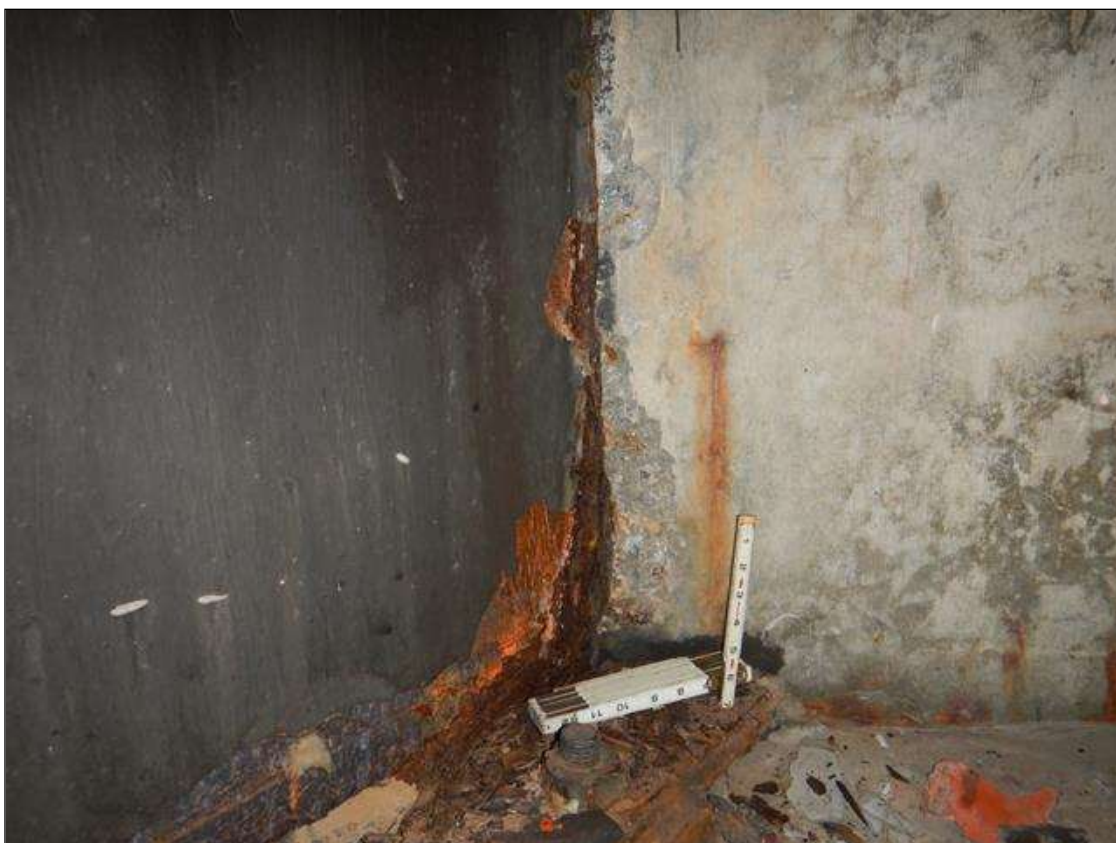
End Bent 2 Abutment: SPALLED AREA IN BAY 1 1.5 FT HIGH X 3 IN WIDE X 1 IN DEEP ALONG RIGHT SIDE OF BEAM 1, NO EXPOSED REBAR

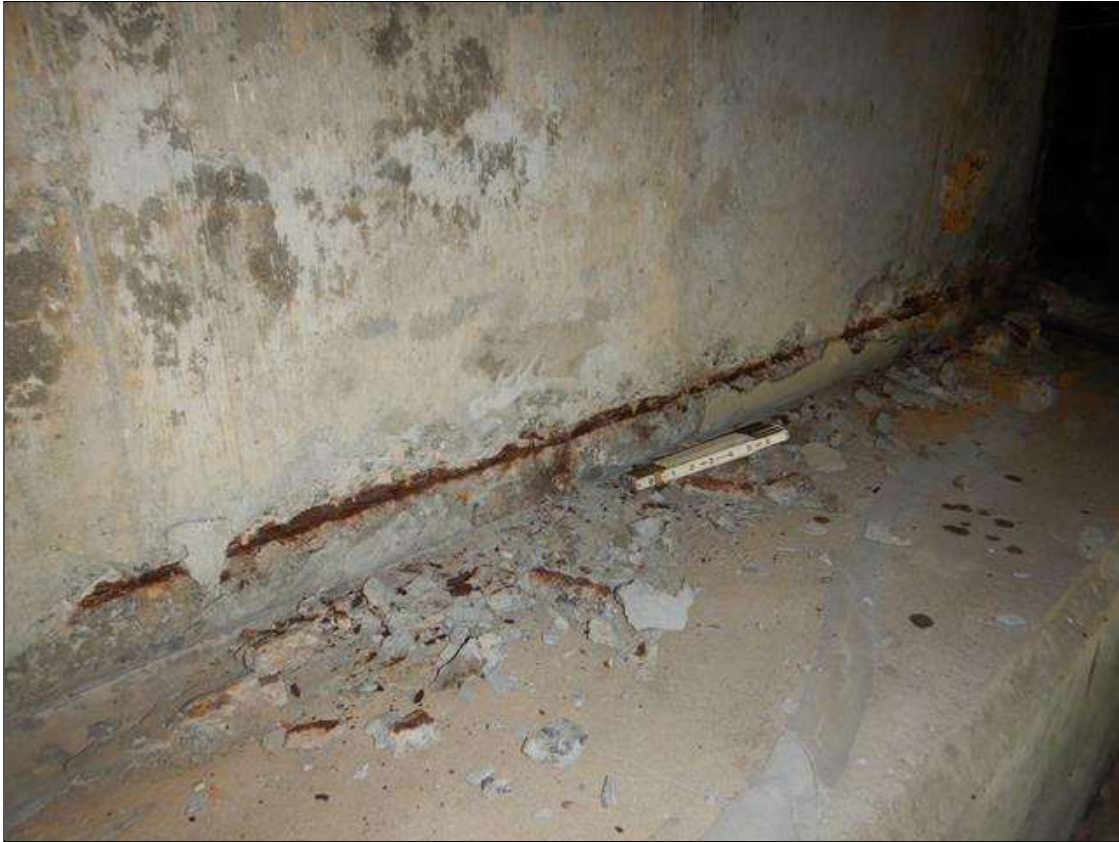
End Bent 2 Abutment: DELAMINATED SPALLED AREA IN BOTTOM CENTER OF BACKWALL IN BAY 1 NEXT TO BEAM 2 FOR 6 FT LONG X 4 IN HIGH X 1/2 IN DEEP WITH EXPOSED REBAR. 80% SECTION REMAINING IN EXPOSED REBAR

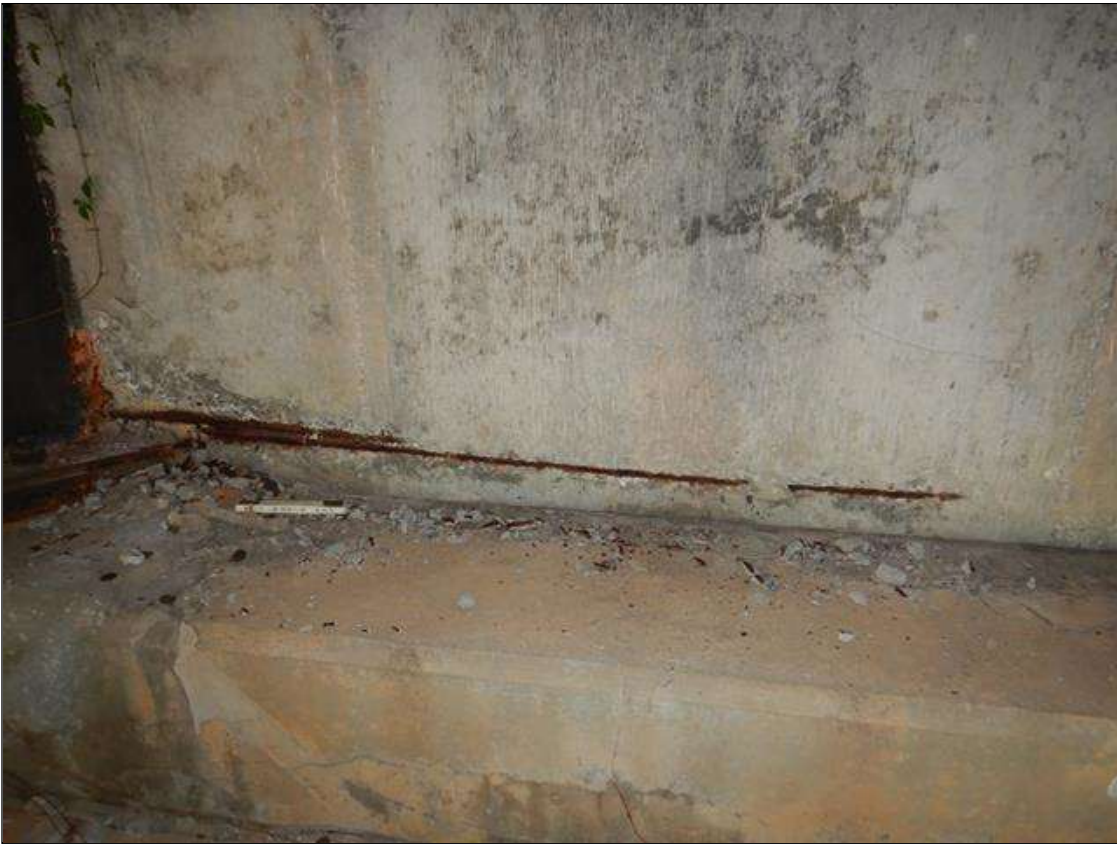
End Bent 2 Abutment: DELAMINATED SPALLED WITH EXPOSED REBAR AREA IN BAY 2 NEXT TO BEAM 2 5 FT WIDE X 6 IN HIGH X 1.5 IN DEEP. 80% SECTION REMAINING IN EXPOSED REBAR. (PAR)

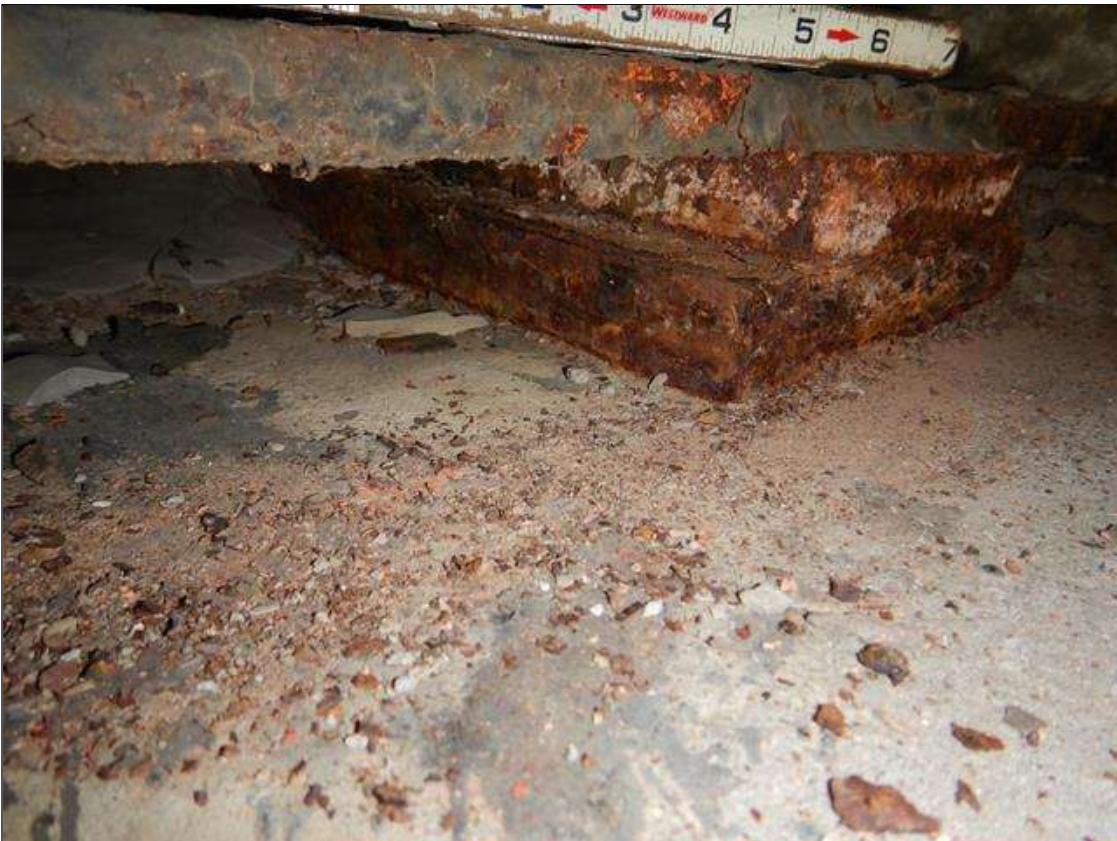
Span 4 Near Bearing: Active Corrosion & Section Loss (1-1/4" Remaining) in plates. ALL OTHER BEARING PLATES AT END BENT 2 ARE SIMILAR

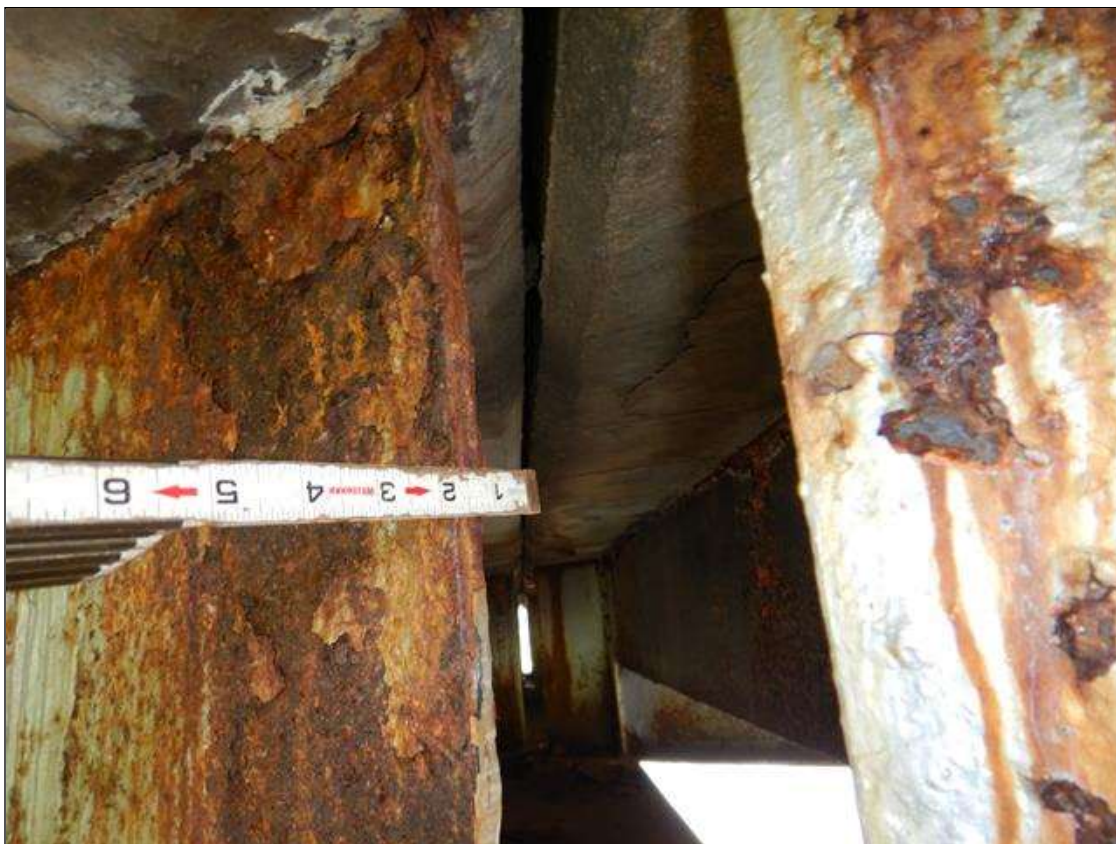
Span 4 Beam 1: BEAM 1, SPAN 4 HAS UP TO 1/8" LOSS ALONG WEB AT PIER 3, 1' HIGH X 1' LONG. (PAR)

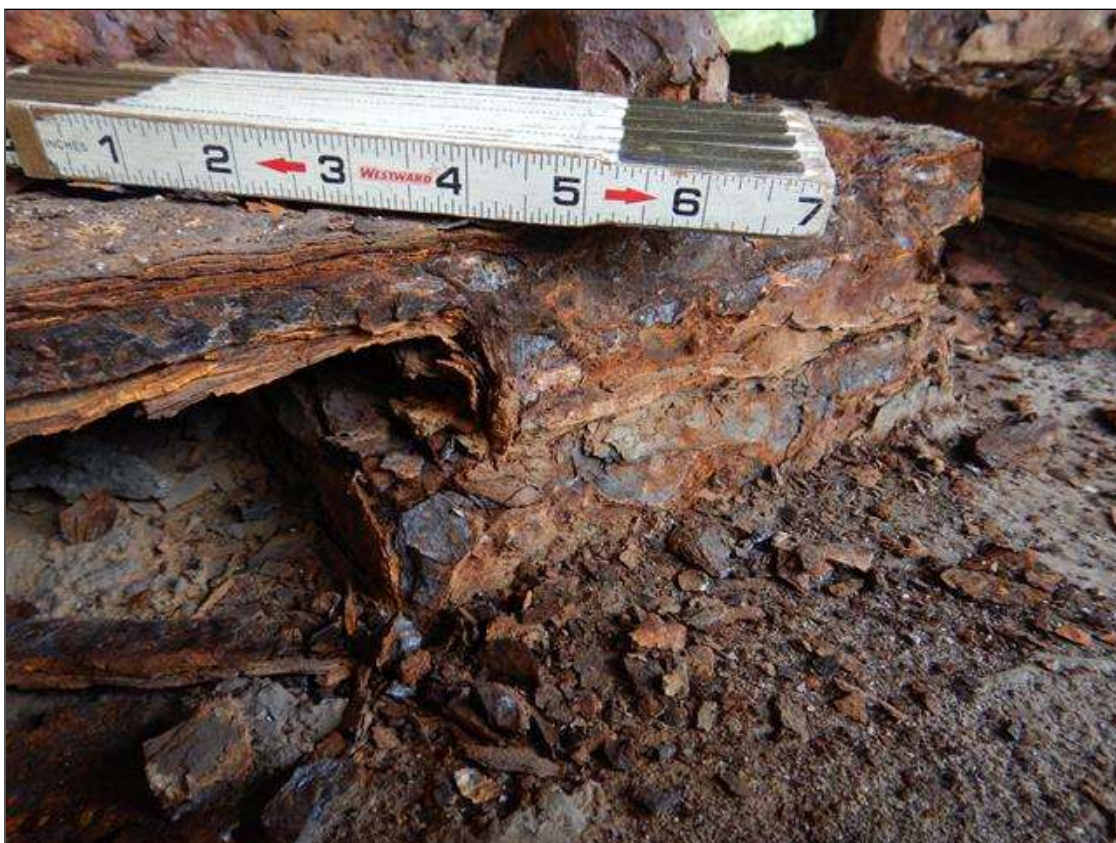
Span 4 Near Bearing: 1 Each of Corrosion: Freckled rust. Corrosion of the steel has initiated.

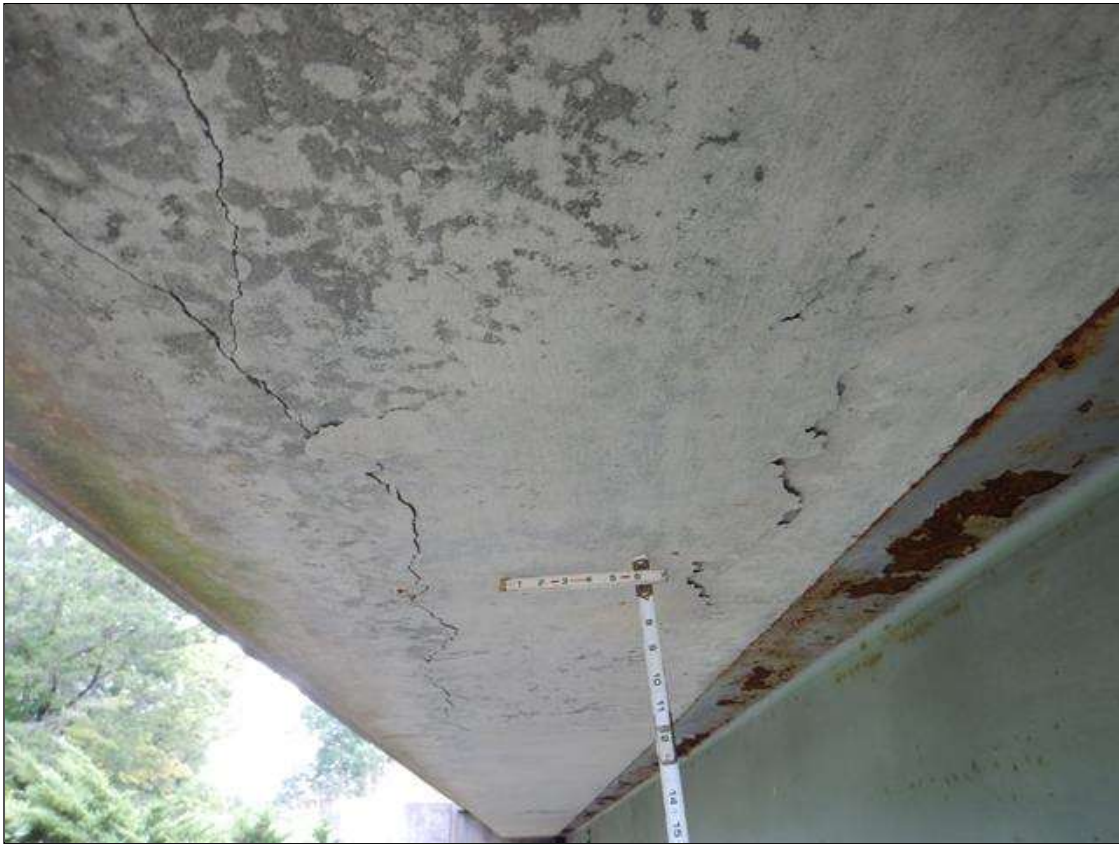
Span 4 Deck: DELAMINATED AREA IN DECK UNDERSIDE GOING FROM BENT 3 TOWARD END BENT 2 FOR 10 FT LONG X 2.5 FT WIDE

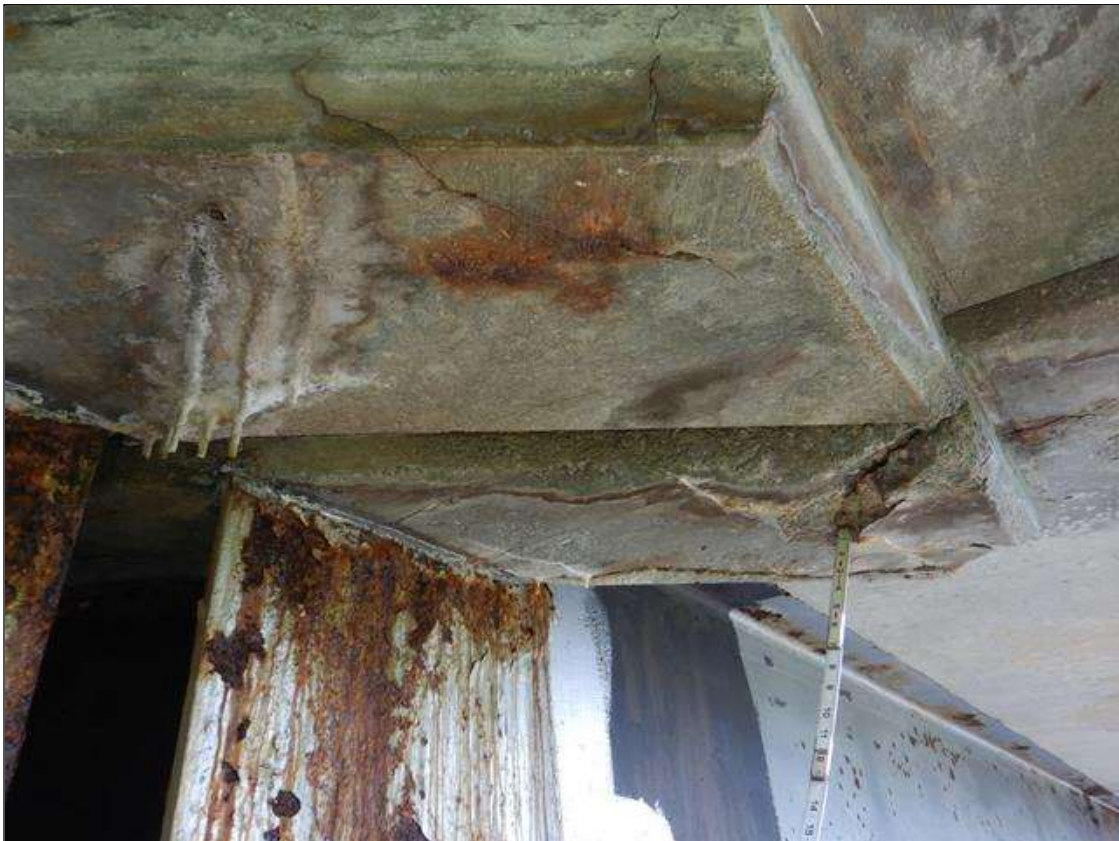
Span 4 Deck: DELAMINATION SPALLED AREA WITH EFFLORESCENCE UNDERSIDE AT BENT 3 OVERHANG 3 FT LONG X 2.5 FT WIDE X 2 IN DEEP

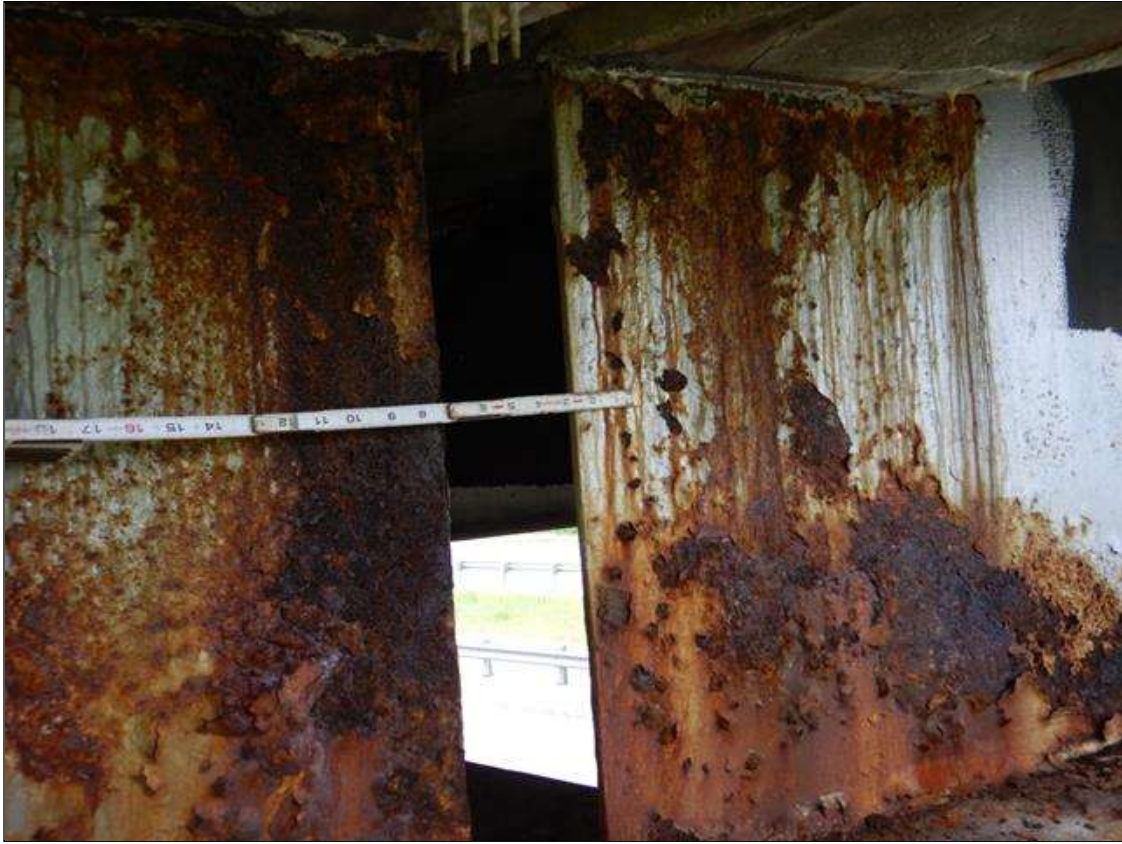
Span 4 Beam 1: HEAVY CORROSION AT BEAM ENDS 1 AND 2 AT BENT 3

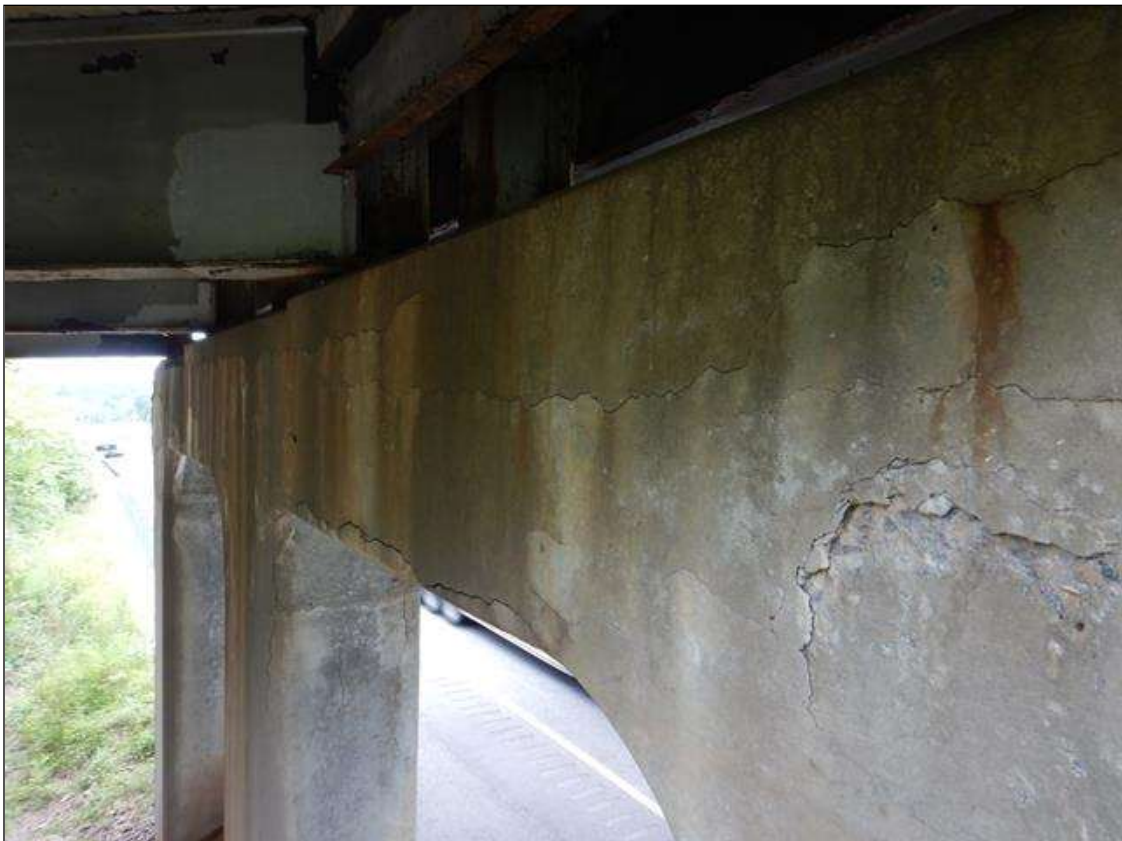
Bent 3 Cap 1: DELAMINATION AND CRACKING ALONG FULL WIDTH OF EAST FACE BENT 3

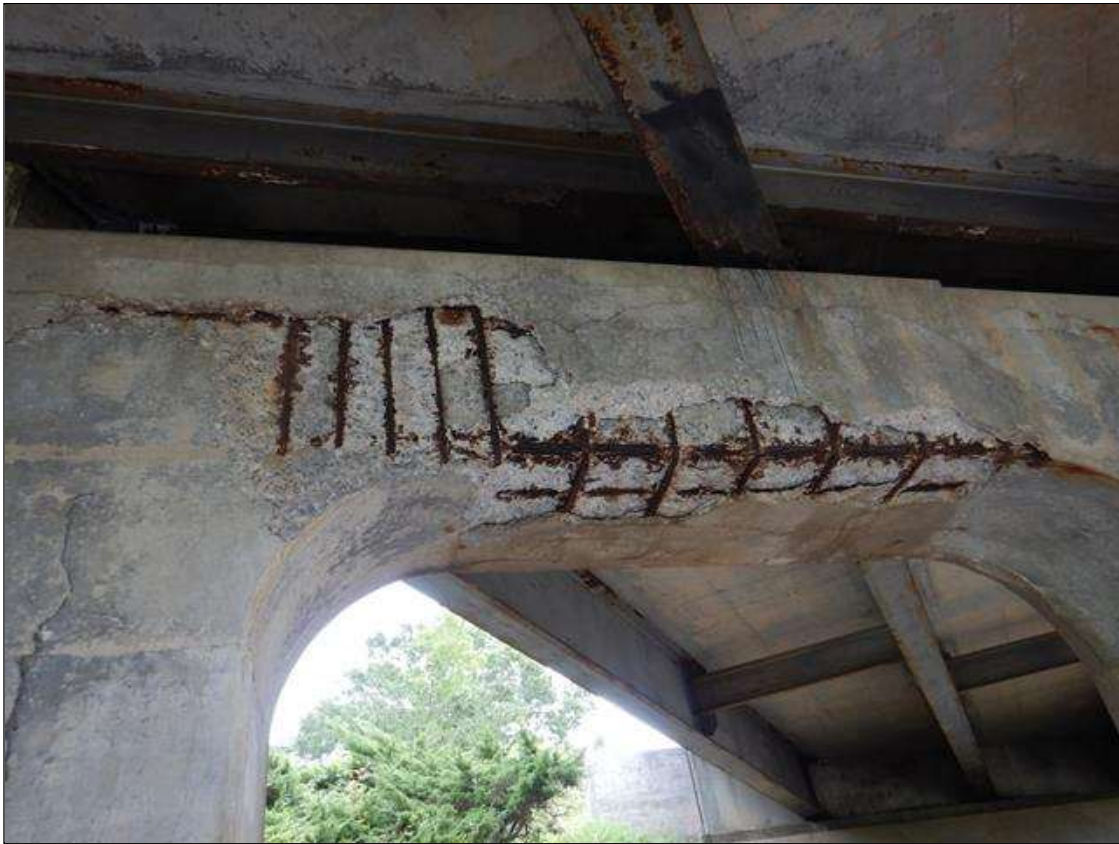
Bent 3 Cap 1: from beam 4 to north end, Top, bottom, east, west and north faces, Spalling with Exposed Steel (up to 4" deep) (Active Corrosion no measurable Section Loss), Cracks (1/4" wide) with rust stains and efflorescence, and Delamination 30' long x up to full height x up to full width.) Spalling/ Delamination on Top corners up to 6" wide, No Bearing Loss for beams 1, 2, or 3. (PAR.)

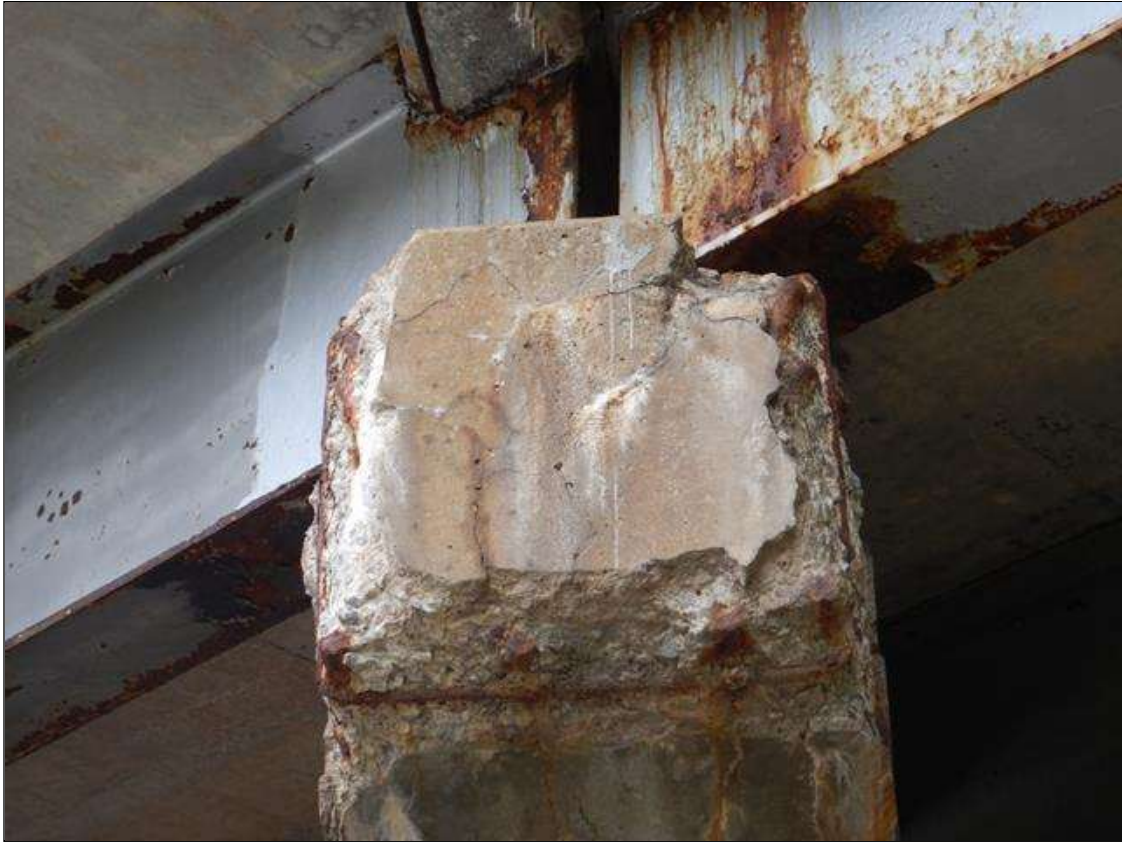
Bent 3 Cap 1: EDGE SPALL AT BEAM AND END CAP ON NORTH END FOR 2 FT LONG X 1 FT WIDE X 2 IN DEEP, WITH EXPOSED REBAR. 80% SECTION REMAINING IN EXPOSED REBAR. (PAR)

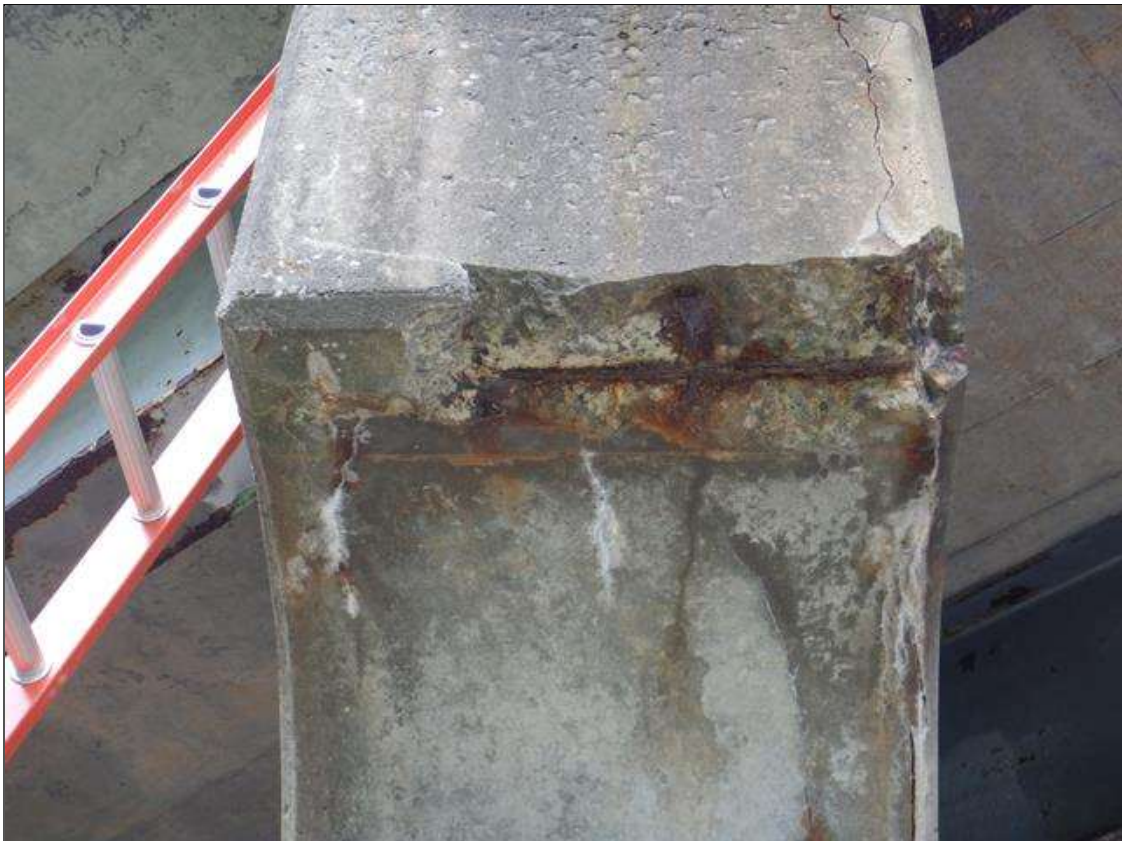
Bent 3 Cap 1: EDGE SPALL AT BEAM AND END CAP ON NORTH END WITH EXPOSED REBAR. 80% SECTION REMAINING IN EXPOSED REBAR. (PAR)

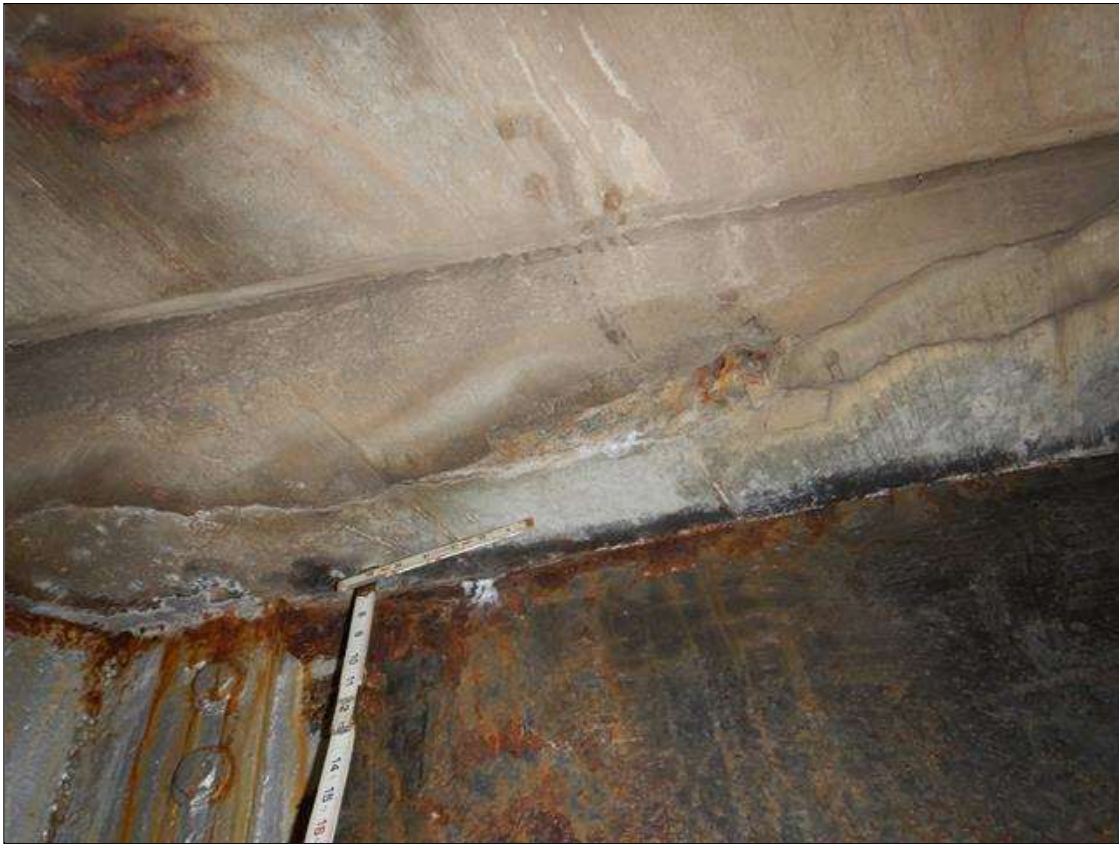
Span 3 Deck: DELAMINATED AREA WITH SPALLING IN DECK UNDERSIDE AT BENT 3 IN BAY 1 WITH CRACKS UP TO 1/8 IN WIDE

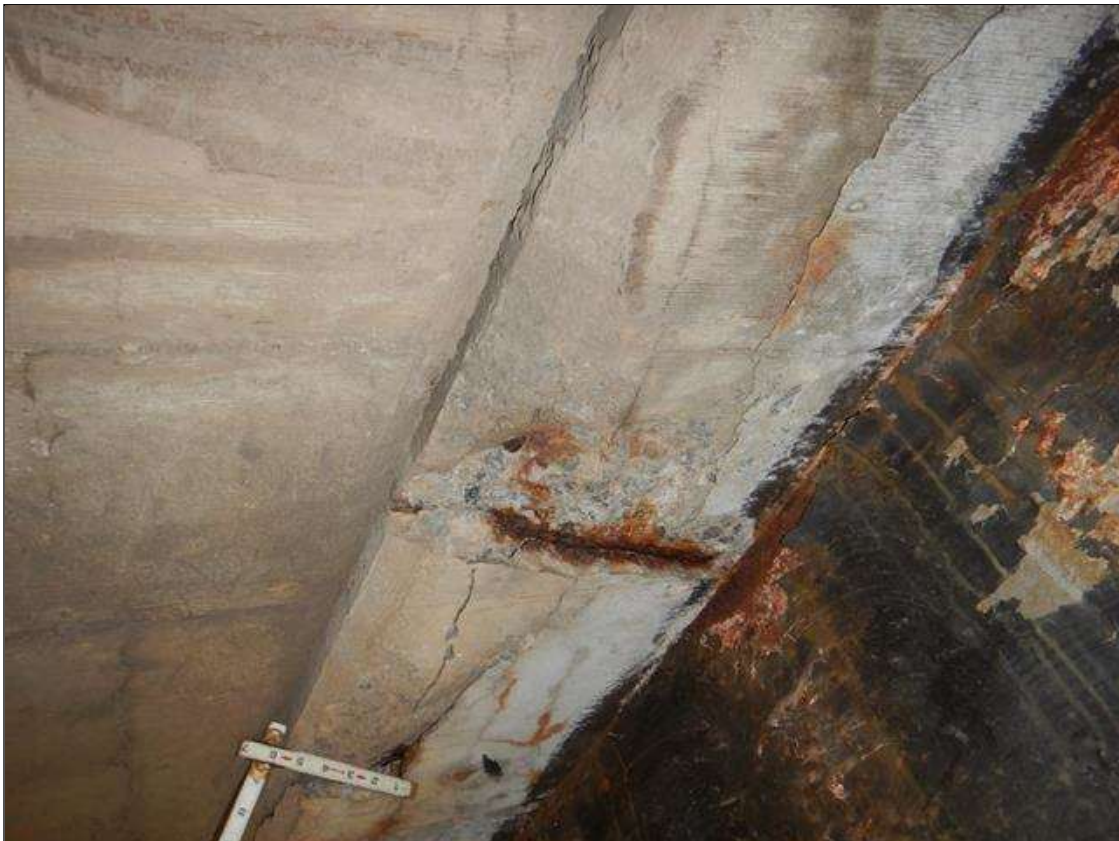
Span 3 Deck: DELAMINATION WITH SPALL FOR 1 FT LONG X 6 IN WIDE X 2 IN DEEP WITH EXPOSED REBAR IN DECK UNDERSIDE AT BENT 3 IN BAY 2 NEXT TO BEAM 2

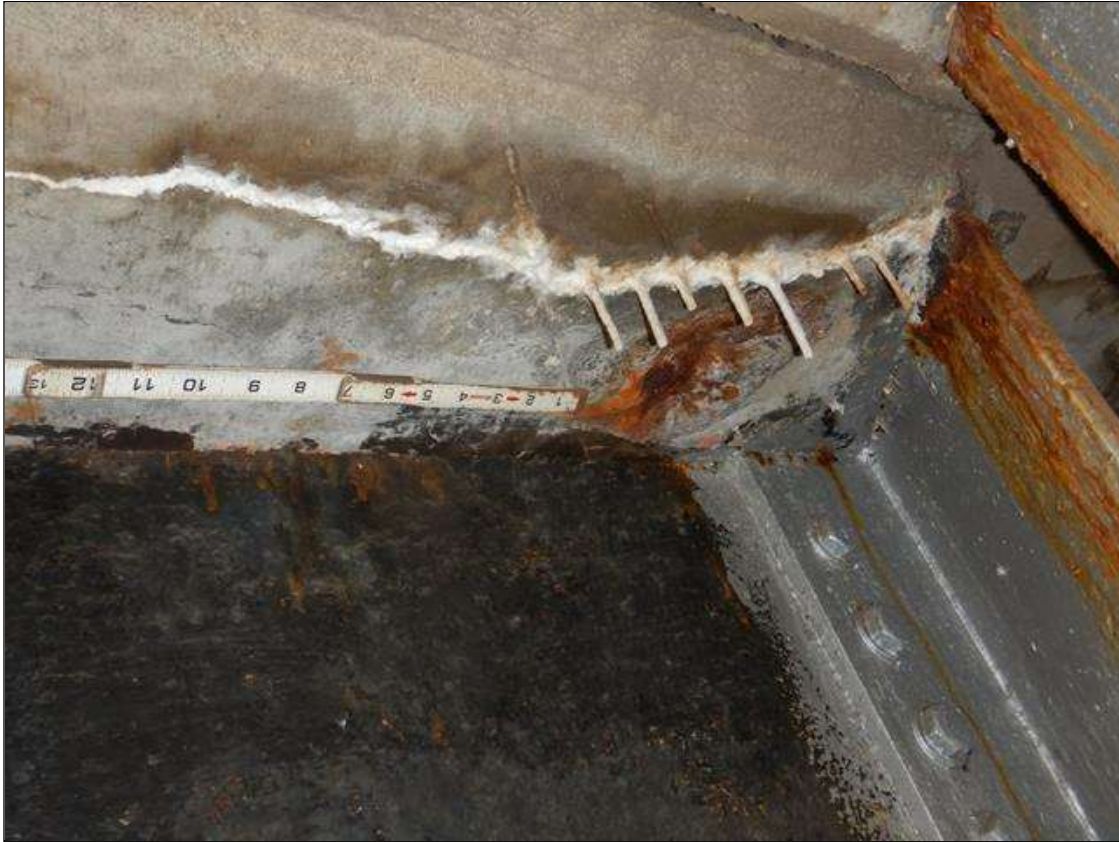
Span 3 Deck: UNDERSIDE DECK AT BENT 3 IN BAY 3 HAS CRACKING UP TO 1/32 IN WITH EFFLORESCENCE. 6 IN DIAMETER SPALL X 1 IN DEEP WITH EXPOSED REBAR. 90% SECTION REMAINING IN EXPOSED REBAR

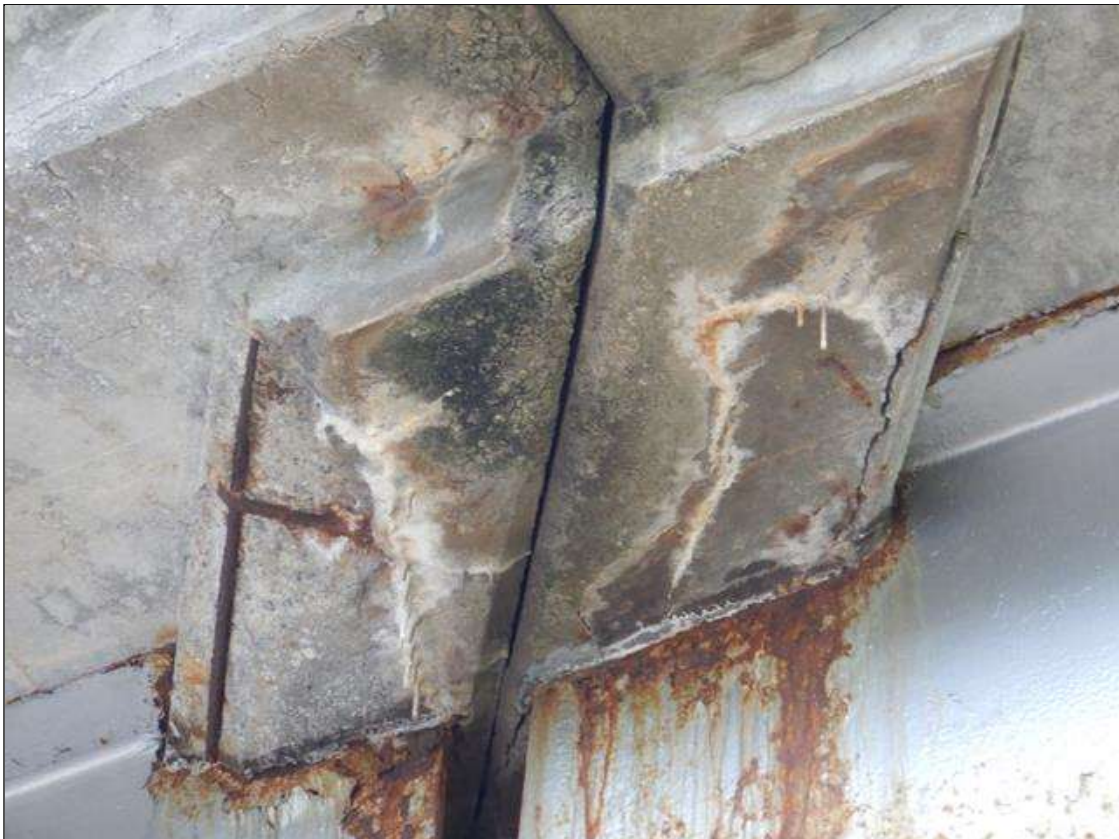
Span 4 Beam 4: RC end diaphragm at Bent 3 IN SPAN 4 right overhang, cracks (1/2" wide) with efflorescence buildup and rust stains.

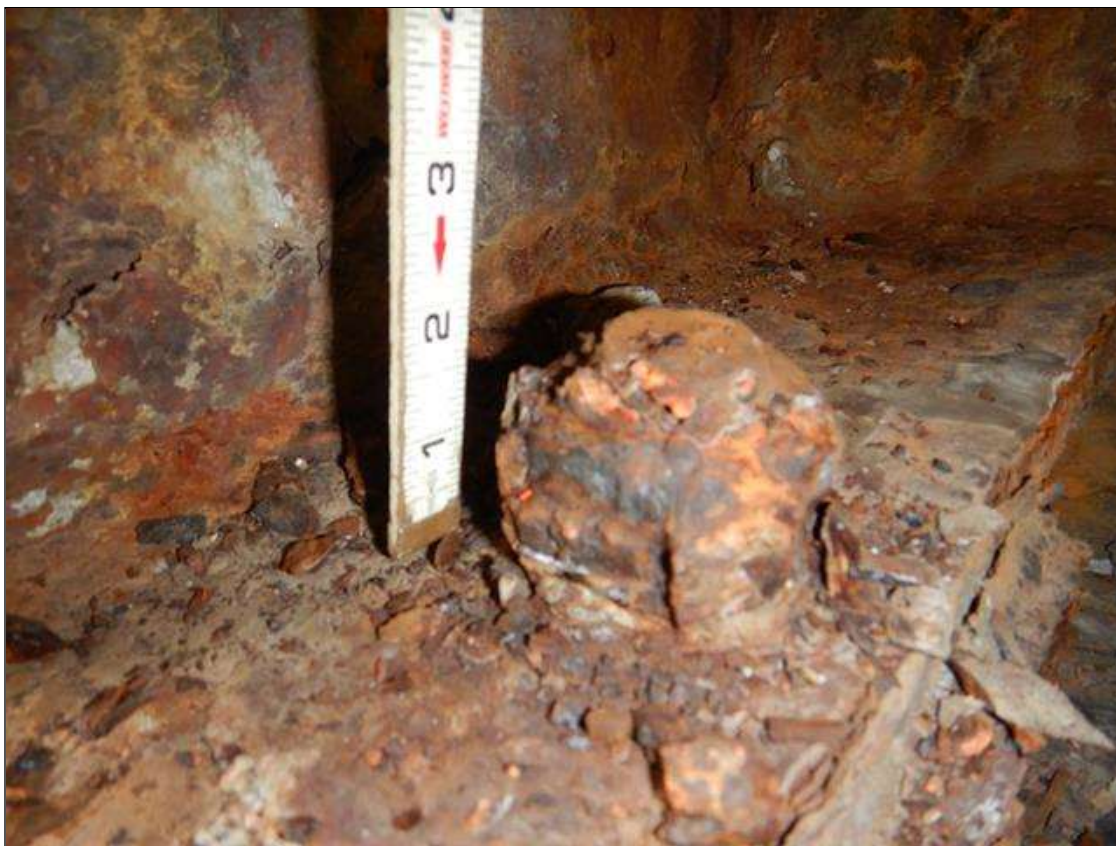
Span 3 Far Bearing: LEFT SIDE ANCHOR BOLT NUT IS CORRODED WITH 80% SECTION REMAINING

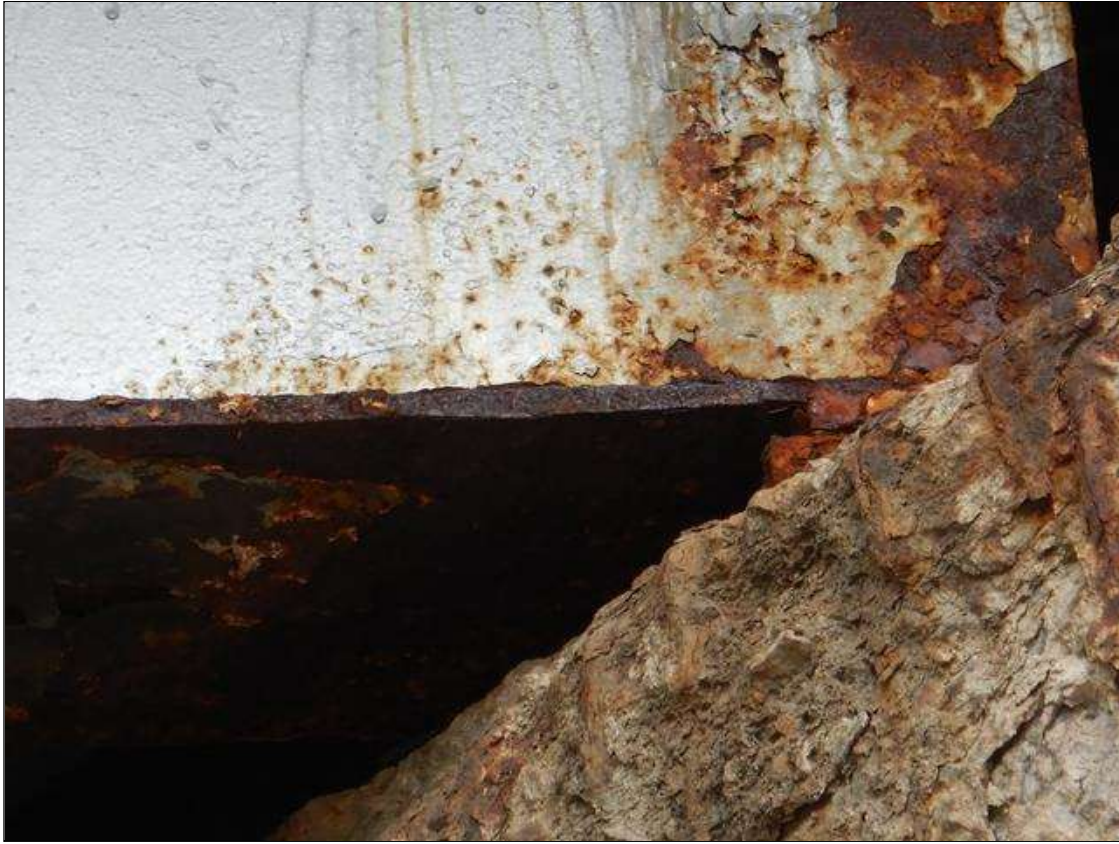
Span 3 Beam 4: at Bent 3, Active Corrosion & Section Loss in lower web, (3/8" Remaining 8" to 4" high x 30" long,) Bottom flange, (9/16" Remaining full width x 18" long,) (Previous PAR 2021 INSPECTION VERIFIED VISUALLY, LADDER ACCESS UNSAFE.) (PAR)

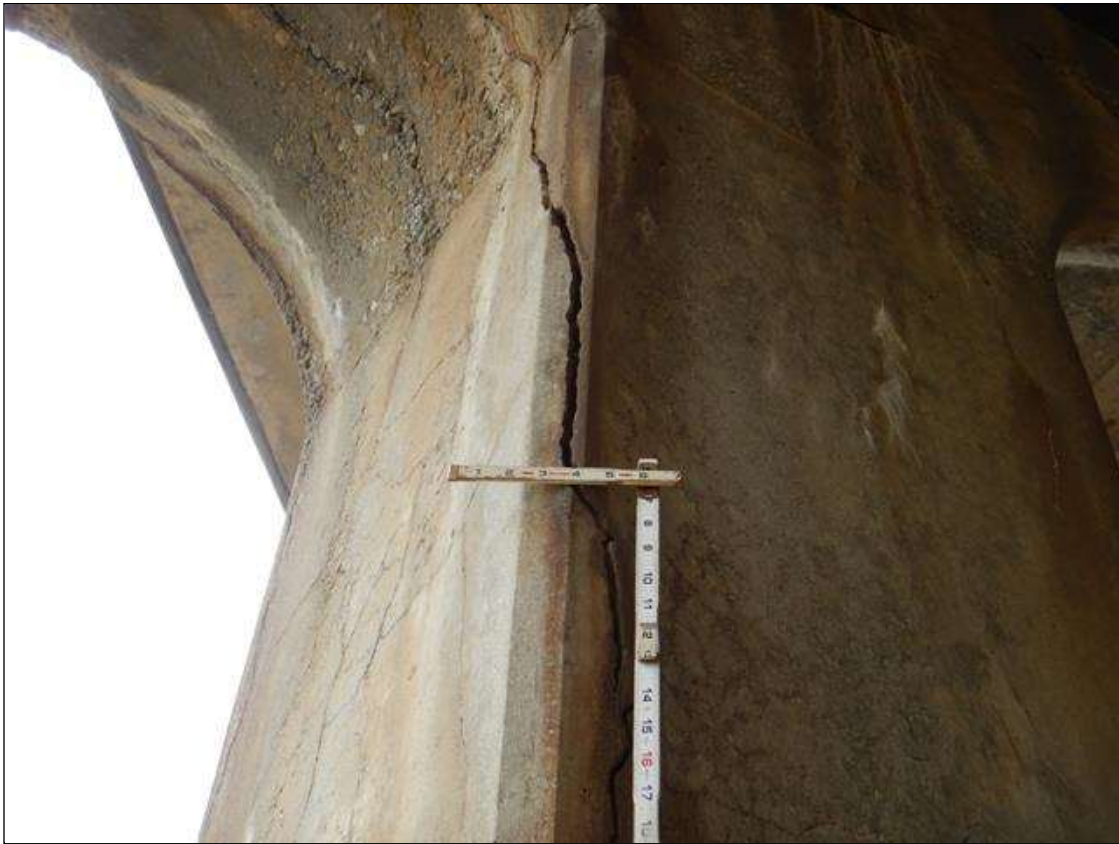
Bent 3 Pile 3: Vertical cracks (1/4" wide) with efflorescence and Delamination (imminent spalling) West face, full height x full width, and east face at 10' below cap (2' wide x 3' high.) (PAR)

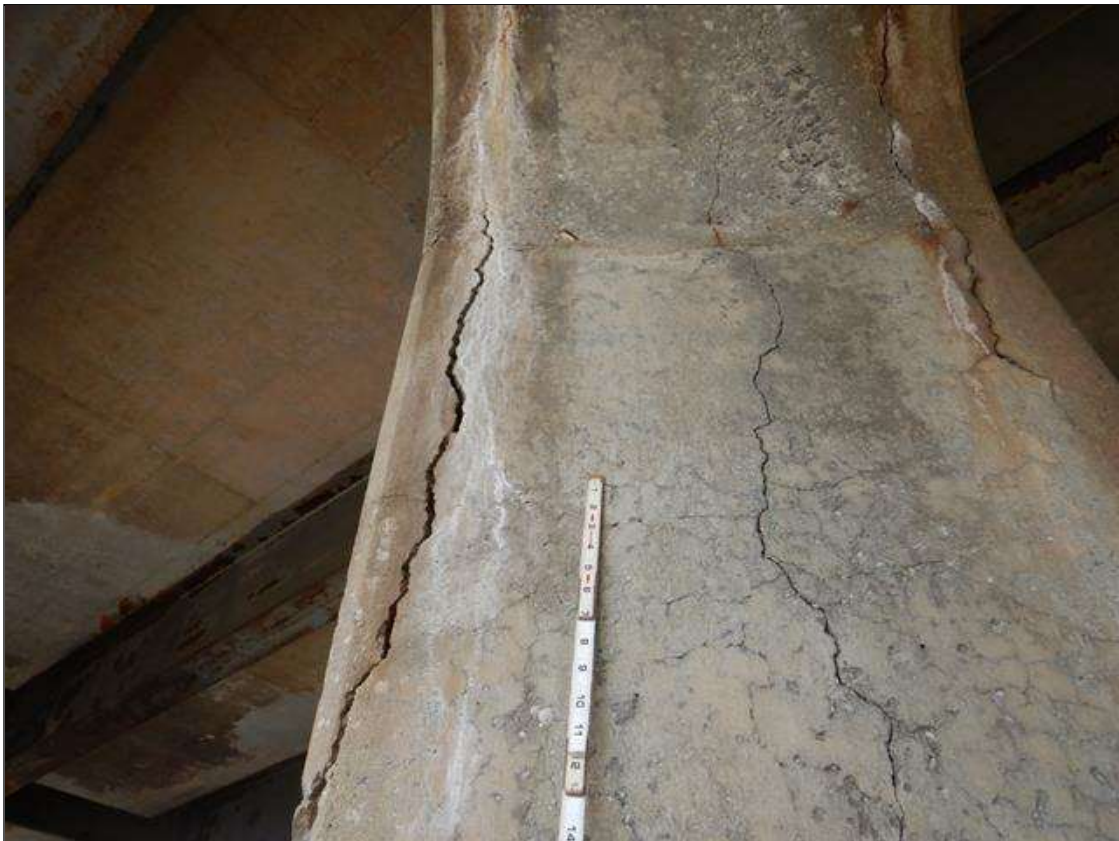
Bent 3 Pile 2: Vertical cracks (1/4" wide) with rust staining and Delamination (imminent spalling) West face, (8' high x 2' wide.) (PAR)

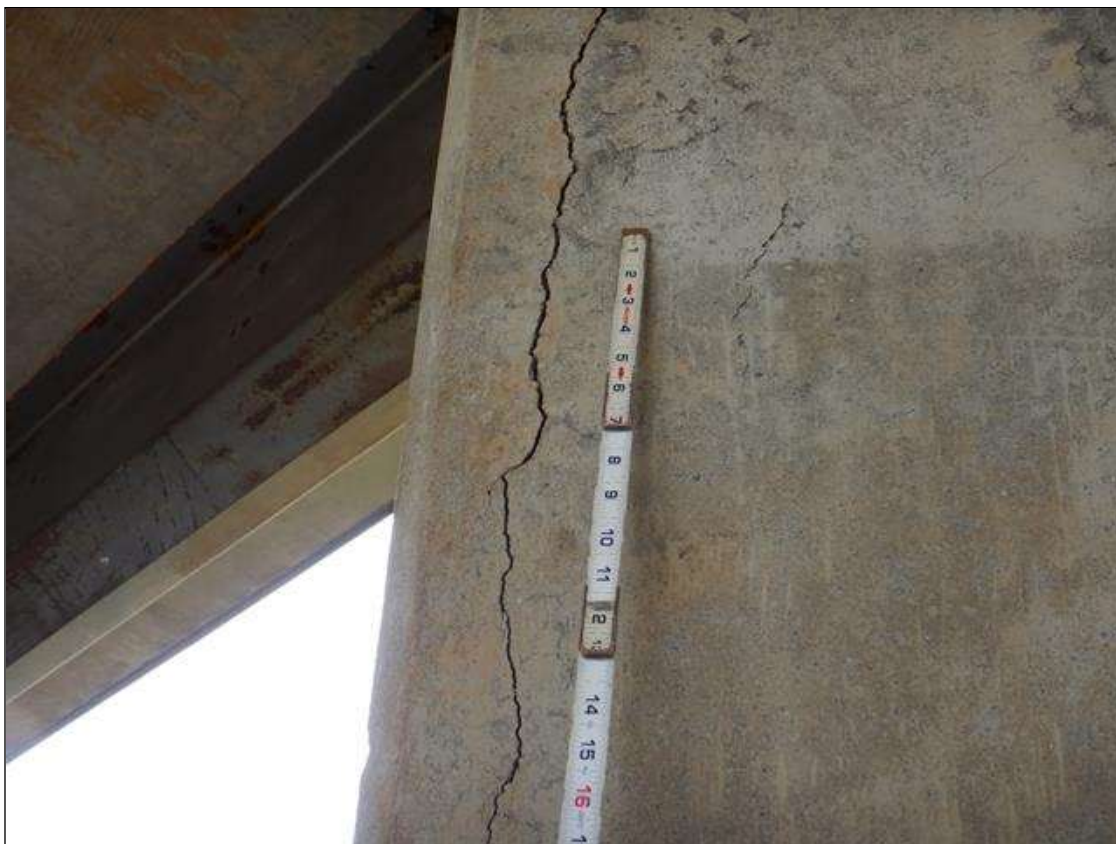
Bent 3 Pile 1: near cap, Northwest Corner, vertical cracks (1/4" wide x 3' long) with Delamination (6" x 4" x 3'.)
