NC DEPARTMENT OF TRANSPORTATION  
 DIVISION OF HIGHWAYS  
 STRUCTURE MANAGEMENT UNIT

ATTENTION: PAR SUBMITTED, NEWLY INSTALLED WEIGHT LIMITS, LOW UNDERCLEARANCE SIGNS, STRUCTURAL DATA MODIFIED, BEAMS SHAPES ADDED

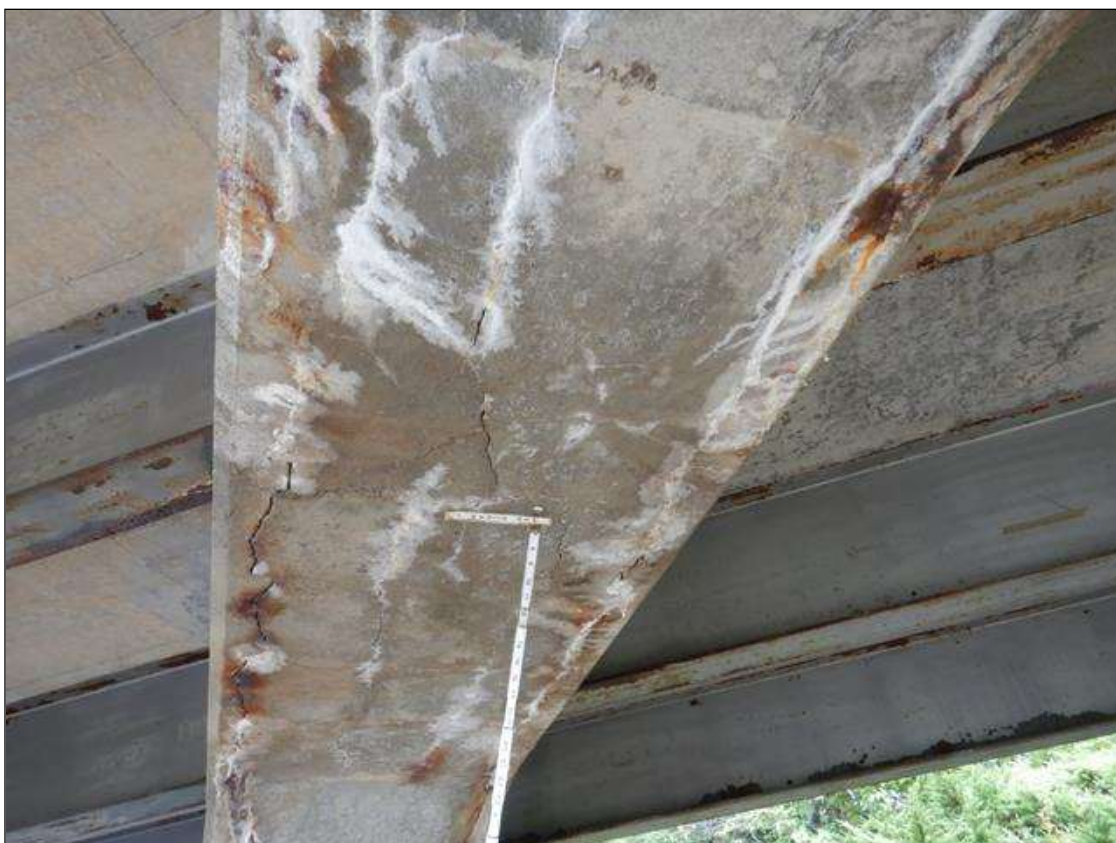
Bent 3 Cap 1: CRACKS FULL WIDTH UNDERSIDE CAP BETWEEN PILES 2 AND 3 WITH HEAVY EFFLORESCENCE BUILDUP

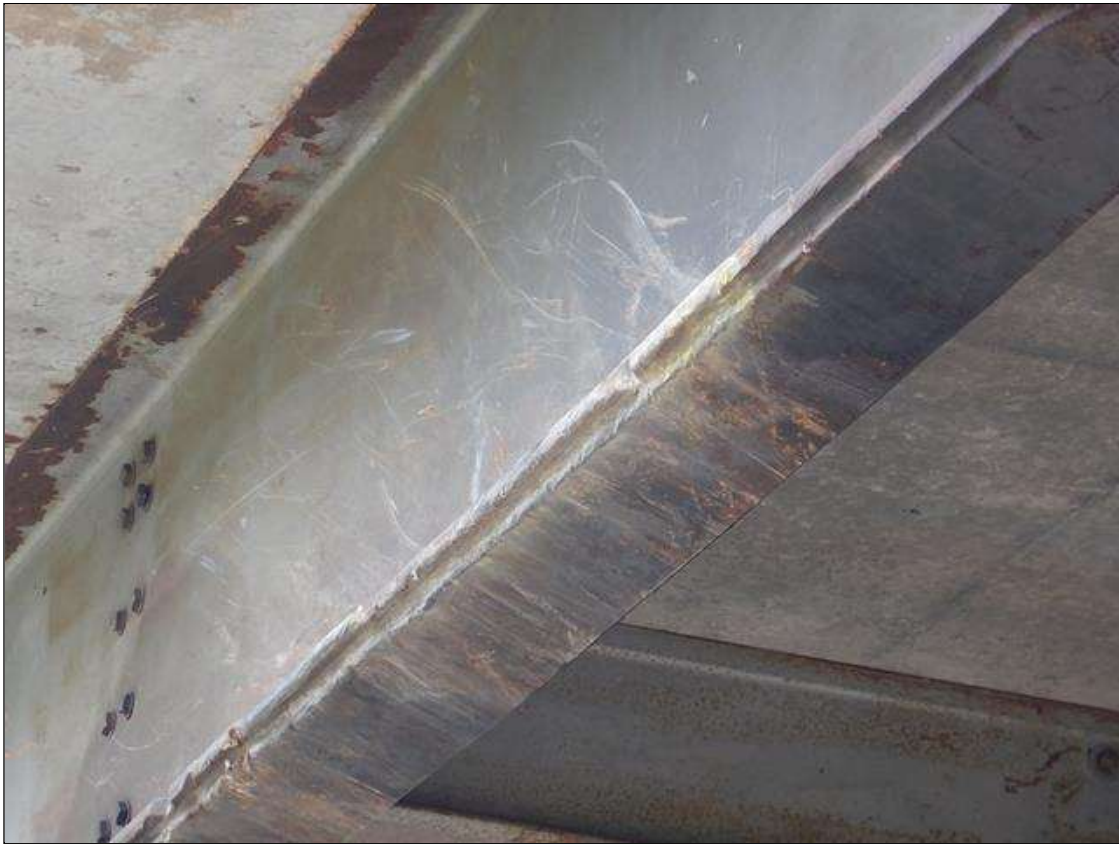
Span 3 Beam 4: Impact damage due to high loads, with Out of plane bending in bottom flange and web. Numerous Points of impact located approximately between 12' and 30' from Bent 3, above US220 North bound lanes. See NCDOT Special Inspections Damage Report dated 21 November, 2011

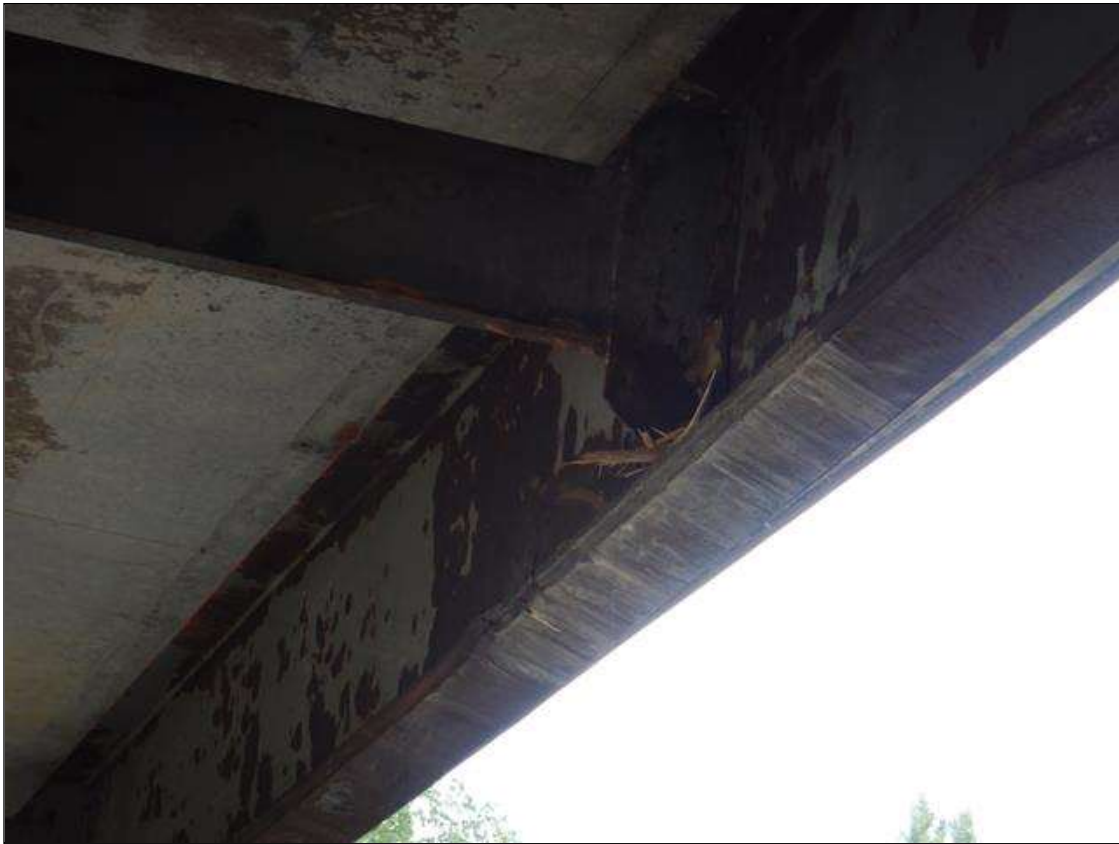
Span 3 Beam 1: Impact damage due to high load, with Out of plane bending in bottom flange and web. Point of impact located approximately 18' from Bent 3, above US220 North.

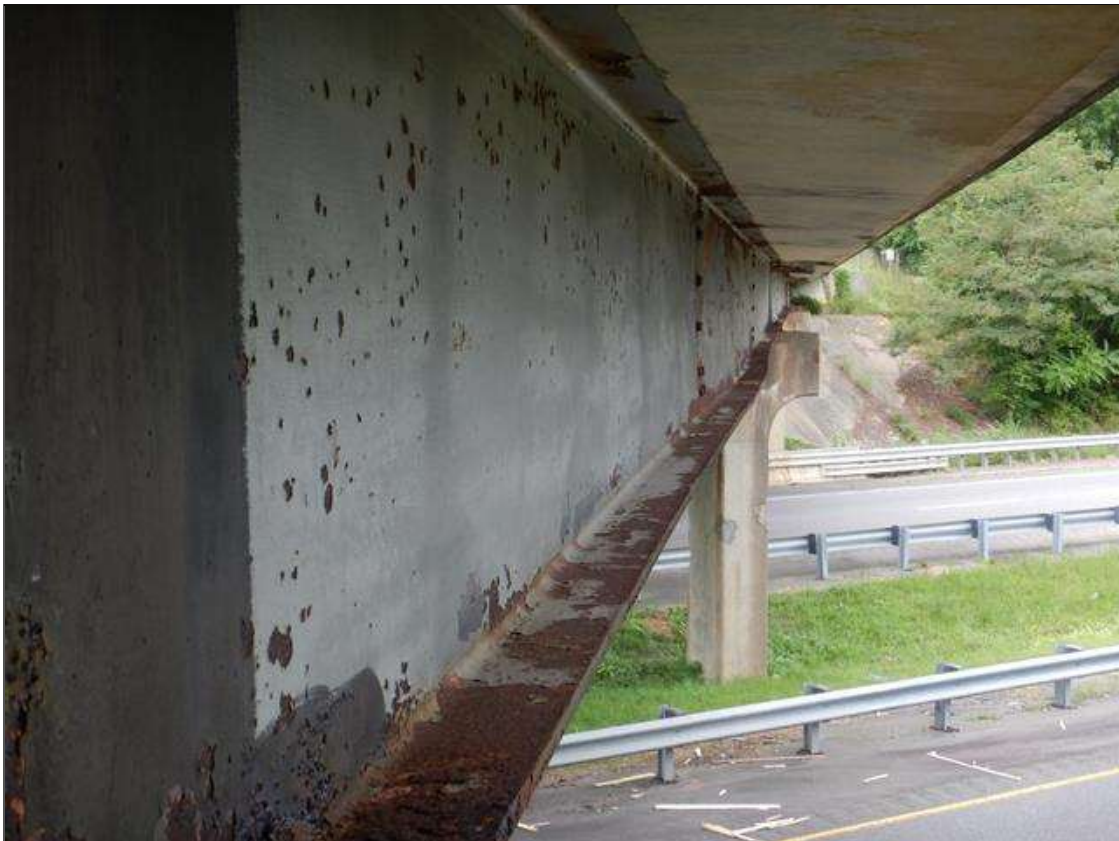
Span 3 Beam 1: Impact damage due to high load, with Out of plane bending in bottom flange and web. Point of impact located approximately 18' from Bent 3, above US220 North.

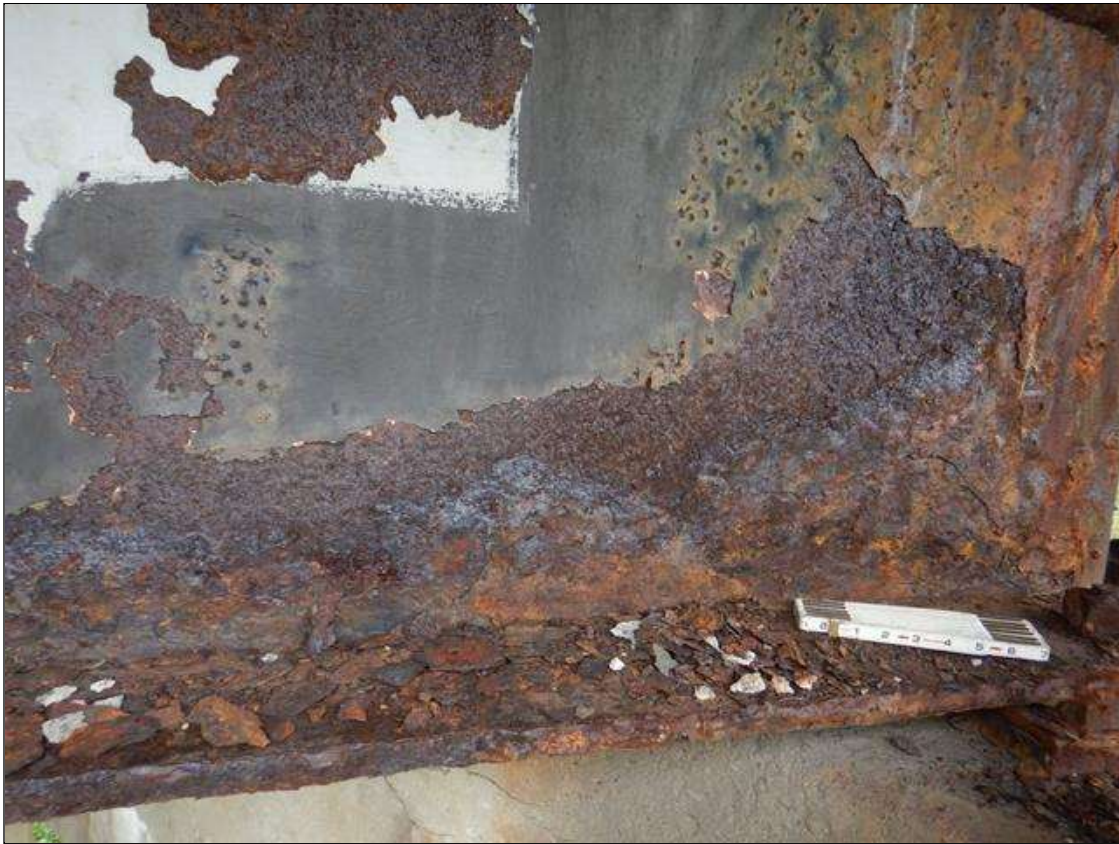
Span 3 Beam 1: at Bent 2, Active Corrosion & Section Loss in lower web, (3/8" Remaining 4" high x 4' long,) Upper Web (3/8" Remaining 5" high x 17" long,) Bottom Flange (3/4" Remaining full width x 3' long.) (PAR)

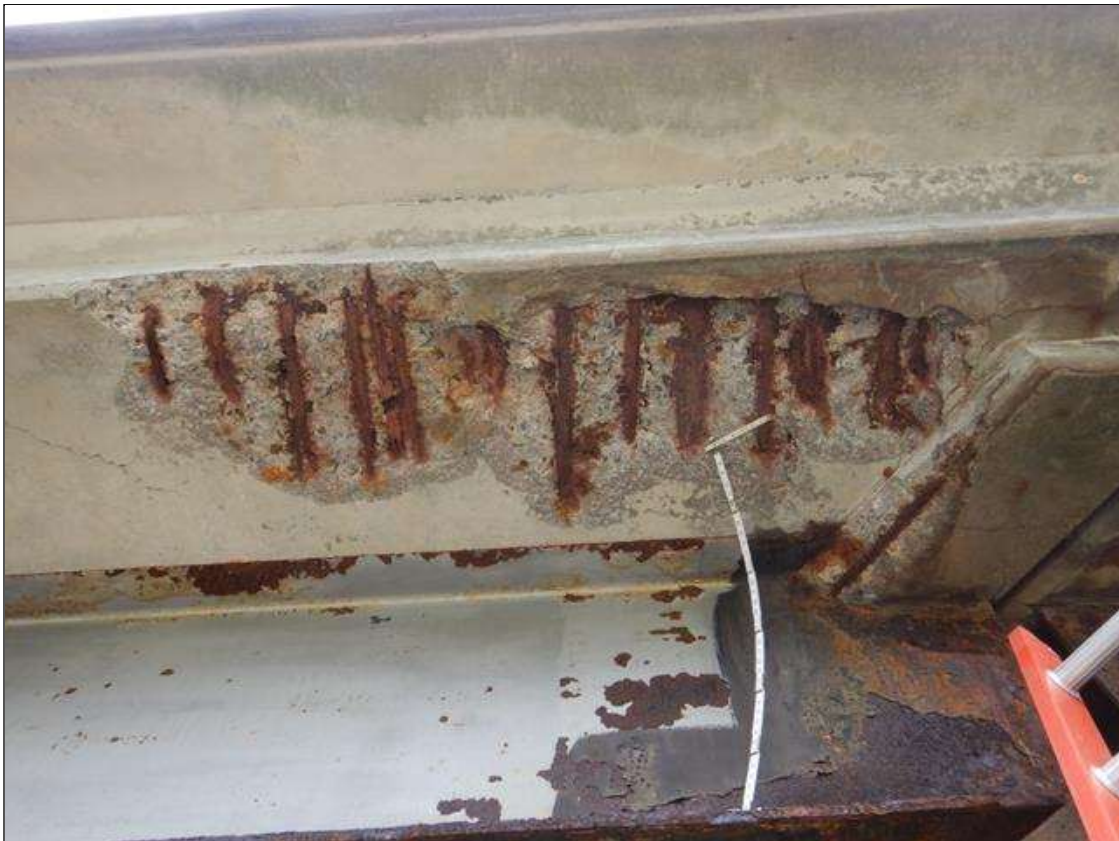
Span 3 Deck: Underside of deck at Bent 2, left overhang, Spall with Exposed Steel/ Delamination, (6' x 2' x 2" deep,) with loose concrete above mowable grass shoulder. (PAR)

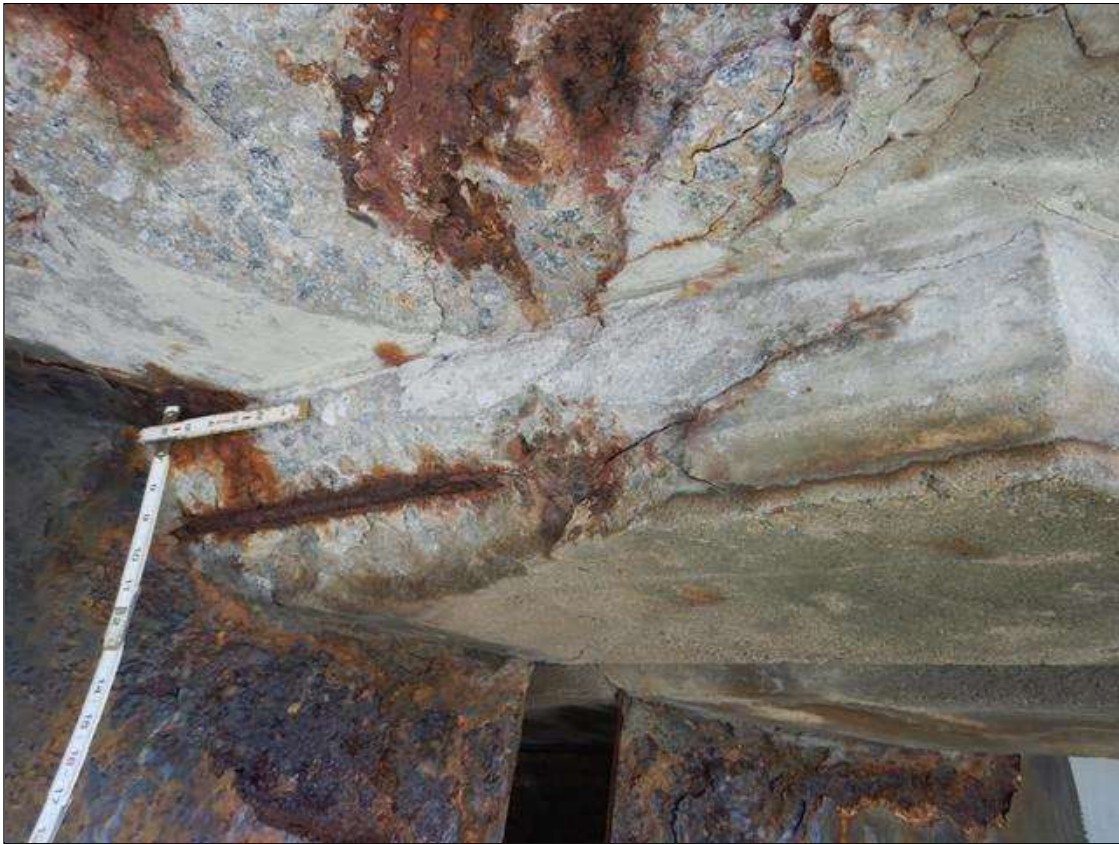
Span 3 Deck: RC DIAPHRAGM ON LEFT OVERHANG UNDERSIDE DECK HAS SPALL WITH EXPOSED REBAR FOR 2 FT WIDE X 6 IN HIGH X 5 IN LONG. 80% SECTION REMAINING ON EXPOSED REBAR.

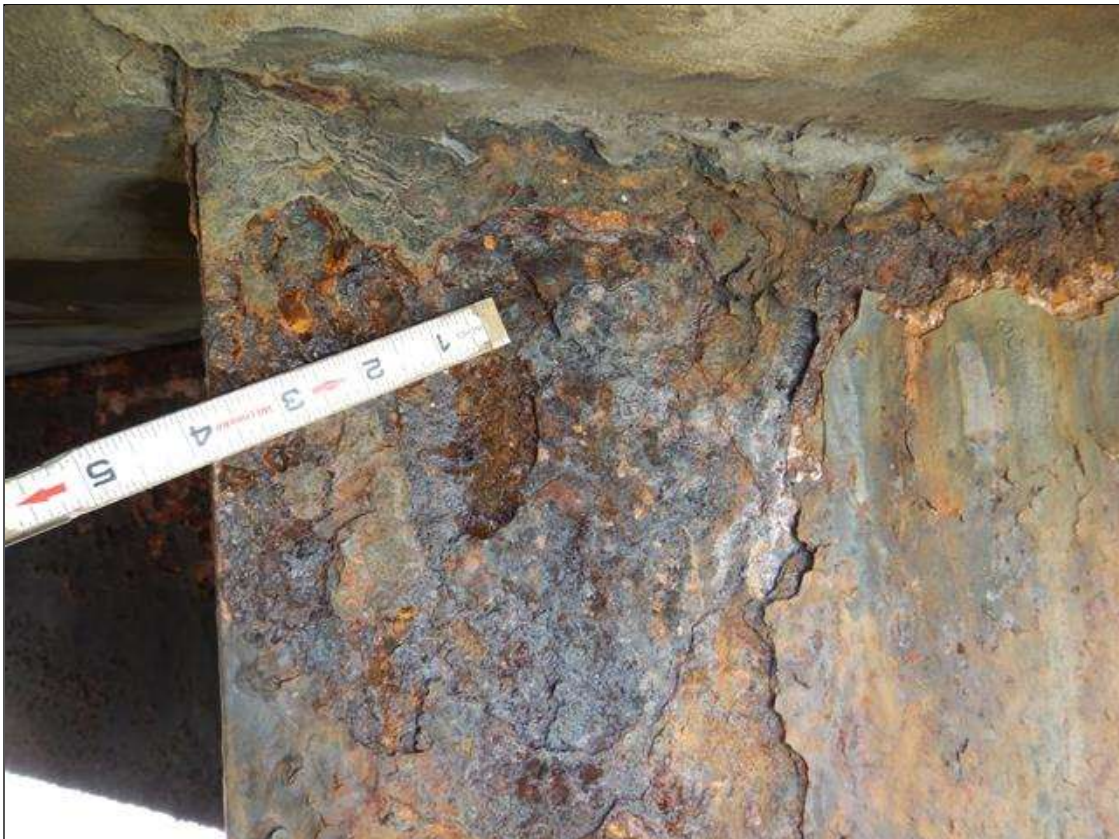
Span 2 Beam 1: at Bent 2, Active Corrosion & Section Loss in Lower web (1/16" Remaining 6" high x 2' long) Upper web (1/8" Remaining 18" long x 8" high,) Bottom Flange (5/8" to 3/4" Remaining full width x 18" long.) (PAR)

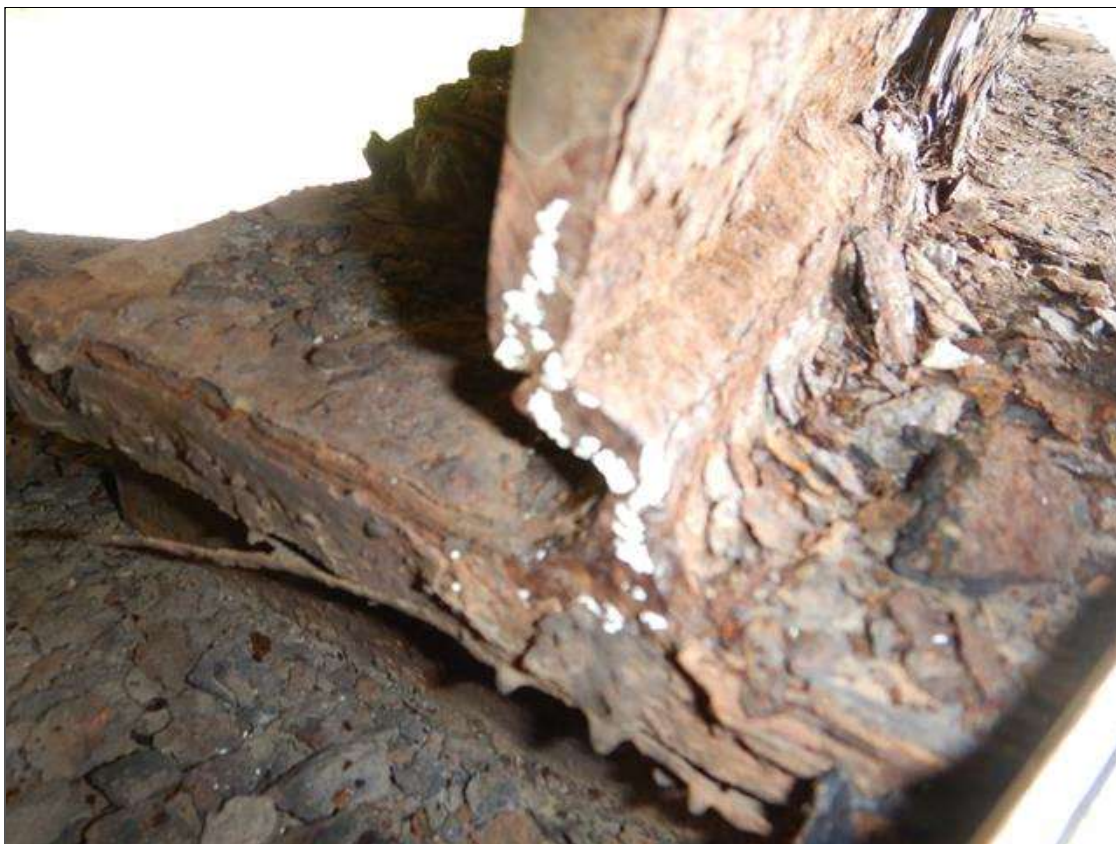
Span 2 Beam 1: DISTORTION FOR 9 IN LONG X 1 IN HIGH AT BOTTOM OF WEB INSIDE OF WEB IS CRACKED. HOLE IN WEB 3 IN IN DIAMETER 9 IN FROM FAR BEARING. (PAR)

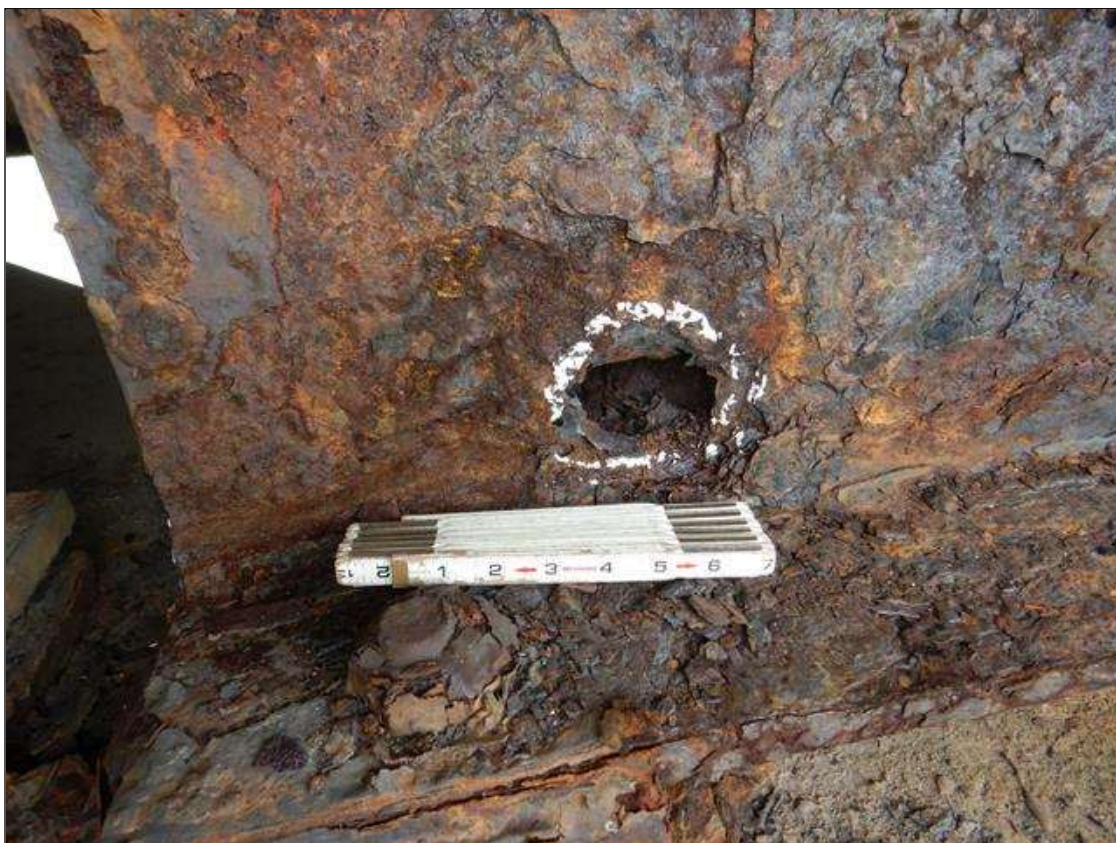
Span 2 Beam 1: DISTORTION FOR 9 IN LONG X 1 IN HIGH AT BOTTOM OF WEB INSIDE OF WEB IS CRACKED. HOLE IN WEB 3 IN IN DIAMETER 9 IN FROM FAR BEARING. (PAR)

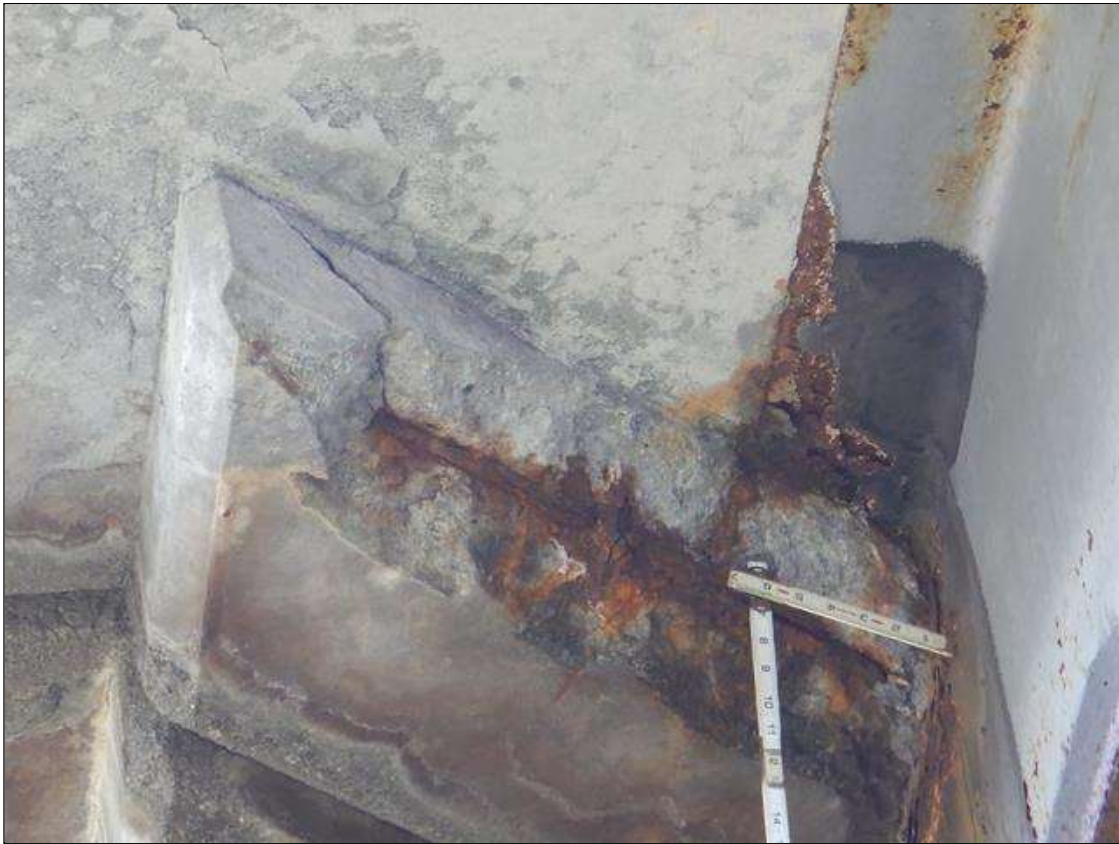
Span 2 Beam 1: RC DIAPHRAGM AT BENT 3 IN SPAN 2 HAS SPALLED AREA 2 FT WIDE X 1 FT LONG X 6 IN HIGH WITH EXPOSED REBAR. 80% SECTION REMAINING IN EXPOSED REBAR

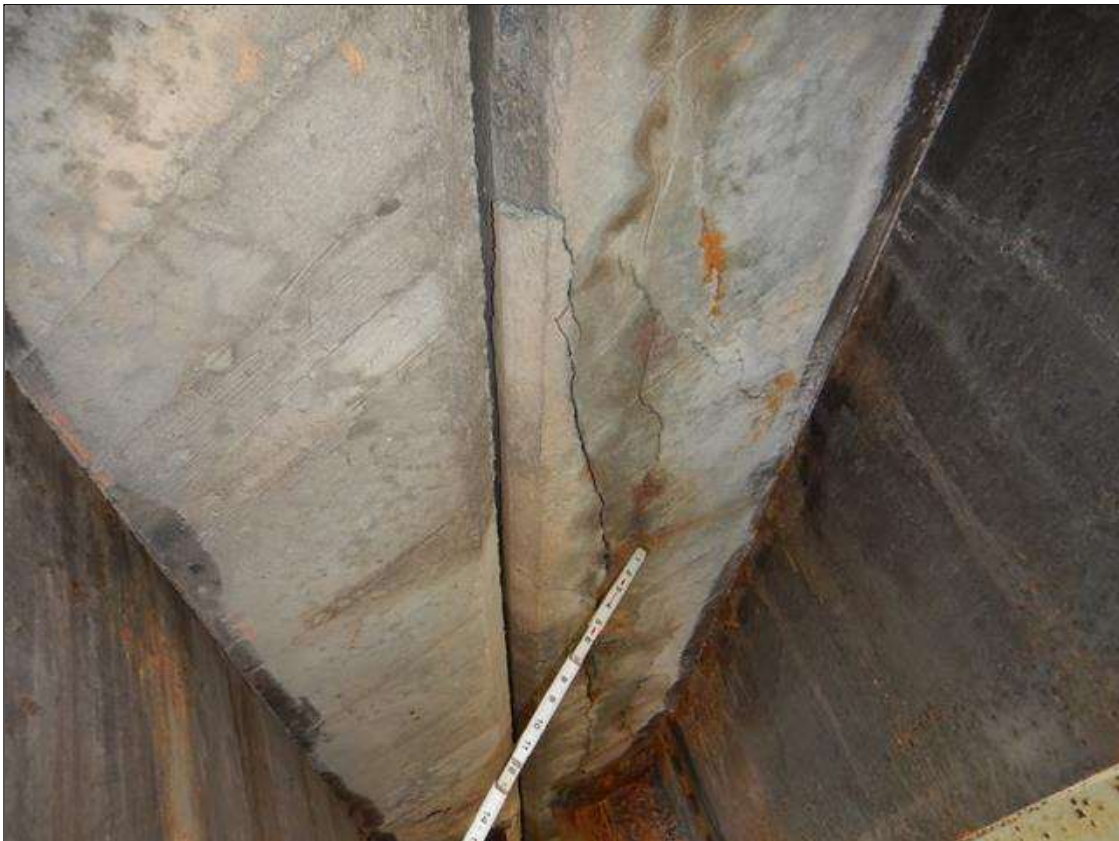
Span 2 Deck: UNDERSIDE DECK HAS CRACKING UP 1/4 IN WIDE X 5 FT LONG IN BAY 1, SIMILAR IN OTHER BAYS

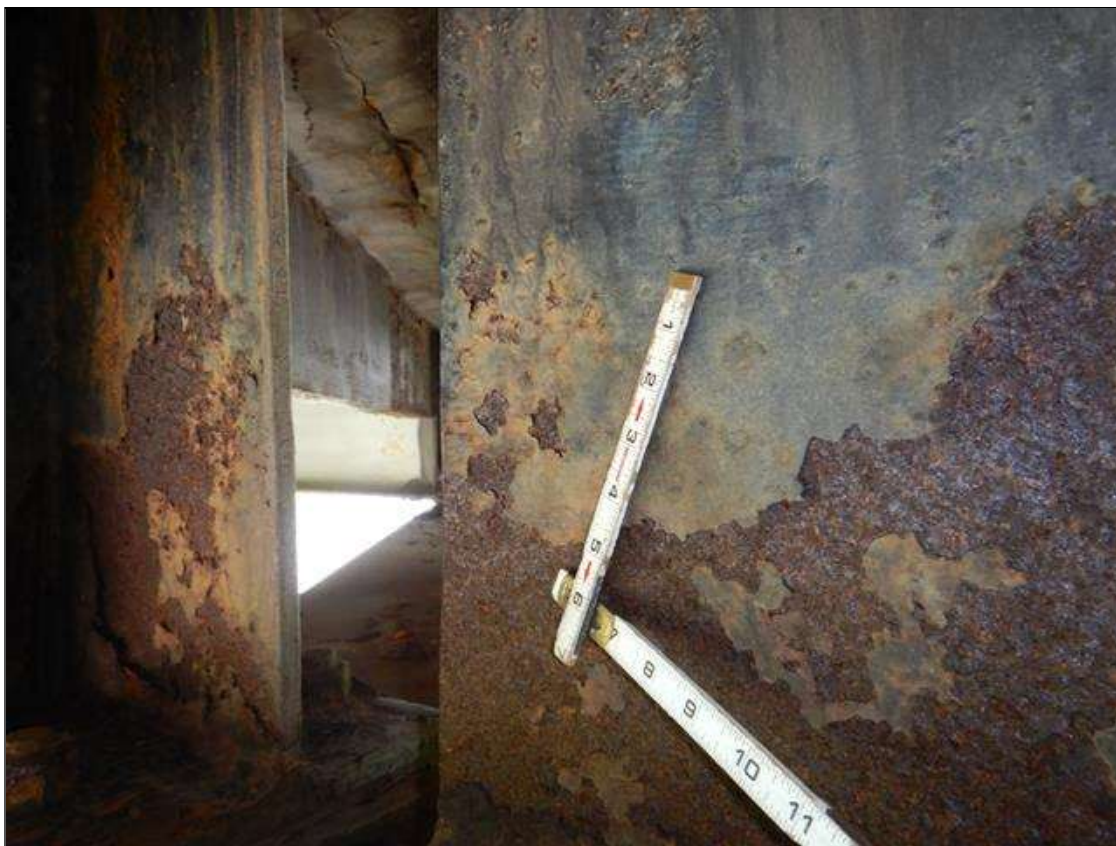
Span 3 Beam 2: at Bent 2, Active Corrosion & Section Loss in lower web, (3/8" Remaining 8" high x 12" long,) Bottom flange, Rust and Scale no Section Loss. (PAR)

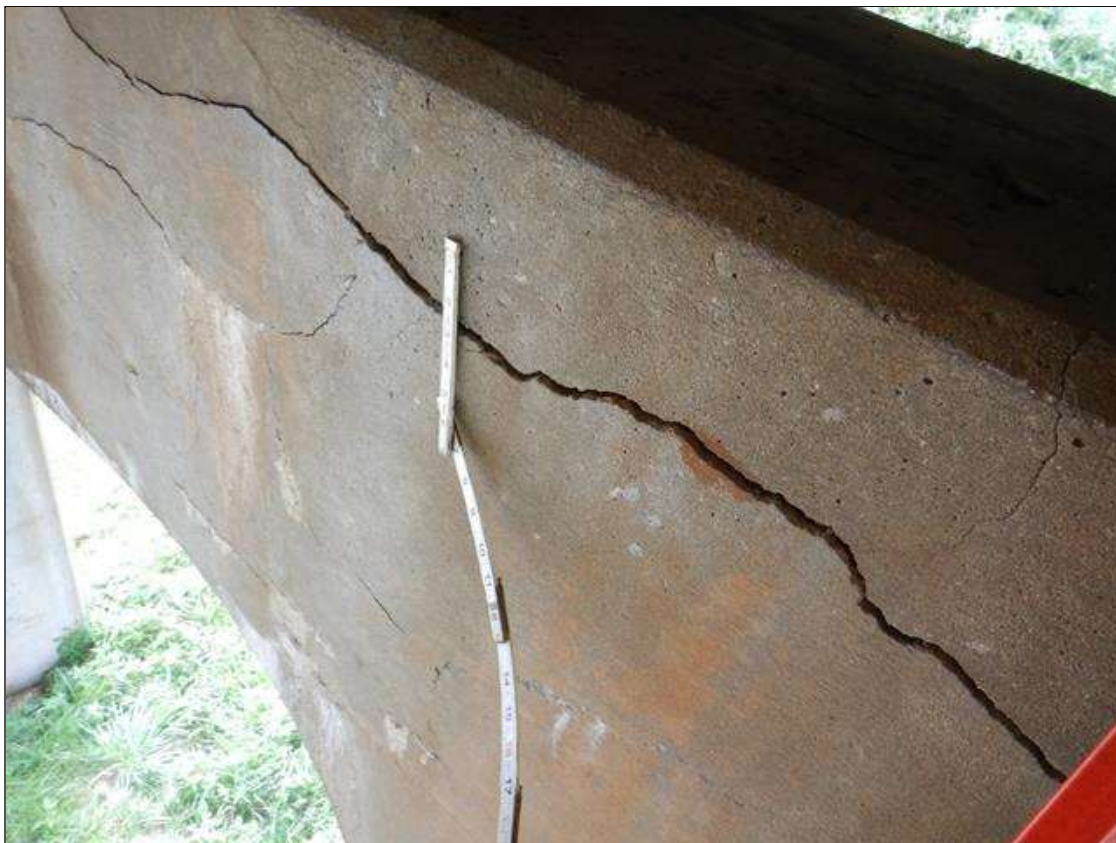
Bent 2 Cap 1: HORIZONTAL CRACKING UP TO 1/4" AND DELAMINATION ALONG LENGTH OF BOTH FACES

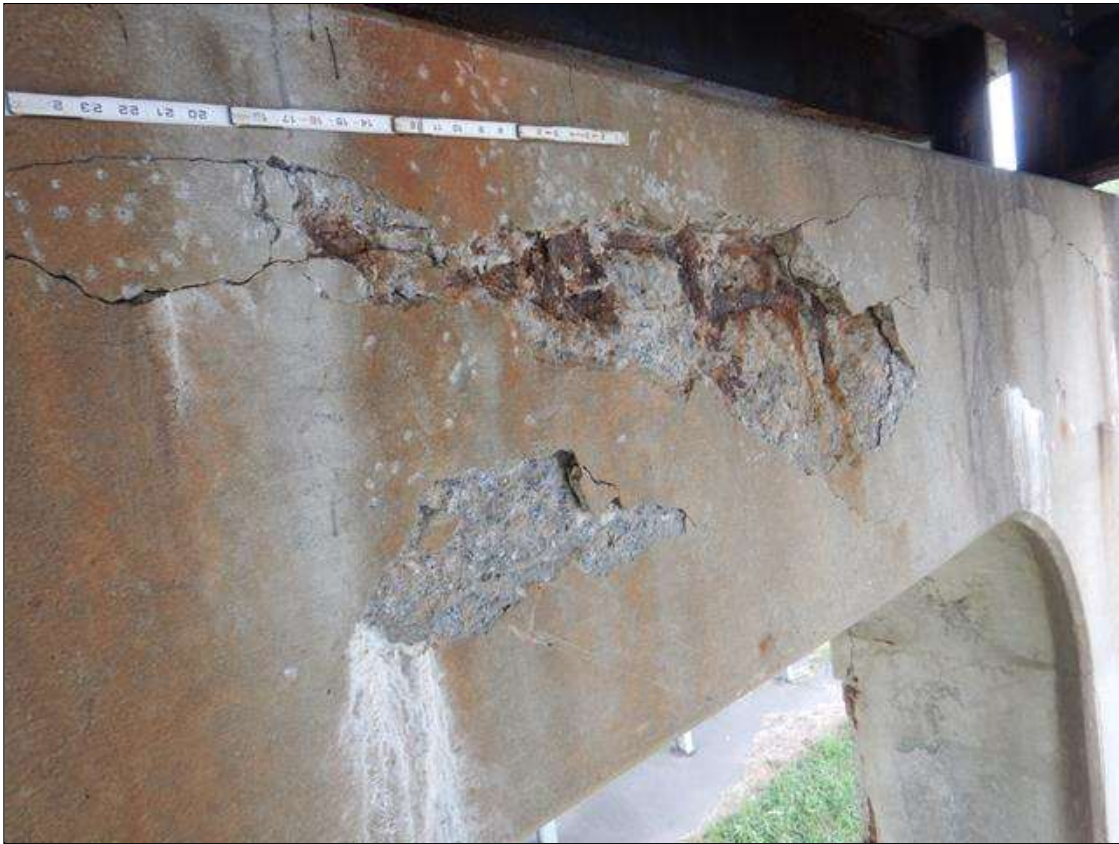
Bent 2 Cap 1: SPALL AT TOP OF CAP IN BAY 1 FOR 5 FT WIDE X 1.5 HIGH X 2.5 IN DEEP WITH 80% SECTION REMAINING IN EXPOSED REBAR EXPOSED REBAR

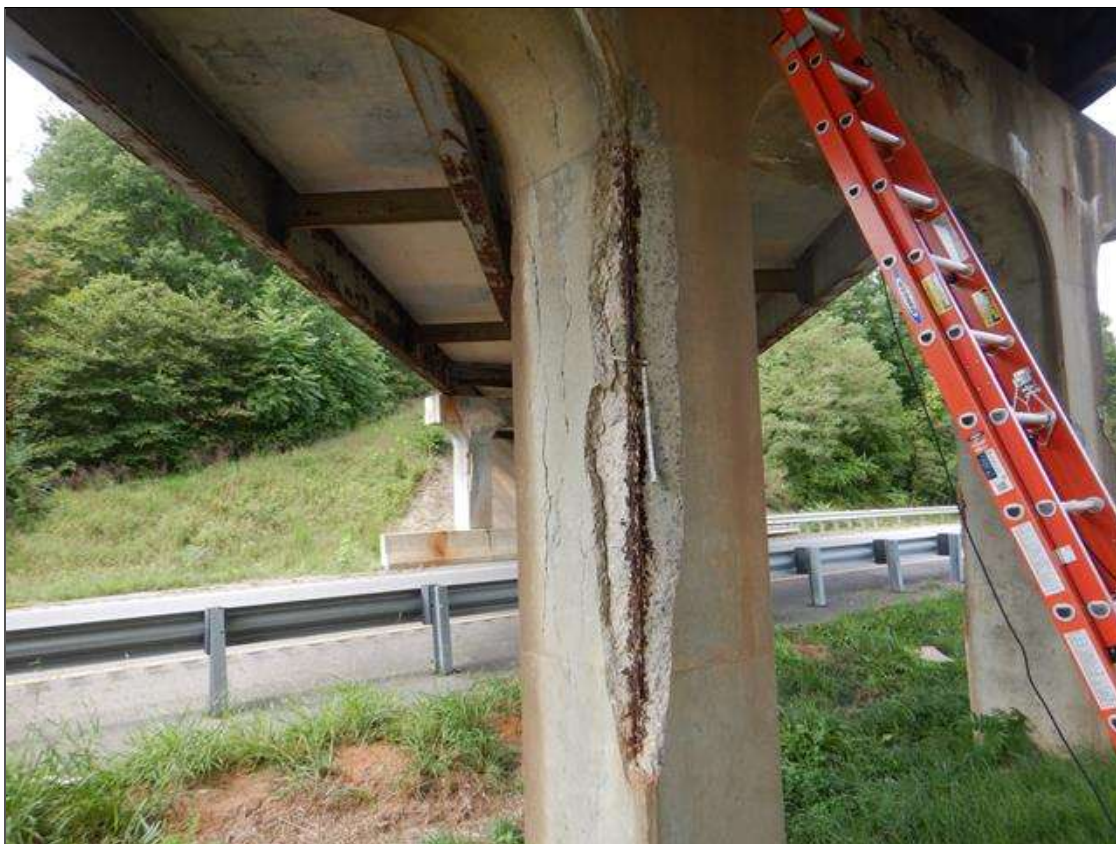
Bent 2 Pile 2: Corner Spalls with Exposed Steel (Active Corrosion no measurable Section Loss,) (up to 8' high x 1 FT LONG x 1 FT,) vertical cracks (1/4" wide x full height) and Delamination in all faces. 80% SECTION REMAINING ON EXPOSED REBAR. (PAR)

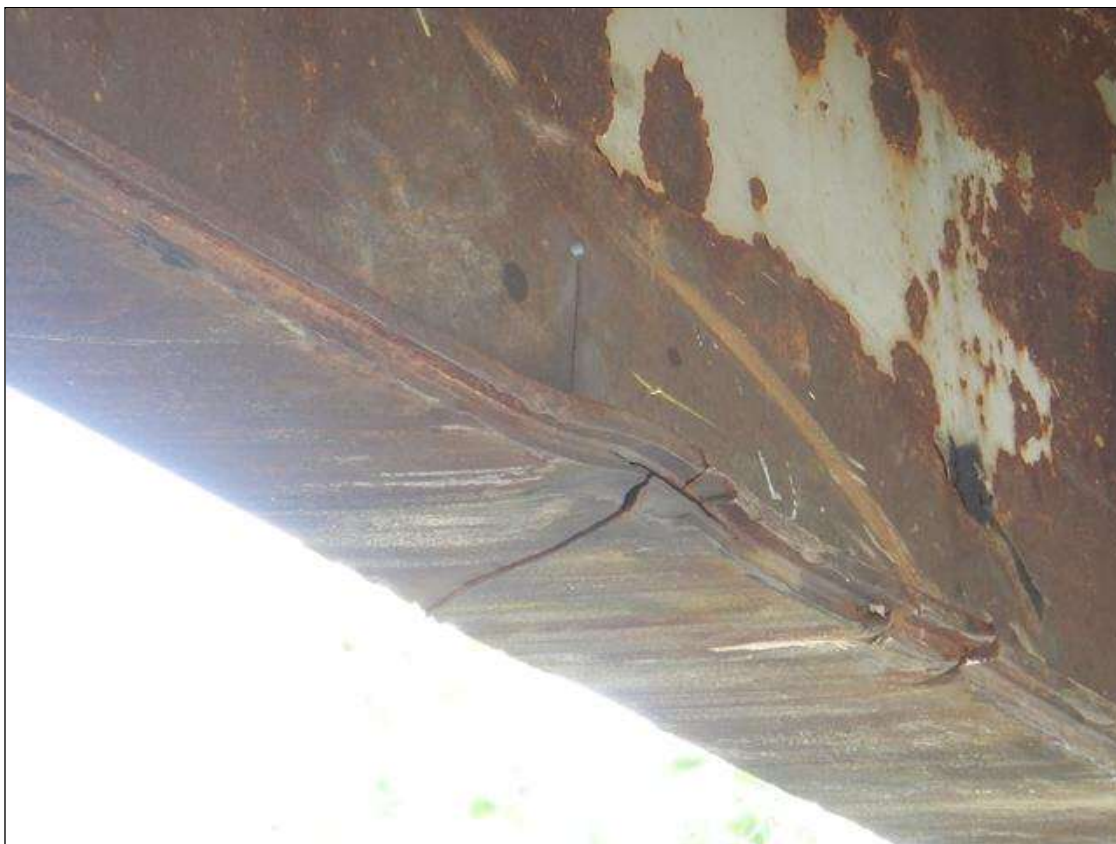
Span 3 Beam 1: 6" LONG X 1/4" WIDE CRACK IN BOTTOM FLANGE EXTENDS INTO WEB VERTICALLY IN BEAM 1 SPAN 3 LOCATED ON SOUTH SIDE OF BEAM. (PAR)

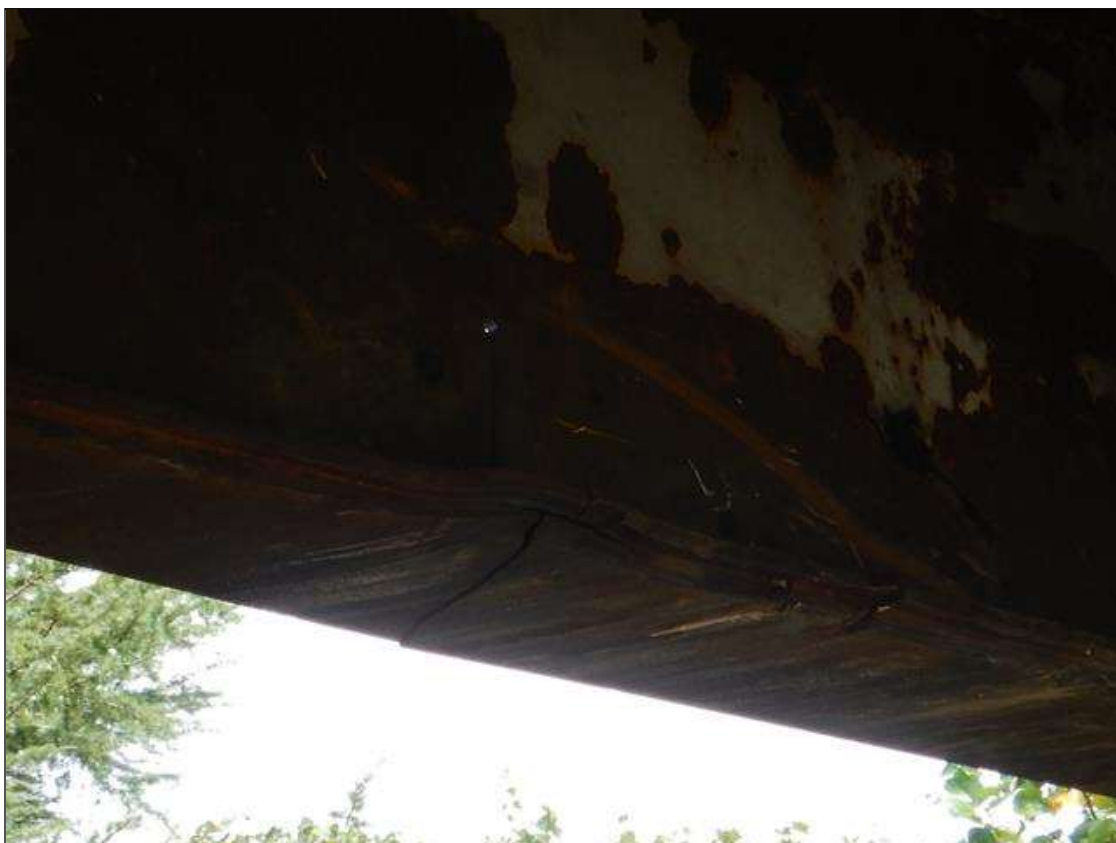
Span 3 Beam 1: 6" LONG X 1/4" WIDE CRACK IN BOTTOM FLANGE EXTENDS INTO WEB VERTICALLY IN BEAM 1 SPAN 3 LOCATED ON SOUTH SIDE OF BEAM. (PAR)

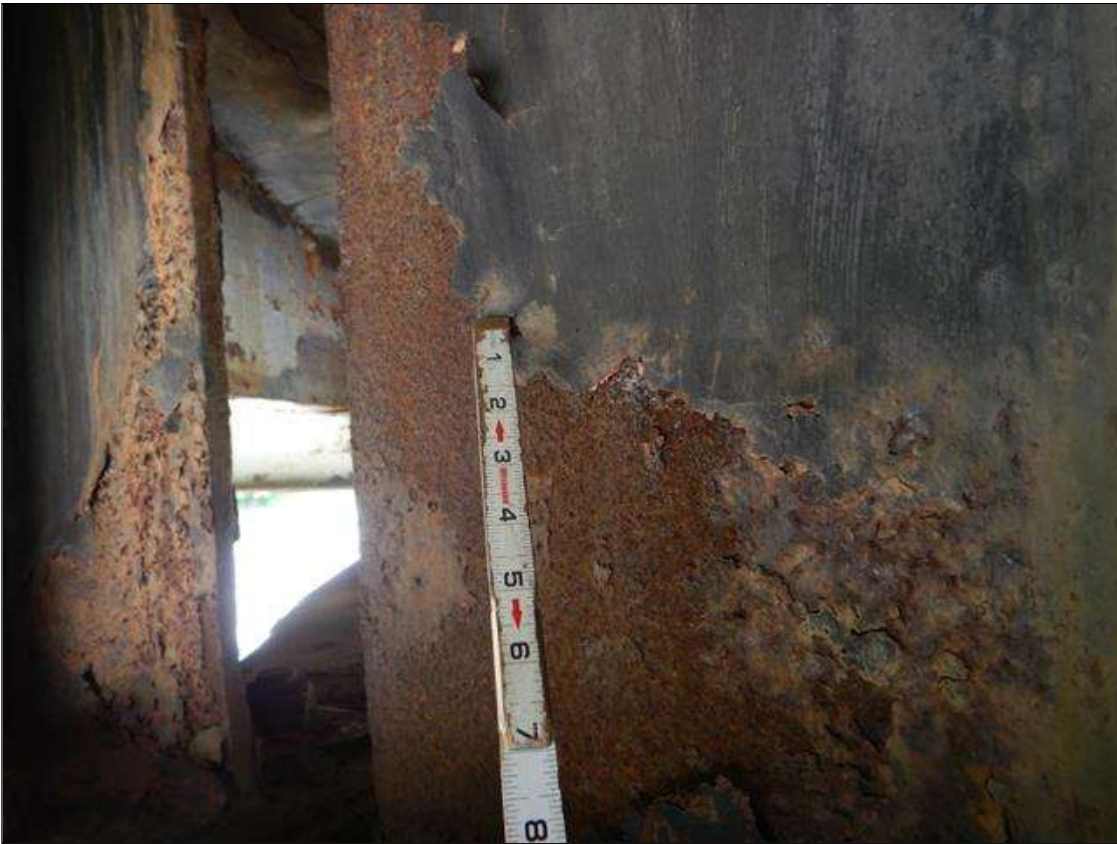
Span 3 Beam 3: at Bent 2, Active Corrosion & Section Loss in Lower Web (5/16" Remaining 12" high x 10" long, then 3" high x 12" long,) Bottom Flange (9/16" Remaining full width x 2' long.) (PAR)

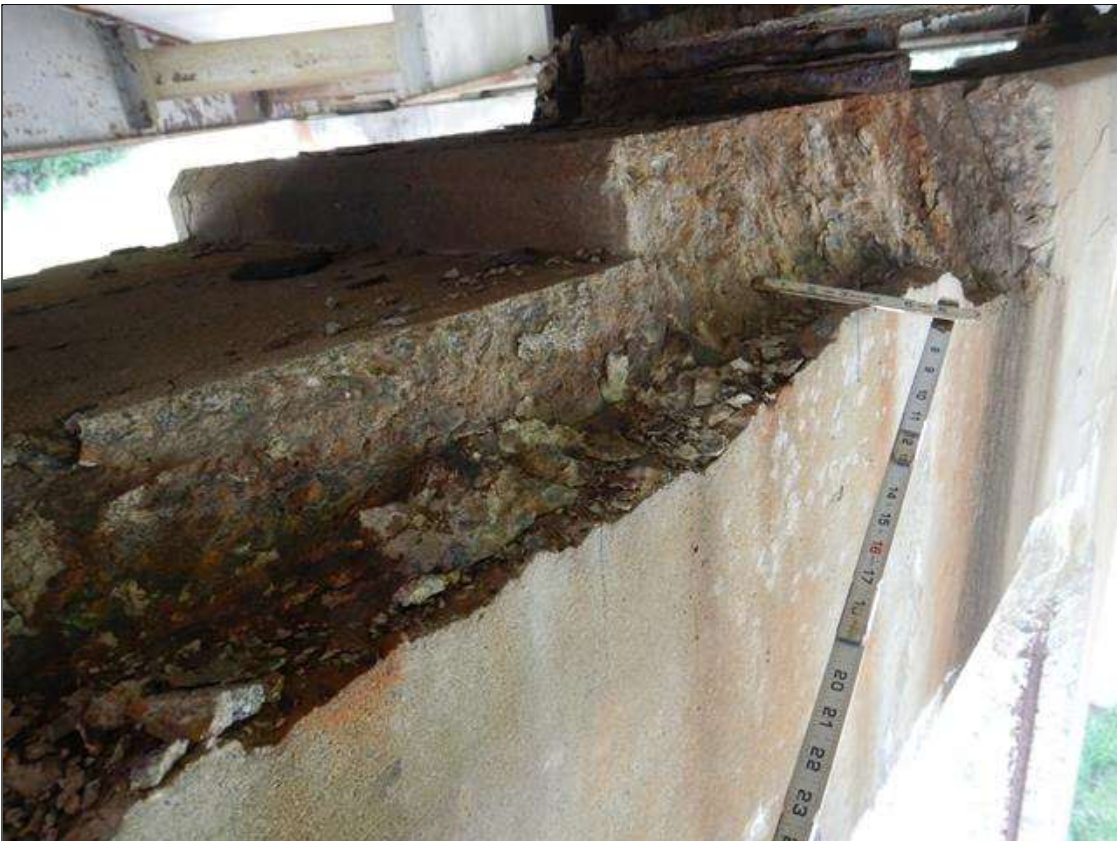
Bent 2 Cap 1: Top corners of cap, east and west faces, in bay 3 to south end, Spall with Exposed Steel (Active Corrosion no measurable Section Loss) and Delamination 6' long x up to 12" high x up to 10" wide.). (PAR)

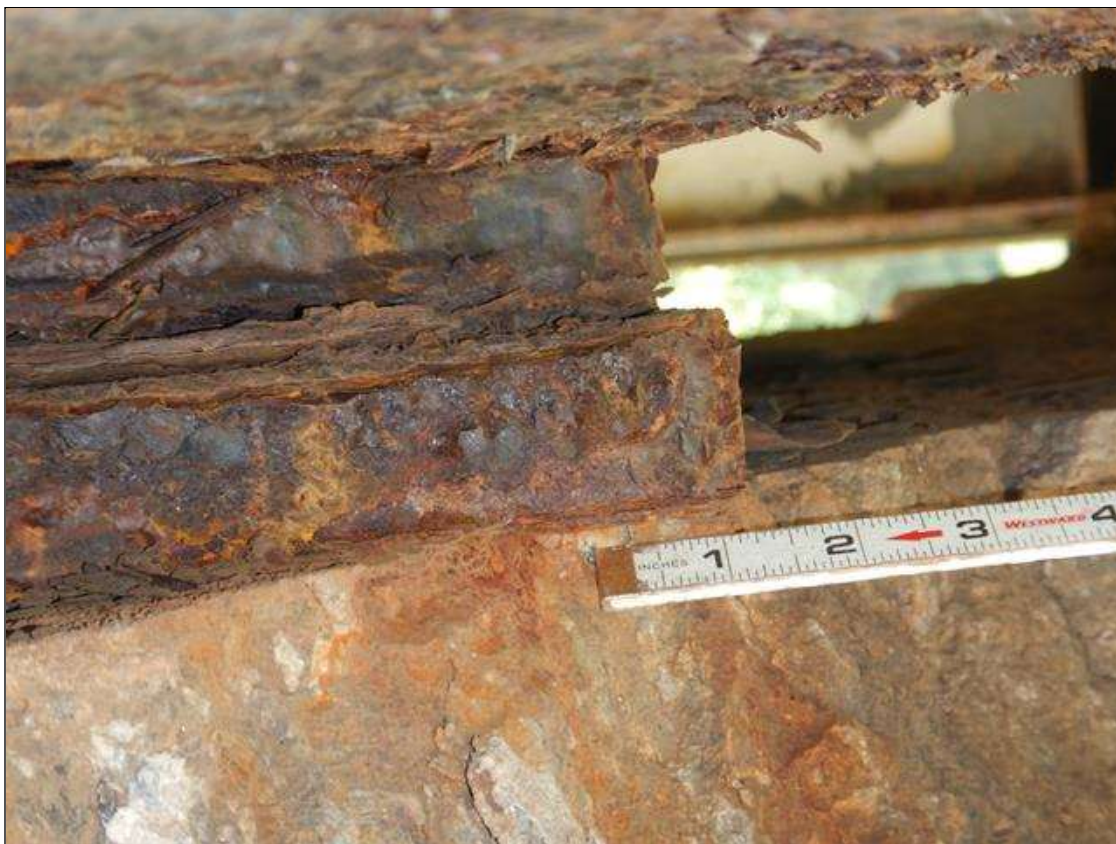
Span 3 Near Bearing: 1 IN UNDERMINING ON BEARING PLATE DUE TO SPALL. (PAR)

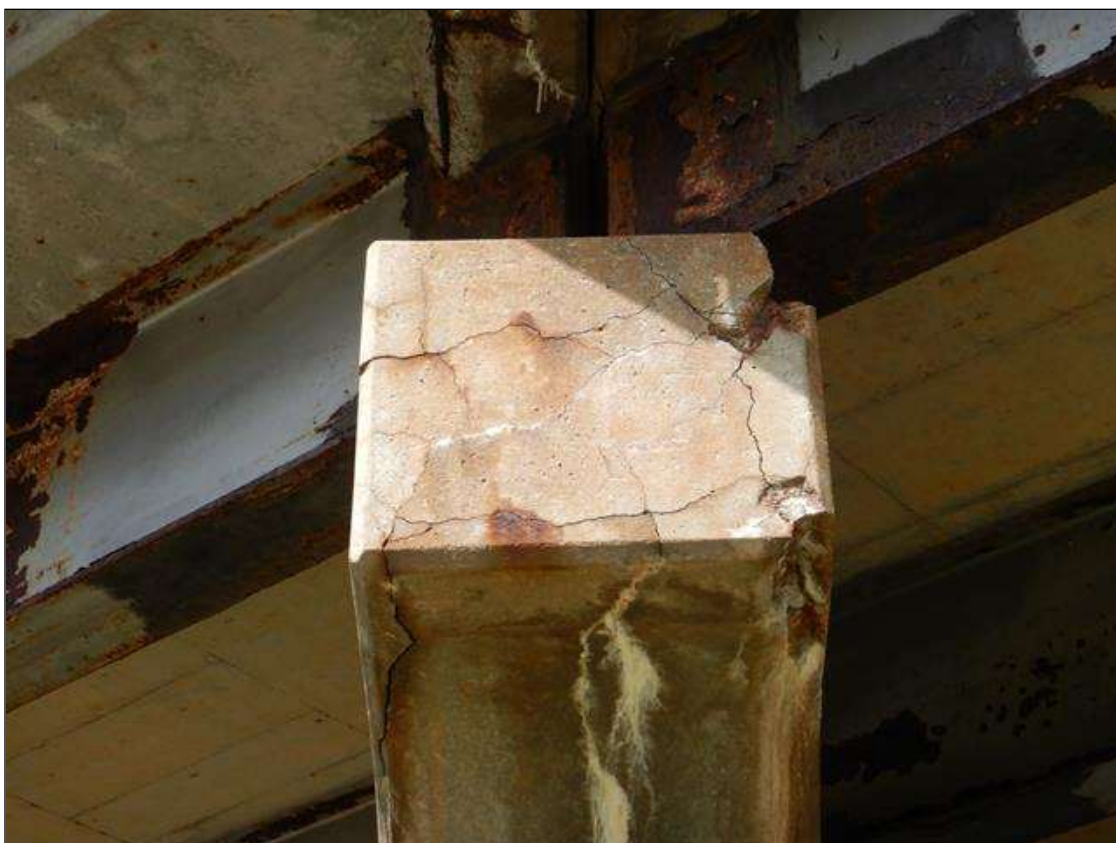
Bent 2 Cap 1: SOUTH SIDE OF CAP END HAS DELAMINATION WITH SPALL FOR 6 IN DIAMETER 1.5 IN DEEP WITH 90% SECTION REMAINING ON EXPOSED REBAR.

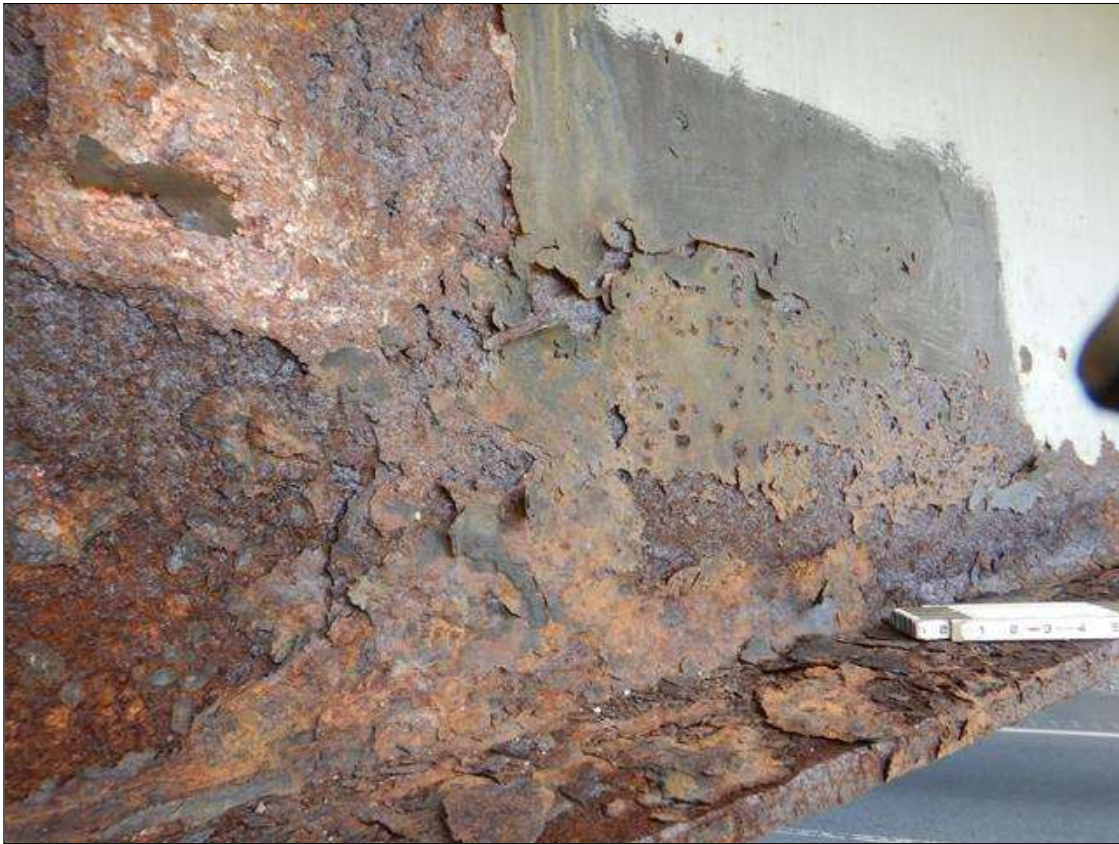
Span 3 Beam 4: at Bent 2, Active Corrosion & Section Loss in Web (5/16" Remaining 9" high x 15" long,) Bottom Flange (11/16" Remaining full width x 15" long.) (PAR)
